# Arboricultural Subsidence Report

## SUBSIDENCE INVESTIGATION AT:

**4 Bury Lane  
Codicote  
Hitchin  
SG4 8XT**

| <b>Report Date:</b> | 09/01/2026 |

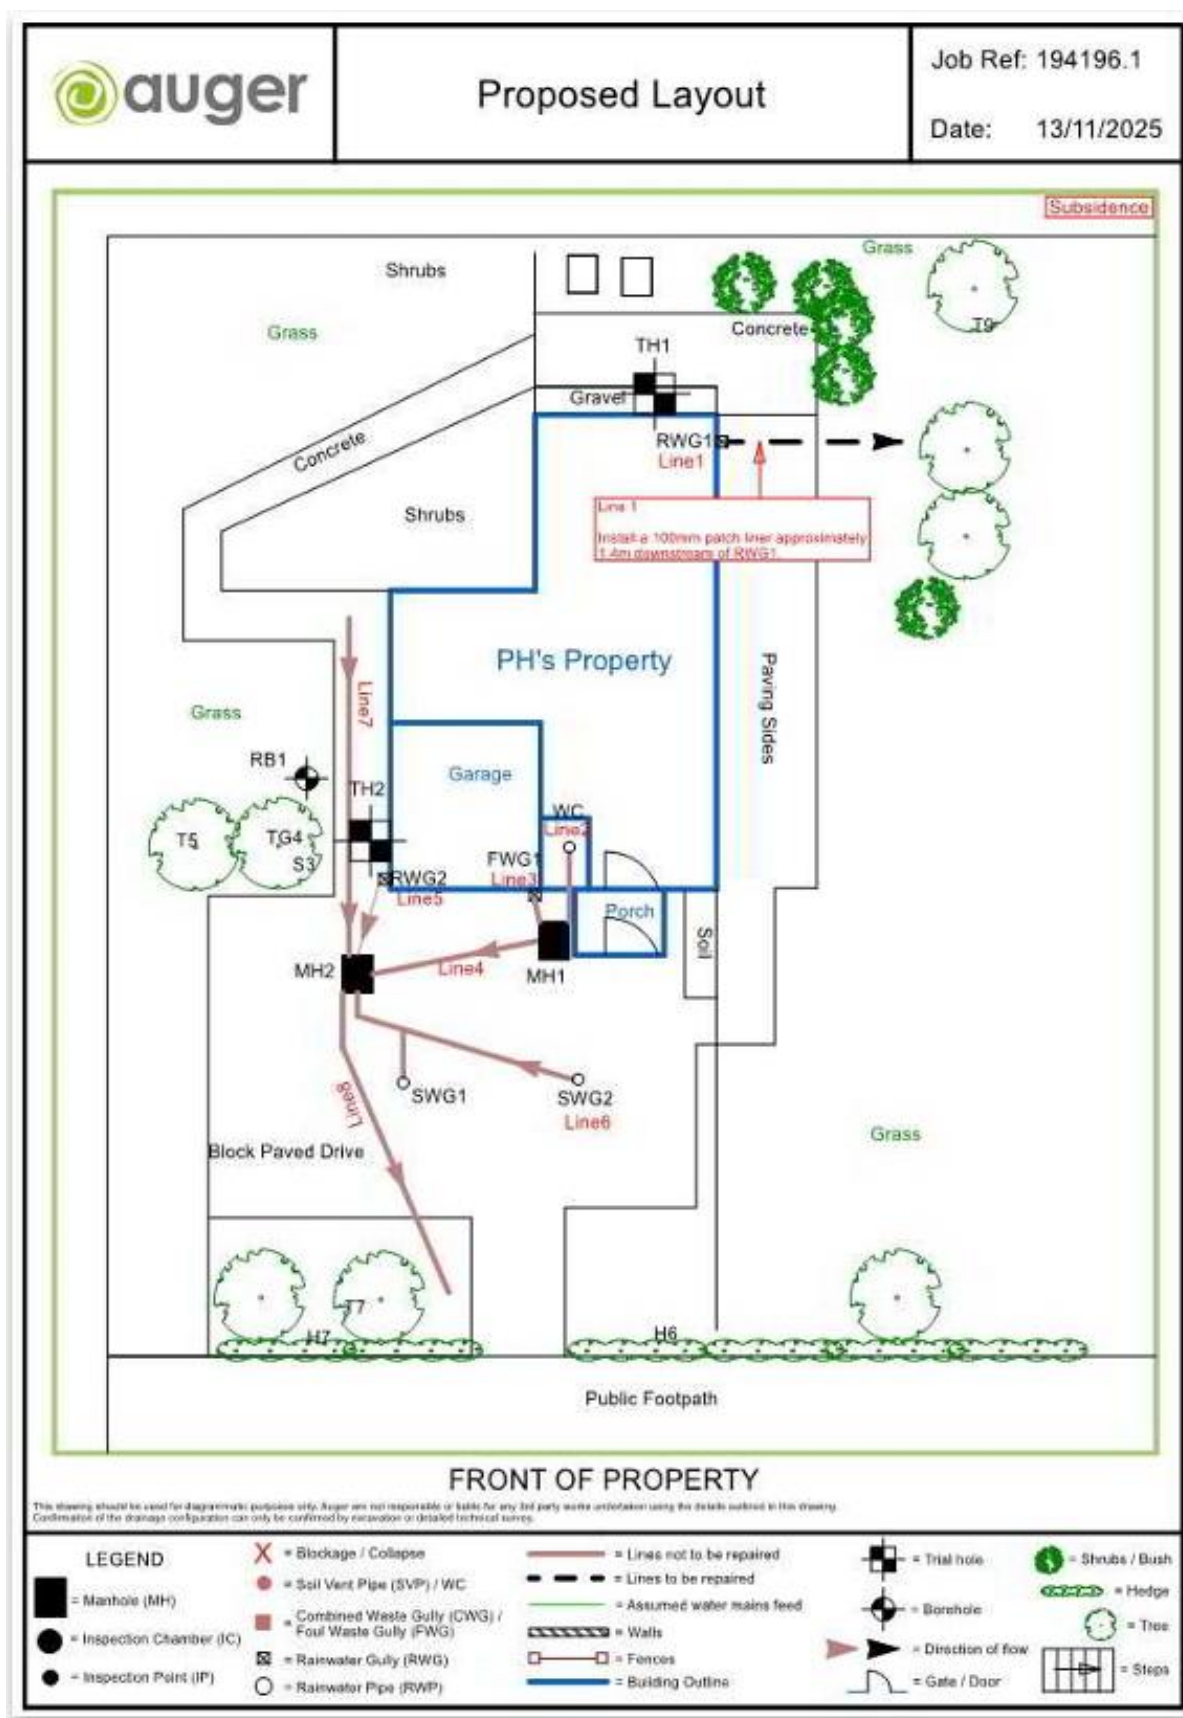
## Site investigation plan showing location of boreholes

Site investigations were carried out by Auger on 13/11/2025 when trial pits were excavated to reveal the foundations and to determine subsoil conditions. The results are summarised in the plan and tables below.
