**W9,W10,W11,W12,W13,W14,W15**

| Project | Walnut Tree Farm<br>Luffenhall<br>Stevenage SG2 7PX |
| Drawing | WINDOW DETAILS<br>EXISTING & PROPOSED |

20079-P007

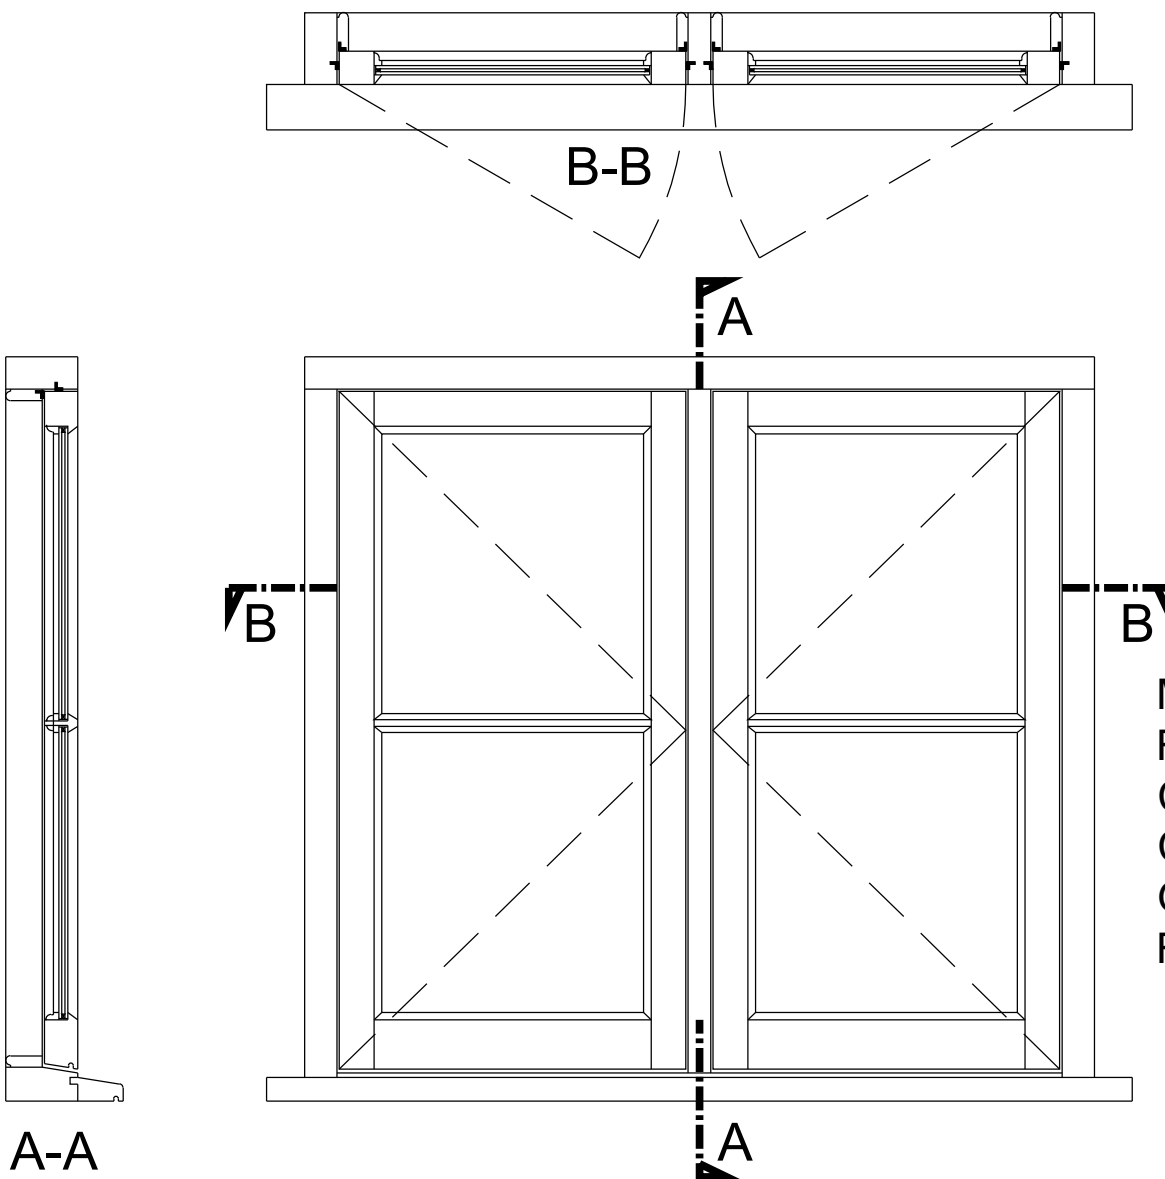
## Double sash window, both opening

Material : saple (hardwood)  
Finish : 2 coats primer 1 top coat  
Colour : sashes white  
Colour : frames black  
Glazing : 4-4-4  
Furniture : 3 point locking  
: monkey tail handles  
: stays to match existing

NOTE: : all replacement windows made to measure to fit existing window openings  
all dimensions to be verified on site before commencing manufacture
