WALNUT TREE FARM  
LUFFENHALL  
STEVENAGE SG2 7PX

WINDOW DETAILS  
EXISTING & PROPOSED

20079-P008

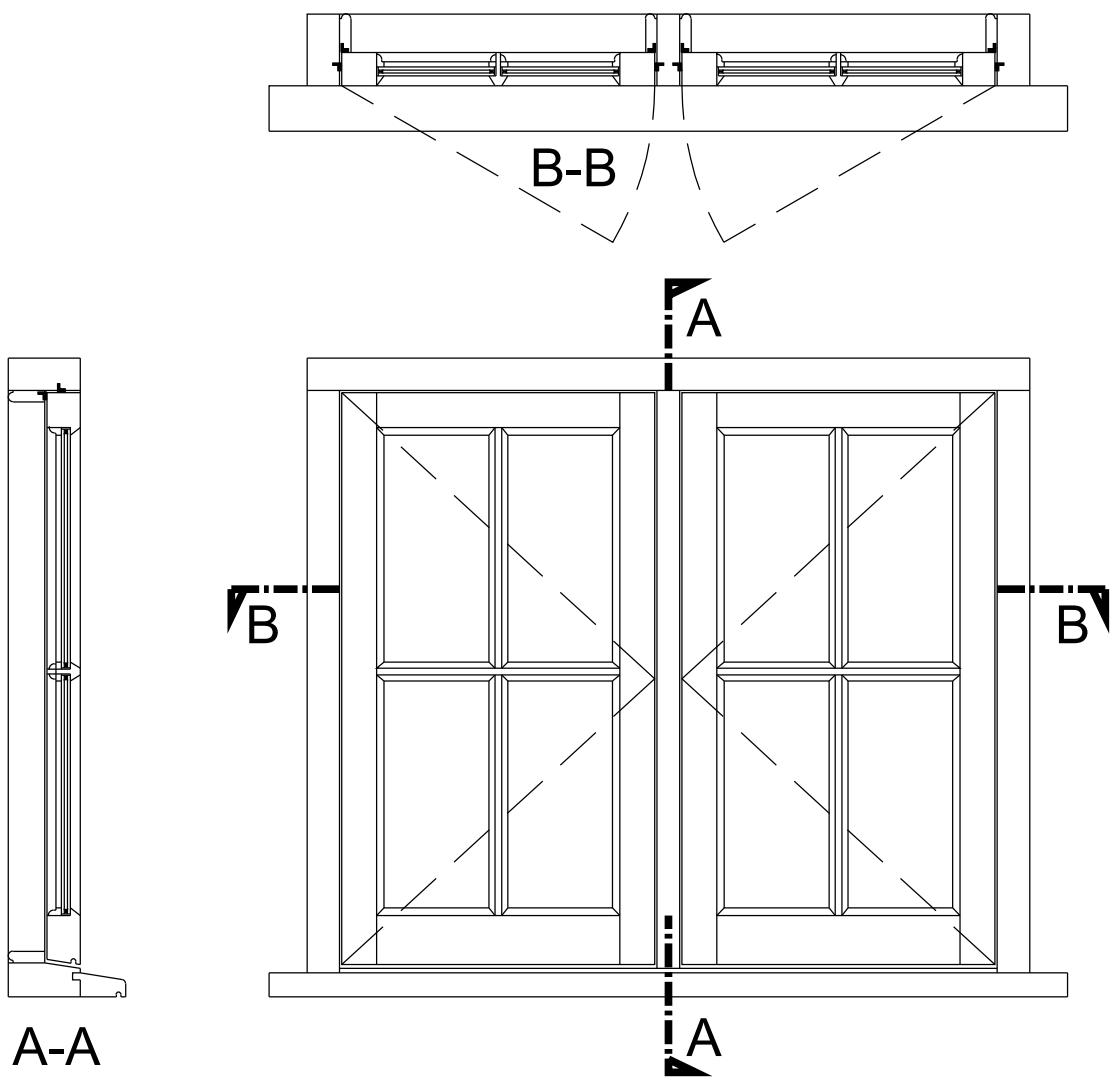
W16,W17,W18,W19

Double sash window with vertical bars,both opening

This double casement style window shows a very high moisture content with loose failed putties to the casement sashes resulting in moisture ingress over a long period of time resulting in the sash base rails cracking and softening particularly around the joints with distortion and loss of strength and discolouration of the exposed bear wood with some fungal growth which is a trait of “wet rot”. The cill also has been affected in the same way it would not be possible to patch repair the affected areas at the structural integrity of the window has been compromised. We recommend replacement of this window as the most cost-effective long-term solution.

This double sash dual opening window which forms the fenestration to a historic dormer window as with the aforementioned windows this has with loose failed putties to the casement sashes resulting in moisture ingress over a long period of time resulting in the sash base rails cracking and softening particularly around the joints with distortion and loss of strength and discolouration of the exposed bear wood with some fungal growth which is a trait of “wet rot”. The cill also has been affected in the same way it would not be possible to patch repair the affected areas at the structural integrity of the window has been compromised, it's worth noting that the window frame forms part of the support for the dormer flat roof. We recommend replacement of this window as the most cost-effective long-term solution as this window provides support to the dormer flat roof.

NOTE: : all replacement windows made to measure to fit existing window openings all dimensions to be verified on site before commencing manufacture

- Material : saple (hardwood)
- Finish : 2 coats primer 1 top coat
- Colour : sashes white
- Colour : frames black
- Glazing : 4-4-4
- Furniture : 3 point locking
  - : monkey tail handles
  - : stays to match existing
