Planning application: Ref 24/01546/FPH: supplementary information (1 page)

7 High Street, Barkway, Herts SG8 8EA

No 7 High Street, Barkway, SG8 8EA

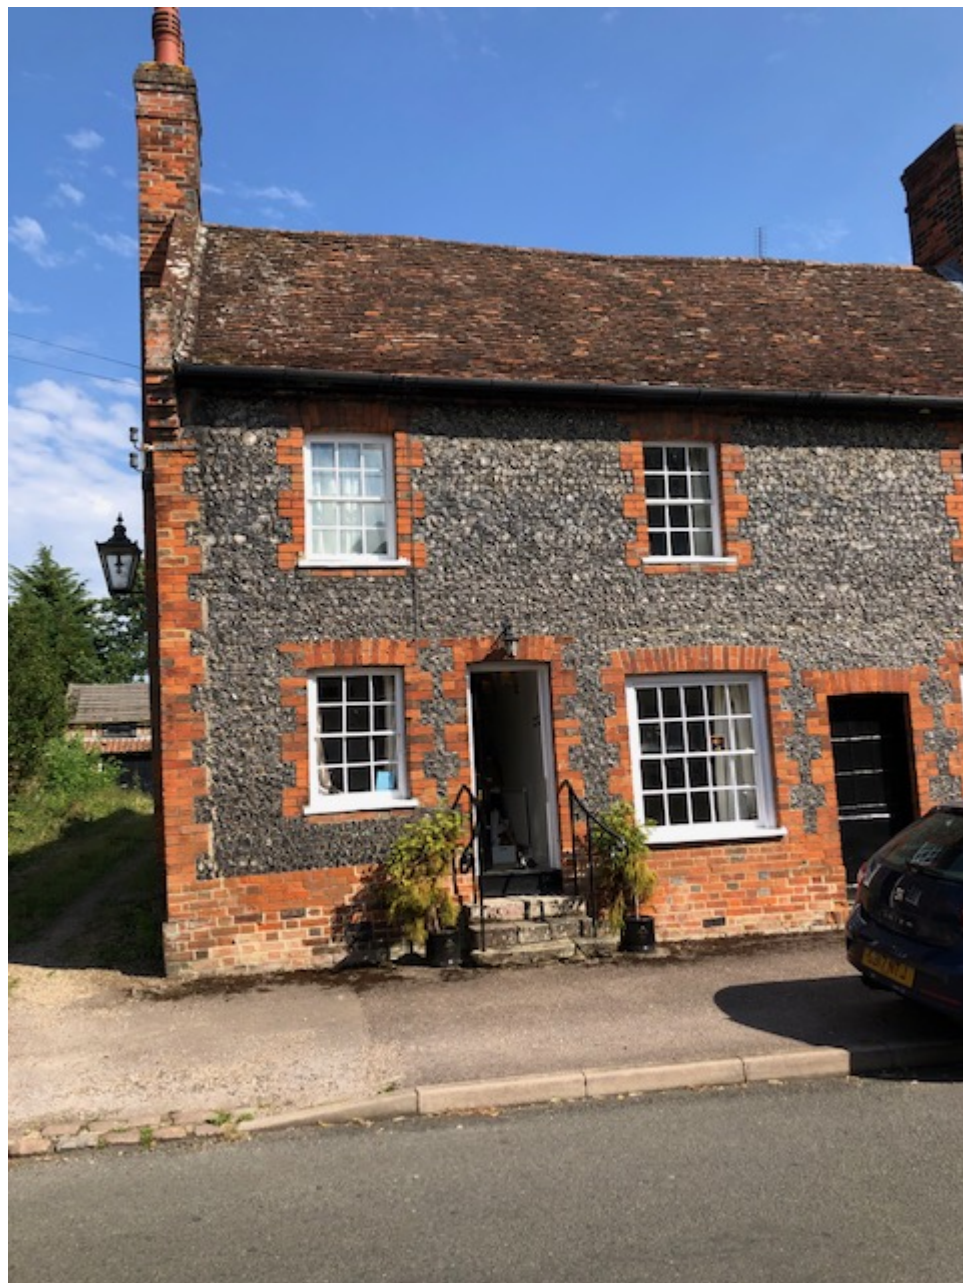
Proposed works: per drawings supplied with the application.  
The photograph here shows a crack down part of the front elevation of the building.

There has been some movement in the front elevation wall, causing a narrow crack in the flintwork to widen over a number of years. While the cause of the crack cannot be ascertained with any certainty, it seems wise to arrest further movement now. Here is an extract from the structural engineer's report (Mr Stuart Ellis of Mason Navarro Pledge):

4.2.1 It appears probable that the current pattern of movement, albeit slow, will continue.

4.3.1 Flint is difficult to work with. It is not readily drilled and the bedding joints are too irregular for insertion of flexible ties.

4.3.2 The floor joists are poorly connected to the floor beams and the beams seem minimally attached to the wall timbers.

4.3.3 Movement is slow and the building's walls just need to be held in check by securing them back to the body of the house.

4.4.1 Apply restraint girdles around the areas of wall affected by movement.

4.4.2 Tie the girdles back to internal structure (roof and floor members) and then ensure connection of that structure back to the members that give them support.

4.4.3 Excavate externally to check for deteriorated mortar and point as necessary.
