# Arboricultural Subsidence Report

## SUBSIDENCE INVESTIGATION AT:

North Lodge  
High Street  
Codicote  
Hitchin  
SG4 8XB

| <b>Report Date:</b> | 01/06/2026 |

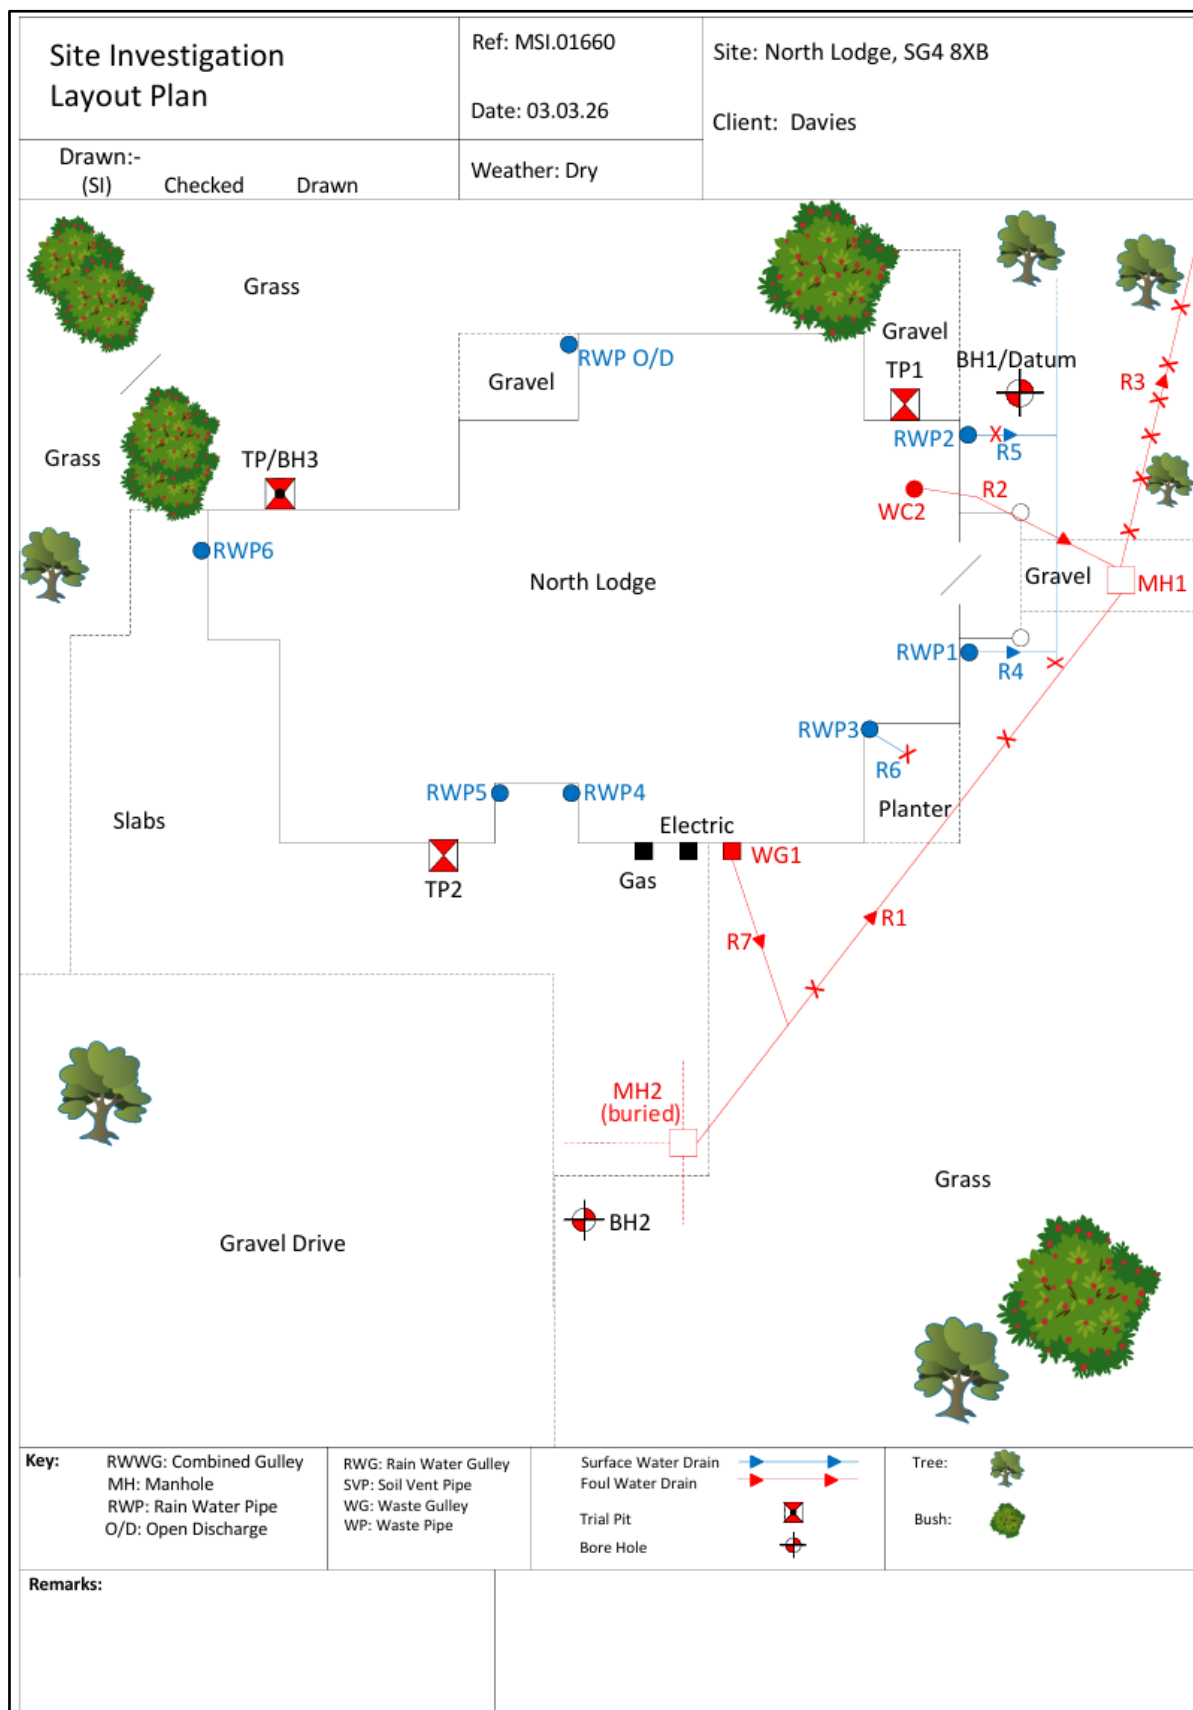
## Site investigation plan showing location of boreholes

Site investigations were carried out by SML on 03/03/2026 when trial pits were excavated to reveal the foundations and to determine subsoil conditions. The results are summarised in the plan and tables below.

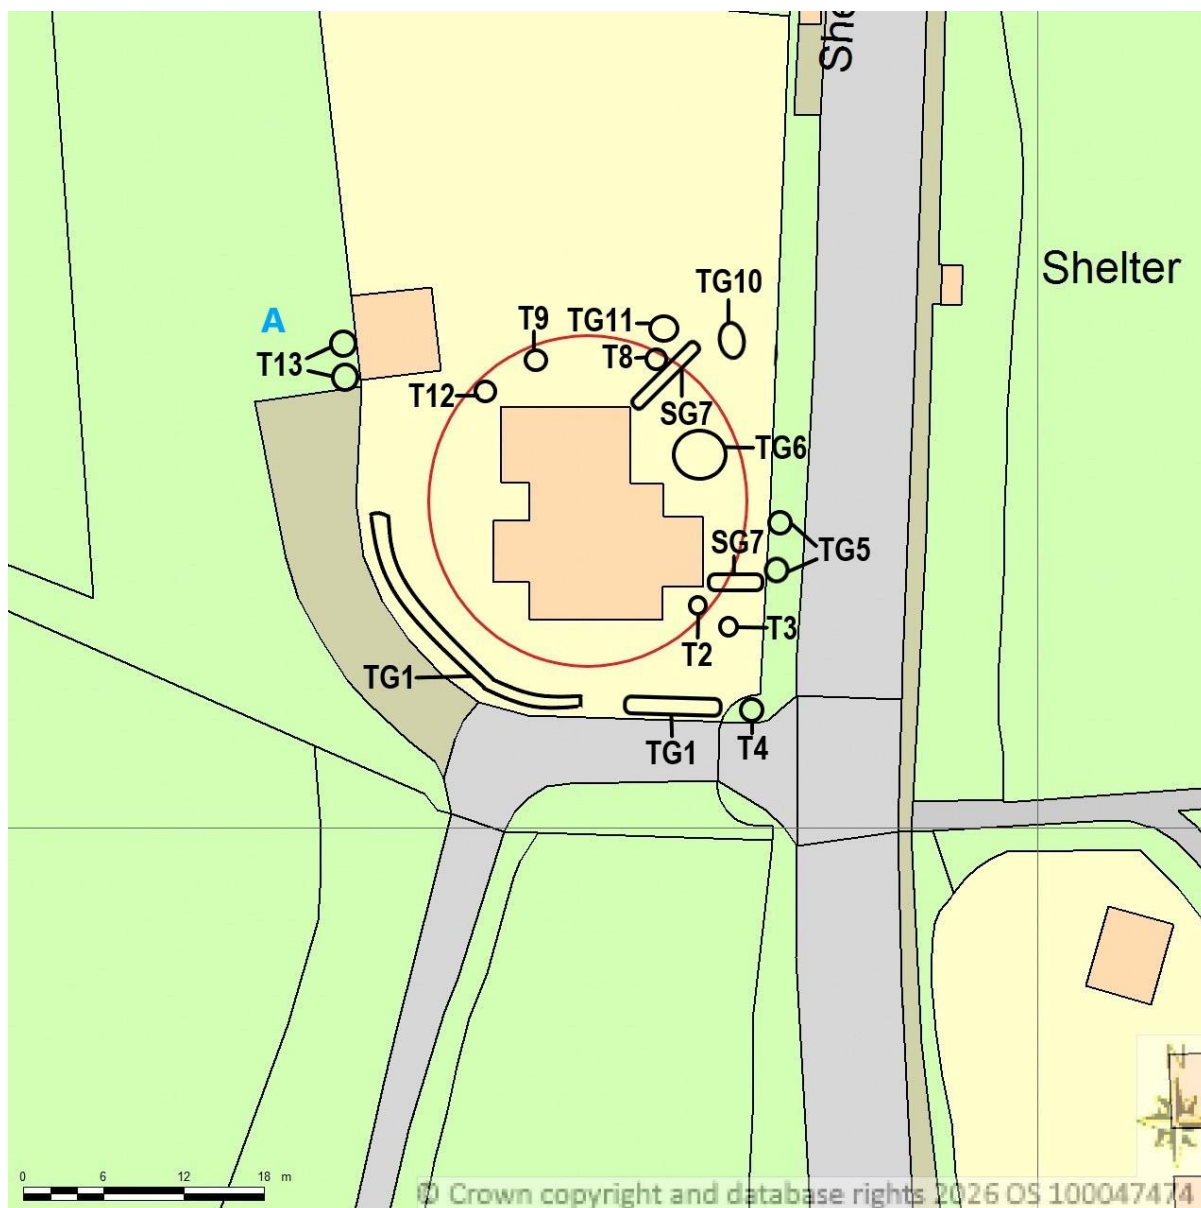
## Tree plan

Tree plan showing area of damage with red circle and location of neighbours as detailed below.
