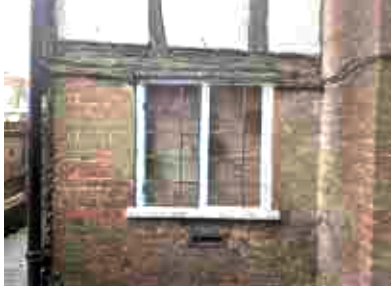
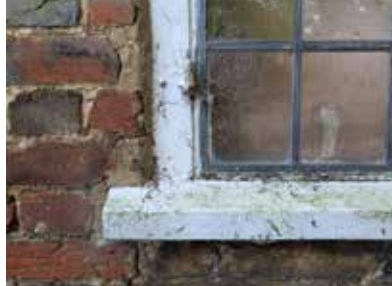
| Reference | Location | Style | Age | Condition | Significance | Internal | External | Detail | Special Features | Glazing Type | Proposed Works |
|---|---|---|---|---|---|---|---|---|---|---|---|
| WG-01 | Plant Room<br>External | Two vertical leaded lights, casement window. Painted frame. | | 3 Poor. Boarded up. Worn imposed lead flashing. Cement infill around frame. | Moderate | | | | Side hung opening lights. Original timber structure at head. Projected sill. | Single. | Retain and repair existing window and historic leaded glazing. Treat timber damage and dry out moisture. Introduce slimline secondary glazing internally. Strip white paint subject to timber condition.. Code 5 Lead Works. |

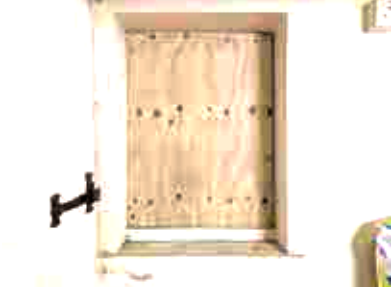
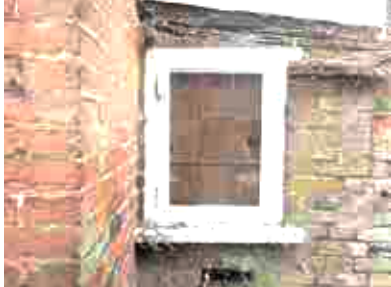
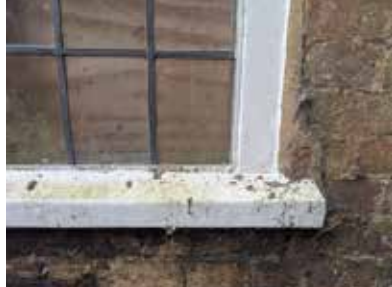
| Reference | Location | Style | Age | Condition | Significance | Internal | External | Detail | Special Features | Glazing Type | Proposed Works |
|---|---|---|---|---|---|---|---|---|---|---|---|
| WG-02 | Plant Room<br>External | Leaded light, casement window. Painted frame. | | 3 Very poor. Boarded up. Significant damp and rot. Cement infill around frame. | Moderate | | | | Side hung opening lights. Original timber structure at head. Projected sill. | Single. Three green tinted panes. | Replace with dark hardwood windows to match existing proportions and appearance. Detailed design, profiles, glazing specification and glazing bar details to be submitted to and approved by the Local Planning Authority prior to installation. |

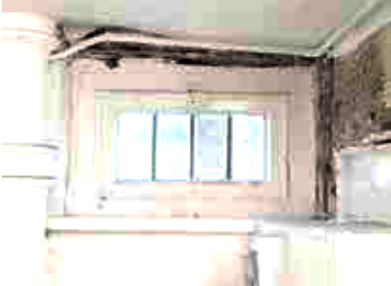
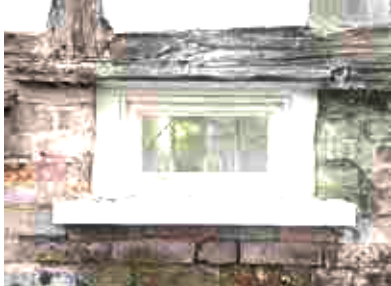
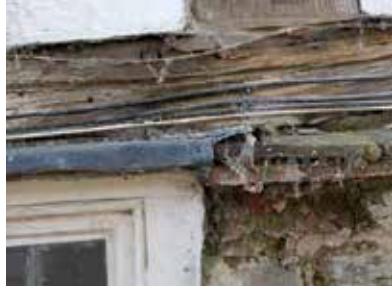
| Reference | Location | Style | Age | Condition | Significance | Internal | External | Detail | Special Features | Glazing Type | Proposed Works |
|---|---|---|---|---|---|---|---|---|---|---|---|
| WG-03 | Flat 06 Bedroom<br>External | Leaded light, casement window. Painted frame. | | 3 Poor. Worn lead flashing. | Moderate | | | | Inward tilt. Original timber structure at head. Projected sill. | Single. One green tinted pane. | Replace with dark hardwood windows to match existing proportions and appearance. Detailed design, profiles, glazing specification and glazing bar details to be submitted to and approved by the Local Planning Authority prior to installation. |

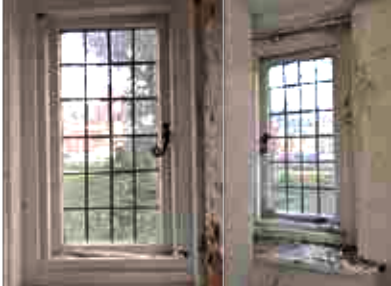
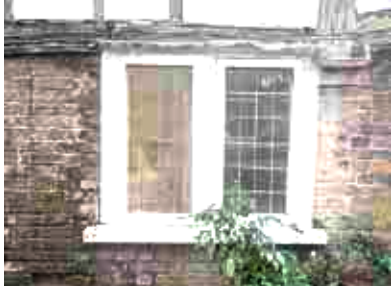
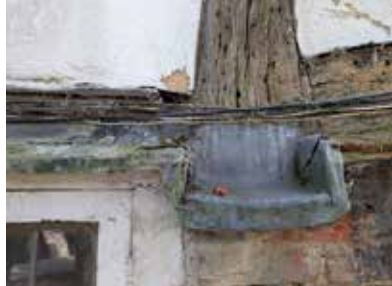
| Reference | Location | Style | Age | Condition | Significance | Internal | External | Detail | Special Features | Glazing Type | Proposed Works |
|---|---|---|---|---|---|---|---|---|---|---|---|
| WG-04 | Flat 06 Bedroom<br>External | Two vertical leaded lights, casement window. Painted frame. | | 4 Poor. Worn lead flashing. | Moderate | | | | Two side hung opening lights. Original timber structure at head. Projected sill. | Single. | Remove partition wall. Retain and repair existing window and historic leaded glazing. Treat timber damage and dry out moisture. Introduce slimline secondary glazing internally. Strip white paint subject to timber condition. Code 5 Lead Works. |

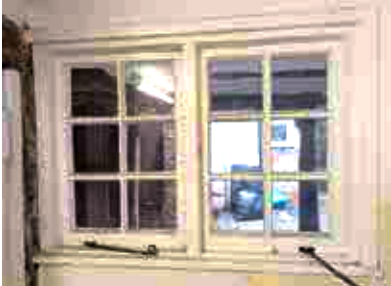
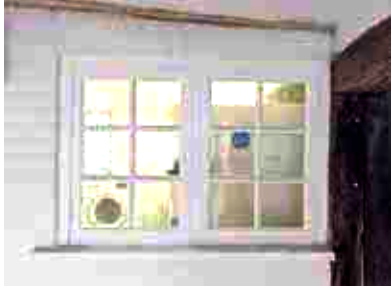
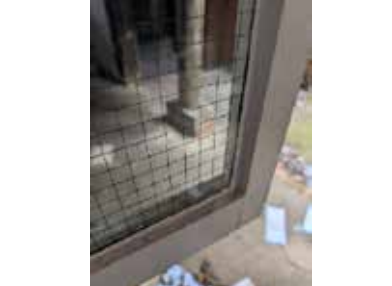
| Reference | Location | Style | Age | Condition | Significance | Internal | External | Detail | Special Features | Glazing Type | Proposed Works |
|---|---|---|---|---|---|---|---|---|---|---|---|
| WG-05 | Flat 06 Bedroom<br>Courtyard | Two vertical lights with glazing bars, casement window. Painted frame. | | 5 Moderate | Harmful | | | | Two side hung opening lights. Projected sill. | Single. | Replace with dark hardwood windows to match existing proportions and appearance. Detailed design, profiles, glazing specification and glazing bar details to be submitted to and approved by the Local Planning Authority prior to installation. |

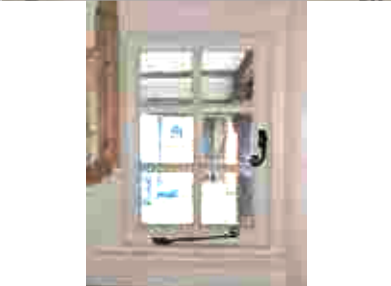
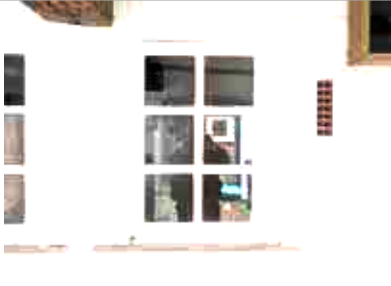
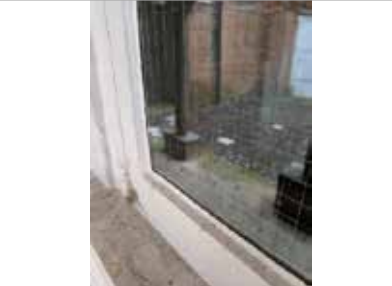
| Reference | Location | Style | Age | Condition | Significance | Internal | External | Detail | Special Features | Glazing Type | Proposed Works |
|---|---|---|---|---|---|---|---|---|---|---|---|
| WG-06 | Flat 06 Bedroom<br>Courtyard | Glazing bars, casement window. Painted frame. | | 5 Moderate | Harmful | | | | Side hung opening light. Projected sill. | Single. | Replace with dark hardwood windows to match existing proportions and appearance. Detailed design, profiles, glazing specification and glazing bar details to be submitted to and approved by the Local Planning Authority prior to installation. |

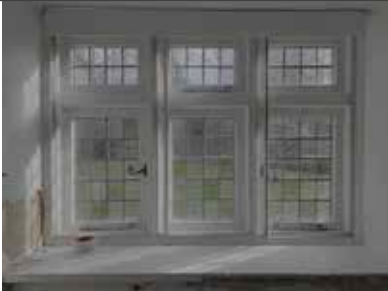
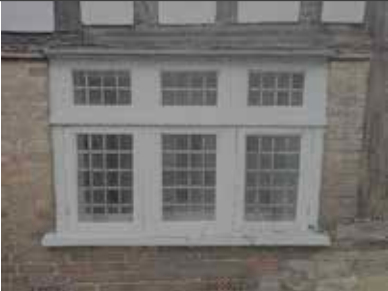
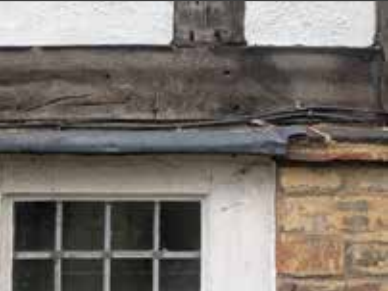
| Reference | Location | Style | Age | Condition | Significance | Internal | External | Detail | Special Features | Glazing Type | Proposed Works |
|---|---|---|---|---|---|---|---|---|---|---|---|
| WG-13 | Flat 04 Kitchen External | Three leaded horizontal lights over three leaded vertical lights, casement window. Painted frame. | | 3 Poor. Worn lead flashing. Lintel works required as per structural survey. | Moderate | | | | Two side hung opening lights, fixed light in centre. Top hung light at top centre. Original timber structure at head. Projected sill. | Single. | Retain and repair existing window and historic leaded glazing. Treat timber damage and dry out moisture. Introduce slimline secondary glazing internally. Strip white paint subject to timber condition. Code 5 Lead Works. Lintel works. |

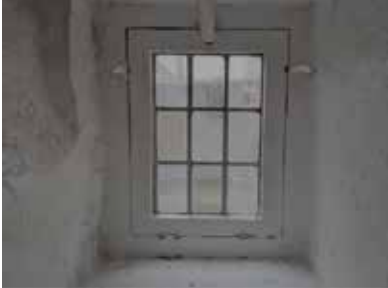
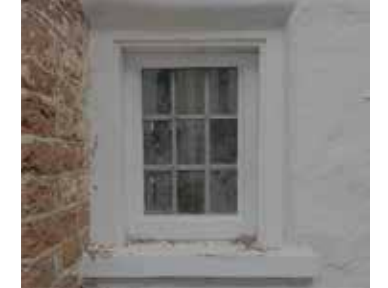
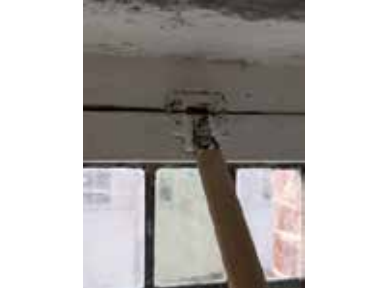
| Reference | Location | Style | Age | Condition | Significance | Internal | External | Detail | Special Features | Glazing Type | Proposed Works |
|---|---|---|---|---|---|---|---|---|---|---|---|
| WG-14 | Flat 04 Bathroom Courtyard | Leaded light, casement window. Painted frame. | | 3 Moderate. | Considerable | | | | Pivot hinge. Opening accessed with timber reacher. Deep into window recess. | Single. | Clean and introduce secondary glazing. |

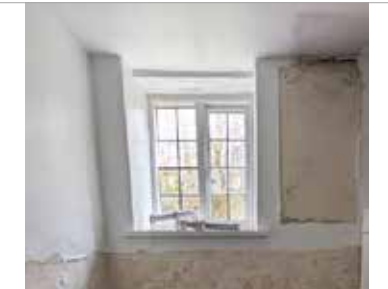
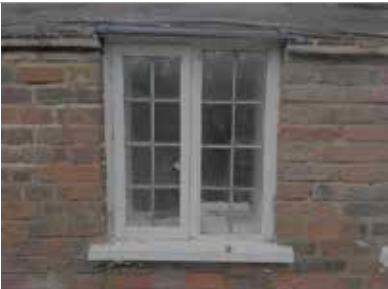
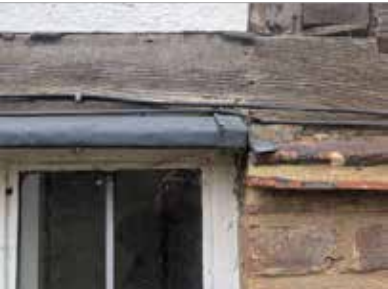
| Reference | Location | Style | Age | Condition | Significance | Internal | External | Detail | Special Features | Glazing Type | Proposed Works |
|---|---|---|---|---|---|---|---|---|---|---|---|
| WG-15 | Flat 03 Kitchen External | Two vertical leaded lights, casement window. Painted frame. | | 3 Poor. Worn lead flashing. Areas of frame in poor condition. | Moderate | | | | One side hung opening light, one fixed light. Projected sill. Original timber structure at head. Projected sill. | Single. | Retain and repair existing window and historic leaded glazing. Treat timber damage and dry out moisture. Introduce slimline secondary glazing internally. Strip white paint subject to timber condition. Code 5 Lead Works. |

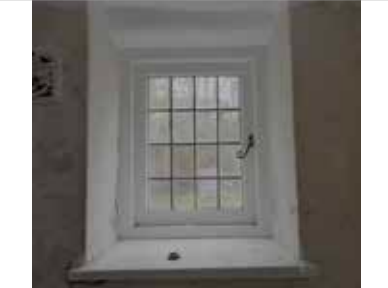
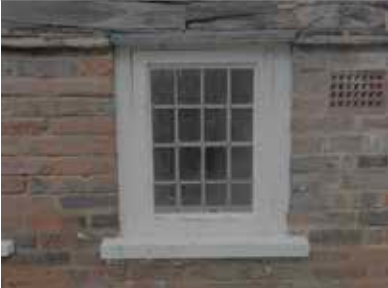
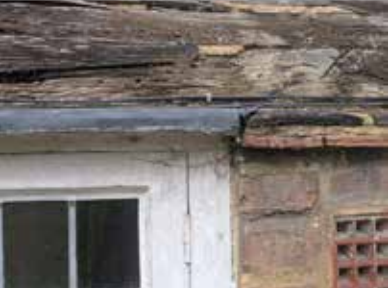
| Reference | Location | Style | Age | Condition | Significance | Internal | External | Detail | Special Features | Glazing Type | Proposed Works |
|---|---|---|---|---|---|---|---|---|---|---|---|
| WG-16 | Flat 03 Bathroom External | Leaded light, casement window. Painted frame. | | 3 Moderate. Worn lead flashing. | Moderate | | | | Side hung opening light. Original timber structure at head. Projected sill. | Single. | Retain and repair existing window and historic leaded glazing. Treat timber damage and dry out moisture. Introduce slimline secondary glazing internally. Strip white paint subject to timber condition.. Code 5 Lead Works. |

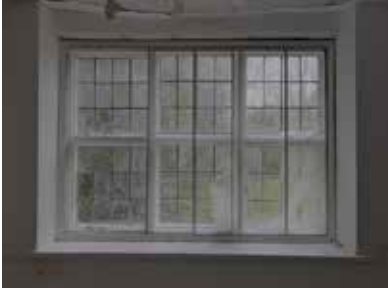
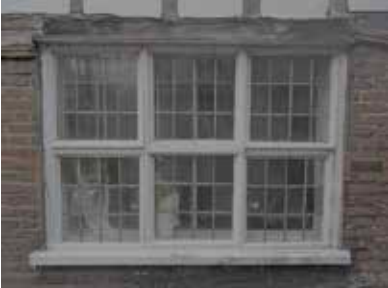
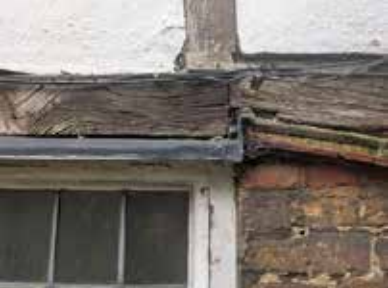
| Reference | Location | Style | Age | Condition | Significance | Internal | External | Detail | Special Features | Glazing Type | Proposed Works |
|---|---|---|---|---|---|---|---|---|---|---|---|
| WG-17 | Flat 03 Liv/Bed External | Two rows of three leaded lights, casement window. Painted frame. | | 2 Poor. Worn lead flashing. Areas of frame in poor condition. Cement infill around edges. Lintel works required as per structural survey. | Considerable | | | | Two side hung opening lights, rest fixed. Projected sill. | Single. Sliding secondary glazing panels internal. Green tinted panes. | Retain and repair existing window and historic leaded glazing. Treat timber damage and dry out moisture. Introduce slimline secondary glazing internally. Strip white paint subject to timber condition. Code 5 Lead Works. Lintel works. |

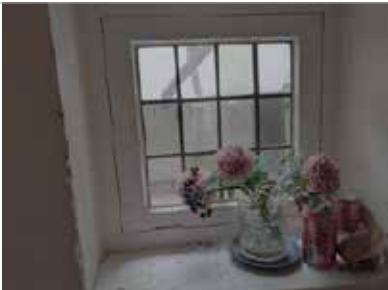
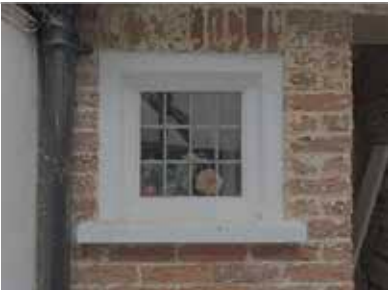
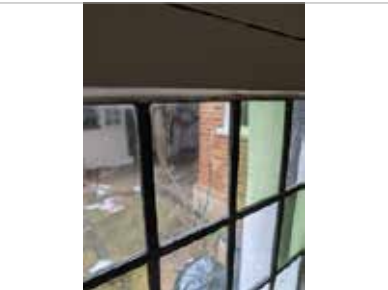
| Reference | Location | Style | Age | Condition | Significance | Internal | External | Detail | Special Features | Glazing Type | Proposed Works |
|---|---|---|---|---|---|---|---|---|---|---|---|
| WG-18 | Stairwell 02 Courtyard | Leaded light, casement window. Painted frame. | | 3 Poor | Considerable | | | | Fixed window. Projected sill. | Single. Green and pink tinted panes. | Replace with dark hardwood windows to match existing proportions and appearance. Detailed design, profiles, glazing specification and glazing bar details to be submitted to and approved by the Local Planning Authority prior to installation. |

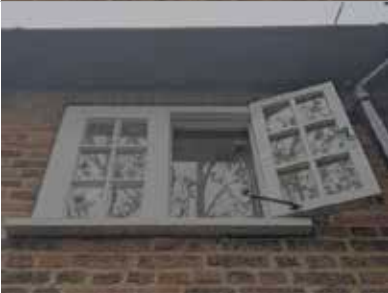
| Reference | Location | Style | Age | Condition | Significance | Internal | | External | Detail | | Special Features | Glazing Type | Proposed Works |
|---|---|---|---|---|---|---|---|---|---|---|---|---|---|
| WF-10 | Flat 11 Kitchen<br>External | Two vertical lights with glazing bars, casement window. Painted frame. | | 5 Poor | Low | | | | | | Side hung opening light. Projected sill. | Single. | Replace with dark hardwood windows to match existing proportions and appearance. Detailed design, profiles, glazing specification and glazing bar details to be submitted to and approved by the Local Planning Authority prior to installation. |

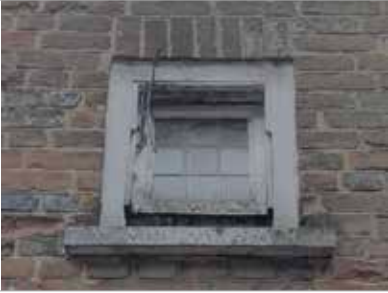
| Reference | Location | Style | Age | Condition | Significance | Internal | | External | Detail | | Special Features | Glazing Type | Proposed Works |
|---|---|---|---|---|---|---|---|---|---|---|---|---|---|
| WF-12 | Flat 11 Bathroom<br>Courtyard | Leaded light, pivot window. Painted frame. | | 4 Very poor | Considerable | | | | | | Horizontal pivot opening. Projected sill. | Single. Green and pink tinted panes. | Replace with dark hardwood windows to match existing proportions and appearance. Detailed design, profiles, glazing specification and glazing bar details to be submitted to and approved by the Local Planning Authority prior to installation. |

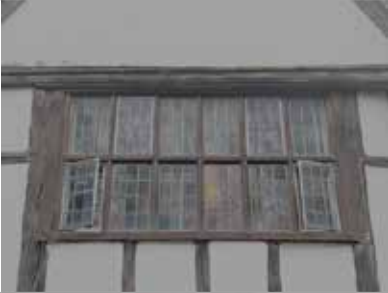
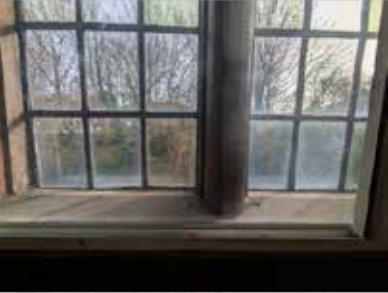
| Reference | Location | Style | Age | Condition | Significance | Internal | | External | Detail | | Special Features | Glazing Type | Proposed Works |
|---|---|---|---|---|---|---|---|---|---|---|---|---|---|
| WF-13 | Flat 10 Liv/Bed<br>External | Two rows of six leaded lights, casement window. Original hardwood frame. | | 2 Good | Exceptional | | | | | | Side hung casement openings. Original timber structure framing opening. | Single. Sliding secondary glazing panels internal. | Retain and repair existing window and historic leaded glazing. Treat timber damage and dry out moisture. Introduce slimline secondary glazing internally. |

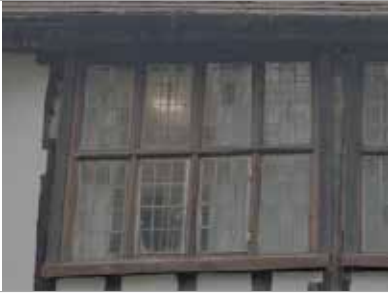
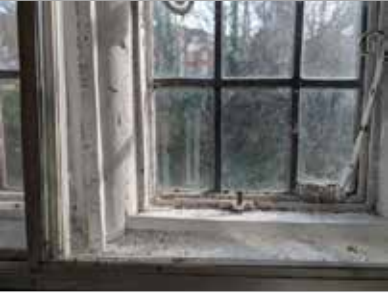
| Reference | Location | Style | Age | Condition | Significance | Internal | | External | Detail | | Special Features | Glazing Type | Proposed Works |
|---|---|---|---|---|---|---|---|---|---|---|---|---|---|
| WF-14 | Flat 10 Kitchen<br>External | Two rows of four leaded lights, casement window. Original hardwood frame with some repairs. | | 2 Poor | Exceptional | | | | | | Side hung casement openings. Original timber structure framing opening with repairs. | Single. Sliding secondary glazing panels internal. | Retain and repair existing window and historic leaded glazing. Treat timber damage and dry out moisture. Introduce slimline secondary glazing internally. Strip internal white paint subject to timber condition. |

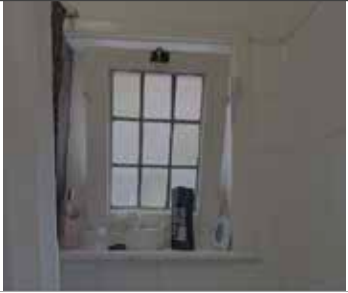
| Reference | Location | Style | Age | Condition | Significance | Internal | | External | Detail | | Special Features | Glazing Type | Proposed Works |
|---|---|---|---|---|---|---|---|---|---|---|---|---|---|
| WF-15 | Flat 10 Bathroom Courtyard | Leaded light, pivot window. | | 4 Poor in areas. | Moderate | | | | | | Horizontal pivot opening. | Single. Tinted panes. | Replace with dark hardwood windows to match existing proportions and appearance. Detailed design, profiles, glazing specification and glazing bar details to be submitted to and approved by the Local Planning Authority prior to installation. |

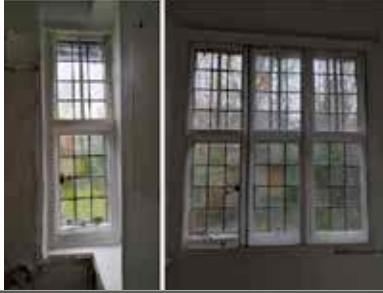
| Reference | Location | Style | Age | Condition | Significance | Internal | | External | Detail | | Special Features | Glazing Type | Proposed Works |
|---|---|---|---|---|---|---|---|---|---|---|---|---|---|
| WF-17 | Flat 09 Kitchen External | Two rows of four leaded lights, casement window. Original hardwood frame with some repairs. | | 2 Moderate | Exceptional | | | | | | Side hung casement openings. Original timber structure framing opening with repairs. | Single. Sliding secondary glazing panels internal. | Retain and repair existing window and historic leaded glazing. Treat timber damage and dry out moisture. Introduce slimline secondary glazing internally. Strip internal white paint subject to timber condition. |

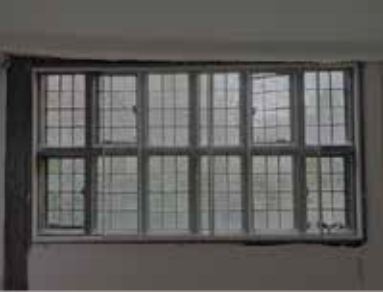
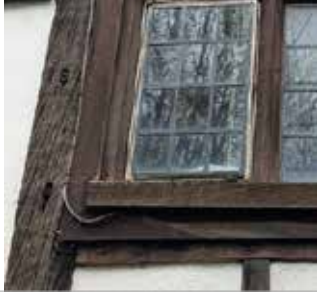
| Reference | Location | Style | Age | Condition | Significance | Internal | | External | Detail | | Special Features | Glazing Type | Proposed Works |
|---|---|---|---|---|---|---|---|---|---|---|---|---|---|
| WF-18 | Flat 09 Liv/Bed External | Two rows of six leaded lights, casement window. Original hardwood frame. | | 2 Good | Exceptional | | | | | | Side hung casement openings. Original timber structure framing opening with repairs. | Single. Sliding secondary glazing panels internal. | Retain and repair existing window and historic leaded glazing. Treat timber damage and dry out moisture. Introduce slimline secondary glazing internally. |

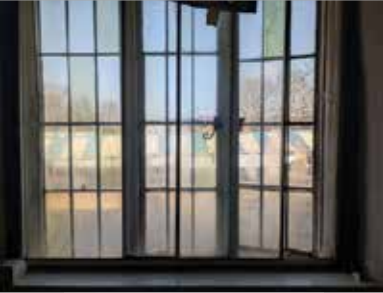
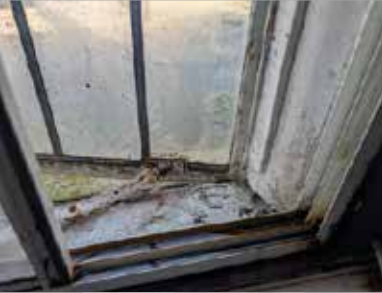
| Reference | Location | Style | Age | Condition | Significance | Internal | | External | Detail | | Special Features | Glazing Type | Proposed Works |
|---|---|---|---|---|---|---|---|---|---|---|---|---|---|
| WF-19 | Flat 08 Liv/Bed External | Three vertical leaded lights, casement window. Original outer hardwood frames. | | 2 Poor | High | | | | | | Side hung casement openings. | Single. Green tinted panes. | Retain and repair existing window and historic leaded glazing. Treat timber damage and dry out moisture. Introduce slimline secondary glazing internally. Strip internal white paint subject to timber condition. |
