## ARBORICULTURAL IMPACT ASSESSMENT REPORT

Land West of Tuthill House,  
Kelshall Tops,  
Therfield,  
Hertfordshire

**OUR REF: SHA 1089 Rev D June 2024**

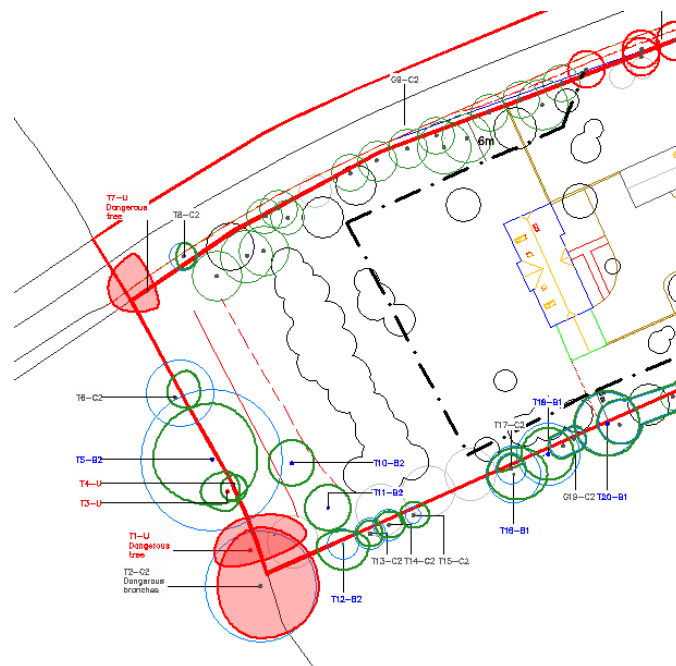
*Plan 1 – extract from SHA 1089 TPPC . Do not scale. North is vertical.*

T7 is an ash tree with a large open cavity on the stem on the eastern and southern side. It appears that the tree is completely hollow with only a narrow band of live wood. There is a high risk of failure into the road, exacerbated by the dense ivy growth. The dangerous trees have been reported to Herts County Council Highways.

All will be retained and protected during works. They benefit the site by providing offsite screening.

The location for the tree protection fencing is shown at appendix 3 (SHA 1089 TPPC) and the specification is found at appendix 5. Tree root barriers for the blackthorn are available commercially, and I recommend <https://www.greenblue.com/gb/products/reroot-2000/>.

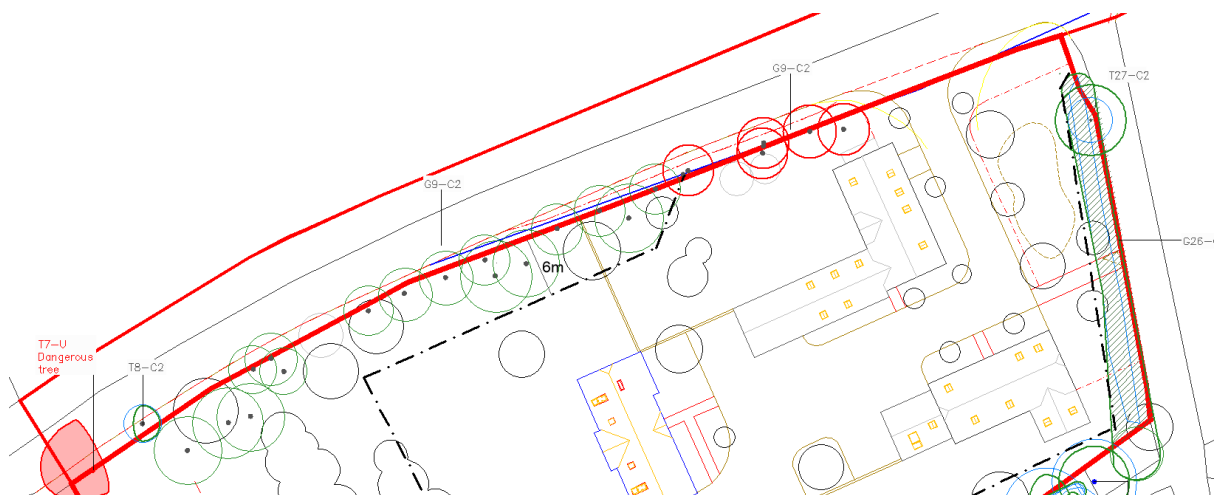
*Plan 2 – extract from SHA 1089 TPP C. Do not scale. North is vertical.*

20m length in the group G9 will be removed and the remainder crown lifted to enable site splay visibility. All other trees can be retained, but I recommend that an area of blackthorn shown red hatched on the plan 2 below is removed to create reasonable side garden. The remainder will be retained and protected during works, but there is potential for active management with infill planting. This will be discussed with the ecologist and landscape architect post planning. I recommend a linear root barrier in front of retained blackthorn to prevent suckering and spreading.

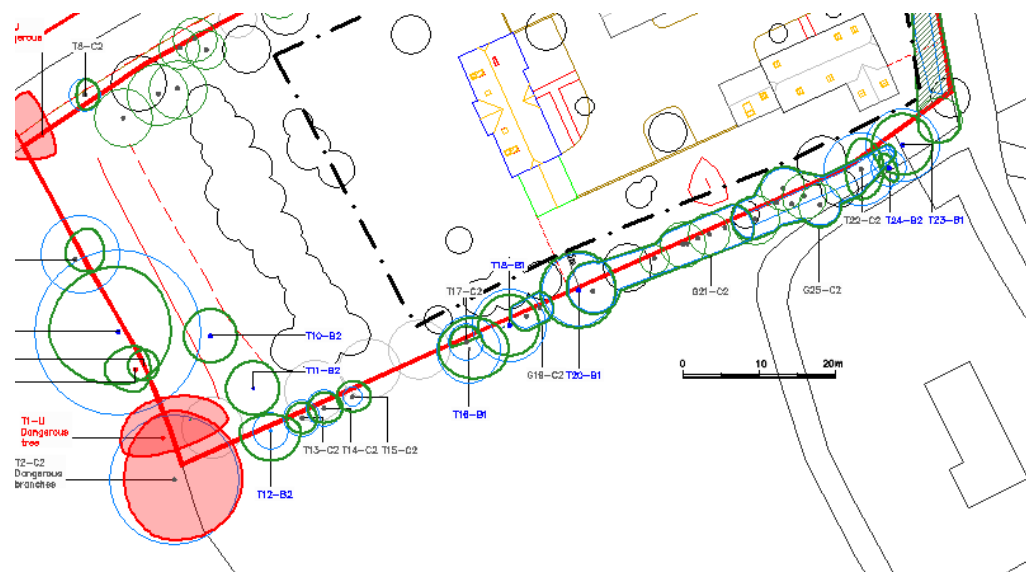
Plan 3 – extract from SHA 1089 TPP C. Do not scale. North is vertical.

All will be retained and the crown spreads and root protection areas are remote from the proposed buildings. The trees will be protected by tree protection fencing.
