## Marlborough Close Weston

# Settle Tree plotter data mapping

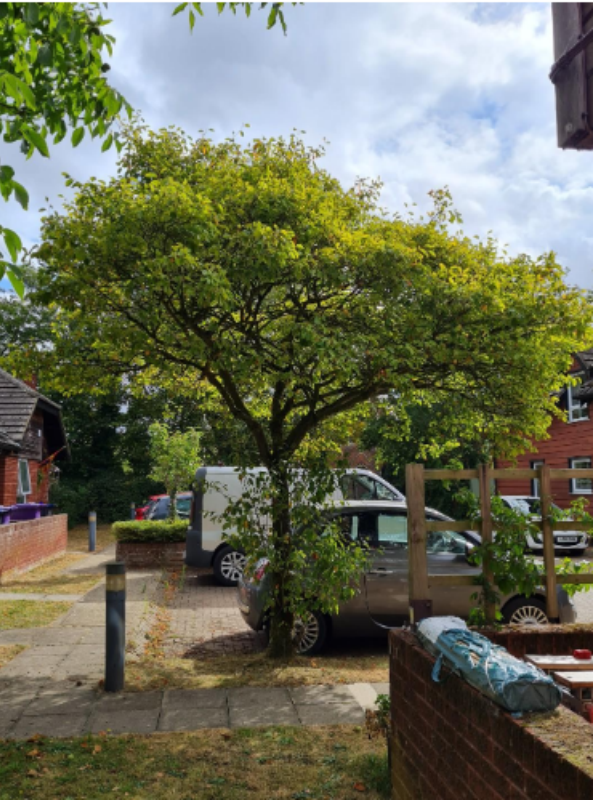
| VTA | BS5837 | OBSERVATIONS | MISC | CAVAT | BBVJV | ATLAS WORKPLACE ADDITIONAL DATA | | WORK RECORDS | HISTORY |
|---|---|---|---|---|---|---|--|---|---|
| | | | | | | Stem epicormic shoots encroaching over footway. | | | |
| | | Trunk Observations | | | | Epicormic growth | | | |
| | | Works Required | | | | Yes | | | |
