## 299 - The Biggin

Condition Survey

02/26: Planning Issue

**Michael Collins Architects**

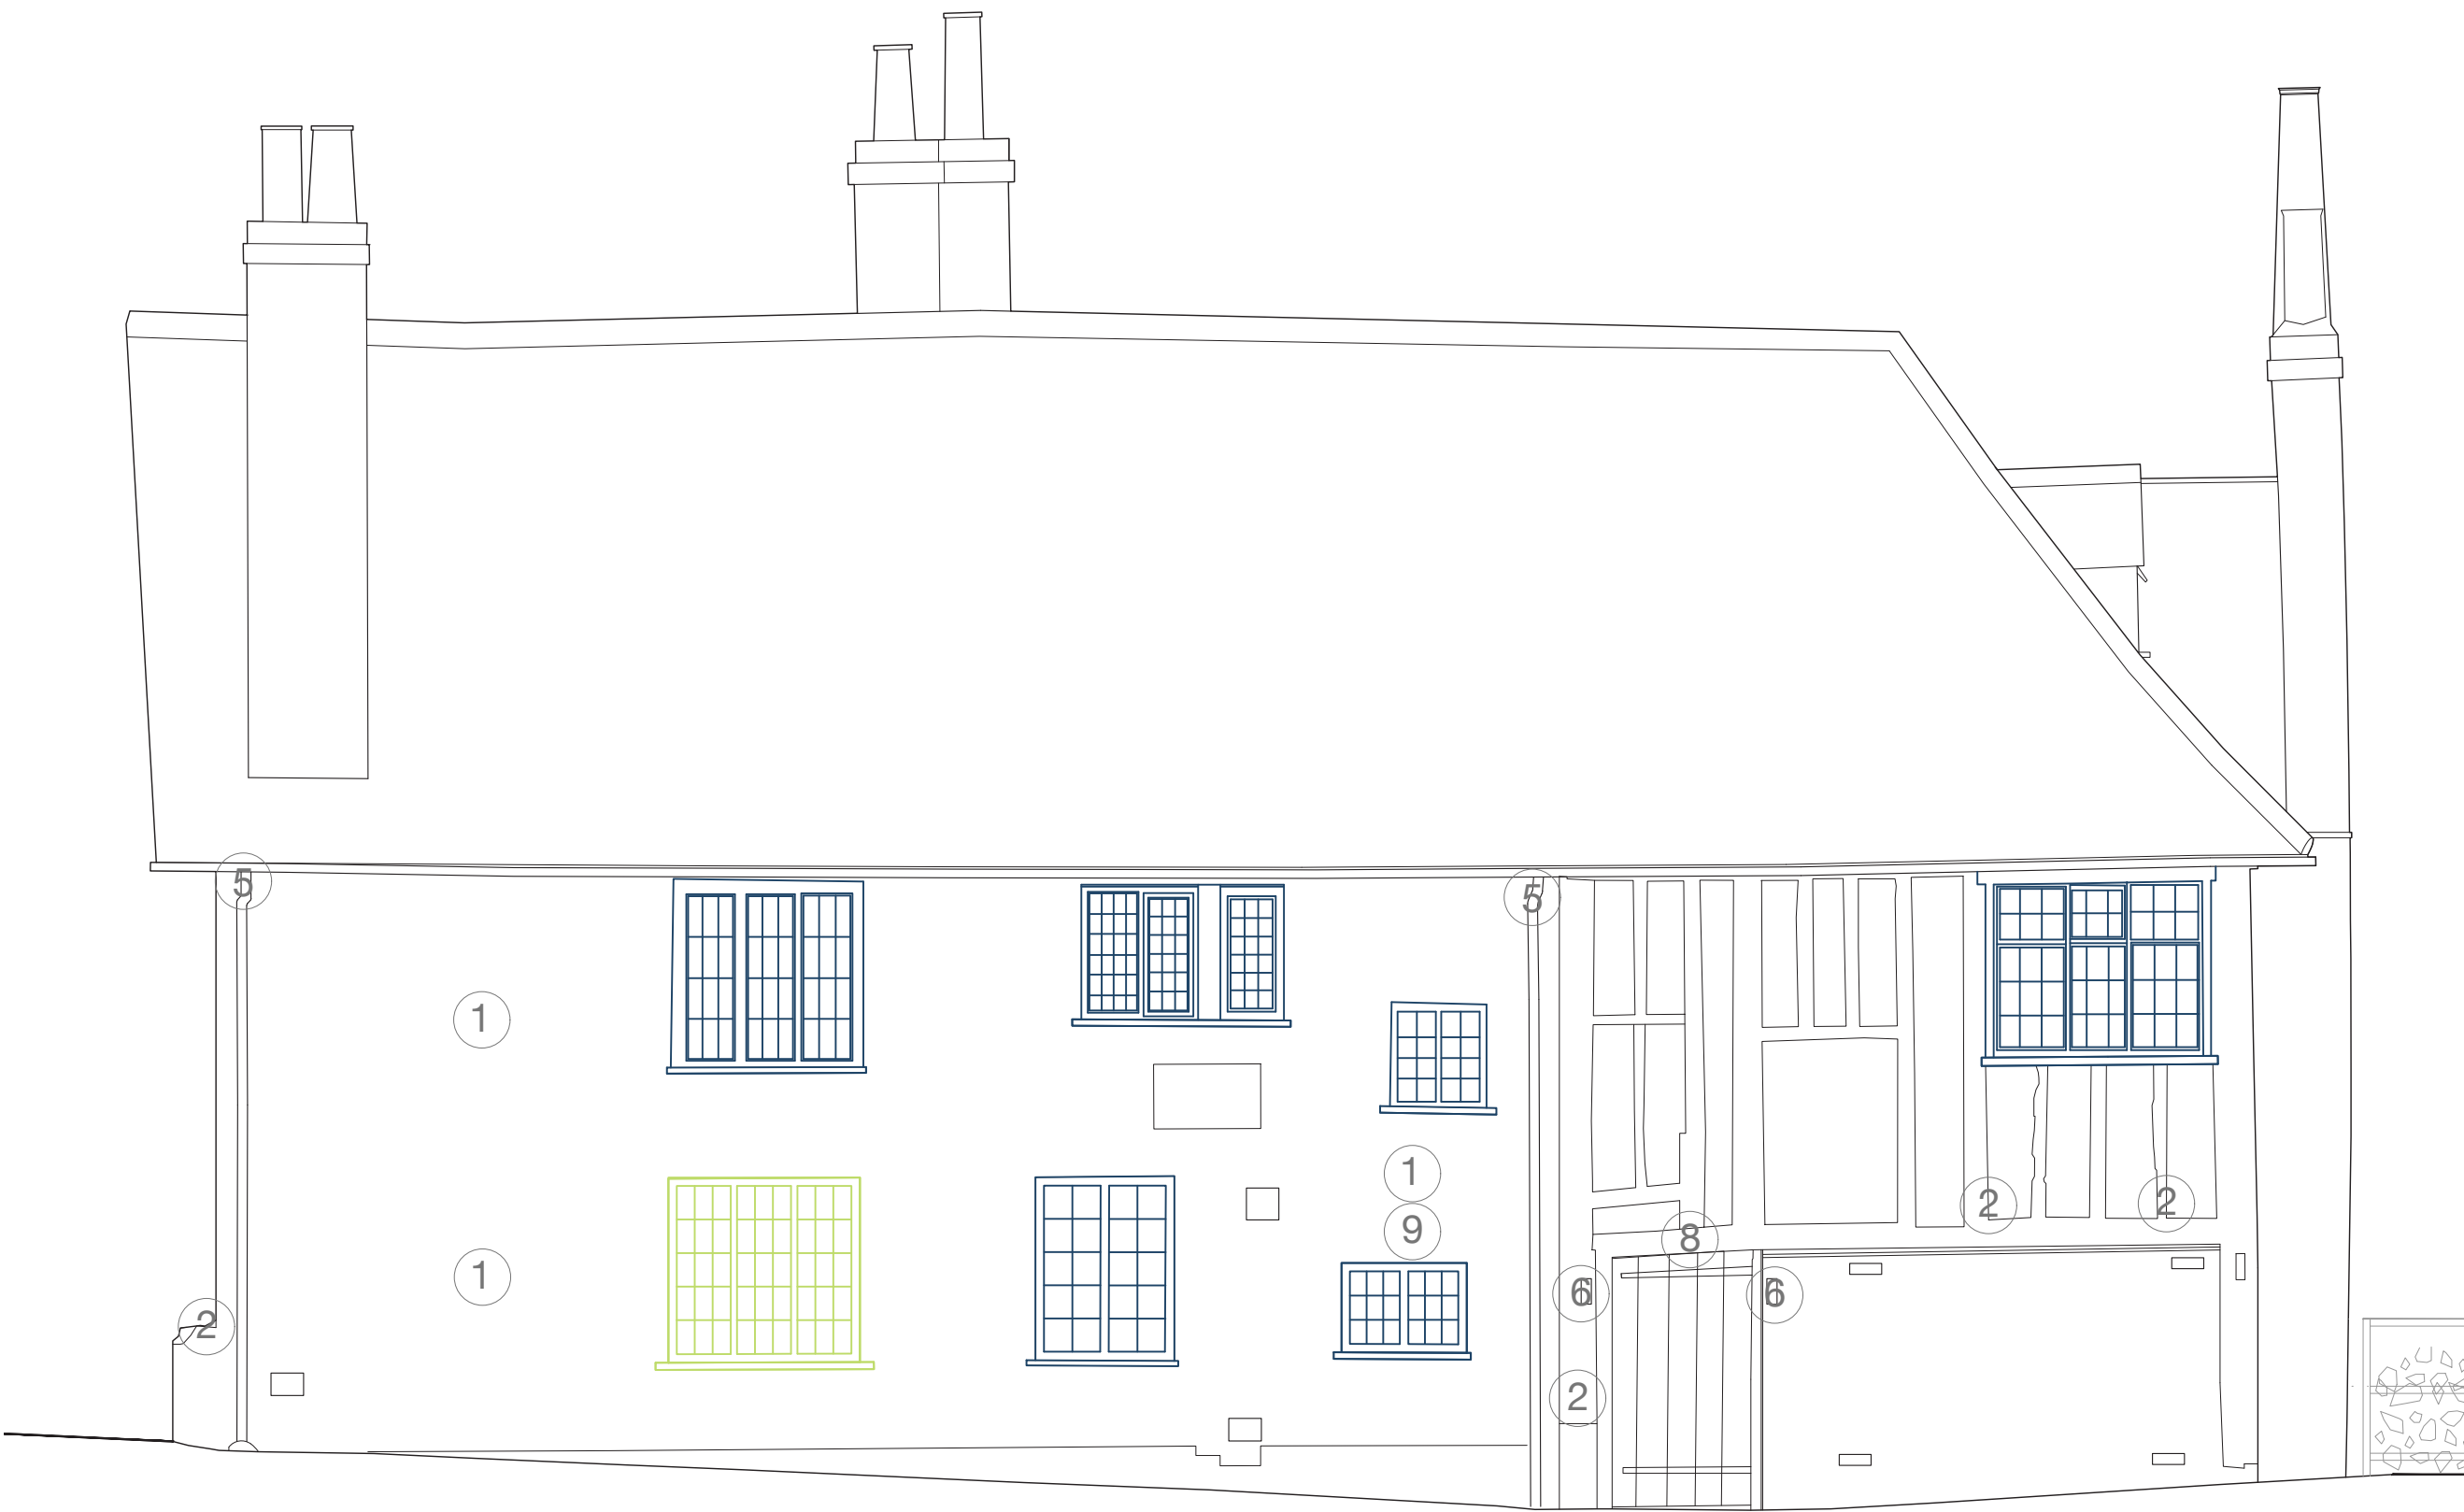
Proposed North Elevation  
Captured at 1:20 at A3. Please refer to drawing 032 for full page.

- 5. Existing cast iron rainwater goods. Poor to fair condition. Replacement and isolated repair required following detailed survey
- 6. Light fitting above door in very poor condition. Not inkeeping with historic fabric. New bronze fittings proposed.

- 7. Flush pointed mixed bond masonry. Bowing evidence in part of the facade.
- 8. Post covered with moss and algae.
- 9. Historic crack, further inspection recommended to confirm that the crack is not progressive.

- 10. Brickwork in reasonable condition considering age. Several bricks de-faced generally due to natural softness of the hand-fired brick. Majority of mortar is lime mortar with some areas of cementitious mortar. Further survey and schedule required to determine what particular bricks require replacement. All cement mortar to be repointed as per structural survey.

- Elevation works key:
- 1. Removal of cement pointing. New lime mortar pointing as per structural survey.
  - 2. Timber repair
  - 3. Removal of cement edging. New french drain.
  - 4. Code 5 lead work to window heads
  - 5. Repairs to existing rainwater goods: cast iron new joint spigots and end-stops
  - 6. New bronze light fitting
  - 7. Remove hedging
  - 8. Removal of fixtures and fittings
  - 9. Lintel works as per structural survey
  - 10. Rectification of existing felt drip detail
- Window Works Key:
- Retain, Repair, Introduce Slimline Glazing: treat damage and dry out moisture. Introduce slimline secondary glazing. Strip white paint subject to timber condition.
  - Retain and Repair: Clean, repair any damage. Courtyard only.
  - Replace: replace with double glazed dark hardwood frames rectangular leaded lights

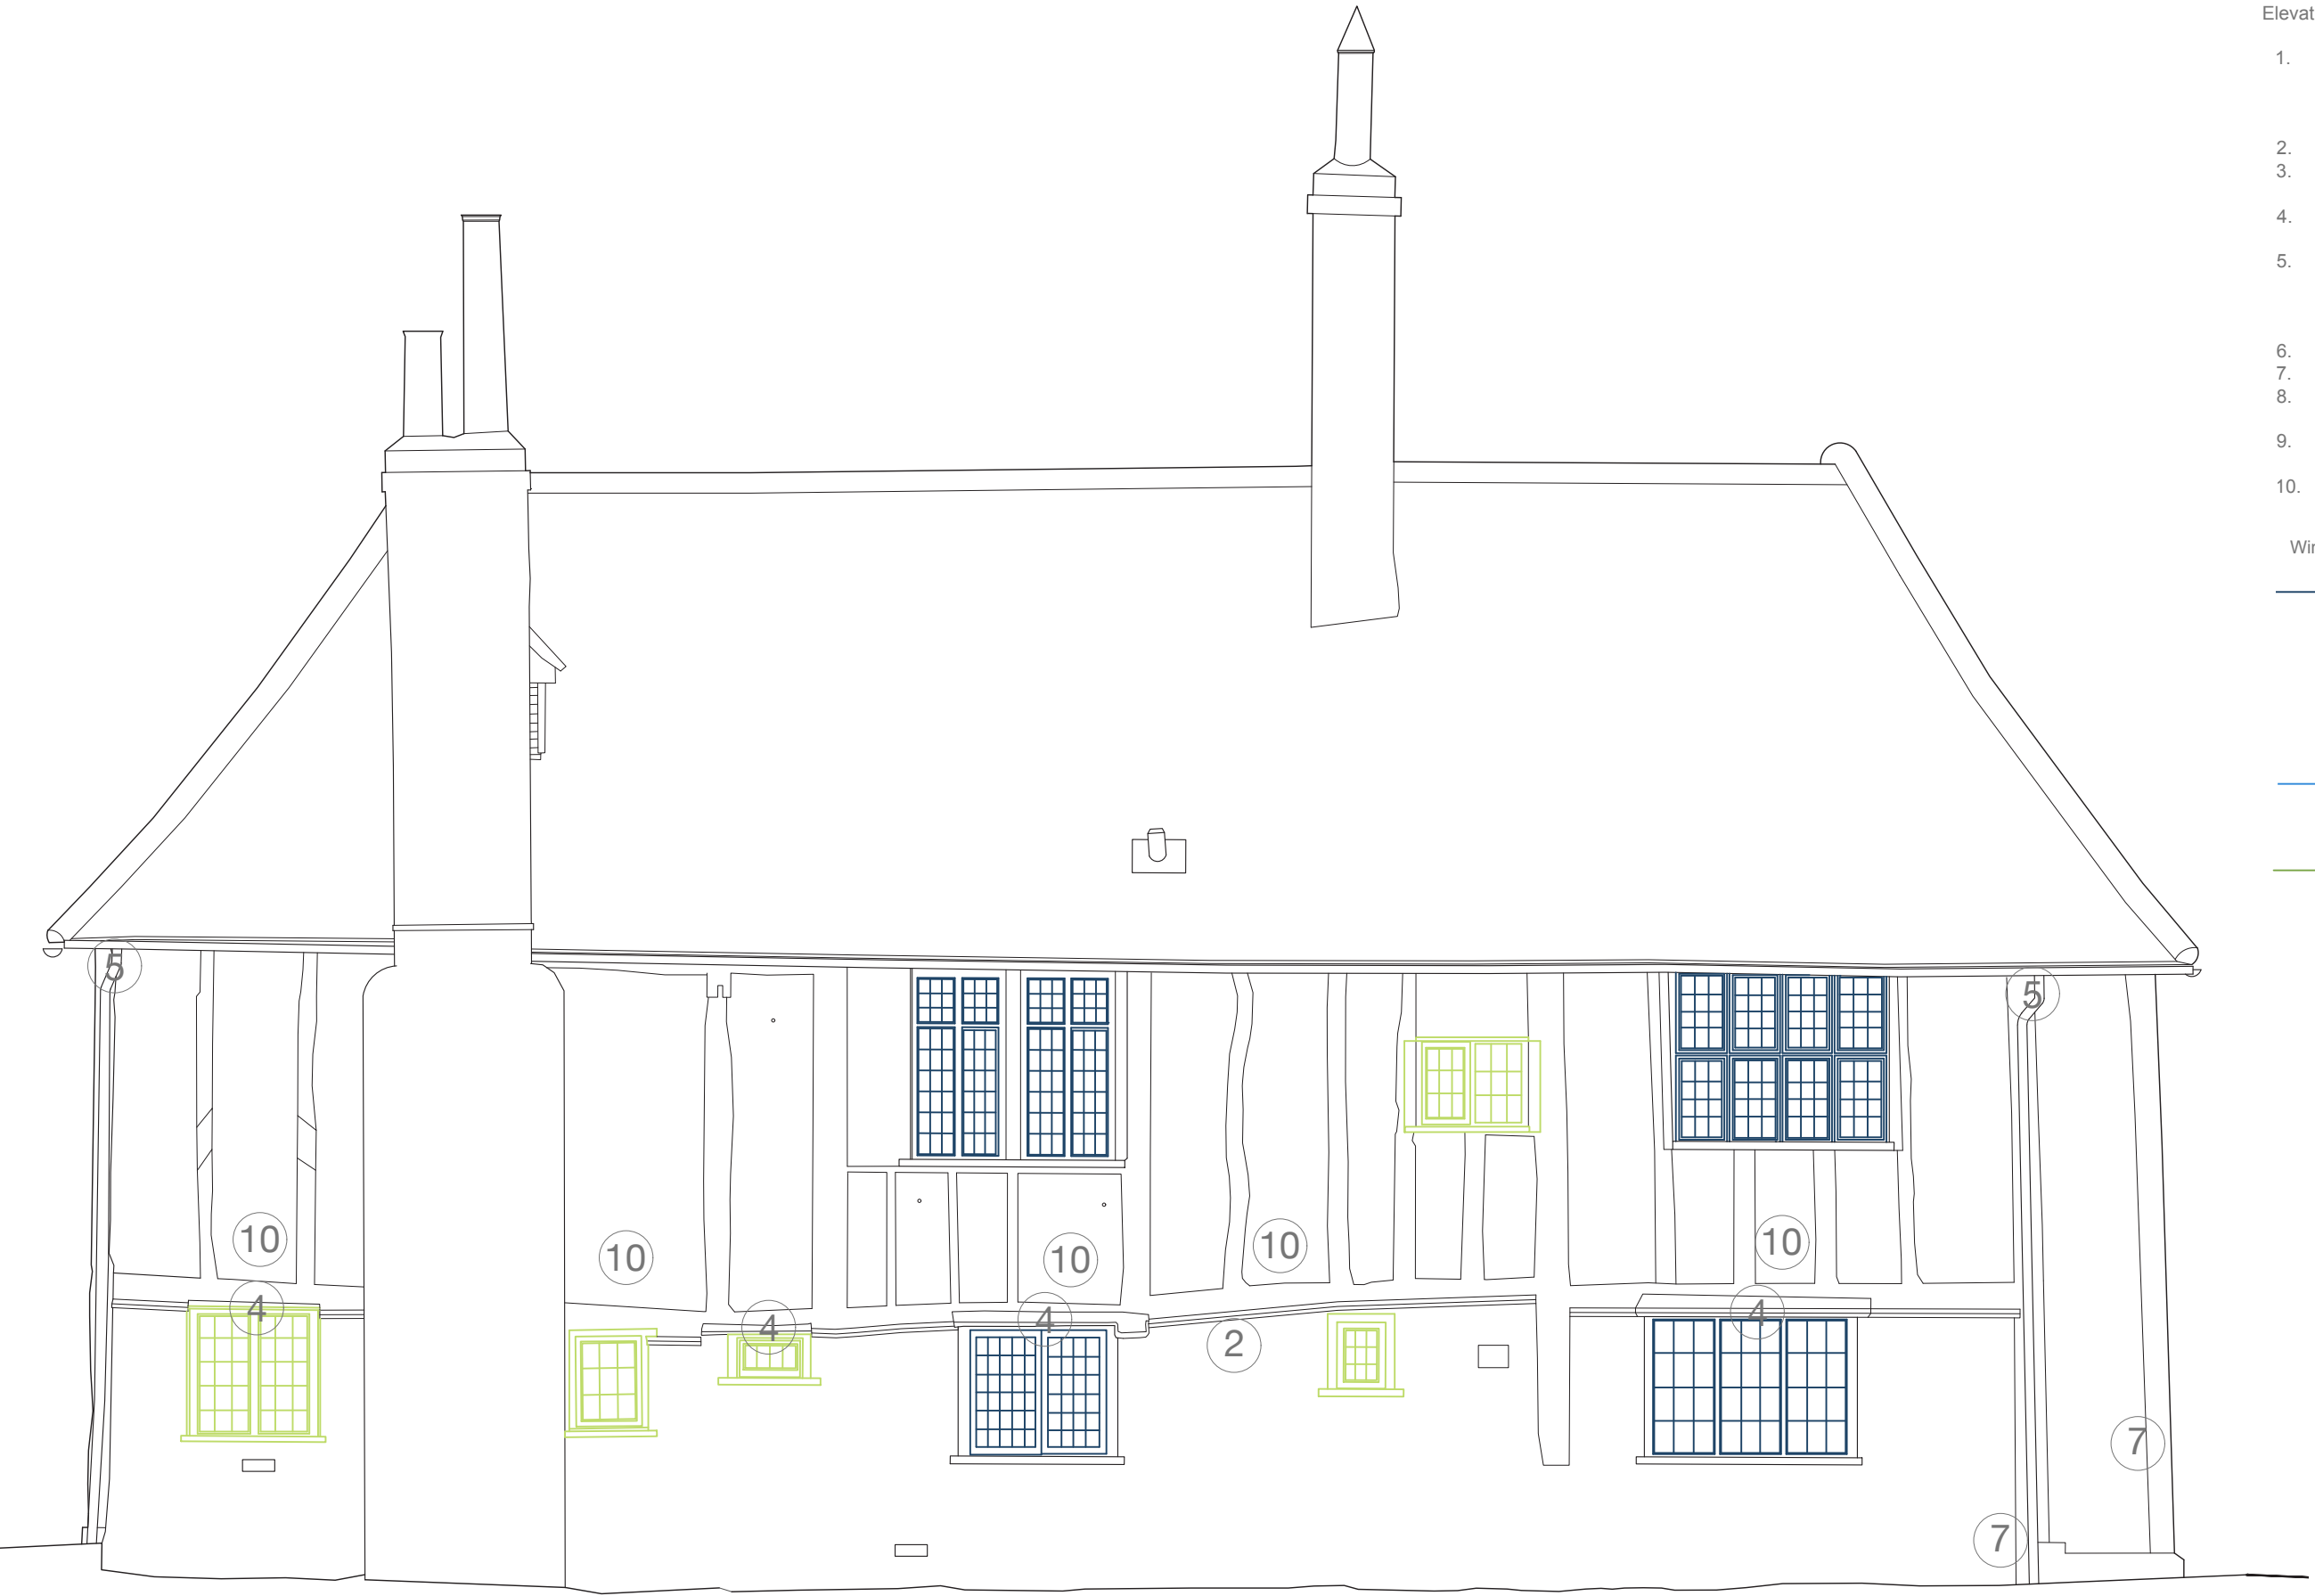
3. Cementitious with roofing felt detail, trapping moisture in the facade. Paint likely unbreatheable encouraging decay.
4. Louvered dormer to attic
5. Base of plate is very damp. Some decay to timbers but may be salvaged.

6. Clear vegetation to determine condition of existing gully outlet to ascertain remedial works. Rot in base of stud above concrete skirt.
7. Existing cast iron rainwater goods. Poor condition. Replacement and isolated repair required following detailed survey

8. Brickwork in reasonable condition considering age. Several bricks de-faced generally due to natural softness of the hand-fired brick. Majority of mortar is lime mortar with some areas of cementitious mortar. Further survey and schedule required to determine what particular bricks require replacement. All cement mortar to be repointed as per structural survey.

1. Removal of cement pointing. New lime mortar pointing as per structural survey.
2. Timber repair
3. Removal of cement edging. New french drain.
4. Code 5 lead work to window heads
5. Repairs to existing rainwater goods: cast iron new joint spigots and end-stops
6. New bronze light fitting
7. Remove hedging
8. Removal of fixtures and fittings
9. Lintel works as per structural survey
10. Rectification of existing felt drip detail

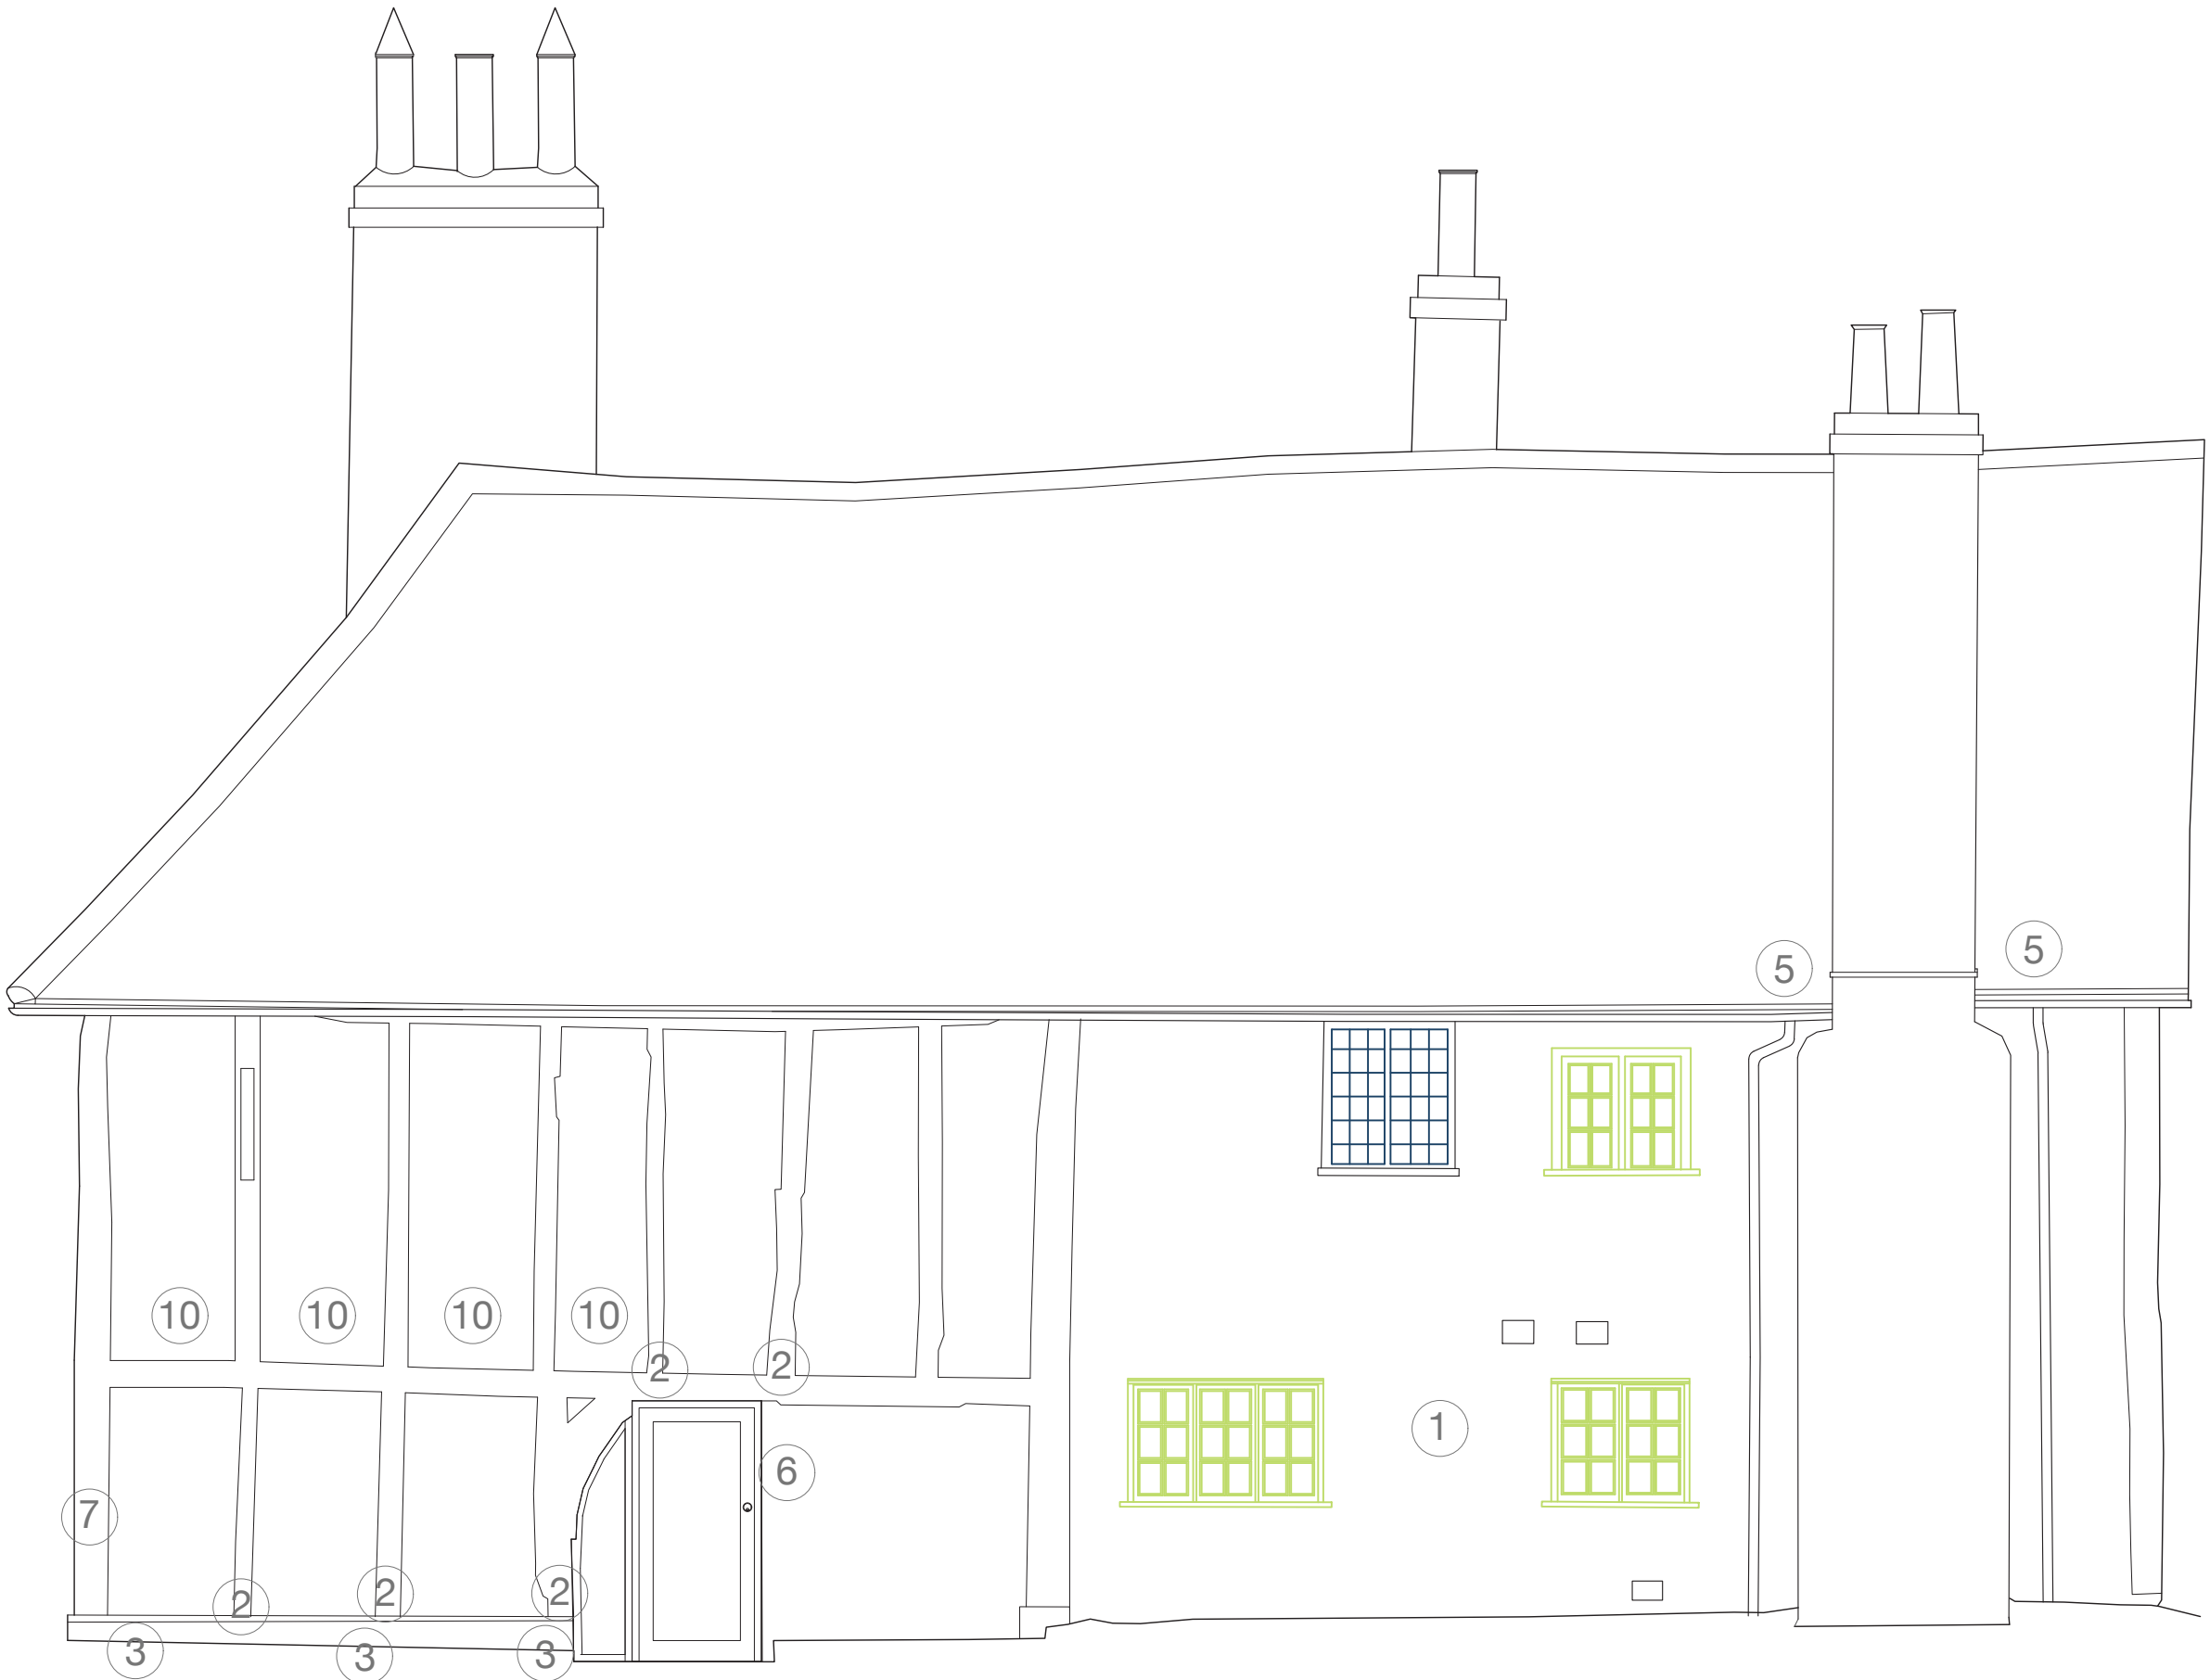
### Proposed South Elevation

1. Surface water drainage issues, rotting posts above. Concrete plinth trapping moisture.
2. Surface drainage water issues. Damp build up.
3. Cement with roofing felt detail, trapping moisture. Unbreathable paint encouraging decay.

4. Planting obstructing survey, likely causing damp build up. Planting to be removed.
5. Windows WG-10, WG-11 and WF-10 with glazing bars to be replaced with hardwood frames and rectangular leading as per window schedule.

6. Timber sounds hollow, further structural investigation needed
7. Existing cast iron rainwater goods. Poor to fair condition. Replacement and isolated repair

8. Chimney tied back to roof
9. Original post and haunch, severely decayed but high historical value.
10. Decay at top of plate and base of stud
11. Back entrance door damaged and lower half bordered up. To be replaced with secure door more inkeeping with historic fabric.

12. Brickwork in reasonable condition considering age. Several bricks de-faced generally due to natural softness of the hand-fired brick. Majority of mortar is lime mortar with some areas of cementitious mortar. Further survey and schedule required to determine what particular bricks require replacement.

1. Removal of cement pointing. New lime mortar pointing as per structural survey.
2. Timber repair
3. Removal of cement edging. New french drain.
4. Code 5 lead work to window heads
5. Repairs to existing rainwater goods: cast iron new joint spigots and end-stops
6. New bronze light fitting
7. Remove hedging
8. Removal of fixtures and fittings
9. Lintel works as per structural survey
10. Rectification of existing felt drip detail

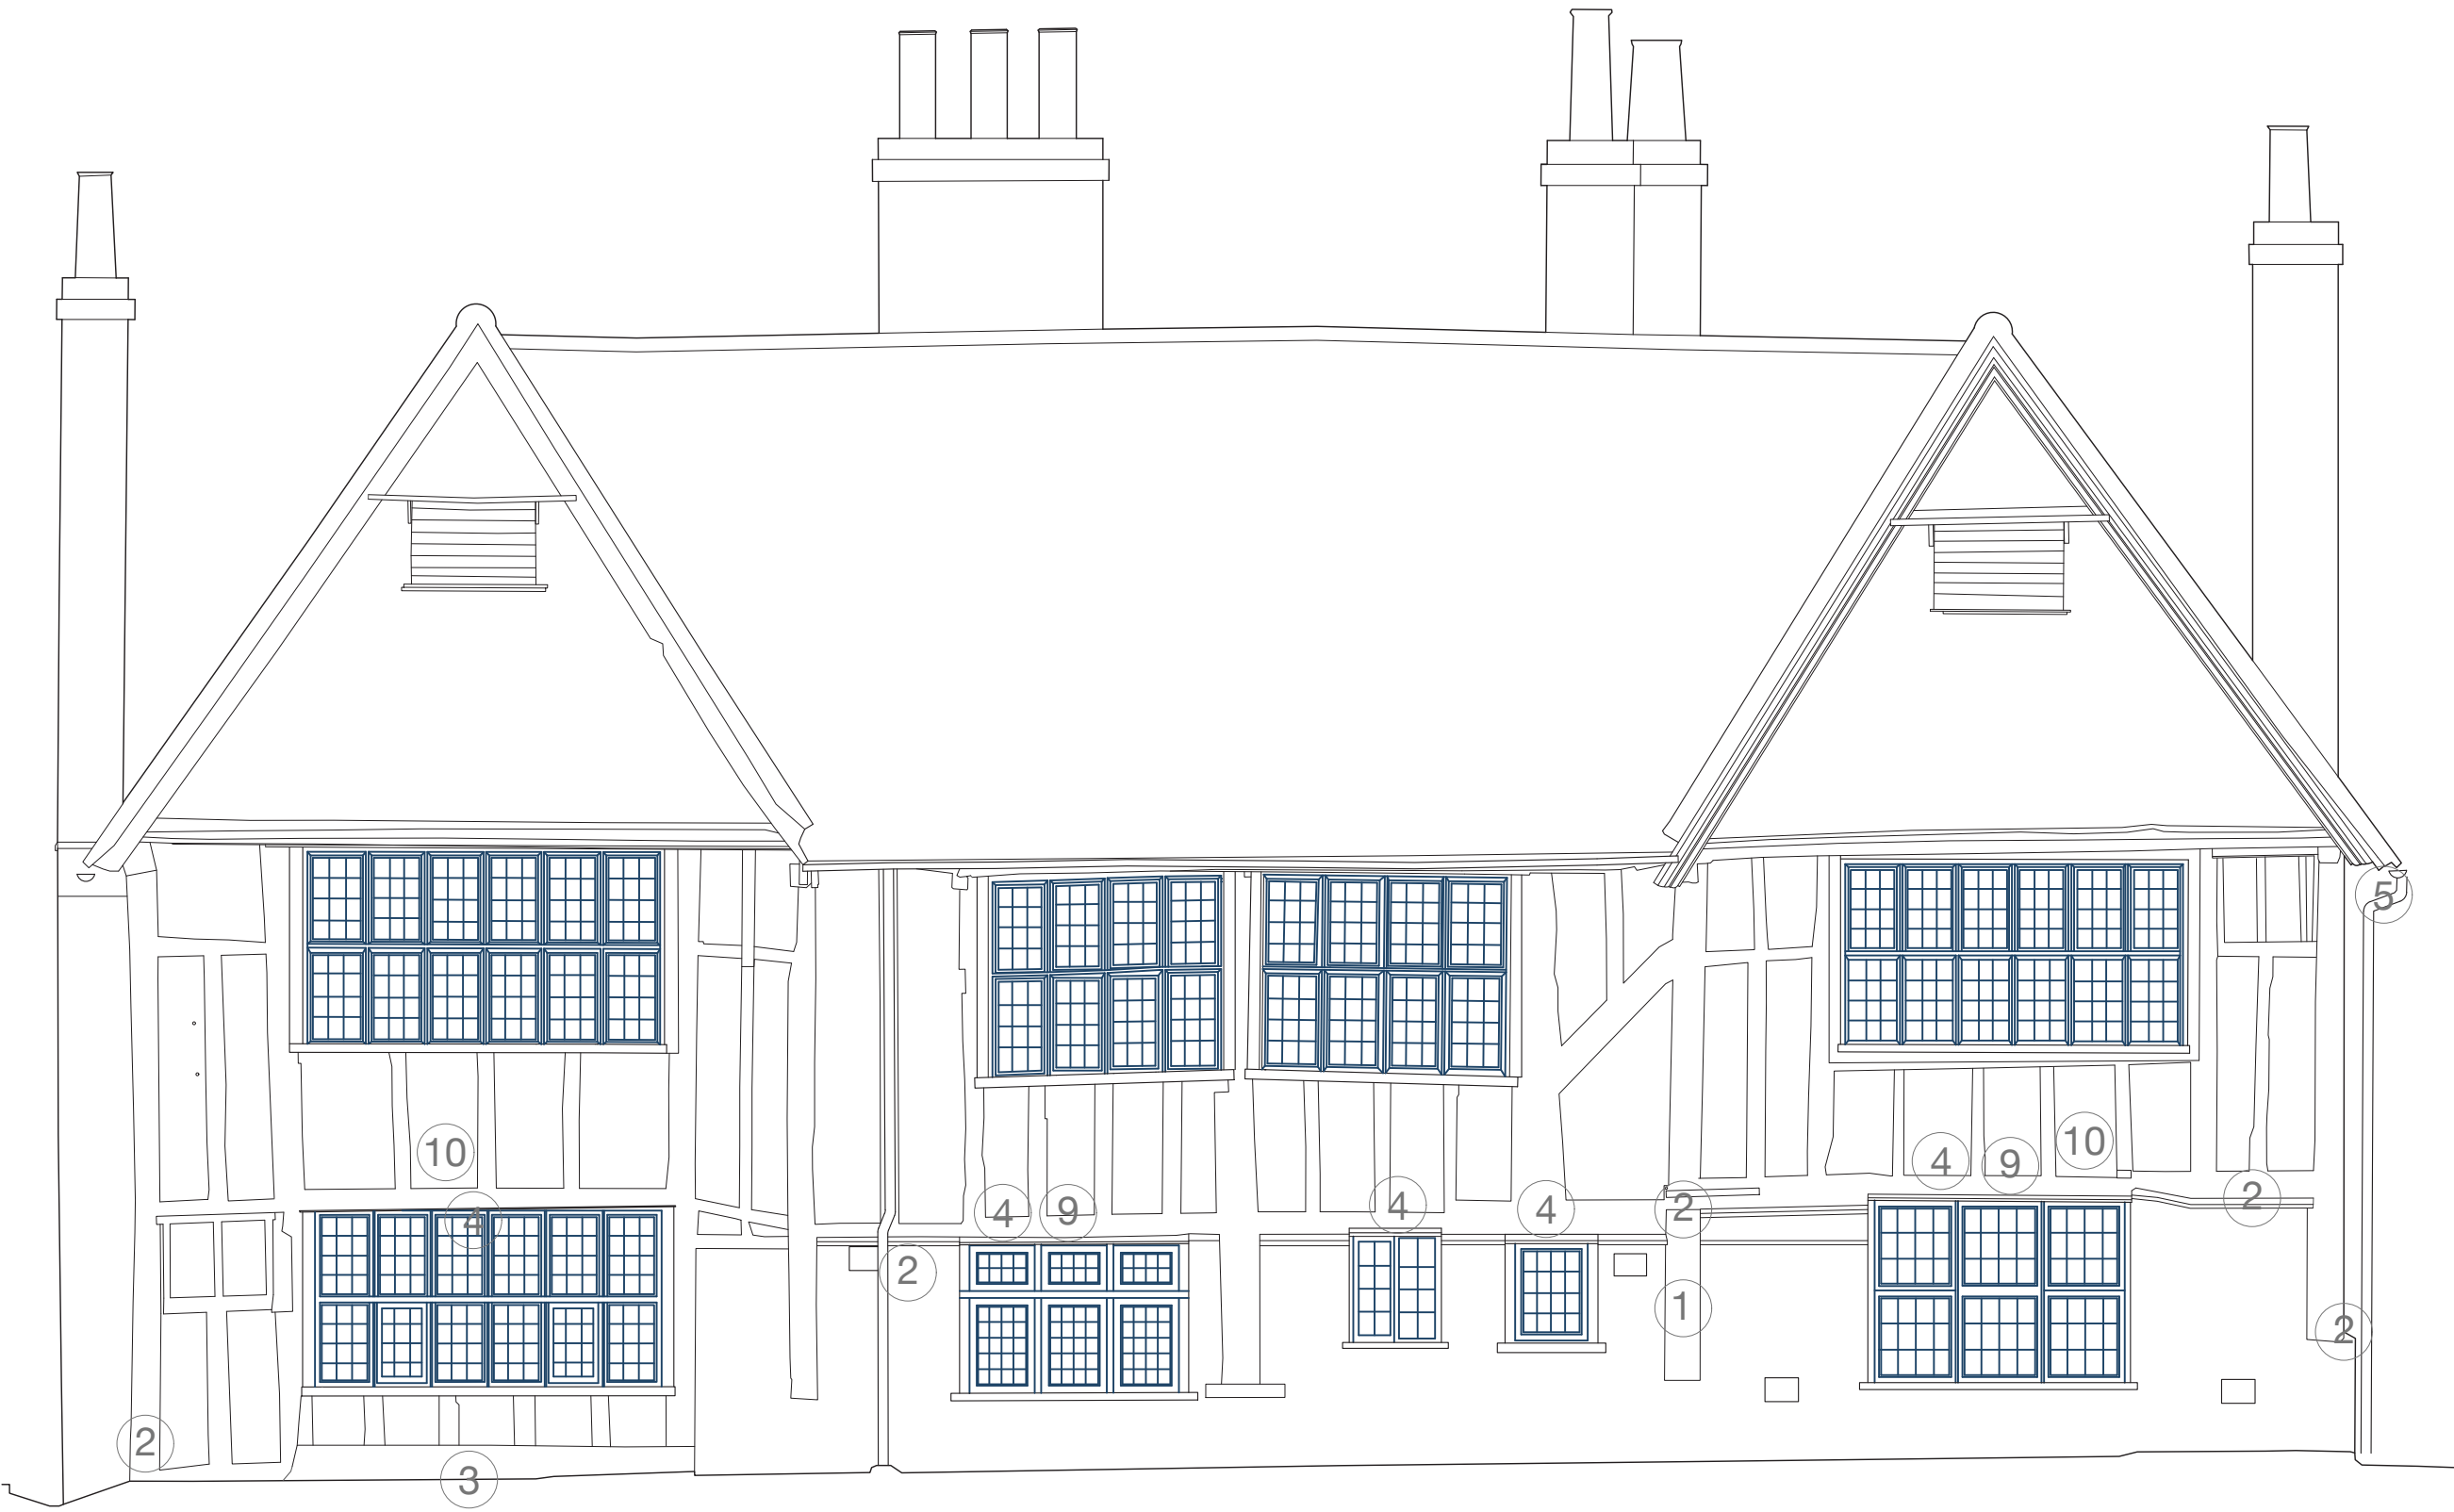
Proposed East Elevation

- 1. Surface water drainage issues. Rotting post above. Cement detail trapping moisture.
- 2. Surface drainage water issues with drainage channel. Damp build up.
- 3. Cementitious with roofing felt detail, trapping moisture in the facade. Paint likely unbreathable encouraging decay.
- 4. Localised rot in post base with cement full around
- 5. Louvres in dormer to attic
- 6. Cement at base but timber condition is adequate
- 7. Timber lintel over window is a replacement and does not bear load on left hand side, the lintel therefore leans on the window for support on the left.
- 8. Timber lintel over window is a replacement and does not bear load at either end, the lintel therefore leans on the window for support.

- Elevation works key:
- 1. Removal of cement pointing. New lime mortar pointing as per structural survey.
  - 2. Timber repair
  - 3. Removal of cement edging. New french drain.
  - 4. Code 5 lead work to window heads
  - 5. Repairs to existing rainwater goods: cast iron new joint spigots and end-stops
  - 6. New bronze light fitting
  - 7. Remove hedging
  - 8. Removal of fixtures and fittings
  - 9. Lintel works as per structural survey
  - 10. Rectification of existing felt drip detail
- Window Works Key:
- Retain, Repair, Introduce Slimline Glazing: treat damage and dry out moisture. Introduce slimline secondary glazing. Strip white paint subject to timber condition.
  - Retain and Repair: Clean, repair any damage. Courtyard only.
  - Replace: replace with double glazed dark hardwood frames rectangular leaded lights

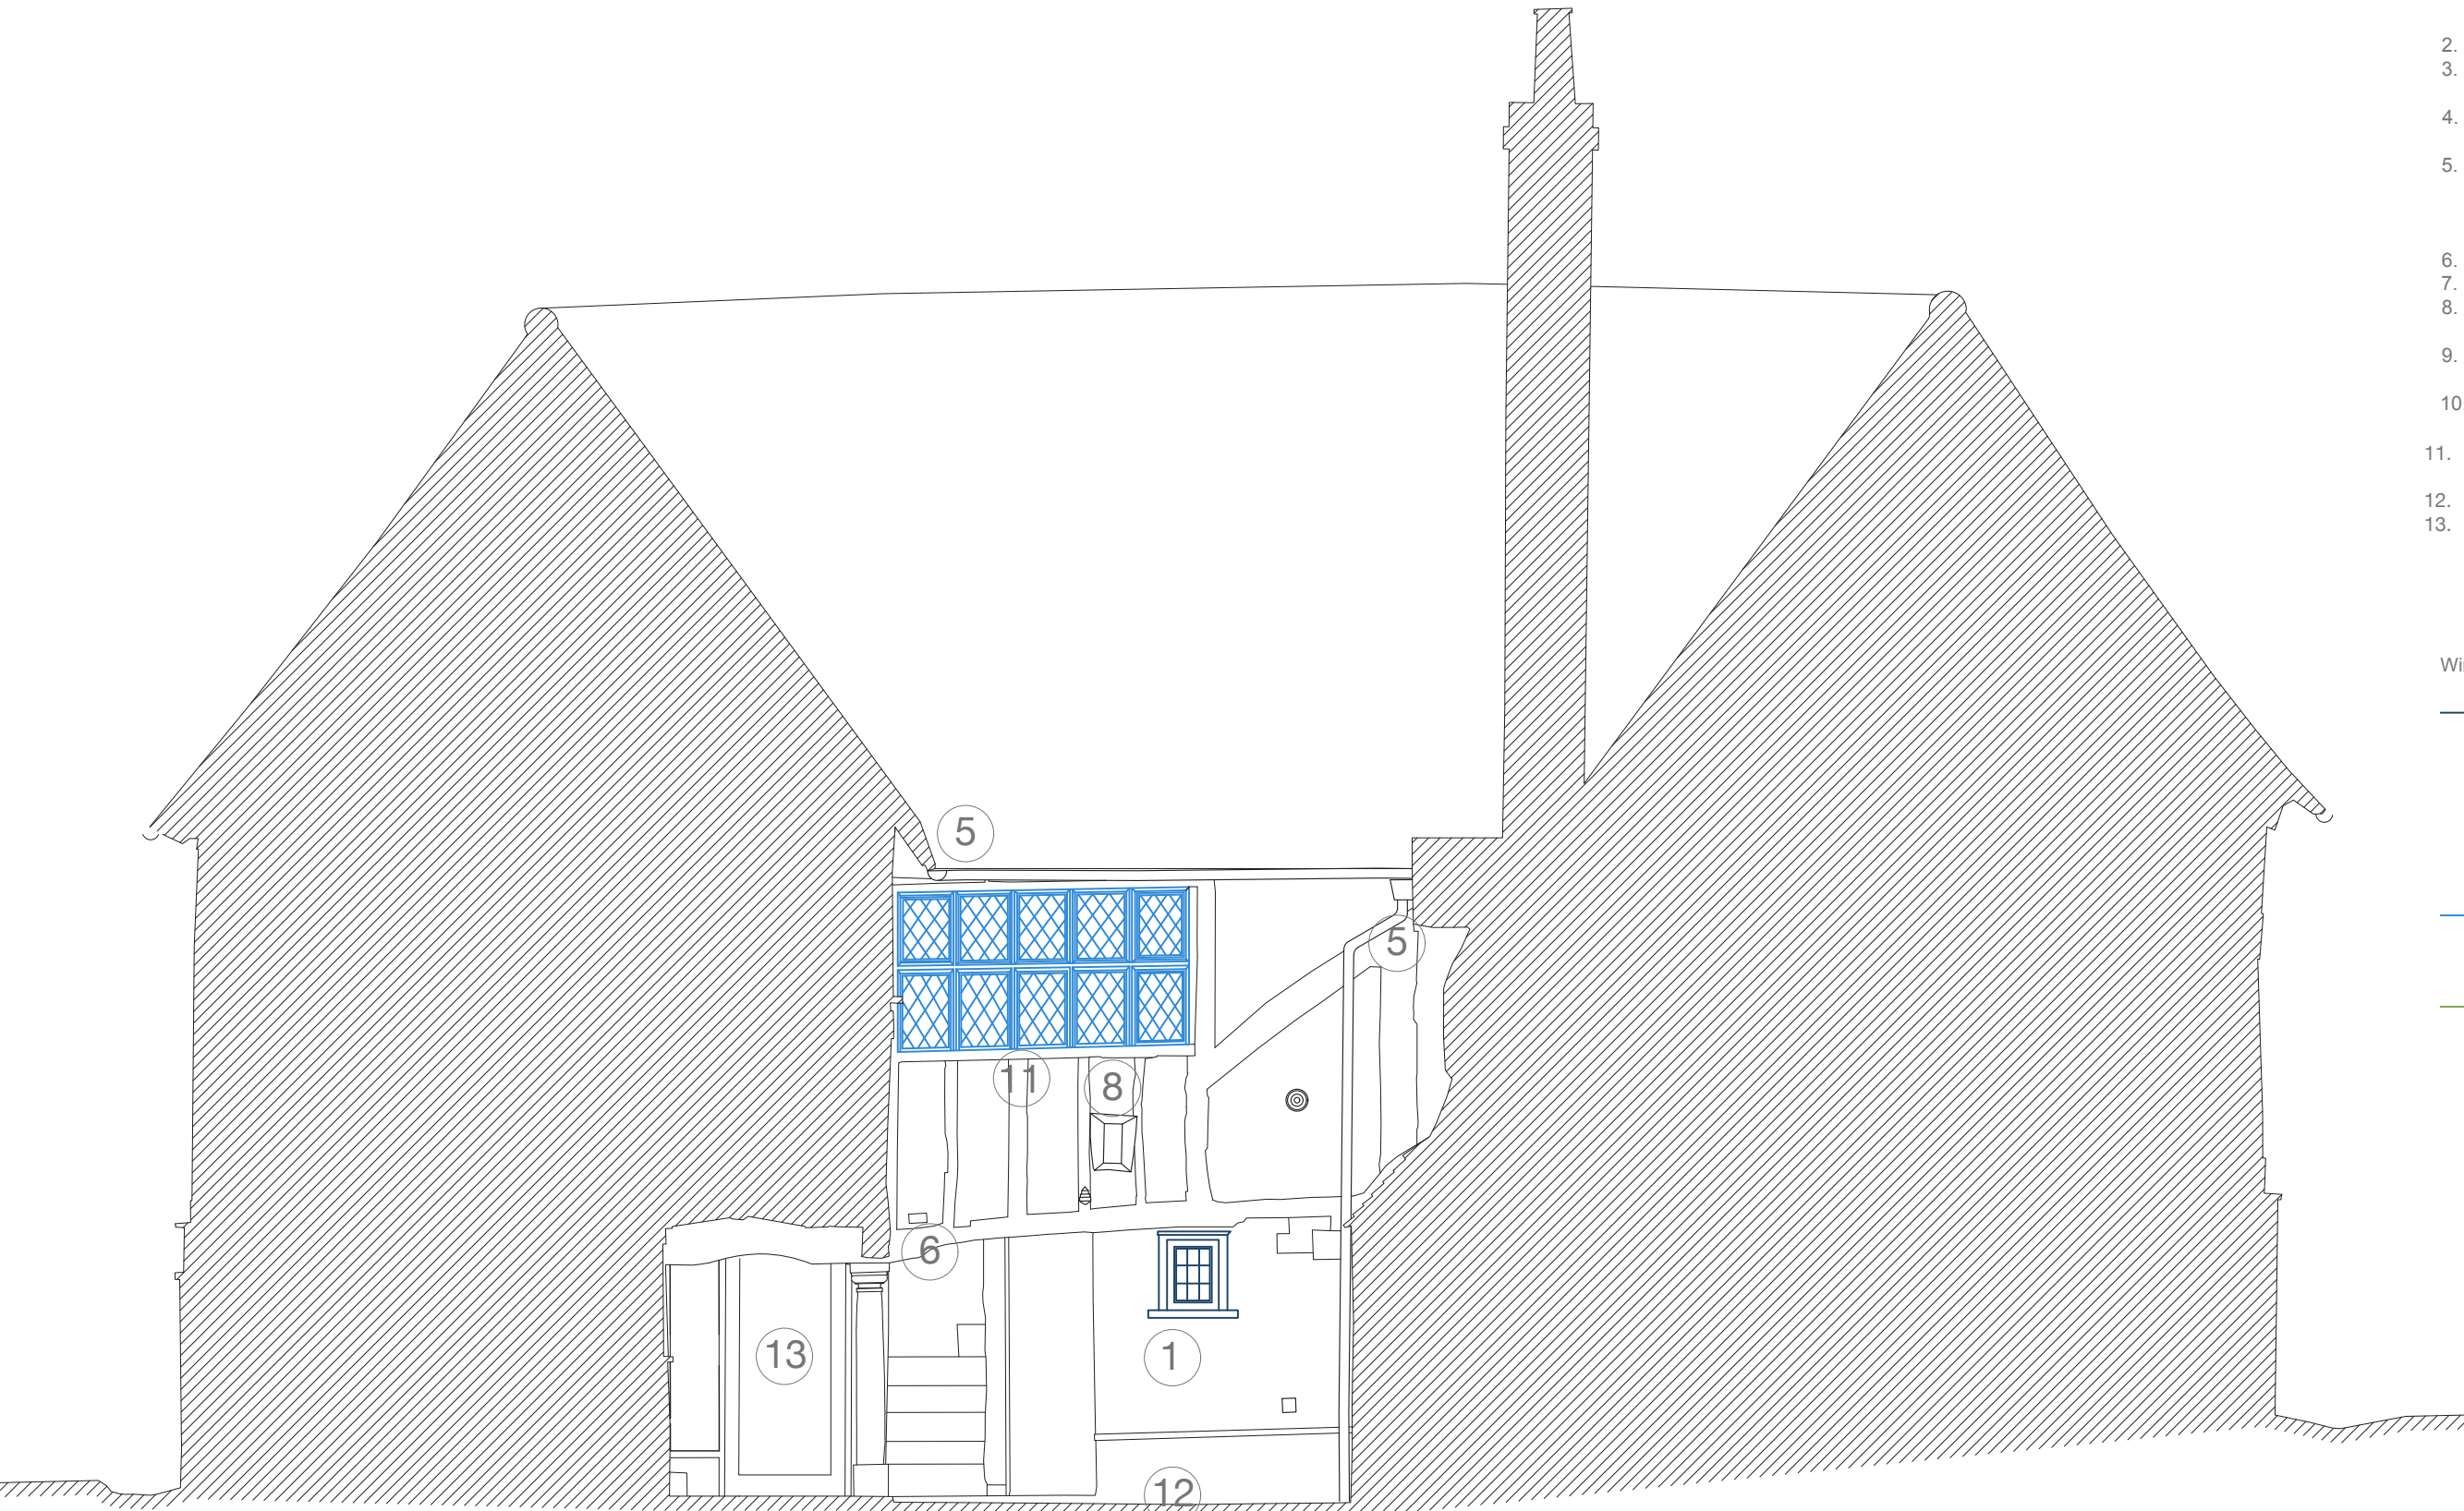
1. Surface drainage water issues due to concrete plinth. Damp build up. Removal of plinth and introduction of french drain.
2. Highly significant historic timbers in a Tuscan style form a cloister. Sound structural condition despite weathered appearance.

7. Existing cast iron rainwater goods. Poor condition. Replacement and isolated repair required following detailed survey
8. Several bricks de-faced generally due to natural softness of the hand-fired brick. Majority of mortar is lime mortar with some areas of cementitious mortar. Further survey and schedule required to determine what particular bricks require replacement.

1. Removal of cement pointing. New lime mortar pointing as per structural survey.
2. Timber repair
3. Removal of cement edging. New french drain.
4. Code 5 lead work to window heads
5. Repairs to existing rainwater goods: cast iron new joint spigots and end-stops
6. New bronze light fitting
7. Remove hedging
8. Removal of fixtures and fittings
9. Lintel works as per structural survey
10. Rectification of existing felt drip detail
11. Remove partition wall from WF-23
12. New permeable paving
13. Replacement door as per window and door schedule and drawing 070
