## 299 - The Biggin

Condition Survey

02/26: Planning Issue

**Michael Collins Architects**

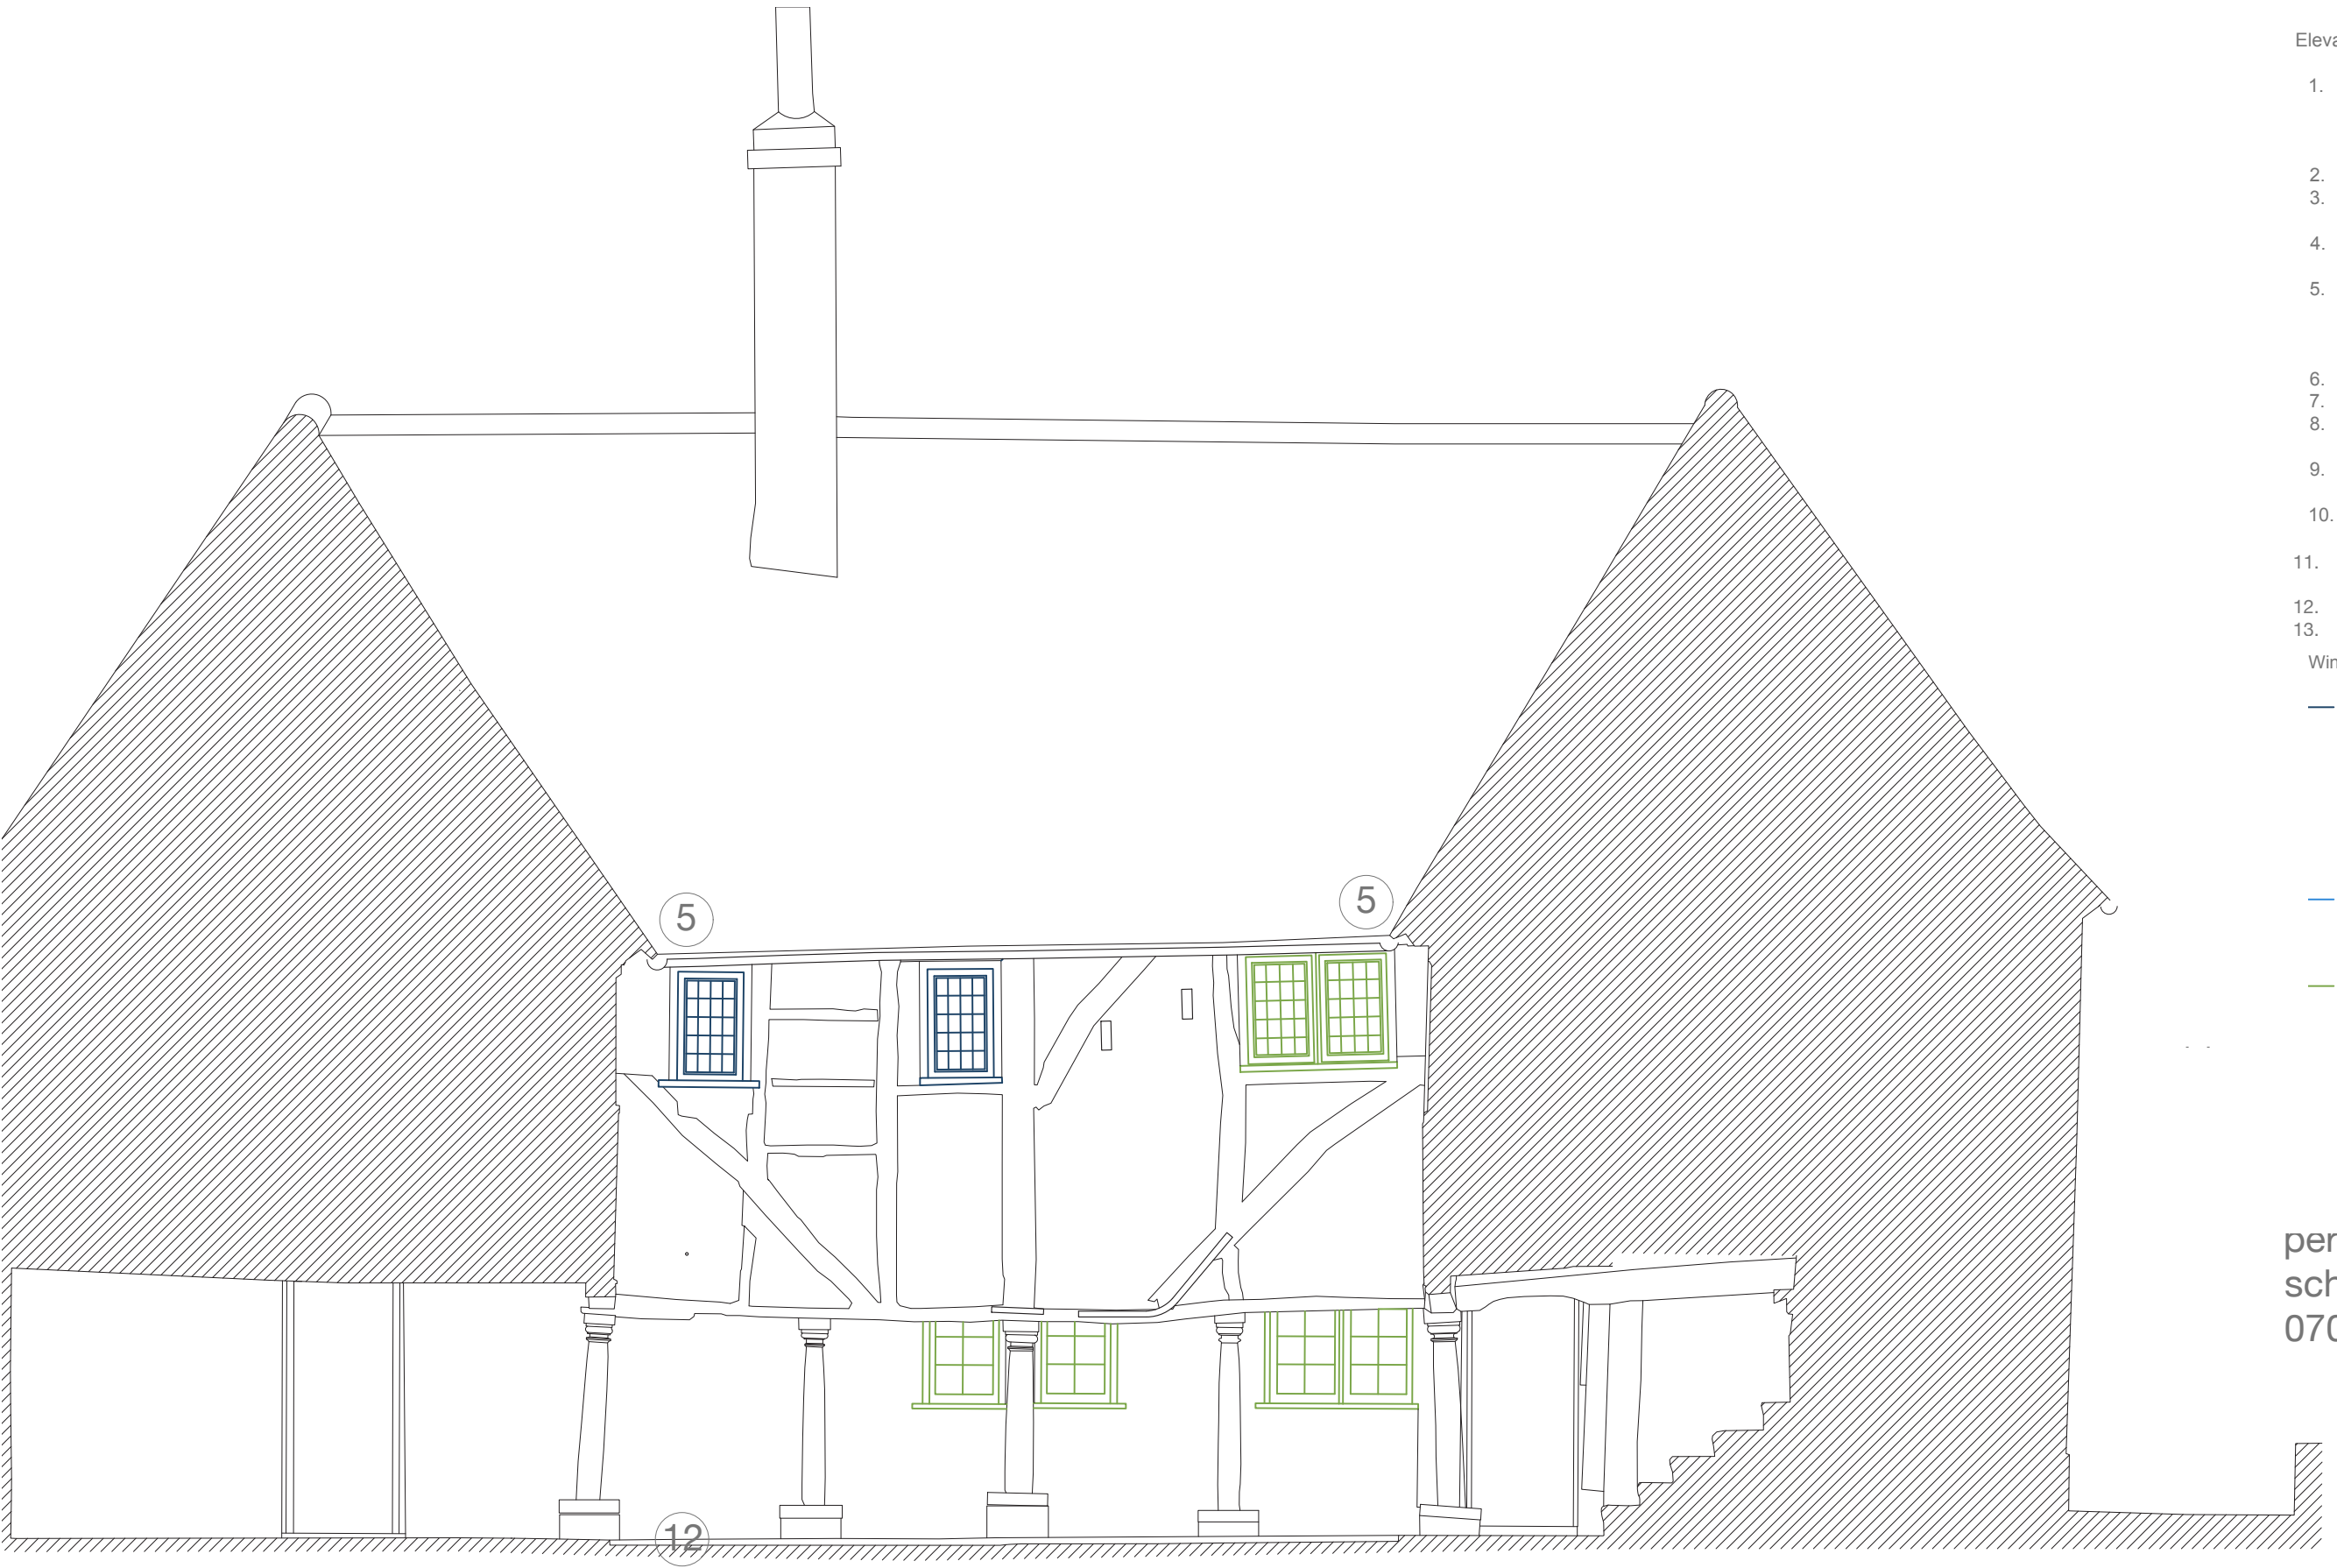
1. Surface drainage water issues due to exposed aggregate ground finish. Moss and algae growth. Removal of cement and introduction of permeable paving proposed.
2. Highly significant historic timbers in a Tuscan style form a cloister. Sound structural condition despite weathered appearance.
3. Tuscan style columns repaired and stabilised with oak bearing plates and timber filler sculpted into the head section in places. Structurally sound.
4. Post littered throughout courtyard. New post box required.
5. Historic raking cut into timber structure signifying a previous support placement, an early form of Acrow Prop as outlined in the structural survey.
6. Existing cast iron rainwater goods in poor condition. Replacement and isolated repair required following detailed survey

1. Removal of cement pointing. New lime mortar pointing as per structural survey.
2. Timber repair
3. Removal of cement edging. New french drain.
4. Code 5 lead work to window heads
5. Repairs to existing rainwater goods: cast iron new joint spigots and end-stops
6. New bronze light fitting
7. Remove hedging
8. Removal of fixtures and fittings
9. Lintel works as per structural survey
10. Rectification of existing felt drip detail
11. Remove partition wall from WF-23
12. New permeable paving
13. Replacement door as

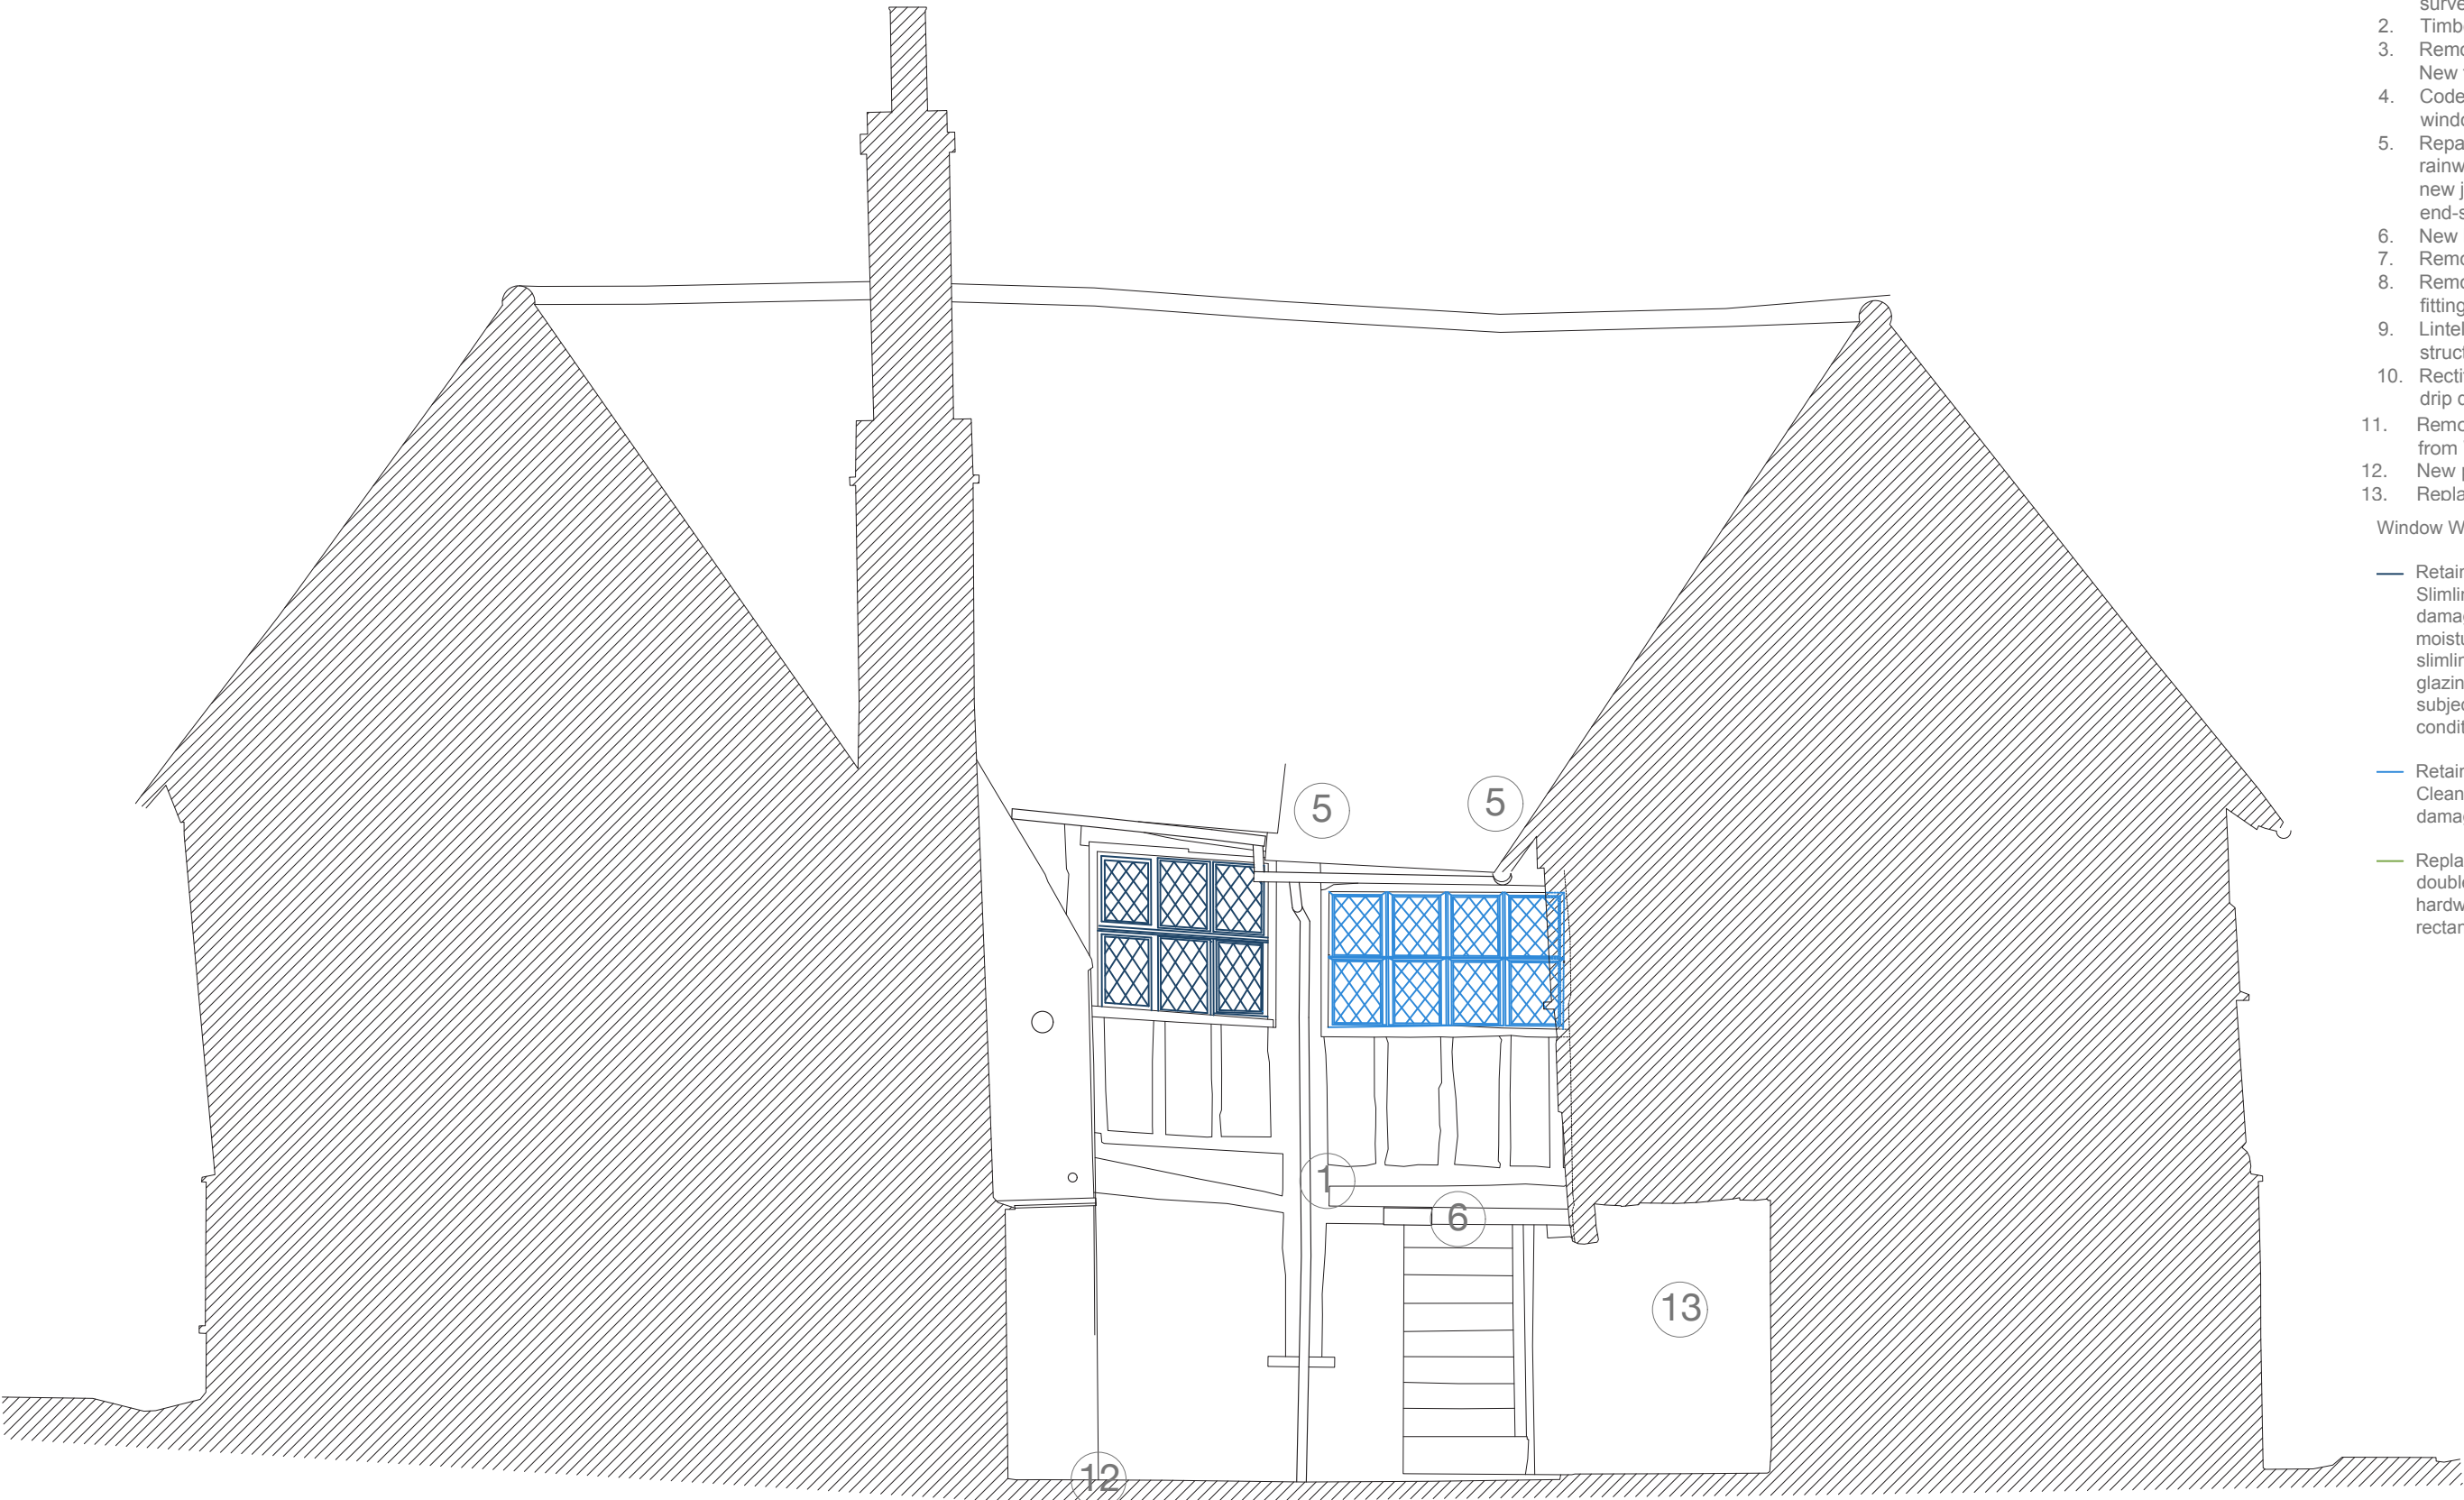
Proposed Courtyard Elevation, North Facing

- 1. Surface drainage water issues due to exposed aggregate ground finish. Moss and algae growth. Removal of cement and introduction of permeable paving proposed.
- 2. Highly significant historic timbers in sound structural condition despite weathered appearance.
- 3. Post littered throughout courtyard. New post box required.
- 4. WF-08 of exceptional historical significance, considered in good condition. Will remain onto an unheated space therefore proposed works to clean.
- 5. WF-11 of exceptional historical significance. Proposed repairs to introduce secondary glazing into Flat 11.
- 6. Existing cast iron rainwater goods. Poor. Replacement and isolated repair required following detailed survey

- 1. Removal of cement pointing. New lime mortar pointing as per structural survey.
- 2. Timber repair
- 3. Removal of cement edging. New french drain.
- 4. Code 5 lead work to window heads
- 5. Repairs to existing rainwater goods: cast iron new joint spigots and end-stops
- 6. New bronze light fitting
- 7. Remove hedging
- 8. Removal of fixtures and fittings
- 9. Lintel works as per structural survey
- 10. Rectification of existing felt drip detail
- 11. Remove partition wall from WF-23
- 12. New permeable paving
- 13. Replacement door as

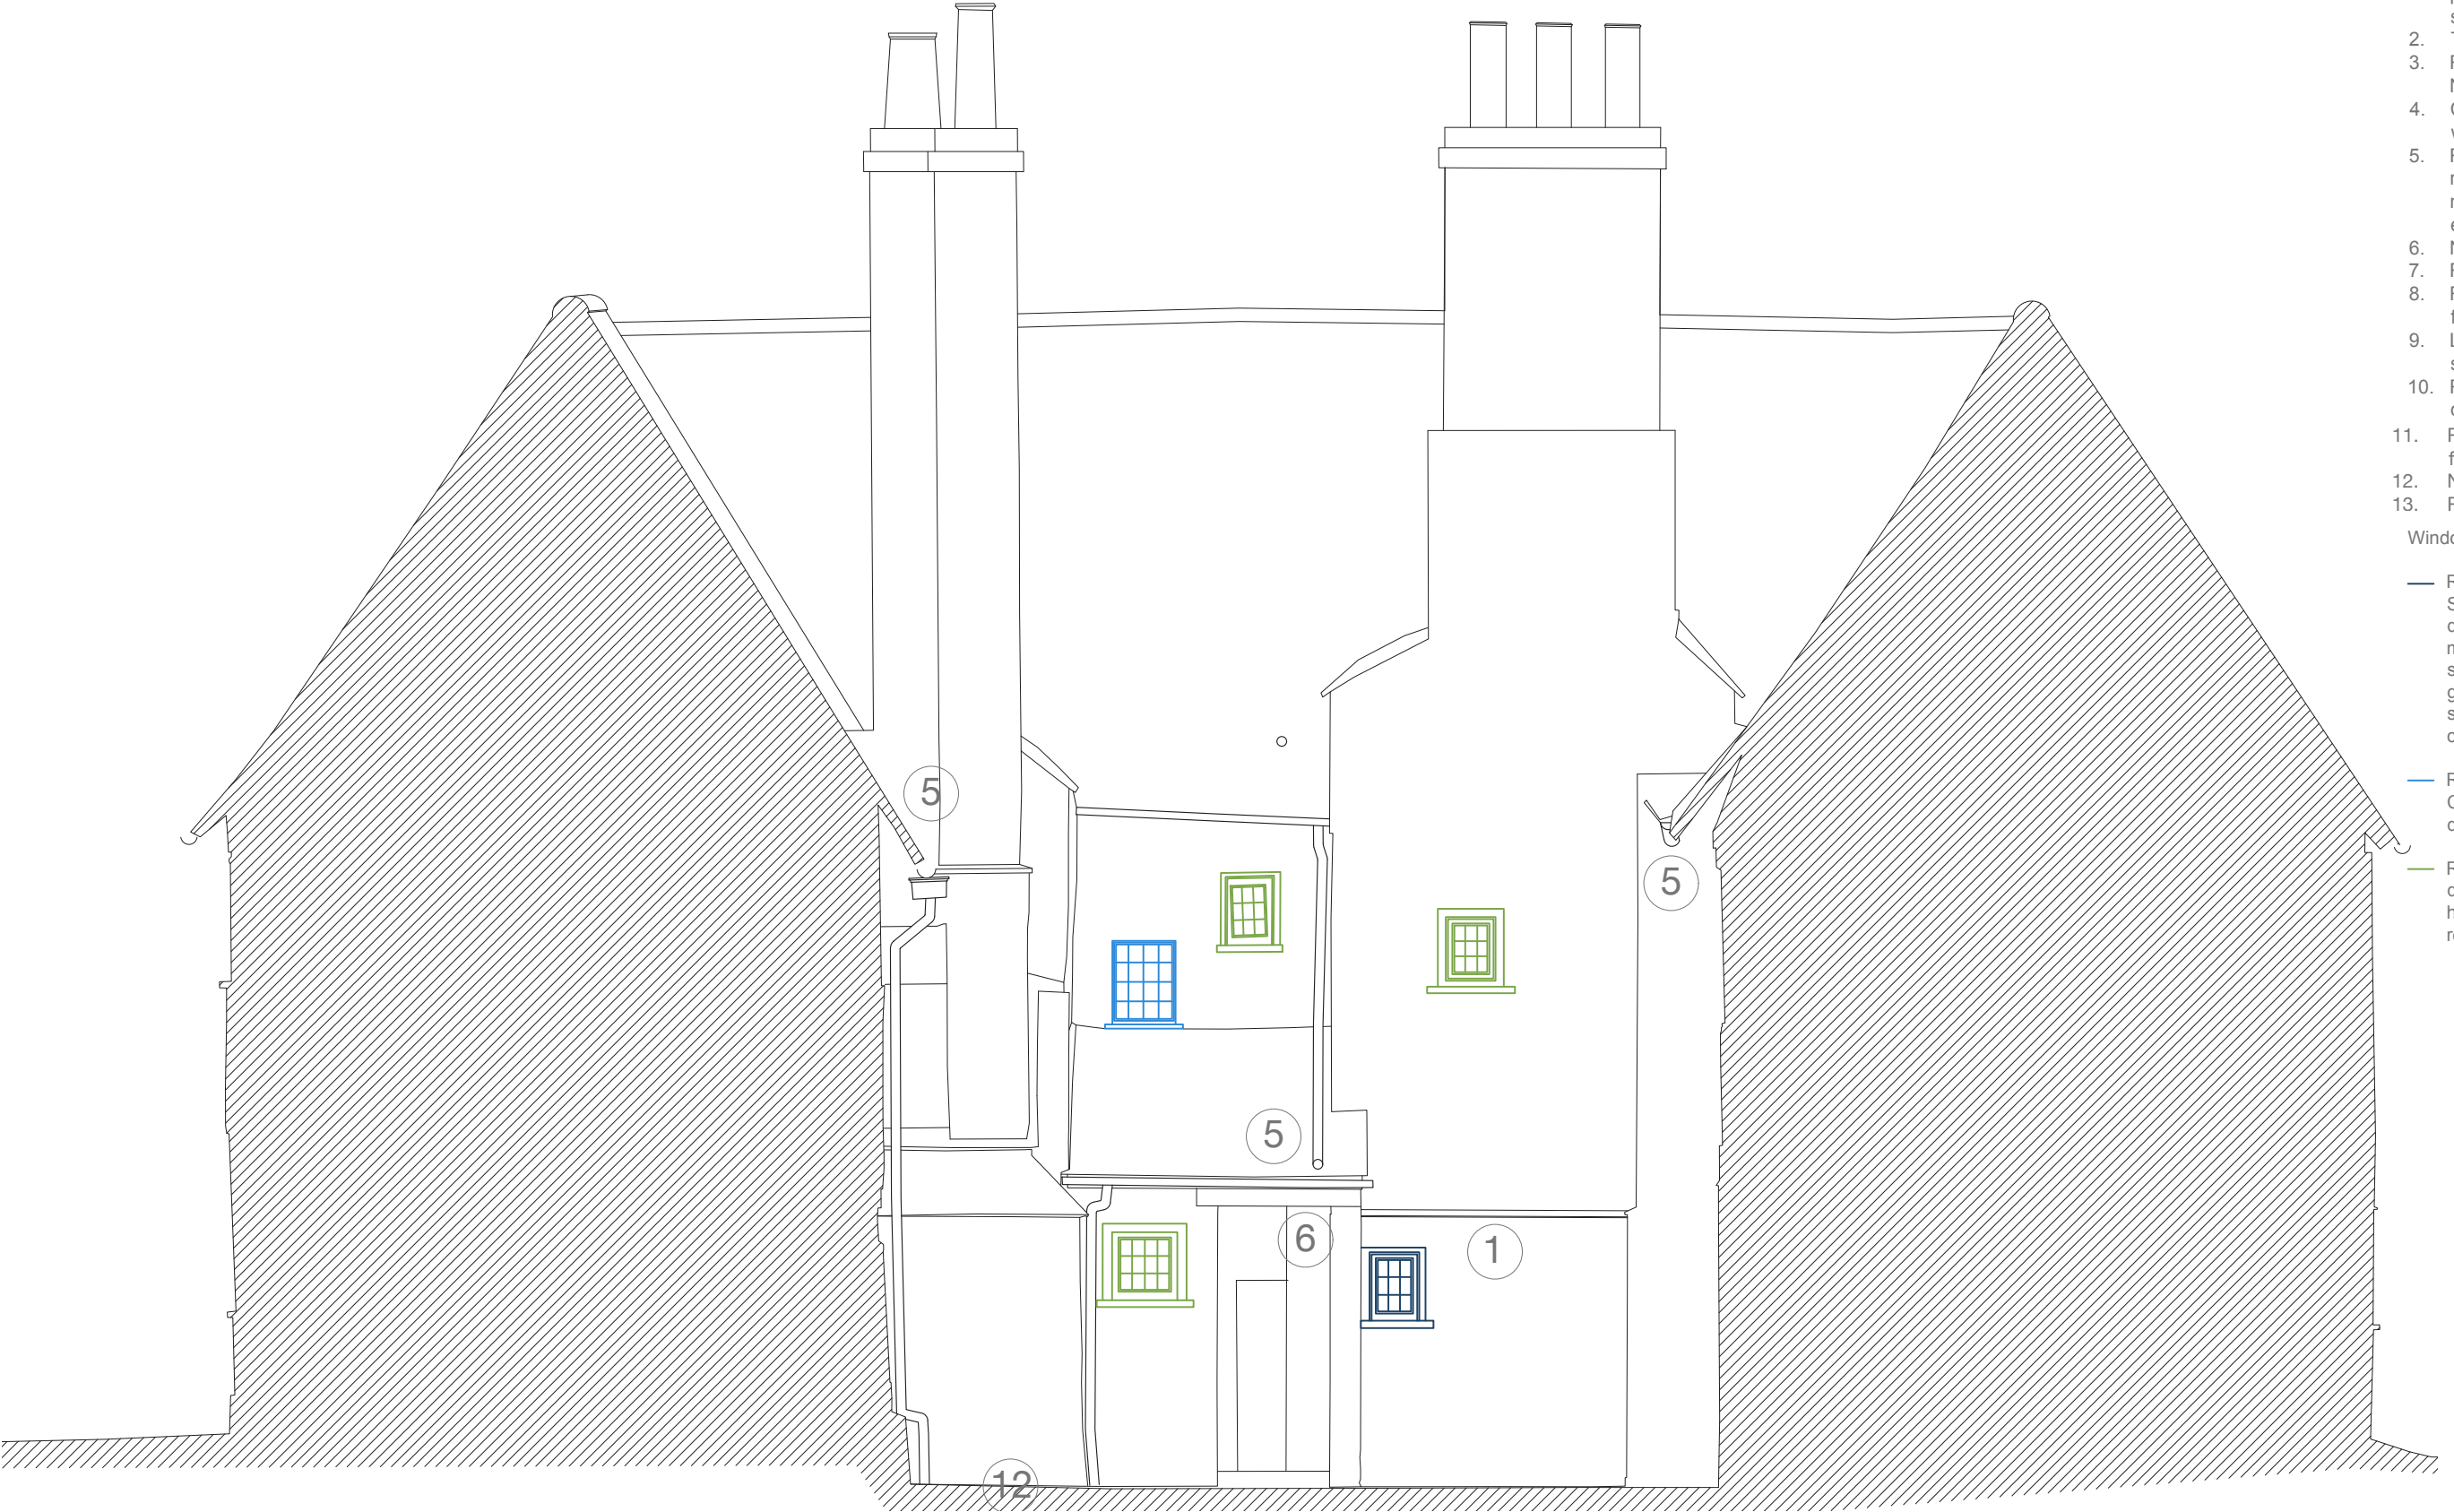
### Courtyard Elevation, West Facing

1. Surface drainage water issues due to exposed aggregate ground finish. Moss and algae growth. Removal of cement and introduction of permeable paving proposed.

1. Removal of cement pointing. New lime mortar pointing as per structural survey.
2. Timber repair
3. Removal of cement edging. New french drain.
4. Code 5 lead work to window heads
5. Repairs to existing rainwater goods: cast iron new joint spigots and end-stops
6. New bronze light fitting
7. Remove hedging
8. Removal of fixtures and fittings
9. Lintel works as per structural survey
10. Rectification of existing felt drip detail
11. Remove partition wall from WF-23
12. New permeable paving
13. Replacement door as

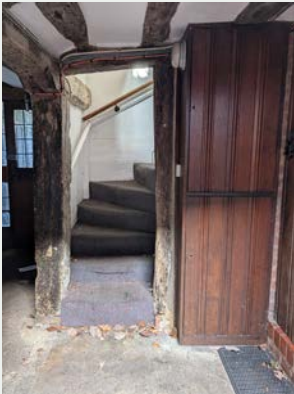
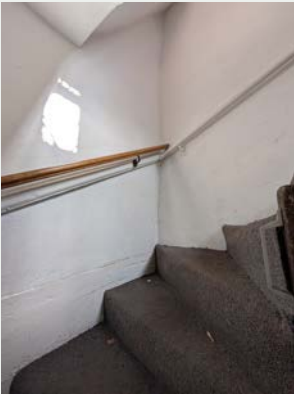
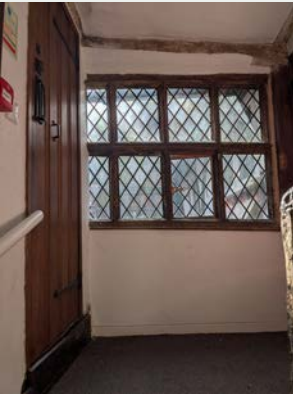
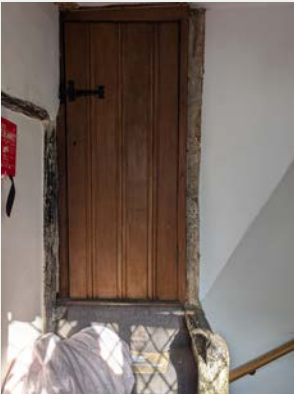
| | | | | | Description | Significance | Condition | Notes | Proposed Repairs |
|---|---|---|---|---|---|---|---|---|---|
| Stairwell 1 (Flats 7+8)<br>WF-23<br>Historic timber work and entrance to attic space | | | | | WF-23 historic window | Exceptional | Modertate | Refer to Window Schedule | Refer to Window Schedule |
| | | | | | Historic timber work | High | Moderate | Unpainted timber with some historic deterioration over time | Clean up and assess condition of timber |

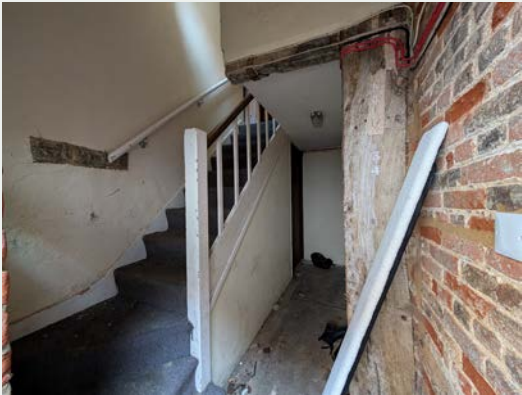
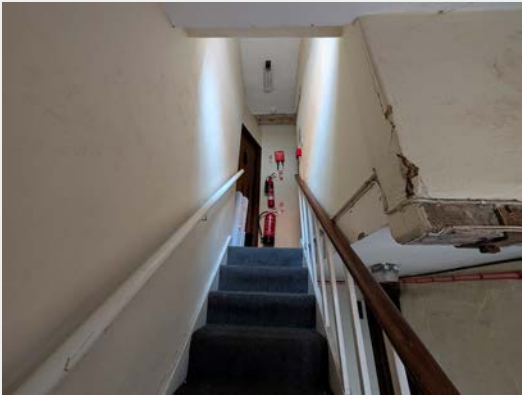
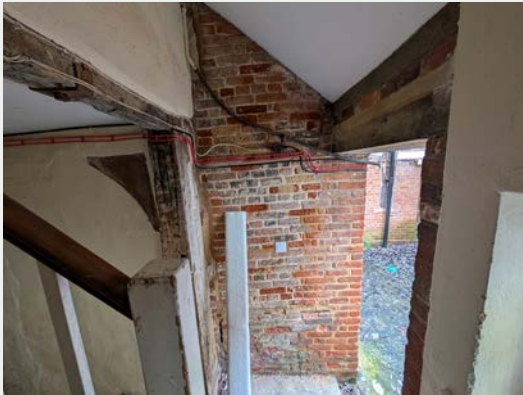
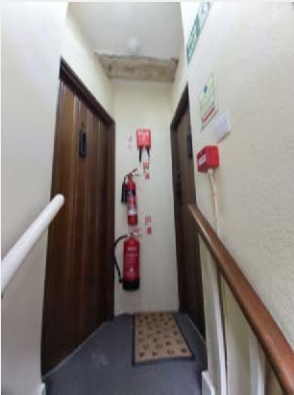
| | | | | | Description | Significance | Condition | Notes | Proposed Repairs |
|---|---|---|---|---|---|---|---|---|---|
| Stairwell 2 (Flats 9+10)<br>WG-18, WF-16<br>Historic stone detail in wall<br>Historic timber beam | | | | | Historic stone detail in wall at foot of the stairs | Exceptional | Poor | Partially obscured by handrail. Has deteriorated over time due to location in a heavy foot traffic area | Sensitively restore where possible |
| | | | | | Historic timber beam | High | Modertate | Unpainted timber | Clean up and assess condition of timber |

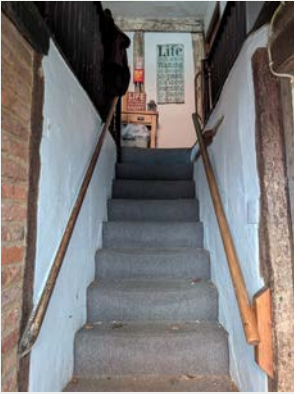
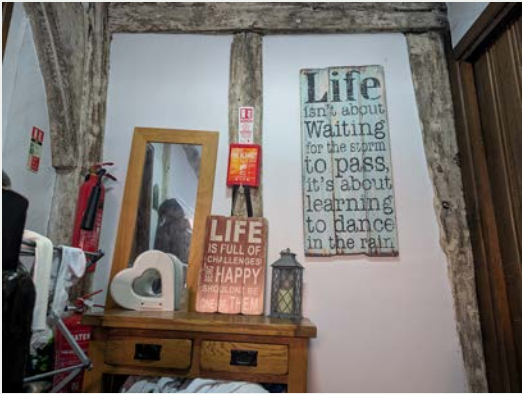
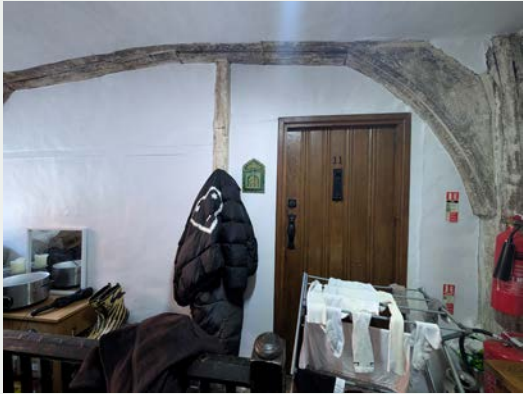
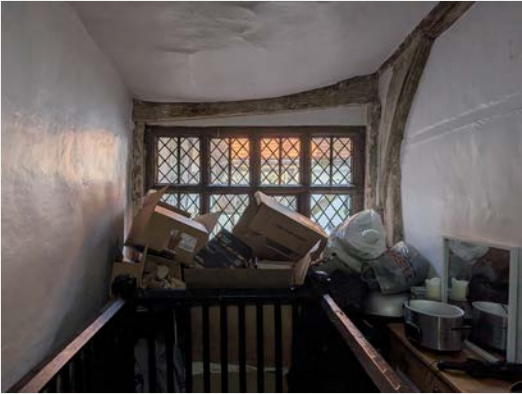
| | | | | | Description | Significance | Condition | Notes | Proposed Repairs |
|---|---|---|---|---|---|---|---|---|---|
| Stairwell (Flats 11+12)<br>WF-08<br>Historic timber beams and studs | | | | | WF-23 historic window | Exceptional | Modertate | Refer to Window Schedule | Refer to Window Schedule |
| | | | | | Historic timber beams and studs | High | Moderate | Unpainted timber generally in fairly good repair though does have some electrical cabling and fixtures attached to it | Remove electrical fittings and other fixtures and accessories. Clean up and assess condition of timber. |

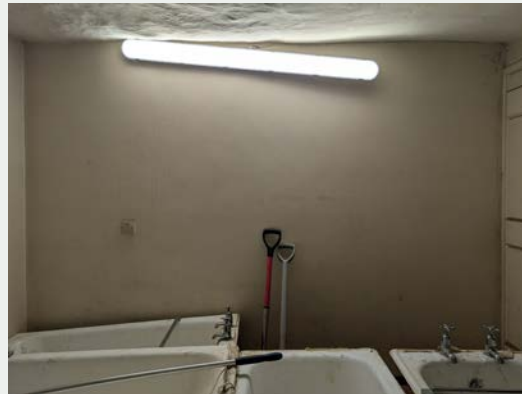
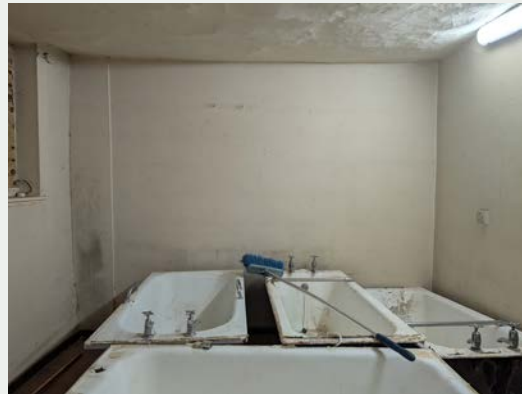
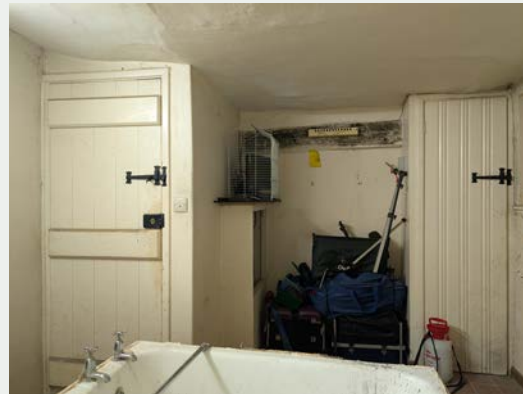
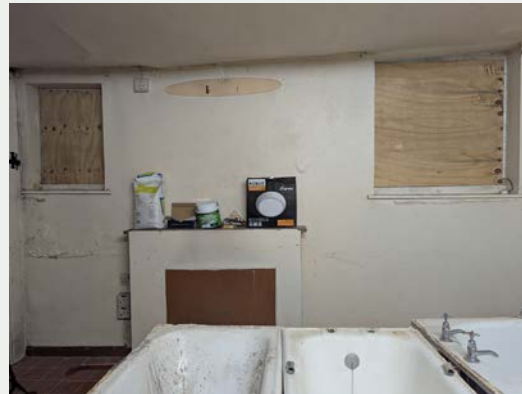
| | | | | | Description | Significance | Condition | Notes | Proposed Repairs |
|---|---|---|---|---|---|---|---|---|---|
| <div>Store Room</div> <div>WG-01, WG-02 (boarded up)</div> <div>Historic timber beam</div> | | | | | Historical timber beam above entrance door (in partition wall between laundry room and store room). | High | Moderate | Some deterioration due to moisture in the air from room use | Remove partitions (store room side).<br>Remove pipe and electrical fittings.<br>Clean up and assess condition of timber |

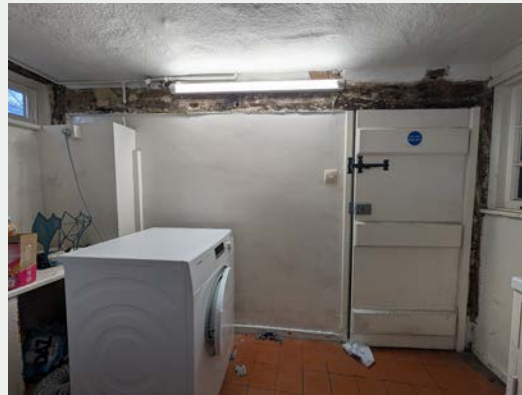
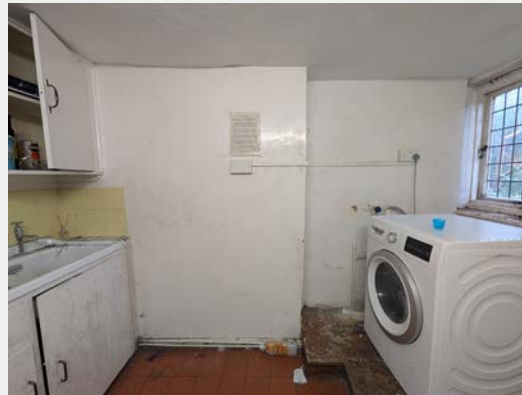
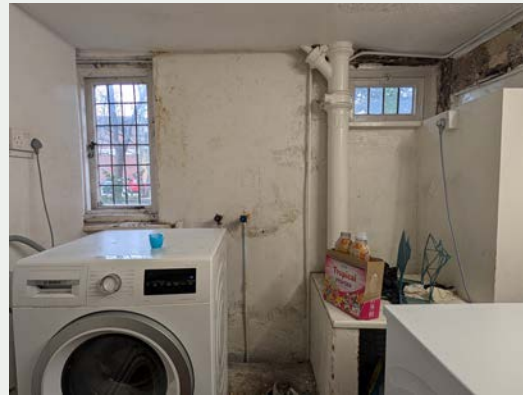
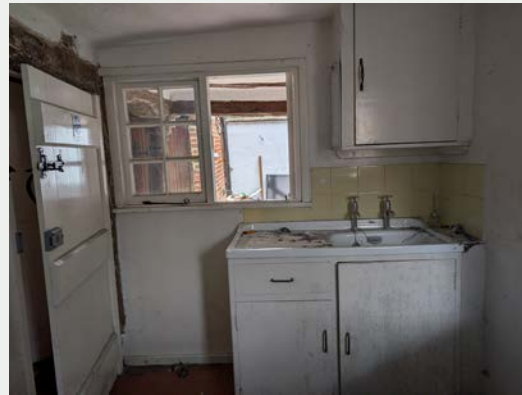
| | | | | | Description | Significance | Condition | Notes | Proposed Repairs |
|---|---|---|---|---|---|---|---|---|---|
| | | | | | Historical timber beam and stud around entrance door (in partition wall between laundry room and store room). | High | Moderate | Some deterioration due to moisture in the air from room use | Remove partitions (store room side).<br>Remove pipe and electrical fittings.<br>Clean up and assess condition of timber |

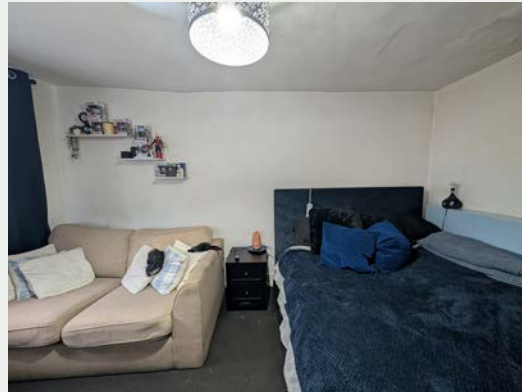
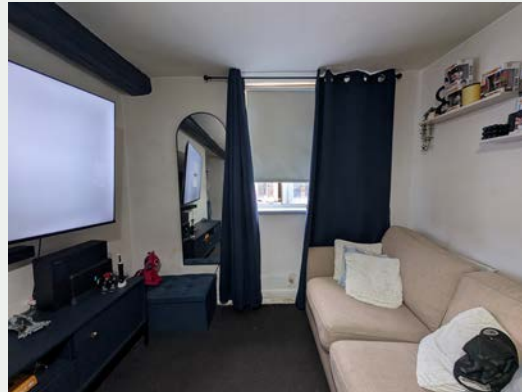
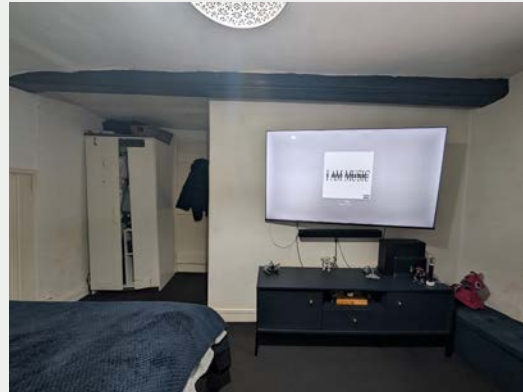
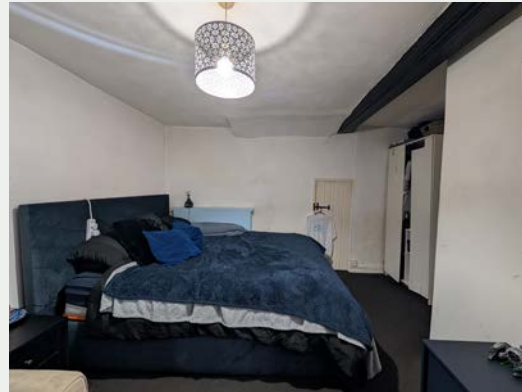
| Flat 2 | | | | | Description | Significance | Condition | Notes | Proposed Repairs |
|---|---|---|---|---|---|---|---|---|---|
| Living/Bedroom<br>WG-19<br>Historic timber beam<br>Meter cupboard (to be retained) | | | | | Historical timber beam in ceiling | High | Good | Historically painted black | Clean up and assess condition of timber |

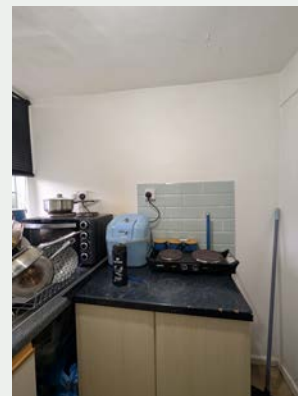
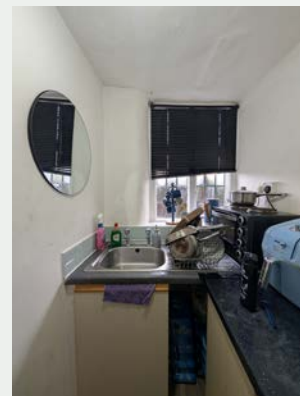
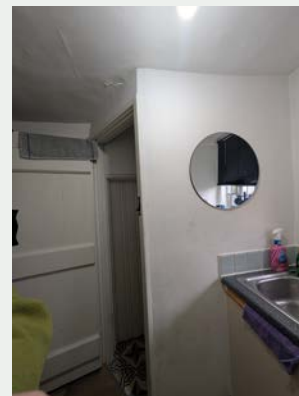
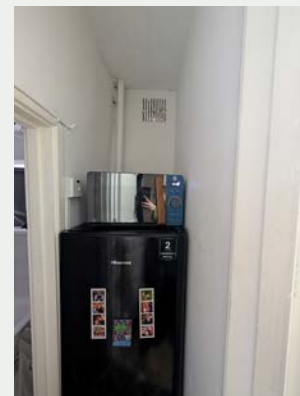
| Flat 2 | | | | | Description | Significance | Condition | Notes | Proposed Repairs |
|---|---|---|---|---|---|---|---|---|---|
| | | | | | No key historic features | Low | Good | | |

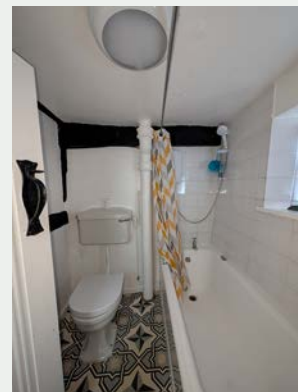
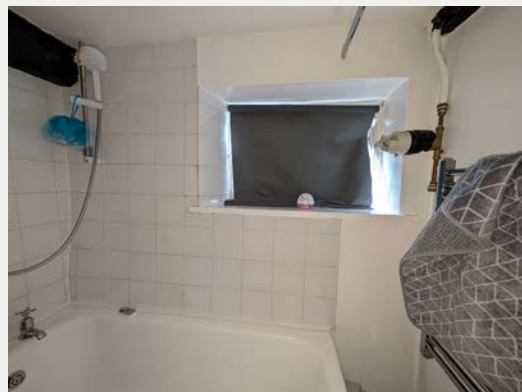
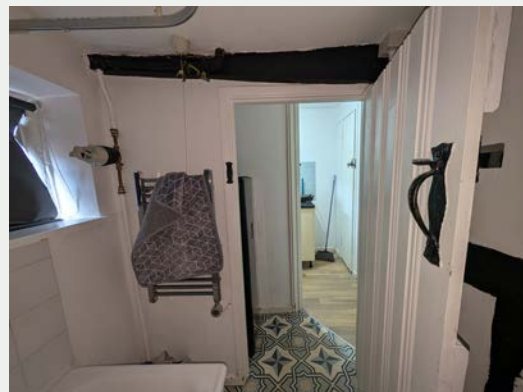
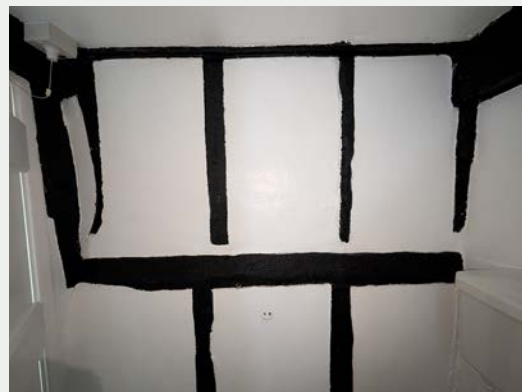
| Flat 2 | | | | | Description | Significance | Condition | Notes | Proposed Repairs |
|---|---|---|---|---|---|---|---|---|---|
| | | | | | Historical timber beams and studs in partition walls | High | Good | Historically painted black | Remove electrical fittings and accessories. Clean up and assess condition of timber |

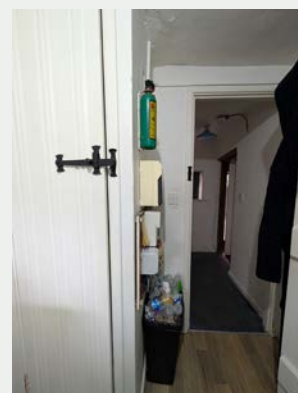
| Flat 2 | | | | | Description | Significance | Condition | Notes | Proposed Repairs |
|---|---|---|---|---|---|---|---|---|---|
| | | | | | No key historic features | Low | Good | | |

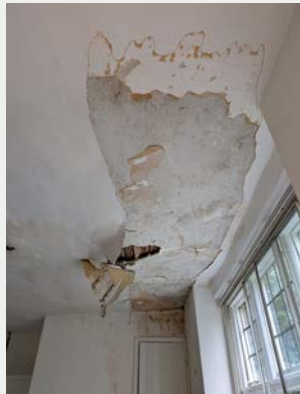
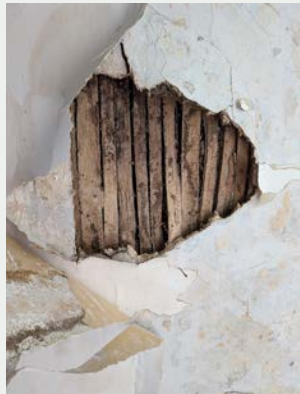
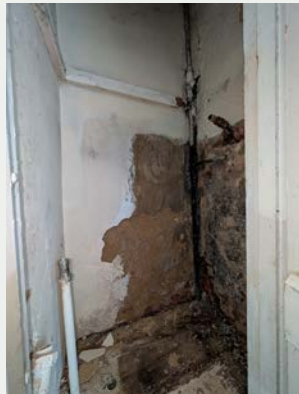
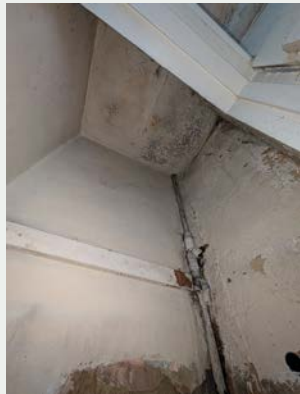
| | | | | | Description | Significance | Condition | Notes | Proposed Repairs |
|---|---|---|---|---|---|---|---|---|---|
| | | | | | Significant water damage to ceiling and cupboard adjacent to chimney breast | Moderate | Very poor | Possible structural damage to ceiling. Building fabric still damp | Strip back affected areas of ceiling and cupboard plaster to assess depth of damage and allow to dry out fully. Reinstate ceiling in the same style where possible. |

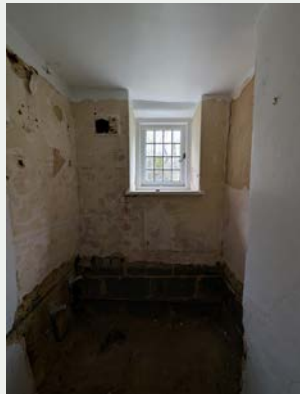
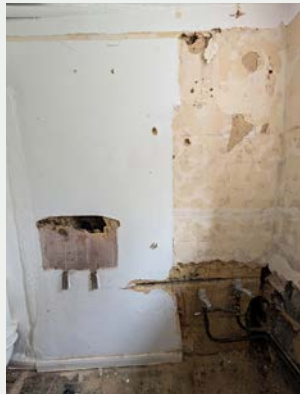
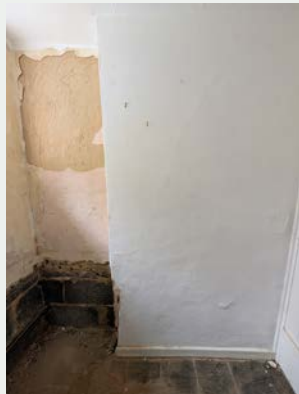
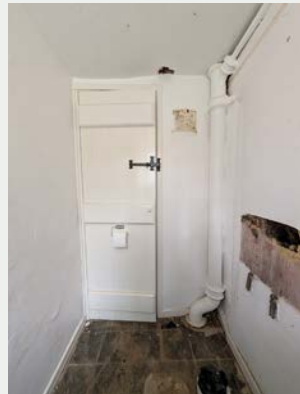
| | | | | | Description | Significance | Condition | Notes | Proposed Repairs |
|---|---|---|---|---|---|---|---|---|---|
| | | | | | Cast iron service pipe | Moderate | Moderate | Pipe work painted over white | Service positions to be kept the same, existing pipe work network utilised where possible |

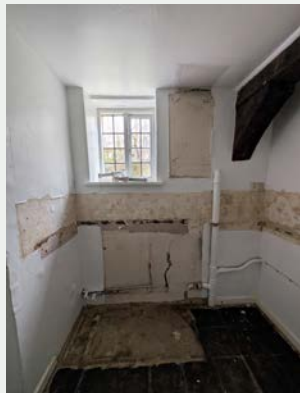
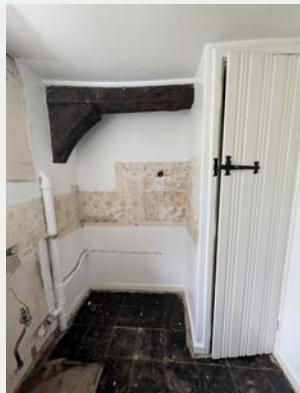
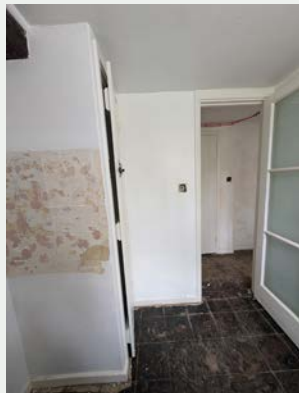
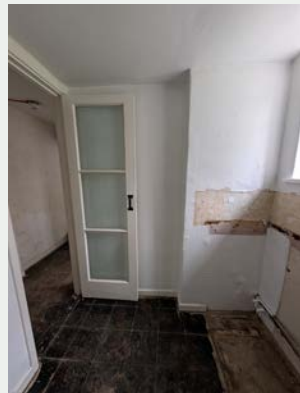
| | | | | | Description | Significance | Condition | Notes | Proposed Repairs |
|---|---|---|---|---|---|---|---|---|---|
| | | | | | Historic timber beam and arched support. Cast iron services. | High | Poor | Glass door is not inkeeping with historic fabric | Replace modern door to kitchen. Storage cupboard removed. Service positions to be kept the same, existing pipe work network utilised where possible. Fittings and fixtures kept seperate from historic timber. |

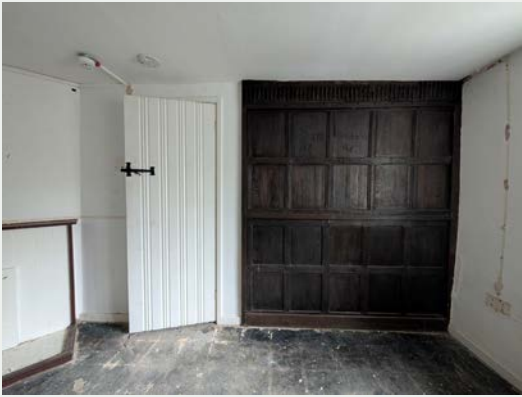
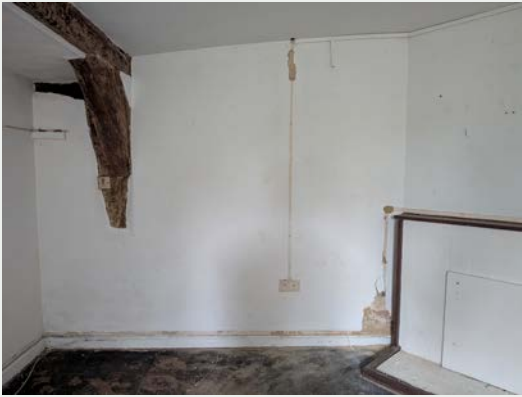
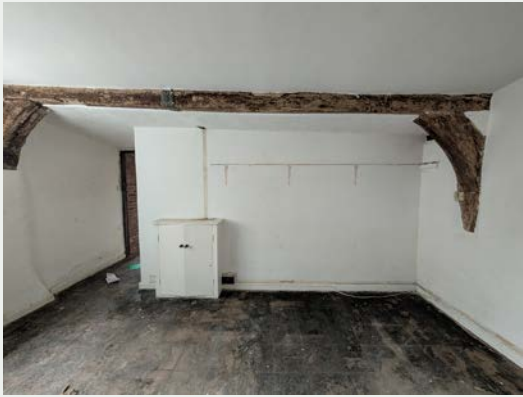
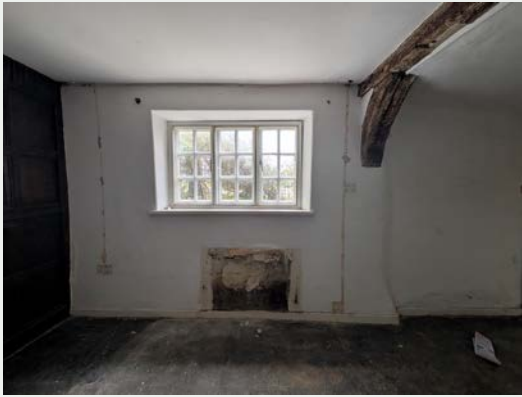
| | | | | | Description | Significance | Condition | Notes | Proposed Repairs |
|---|---|---|---|---|---|---|---|---|---|
| Living/Bedroom<br>WG-10<br>Historic timber panelling<br>Historic timber work<br>Meter cabinet position to be retained | | | | | Historic timber panelling | High | Good | Generally in good repair with some historic graffiti etched into two of the panels | Clean up and assess condition of timber |

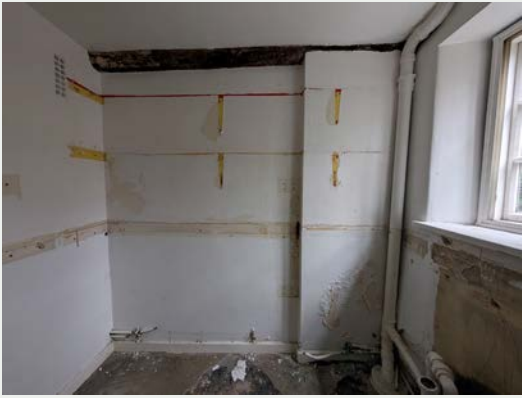
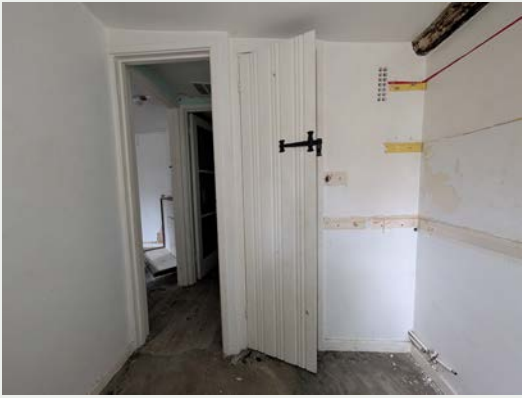
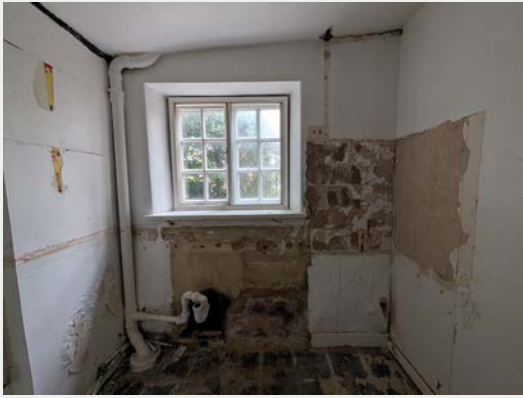
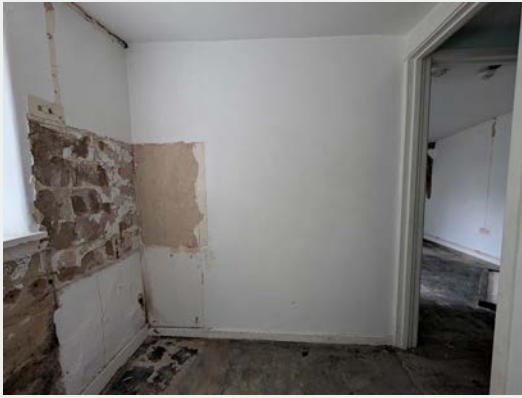
| | | | | | Description | Significance | Condition | Notes | Proposed Repairs |
|---|---|---|---|---|---|---|---|---|---|
| Kitchen<br>WG-11<br>Historic timber beam | | | | | Historic timber beam in ceiling adjacent to partition | High | Moderate | Some deterioration due to room use | Clean up and assess condition of timber |
