## 299 - The Biggin

Condition Survey

02/26: Planning Issue

**Michael Collins Architects**

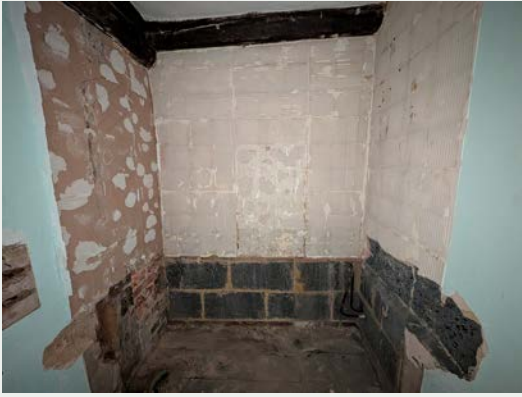
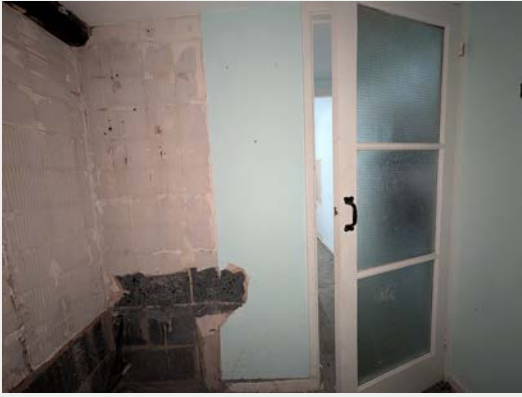
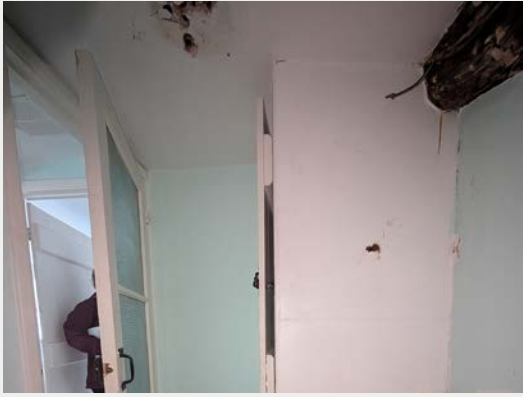
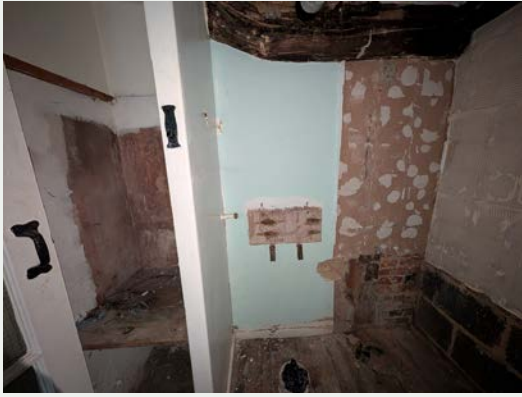
| | | | | | Description | Significance | Condition | Notes | Proposed Repairs |
|---|---|---|---|---|---|---|---|---|---|
| Bathroom<br>Historic timber beam | | | | | Historic timber beams in ceiling adjacent to partitions | High | Moderate | Some deterioration due to room use. Does have some electrical cabling and fixtures attached to it | Remove electrical fittings and accessories. Clean up and assess condition of timber |

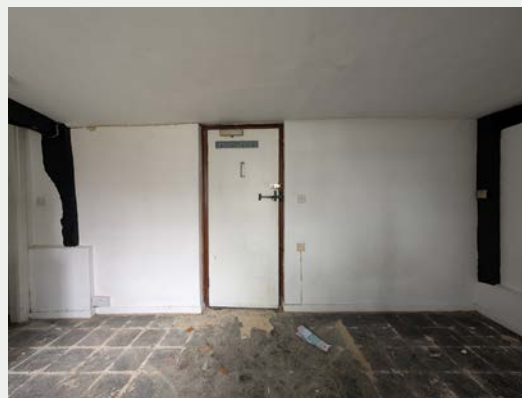
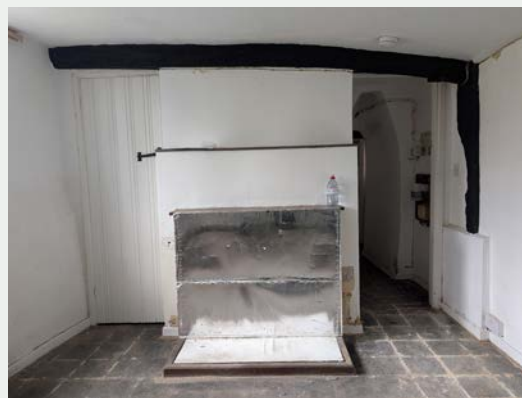
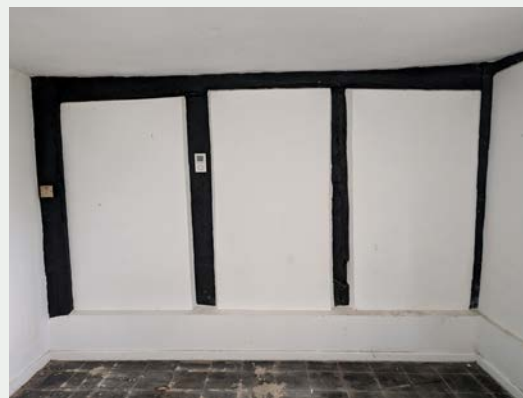
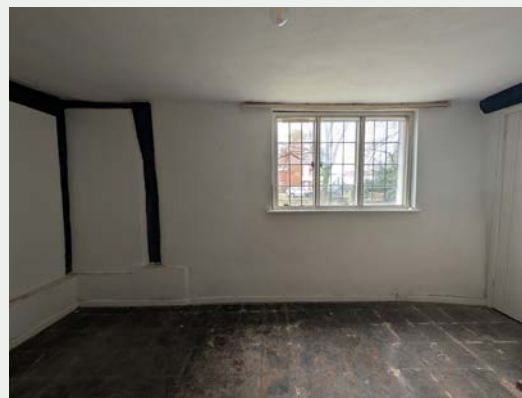
| | | | | | Description | Significance | Condition | Notes | Proposed Repairs |
|---|---|---|---|---|---|---|---|---|---|
| Living/Bedroom<br>WG-09<br>Historic timber beams and studs | | | | | Historical timber beams and studs in partition walls | High | Poor | Historically painted black. Some electrical cabling and fixtures attached to structure. Elevation with four studs is the external south western wall with significant damp and rot. | Remove electrical fittings and accessories. Clean up and assess condition of timber. Internal works may be required as part of the facade remediation. |

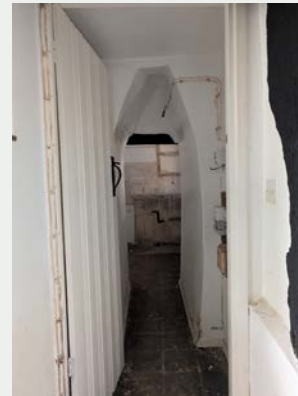
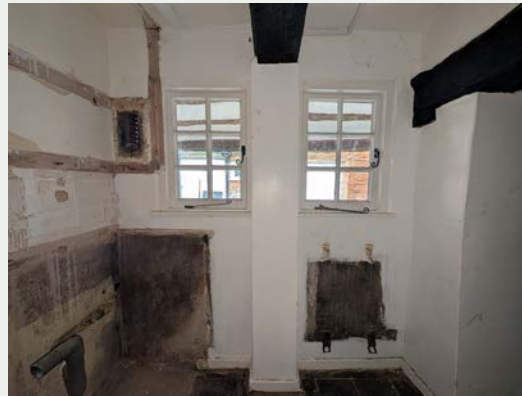
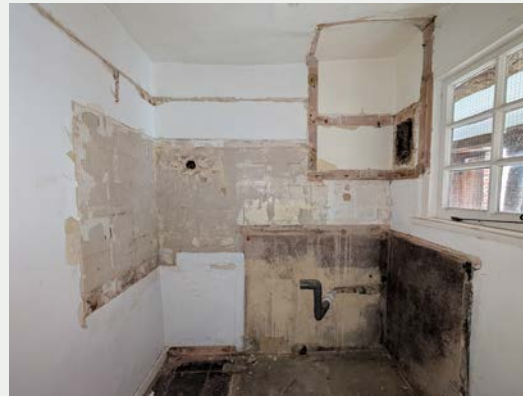
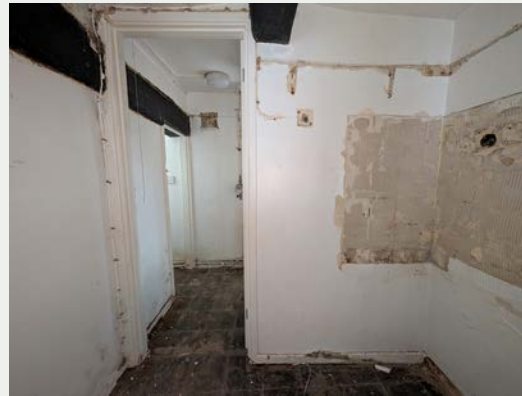
| | | | | | Description | Significance | Condition | Notes | Proposed Repairs |
|---|---|---|---|---|---|---|---|---|---|
| | | | | | Historic timber beams in ceiling | High | Moderate | Historically painted black | Clean up and assess condition of timber |

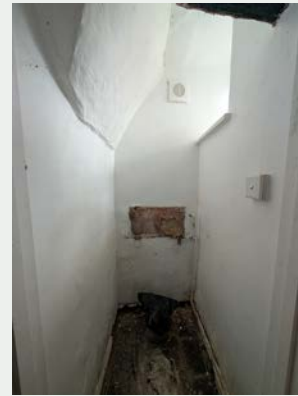
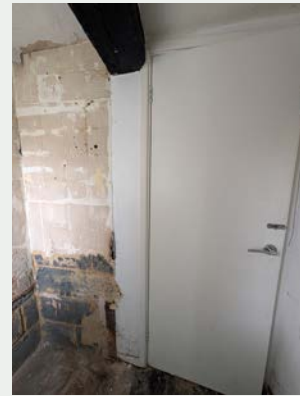
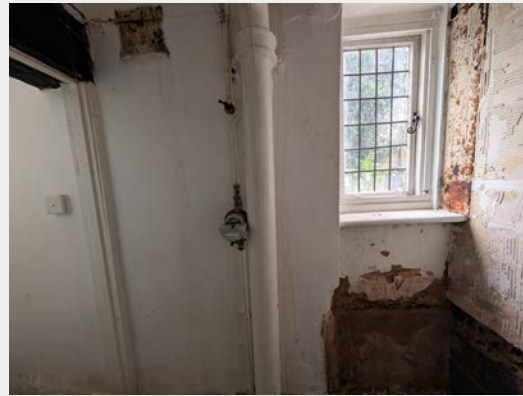
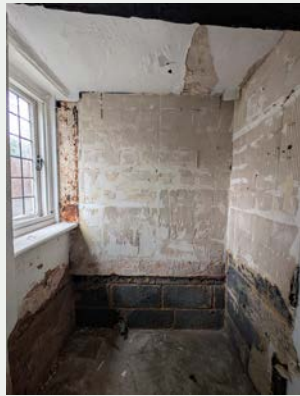
| | | | | | Description | Significance | Condition | Notes | Proposed Repairs |
|---|---|---|---|---|---|---|---|---|---|
| | | | | | Historic timber beam in ceiling | High | Moderate | Historically painted black. Generally in good repair though does have some electrical cabling and fixtures attached to it | Remove electrical fittings and accessories. Clean up and assess condition of timber |

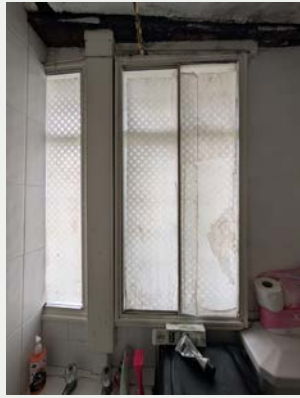
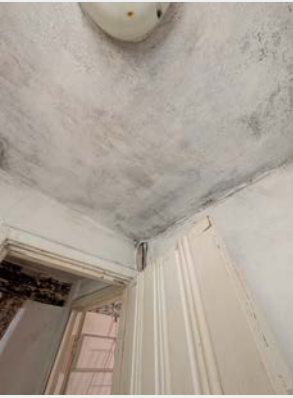
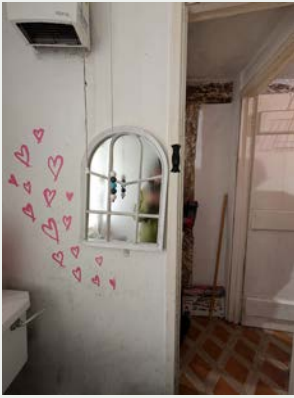
| | | | | Description | Significance | Condition | Notes | Proposed Repairs |
|---|---|---|---|---|---|---|---|---|
| Bathroom<br>WF-03 Room in very poor condition due to lack of ventilation and build up of condensation, damp, and mold | | | | | High | Very poor | Unpainted but weathered timbers | Timbers will be retained new fittings separate. Room will need to be unoccupied and dried out/ventilated. |

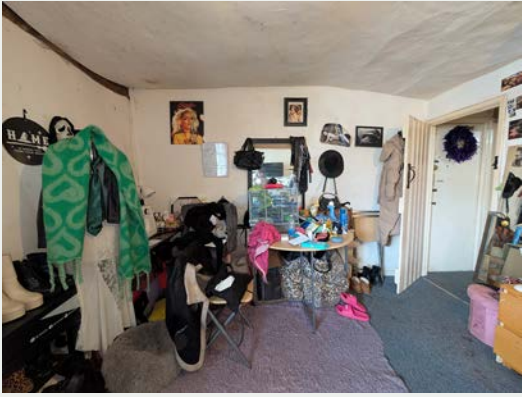
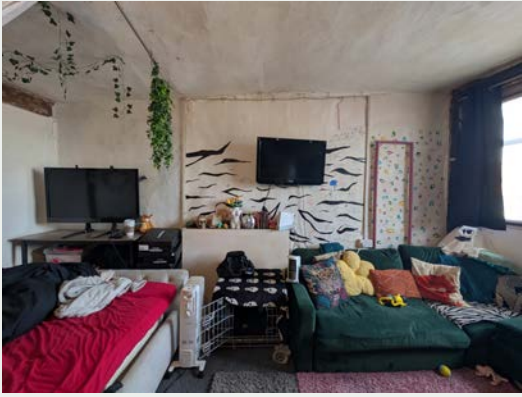
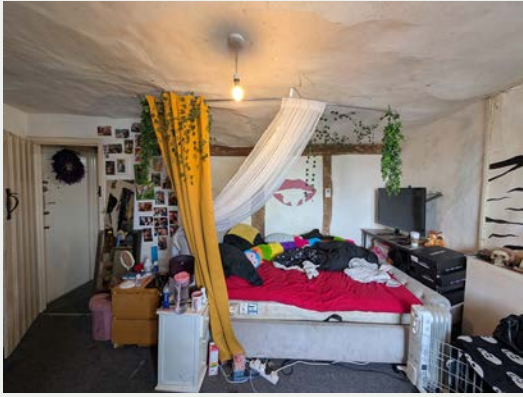
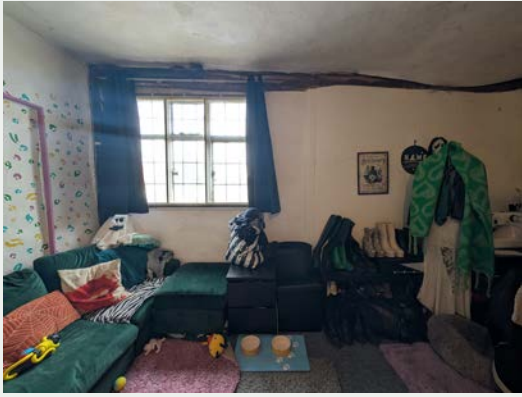
| | | | | Description | Significance | Condition | Notes | Proposed Repairs |
|---|---|---|---|---|---|---|---|---|
| Living/Bedroom<br>WF-01 | | | | | High | Poor | Unpainted but weathered timbers | Timbers will be retained new fittings separate. Room will need to be unoccupied and dried out/ventilated. |

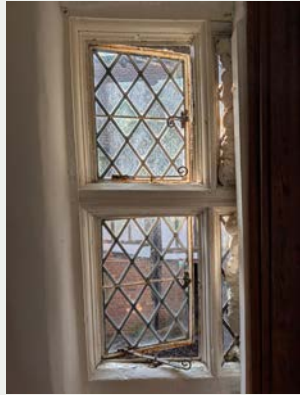
| | | | | Description | Significance | Condition | Notes | Proposed Repairs |
|---|---|---|---|---|---|---|---|---|
| Entrance<br>WF-23 obstructed by partition wall. | | | | Diamond leaded window facing into the courtyard, partially in entrance to Flat 8. | Exceptional | Poor | Openings not all functioning | Partition wall to be removed with great care and further details to following |

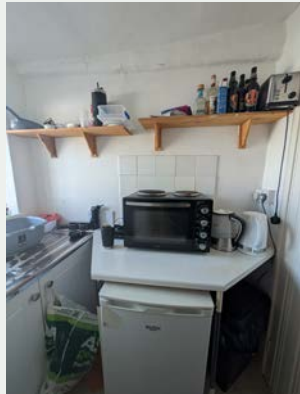
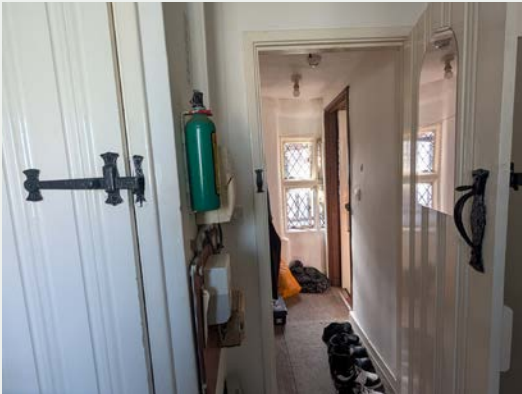
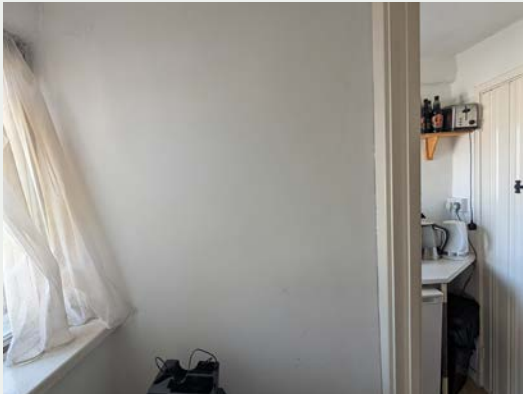
| | | | | Description | Significance | Condition | Notes | Proposed Repairs |
|---|---|---|---|---|---|---|---|---|
| Kitchen and Store<br>WF-20, WF-21. Partition wall to be removed. | | | | No key historic features | Low | Poor | | |

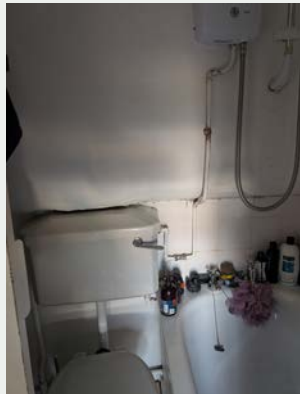
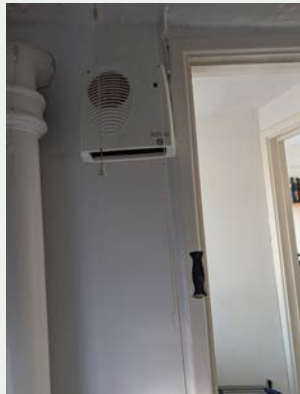
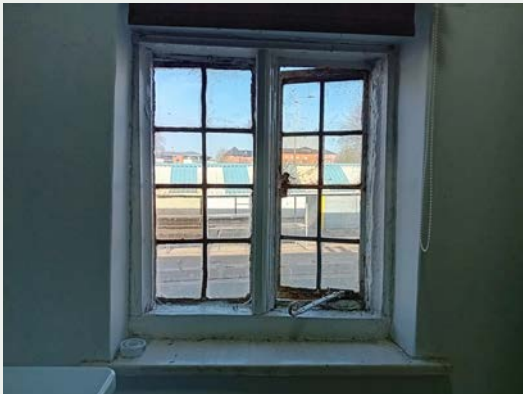
| | | | | Description | Significance | Condition | Notes | Proposed Repairs |
|---|---|---|---|---|---|---|---|---|
| Bathroom | | | | No key historic features. | Low | Poor | | |

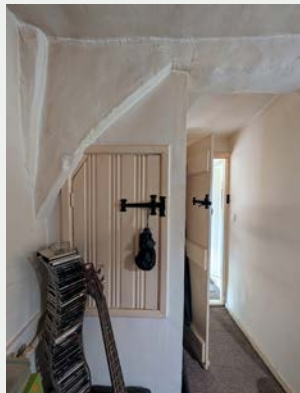
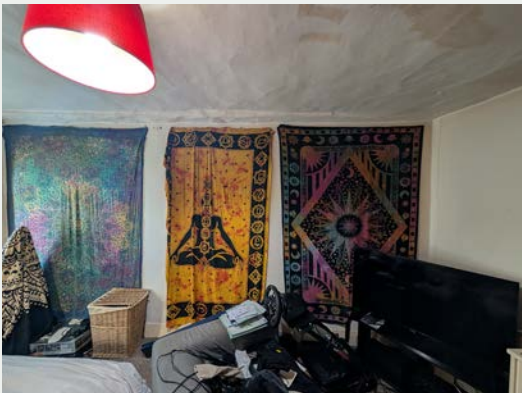
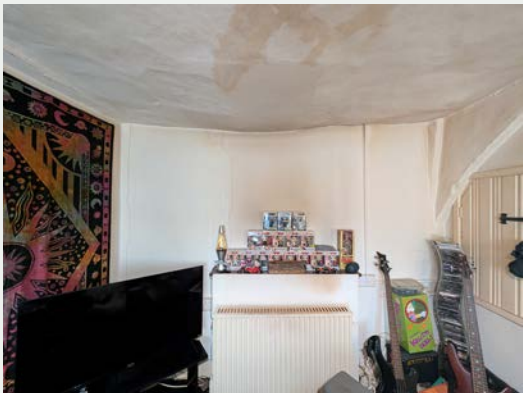
| | | | | Description | Significance | Condition | Notes | Proposed Repairs |
|---|---|---|---|---|---|---|---|---|
| Living/Bedroom<br>Window is left consistently closed, room therefore kept dark and un-ventilated | | | | Historic beam across entry elevation and arch above storage cupboard | High | Poor | Painted over significantly | Historic features painted over to a point paint cannot be stripped. Retain and keep additional fittings separate. |

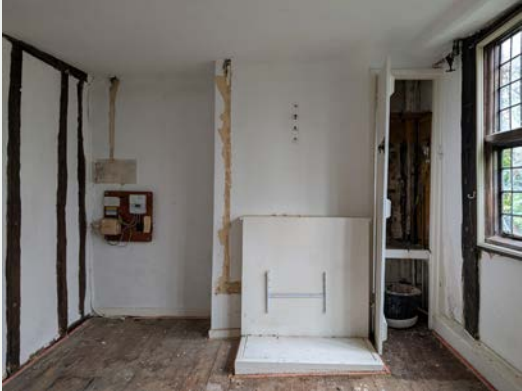
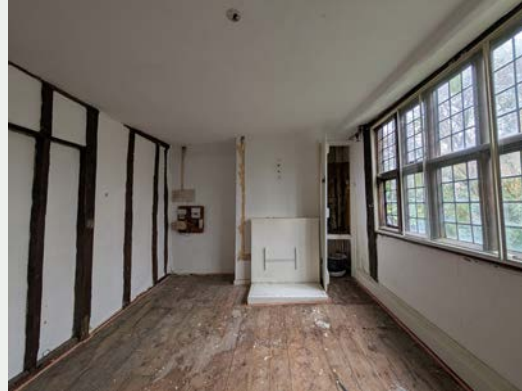
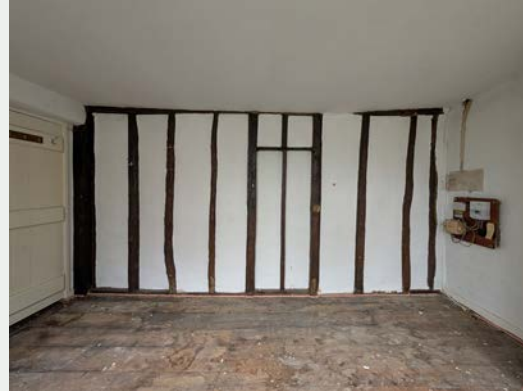
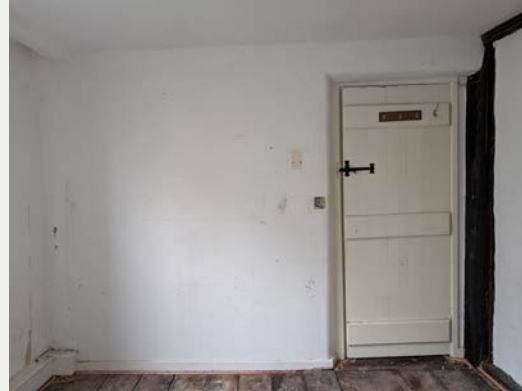
| | | | | | Description | Significance | Condition | Notes | Proposed Repairs |
|---|---|---|---|---|---|---|---|---|---|
| Living/Bedroom<br>WF-18 | | | | | Full wall of historic timbers. Boarded up fire place. Electric meter readers.. | Moderate | Poor | Full wall of historic timbers | Historic timbers to be retained and fittings kept separate. Electric meter readers to be kept in the same location but concealed. Fireplace to be exposed. |

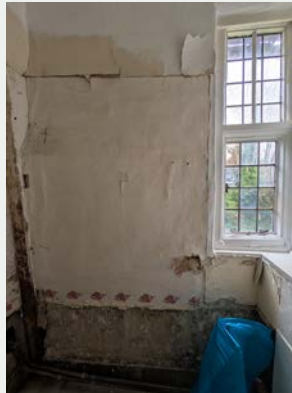
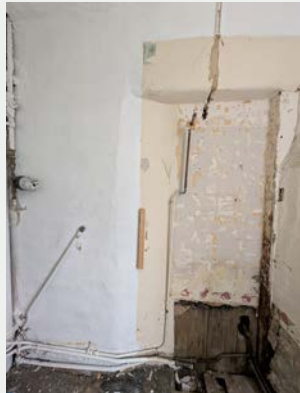
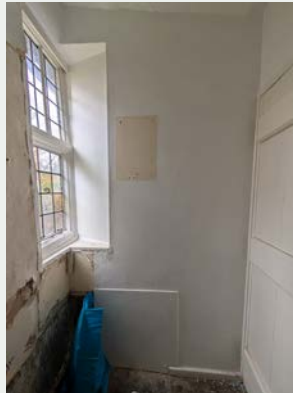
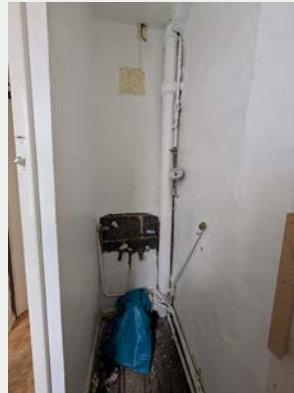
| | | | | | Description | Significance | Condition | Notes | Proposed Repairs |
|---|---|---|---|---|---|---|---|---|---|
| Bathroom<br>WF-17 | | | | | Window met with partition wall. | Low | Poor | | New bathroom fitted. |

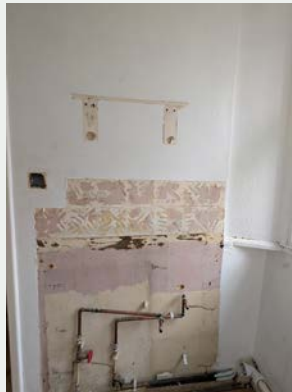
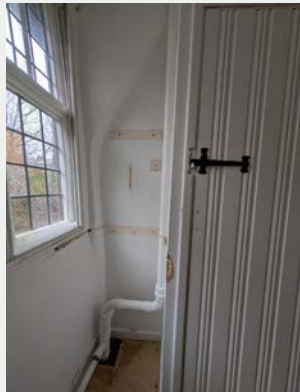
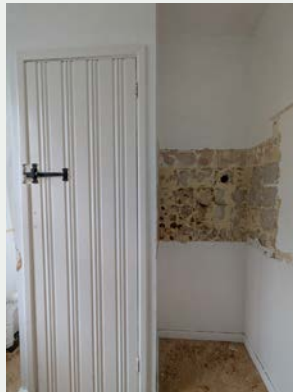
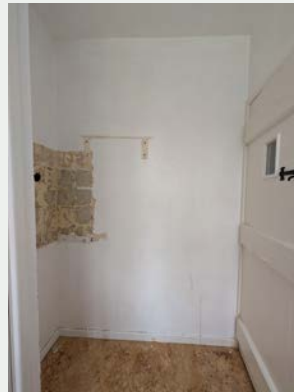
| | | | | | Description | Significance | Condition | Notes | Proposed Repairs |
|---|---|---|---|---|---|---|---|---|---|
| Kitchen<br>WF-17 | | | | | Window met with partition wall. | Low | Poor | Arched chimney stack in wall | Removal of cabinet. New kitchen fitted. |

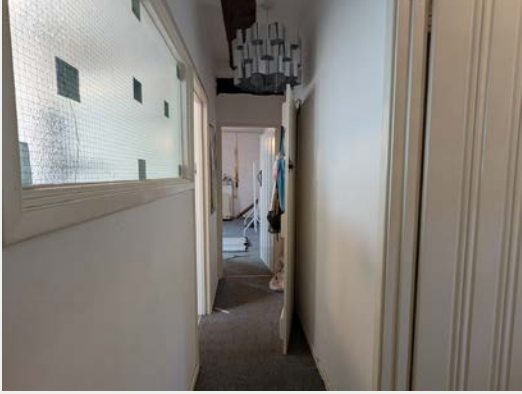
| | | | | Description | Significance | Condition | Notes | Proposed Repairs |
|---|---|--|--|---|---|---|---|---|
| Entrance Corridor | | | | Beam across corridor, beam above opening to living room | Moderate | Moderate | Beam above living room painted black | Keep fittings separate from timbers |

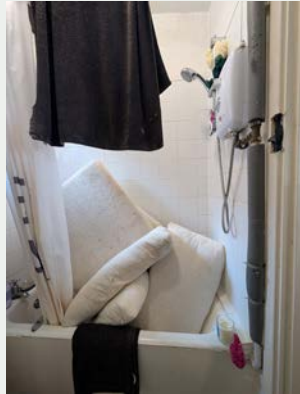
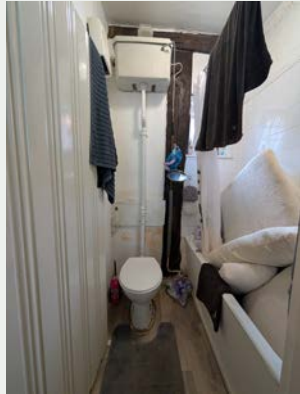
| | | | | Description | Significance | Condition | Notes | Proposed Repairs |
|---|---|--|--|---|---|---|---|---|
| Bathroom<br>WF-15 | | | | Timber stud and beam | Moderate | Moderate | Fittings screwed into column | Fittings removed |

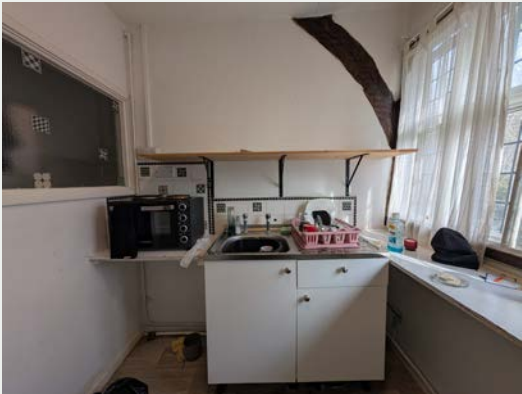
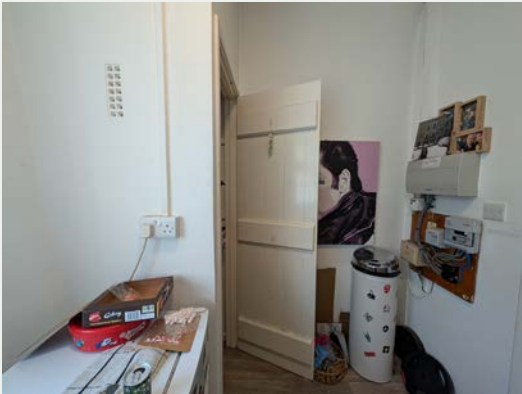
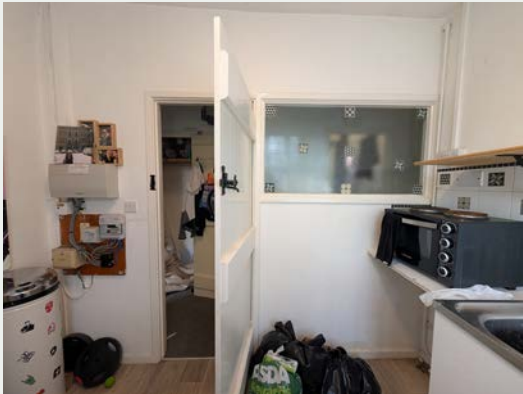
| | | | | Description | Significance | Condition | Notes | Proposed Repairs |
|---|---|--|--|---|---|---|---|---|
| Kitchen<br>WF-14 | | | | Arched historic timber across partition wall | Moderate | Moderate | Partially revealed in partition wall | Retain |

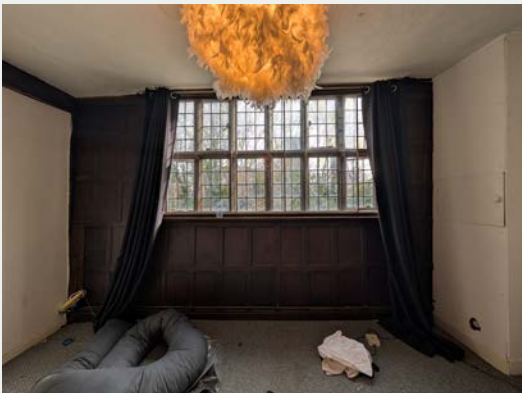
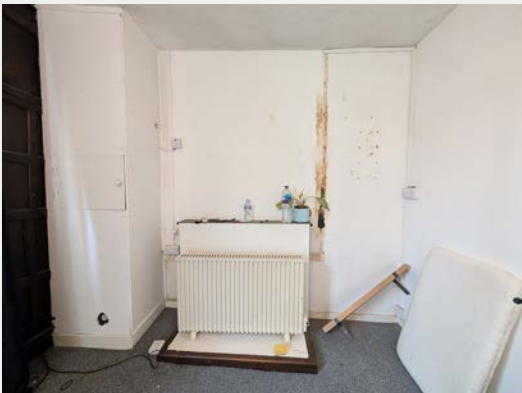
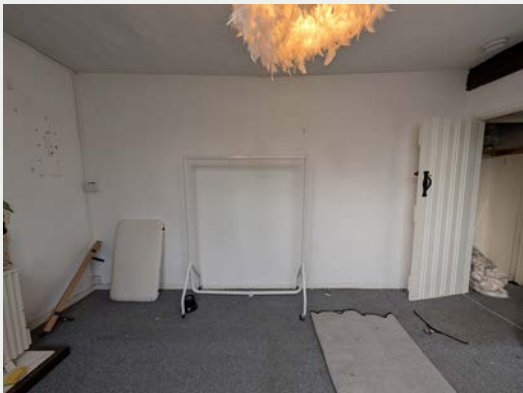
| | | | | Description | Significance | Condition | Notes | Proposed Repairs |
|---|---|--|--|---|---|---|---|---|
| Living/Bedroom<br>WF-13 | | | | Timber panelling, timber beam above doorway | High | Moderate | N/A | Keep fittings separate from panelling |

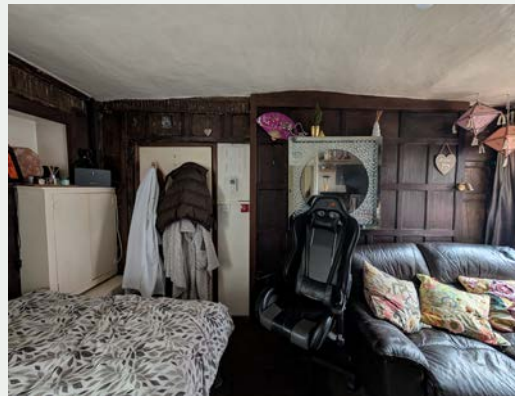
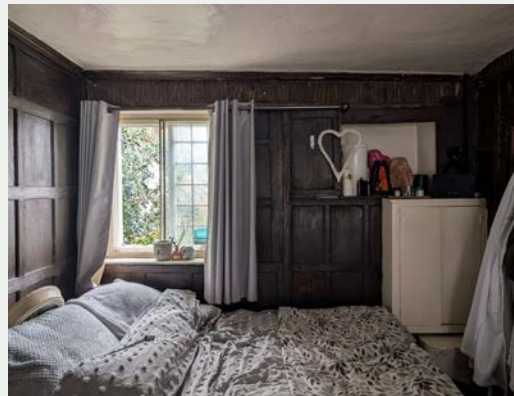
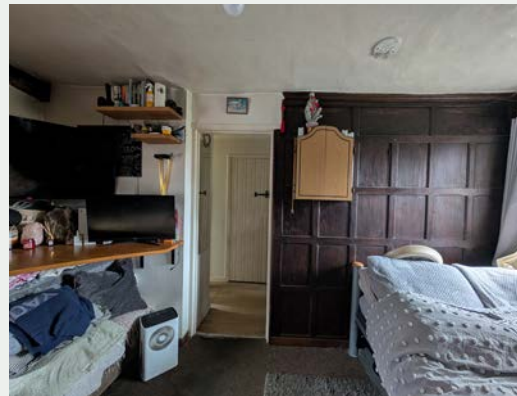
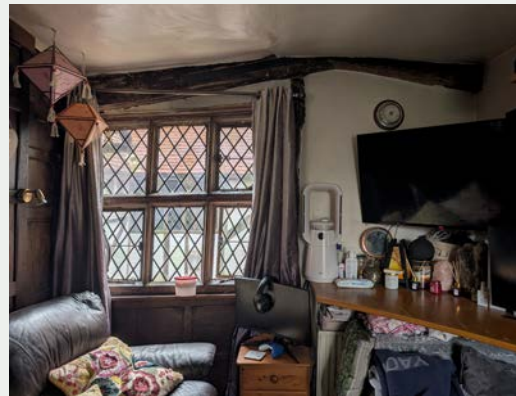
| Flat 11 | | | | | Description | Significance | Condition | Notes | Proposed Repairs | |
|---|---|---|---|---|---|---|---|---|---|---|
| Living/Bedroom<br>WF-05<br>WF-04<br>WF-07 | | | | | Highly significant historic timber panelling with inscriptions and drawings. WF-11 of exceptional historic value, openings working. | Exceptional | Moderate | Various historic inscriptions on parts of panelling. The room has been kept relatively well ventilated by the current tenant however there are some fixtures to the panelling and some panels loose on the southern wall. | Retain and keep fittings seperate. | |

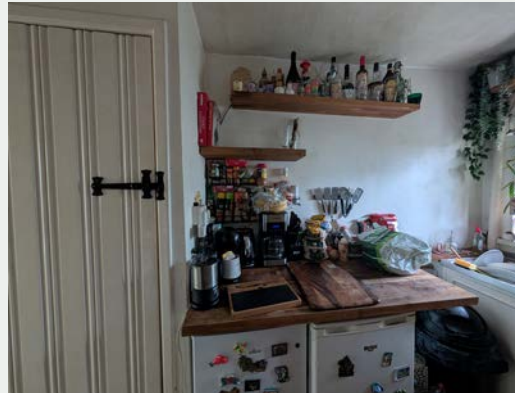
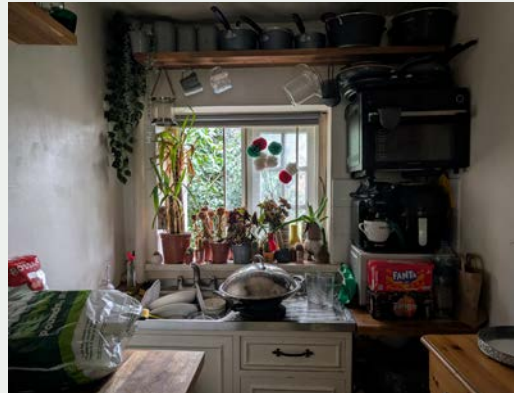
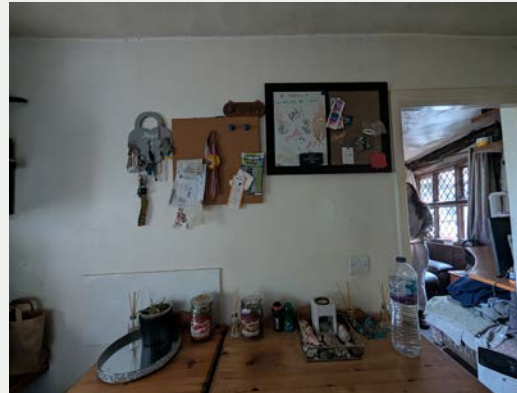
| Flat 11 | | | | | Description | Significance | Condition | Notes | Proposed Repairs | |
|---|---|---|---|---|---|---|---|---|---|---|
| | | | | | | WF-10 has glazing bars and stands out as an anomaly within the historic fabric. No key exposed historic elements. | Low | Moderate | Kitchen storage in cupboards alongside hallway to be removed. | Partition wall between living room and bedroom to be removed. WF-10 to be replaced. |

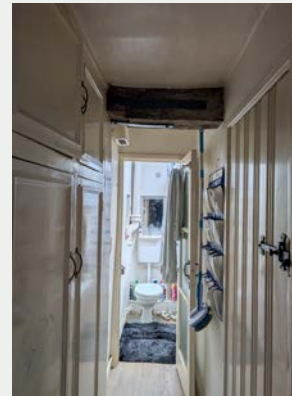
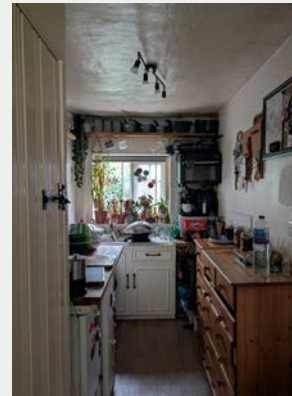
| Flat 11 | | | | | Description | Significance | Condition | Notes | Proposed Repairs | |
|---|---|---|---|---|---|---|---|---|---|---|
| | | | | | | One timber beam over hallway with iron fixtures. | Moderate | Moderate | Unpainted but weathered timbers | Retain and keep fittings seperate |

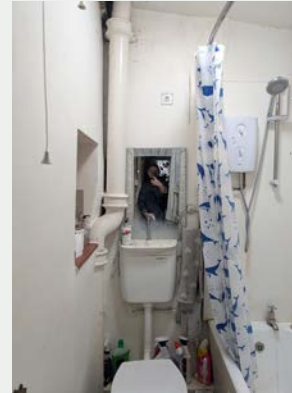
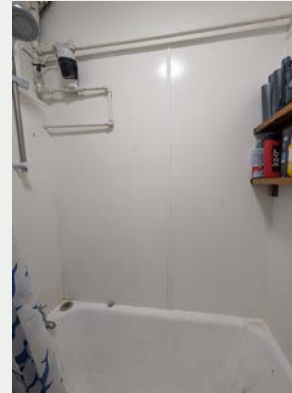
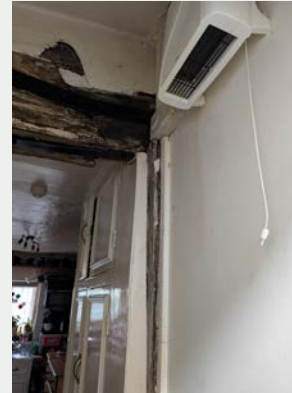
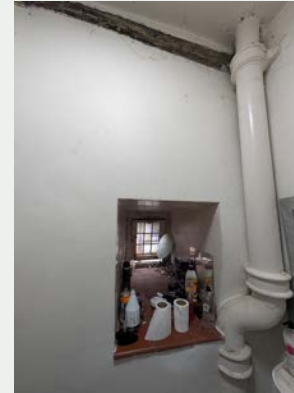
| Flat 11 | | | | | Description | Significance | Condition | Notes | Proposed Repairs | |
|---|---|---|---|---|---|---|---|---|---|---|
| | | | | | | Historic timber beam, cast iron service pipe in deep recess. | High | Poor | Bathroom very poorly ventilated and with significant amounts of mold on historic beam and cast iron services. Timber rotting. Window in deep recess. | Clothes rail removed. Door to storage cupboard to be removed to bring light into the main living/bedroom and reveal the historic stack silhouette. |

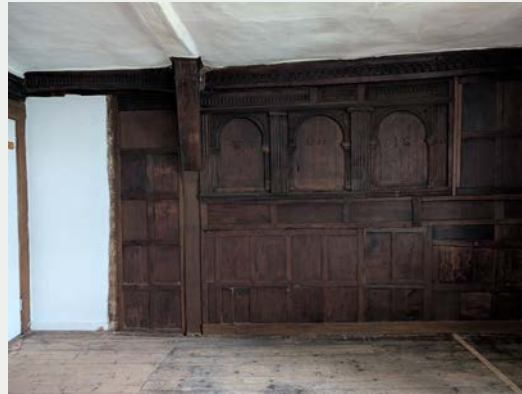
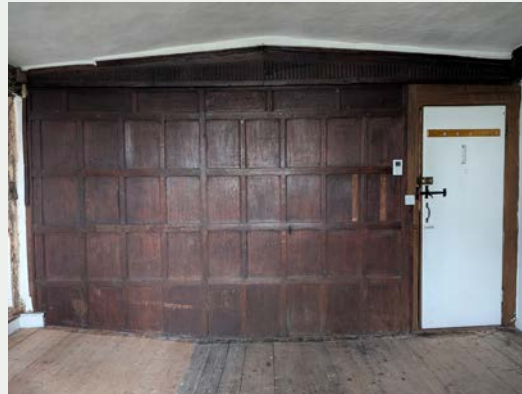
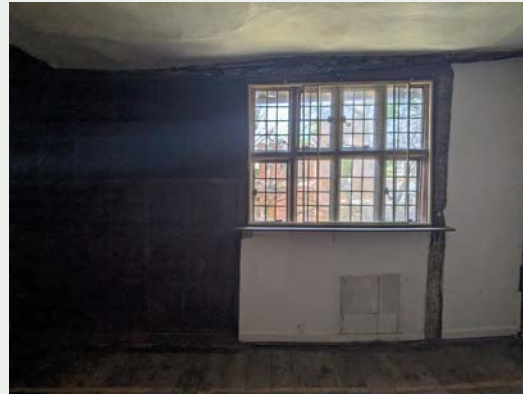
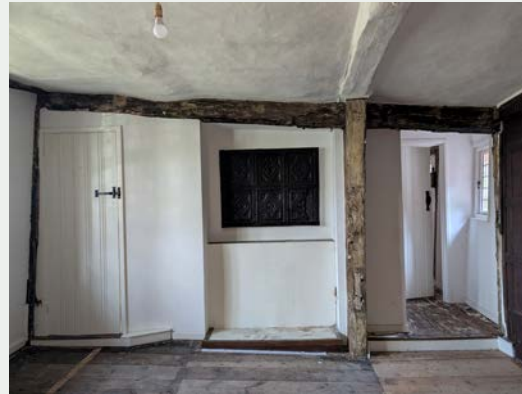
| Flat 12 | | | | | Description | Significance | Condition | Notes | Proposed Repairs | | | |
|---|---|--|--|--|---|---|---|---|---|---|---|---|
| Living/Bedroom<br>WF-05<br>WF-04<br>WF-07 | | | | | | | | Historic timber panelling, various original timber columns and beams. Floor has a significant drop. | High | Moderate | Some timbers have been painted over lightly with white paint. | Key notes/features |

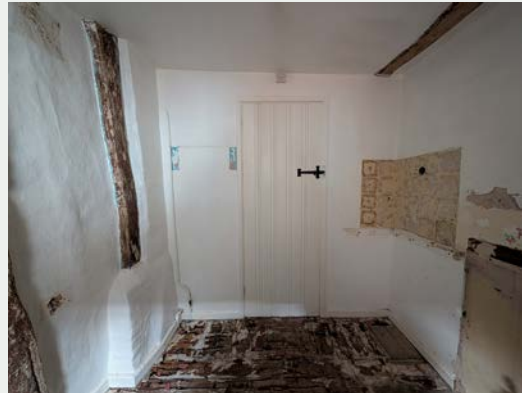
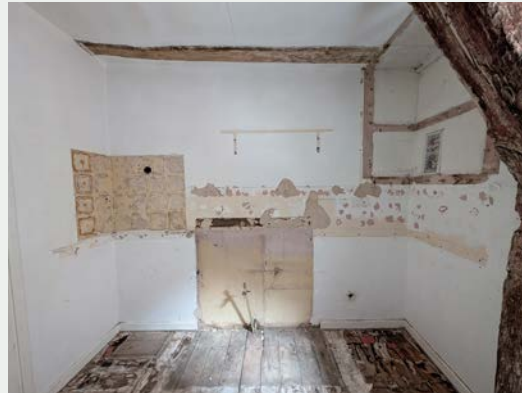
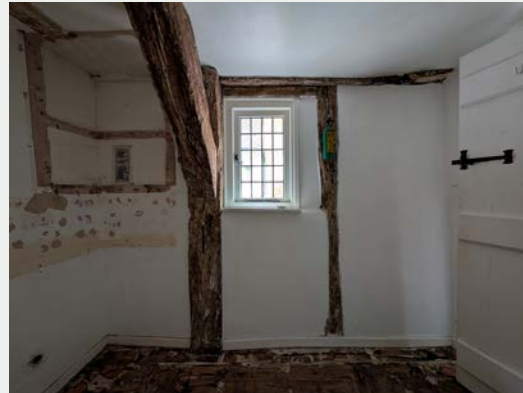
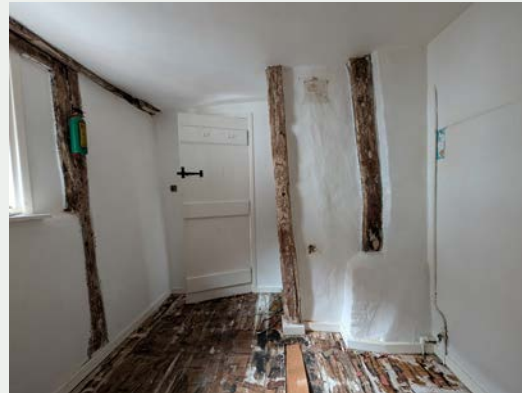
| Flat 12 | | | | | Description | Significance | Condition | Notes | Proposed Repairs | | | |
|---|---|--|--|--|---|---|---|---|---|---|---|---|
| Kitchen<br>WF-06 | | | | | | | | Four historic timber columns, one timber beam and archway | High | Moderate | Unpainted but weathered timbers | Retain and keep fittings seperate |

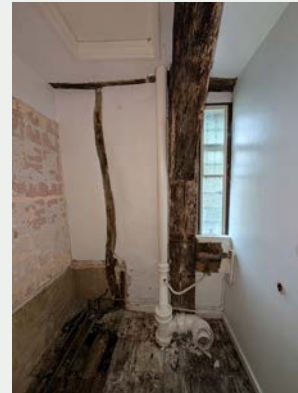
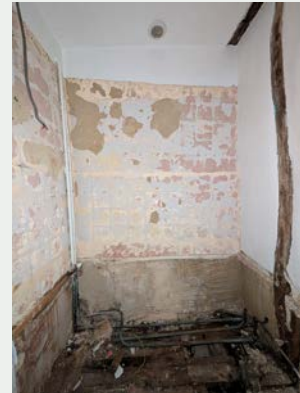
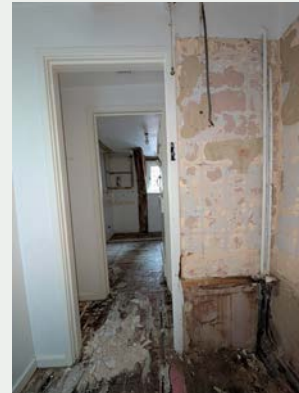
| Flat 12 | | | | | Description | Significance | Condition | Notes | Proposed Repairs | | | |
|---|---|--|--|--|---|---|---|---|---|---|---|---|
| Bathroom<br>Part of WF-03, obstructed by partition wall | | | | | | | | One primary timber column and beam with arched support, one pair of secondary timbers | Moderate | Moderate | Unpainted but weathered timbers | Retain and keep fittings seperate |

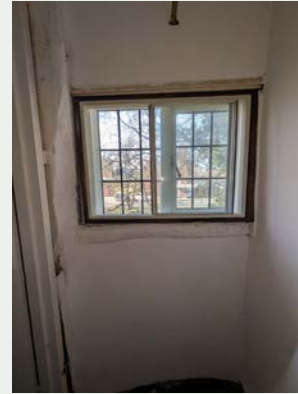
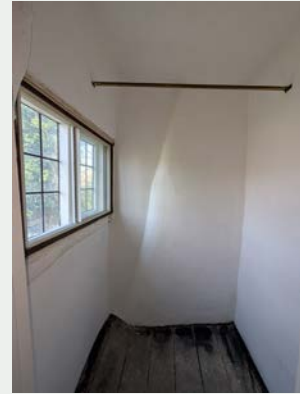
| Flat 12 | | | | | Description | Significance | Condition | Notes | Proposed Repairs | | | |
|---|---|--|--|--|---|---|---|---|---|---|---|---|
| Store Room<br>WF-04 | | | | | | | | Stack visible in wall | Moderate | Good | Painted and recessed into wall. Clothes rail fixed to walls. | Clothes rail removed. Door to storage cupboard to be removed to bring light into the main living/bedroom and reveal the historic stack silhouette. |
