299 - The Biggin: Window Schedule

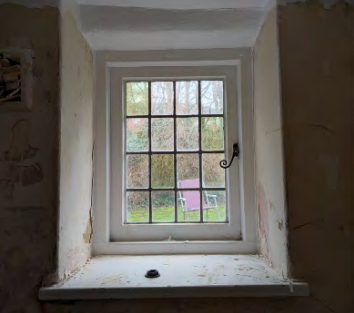
| Reference | Location | Style | Age | Condition | Significance | Internal | External | Detail | Special Features | Glazing Type | Proposed Works |
|---|---|---|---|---|---|---|---|---|---|---|---|
| WG-16 | Flat 03 Bathroom<br>External | Leaded light, casement window. Painted frame. | | 3 Moderate. Worn lead flashing. | Moderate | | | | Side hung opening light. Original timber structure at head. Projected sill. | Single. | Strip paint subject to timber condition. Add slimline secondary glazing. Code 5 Lead Works. |

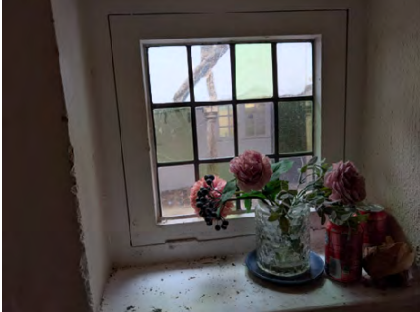
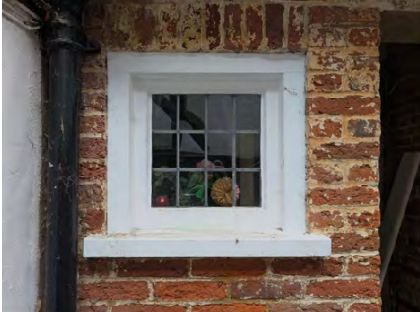
| Reference | Location | Style | Age | Condition | Significance | Internal | External | Detail | Special Features | Glazing Type | Proposed Works |
|---|---|---|---|---|---|---|---|---|---|---|---|
| WG-18 | Stairwell 02<br>Courtyard | Leaded light, casement window. Painted frame. | | 3 Poor | Considerable | | | | Fixed window. Projected sill. | Single. Green and pink tinted panes. | Replace with hardwood frame and rectangular leading. |

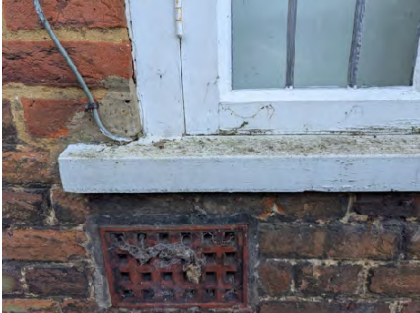
| Reference | Location | Style | Age | Condition | Significance | Internal | External | Detail | Special Features | Glazing Type | Proposed Works |
|---|---|---|---|---|---|---|---|---|---|---|---|
| WG-19 | Flat 02 Liv/Kit/Bed<br>External | Six leaded lights across two rows, casement window. Painted frame. | | 3 Moderate. | Considerable | | | | Two side hung and one top hung opening lights. | Single. Green and pink tinted panes. | Replace with hardwood frame and rectangular leading. |

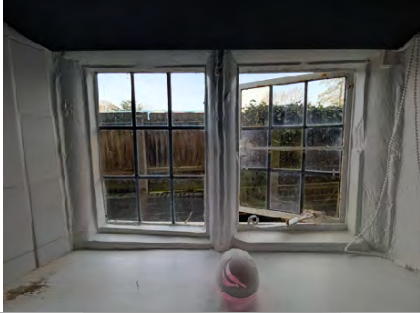
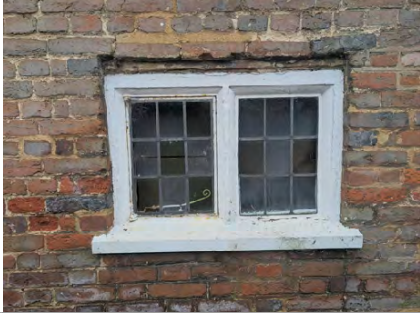
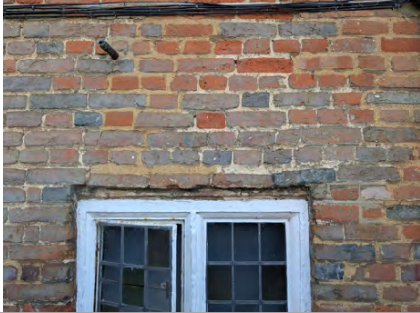
| Reference | Location | Style | Age | Condition | Significance | Internal | External | Detail | Special Features | Glazing Type | Proposed Works |
|---|---|---|---|---|---|---|---|---|---|---|---|
| WG-21 | Flat 02 Bathroom<br>External | Two leaded lights.<br>Painted frame. | | 3 Poor. Window head<br>collapsing. | Moderate | | | | Leaded lights. One<br>side hung opening<br>light, one fixed<br>light. Projected sill. | Single. Green and<br>orange tinted<br>panes. | Strip paint subject<br>to timber condition.<br>Add slimline<br>secondary glazing.<br>New lintel. |

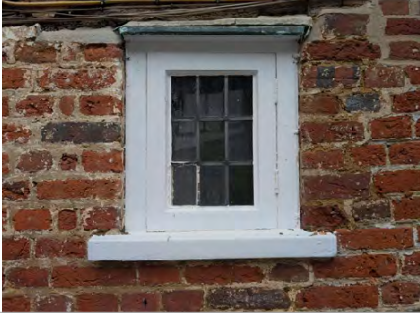
| Reference | Location | Style | Age | Condition | Significance | Internal | External | Detail | Special Features | Glazing Type | Proposed Works |
|---|---|---|---|---|---|---|---|---|---|---|---|
| WG-22 | Flat 02 Lobby<br>Courtyard | Leaded light,<br>casement window.<br>Painted frame. | | 3 Moderate. | Considerable | | | | Side hung opening.<br>Projected sill. | Single. | Strip paint subject<br>to timber condition.<br>Add slimline<br>secondary glazing.<br>Code 5 leadworks. |

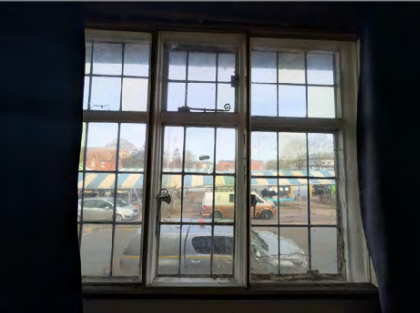
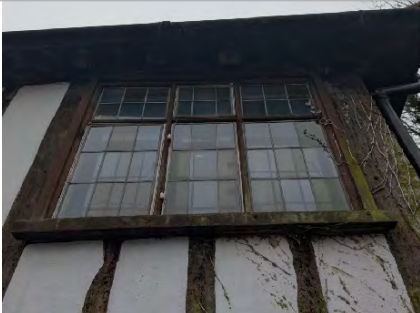
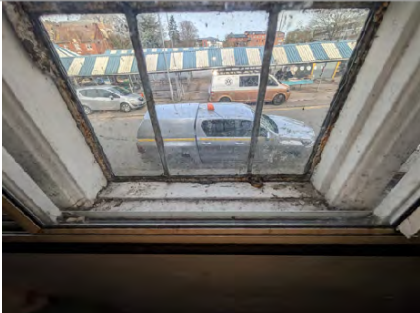
| Reference | Location | Style | Age | Condition | Significance | Internal | External | Detail | Special Features | Glazing Type | Proposed Works |
|---|---|---|---|---|---|---|---|---|---|---|---|
| WF-01 | Flat 07 Liv/Bed<br>External | Six leaded lights<br>across two rows,<br>casement window.<br>Original hardwood<br>frame. | | 3 Very poor | Considerable | | | | Leaded lights. Two<br>side hung opening<br>light, one fixed<br>light. | Single. | Sensitive repairs<br>and cleaning.<br>Introduction of<br>slimline secondary<br>glazing to improve<br>building<br>performance. |

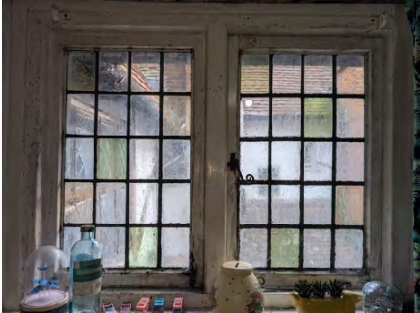
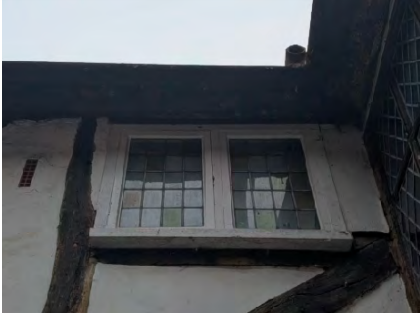
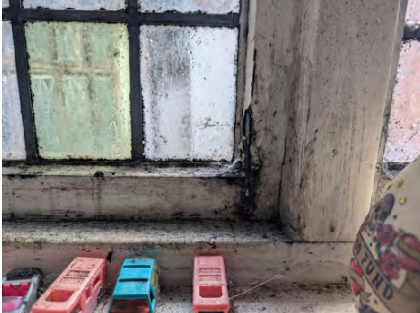
| Reference | Location | Style | Age | Condition | Significance | Internal | External | Detail | Special Features | Glazing Type | Proposed Works |
|---|---|---|---|---|---|---|---|---|---|---|---|
| WF-02 | Flat 07 Kitchen<br>Courtyard | Two leaded lights,<br>casement window.<br>Painted frame. | | 3 Very poor | Considerable | | | | Leaded lights. One<br>side hung opening<br>light, one fixed<br>light. Projected sill. | Single. Side hung<br>casement opening. | Replace with<br>hardwood frame<br>and rectangular<br>leading. |

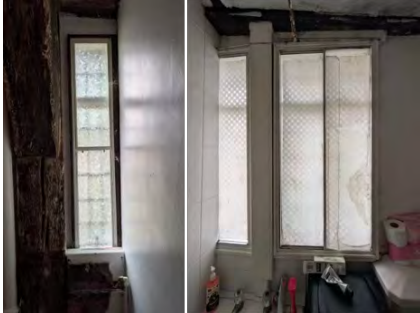
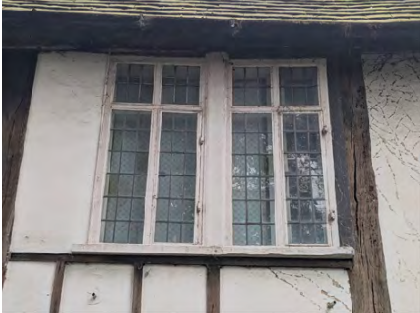
| Reference | Location | Style | Age | Condition | Significance | Internal | External | Detail | Special Features | Glazing Type | Proposed Works |
|---|---|---|---|---|---|---|---|---|---|---|---|
| WF-03 | Flat 07 Bathroom<br>External | Eight leaded lights<br>across two rows,<br>casement window.<br>Painted frame. | | 3 Poor. Obstructed<br>by imposed internal<br>wall. | Considerable | | | | Leaded lights. Two<br>side hung opening<br>light, two fixed<br>lights. | Single. Frosted<br>sliding secondary<br>glazing panels<br>internal. Side hung<br>casement<br>openings. | Replace with<br>hardwood frame<br>and rectangular<br>leading. |

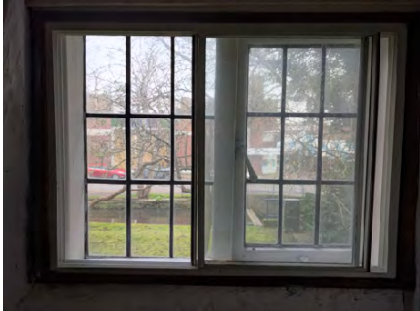
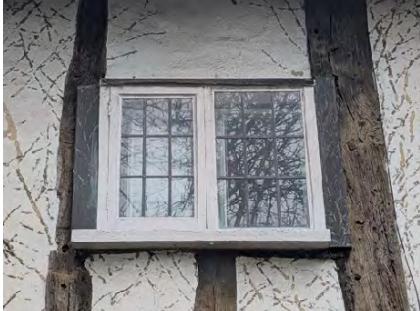
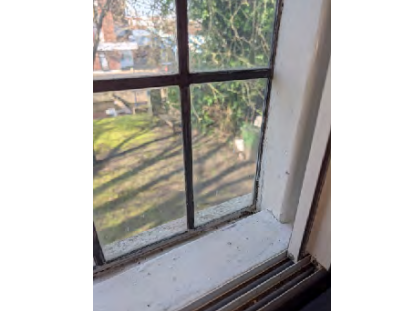
| Reference | Location | Style | Age | Condition | Significance | Internal | External | Detail | Special Features | Glazing Type | Proposed Works |
|---|---|---|---|---|---|---|---|---|---|---|---|
| WF-04 | Flat 12 Cupboard External | Two leaded lights. Painted frame with irregular repairs (mismatched timber detailing) | | 3 Moderate | Considerable | | | | One side hung opening light, one fixed light. | Single. Sliding secondary glazing panels internal. | Replace with hardwood frame and rectangular leading. |

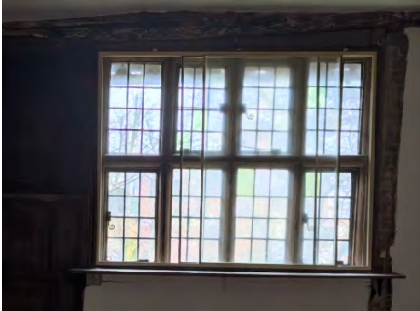
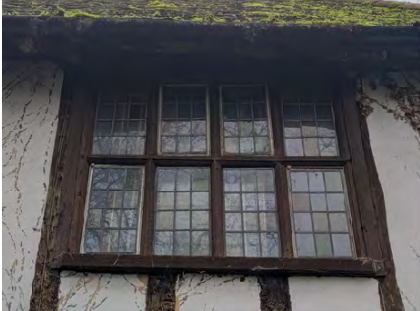
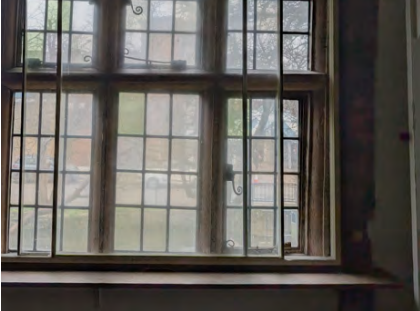
| Reference | Location | Style | Age | Condition | Significance | Internal | External | Detail | Special Features | Glazing Type | Proposed Works |
|---|---|---|---|---|---|---|---|---|---|---|---|
| WF-05 | Flat 12 Liv/Bed External | Eight leaded vertical lights across two rows, casement window. Original hardwood frames. | | 3 Good | Considerable | | | | Multiple side hung opening lights. Original timber structure framing opening. | Single. Sliding secondary glazing panels internal. | Sensitive repairs and cleaning. Introduction of slimline secondary glazing to improve building performance. |

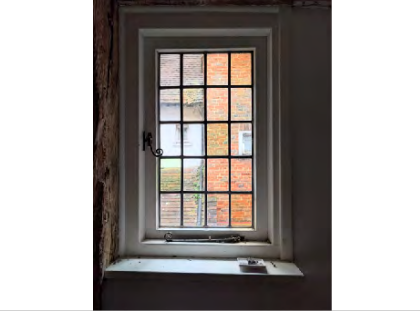
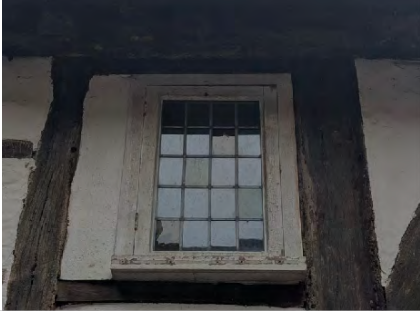
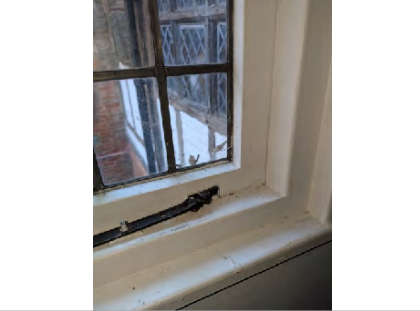
| Reference | Location | Style | Age | Condition | Significance | Internal | External | Detail | Special Features | Glazing Type | Proposed Works |
|---|---|---|---|---|---|---|---|---|---|---|---|
| WF-06 | Flat 12 Kitchen Courtyard | Leaded light, casement window. Painted frame. | | 4 Good | Considerable | | | | Side hung opening light. Original timber structure partially framing opening. | Single. Green and orange tinted panes. | Strip paint subject to timber condition. Add slimline secondary glazing. |

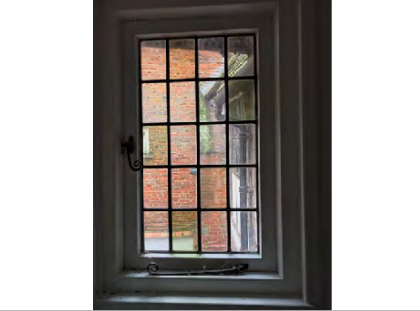
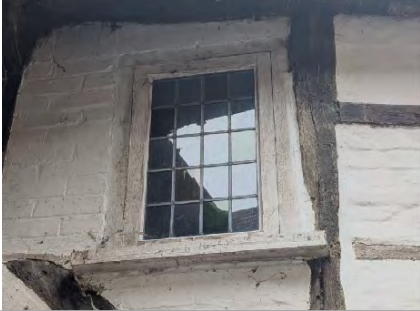
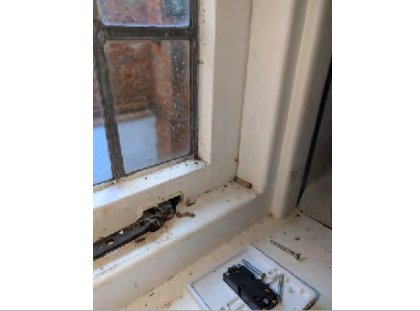
| Reference | Location | Style | Age | Condition | Significance | Internal | External | Detail | Special Features | Glazing Type | Proposed Works |
|---|---|---|---|---|---|---|---|---|---|---|---|
| WF-07 | Flat 12 Liv/Bed Courtyard | Leaded light, casement window. Painted frame. | | 4 Good | Considerable | | | | Side hung opening light. Projected sill. | Single. | Strip paint subject to timber condition. Add slimline secondary glazing. |

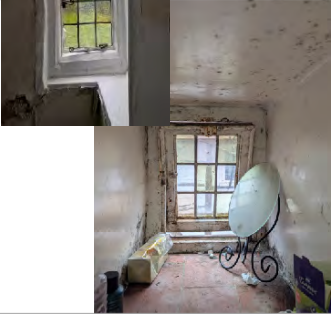
| Reference | Location | Style | Age | Condition | Significance | Internal | External | Detail | Special Features | Glazing Type | Proposed Works |
|---|---|---|---|---|---|---|---|---|---|---|---|
| WF-12 | Flat 11 Bathroom<br>Courtyard | Leaded light, pivot window. Painted frame. | | 4 Very poor | Considerable | | | | Horizontal pivot opening. Projected sill. | Single. Green and pink tinted panes. | Replace with hardwood frame and rectangular leading. |

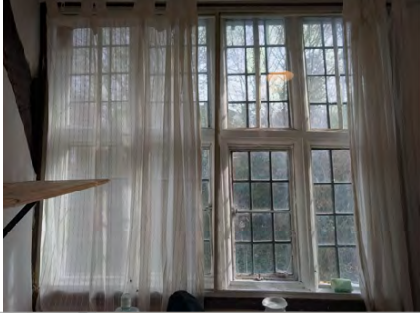
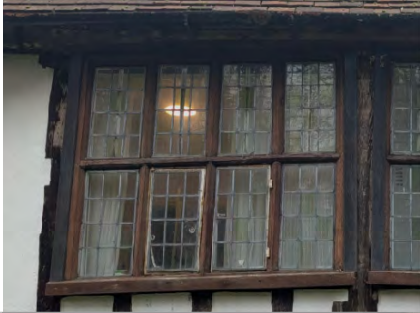
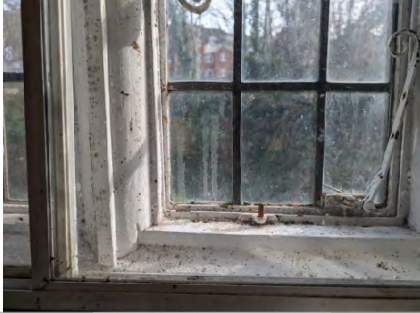
| Reference | Location | Style | Age | Condition | Significance | Internal | External | Detail | Special Features | Glazing Type | Proposed Works |
|---|---|---|---|---|---|---|---|---|---|---|---|
| WF-14 | Flat 10 Kitchen<br>External | Two rows of four leaded lights, casement window. Original hardwood frame with some repairs. | | 2 Poor | Exceptional | | | | Side hung casement openings. Original timber structure framing opening with repairs. | Single. Sliding secondary glazing panels internal. | Sensitive repairs and cleaning. Strip internal paint. Introduction of slimline secondary glazing to improve building performance. |

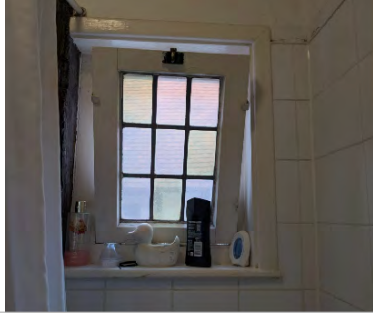
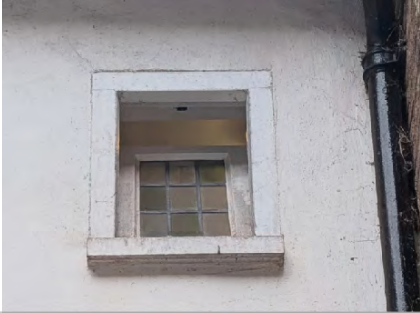
| Reference | Location | Style | Age | Condition | Significance | Internal | External | Detail | Special Features | Glazing Type | Proposed Works |
|---|---|---|---|---|---|---|---|---|---|---|---|
| WF-15 | Flat 10 Bathroom<br>Courtyard | Leaded light, pivot window. | | 4 Poor in areas. | Moderate | | | | Horizontal pivot opening. | Single. Tinted panes. | Replace with hardwood frame and rectangular leading. |

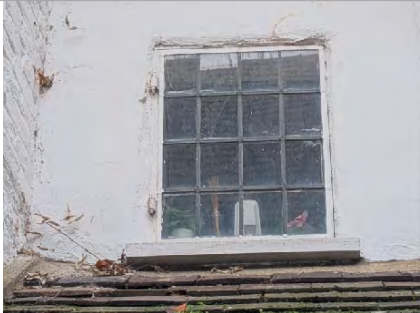
| Reference | Location | Style | Age | Condition | Significance | Internal | External | Detail | Special Features | Glazing Type | Proposed Works |
|---|---|---|---|---|---|---|---|---|---|---|---|
| WF-16 | Stairwell 02<br>Courtyard | Leaded light, casement window. Painted frame. | | 3 Moderate. | Considerable | | | | Side hung opening light. Projected sill. | Single. | Clean. |

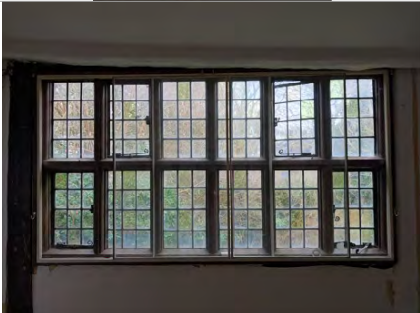
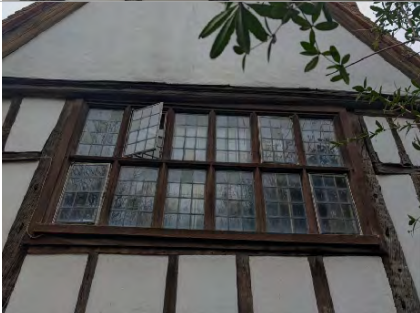
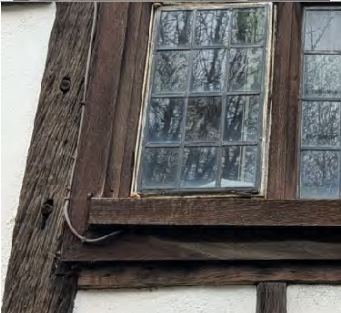
| Reference | Location | Style | Age | Condition | Significance | Internal | External | Detail | Special Features | Glazing Type | Proposed Works |
|---|---|---|---|---|---|---|---|---|---|---|---|
| WF-18 | Flat 09 Liv/Bed<br>External | Two rows of six leaded lights, casement window. Original hardwood frame. | | 2 Good | Exceptional | | | | Side hung casement openings. Original timber structure framing opening with repairs. | Single. Sliding secondary glazing panels internal. | Sensitive repairs and cleaning. Introduction of slimline secondary glazing to improve building performance. |

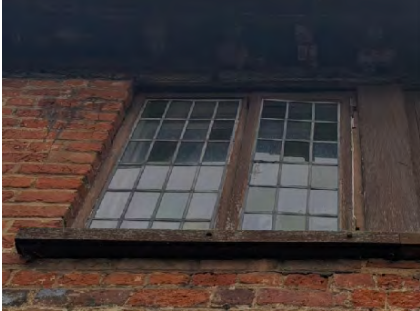
| Reference | Location | Style | Age | Condition | Significance | Internal | External | Detail | Special Features | Glazing Type | Proposed Works |
|---|---|---|---|---|---|---|---|---|---|---|---|
| WF-20 | Flat 08 Liv/Bed<br>External | Two vertical leaded lights, casement window. Original outer hardwood frame. | | 2 Poor | Considerable | | | | Side hung casement openings. Projected sill. | Single. Green tinted panes. | Sensitive repairs. Introduction of slimline secondary glazing to improve building performance. Strip internal paint. |

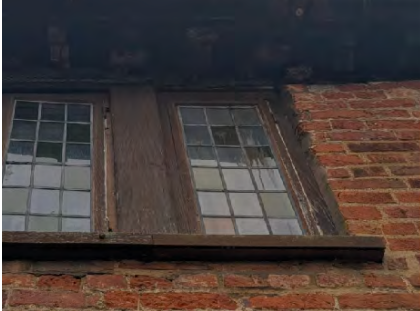
| Reference | Location | Style | Age | Condition | Significance | Internal | External | Detail | Special Features | Glazing Type | Proposed Works |
|---|---|---|---|---|---|---|---|---|---|---|---|
| WF-21 | Flat 08 Liv/Bed<br>External | Two vertical leaded lights, casement window. Original outer hardwood frame. | | 2 Poor | Considerable | | | | Side hung casement openings. Projected sill. | Single. Green and orange tinted panes. | Sensitive repairs. Introduction of slimline secondary glazing to improve building performance. Strip internal paint. |

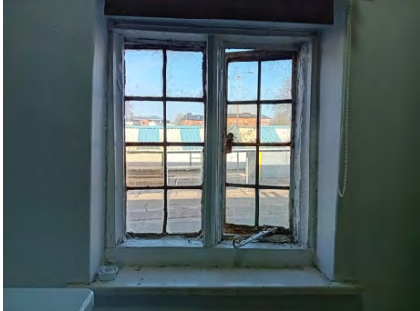
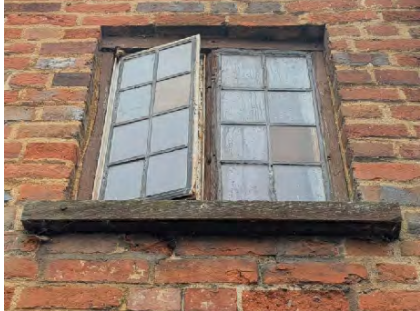
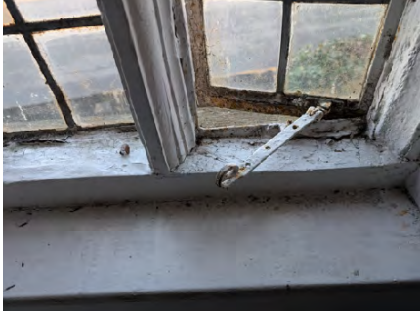
| Reference | Location | Style | Age | Condition | Significance | Internal | External | Detail | Special Features | Glazing Type | Proposed Works |
|---|---|---|---|---|---|---|---|---|---|---|---|
| WF-22 | Flat 08 Bathroom<br>External | Two vertical leaded lights, casement window. Original outer hardwood frame. | | 2 Very poor | Moderate | | | | Side hung casement openings. Projected sill. | Single Orange tinted panes. | Sensitive repairs. Introduction of slimline secondary glazing to improve building performance. Strip internal paint. |
