# Baldock, St Mary's Church Hall, Bat Survey 2024

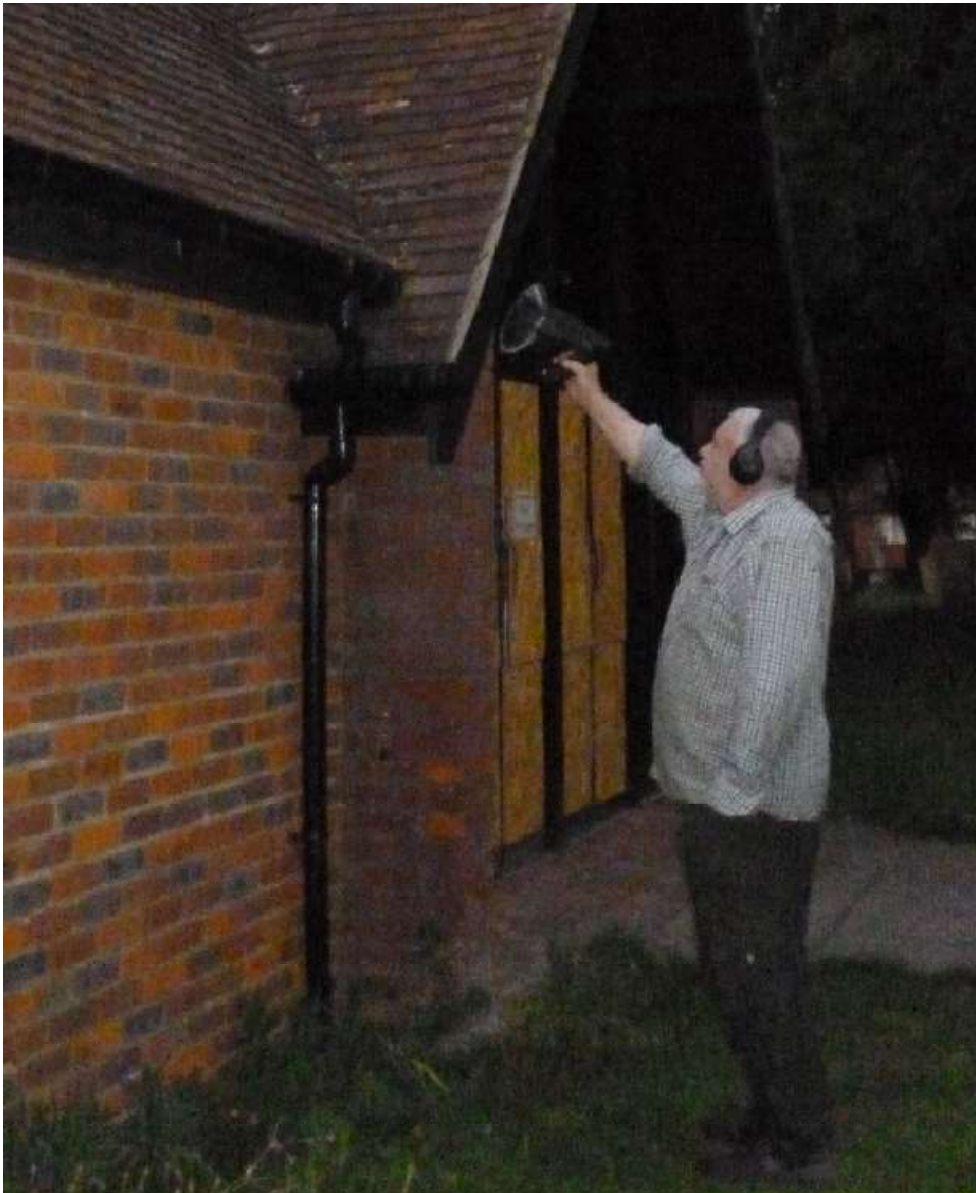
To aid the initial ground level walkover a 300 mm parabolic microphone was used to record any pre-emergence chattering, nothing was recorded.

**The conclusion was that there are no potential entry points and no roosting opportunities in this building. The potential suitability for this building is therefore negligible.**

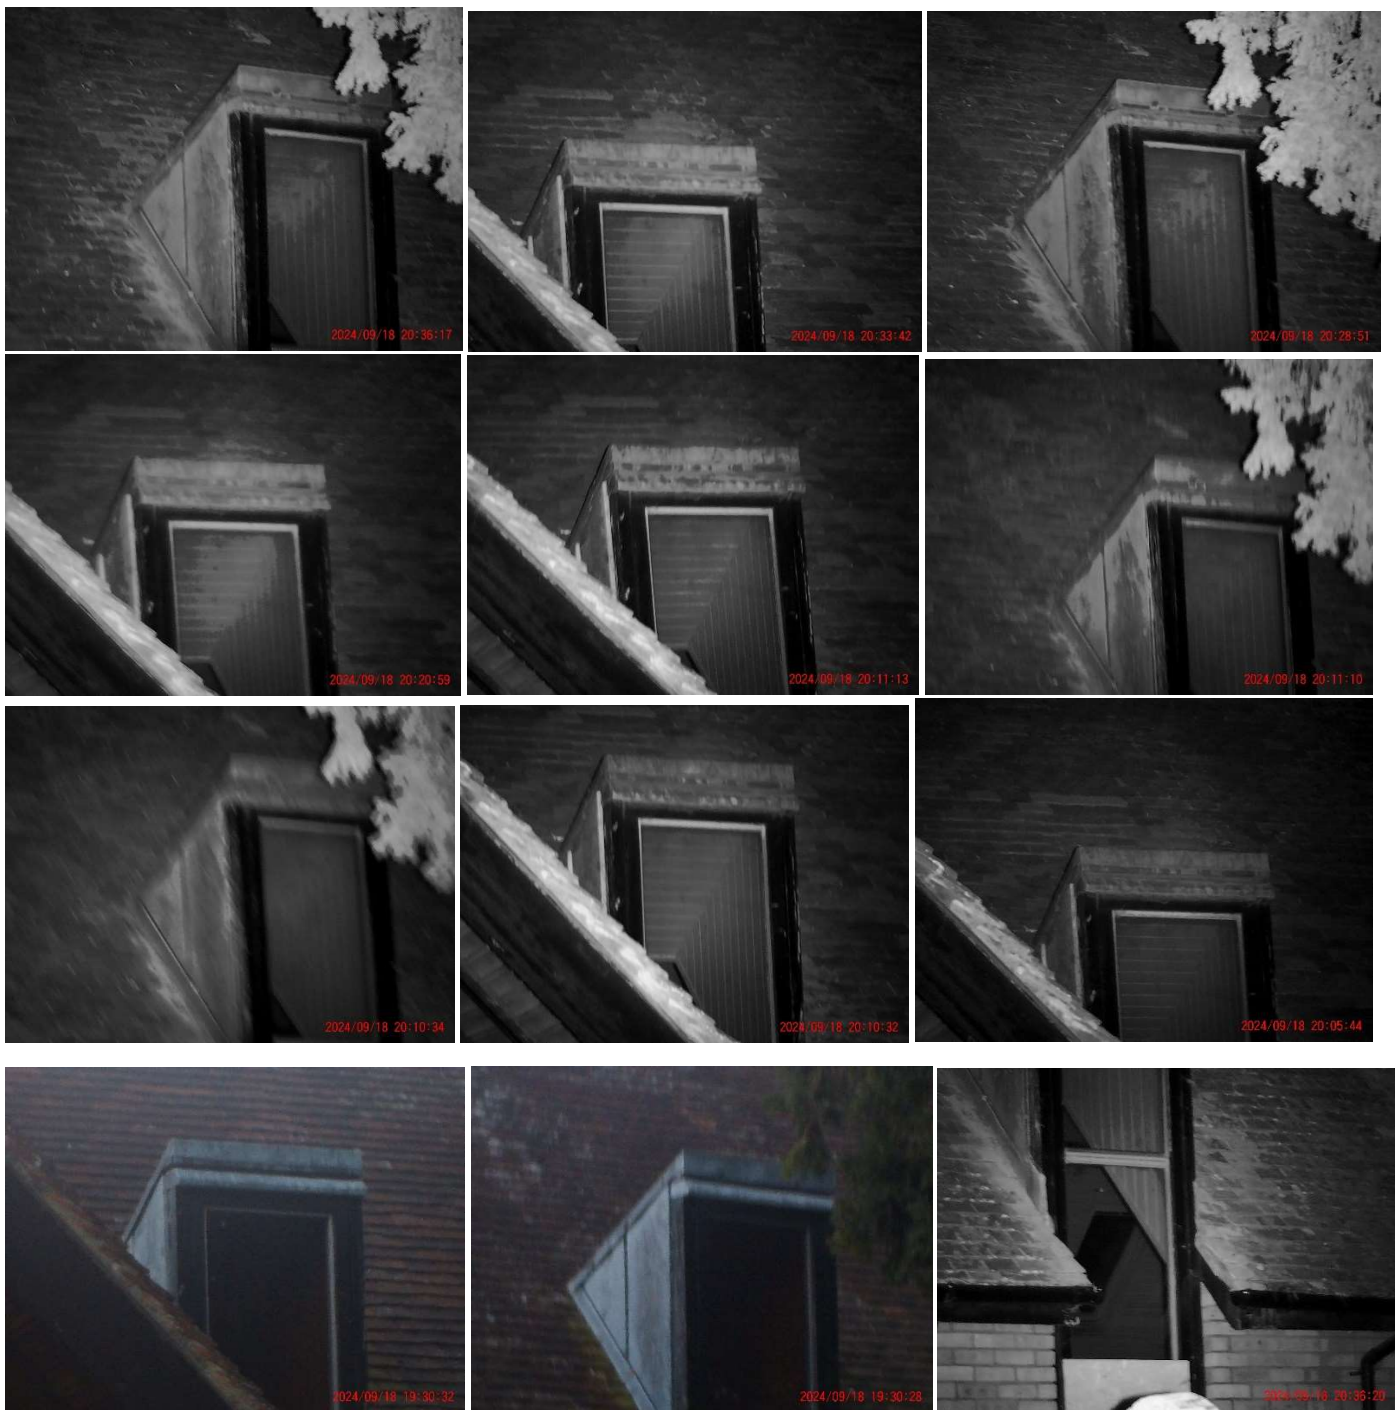
Infra-Red images below

**No record of emergence from anywhere around the building.**
