**641-KS-06-MB-SH-A-90910 – P01**
**Temple Dinsley Level 0, GA – Ground Floor – Common Areas – Entrance Hall**

**641-KS-06-MB-SH-A-90920 – P01**  
**Temple Dinsley Level 1, GA – First Floor – Common Areas**

**641-KS-06-MB-SH-A-90930 – P01****Temple Dinsley Levels 0 & 1, GA – Middle Entrance – Common Areas – Ground & First Floors**

**641-KS-06-MB-SH-A-90940 – P01**  
**Temple Dinsley Levels B1, 0 & 1, GA – East Stair + Lift**

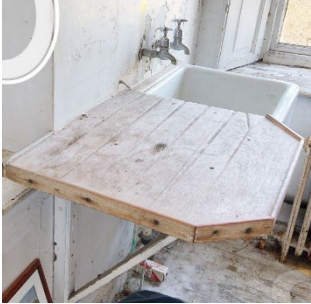
| Reference | Proposal | Significance of affected fabric | Impact | Reasoning and mitigation |
|---|---|---|---|---|
| J-Internal fixtures and fittings WME-EH-J.D3 | Removal C20 butler's sink and taps, wooden drainer and associated pipework and drainage | Neutral | Neutral Impact | <p>Butler's sink &amp; drainer</p> <p>There is evidence that a wc was located within the recess adjacent to the north wall. It is proposed that a new wc is re-</p> |

| Reference | Proposal | Significance of affected fabric | Impact | Reasoning and mitigation |
|---|---|---|---|---|
| | | | | <p>installed in this space to serve the entrance area for visitors to the building.</p> <p>Removal of the existing sink and fittings and replacement with an appropriately sized new basin and fittings will return the room to use.</p> |

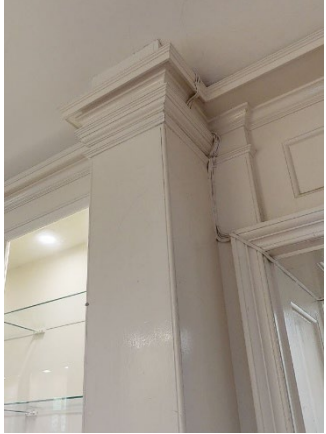
| Reference | Proposal | Significance of affected fabric | Impact | Reasoning and mitigation |
|---|---|---|---|---|
| A-Walls<br>ME-A.P1 | Investigate construction of EC20 timber lined pilasters forming compartment partition to Apartment 10. | High<br>Early EC20 (1909)<br>Lutyens | Low<br>Impact<br><br>Enhance | <p>LHS pilaster below curved ceiling</p> <p>Retain EC20 (1909) Lutyens mouldings at head and remove MC20 mouldings to both sides.<br/>Carefully remove pilaster panel to both sides to determine internal construction and appropriate method of compartmentation. Reinstall panels, sand back oil based paint finish and redecorate with flame retardant breathable paint.</p> <p>The pilasters will be retained in their original state with MC20 additions removed. The proposed infill partition is reversible.</p> |

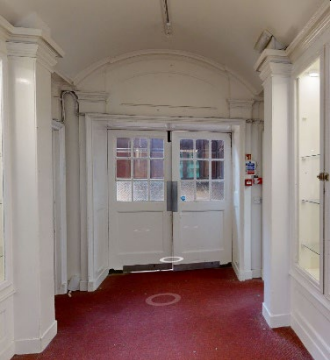
| Reference | Proposal | Significance of affected fabric | Impact | Reasoning and mitigation |
|---|---|---|---|---|
| A-Walls<br>ME-A.P2 | Alterations to previously adjusted door opening. | Moderate – Low<br>MC20 alterations to 1909 Lutyens | Low<br>Impact<br><br>Enhance | |

| Reference | Proposal | Significance of affected fabric | Impact | Reasoning and mitigation |
|---|---|---|---|---|
| | | | | <p>Adjusted doorcase</p> <p>MC20 doors and panelled lining and architrave to be removed. Pilasters to be reformed to the original Lutyens proportions.</p> |

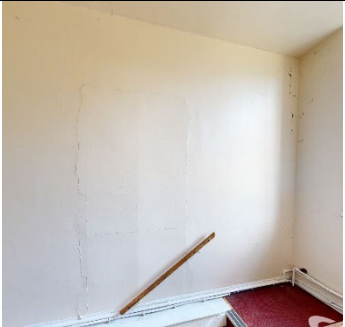
| Reference | Proposal | Significance of affected fabric | Impact | Reasoning and mitigation |
|---|---|---|---|---|
| A-Walls<br>ME-A.P3 | Investigate construction of wall and infilled opening and upgrade as necessary to form compartment wall to Apartment 10. | High-moderate<br>Early C20<br>1909 Lutyens<br><br>Low<br>C20 infill | Low<br>Impact<br><br>Enhance | <p>Wall adjacent to cellar stairs<br/>Wall to be upgraded to comply with building Regulations requirements for fire and sound insulation. The appearance of the wall will be improved.</p> |

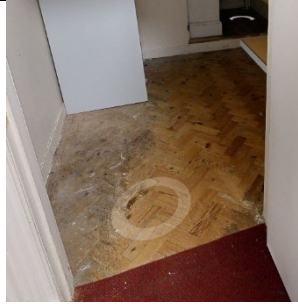
| Reference | Proposal | Significance of affected fabric | Impact | Reasoning and mitigation |
|---|---|---|---|---|
| B-Floors<br>ME-B.P1 | Investigate construction of floor within below stairs cupboard/store. | High-Moderate<br>Early C20<br>1909 Lutyens | Low<br>Impact | <p>Floor in below stairs cupboard</p> <p>Open up oak parquet floor and timber boards at higher level to rear to investigate construction. Carry out repairs as necessary. Insulation strategy to be confirmed. Oak parquet to be repaired and sanded back to a smooth clean surface and flame retardant breathable varnish applied.</p> |

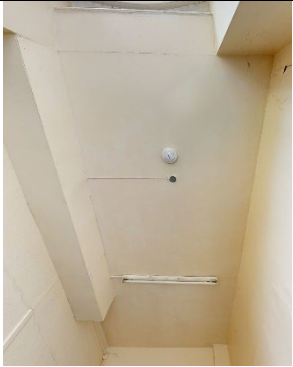
| Reference | Proposal | Significance of affected fabric | Impact | Reasoning and mitigation |
|---|---|---|---|---|
| C-Ceilings<br>ME-C. P1 | Investigate construction of ceiling over cellar stairs. | Neutral<br>Plasterboard ceiling. | Low<br>Impact | <p>Ceiling over cellar stairs</p> <p>Straight crack to ceiling behind window suggests ceiling is plasterboard. Investigate to determine requirement for underlining to comply with Building Regulations compartmentation to 1<sup>st</sup> floor.</p> |

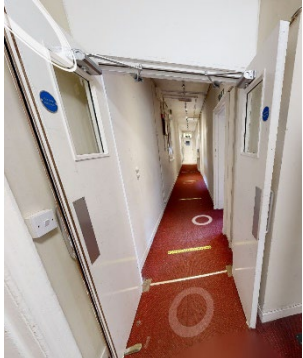
| Reference | Proposal | Significance of affected fabric | Impact | Reasoning and mitigation |
|---|---|---|---|---|
| D-Doors<br>ME-D.D1 | Removal of all C20 fire doors/frames/glazed screens located in entrance area and in corridor and to cellar stair lobby. | Neutral<br>Late C20 alterations | Low<br>Impact | <p>Glazed lobby doors to be removed. Cupboard door to be replaced.</p> <p>Lobby doors to be replaced</p> |

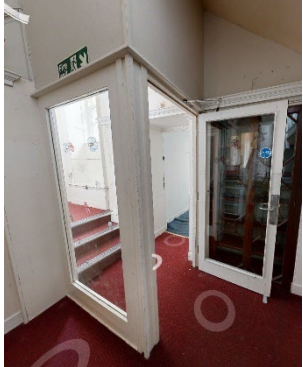
| Reference | Proposal | Significance of affected fabric | Impact | Reasoning and mitigation |
|---|---|---|---|---|
| D-Doors<br>ME-D.D2 | Removal of C20 fire doors/frames/glazed screens located off landings from 1 <sup>st</sup> to 2 <sup>nd</sup> floor. | Neutral<br>Late C20 alterations | Low<br>Impact | <p>1<sup>st</sup> floor landing lobby<br/>Remove doors and partitions above and make good to below stair linings.</p> |

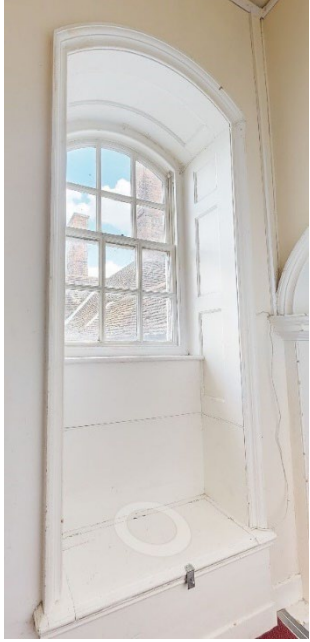
| Reference | Proposal | Significance of affected fabric | Impact | Reasoning and mitigation |
|---|---|---|---|---|
| E-Windows<br>ME-E.D1 | Removal of EC20 timber sash window, panelling and masonry | High-Moderate<br>EC20 (1909)<br>Lutyens window<br>adjusted during C20 | Moderate<br>Impact | <p>Location in east wing external wall for new opening to proposed link to lift</p> <p>Timber panelling around opening will be retained. Lift access is necessary to provide resident/visitor access to upper floor apartments.</p> <p>The window has been previously adjusted to allow for C20 flat roof extensions to be constructed. The window does not provide a significant view. It cannot be seen from the ground and will not harm the appearance of the building.</p> |

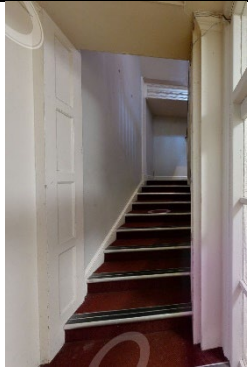
| Reference | Proposal | Significance of affected fabric | Impact | Reasoning and mitigation |
|---|---|---|---|---|
| H-Stairs<br>ME-H.P2 | Repairs and renovation to stair flights from ground to 1 <sup>st</sup> floor | Moderate<br>EC20 (1909)<br>Lutyens | Low<br>Impact | <p>Stair to 1<sup>st</sup> floor</p> <p>Existing carpet covering and nosings to be removed to allow investigation of construction. Upgrading works will be carried out to the stair to comply with Building Regulations fire protection and impact sound requirements.</p> <p>Oil based paint finish to doorcase panels to be sanded back to a smooth surface and redecorated in a flame retardant and breathable paint.</p> <p>Repairs and redecoration to timber pilasters, mouldings and rails along flights from ground to 2<sup>nd</sup> floor</p> |

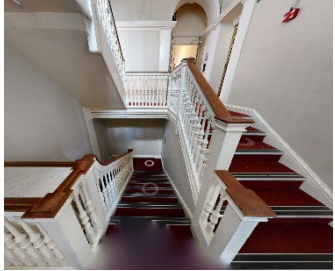
| Reference | Proposal | Significance of affected fabric | Impact | Reasoning and mitigation |
|---|---|---|---|---|
| H-Stairs<br>ME-H.P3 | Repairs and renovation to stair flights from 1 <sup>st</sup> to 2 <sup>nd</sup> floor including balustrade and handrails | High-Low<br>EC20 (1909)<br>Lutyens<br><br>Stair from 1 <sup>st</sup> floor landing to 2 <sup>nd</sup> floor is MC20 replica | Low Impact | <p>View of Middle Entrance stair from 1<sup>st</sup> floor landing</p> |

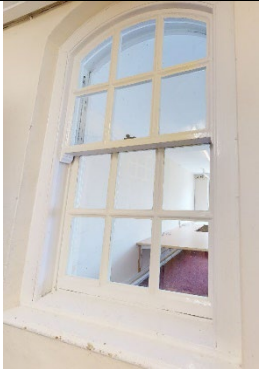
| Reference | Proposal | Significance of affected fabric | Impact | Reasoning and mitigation |
|---|---|---|---|---|
| E-Windows<br>ES-E.R2 | Upgrade internal window to Apartment 30 | Moderate<br>Late C19? C20<br>Lutyens | Low<br>Impact | <p>Internal window W03</p> <p>Allow to upgrade window to form compartment to Apartment 30 as necessary to comply with Building Regulations requirements for fire and sound.</p> <p>Intervention is reversible.</p> |

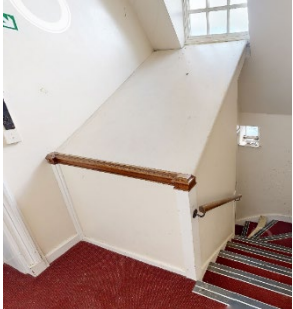
| Reference | Proposal | Significance of affected fabric | Impact | Reasoning and mitigation |
|---|---|---|---|---|
| | | | | <p>Existing stair enclosure</p> <p>Remove sloping soffit over stairs at landing Level 1 and reinstate balustrading.</p> |

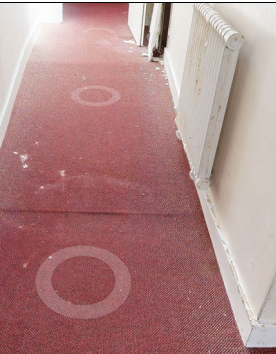
| Reference | Proposal | Significance of affected fabric | Impact | Reasoning and mitigation |
|---|---|---|---|---|
| | | | | <p>Corridor ramp</p> <p>Original C20 corridor steps have been overlaid with a ramp construction as part of the C20 alterations. The existing wall (RHS) will be removed as part of the proposed works to for the Apartment 5 Lander entrance enclosure. The C20 ramp construction will be removed and the existing steps recorded and left in place/replaced following the upgrading works necessary to the floor construction to comply with Building Regulations. New steps will be formed further into the corridor.</p> |

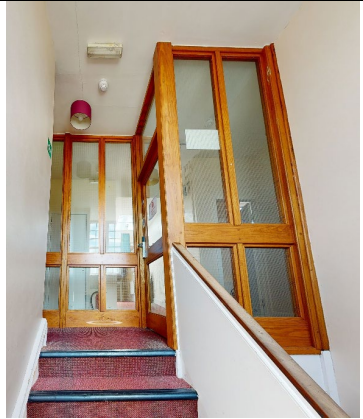
| Reference | Proposal | Significance of affected fabric | Impact | Reasoning and mitigation |
|---|---|---|---|---|
| | | | | <p>Compartment screen at stairwell landing</p> <p>The partition intrudes into the volume and views.</p> |

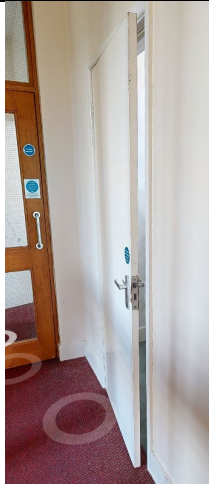
| Reference | Proposal | Significance of affected fabric | Impact | Reasoning and mitigation |
|---|---|---|---|---|
| D-Doors<br>WME2-<br>D.D2 | Painted flush panel<br>C20 cupboard door<br>ironmongery in corridor | Neutral/Negative<br>Late C20 alterations | Neutral | <p>Corridor cupboard door to be removed</p> |

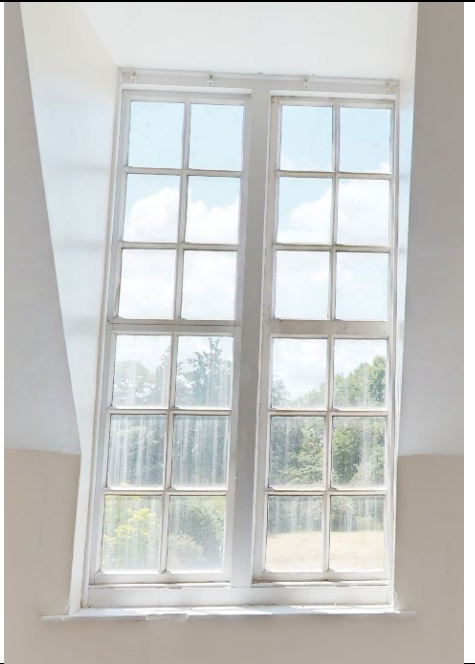
| Reference | Proposal | Significance of affected fabric | Impact | Reasoning and mitigation |
|---|---|---|---|---|
| E-Windows<br>Common<br>WME2-<br>E.R1 | Renovation of C20<br>timber casement<br>dormer window | Low<br>C20 (1935)<br>alterations | Benefit &<br>Enhance | |

| Reference | Proposal | Significance of affected fabric | Impact | Reasoning and mitigation |
|---|---|---|---|---|
| | | | | <p>MC20 dormer window above stairwell<br/>WW W01</p> <p><b>No historic fabric affected.</b><br/>The existing timber multi-pane window will be repaired/renovated/redecorated and upgraded with slim-line double glazing which will improve the comfort of the internal environment and the viability of the historic building for future use. Splice repairs to be carried out where required. Resin for more localised repair. Perished putty replacement. Easing of window as required. Original 'monkey tail' casement latches to be retained for reuse. New ironmongery/locking is to comply with building regulations where required. The repairs will improve the appearance and longevity of the window.</p> |

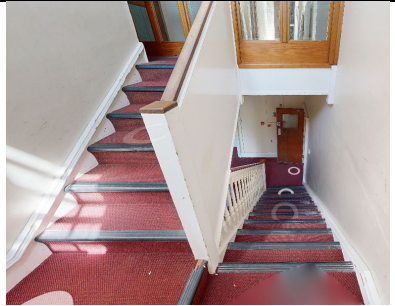
| Reference | Proposal | Significance of affected fabric | Impact | Reasoning and mitigation |
|---|---|---|---|---|
| H-Stairs<br>WME2-<br>H.P1 | Upgrading of MC20 stair and balustrade between 1 <sup>st</sup> and 2 <sup>nd</sup> floor levels. | Low<br>MC20 (1935)<br>alterations | Low<br>impact<br>Benefit | <p>Common stair to 2<sup>nd</sup> floor</p> <p>Existing carpet covering and nosings to be removed to allow investigation of construction. Upgrading works will be carried out to the stair to comply with Building Regulations fire protection and sound separation requirements. Improves viability of the building use.</p> |

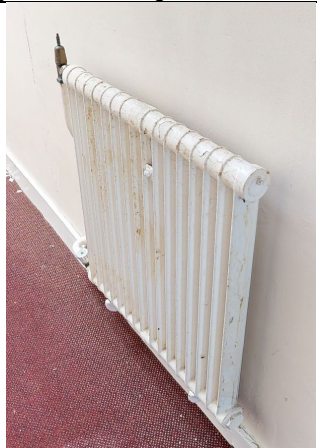
| Reference | Proposal | Significance of affected fabric | Impact | Reasoning and mitigation |
|---|---|---|---|---|
| J-Internal<br>fixtures<br>and fittings<br>WME2-<br>J.D1 | Renovation / removal of C20 cast iron wall mounted radiator | Neutral C20 | Neutral<br>Impact | <p>C20 radiator to be removed or renovated</p> |

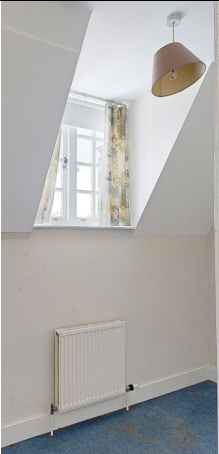
| Reference | Proposal | Significance of affected fabric | Impact | Reasoning and mitigation |
|---|---|---|---|---|
| A-Walls<br>ME-A.D2 | Remove section of external wall including dormer window | Neutral<br>C20 alterations<br><br>Neutral<br>MC20 window | Low – Neutral Impact | <p>Location in east external wall for new opening to proposed link to lift</p> <p>Lift access is necessary to provide resident/visitor accessibility to upper floor apartments.</p> <p>The location of the alterations are unobtrusive within the hidden roof above the Hall and the fabric was changed when the roof was raised.</p> <p>Refer to F-New openings CAF.D2</p> |

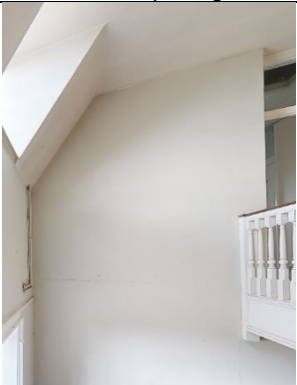
| Reference | Proposal | Significance of affected fabric | Impact | Reasoning and mitigation |
|---|---|---|---|---|
| B-Floors<br>ME-A.P2 | Form extension to landing over stairwell to provide access to Apartment 19 Helena. | Neutral<br>C20 alterations | Neutral | <p>Location of proposed extension to landing in front of existing wall</p> <p>The stair at this level is C20 and the landing detail and balusters would match the existing. It provides access to Apartment 19.</p> <p>The location is unobtrusive and the fabric was changed when the roof was raised.</p> <p>Refer to Helena Impact Table F-New openings 19F. D1</p> |

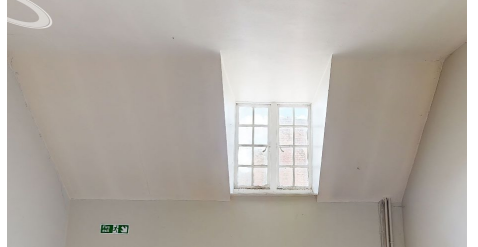
| Reference | Proposal | Significance of affected fabric | Impact | Reasoning and mitigation |
|---|---|---|---|---|
| C-Ceilings ME-C. D1 | Removal of MC20 plasterboard linings to sloping section of ceiling adjacent to dormer window. | Moderate<br>Lutyens 1909 roof raised c1935<br><br>Neutral C20<br>Plasterboard linings C20 alterations | Low Impact<br><br>Benefit | <p>Dormer window over stairwell EW W02</p> <p>Plasterboard linings to sloping sections of ceiling are to be removed to allow the roof structure to be assessed/recorded/condition investigated, the roof void insulated. This is considered to be a positive impact which will benefit the building fabric, the internal environment and the viability of the building for future use.</p> <p>The coved/rolled plaster junction between the flat and sloping ceiling will be reinstated.</p> <p>No historic fabric is affected.</p> |

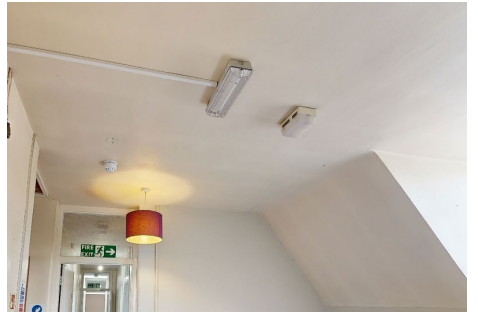
| Reference | Proposal | Significance of affected fabric | Impact | Reasoning and mitigation |
|---|---|---|---|---|
| C-Ceilings ME-C. D2 | Removal of existing plasterboard ceilings above stair and throughout 2 <sup>nd</sup> floor circulation area. | Moderate<br>Lutyens 1909 roof raised c1935<br><br>Neutral C20 alterations<br>Plasterboard linings | Low-Moderate Impact | <p>Flat ceiling in corridor and over stairwell</p> <p>Remove existing services access hatch to roof void in ceiling at head of stairs</p> |

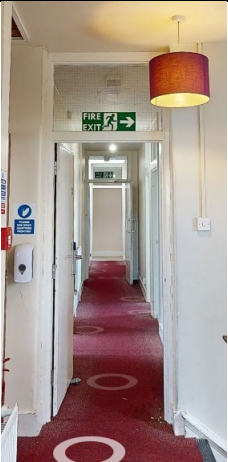
| Reference | Proposal | Significance of affected fabric | Impact | Reasoning and mitigation |
|---|---|---|---|---|
| D-Doors<br>ME-D.D1 | Removal of existing painted flush panel C20 fire door/frame/glazed panel over. | Neutral/Negative<br>Late C20 alterations | Low Impact | <p>Existing C20 door to be removed</p> |

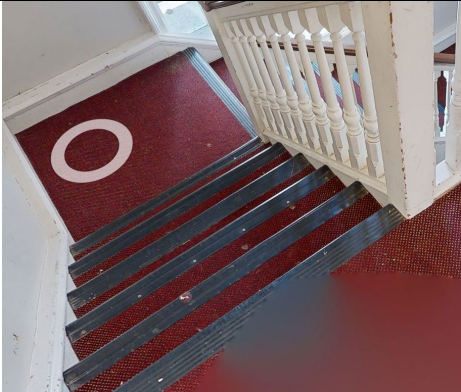
| Reference | Proposal | Significance of affected fabric | Impact | Reasoning and mitigation |
|---|---|---|---|---|
| H-Stairs<br>ME-H.P1 | Upgrading of MC20 stair and balustrade between 1 <sup>st</sup> and 2 <sup>nd</sup> floor levels. | Low<br>MC20 (1935) stair flights to access the units in the roof | Low Impact | <p>Common stair to 2<sup>nd</sup> floor</p> <p>Existing carpet covering and nosings to be removed to allow investigation of construction. Upgrading works will be carried out to the stair to comply with Building Regulations fire protection and impact sound requirements.</p> |

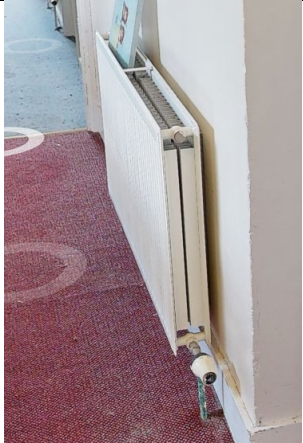
| Reference | Proposal | Significance of affected fabric | Impact | Reasoning and mitigation |
|---|---|---|---|---|
| J-Internal fixtures and fittings<br>ME-J.D1 | Removal of C20 pressed steel wall mounted radiator | Neutral | Neutral Impact | <p>C20 radiator to be removed</p> <p>Radiator and associated pipework to be removed.</p> |
