**The White Horse, Kimpton**  
**Condition Report**  
December 2024

## 1.0 EXECUTIVE SUMMARY

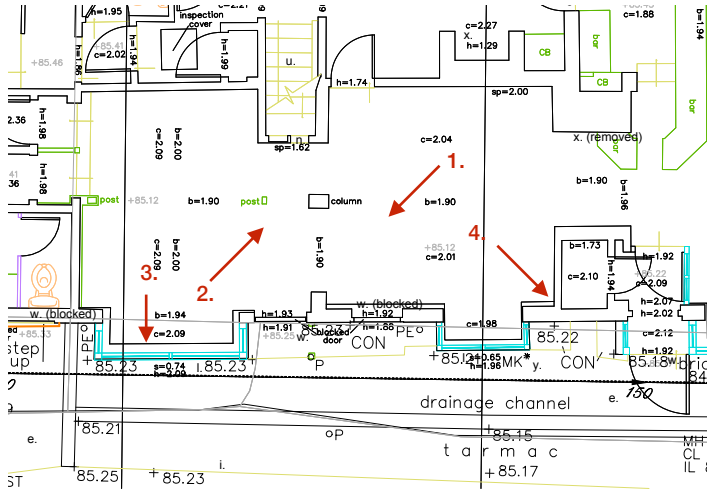
- Walls lined at low level with modern, painted wainscoting. North wall comprised of modern timber stud walling with a historic masonry wall, incorporating fireplace between the Front of House Area and Kitchen. Existing cupboard contains evidence of potential historic inglenook. Evidence of corrosion to modern steelwork as observed through opening up works. Blocking up of external doorway renders condition of fabric unknown.

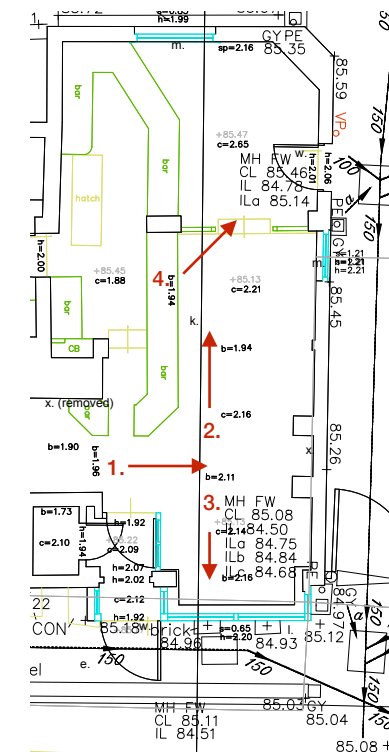
- East wall contains a fireplace with modern brickwork surround - further investigation recommended to establish condition of elements i.e hearth, flue, grate etc.

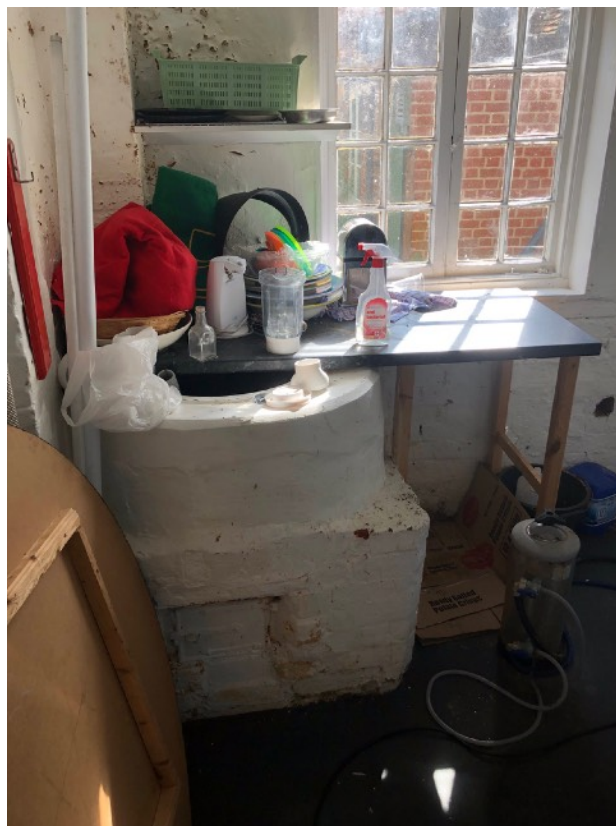
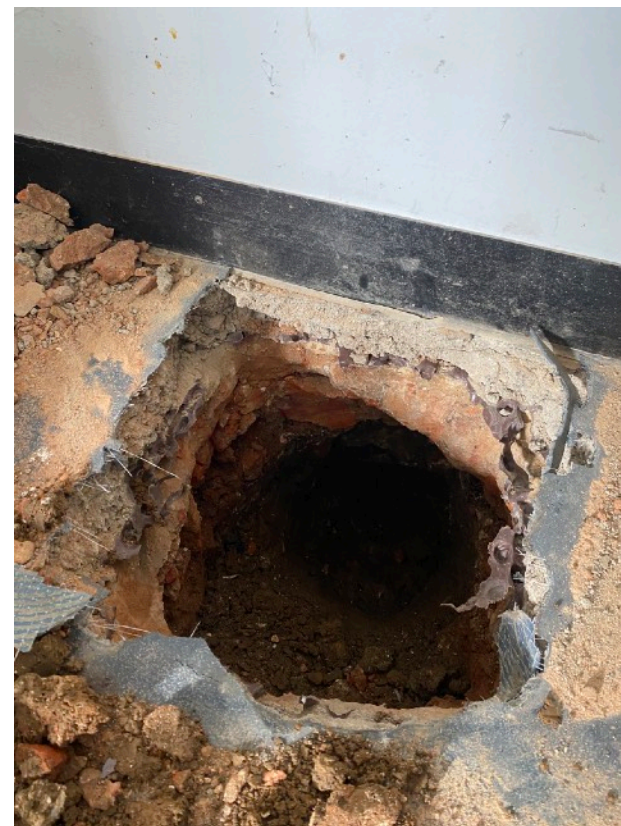
- Copper washing basin on brick base. Electrical switch board.

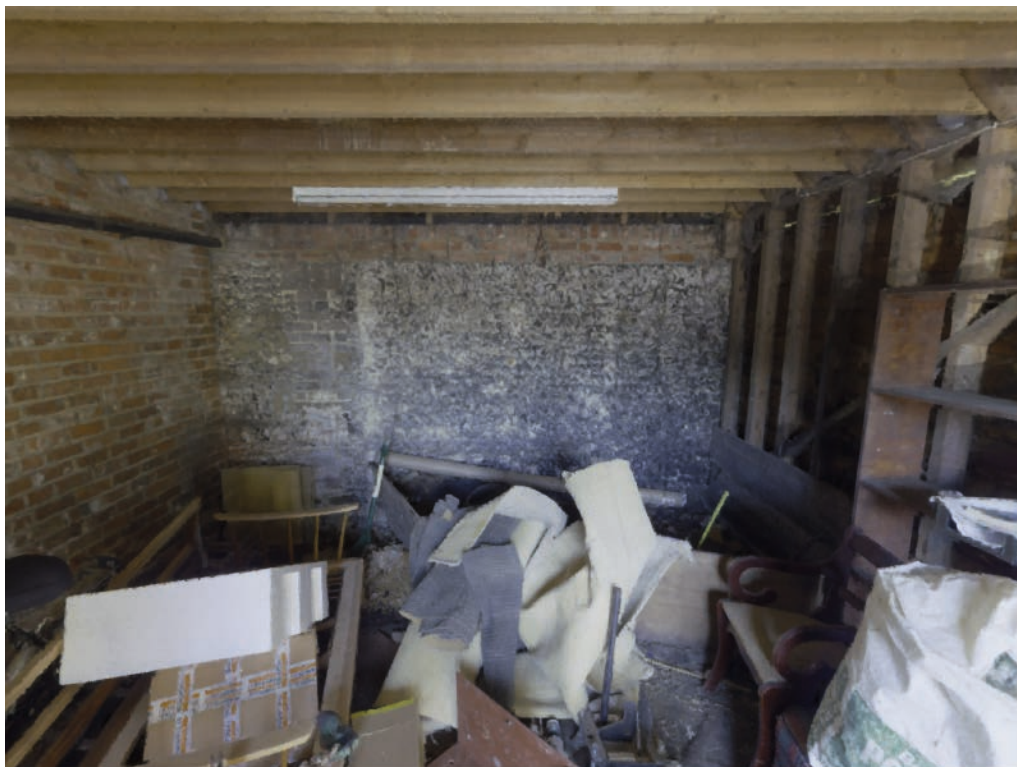
- Varying materiality. Evidence of historic flint wall forming part of the Western boundary wall with flush pointed stretcher bond brickwork to the south. North wall formed in timber stud with exposed inner face of timber cladding boards evident. Fair condition.

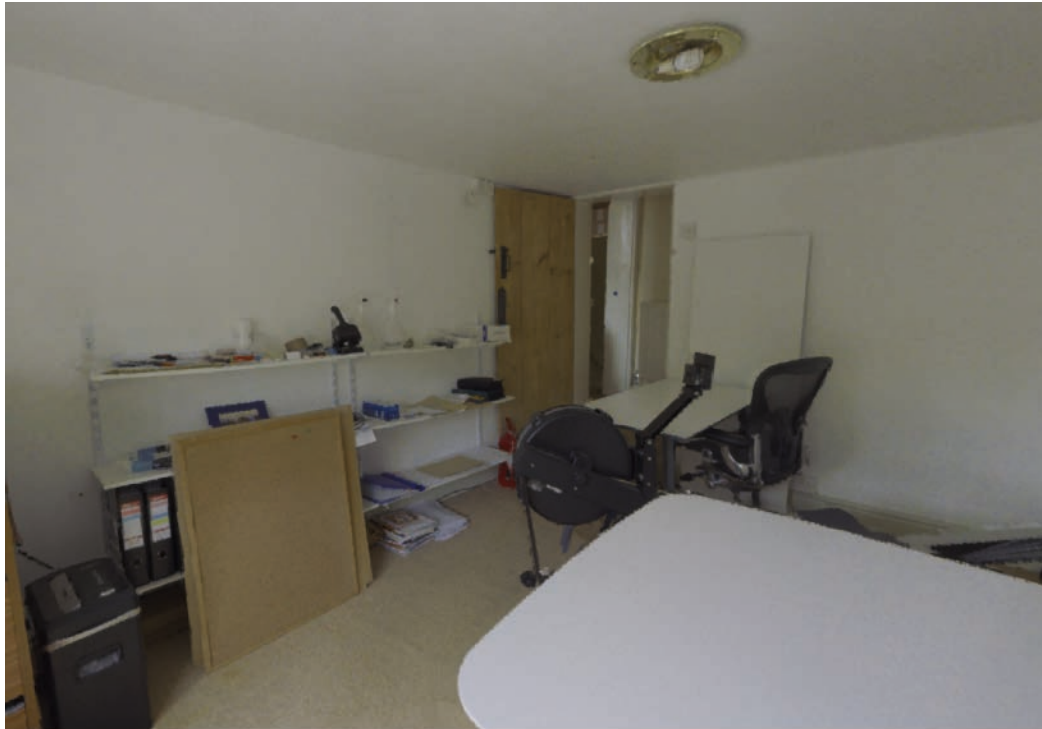
- Papered and painted finish on lath and plaster. Historic timber wall to North. Evidence of damp ingress and boast plaster to head of stairs. Fair to Poor condition.

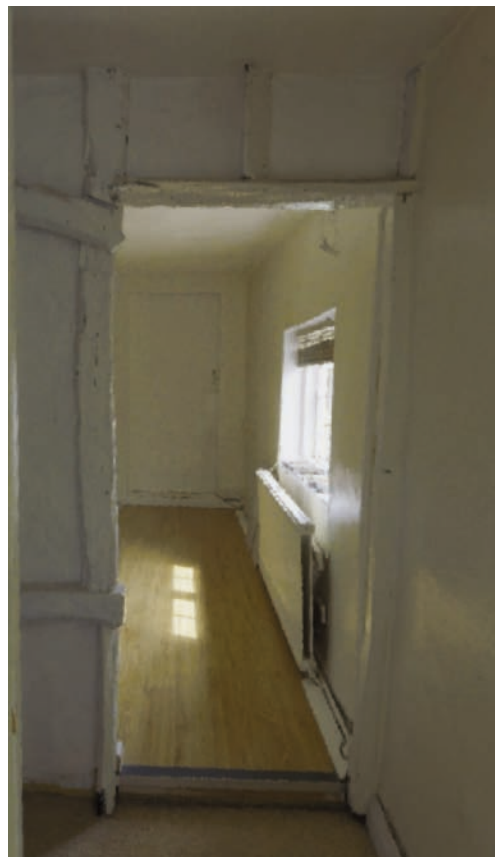
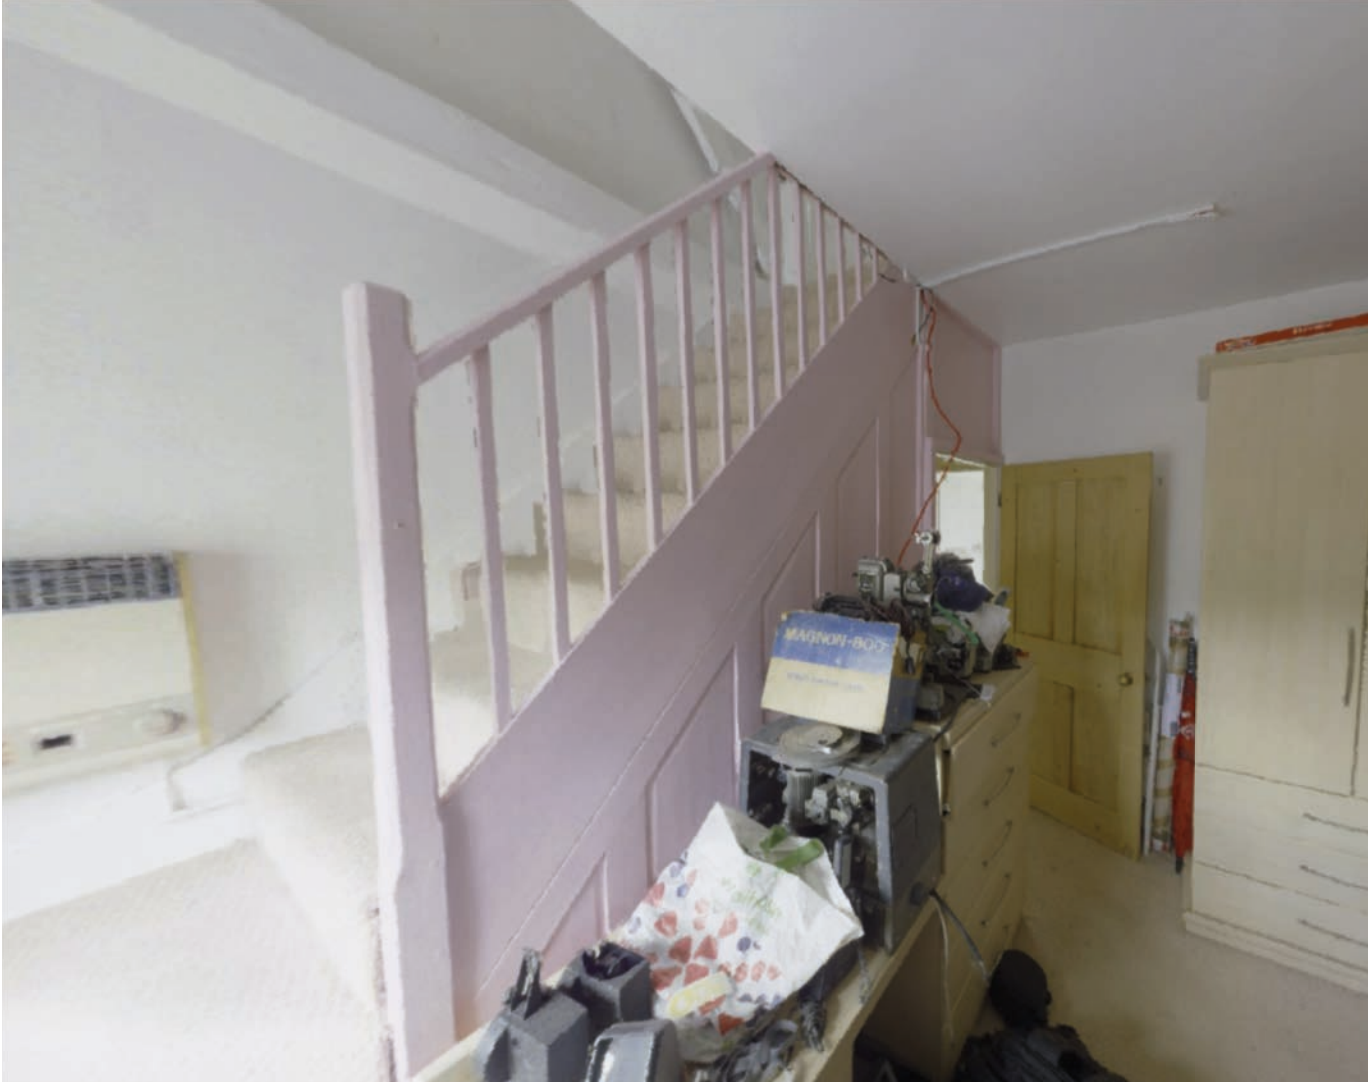
- Papered and painted finish. Historic timber wall to North with original lath and plaster evident. Evidence of historic timber frame to small lobby to the East. Evidence of bowing to South external wall.

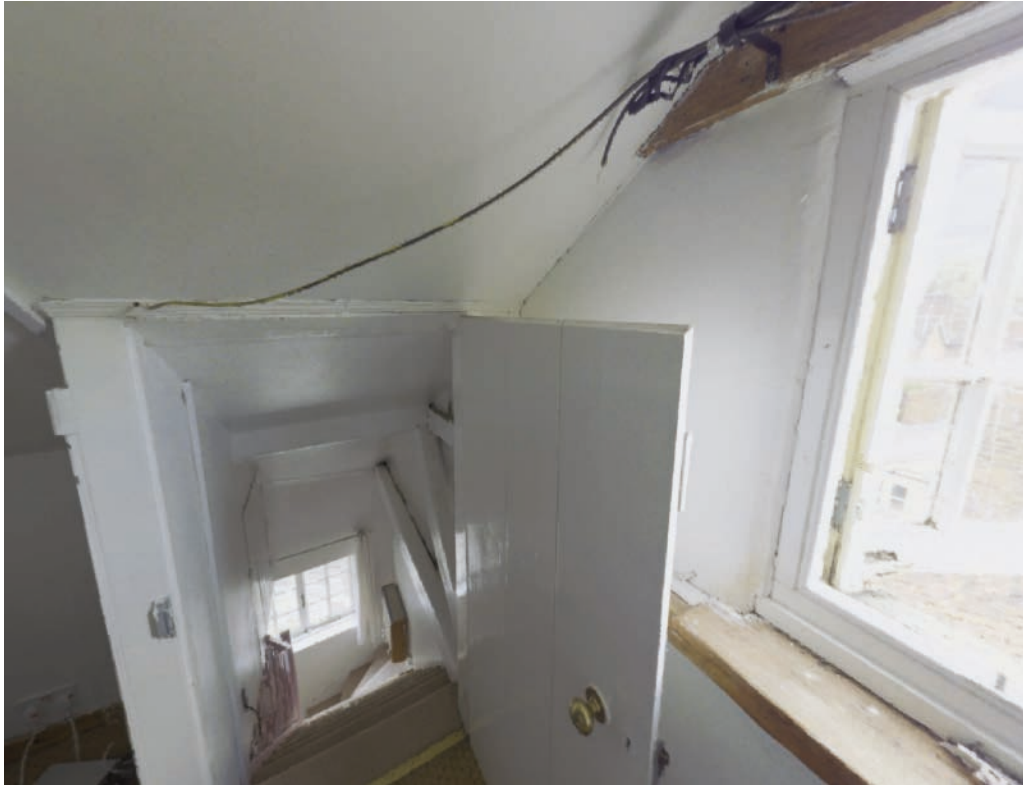
- Masonry substrate with papered and painted finish. Fair condition.
