## **HERITAGE STATEMENT AND IMPACT ASSESSMENT**

for proposed alteration and extension of

### **HOLBORN BARN, DANE END, THERFIELD**

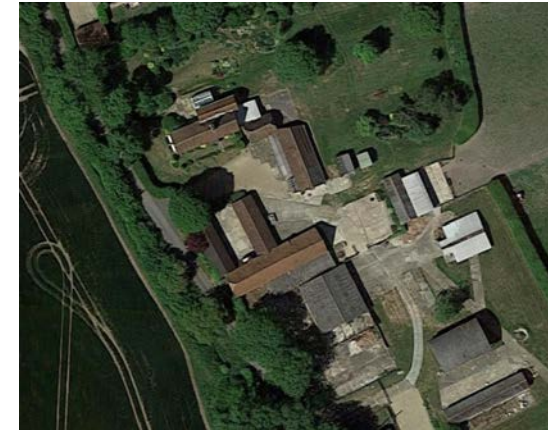
Fig. 2: Site plan as existing.

- 1. Holborn Barn
- 2. Holborn Farmhouse
- 3. Stables
- 4. Shelter shed
- 5. Lean-to additions to the barn

The barn is part of a small farmstead in the parish of Therfield, consisting of an historic farmhouse and a group of agricultural buildings, some historic and some modern, arranged in a loose courtyard plan (Figs 1 and 2). The landscape of North Hertfordshire is characterised by small, dispersed farmsteads such as this, mostly in arable cultivation. The name is said to be a corruption of 'Old Bourne', a reference to a stream that runs past the farm.

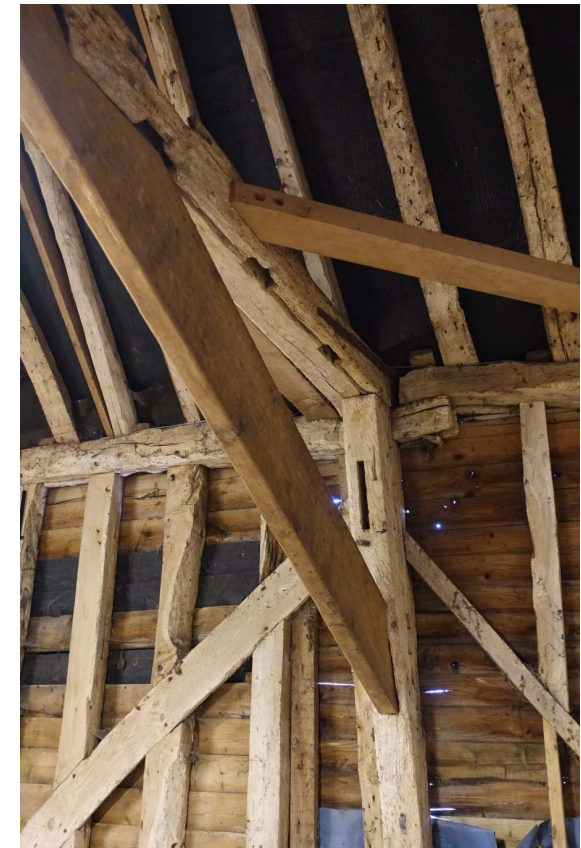
Fig. 8 (*above*): The post and truss at the south end of Bay 5, formerly the end (west) wall of the barn; note the mortices for downward braces and studs, and the lighter studwork in Bay 6 (right-hand side of photo).

Evidence for the original size of the barn can be seen in the posts and tie beam at the west end of Bay 5: the mortices for the original downward bracing in what would have been the west wall of the barn can be seen in the posts, while the underside of the tie beam has the mortices for the upright studs of the original wall and the groove down the middle which is present on the tie beam in the east wall and the north and south wall plates.

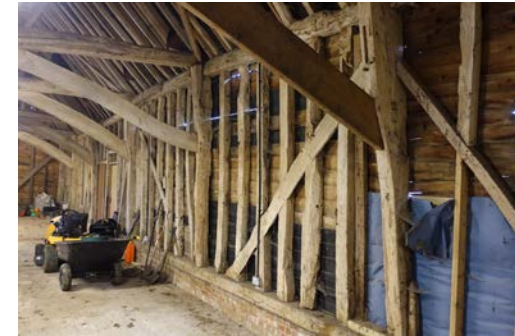
Fig. 10: The south wall of bays 1 to 5 (and part of Bay 6), showing a mixture of old and new timbers.

**Timber frame.** The impressive timber frame, though subject to considerable alteration and repair, retains much of its historic form and large amounts of original fabric. Bays 1-5 formed the original barn; some of the timbers in the bays 6-7 extension appear historic (possibly re-used timbers from the former west wall). Generally, however, the timberwork in bays 6-7 is inferior to that in bays 1-5 and there are few substantial timbers of the kind found in the earlier part of the barn. There have been extensive modern repairs to the timber framing of the walls and roof, including a new truss between bays 1 and 2, various brackets and bracing, and machine-sawn replacement structural

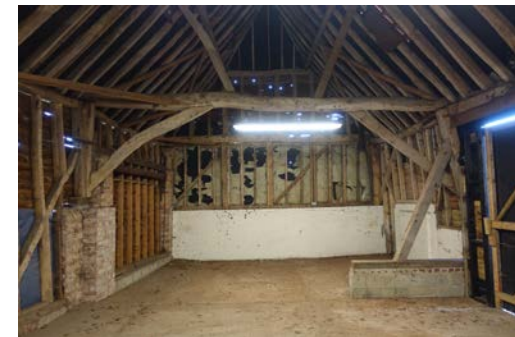
Fig. 11: Bays 6 and 7 looking west – later and more altered than bays 1 to 5.

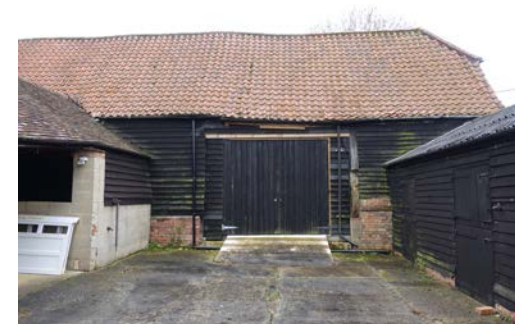
Fig. 12: The much-altered western cart entrance on the north side of the barn (Bay 6).

The existing cart doors on the north side of the barn are modern. The list description (1986) describes the doors to Bay 6 as being blocked, but they have since been reinstated, by cutting back the weatherboarding and installing a new set of doors which sit within what appear to be an older lintel and posts (Fig. 12).

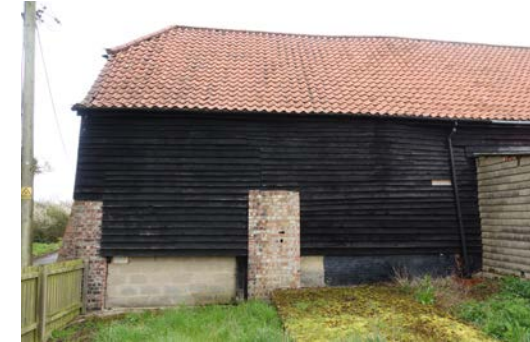
Fig. 13: west end of the south wall, showing the blocked opening between brick piers, overlaid with weatherboarding.

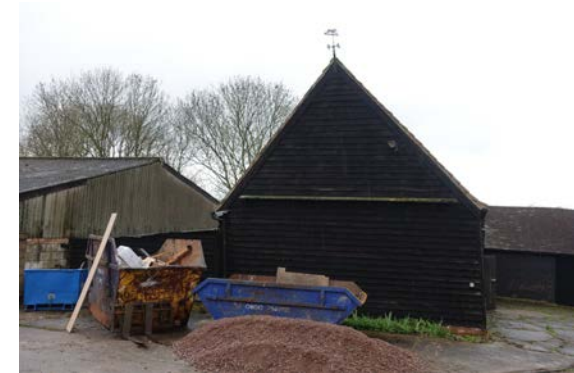
Fig. 14: East end of the barn; note the lean to the left (south).

The east wall leans to the south, but this appears to be historic movement (Fig. 14). At the south-west corner is a brick buttress, keyed into a brick pier, likely to have been added to arrest historic structural problems (Fig. 15); the adjoining stables may be having a buttressing effect on the other corner.

On the east wall there are three tiers of vertical studs. The upper two tiers appear to be composed entirely historic timbers, but the timbers in middle of the lower tier have all been replaced. This wall's lean to the south is only evident in the historic timbers, not in the modern replacement timbers at the centre of the wall.

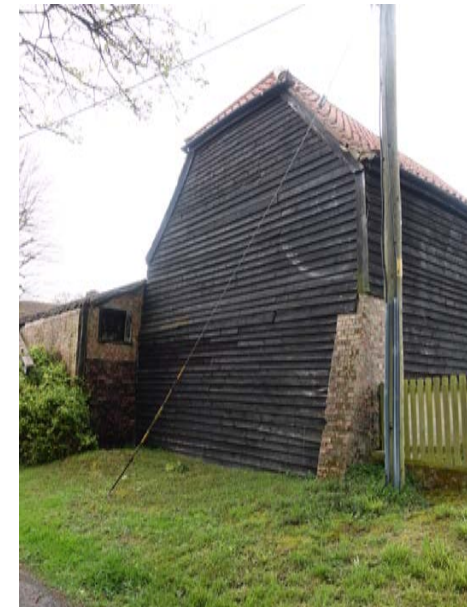
Fig. 15: West end of the barn.

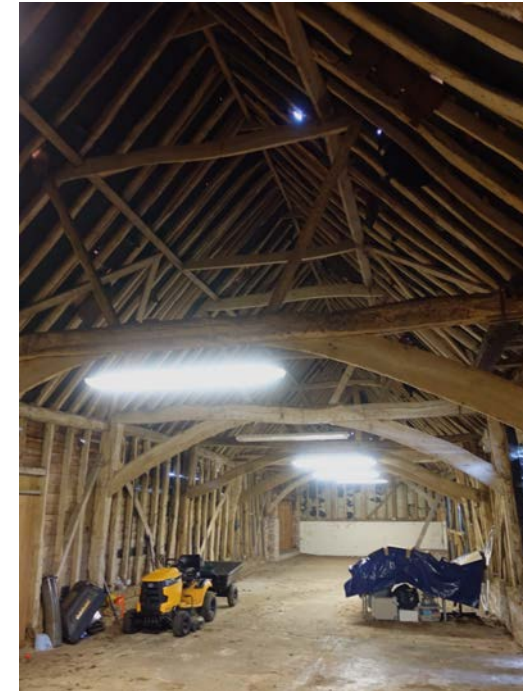
Fig. 16: General view of the interior looking west.

There is a concrete floor throughout, which drops to the west, following the fall in the site.

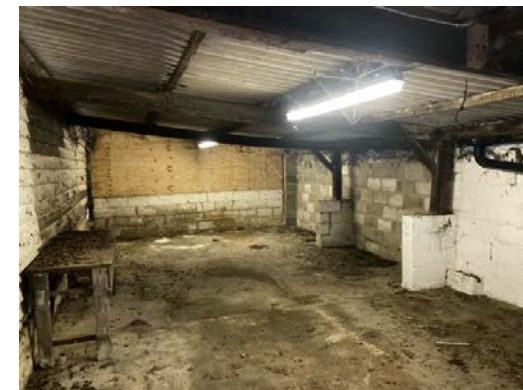
Fig. 17: Interior of the lean-to addition.

Between the 1896 and 1922 OS revisions a lean-to was added on the south side of the barn (*see* Fig. 3), extending from the east wall to the end of Bay 3. This was extended by two bays later in the 20th century with a blockwork structure. The earlier lean-to is likely to have been quite lightly built as it has been rebuilt with blockwork walls and corrugated fibre roof (Fig. 17).

On the south side of the barn there is a lean-to extension, accessed through a small door in Bay 3. It is entirely of modern construction, of two phases: adjoining bays 1–3, it has low blockwork walls, with black-stained weatherboarding above; the part adjoining bays 4–5 has blockwork walls, which on the outside imitate the form of weatherboarding. It has a shallow-pitched roof covered in a corrugated fibre.

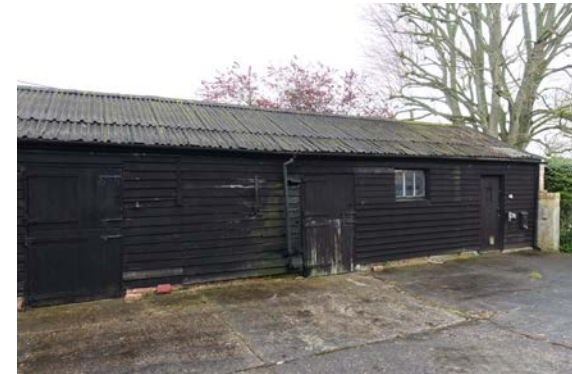
Fig. 18: Stables seen from the yard.

The wall facing into the yard is of traditional black-stained weatherboarding over a brick plinth, with three stable doors. The return walls and the west wall, facing the road, have been rebuilt in brick. The roof covering of corrugated fibre is failing.

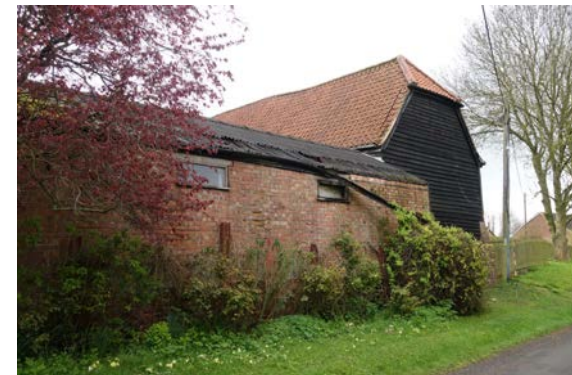
Fig. 19: Stables seen from the road.

The stables show signs of past structural problems, with metal posts propping up parts of the roadside wall.

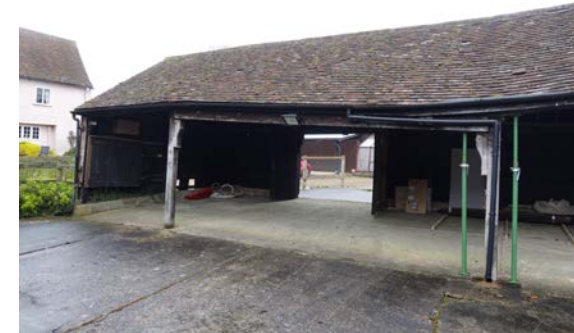
Fig. 20: View of the open (west) side of the shelter shed.

The sagging of the edge beam and presence of two scaffolding props on the open west side indicate that currently the shed is structurally unsound. (Figs. 20 and 21).

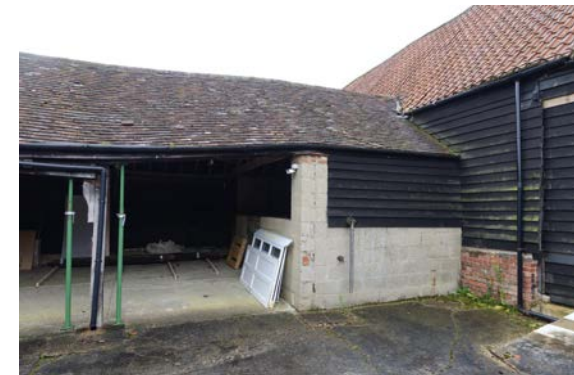
Fig. 21: The junction between the shelter shed and barn.

The ridgeline of the shelter shed is above the eaves level of the barn roof and where the two roofs meet there is an awkward junction detail (Fig. 21).
