# KAY PILSBURY THOMAS ARCHITECTS

## HERITAGE, DESIGN AND ACCESS STATEMENT FOR PROPOSED WORKS AT JULIANS PARK

**RENOVATION TO VILLA ROOF & PROPOSED NEW ROOF ACCESS, EXTERNAL RENDER AND STONE REPAIRS & INTERNAL ALTERATIONS AT GROUND, 1<sup>ST</sup> & 2<sup>ND</sup> FLOORS.**

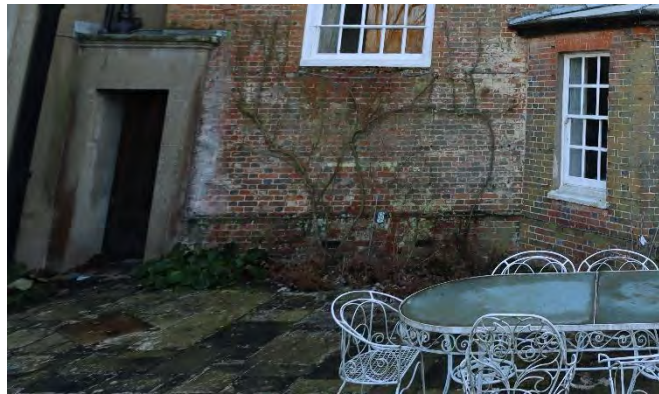
Location of infilled window at low-level

It is proposed that a cloakroom be installed within the former service corridor between the north-east Vestibule and the Dining Room, to serve this side of the house. The existing door off the Vestibule will be retained, and the low-level window on the north wall will be reinstated within the infilled opening.

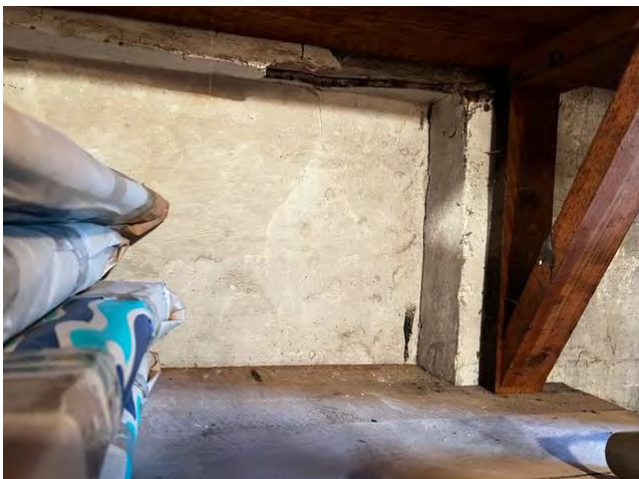
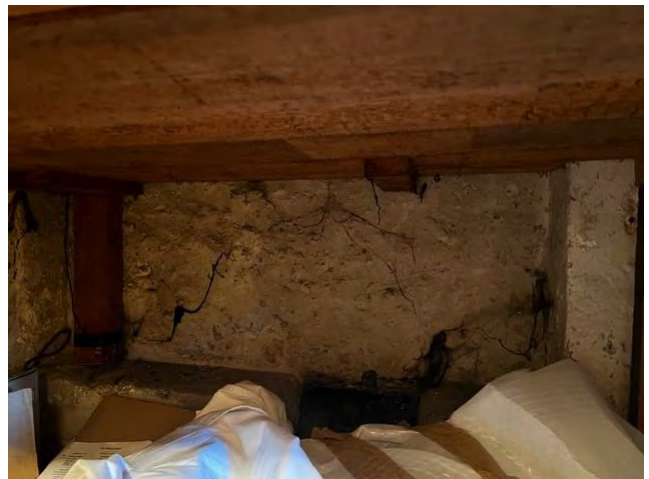
Evidence of infilled window from internal side of redundant service corridor

This is a redundant space, the connection to the Dining Room having been previously blocked up, and this proposal will return it into use. (Historic Recording p.35-36)

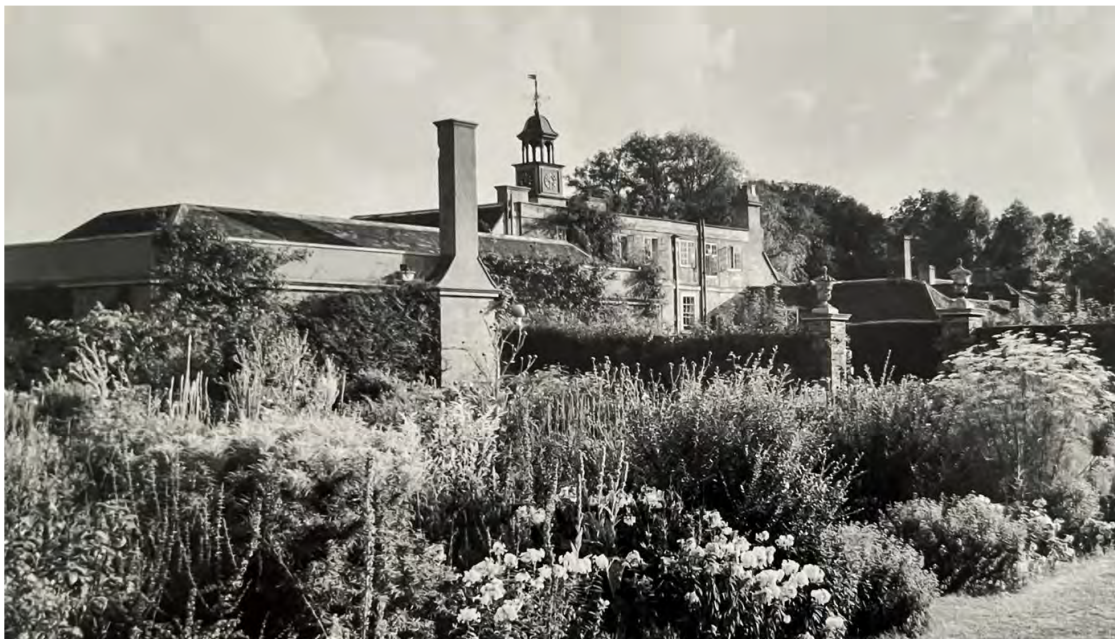
Original Music Room chimney stack

The original chimney stack has been reduced from its original height at some point, and this will be reinstated using photographic evidence.

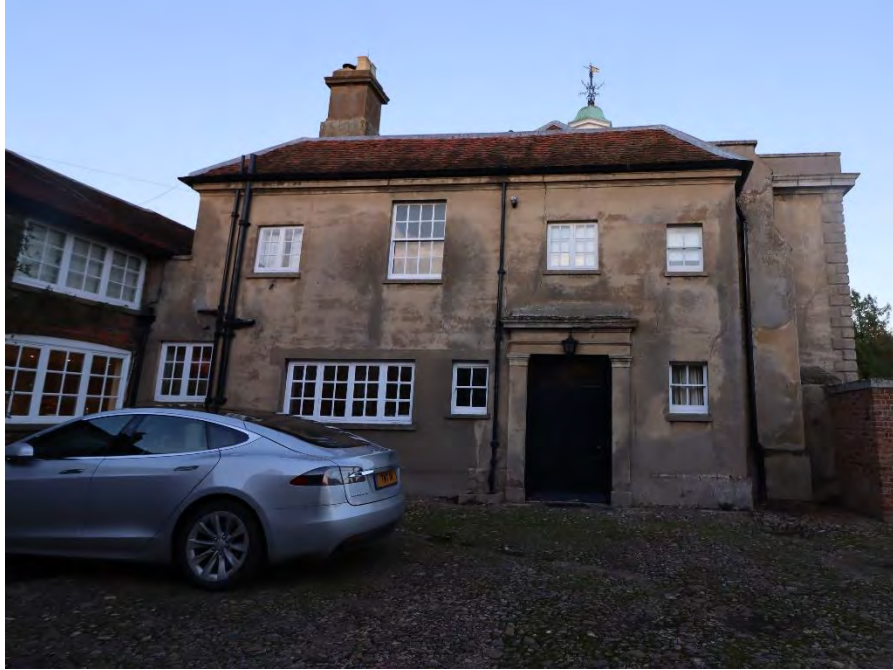
Existing drainage arrangement on west elevation of Villa. New sanitaryware installations at 1<sup>st</sup> floor will use existing routes

- New drainage to connect to existing drainage routes.

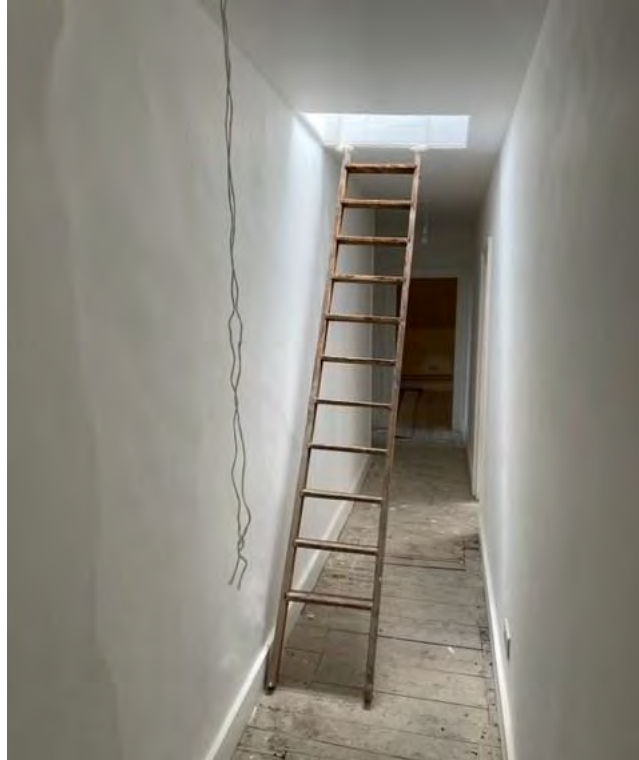
Existing MC20<sup>th</sup> fixed ladder to be removed.  
Construction materials of ceiling to be confirmed.

The existing roof access arrangement is via a timber ladder and a rooflight with a high kerb which is not considered to be safe. The ladder also obstructs the second floor corridor.

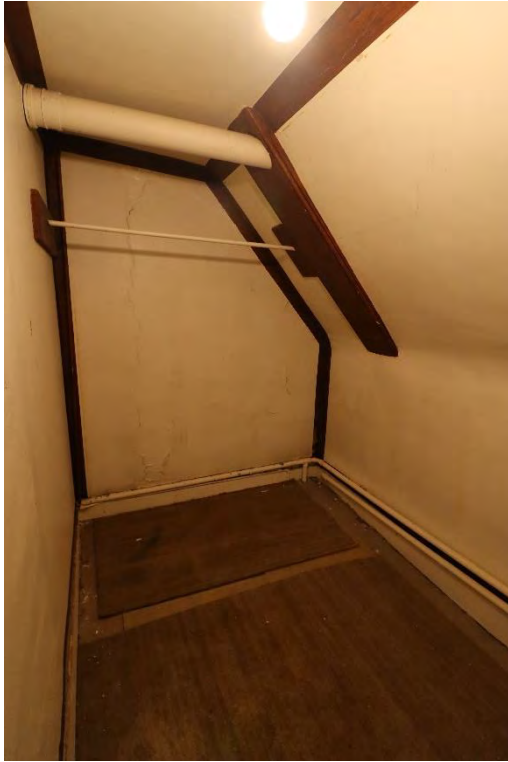
Ensuite bathroom proposed for Bedroom 6

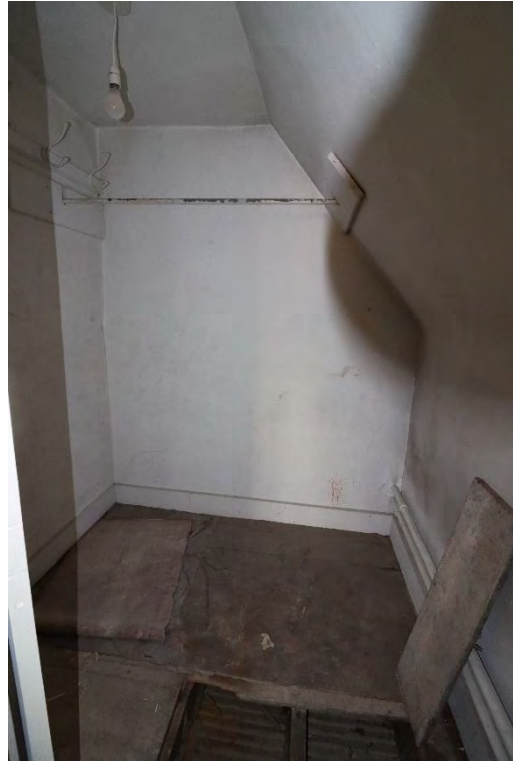
Ensuite bathroom proposed for Bedroom 7

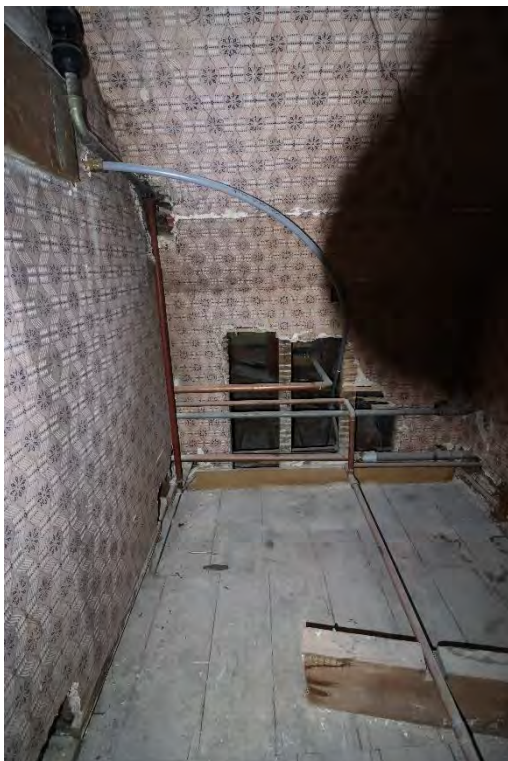
Ensuite bathroom proposed for Bedroom 8

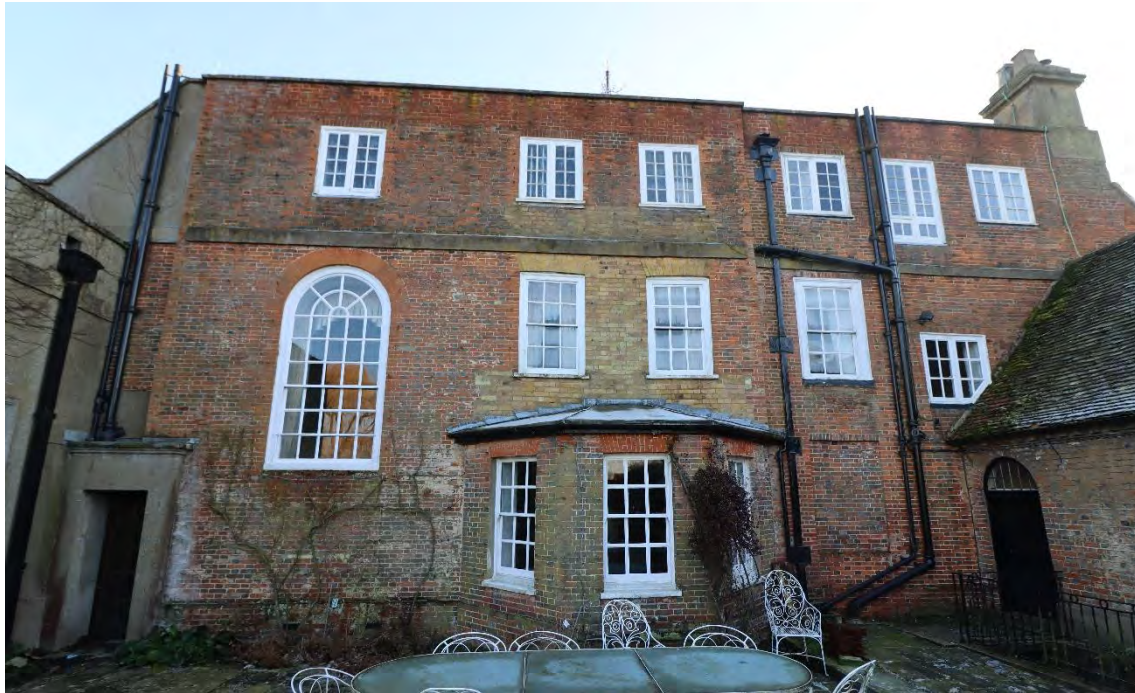
Existing drainage on rear (north) elevation of Villa (to right and left)

The existing bathroom on the west side will be retained and upgraded using the existing drainage routes. The 2no proposed ensuite bathrooms in the north-east corner will connect to an existing external soil stack on the north elevation of the Villa.

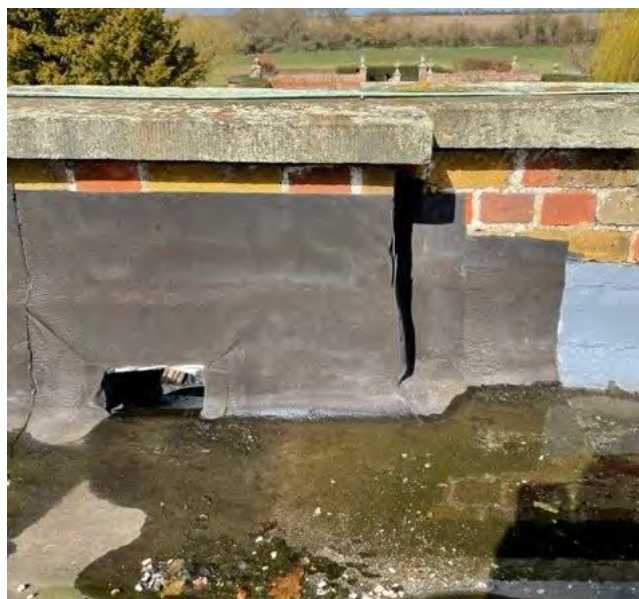
Villa flat roof outlet to north parapet wall

There is a parapet wall to the northside which is the location of the only rainwater outfall for the central flat section of roof. Opening up has been carried out to the ceiling below this area which possibly indicates that there has been failure of the asphalt. An overflow adjacent to the existing north parapet rainwater outlet will be installed as part of the proposed roof works.

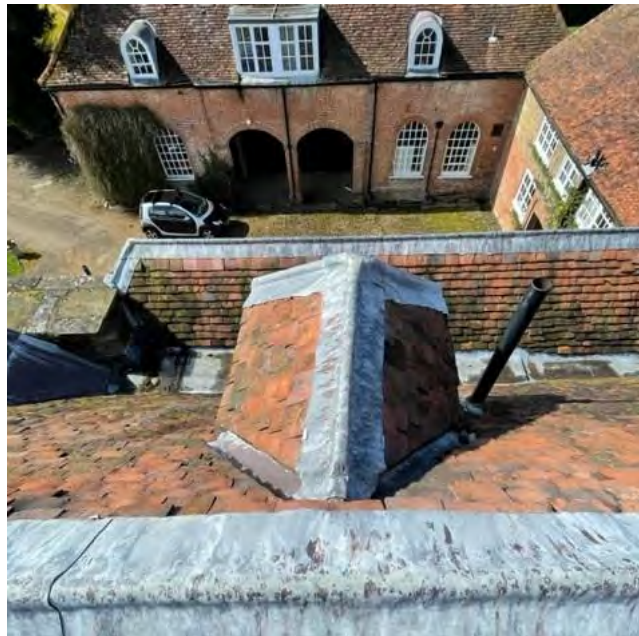
Dormer window to second floor west side bathroom

There are two curved lead clad dormer windows on the south slope to the east and west corner bedrooms, and a tiled hipped roof dormer with lead roll ridge, hips and lead clad cheeks to the west slope, which lights the second floor bathroom.

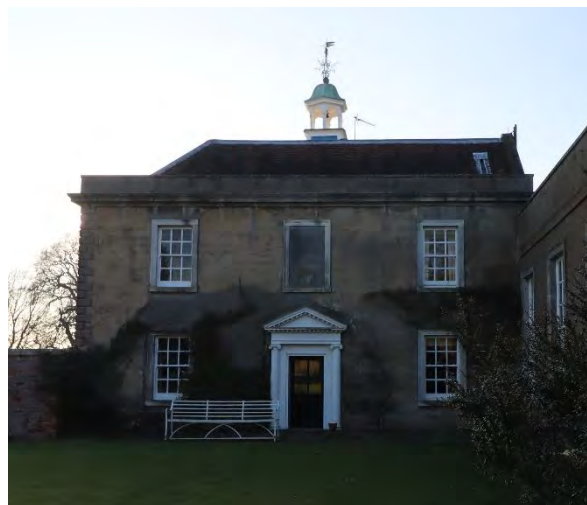
Lead chute to right of east tiled roof

A lead chute rainwater outlet on the north-east tiled slope was incorporated at some point following the 1939 works, possibly due to ponding. The connection with the outlet has been removed and it now appears to be redundant.

The condition of the lead chute will be investigated and it will be retained unless it is found to compromise the watertightness of the roof.

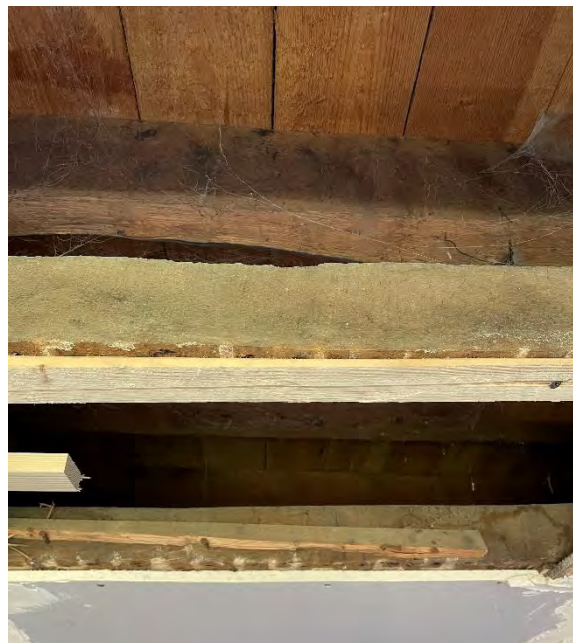
Photo taken in central north room indicating roof build-up.  
The lower timbers are assumed to be 1939 from works.

The proposal is to remove the existing C20<sup>th</sup> 3 layer felt roof covering, decking and timber firrings and the layer of timber boarding installed directly above the joists. Removal of these boards will provide access to the roof void for inspection of the structural timber and to carry out any necessary repairs. The roof void will then be insulated with sheep wool.

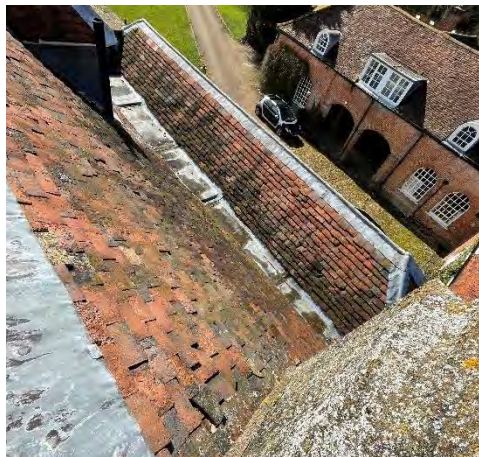
West side stepped valley gutter

The lead lined parapet gutters and outfalls to the north-east and to the south and the stepped valley gutter at the base of the west slope of the Villa, will be inspected and repaired/replaced as necessary.

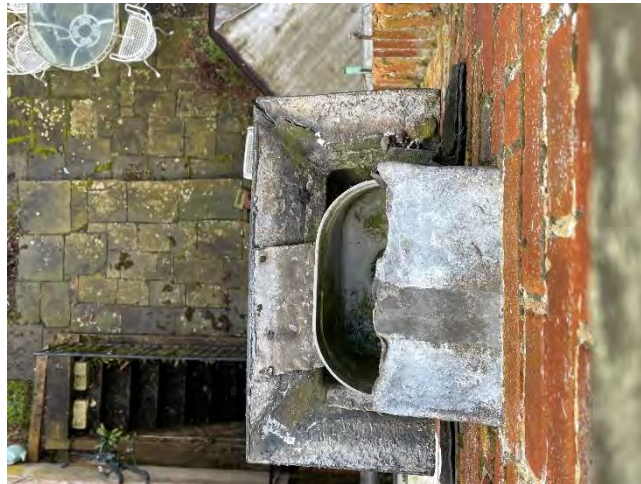
Rainwater outlet on north side from Villa flat roof

The north side parapet rainwater outlet discharges into a hopper which is connected to a square section cast iron rainwater pipe which will be inspected and repaired as necessary.

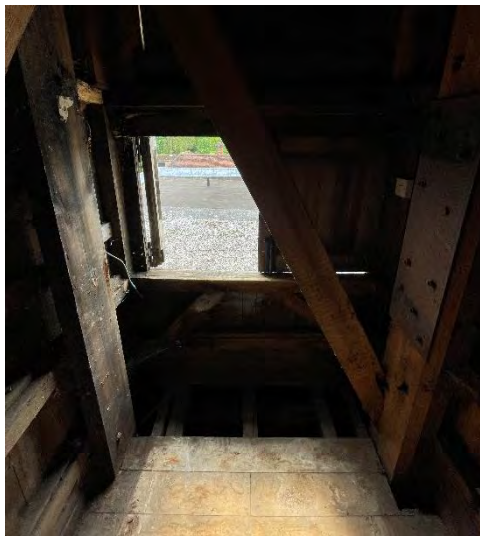
Bracing within the body of the clocktower

C20th timber bracing has been installed within the body of the clocktower which will need to be removed along with the floorboards and joists to allow installation of the ladder.

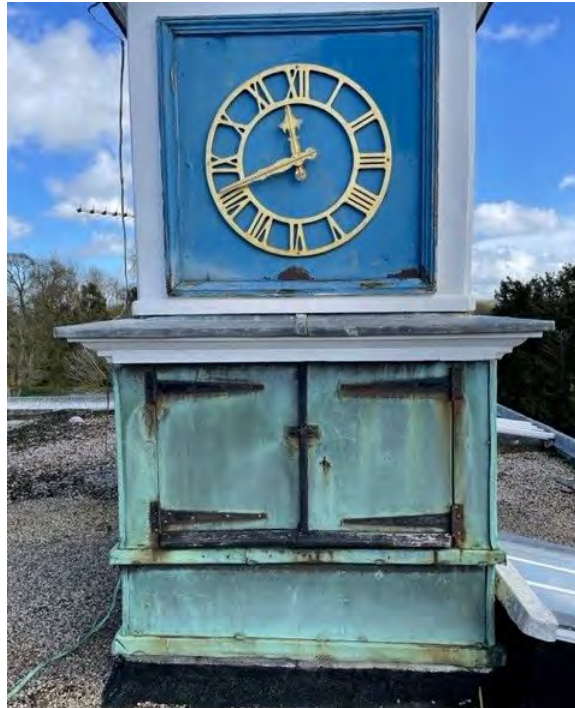
West face of clocktower.  
Existing doors to be increased in length to provide ease of access onto roof.

The existing doors on the west side will be adjusted to increase their length into the base of the clocktower thereby providing safe access onto the roof from the proposed automatic ladder, which will remove the necessity of climbing over a high kerb.

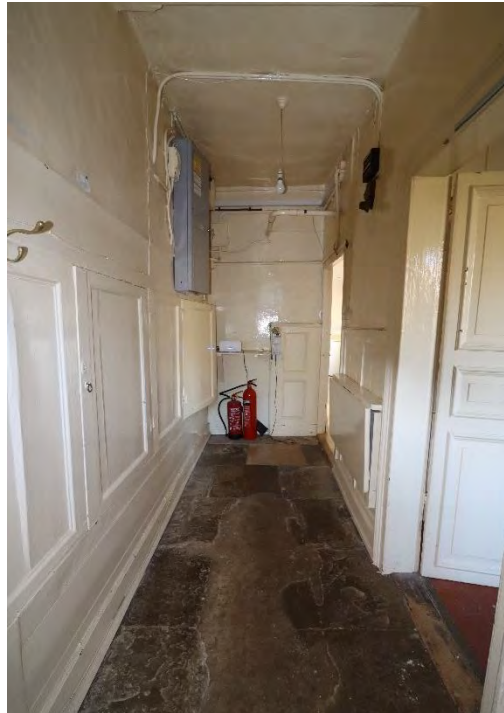
Butler's Pantry Service Corridor  
EC18<sup>th</sup> reclaimed cupboard doors concealing C17<sup>th</sup> fireplace to left side  
and worn flagstone floor

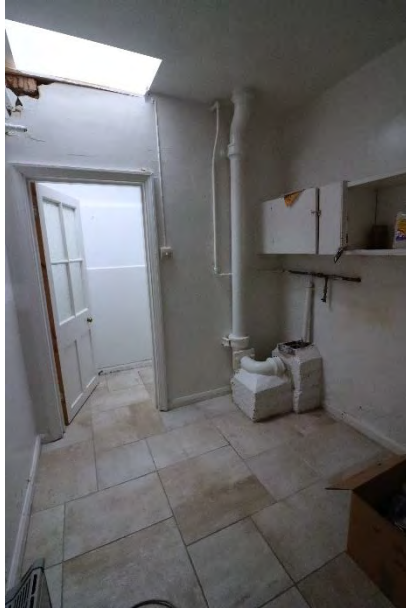
C20<sup>th</sup> door to WC to be removed

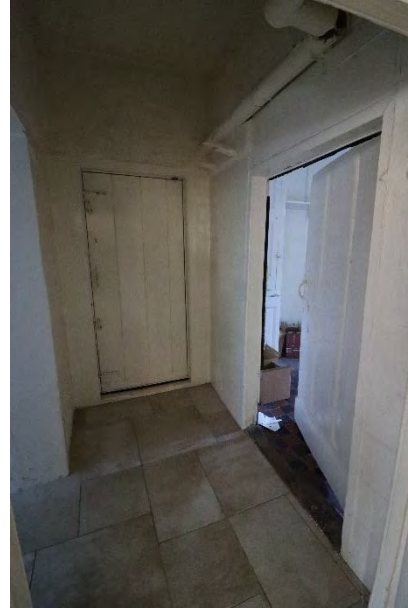
C20<sup>th</sup> door to store to be removed

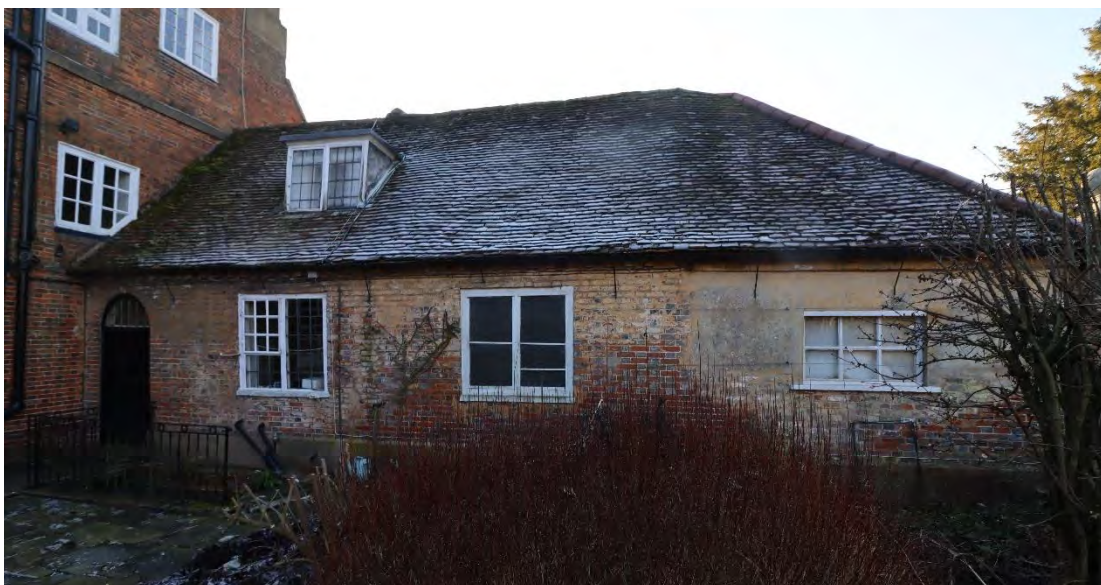
West elevation of service wing

Remove MC20<sup>th</sup> windows (3no west elevation, 1no north elevation) and replace with new timber windows to match existing. Glaze with slim-line units. Refer to Historic Building Recording P.9 -14.

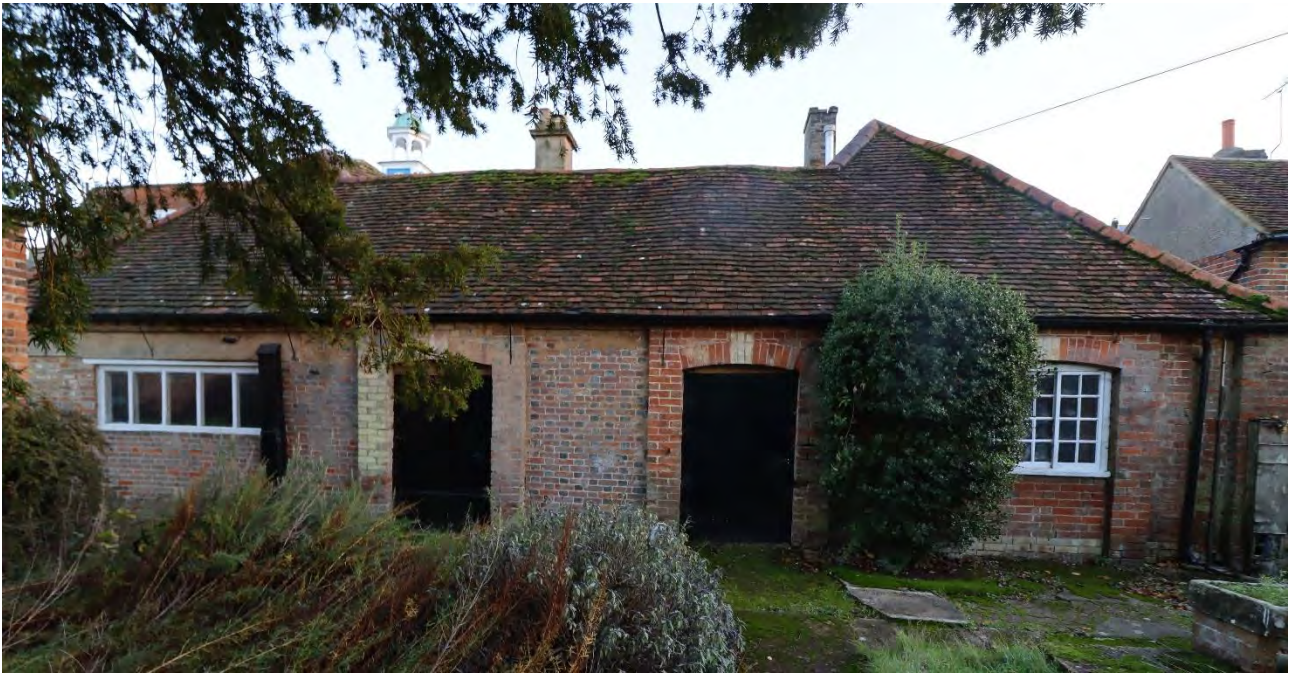
The C20<sup>th</sup> fixed light window to the north-west corner (lhs) will be removed and replaced to match with flush opening casements incorporated.

| 38 | Remove fixed light window to north elevation and replace with matching high quality timber window | Low<br><br>MC20th window | Low Impact | The existing window is MC20th (Historic Recording p11) and is of poor construction without an external or internal sill. The replacement window will match the existing simple form but with opening casements added to the end lights to provide ventilation to the proposed Laundry Room. The new window will be fitted with slim-line double glazing and integral beads which will be thermally efficient. The new window will enhance the appearance of the elevation and will not affect the C18th brickwork. |

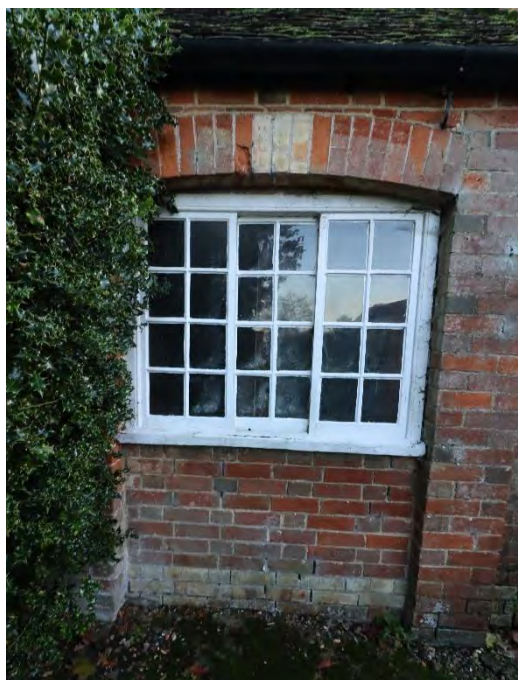
Replica MC20<sup>th</sup> sliding sash window and recessed brick panel below will be removed to provide an opening into the proposed link corridor

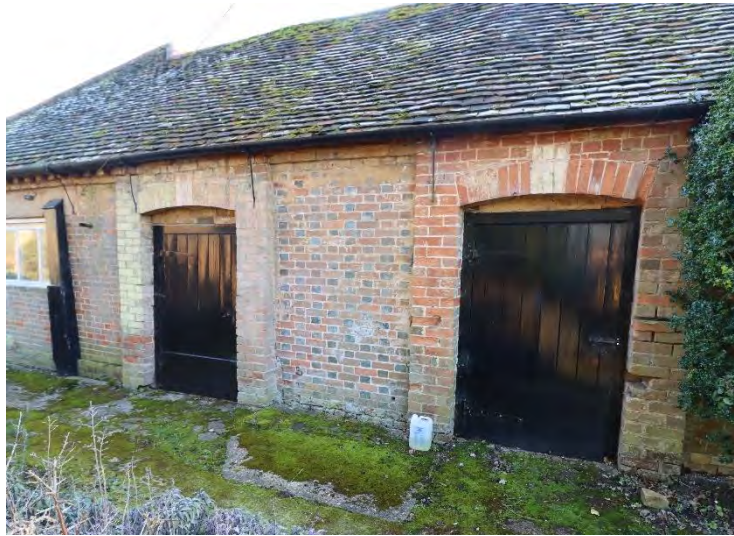
The 2no existing MC20<sup>th</sup> timber ledge and brace external doors to the north elevation of the service wing store and plant room will be retained. The existing frames will be fitted with full height windows. The doors will be positioned adjacent and held open on parliament hinges.

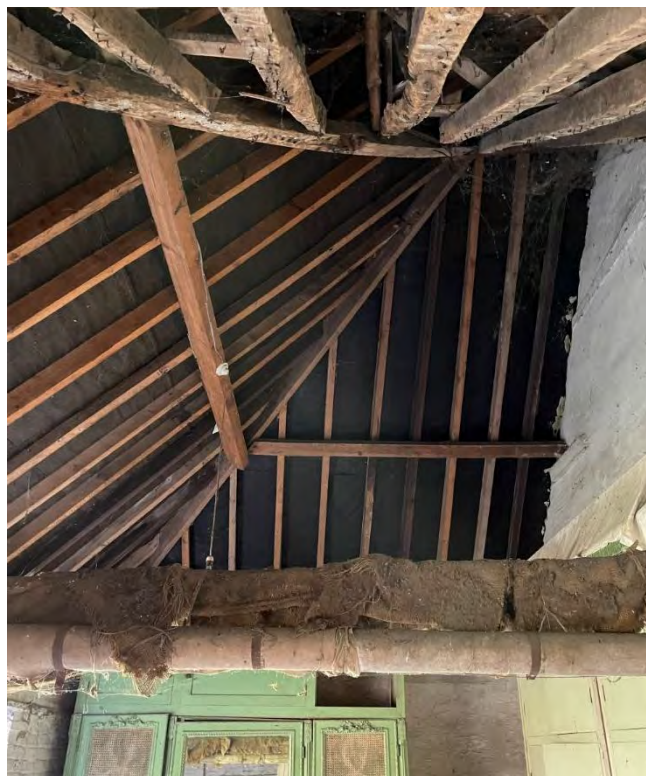
Location above existing store for new floor

The existing Store in the north-east corner of the service wing is open to the rafters, and it is proposed that as part of the conversion of this space to a Laundry, a floor is installed to support hot water storage plant. Access will be via an opening to be formed in the MC20<sup>th</sup> plastered studwork partition which forms the back of the linen store at 1<sup>st</sup> floor, which can be seen on the right in the photo above. This will provide safe and convenient access to the plant room for maintenance.

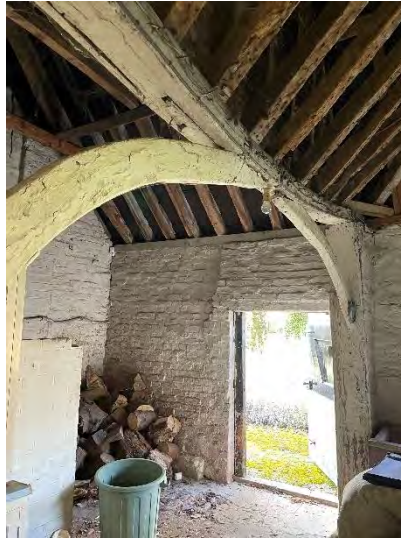
Timber brace to be repaired/strengthened

- Carry out structural repairs to existing roof timbers and beams and structural repair/remedial strengthening works to failing timber brace in Store (Historic Building Recording 26.05.23 p.33)

| 42 | Carry out structural repairs to existing timber brace in Store | High-Moderate | Low Impact<br><br>Benefit | Necessary repairs to structural timber brace (Historic Recording p32) A design for conservation structural repairs will be submitted for approval. Conservation benefit. |

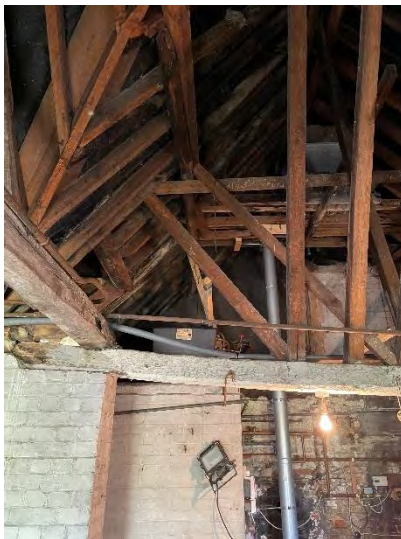
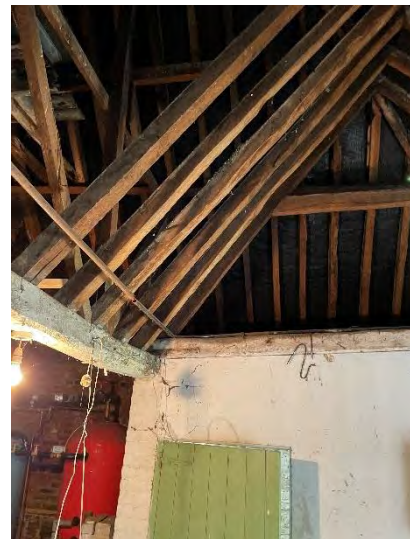
- There are 3no horizontal timber beams supporting the roof structure over the existing boiler room. These are likely to be C19th reclaimed beams used in the 1939 works. The deflected beam running east-west will be replaced with an oak flitch beam and will span from wall to wall following removal of the MC20th brick partitions currently supporting the existing beam.

Brick pier and workshop partitions to be removed

| 35 | Removal of C20th structural brick piers supporting horizontal timber beams | Low | Low Impact<br><br>Enhance | The 3no horizontal timber beams in the boiler room are possibly C19th reclaims and as such are not original to the construction of the service wing. 1no deflected beam will be replaced with an oak fitch beam which will allow removal of the MC20th masonry supports. |

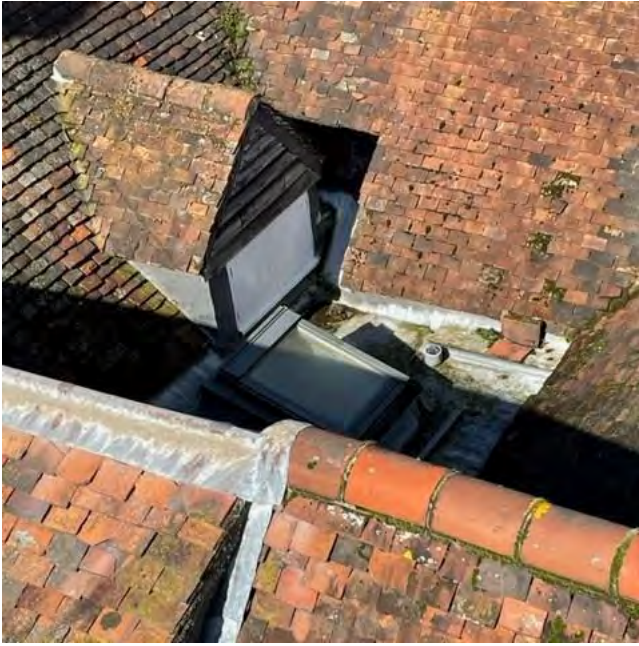
Dormer access hatch above Boiler Room - internal and external views

- The timber doors fitted to the hidden dormer on the internal west slope (photo below) will be replaced with a glazed access window and the dormer will be refurbished along with the roof works.

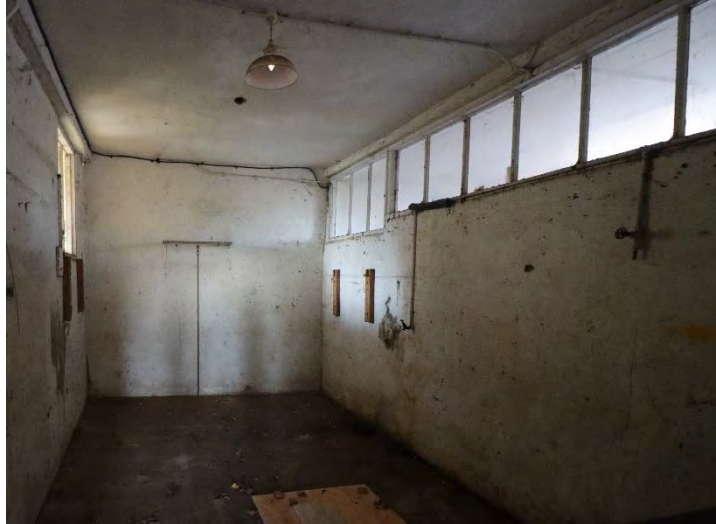
C20<sup>th</sup> partition to be removed (rhs)

A MC20<sup>th</sup> century top-glazed partition will be removed to provide an open plan living/kitchen/dining area, (rhs photo below) and a new door opening will be formed through the existing MC20<sup>th</sup> brick wall into the entrance area to the west (lhs photo below). This opening will provide access to the first floor via the existing C20<sup>th</sup> timber stair.

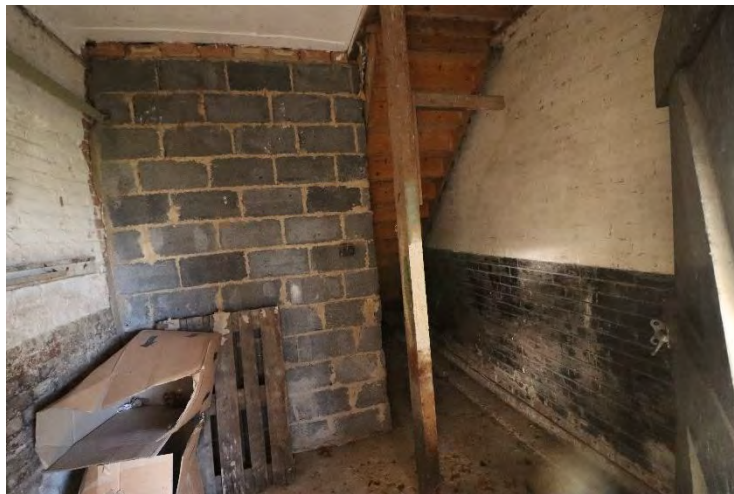
Blockwork partition to be removed and approx location for proposed new door opening (rhs)

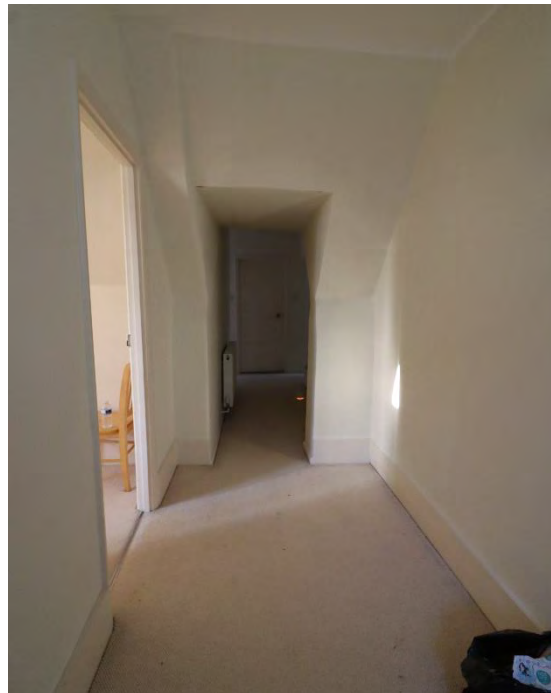
Division of 1<sup>st</sup> floor corridor will be located at far end  
(beyond radiator to lhs)

At 1<sup>st</sup> floor the existing bedroom and bathroom accommodation has previously been upgraded and will be retained as the existing layout. The proposed work at 1<sup>st</sup> floor is limited to the construction of a timber stud partition which will divide the accommodation into two separate annexes.

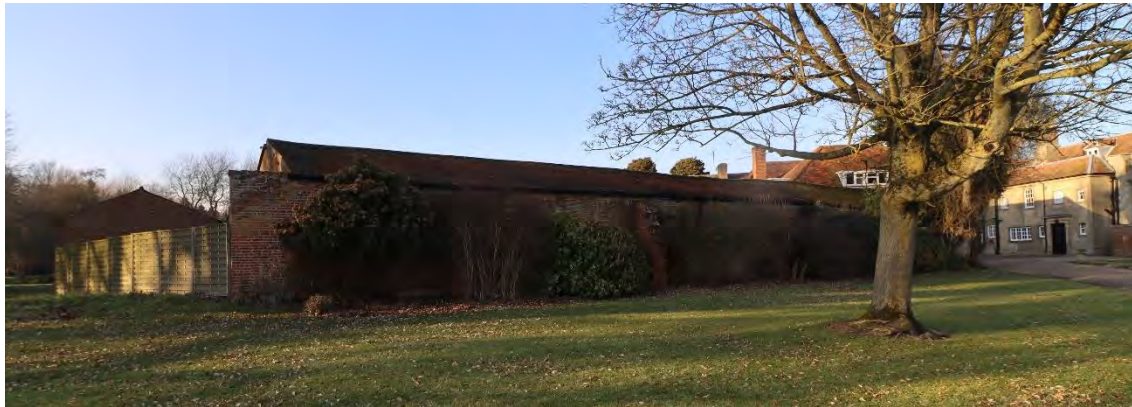
The brick wall which forms the south-east side of the main garage block, and running south-west from the former Coach House is all that remains of the pre-C20<sup>th</sup> structures (Historic Recording p.24)

South-east view and pre-C20<sup>th</sup> wall

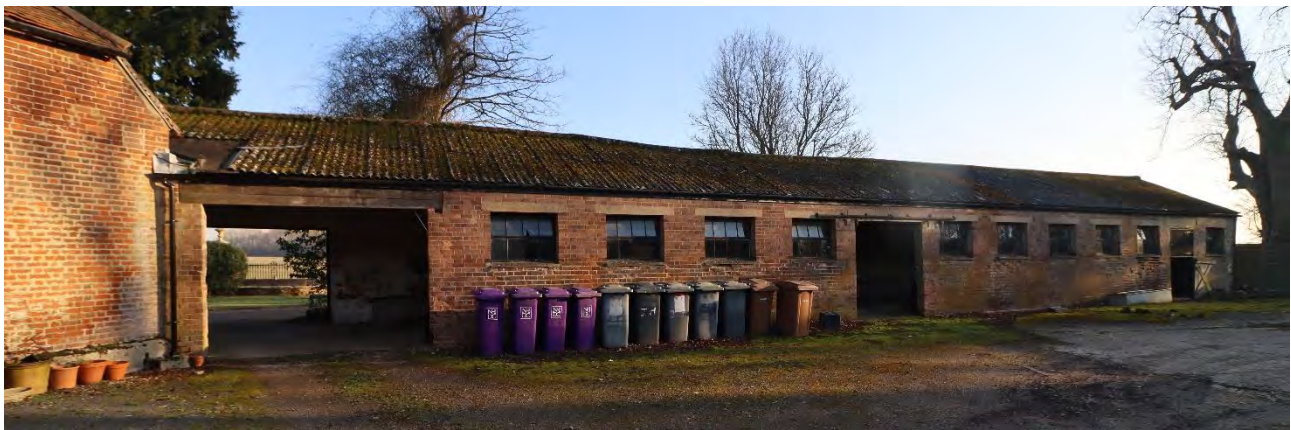
The roof slope on the south-east side is laid with plain clay tiles, and to the north-west side it is corrugated cement sheet.

MC20<sup>th</sup> garages (north-west elevation)

It is proposed that the existing MC20<sup>th</sup> garages be removed and the EC18<sup>th</sup>/EC19<sup>th</sup> wall (Historic building Recording p.47) be retained and incorporated into the new garage construction.

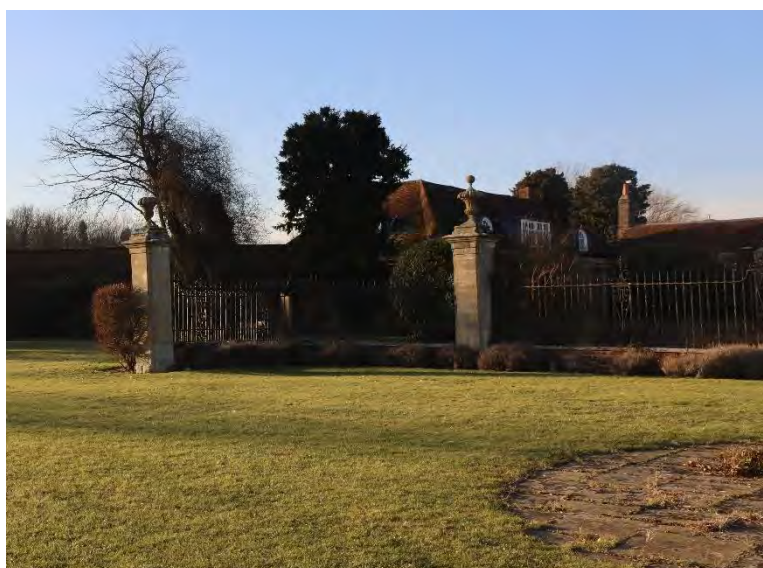
Later additions to the south wall of the Entrance Courtyard

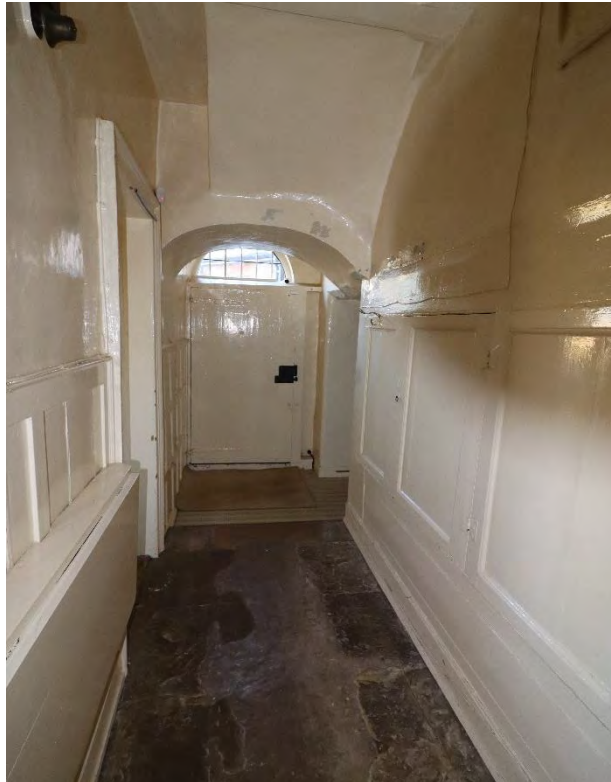
Service Corridor at rear of Main Villa. C17th fireplace behind cupboard doors (rhs)

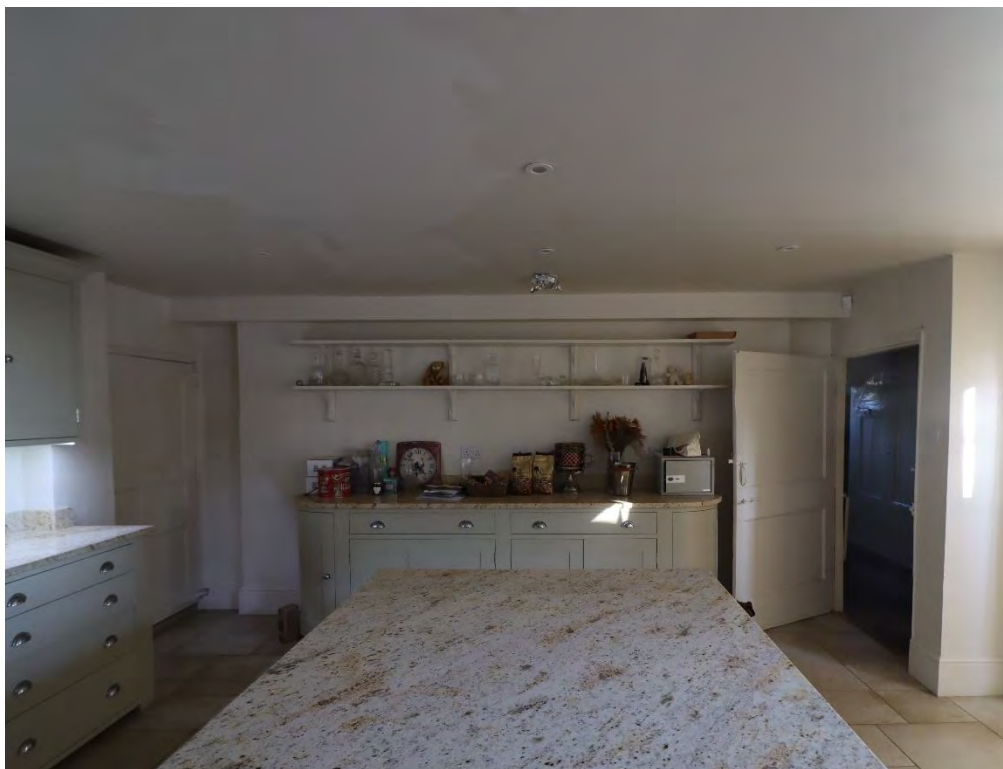
MC20th wall (forming Butler's Pantry) and shelving to be removed

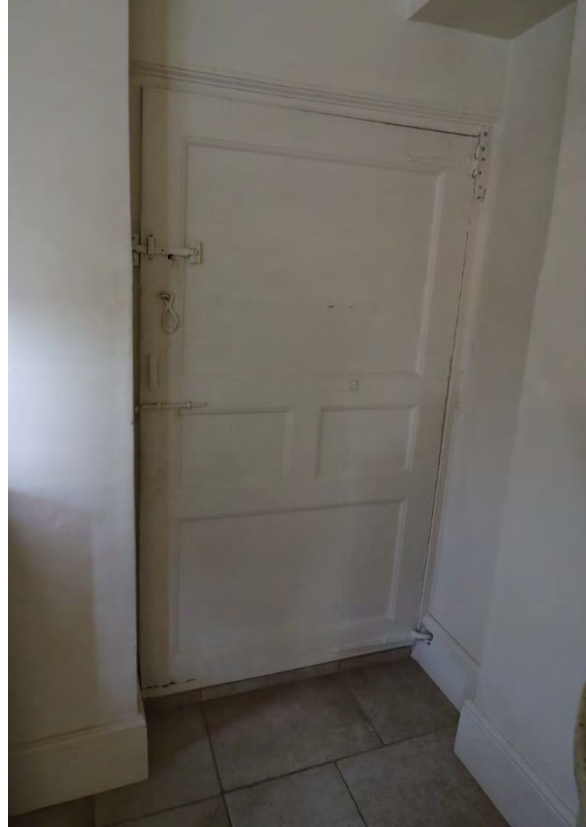
Georgian door (Historic Recording P20) to be relocated to form lobby to Master Bedroom suite

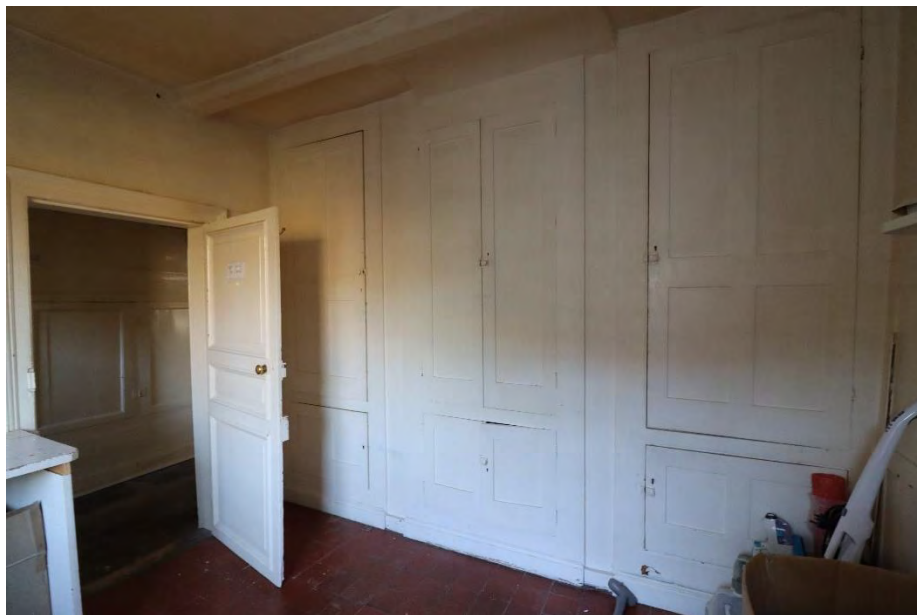
Butler's Pantry. Existing door to be relocated to form lobby in corridor.  
MC20th fitted cupboards to be relocated to new Butler's Pantry

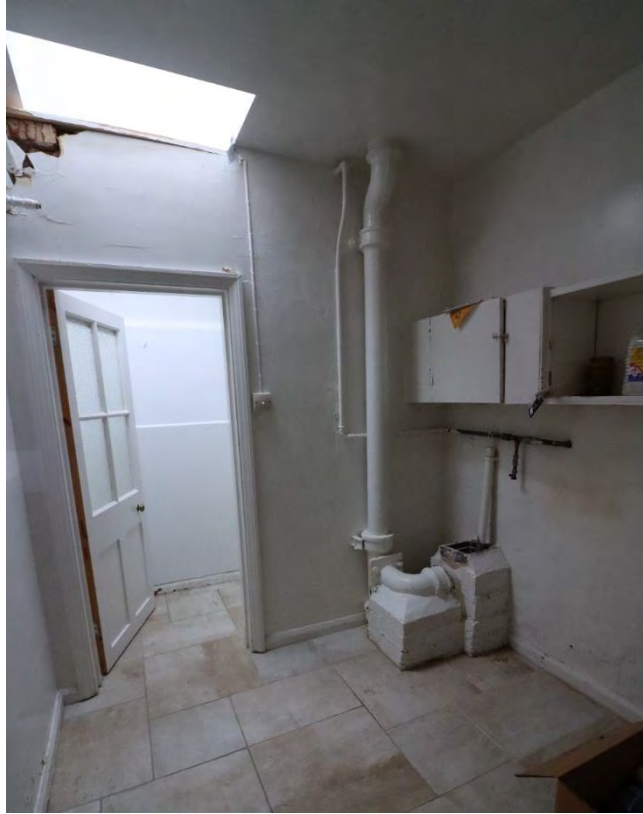
Lobby to Cloakroom. C18th walls to right & left to remain. MC20th door, partition and rooflight to be removed

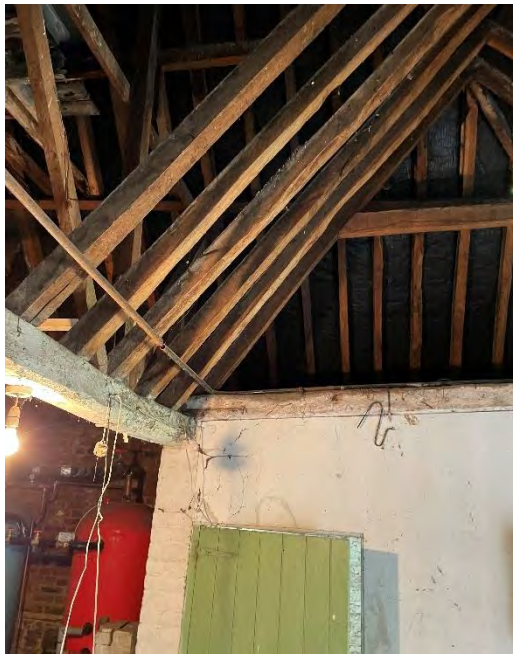
Existing Boiler Room. MC20th partition and door forming workshop to be removed. Historic rafters to remain.

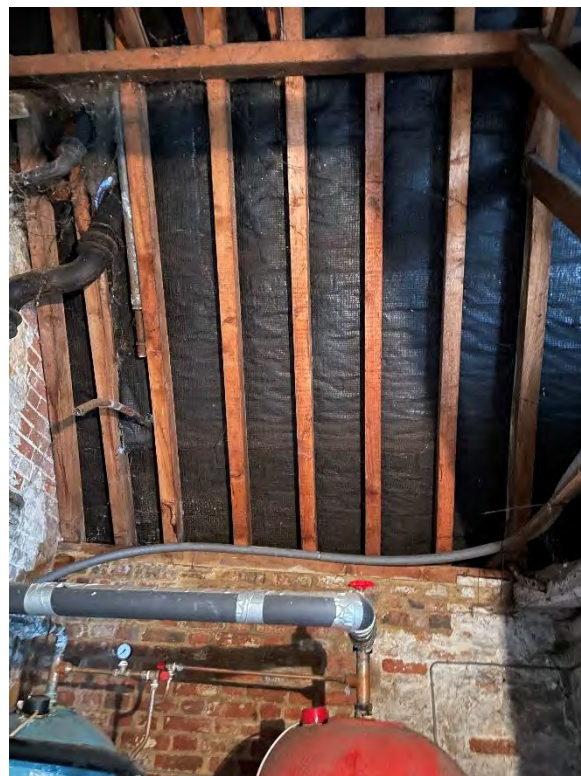
Boiler Room. West slope of roof. Machined softwood and modern sarking felt (Historic Recording P 37)

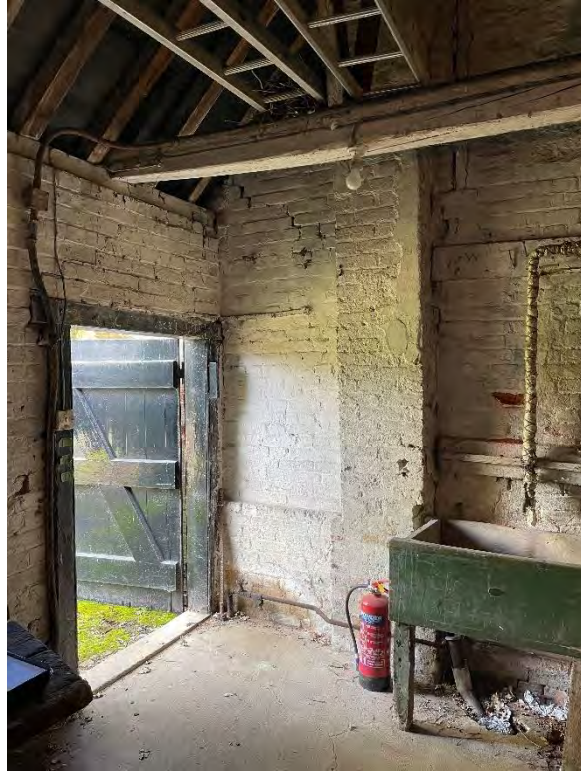
Boiler Room. Masonry flue and brick infill panel (rhs of MC20th door) to be removed

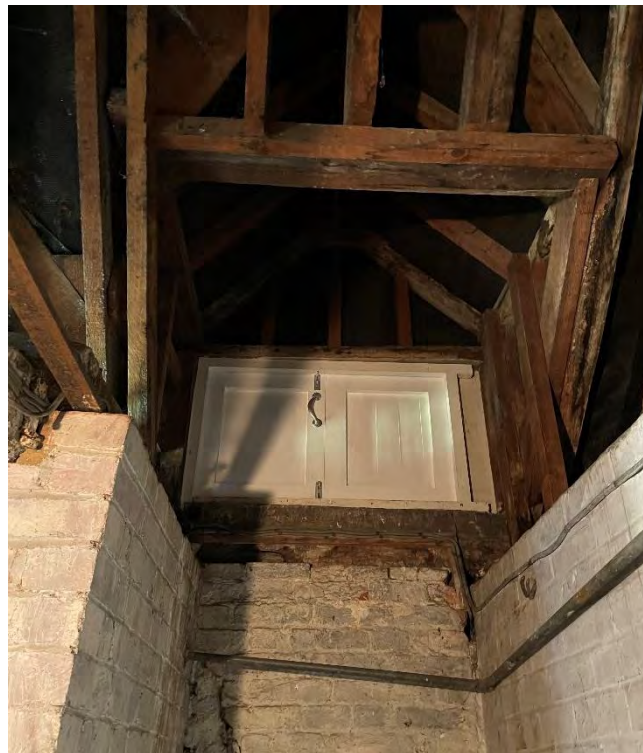
MC20th masonry pier) (lhs) to be removed. Timber access hatch to flat roof to be removed and replaced with an opening casement window.

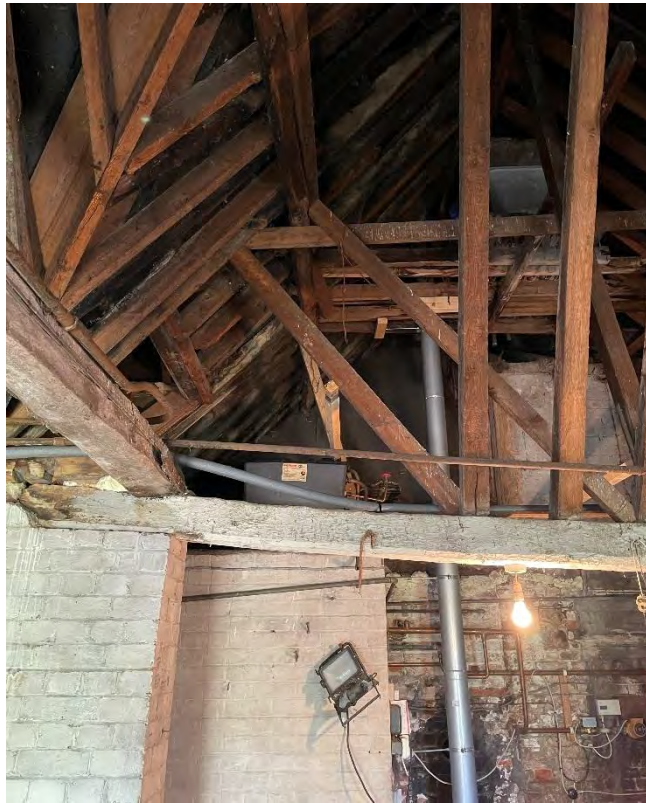
Structural solution for support of deflecting timber beam to be confirmed. MC20th corner to kitchen food cupboard behind pier
