# KAY PILSBURY THOMAS ARCHITECTS

## HERITAGE, DESIGN AND ACCESS STATEMENT FOR PROPOSED WORKS AT JULIANS PARK

**RENOVATION TO VILLA ROOF & PROPOSED NEW ROOF ACCESS, EXTERNAL RENDER AND STONE REPAIRS & INTERNAL ALTERATIONS AT GROUND, 1<sup>ST</sup> & 2<sup>ND</sup> FLOORS.**

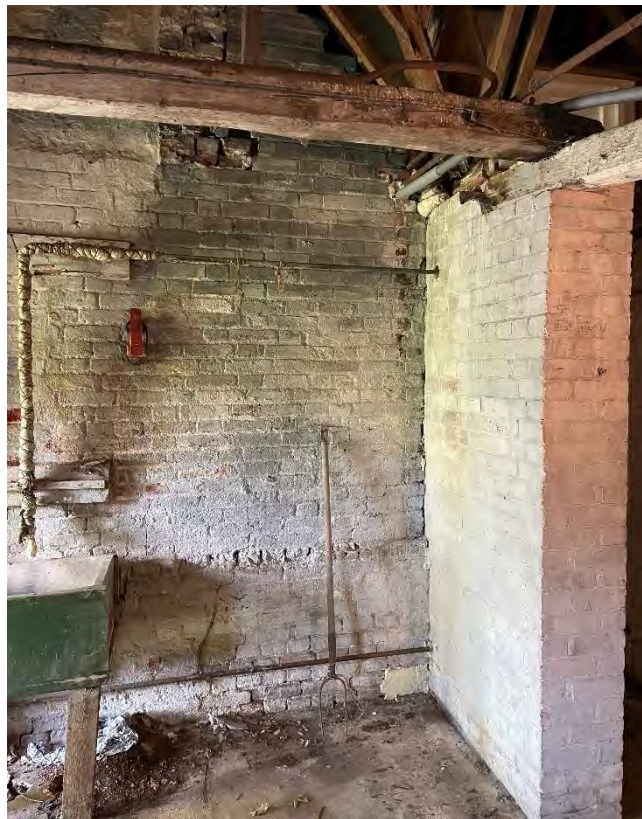
MC20th brick pier to be removed. Support to timber beams to be confirmed.

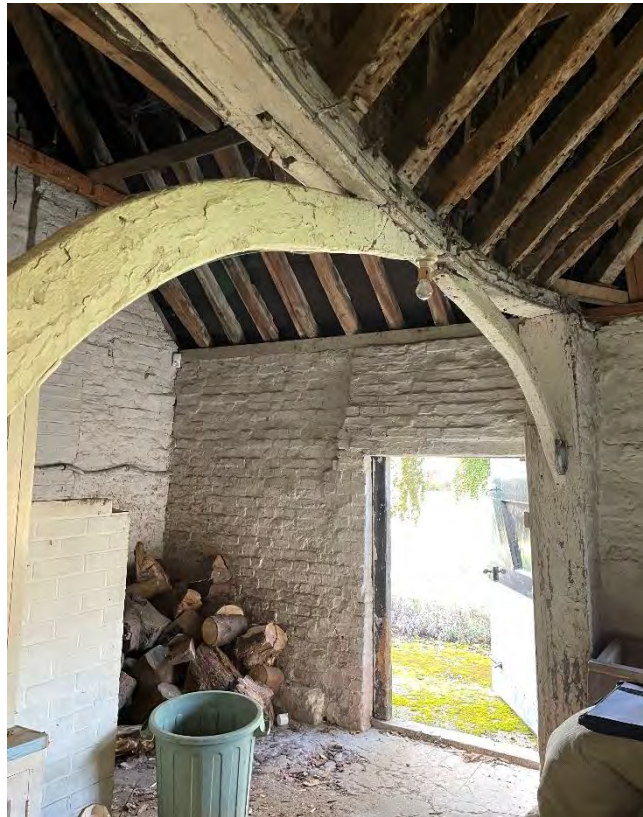
Store. Timber frame and spandrels with failing scarf joint to be repaired.

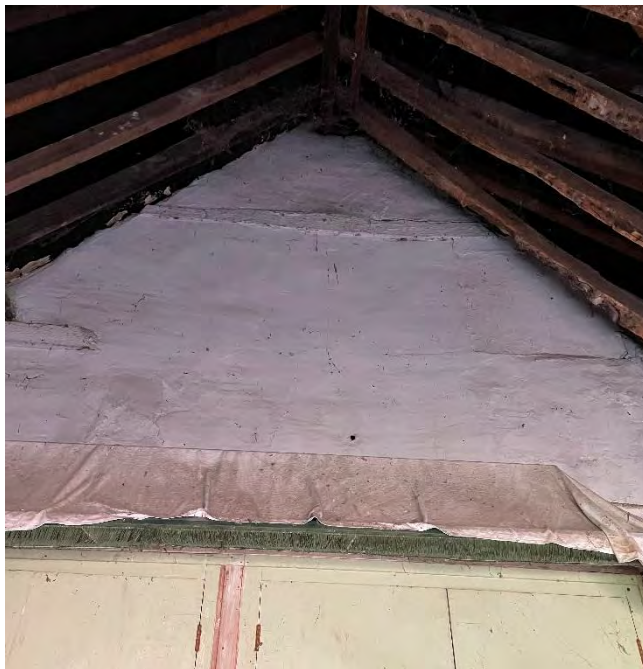
Opening to be removed in timber stud gable wall (from  
1<sup>st</sup> floor Linen Room)

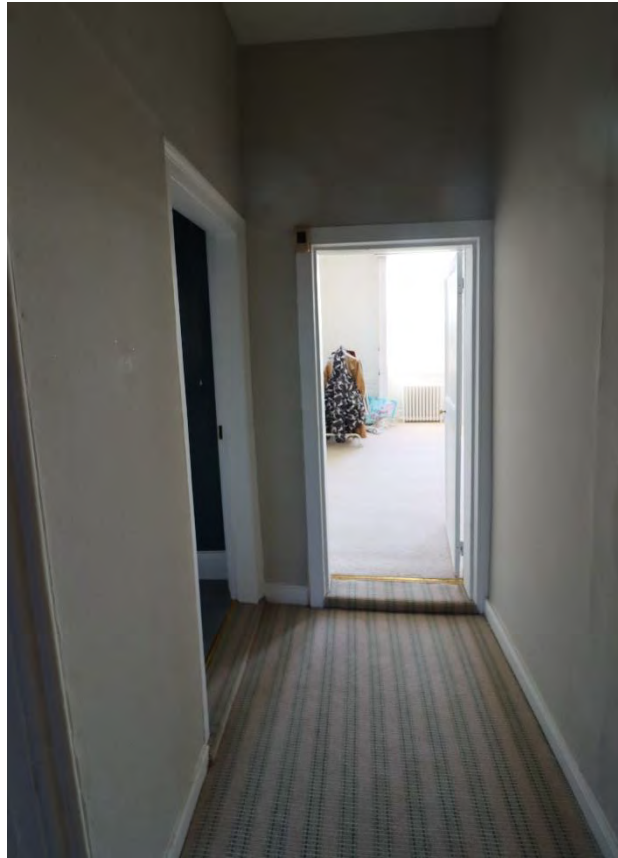
Corridor approaching Master Bedroom. Door and partition to be reinstated along line of removed partition to rhs

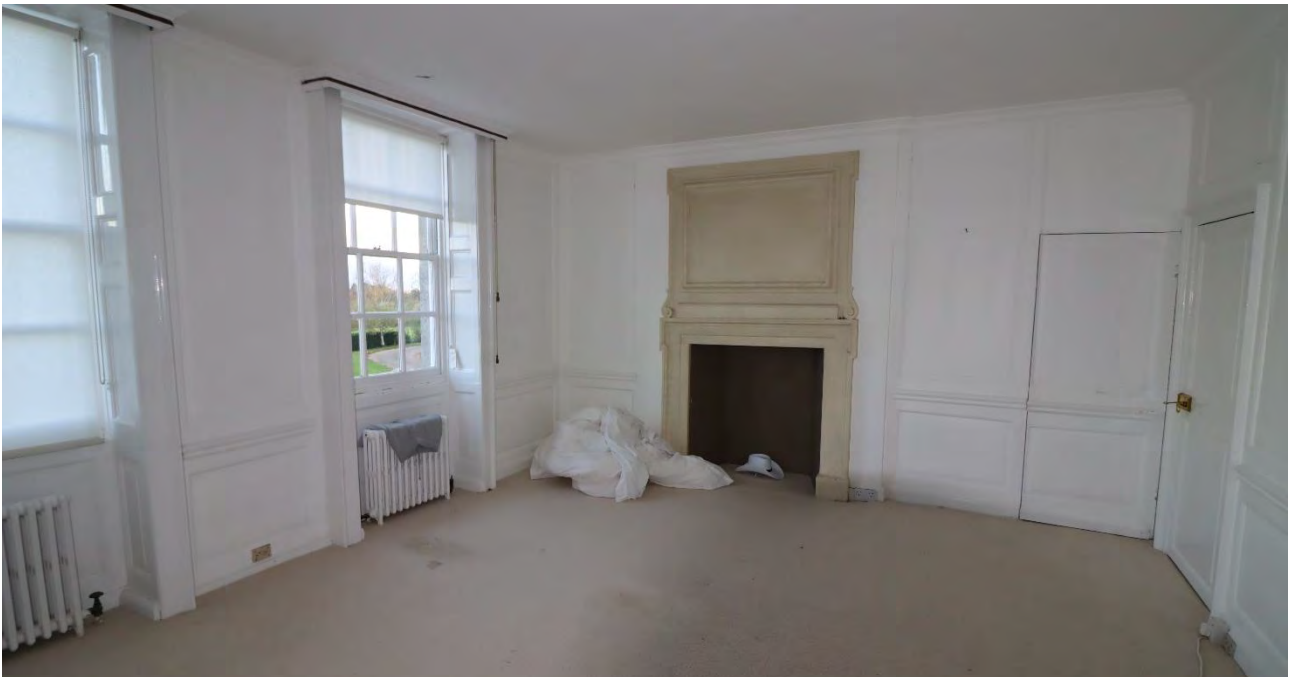
First Floor south-west bedroom to be converted to Master Bedroom Ensuite Bathroom  
2no doors (rhs) to be retained and fixed shut.

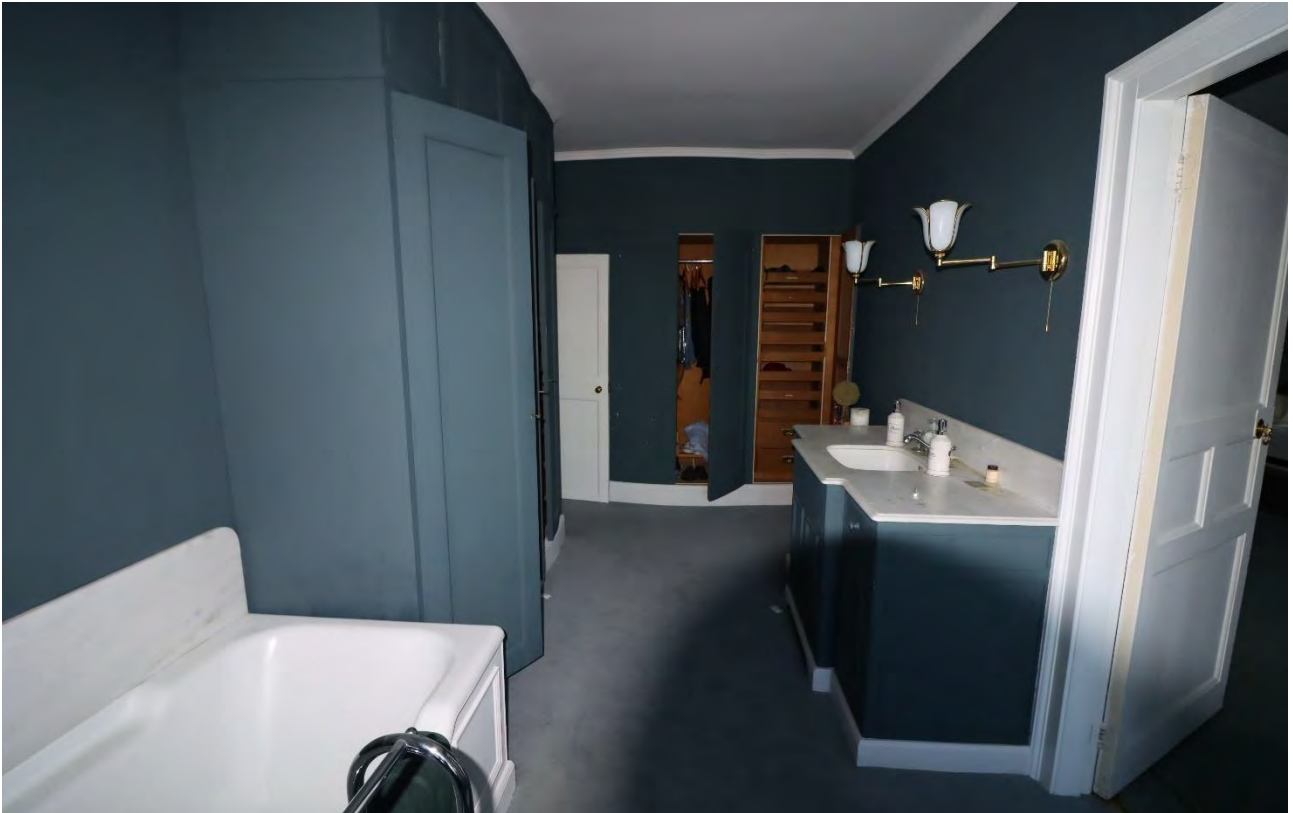
Existing ensuite bathroom to be converted to Dressing Room serving Master Bedroom Suite

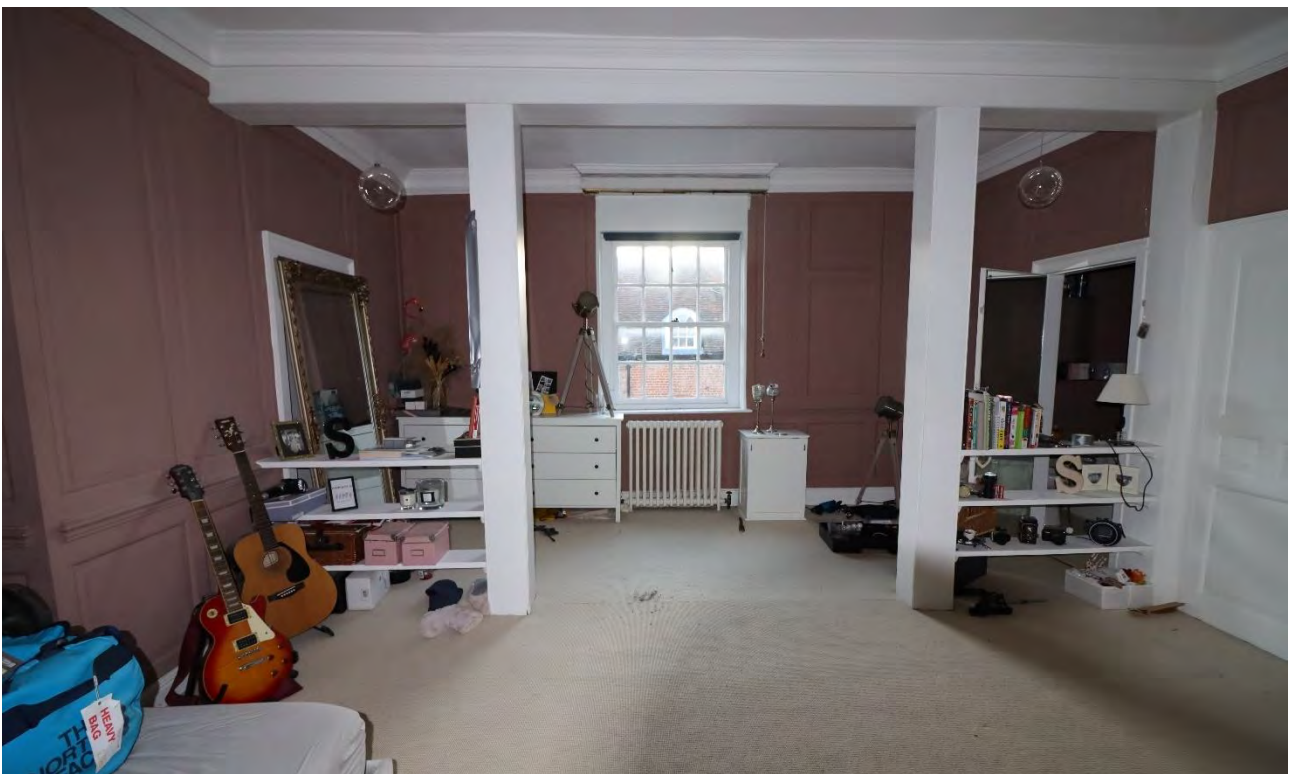
Bedroom 2 existing door (behind mirror lhs) to be opened up from bathroom side

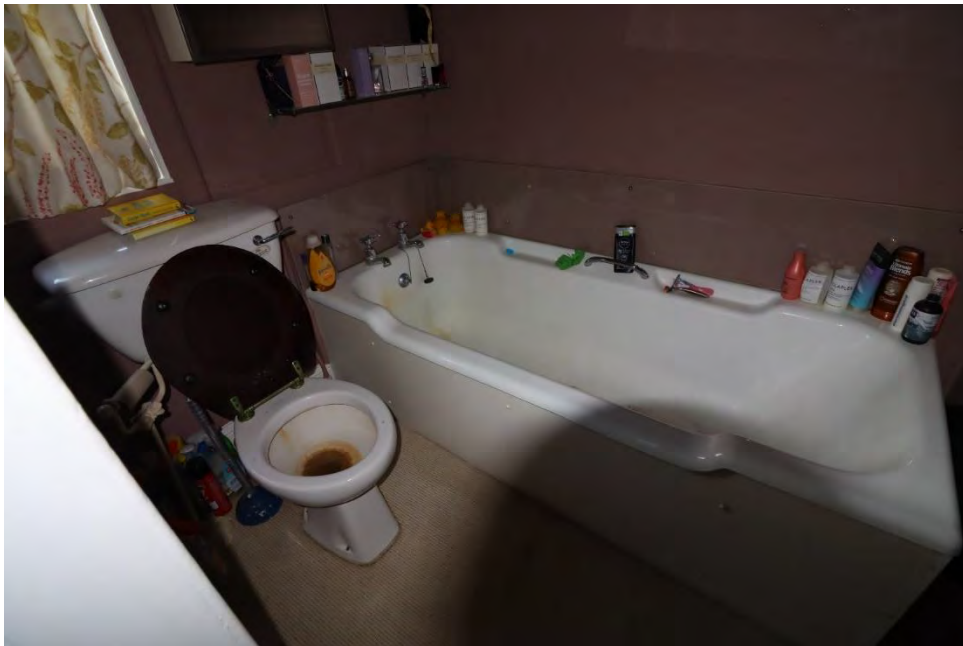
Existing ensuite to Bedroom 2. MC20th sanitaryware, plumbing and drainage to  
be removed. Room to be converted to a Dressing Room

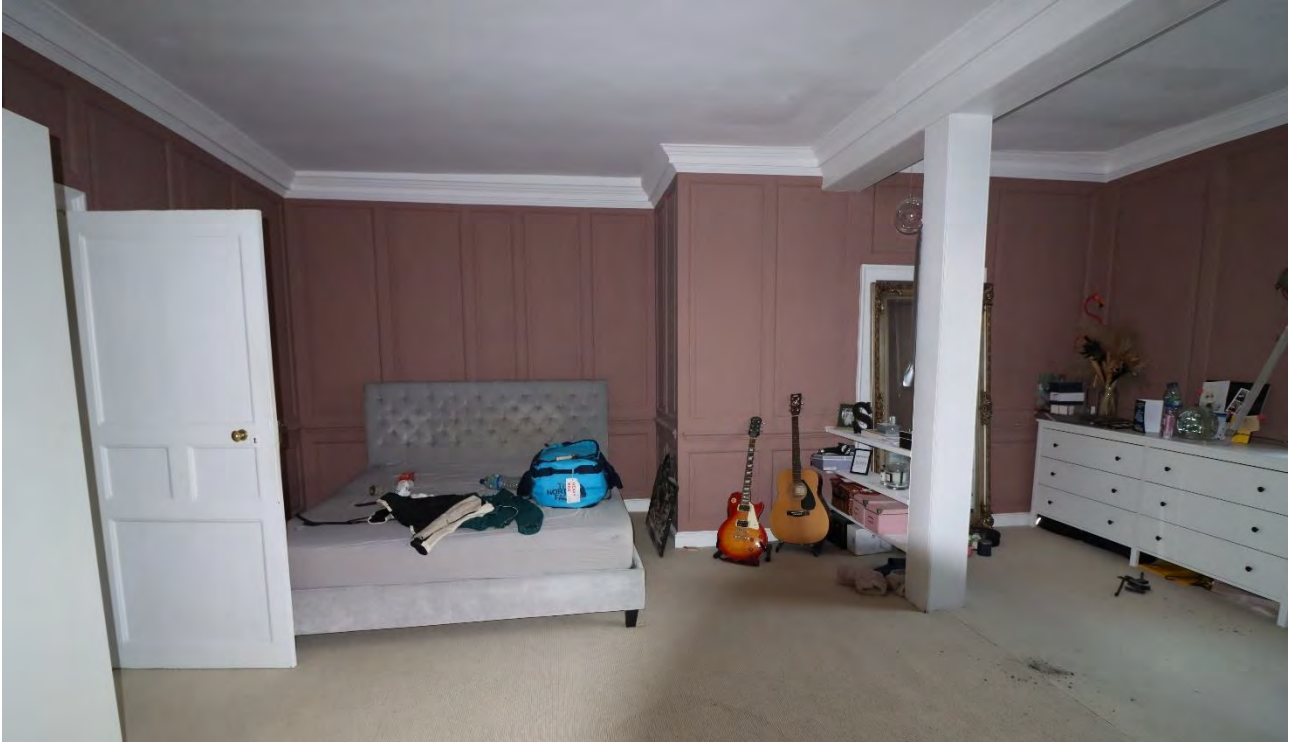
Matching door from kitchen to be relocated to form lobby adjacent to Bedroom 2 door

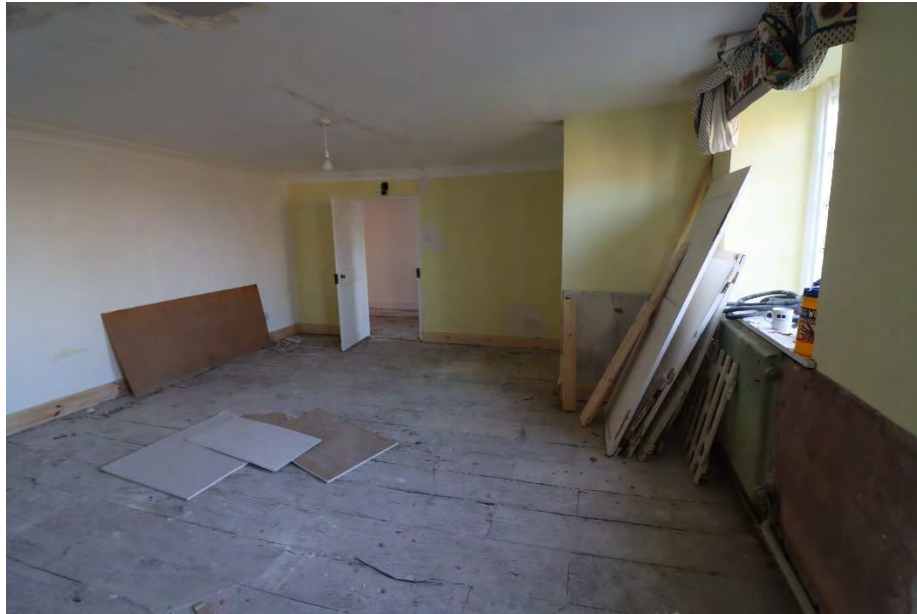
MC20th WC partitions to be removed (rhs)

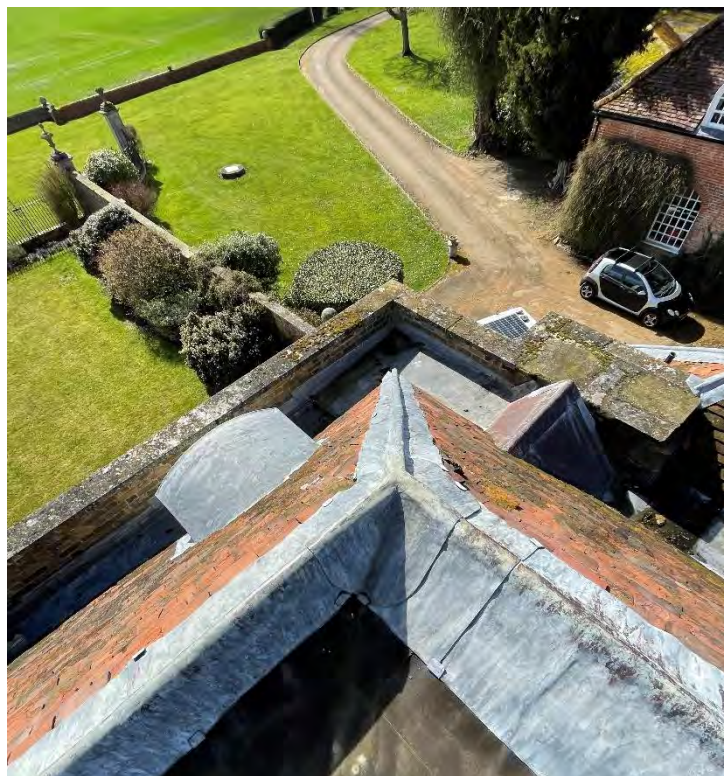
Top of west side lead clad dormer window

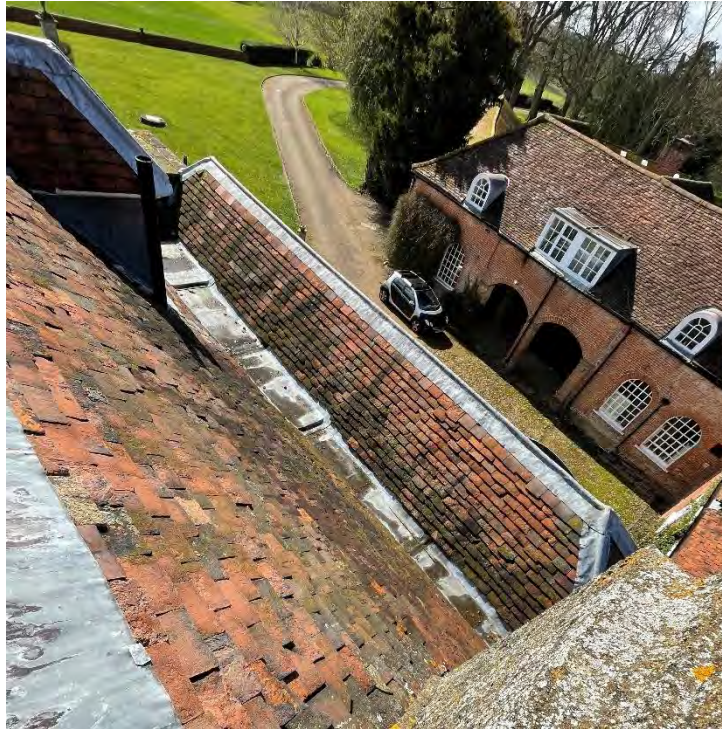
View to lead stepped valley gutter and tiled dormer window to 2<sup>nd</sup> floor bathroom (west side)

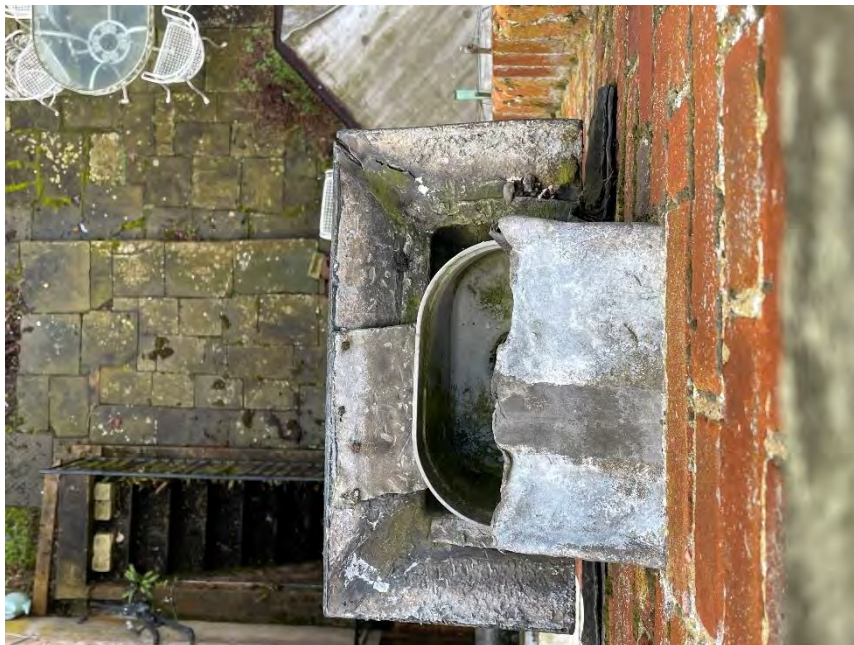
Existing rainwater outfall from flat roof to hopper (north elevation)

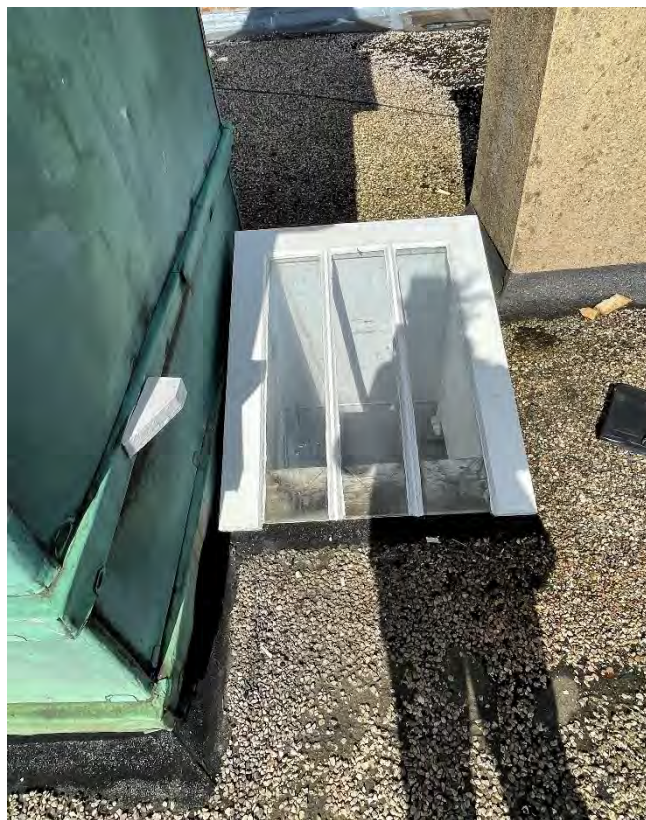
Rooflight R2 currently used for access to roof via fixed ladder in 2<sup>nd</sup> floor corridor

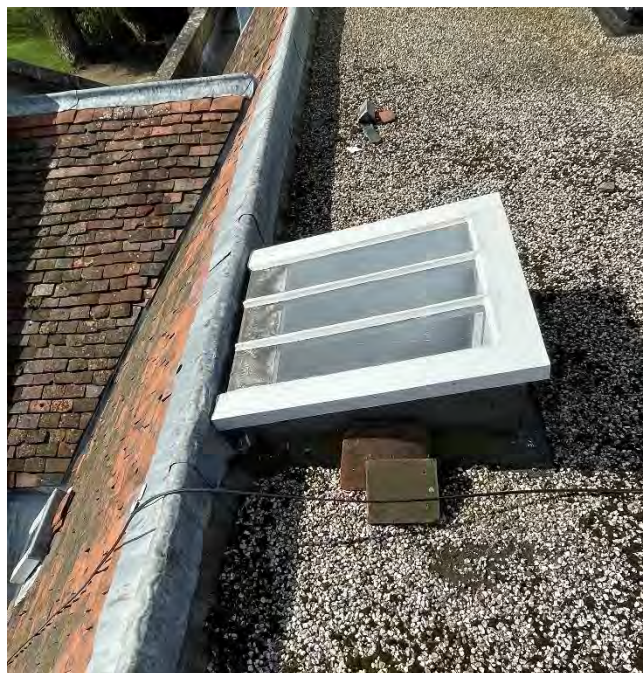
Rooflight R3 located against upstand kerb

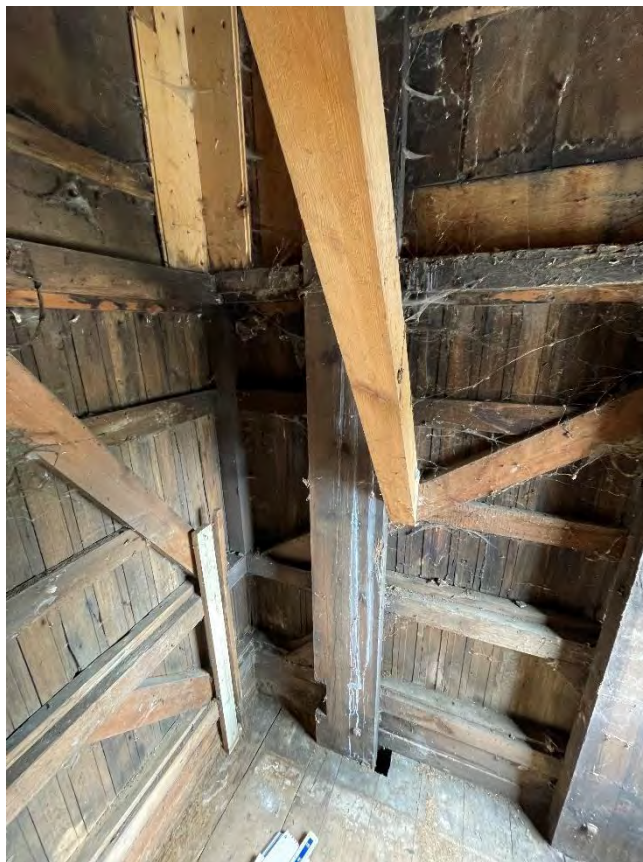
C20th bracing inside clocktower proposed to be removed to allow insertion of new ladder

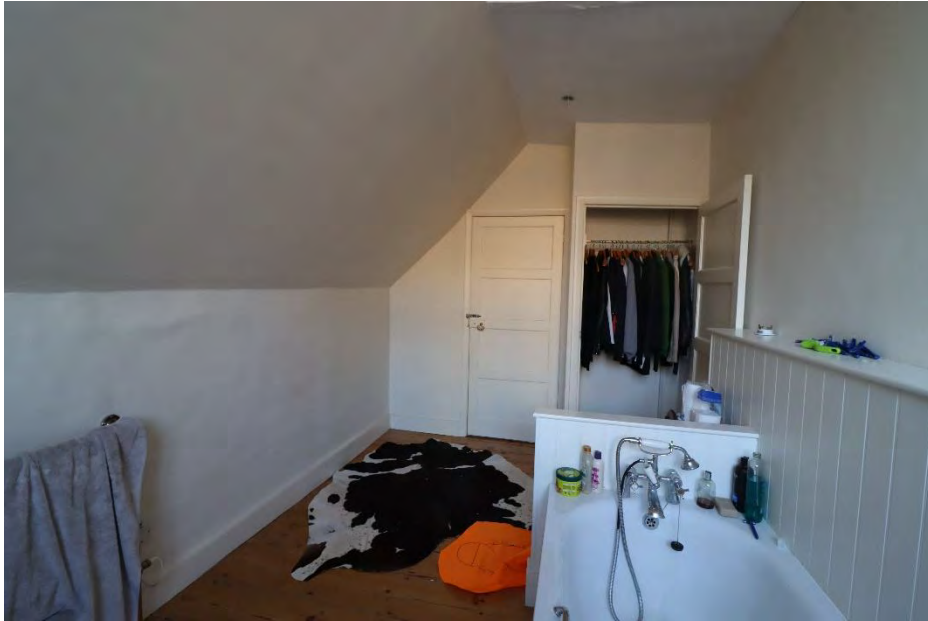
First Floor bathroom to Coach House to become part of proposed second annexe.

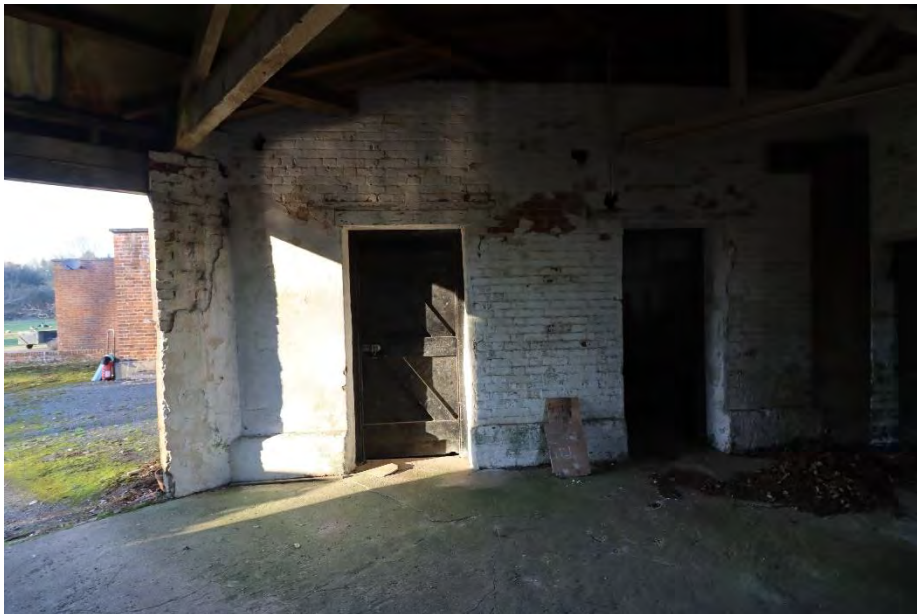
2no external ledge and brace doors (to be retained) to south wall of former Coach House. Door into Store (lhs) to be re-hung.

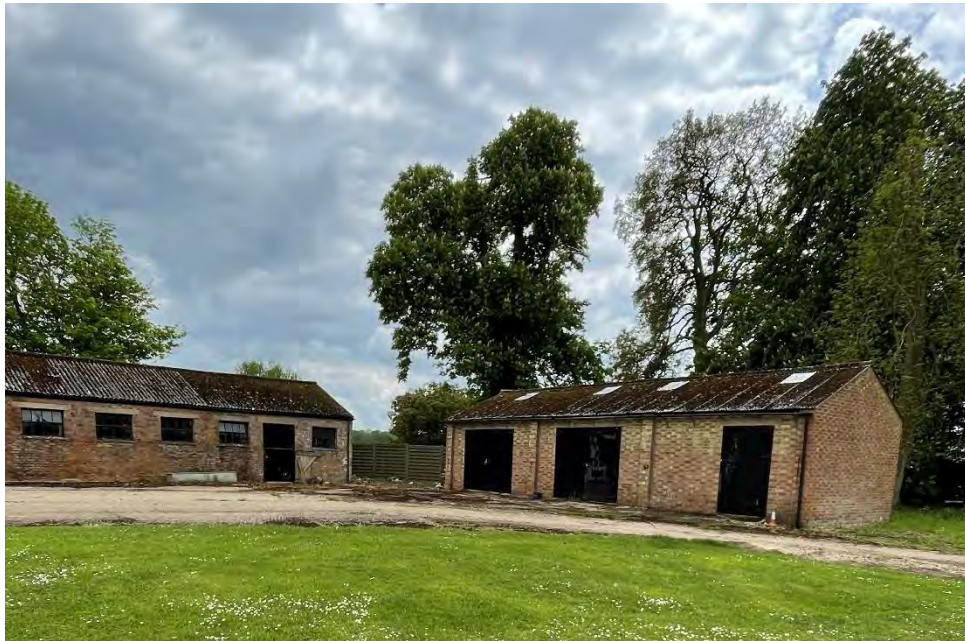
MC20th garages (lhs) 1960's garage block (rhs)e

| 61 | Remove 2no. existing MC20 <sup>th</sup> garage blocks and replace with a new garage building | Moderate<br>C18 <sup>th</sup> /19 <sup>th</sup> wall<br>Low<br>MC20 <sup>th</sup> garage | Low Impact<br>Benefit and Enhance | The Long Garage is part of the 1939 works. It is constructed from poor quality materials and is of low architectural merit. The south-east wall will be retained and repaired/repointed and incorporated into the new building.<br>The smaller garage block is of 1960's construction. The proposed new building will be located approximately on the footprint of the existing buildings. It will be constructed from high quality materials and will enhance the setting of the heritage asset.<br>Repairs to the C18 <sup>th</sup> /19 <sup>th</sup> wall associated with these works will be a conservation benefit. |
