## East Wing – Proposed Apartment 17 – Plan of Significance

**641-KS-06-MB-SH-A-90017- P01****Temple Dinsley Level 1, GA – Apartment 17 - Almina**

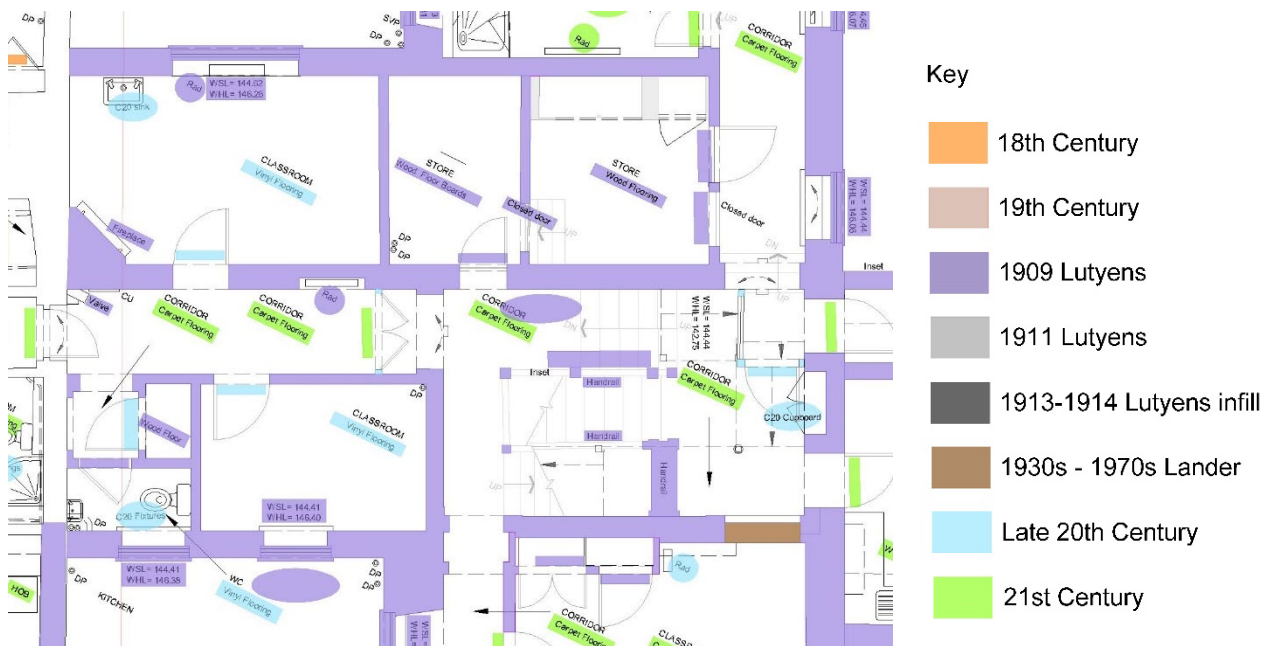
Extract from Level 1 GA, Plan as Existing. Plan of significance shows the evolution of the east link.

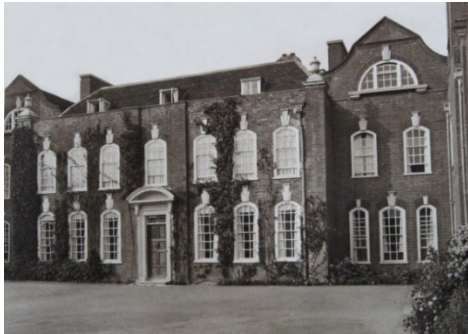
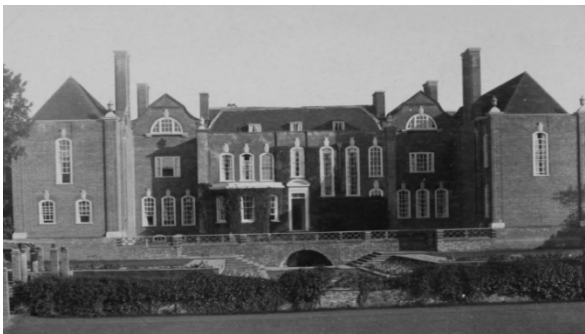
Photos of front and rear elevations of central block post EC20 Lutyens works, showing the east link connecting the Central Block with the East Wing.

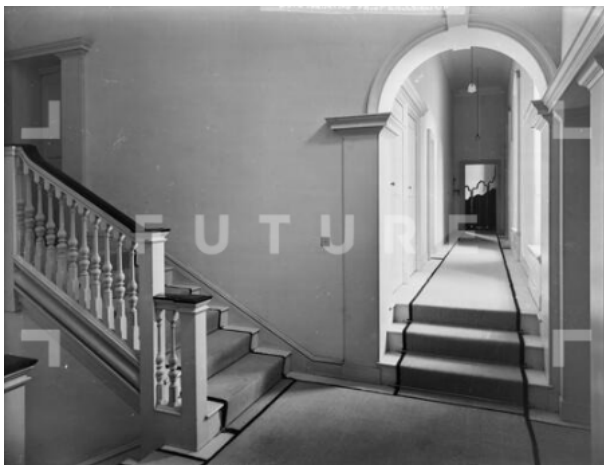
Country Life archive photo of the interior of the services staircase and corridor to the northern end of the East Wing.

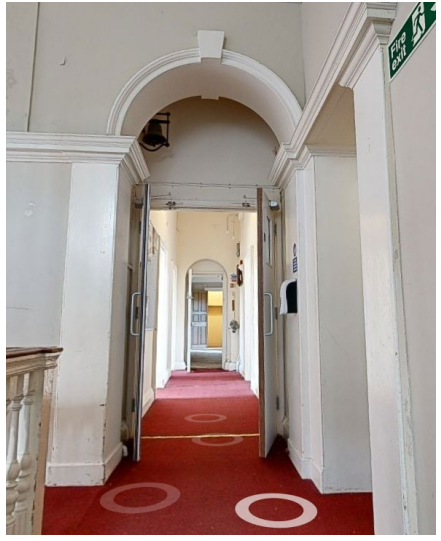
| Reference | Proposal | Significance of affected fabric | Impact | Reasoning and mitigation |
|---|---|---|---|---|
| <u>A-Walls</u><br>17A.D1<br>17D.D1 | Removal of fire double solid doors and demolition of lightweight compartment partition. | Neutral/negative.<br>Late C20 alteration by the School. | Moderate Benefit. | <p>The partition is a modern alteration added by the School, it is assumed to be for fire compartmentation. It impedes the appreciation of the moulded archway from the central corridor side. By taking down the partition the apartment benefits from a longer corridor.</p> |

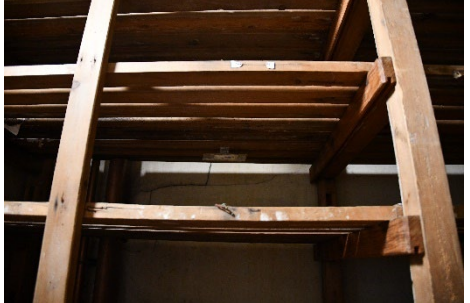
| Reference | Proposal | Significance of affected fabric | Impact | Reasoning and mitigation |
|---|---|---|---|---|
| <u>A-Walls</u><br>17A.R1 | Existing lath and plaster wall is damaged, showing cracks and bulging of the plaster. Carry out like for like repairs. | High.<br>Early C20 Lutyens | Low Benefit. | <p>Wall behind sw shelving units. Like for like repairs are beneficial.</p> |

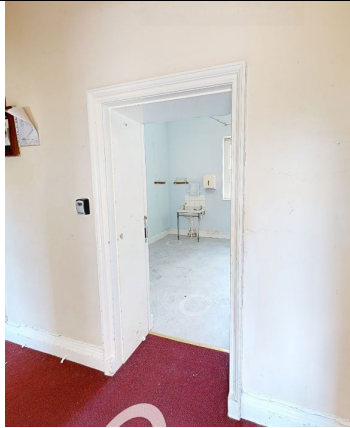
| Reference | Proposal | Significance of affected fabric | Impact | Reasoning and mitigation |
|---|---|---|---|---|
| <u>A-Walls</u><br>17A.P1 | Infill doorway. Proposal to be read in conjunction with reference 17D.D3 | High.<br>Early C20 Lutyens | Moderate harm | |

| Reference | Proposal | Significance of affected fabric | Impact | Reasoning and mitigation |
|---|---|---|---|---|
| | Allow design for infill on landing / corridor side to reflect the appearance of a panelled door to match existing c1908 doors. | | | <p>No historic fabric is affected as infill is lightweight and reversible. The design of the infill is to reflect the appearance of existing doors to limit effect.</p> |

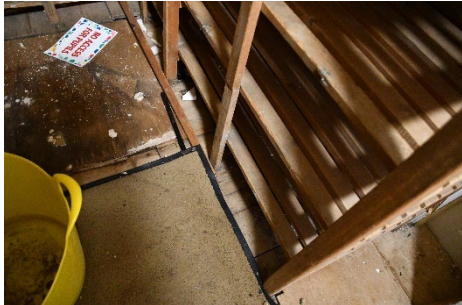
| Reference | Proposal | Significance of affected fabric | Impact | Reasoning and mitigation |
|---|---|---|---|---|
| <u>B-Floors</u><br>17B.R1 | Careful lift and cart away damaged/rotten timber floorboards, salvaged when possible for reuse. Lay new timber floor boards of similar matching size and softwood. | High.<br>Early C20 Lutyens | Low.<br>Benefit. | <p>Due to rainwater ingress the floorboards in this area are badly damaged, beyond repair. Required for the longevity of the building.</p> |

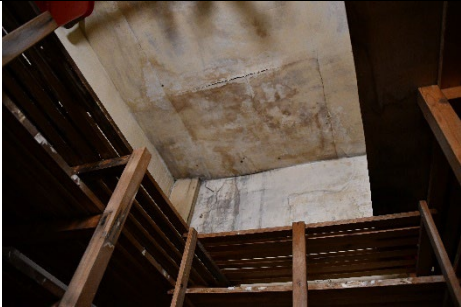
| Reference | Proposal | Significance of affected fabric | Impact | Reasoning and mitigation |
|---|---|---|---|---|
| <u>C-Ceiling</u><br>17C.R1 | Like for like repairs when possible and/or replacement to severely damaged lath and plaster ceiling. | High.<br>Early C20 Lutyens | Benefit. | |

| Reference | Proposal | Significance of affected fabric | Impact | Reasoning and mitigation |
|---|---|---|---|---|
| | | | | <p>Due to rainwater ingress the lath and plaster ceiling has been badly damaged, beyond repair in some parts of the ceiling. Lay a new lath and plaster ceiling in this area.</p> |

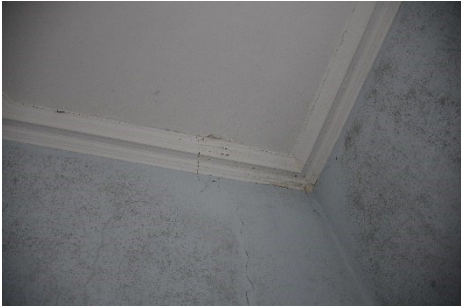
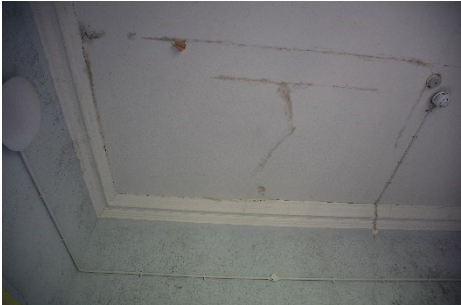
| Reference | Proposal | Significance of affected fabric | Impact | Reasoning and mitigation |
|---|---|---|---|---|
| <u>C-Ceiling</u><br>17C.R2 | Plastered ceiling like for like repairs, including cornice. | High.<br>Early C20 Lutyens | Benefit. | <p>Due to rainwater ingress the lath and plaster ceiling has been damaged in some parts of the ceiling. Stabilise loose areas where possible and replace in lime plaster to match where unsound.</p> |

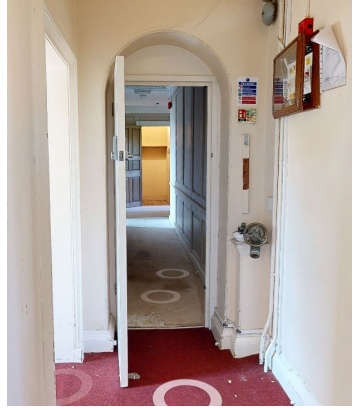
| Reference | Proposal | Significance of affected fabric | Impact | Reasoning and mitigation |
|---|---|---|---|---|
| <u>D-Doors</u><br>17D.D2<br>17G.P5 | Modern door, doorcase and partition under the archway to be removed. | Negative.<br>C20 addition. | Low impact | |

| Reference | Proposal | Significance of affected fabric | Impact | Reasoning and mitigation |
|---|---|---|---|---|
| | | | | <p>The existing modern door and infill is unsympathetic and detracts from the appearance of the historic outer arch. The proposal to infill in timber stud reveals the simplicity of the C18 arch. The proposal is reversible, built in lightweight non-load bearing timber stud partition, as part of the compartment wall for fire and acoustic separation.</p> |

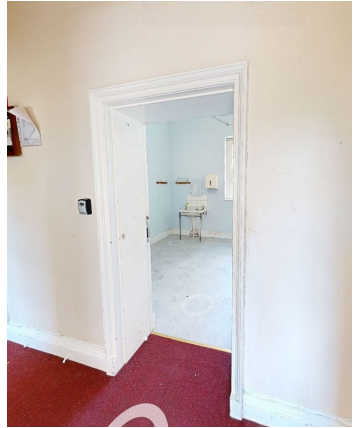
| Reference | Proposal | Significance of affected fabric | Impact | Reasoning and mitigation |
|---|---|---|---|---|
| <u>D-Doors</u><br>17D.D3 | Modern solid timber door to be removed, architrave, lining and doorcase. | Door.<br>Negative.<br>C20 addition.<br><br>Opening and linings.<br>High.<br>Early C20 Lutyens | Moderate harm | <p>The siting of the shower room at the end of the corridor collisions with the doorway to the north room.<br/>Following careful consideration to the shower room location it was resolved that the back end of the corridor was the place with the least impact to the original layout and spacing, mainly to the south rooms. The location only impact involves the relocation of the existing doorway closer to the new main entrance.<br/>The reason for this is the positioning of the main entrance to the apartment in order to reveal the historic arch on the stair landing which is highly significant.</p> |

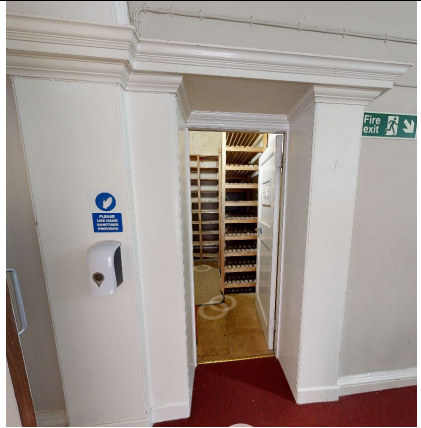
| Reference | Proposal | Significance of affected fabric | Impact | Reasoning and mitigation |
|---|---|---|---|---|
| <u>D-Doors</u><br>17D.R1<br>17G.P2 | Refurbish original door with a solid top panel. Unhinge the door and set it forward within the doorway width, with a | High.<br>Early C20 Lutyens | Moderate | |

| Reference | Proposal | Significance of affected fabric | Impact | Reasoning and mitigation |
|---|---|---|---|---|
| | new doorcase matching existing. To be set back from the front face of the common area pilasters. | | | <p>The proposal involves retaining the doorway feature, while shutting the door permanently and insert a Fire compartmentation wall behind.</p> |

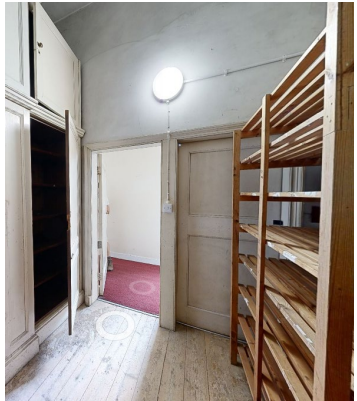
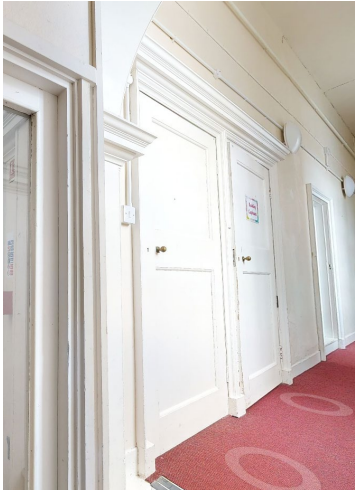
| Reference | Proposal | Significance of affected fabric | Impact | Reasoning and mitigation |
|---|---|---|---|---|
| D-Doors<br>17D.R2<br>17G.P3 | Refurbish and redecorate original Lutyens doors. To be shut permanently. Ironmongery to be retained. New fire compartmentation partition inserted behind. | High.<br>Early C20 Lutyens | Low | <p>The proposal involves retaining all joinery elements facing the corridor and the new kitchen, these are the architraves, doors, lining and doorcases, while inserting a fire compartment wall on the kitchen side. The proposal is reversible.</p> |

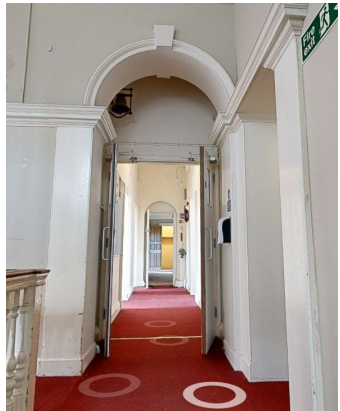
| Reference | Proposal | Significance of affected fabric | Impact | Reasoning and mitigation |
|---|---|---|---|---|
| <u>D-Doors</u><br>17D.P1<br>17G.P1<br><br>17-DF01 | Original Lutyens moulded archway retained and new fire compartment wall and main entrance door inserted within archway thickness. | High.<br>Early C20 Lutyens | Low-moderate impact. | <p>The partition is set back from the face on both sides, so the mouldings are clearly read and appreciated.</p> <p>The new partition will comply with Fire Compartmentation, Sound and Thermal transmission.</p> <p>Door to be fire rated, main entrance security grade door. Door design in the style of the architectural style of this part of the building.</p> |

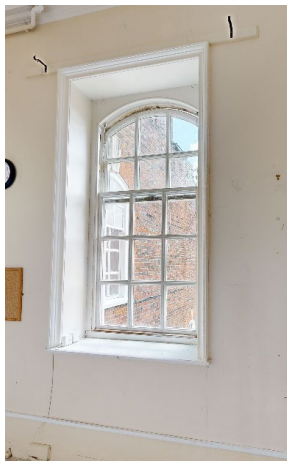
| Reference | Proposal | Significance of affected fabric | Impact | Reasoning and mitigation |
|---|---|---|---|---|
| <u>E-Windows</u><br>17E.R1 | EC20 'Lutyens' timber sash windows repairs. Splice repairs when required. Resin repairs for localized repairs. Replacement of broken glass panes. Perished putty replacement. Easing of window sashes and adjusting of window weights. Original ironmongery to be retained. Ease and adjust as required. New ironmongery to comply with Building Regulations. To redecorate internally and externally. | High.<br>Early C20 Lutyens | Benefit | <p>Original sash windows are to be retained and repaired carefully. Ironmongery retained and repaired.</p> <p>The like-for-like repairs are beneficial for the viability and appearance of the building. Replacement of non-original</p> |

| Reference | Proposal | Significance of affected fabric | Impact | Reasoning and mitigation |
|---|---|---|---|---|
| | | | | ironmongery to sympathetically reflect the style of the window will improve their appearance. |

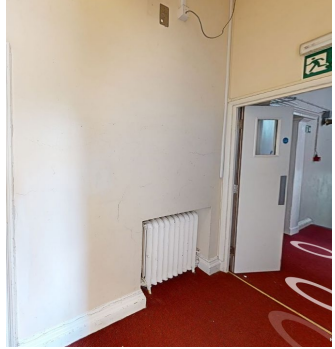
| Reference | Proposal | Significance of affected fabric | Impact | Reasoning and mitigation |
|---|---|---|---|---|
| <u>F- New openings</u><br>17F.D1 | Opening up of load bearing wall to form a doorway into the living space of the apartment. Relocate cast iron rad somewhere else in the apartment. | High.<br>Early C20 Lutyens | Low-moderate impact. | <p>Following from above reference 17D.D3, the location chosen for the relocation of the doorway to the living space is the existing low level wall niche that presently hosts a radiator. This is to minimise the impact on historic fabric.</p> |

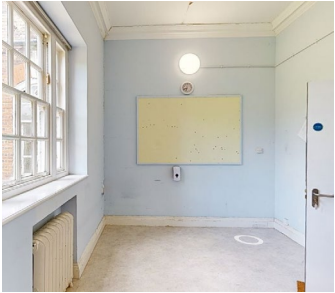
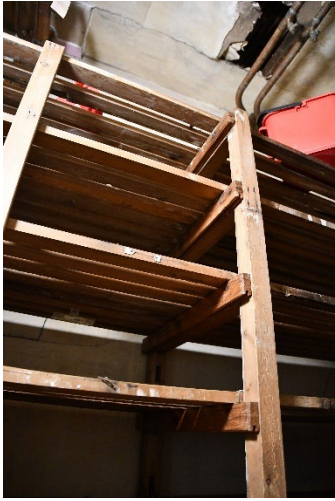
| Reference | Proposal | Significance of affected fabric | Impact | Reasoning and mitigation |
|---|---|---|---|---|
| <u>F- New openings</u><br>17F.D2<br>17A.R1 | Part opening of partitioning to create an open plan living space.<br><br>Carry out repairs to the water damaged lath and plaster wall finish. | High.<br>Early C20 Lutyens | Low-moderate impact. | <p>Two of the three north facing rooms, used as storerooms, are windowless, so to be able to incorporate them to the apartment, these have to be opened up and connected to the larger room with the window, as the source of natural light, ventilation and means of escape.</p> |

| Reference | Proposal | Significance of affected fabric | Impact | Reasoning and mitigation |
|---|---|---|---|---|
| | | | | The opening to the original partition will be kept to the minimum practical. |

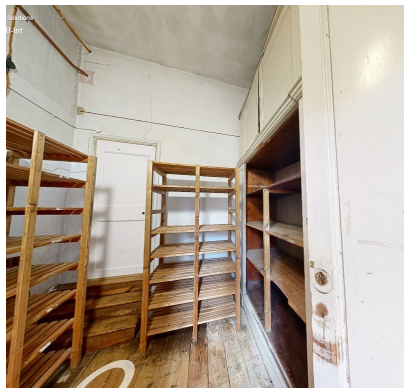
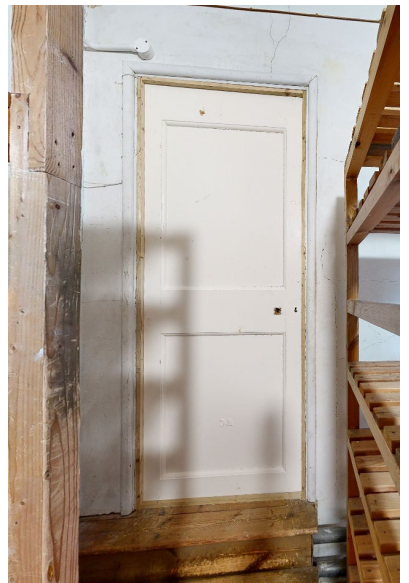
| Reference | Proposal | Significance of affected fabric | Impact | Reasoning and mitigation |
|---|---|---|---|---|
| <u>F- New openings</u><br>17F.D3 | <p>Part opening of partitioning to create an open plan living space. Remove doorway.</p> <p>Carry out repairs to the water damaged lath and plaster wall finish.</p> | High.<br>Early C20 Lutyens | Low-moderate impact. | <p>For the reason above mentioned (17F.D3), the lower storeroom will be opened up and connected to the upper rooms. This space will be used as the kitchen. The opening to the original partition will be kept to the minimum practical.</p> |

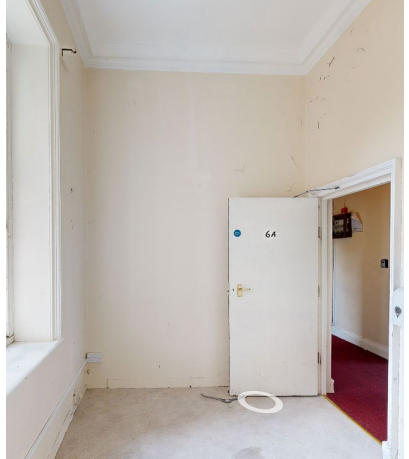
| Reference | Proposal | Significance of affected fabric | Impact | Reasoning and mitigation |
|---|---|---|---|---|
| <u>F- New openings</u><br>17F.D4 | Forming small openings to form a wardrobe door and a walkway into the dressing alcove. | High.<br>Early C20 Lutyens | Low-moderate impact | |

| Reference | Proposal | Significance of affected fabric | Impact | Reasoning and mitigation |
|---|---|---|---|---|
| | | | | <p>The bedroom and the apartment itself are modest, therefore dressing/storage spaces are essential. Opening up spaces, where possible, creates the sense of roominess, which the room will benefit from.</p> <p>The new openings in the original partition are kept to the minimum.</p> |

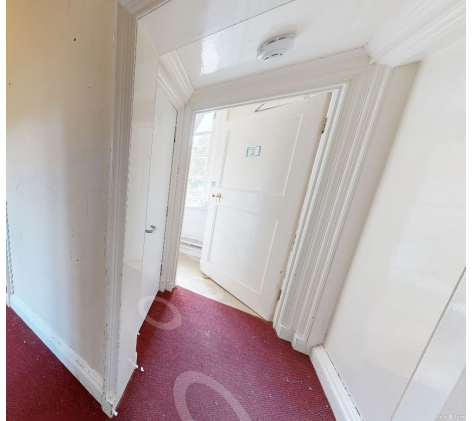
| Reference | Proposal | Significance of affected fabric | Impact | Reasoning and mitigation |
|---|---|---|---|---|
| <u>G-New internal partitions 17G.P4</u> | Both doors (original panelled door and modern solid door) to be removed. Architraves and lining to remain. Opening to be infilled with lightweight partitioning, and plastered finish. | High.<br>Early C20 Lutyens | Low | <p>By blocking both doorways, the lobby space can become a part of the shower room. The doorway architraves and lining, the cornice and skirting will remain. The infill is reversible.</p> |

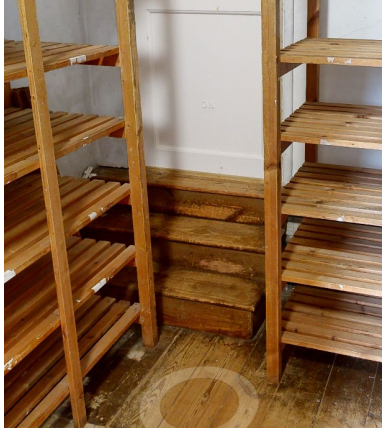
| Reference | Proposal | Significance of affected fabric | Impact | Reasoning and mitigation |
|---|---|---|---|---|
| <u>H-Stairs</u><br>17H.R1 | Retain, repair and oil existing timber steps. | High.<br>Early C20 Lutyens<br><br>The steps are currently obstructed by the later C20 school shelves. | Low.<br>Benefit. | <p>The steps are retained.<br/>Like for like repairs are a benefit.</p> |

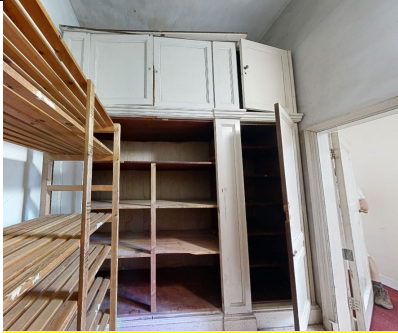
| Reference | Proposal | Significance of affected fabric | Impact | Reasoning and mitigation |
|---|---|---|---|---|
| <u>J-Internal fixtures and fittings</u><br>17J.D1 | Remove and relocate Lutyens cupboards. | High.<br>C20 Lutyens<br><br>Neutral.<br>School shelves (fittings). | Moderate | <p>Cupboards appear to have been relocated from somewhere else. Indicators of this are that the skirting and cornice continue around the side elevations. Alternative position to be agreed with Heritage Officer.</p> <p>School shelves are to be removed as they are later insertions. They have minimal fixings to the fabric which will be repaired like for like.</p> |

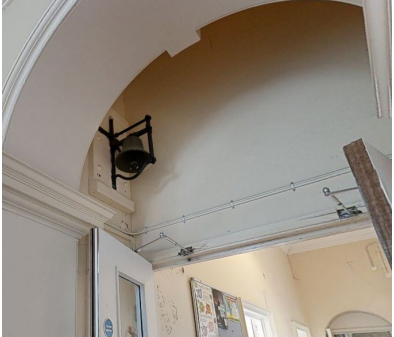
| Reference | Proposal | Significance of affected fabric | Impact | Reasoning and mitigation |
|---|---|---|---|---|
| <u>J-Internal fixtures and fittings</u><br>17J.R1 | Retain school bell. | Low<br>Mid-late C20 addition. | Benefit | <p>The bell is thought to be added by the school.<br/>It shows clear evidence of its evolution and past use as a school, which adds interest and character to the space.</p> |

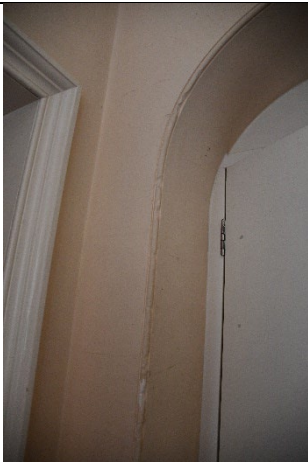
| Reference | Proposal | Significance of affected fabric | Impact | Reasoning and mitigation |
|---|---|---|---|---|
| <u>M-Finishes</u><br>17M.R1 | Repair plaster beaded edge in the archway. | High.<br>Early C20 Lutyens | Benefit | <p>Damaged due to its location, it is proposed to carry out repairs to reinstate the beading.</p> |

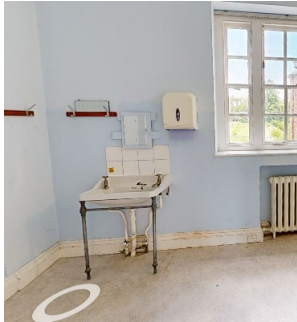
| Reference | Proposal | Significance of affected fabric | Impact | Reasoning and mitigation |
|---|---|---|---|---|
| <u>P-Services</u><br>17P.D1 | Remove modern wash hand basin and associated plumbing. | Neutral C20 alteration by the School. | Neutral Benefit | <p>These plumbing services and fixtures for school use are redundant. To be removed carefully and adjacent surfaces repaired so no historic fabric is affected.</p> |

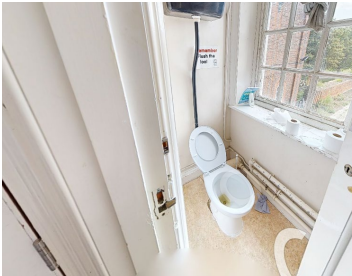
| Reference | Proposal | Significance of affected fabric | Impact | Reasoning and mitigation |
|---|---|---|---|---|
| <u>P-Services</u><br>17P.D2 | Remove modern sanitaryware and associated plumbing. | Neutral/negative. Late C20 alteration by the School. | Neutral. Benefit | <p>The present WC becomes a dressing alcove. The pieces are modern of no historic value.</p> |
