## Second Floor – Proposed Apartment 20 – Plan of Significance

**641-KS-06-MB-SH-A-90020 – P02**  
**Temple Dinsley Level 2, GA – Apartment 20 - Weaver**

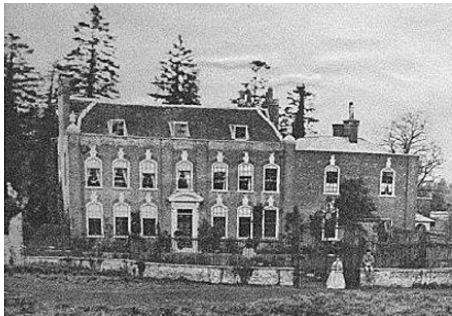
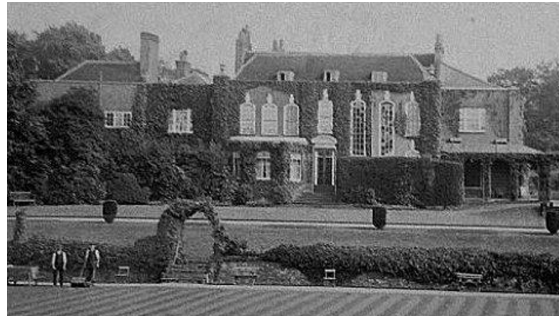
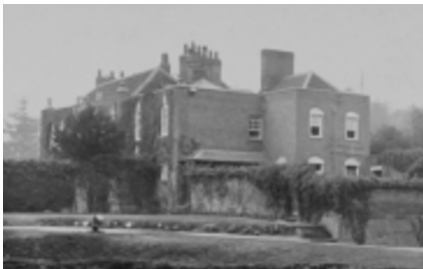
(LHS) South elevation Temple Dinsley – Late (?) C19 shows the Georgian front of Temple Dinsley with a wing added to the East. (RHS) North elevation of Temple Dinsley pre 1909 indicating East and West wings. (Left) The larger pre-1909 east wing viewed from the south-east.

Views of the East wing and the 1909 service wing as designed by Lutyens (LHS) and the 1909 Ground Floor Plan layout (RHS).

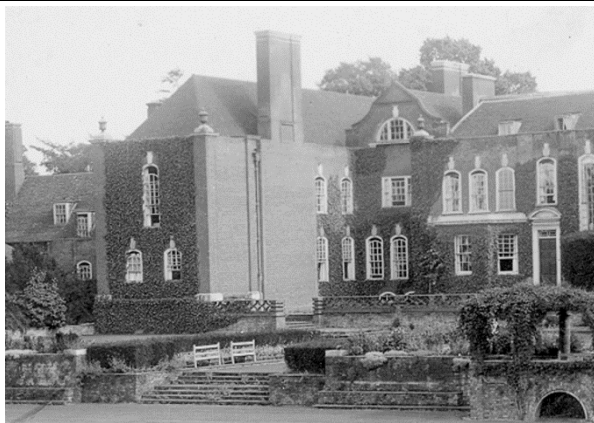
View of the East wing from the north prior to the roof being raised in 1935.

The roofs of both the East and West cross-wings were raised by 4ft in 1935 to provide additional headroom for accommodation for Princess Helena College and the dormer windows were added to the roofs at this time.

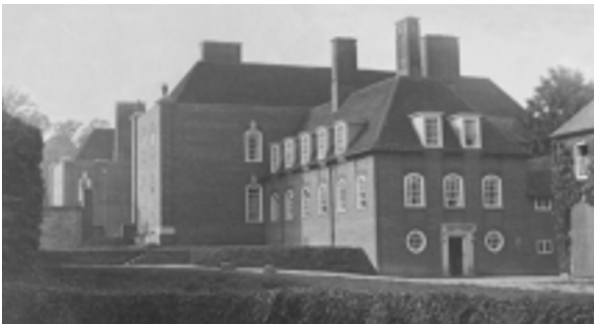
View of the service wing from the east (above). The 1909 Lutyens East Wing was later extended to connect with the original stable block (below)

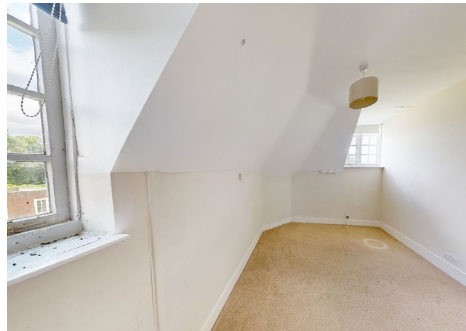
| Reference | Proposal | Significance of affected fabric | Impact | Reasoning and mitigation |
|---|---|---|---|---|
| A-Walls<br>20A. D1 | Removal of MC20 plaster finish including timber skirtings to all external masonry walls to all areas. | Low | Neutral Benefit | <p>LHS north room (29a)</p> |

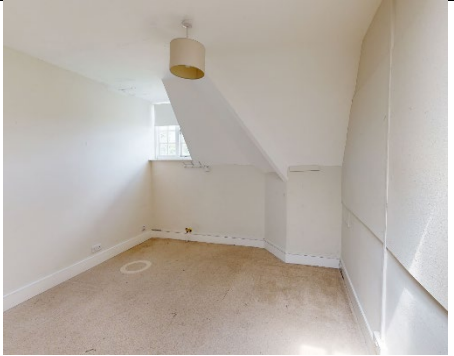
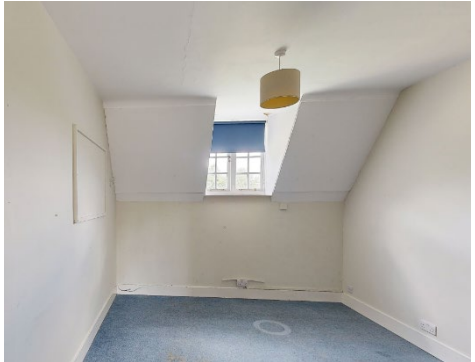
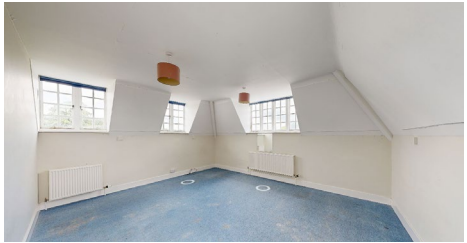
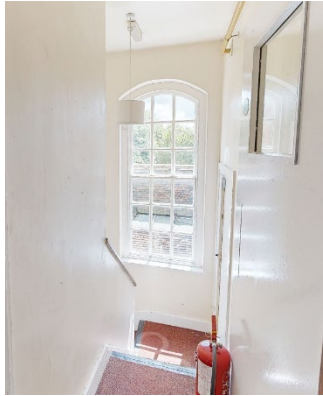
| Reference | Proposal | Significance of affected fabric | Impact | Reasoning and mitigation |
|---|---|---|---|---|
| | | | | <p>RHS north room (29b)<br/> The wall to the east side is an internal partition. Wall to the north is external.</p> <p>1no external wall below window in Room 30a</p> <p>3no external walls in Room 30b</p> <p>External walls to existing stairwell (south and east walls)</p> |

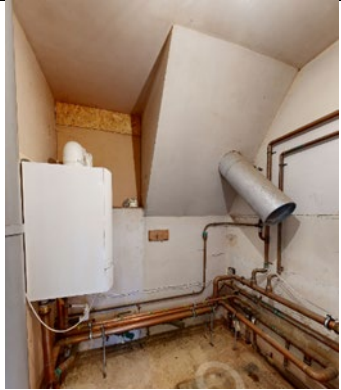
| Reference | Proposal | Significance of affected fabric | Impact | Reasoning and mitigation |
|---|---|---|---|---|
| | | | | <p>Boiler Room<br/>External wall to west.</p> |

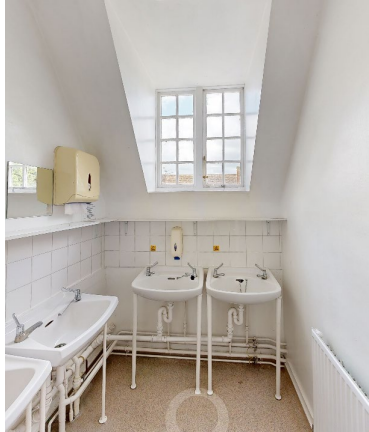
| Reference | Proposal | Significance of affected fabric | Impact | Reasoning and mitigation |
|---|---|---|---|---|
| | | | | <p>Partially tiled external wall to washroom<br/>(west side of east wing)</p> |

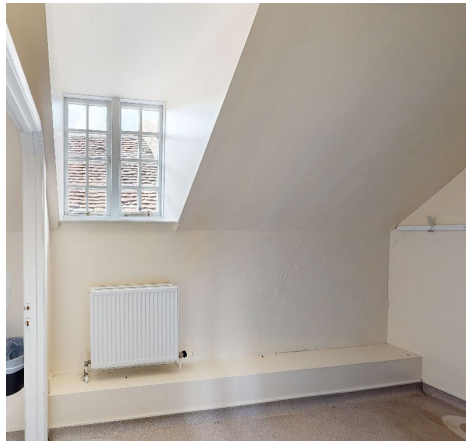
| Reference | Proposal | Significance of affected fabric | Impact | Reasoning and mitigation |
|---|---|---|---|---|
| | | | | <p>Damp to shower room wall<br/>(east side of east wing)</p> |

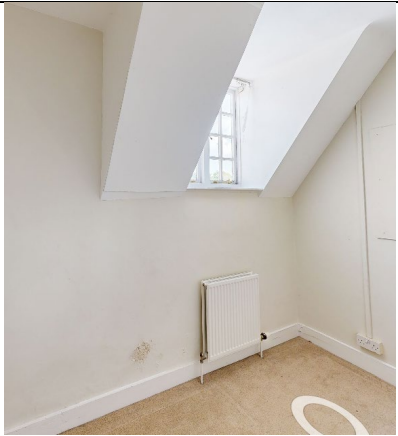
| Reference | Proposal | Significance of affected fabric | Impact | Reasoning and mitigation |
|---|---|---|---|---|
| | | | | <p>Room 31 (east side of east wing) damp ingress at low level</p> <p>The low wall constructed in 1935 to raise the level of the Lutyens hipped roof is masonry construction. There is evidence at low level of damp penetration in some areas to the east side (Room 31 and the shower room) Investigation of external flashings and junctions with roofs to the east and west sides will be necessary to prevent further ingress of damp. All areas of plaster and timber skirtings will be removed to allow the masonry to fully dry out where there is damp penetration. Removal of damp plaster and repair of external copper and leadwork will prevent further deterioration of the masonry wall and is considered a benefit.</p> |

| Reference | Proposal | Significance of affected fabric | Impact | Reasoning and mitigation |
|---|---|---|---|---|
| A-Walls 20A.R1 | Repairs to upstand wall, hung tiles, copper gutter, lead flashings and C20 flat roof/wall junction to prevent damp ingress. | Low 1935 alterations | Low Impact<br>Benefit | The construction of the upstand wall and associated copper gutter, lead flashings and hung tiles are to be investigated where evidence of damp ingress is apparent. Proposals for repairs will be submitted for approval. |

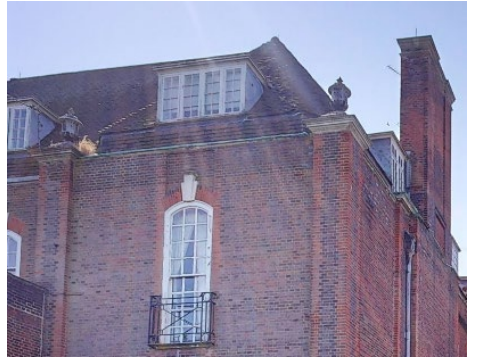
| Reference | Proposal | Significance of affected fabric | Impact | Reasoning and mitigation |
|---|---|---|---|---|
| A-Walls 20A.P3 | Alteration to C20 upstand wall and external cladding to north elevation. | Low<br>1935 alterations | Low Impact<br><br>Enhance | MC20 masonry upstand wall and associated hung tile cladding and flashings to be adjusted to suit increased depth of proposed replacement window.<br>Existing sill level to be reduced by approx 540mm to match adjacent windows (Refer to E-windows 20E.D1 D2 & D3)<br><br> <p>Sill height to window to be reduced</p> |

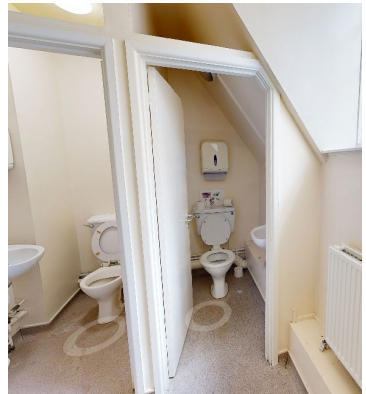
| Reference | Proposal | Significance of affected fabric | Impact | Reasoning and mitigation |
|---|---|---|---|---|
| A-Walls 20A.P4 | Upgrading of existing partition between existing common area corridor and Weaver Apartment 20. | Low<br>C20 partition | Low Impact | <p>Partition to stairwell (currently WCs)</p> <p>Construction of existing partition is to be investigated and upgraded to form a fire rated compartment and sound separation to the stairwell to comply with Building Regulations requirements.<br/><br/>Refer to 20R.P1</p> |

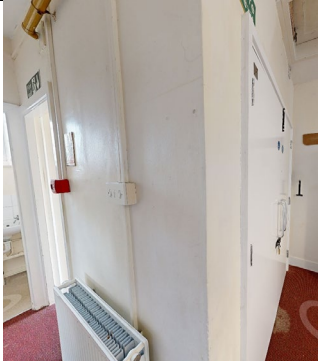
| Reference | Proposal | Significance of affected fabric | Impact | Reasoning and mitigation |
|---|---|---|---|---|
| A-Walls<br>20A.D3 | Removal of C20 internal timber stud partitions dividing all rooms to east and west sides including bathroom accommodation, and removal of MC20 internal masonry walls enclosing stairs and lift.<br><b>Refer to dwg 02032 for demolitions and existing partitions to be retained.</b> | Low<br>C20 fabric. | Low<br>Impact | <p>Remove all C20 partitions forming lift enclosure</p> <p>Remove all C20 internal partitions forming stair, WC and lift enclosure.</p> <p>C20 lift enclosure on stairwell to be removed</p> |

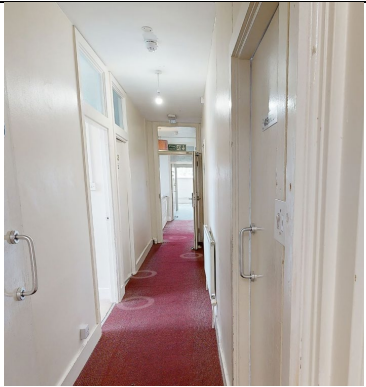
| Reference | Proposal | Significance of affected fabric | Impact | Reasoning and mitigation |
|---|---|---|---|---|
| | | | | <p>Existing corridor<br/>Remove plasterboard lined timber partitions forming central corridor.</p> |

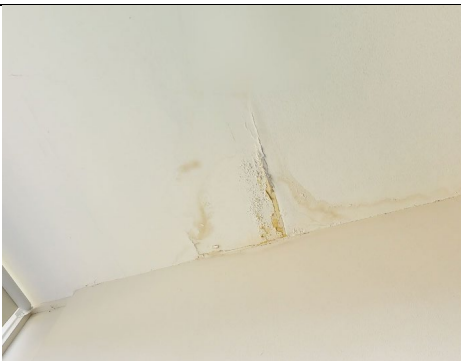
| Reference | Proposal | Significance of affected fabric | Impact | Reasoning and mitigation |
|---|---|---|---|---|
| C-Ceilings<br>20C. D1 | Removal of existing plasterboard to ceilings throughout 2 <sup>nd</sup> floor accommodation including linings around rooflights and roof void access hatch on stairwell landing. | <p>Roof structure<br/>High<br/>Early C20<br/>1909 Lutyens to East Wing</p> <p>Low<br/>MC20/LC20 to east side additions</p> <p>Plasterboard linings<br/>Neutral/Negative<br/>MC20 (1935 alterations)</p> | Low-Moderate Impact | <p>Room 29a<br/>Evidence of water ingress from roof.</p> <p>Junction between flat lead dormer roof and tiled slope above to be investigated and any necessary repairs carried out.</p> |

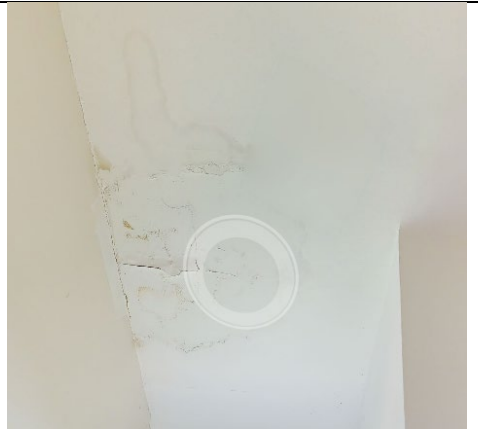
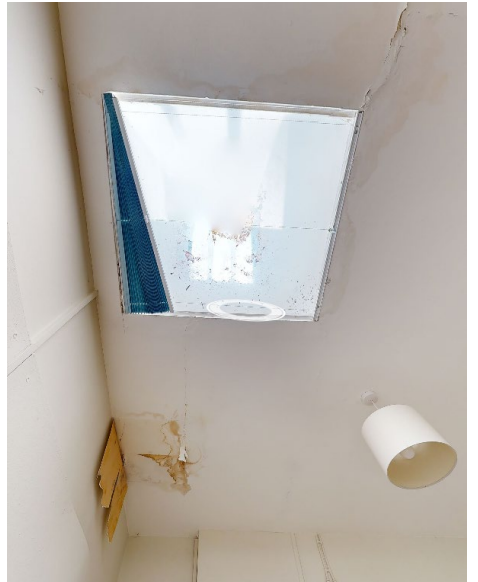
| Reference | Proposal | Significance of affected fabric | Impact | Reasoning and mitigation |
|---|---|---|---|---|
| | | | | <p>Room 29b<br/>Evidence of water ingress from roof.</p> <p>Junction between flat lead dormer roof and tiled slope above to be investigated and any necessary repairs carried out.</p> <p>Room 29b<br/>Evidence of water ingress around existing rooflight and at junction with external wall and ceiling. These linings will be removed to allow the roof structure to be assessed/recorded/ condition investigated and the roof void insulated. This is considered a positive impact which will benefit the building fabric and the internal environment.</p> |

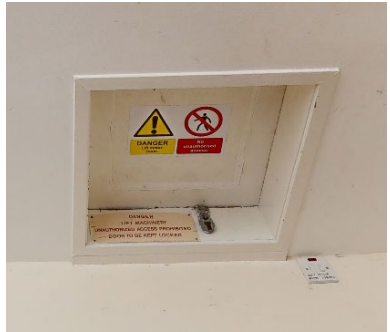
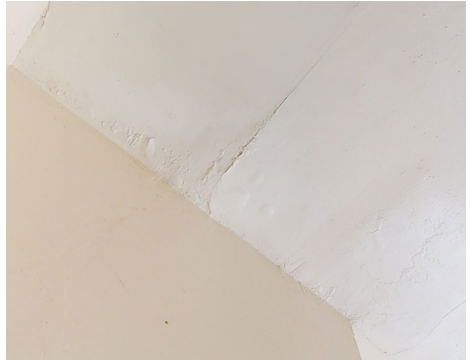
| Reference | Proposal | Significance of affected fabric | Impact | Reasoning and mitigation |
|---|---|---|---|---|
| | | | | <p>Lift lobby rooflight</p> <p>Plasterboard ceiling to lobby and linings to rooflight to be removed.</p> <p>Replacement/retention of existing rooflights to be confirmed.</p> <p>Roof void access hatch to be removed along with plasterboard ceiling linings.</p> <p>Ceiling to stairwell<br/>(above 2<sup>nd</sup> floor landing)</p> <p>Evidence of water ingress from flat roof above. Existing C20 roof coverings &amp; decking to be repaired/replaced. C20 plasterboard linings to be removed and any necessary repairs to timber joists carried out prior to installation of insulation and new linings.</p> |

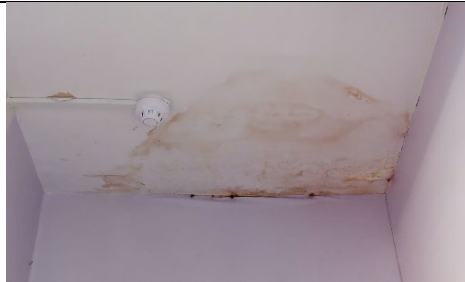
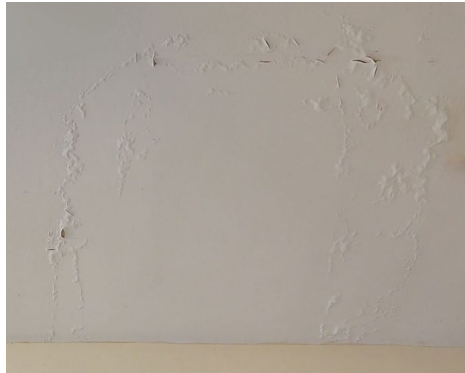
| Reference | Proposal | Significance of affected fabric | Impact | Reasoning and mitigation |
|---|---|---|---|---|
| | | | | <p>Ceiling outside Room 30a<br/>Evidence of water ingress from roof above lobby</p> <p>Corridor ceiling adjacent Room 32<br/>Evidence of water ingress from roof</p> |

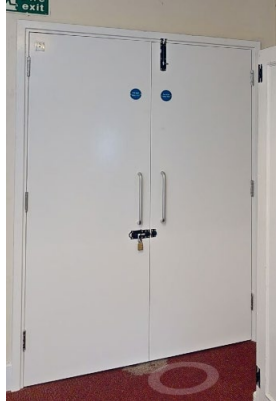
| Reference | Proposal | Significance of affected fabric | Impact | Reasoning and mitigation |
|---|---|---|---|---|
| D-Doors 20D.D2 | Painted flush panel C20 fire rated doors and ironmongery to the goods lift to be removed. | Neutral<br>C20 alterations | Low Impact | <p>C20 double doors to goods lift to be removed</p> |

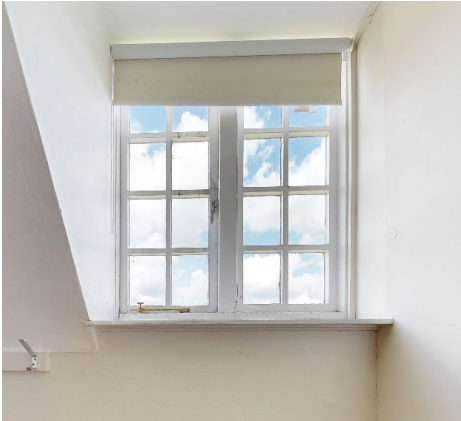
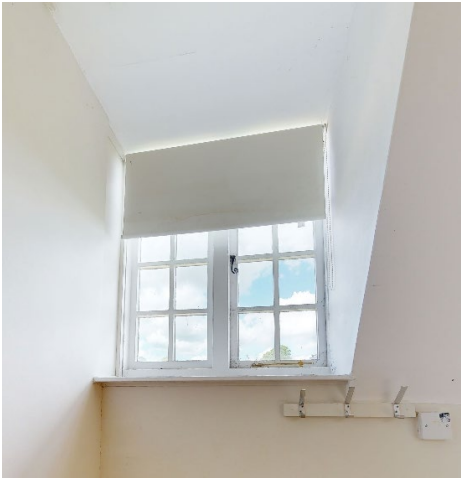
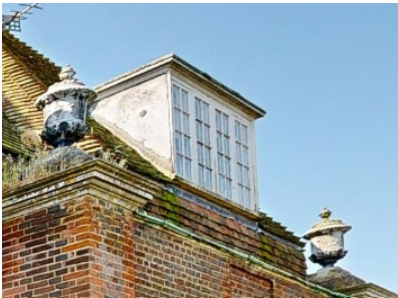
| Reference | Proposal | Significance of affected fabric | Impact | Reasoning and mitigation |
|---|---|---|---|---|
| E-Windows<br>20E.D1 | Removal of C20 timber dormer window | Low C20 alterations | Low Impact<br><br>Benefit & Enhance | <p>Right side of window Room 29a</p> <p>Left side of window Room 29b</p> <p>External view of window W09</p> |

| Reference | Proposal | Significance of affected fabric | Impact | Reasoning and mitigation |
|---|---|---|---|---|
| | | | | <p>Window is to be removed and replaced with a new window with a reduced sill height of the adjacent west side window. The reduced sill level will enhance aspect/views out of the room. Slim-line double glazing will improve the comfort of the internal environment and the viability of the historic building for future use.</p> <p>Refer to note A-Walls 20A.P3</p> |

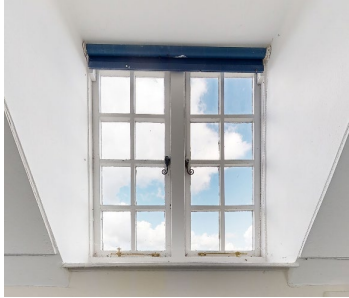
| Reference | Proposal | Significance of affected fabric | Impact | Reasoning and mitigation |
|---|---|---|---|---|
| E-Windows 20E.D2 | Removal of 4no C20 timber dormer windows (north and south elevations of east wing) | Low C20 alterations | Low Impact<br><br>Benefit & Enhance | <p>External view of 4no dormer windows</p> <p>Typical internal view of windows</p> <p>Windows to be removed and replaced with a new windows with reduced sill height. The reduced sill level will enhance aspect/views out of the room. Slim-line double glazing will improve the comfort of the internal environment and the viability of the historic building for future use.</p> <p>Refer to note A-Walls 20A.P3</p> |

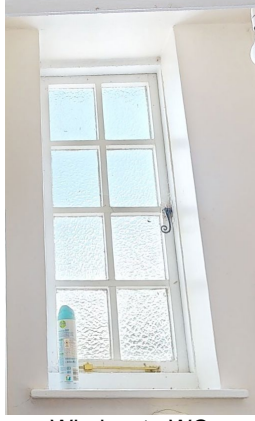
| Reference | Proposal | Significance of affected fabric | Impact | Reasoning and mitigation |
|---|---|---|---|---|
| E-Windows 20E.R1 | Renovation of C20 timber casement and dormer windows<br>W03<br>W01<br>W04 & W14 | Low C20 alterations | Low Impact<br><br>Benefit & Enhance | <p>Window to WC</p> <p>The existing timber multi-pane windows will be repaired/renovated/redecorated and upgraded with slim-line double glazing which improve the comfort of the internal environment and the viability of the historic building for future use. Splice repairs to be carried out where required. Resin for more localised repair. Perished putty replacement. Easing of window as required. Original 'monkey tail' casement latches to be retained for reuse. New ironmongery/locking is to comply with building regulations where required. The repairs will improve the appearance and longevity of the window.</p> |

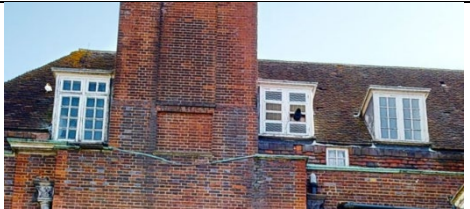
| Reference | Proposal | Significance of affected fabric | Impact | Reasoning and mitigation |
|---|---|---|---|---|
| E-Windows 20E.R2 | Renovation of 4no C20 timber windows (west elevation of east wing)<br><br>Insert photo from RHS to LHS<br><br>Dormer to Room 29a<br>Dormer to plant room<br>Casement to WC<br>Dormer to washroom | Low C20 (1935) alterations by school | Low Impact<br><br>Benefit & Enhance | <p>4no windows to be repaired<br/>3no existing timber multi-pane casement dormer windows and low level casement to existing WC are to be repaired/renovated/redecorated and upgraded with slim-line double glazing which will improve the comfort of the internal environment and the viability of the historic building for future use. Splice repairs to be carried out where required. Resin for more localised repair. Perished putty replacement. Easing of window as required. Original 'monkey tail' casement latches to be retained for reuse. New ironmongery/locking is to comply with building regulations where required. The repairs will improve the appearance and longevity of the window. Note: Dormer window to RHS of the chimney is located in the existing plant room and is boarded over on the internal side.</p> |

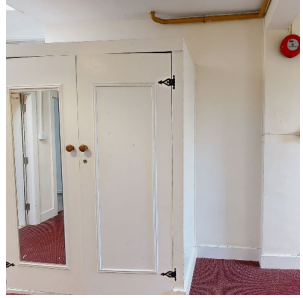
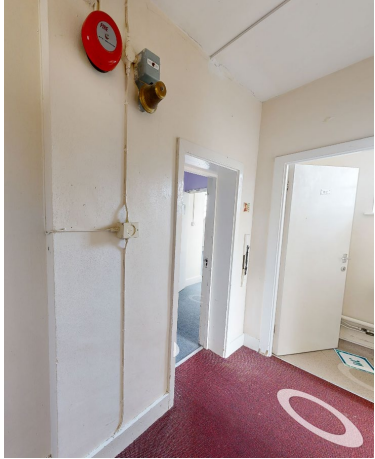
| Reference | Proposal | Significance of affected fabric | Impact | Reasoning and mitigation |
|---|---|---|---|---|
| F-New openings<br>20F. D1 | Form opening in masonry partitions between lift lobby and Room 29b and Room 30A | Low<br>C20 alterations | Low<br>Impact | <p>Remove section of wall to form 2no new door openings</p> <p>Remove masonry partition including north wall of wc</p> |

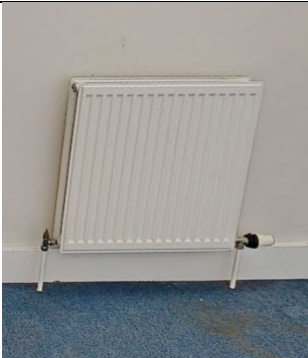
| Reference | Proposal | Significance of affected fabric | Impact | Reasoning and mitigation |
|---|---|---|---|---|
| J-Internal fixtures and fittings 20J.D2 | Removal of C20 wall mounted radiators and pipework | Low C20 school insertions | Low Impact | <p>Steel panel radiators to be removed</p> <p>Existing heating system is C20. Radiators and associated pipework are to be removed.</p> |

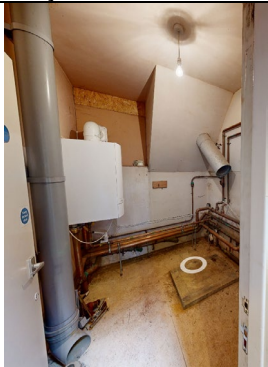
| Reference | Proposal | Significance of affected fabric | Impact | Reasoning and mitigation |
|---|---|---|---|---|
| P-Services 20P.D1 | Removal of existing services and associated equipment. | Low | Low Impact Benefit | <p>Existing plant room</p> |

| Reference | Proposal | Significance of affected fabric | Impact | Reasoning and mitigation |
|---|---|---|---|---|
| | | | | <p>The existing electrics, lighting/emergency lighting, smoke/fire alarms and associated trunking and conduits are related to use by the school and are to be removed and replaced to an appropriate residential standard.</p> <p>Existing plant room to be stripped of all existing service installations. Existing floor hatch to be investigated, all services within floor void are to be removed and opening in floor will be made good as a compartment to meet Building Regulations requirements.</p> |
