Racquets – Proposed Apartment 26 – Plan of Significance – Refer to Phasing Plan 641-KS-30-MB-DR-A-02050

641-KS-06-MB-SH-A-90026 – P02

Temple Dinsley Level -1, 0, 1 & 2, GA – Apartment 26 – Racquets

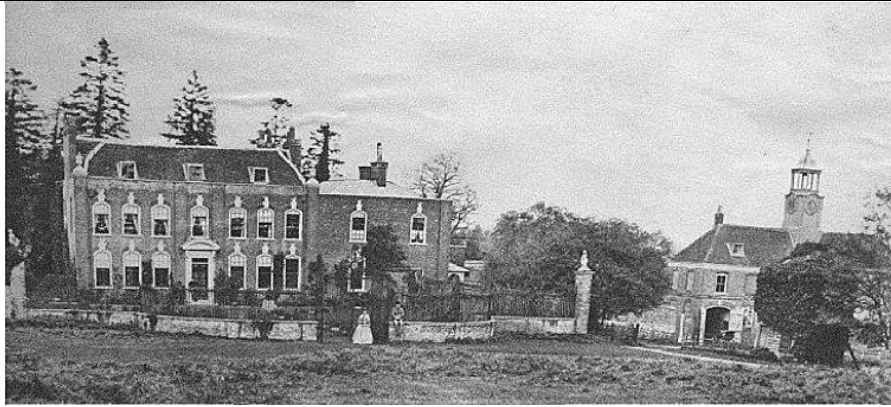
Mid 19 photograph showing the Stable Block with the large central clock tower that was later destroyed in a fire, in 1888. Notice the lack of chimney stacks to the roof of the Stable Block and the large coach doors that were mirrored on the East end.

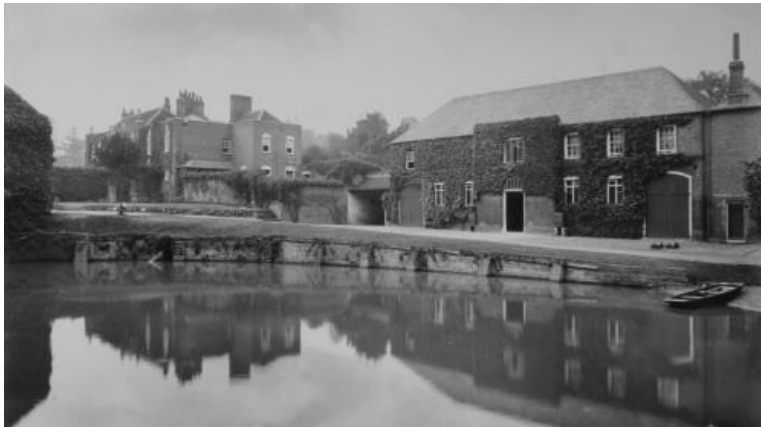
Late C19/Early C20 photograph taken of the Pond and Stable Block at Temple Dinsley prior to Lutyens' 1909 alterations.

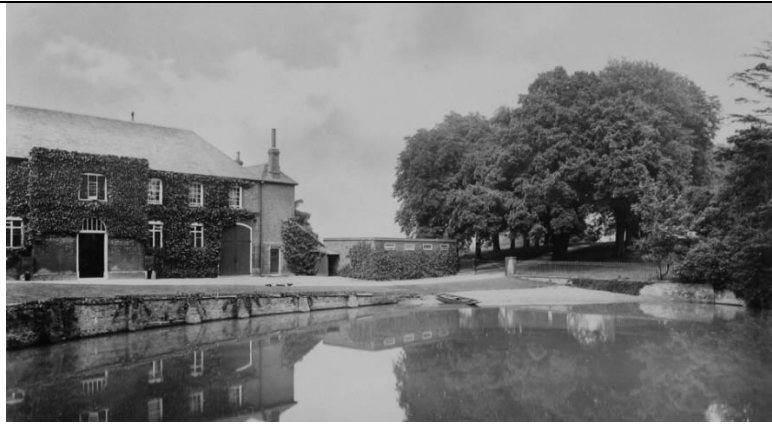
Late C19/Early C20 photograph taken of the Pond and Stable Block at Temple Dinsley prior to Lutyens' 1909 alterations. Shows there were additional buildings attached to the East end of the Stable Block and the East and Coach door.

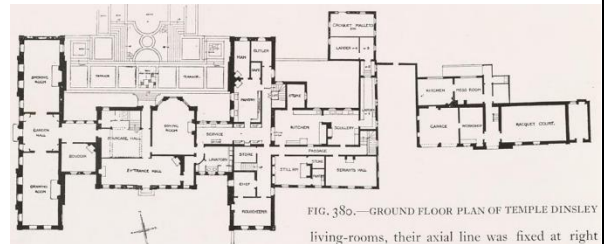
Partial plan layout featured in article by Sir Lawrence Weaver for Country Life in 1911.

This shows us the coach door to the East had been infilled to form the Racquet Court and the tall narrow building against the East Elevation of the Stable block had been retained. The West Coach door looks to have been altered to form two garage doors. The plan of the Stable Block retained a central staircase which gave access to sleeping quarters for staff who would use the kitchen and mess room at ground floor. In this first Lutyens' scheme there are no dormer windows which suggests that these were added at a later date when the school was in occupation of the building and additional accommodation was required.

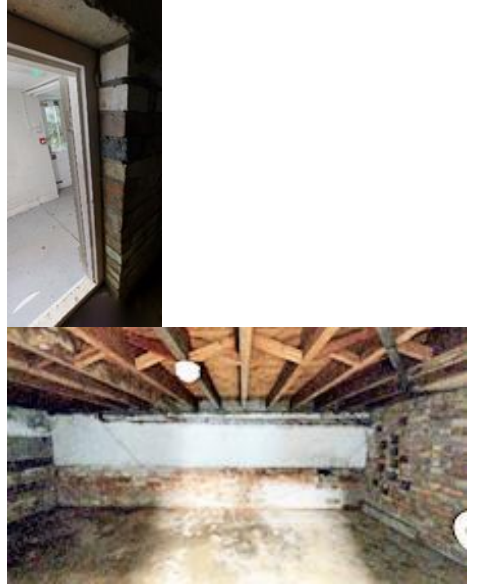
| Reference | Proposal | Significance of affected fabric | Impact | Reasoning and mitigation |
|---|---|---|---|---|
| | | | Low harm – Neutral impact | <p>The undercroft is a poor quality space altered in the C20 and has a low ceiling. To form an acceptable floor to ceiling height for the accommodation at this level excavation of the unmade floor shall be necessary and trials holes will be required to ensure that the footings of the Stable Block are sufficient, or, to allow proposals for a structural footing to be installed.</p> |

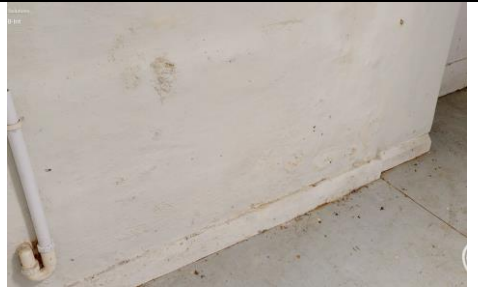
| Reference | Proposal | Significance of affected fabric | Impact | Reasoning and mitigation |
|---|---|---|---|---|
| A-Walls 26A.P2 | Allow to line and skim / skim all walls at basement level using lime render build up. | <p>High C18/C19 Stable Block</p> <p>Low - Neutral Alterations 1930-1960 Alterations LC20</p> | Low | <p>Extent subject to investigation. Signs of damp/salts on internal face of wall could be caused by leaking drainage, concrete floor slab, inappropriate paints/render or all of the above. Ideally all</p> |

| Reference | Proposal | Significance of affected fabric | Impact | Reasoning and mitigation |
|---|---|---|---|---|
| | | | | areas shall be addressed to provide a breathable wall build up. Low impact and benefit to long term use of the building. |

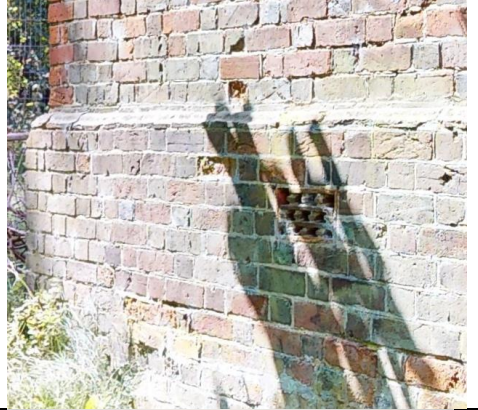
| Reference | Proposal | Significance of affected fabric | Impact | Reasoning and mitigation |
|---|---|---|---|---|
| A-Walls<br>26A.D1 | Investigation and excavation of ground levels and formation of new low level window openings for construction of full basement and external lightwells. | High<br>C18/C19 Stable Block<br><br>Low - Neutral<br>Alterations<br>1930-1960<br>Alterations<br>LC20 | Low-Moderate harm | <p>All excavations are for proposals that visually changed Elevation below ground level which allows for alteration whilst having minimal impact on the setting and overall views – South and West Elevations.</p> <p>The undercrofts have low ceilings. To form an acceptable floor to ceiling height for the accommodation at this level excavation of the unmade floor shall be necessary and trials holes will be required to ensure that footings are sufficient, or, to allow proposals for a structural footing / underpinning / retaining walls to be installed. No historic fabric shall be lost. Proposals are considered moderate-low as these lower sections of wall include the C18/C19 plinth to be retained but extensive alteration to these elevations has taken place and the opening proposed are small, in keeping elsewhere and take into account the architectural detailing of the remaining curved plinth brick.</p> |

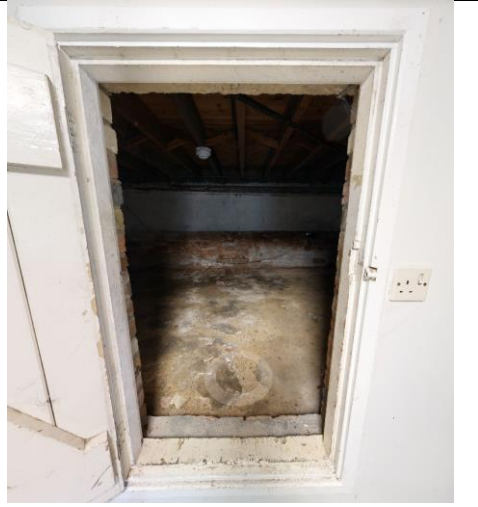
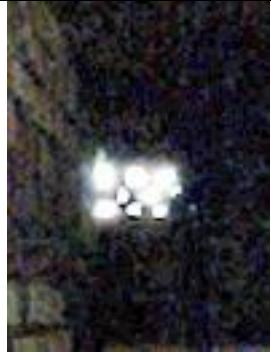
| Reference | Proposal | Significance of affected fabric | Impact | Reasoning and mitigation |
|---|---|---|---|---|
| A-Walls<br>26A.P3 | Undercroft walls lined and insulated. | High<br>C18/C19 Stable Block<br><br>Low<br>Alterations<br>1930-1960<br>Alterations<br>LC20 | Low-Moderate harm | |

| Reference | Proposal | Significance of affected fabric | Impact | Reasoning and mitigation |
|---|---|---|---|---|
| | | | | <p>Undercroft ventilates subfloor of the Racquet Court and ventilation will be maintained.</p> <p>To convert to habitable accommodation excavation required Walls to be lined with breathable build-up. No loss of historical fabric however alterations are assumed low-moderate harm due to associated excavation works required and change to use of space. Original Lutyens' vents to be retained and visible on internal wall face.</p> |

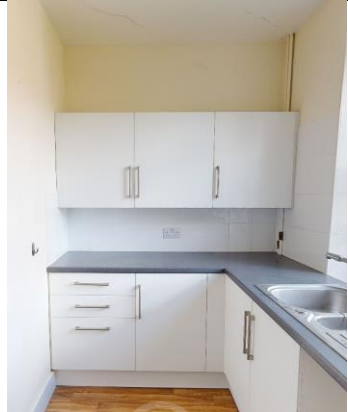
| Reference | Proposal | Significance of affected fabric | Impact | Reasoning and mitigation |
|---|---|---|---|---|
| A-Walls 26A.P4 | West wall lined to form route for services and compartmentation. | High<br>C19 Stable Block<br><br>Low<br>Alterations<br>1930-1960<br>Alterations<br>LC20 | Low | <p>Room has already undergone alteration during the latter part of the C20. The lining of the wall will not have a negative impact on the space and will bring many benefits.</p> |

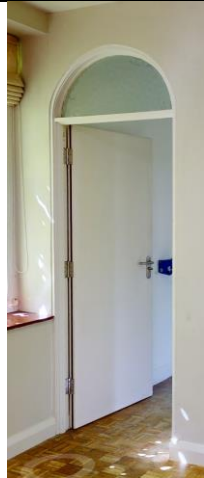
| Reference | Proposal | Significance of affected fabric | Impact | Reasoning and mitigation |
|---|---|---|---|---|
| A-Walls 26A.P5 | Doorway infilled and new compartment wall formed. | High<br>C19 Stable Block<br><br>Low<br>Alterations<br>1930-1960<br>Alterations<br>LC20 | Low | <p>1930's doors that have undergone alteration. Doorway to be infilled to form compartment wall on the other side of the doorway to allow the retention of the door frame – which lines through to the window</p> |

| Reference | Proposal | Significance of affected fabric | Impact | Reasoning and mitigation |
|---|---|---|---|---|
| | | | | reveal and allows for the semi circular glazed fanlight to be retained as a feature and suggests the former doorway. Considered low impact. |

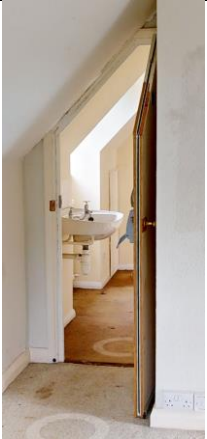
| Reference | Proposal | Significance of affected fabric | Impact | Reasoning and mitigation |
|---|---|---|---|---|
| A-Walls 26A.P8 | Doorway infilled and new compartment wall formed. | LC20 doorway. | Low | <p>This opening gave access through to adjacent accommodation. Infill and formation of a compartment wall is of low impact.</p> |

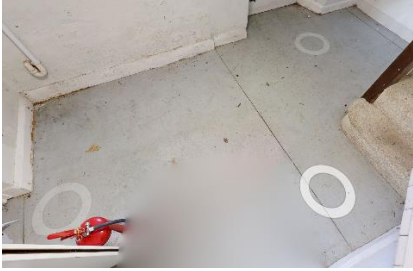
| Reference | Proposal | Significance of affected fabric | Impact | Reasoning and mitigation |
|---|---|---|---|---|
| B-Floors<br>26B.D1<br>26B.P1 | Remove late C20/early C21 floor finish and slab/screed.<br>Form new breathable insulated floor slab / breather perimeter. | High<br>C18/C19 Stable Block<br><br>Low<br>Alterations<br>1930-1960<br>Alterations<br>LC20 | Low | <p>Investigation and trial holes of the surrounding floor level shall be required to determine the existing footing depth and structural proposal. No historic fabric removed however additional footings may be required.<br/>New breathable insulated floor build up proposed or breather perimeter.</p> |

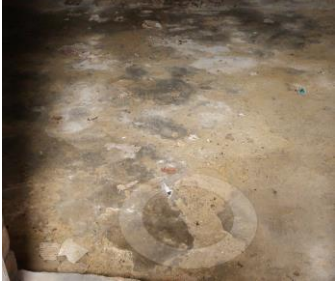
| Reference | Proposal | Significance of affected fabric | Impact | Reasoning and mitigation |
|---|---|---|---|---|
| B-Floors<br>26B.D2<br>26B.P2 | Excavation of unmade floor to allow floor to ceiling height to be increased.<br>Form new breathable insulated floor slab / breather perimeter. | High<br>C18/C19 Stable Block<br><br>Neutral<br>Alterations<br>1930-1960<br>Alterations<br>LC20 | Subject to investigation<br><br>Low likely | <p>The existing floor is C20 poor quality. Investigation and trial holes of the surrounding floor level shall be required to determine the existing footing depth and structural proposal. No historic fabric removed however additional footings may be required.<br/>New breathable insulated floor build up proposed or breather perimeter.<br/>Floor level lowered sympathetically using breathable materials to improve the condition of the existing historic fabric.<br/>Alterations considered moderate due to the associated excavation.</p> |

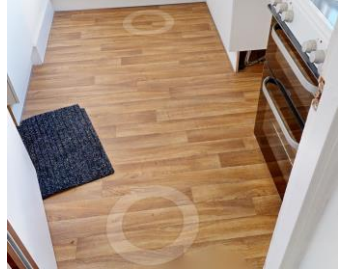
| Reference | Proposal | Significance of affected fabric | Impact | Reasoning and mitigation |
|---|---|---|---|---|
| B-Floors<br>26B.P4 | Replace modern floor finish. | Neutral<br>Early C21 flooring. | Low | <p>Modern lino floor finish to be lifted and replaced with wood/tile/carpet floor finish. Substrate likely original floorboards and joists to be retained with insulation and services run between joists. Low impact. Benefit.</p> |

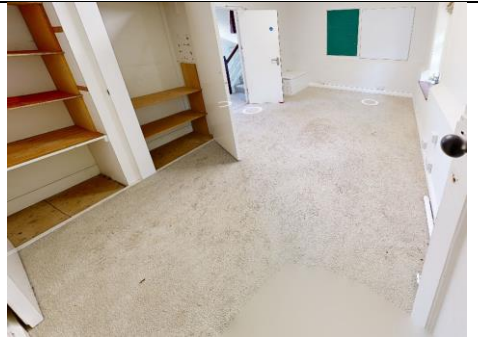
| Reference | Proposal | Significance of affected fabric | Impact | Reasoning and mitigation |
|---|---|---|---|---|
| B-Floors<br>26B.P5 | Replace modern C20/C21 floor finish. Ensuite and Bathroom to have new tile flooring laid including decoupling membrane. | Neutral<br>Early C21 flooring | Low<br>Benefit | <p>Modern carpet finish to be lifted and replaced with wood/tile/carpet floor finish. Substrate, likely original floorboards, and joists to be retained with insulation and services run between joists. Low impact. Benefit.</p> |

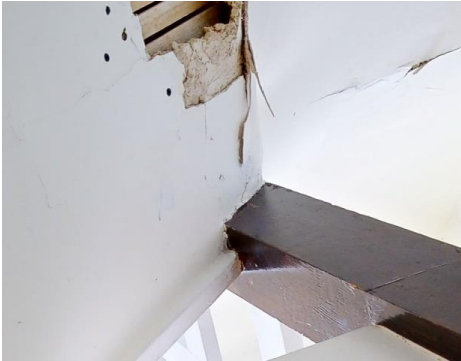
| Reference | Proposal | Significance of affected fabric | Impact | Reasoning and mitigation |
|---|---|---|---|---|
| C-Ceilings 26C.R1 | Ceilings to ground floor lobby (Level -1) to be retained and repaired. Service ran in floor voids above, lifting floor boards. | High<br>C18/C19 Stable block<br><br>Low<br>Alterations 1930-1960<br>Alterations LC20 | Low<br>Impact<br>Benefit | <p>Repairing the existing ceilings and installing services by lifting floor boards in upper level avoids loss of historic linings and fabric. Considered low impact and benefit.</p> |

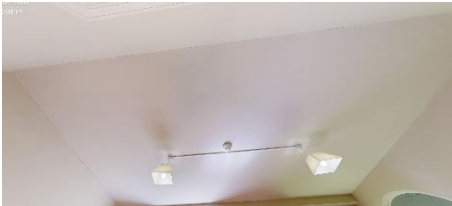
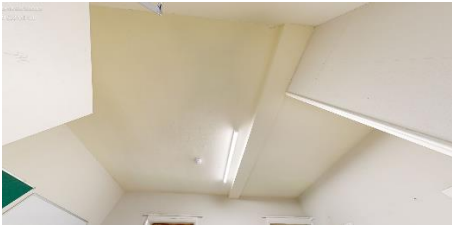
| Reference | Proposal | Significance of affected fabric | Impact | Reasoning and mitigation |
|---|---|---|---|---|
| C-Ceilings 26C.R2 | Ceilings to first and second floors (Level 0 and Level 1) to be retained and repaired. Service to run in floor voids above, lifting floor boards. | Low<br>Alterations 1930-1960<br>Alterations LC20 | Low<br>Impact<br>Benefit | <p>Repairing the existing ceilings and installing services by lifting floor boards in upper level avoids loss of historic linings and fabric. Considered low impact and benefit.</p> |

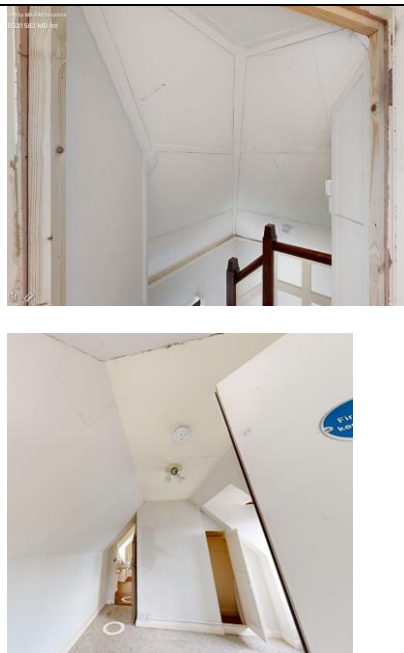
| Reference | Proposal | Significance of affected fabric | Impact | Reasoning and mitigation |
|---|---|---|---|---|
| C-Ceilings<br>26C.D1 | Ceiling – Remove all modern linings that have been applied to insulate and underdraw the existing rafters. | Structure<br>High<br>C19 Stable block<br><br>Linings<br>Neutral/Negative<br>Late C20/C21 alterations | Low<br>Impact<br>Benefit | <p>Lined with modern boards. These shall be removed which is considered a positive impact and will allow the condition of the roof structure to be assessed and recorded and any necessary repairs carried out. Insulating and lining from inside considered low impact.</p> |

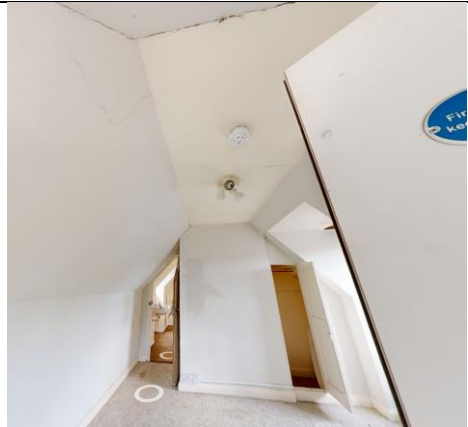
| Reference | Proposal | Significance of affected fabric | Impact | Reasoning and mitigation |
|---|---|---|---|---|
| C-Ceilings<br>26C.P3 | Reline ceiling with plasterboard and skim/savolit and lime render (to match existing). | Structure<br>High<br>C19 Stable<br><br>Additions<br>Neutral/Negative<br>Late C20/C21 alterations | Low<br>Impact<br>Benefit | <p>Vaulted ceiling and dwarf walls lined with wood chip. The condition/ material of the substrate is unknown. Once insulated the roof shall be lined like for like with plasterboard and skim or wood wool boards and lime render.</p> |

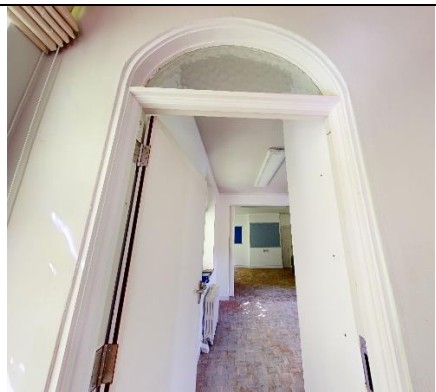
| Reference | Proposal | Significance of affected fabric | Impact | Reasoning and mitigation |
|---|---|---|---|---|
| D-Doors<br>26D-DB03<br>26D-DB03 | Retain Semi-circular light at high level as feature. Wall lined on Apartment 25 side with sealed panel behind light. Doorway reveals will be expressed in Apartment 26.<br>Late C20 fire door removed as this wall shall form part of compartment wall. | Low<br>Alterations<br>1930-1960<br>Alterations<br>LC20<br>doorframe and fanlight<br><br>Low<br>Late C20 fire door | Low<br>Impact | <p>Door has been altered during latter part of C20 however the example of door surround and frame is to be retained and expressed with new apartment with compartment wall built on its West side. Glazed semi circular fanlight visible. No loss of historic fabric and former door opening expressed. Alteration considered low impact.</p> |

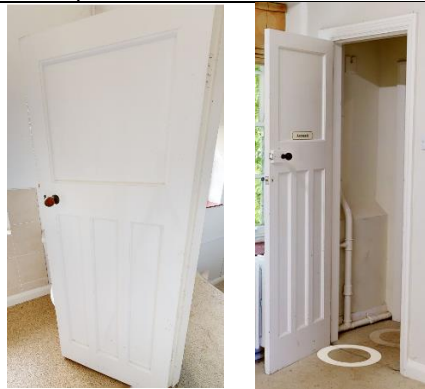
| Reference | Proposal | Significance of affected fabric | Impact | Reasoning and mitigation |
|---|---|---|---|---|
| D-Doors<br>26D-DG01<br><br>26D-DG02 | Early C20 doors to be retained and reused.<br><br>To be repositioned for door to ensuite. | Low<br>Alterations<br>1930-1960<br>Alterations<br>LC20 | Low<br>Impact | <p>Reused 1930s panelled doors reused for ensuite and bathroom. Low Impact.</p> |

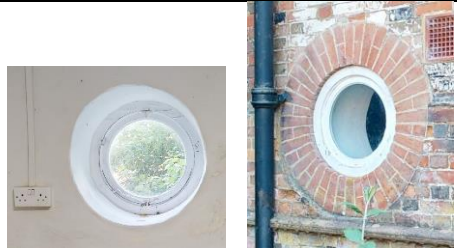
| Reference | Proposal | Significance of affected fabric | Impact | Reasoning and mitigation |
|---|---|---|---|---|
| E-Windows<br>26E-WLB05 | Retained and repaired. | Neutral<br>Late C20 school insertions | Benefit | <p>LC20 insertions cut into original C18 plinth. To be retained with repointing improved and repositioned services.</p> |

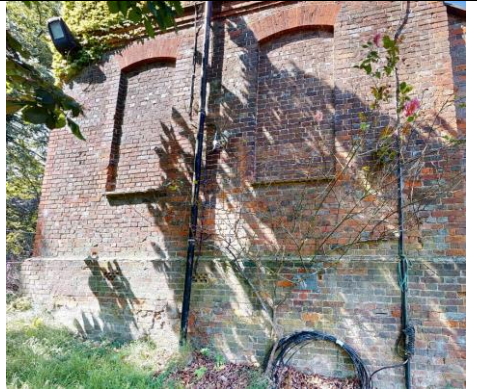
| Reference | Proposal | Significance of affected fabric | Impact | Reasoning and mitigation |
|---|---|---|---|---|
| | | | | <p>Proposed lightwell detail to match existing.</p> <p>Similarly, frame and glazing bar details for new windows to match existing with narrow double glazing. Ironmongery to be confirmed. Sympathetic approach considered moderate.</p> |

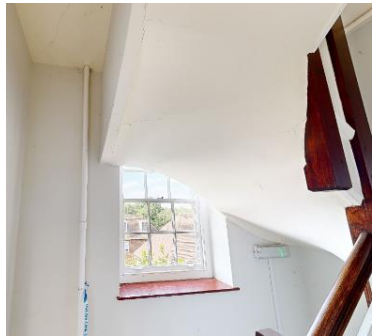
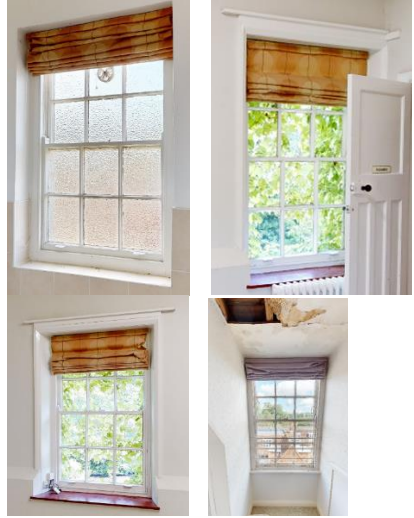
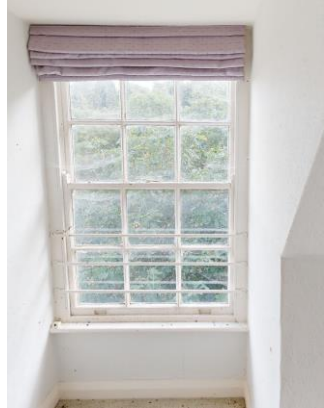
| Reference | Proposal | Significance of affected fabric | Impact | Reasoning and mitigation |
|---|---|---|---|---|
| E-Windows<br>26E-WB01 to<br>26E-WB04<br><br>26E-WG01 to<br>26E-WG04<br><br>26E-WF01 and<br>26E-WF02 | Retained and repaired. | High<br>C19 Stable Block<br><br>Low<br>Alterations<br>1930-1960<br>Alterations<br>LC20 | Low<br>Impact<br>Benefit | |

| Reference | Proposal | Significance of affected fabric | Impact | Reasoning and mitigation |
|---|---|---|---|---|
| | | | | <p>Minimal like-for-like conservation repairs. Allow: Splice repairs carried out where required. Resin repairs for more localised repair. Replacement lights for any broken panes. Perished putty replacement. Easing of windows and weights adjusted as required. Original ironmongery retained. New ironmongery shall be required to comply with building regulations. Renewal of finishes. These repairs will aid the longevity of these significant windows.</p> |

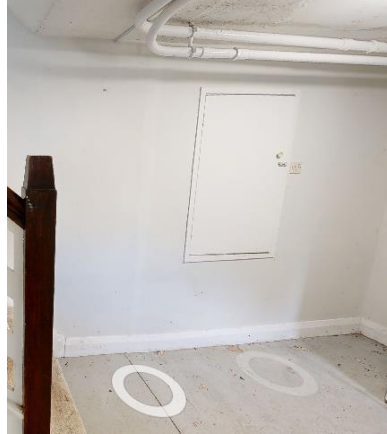
| Reference | Proposal | Significance of affected fabric | Impact | Reasoning and mitigation |
|---|---|---|---|---|
| F-New Openings 26F.D1 | Form new opening in section of EC20 wall. | <p>High Setting<br/>C18/C19 Stable block</p> <p>Low Alterations<br/>1930-1960<br/>Alterations<br/>LC20</p> | Low Impact | <p>Opening formed in wall to undercroft. The line of the existing wall will be continued through to contain stair. Service area and</p> |

| Reference | Proposal | Significance of affected fabric | Impact | Reasoning and mitigation |
|---|---|---|---|---|
| | | | | section of wall is of low value therefore low impact. |

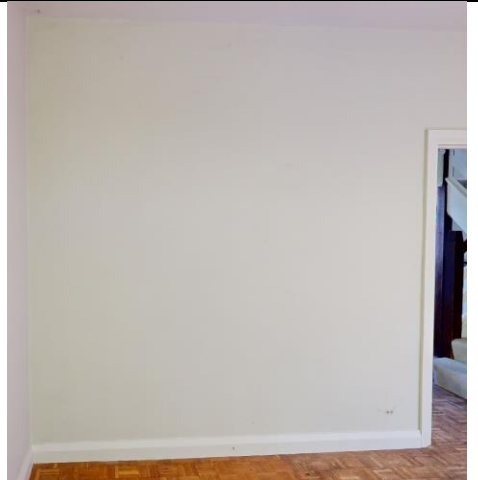
| Reference | Proposal | Significance of affected fabric | Impact | Reasoning and mitigation |
|---|---|---|---|---|
| F-New Openings<br>26F.D2 | Form new opening in section of EC20 wall. | High Setting<br>C18/C19 Stable block<br><br>Low Alterations<br>1930-1960 Alterations<br>LC20 | Low Impact | <p>Opening formed in wall at Level 0 (first floor). The line of the existing wall will be continued through to contain stair. Service area and section of wall is of low value therefore low impact.</p> |

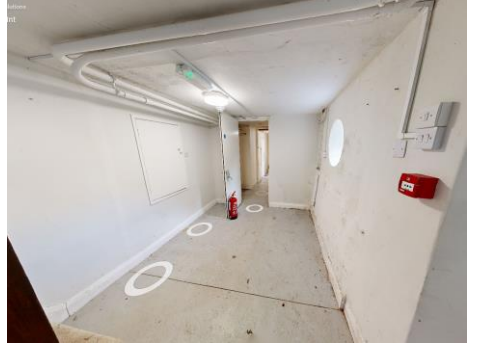
| Reference | Proposal | Significance of affected fabric | Impact | Reasoning and mitigation |
|---|---|---|---|---|
| G-New Internal Partitions<br>26G.P1 | New timber stud partition to form ensuite. Existing early C20 door to be reused. | High Setting<br>C18/C19 Stable block<br><br>Low Alterations<br>1930-1960 Alterations<br>LC20 | Low Impact | <p>New partition for WC divides existing lobby however there are alterations visible at skirting level that suggest there was a former partition on this line. The lobby will receive daylight from the glazed door. The circular window shall light the WC. The raised hatch door to the undecroft shall also be filled in with a new opening formed.</p> |

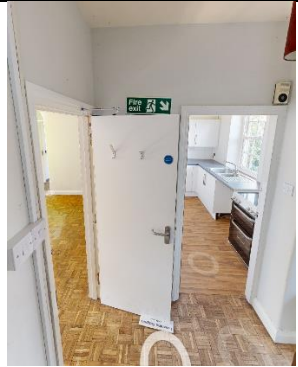
| Reference | Proposal | Significance of affected fabric | Impact | Reasoning and mitigation |
|---|---|---|---|---|
| G-New Internal Partitions<br>26G.P2 | Doorways infilled and new compartment wall formed. | LC20 doorway. | Low Impact | <p>Arrangement of doorways off landing altered to infill both doors forming one shared door. The proportion of rooms and landing arrangement is unaltered however there is an opportunity to form</p> |

| Reference | Proposal | Significance of affected fabric | Impact | Reasoning and mitigation |
|---|---|---|---|---|
| | | | | compartment wall to the stair and replace late C20/early C21 fire doors, with no historic significance, with a visually pleasing in keeping panelled fire door. |

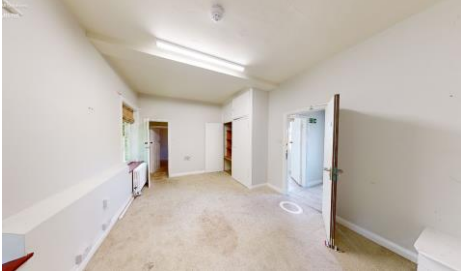
| Reference | Proposal | Significance of affected fabric | Impact | Reasoning and mitigation |
|---|---|---|---|---|
| G-New Internal Partitions 26G.P3 | New timber stud partition to far end of room to form ensuite. Existing early C20 door to be reused. | High Setting<br>C18/C19 Stable block<br><br>Low Alterations<br>1930-1960 Alterations<br>LC20 | Low Impact | <p>The large sash windows are unaltered and retained providing daylight and views to the ensuite and bedroom. The overall proportions of the room are altered however alteration is sympathetic and reversible.</p> |

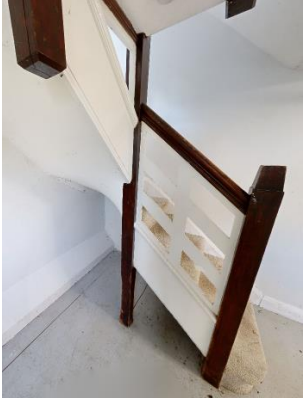
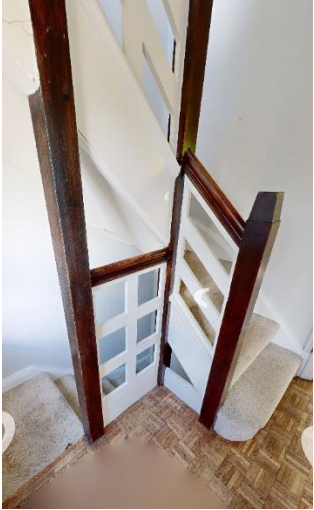
| Reference | Proposal | Significance of affected fabric | Impact | Reasoning and mitigation |
|---|---|---|---|---|
| H-Stairs 26H.R1 | LC20 Stair retained and repaired. | High Setting<br>C18/C19 Stable block<br><br>Alterations<br>LC20 | Neutral | <p>Retained and repaired. Neutral Impact</p> |

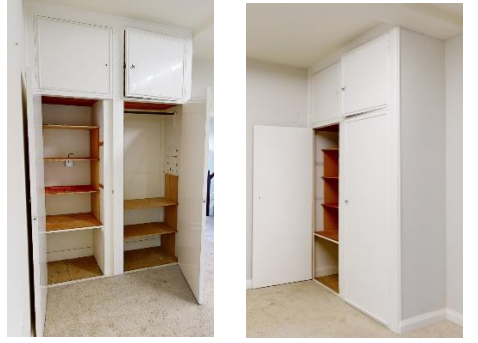
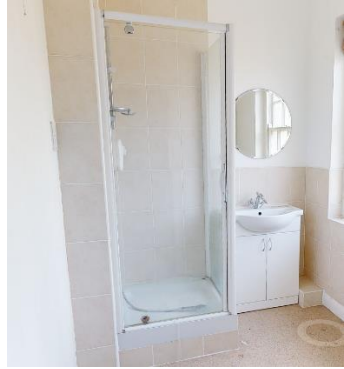
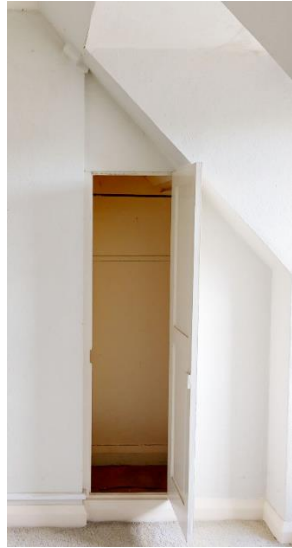
| Reference | Proposal | Significance of affected fabric | Impact | Reasoning and mitigation |
|---|---|---|---|---|
| J-Internal Fixtures and Fittings 26J.D1<br>26J.D2<br>26J.D3<br>26J.D4<br>26J.D5 | Removal of modern C20/C21 units and shelving. | Neutral<br>Late C20 / C21 school insertions | Neutral Impact | |

| Reference | Proposal | Significance of affected fabric | Impact | Reasoning and mitigation |
|---|---|---|---|---|
| | | | | <p>No contribution to historic significance.<br/>Neutral Impact.</p> |
