# Church of St Mary the Virgin, Ashwell

## Statement of Significance

Adam Menuge

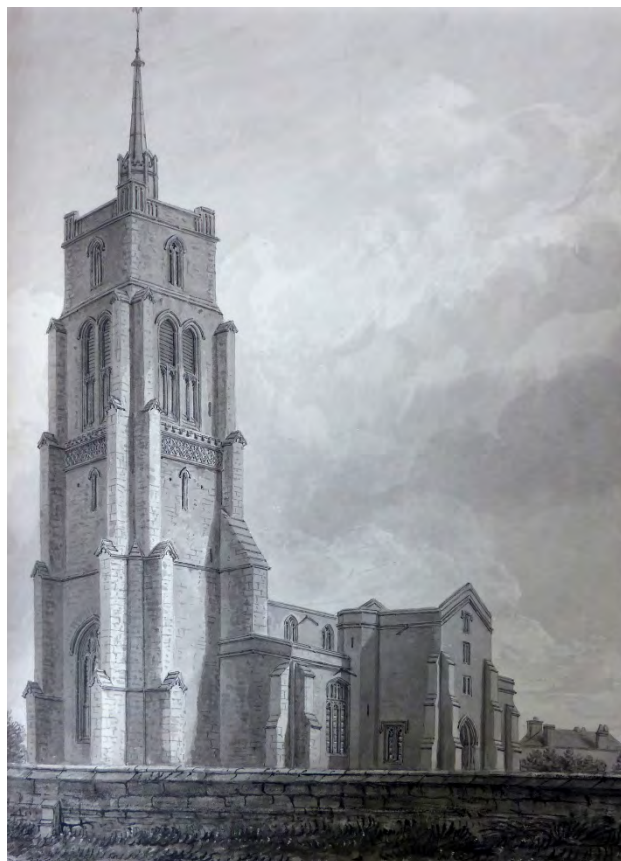
Fig. 5 (left). The tower as depicted by John Buckler in 1837. (Hertfordshire Archives & Local Studies; slightly cropped)

renewed since that date. However, one of Morice's views, showing the church from the south-east, shows two intermediate merlons on the east elevation only, hinting at a more elaborate original form. John Buckler's 1837 view shows blind lancet panels – possibly flushwork – in the corner merlons and extending irregularly a little to each side, as though an originally continuous scheme survived only in part.<sup>46</sup> James Harraden's view from the south-east, published in 1826, gives support to this interpretation so far as the east elevation is concerned.<sup>47</sup>

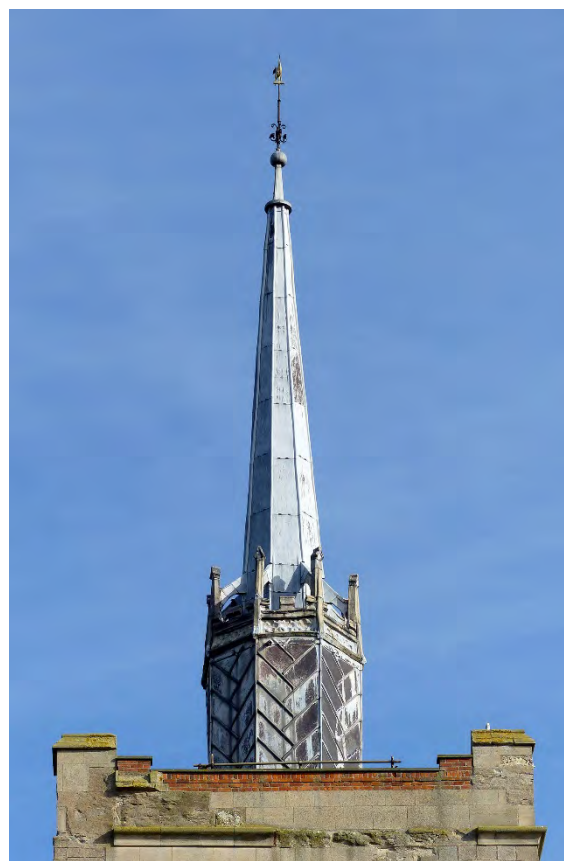
Fig. 6 (right). The spike, from the west.

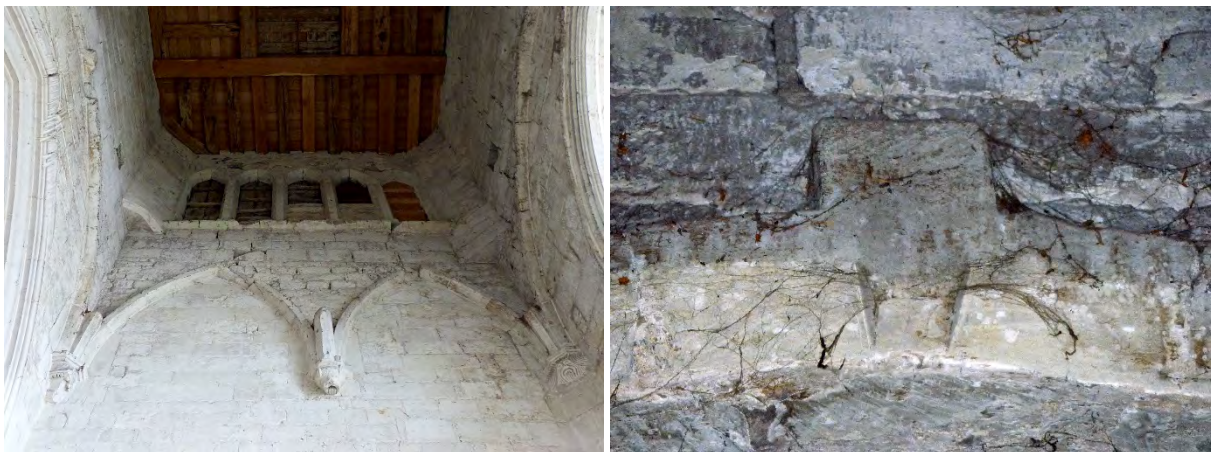
Fig 7 (left). Remains of the vault, with the gallery arcade above, viewed from the north.

Fig. 8 (right). The chamfered wall-rib on the west wall, showing the return of the central ridge rib. Similar evidence survives on the east wall above the tower arch.

Internally the first stage originally had a vaulted ceiling which would have formed the floor of the ringing chamber in the second stage (Fig. 7). The vault was later removed but the corbelled springers for the chamfered vault ribs survive in the four corners of the tower and midway along the north and south walls. The corbels are carved in the form of human and grotesque heads. The returns for a central ridge rib can be made out on the east and west walls (Fig. 8). The evidence thus points to a sexpartite vault extending in two bays from east to west.

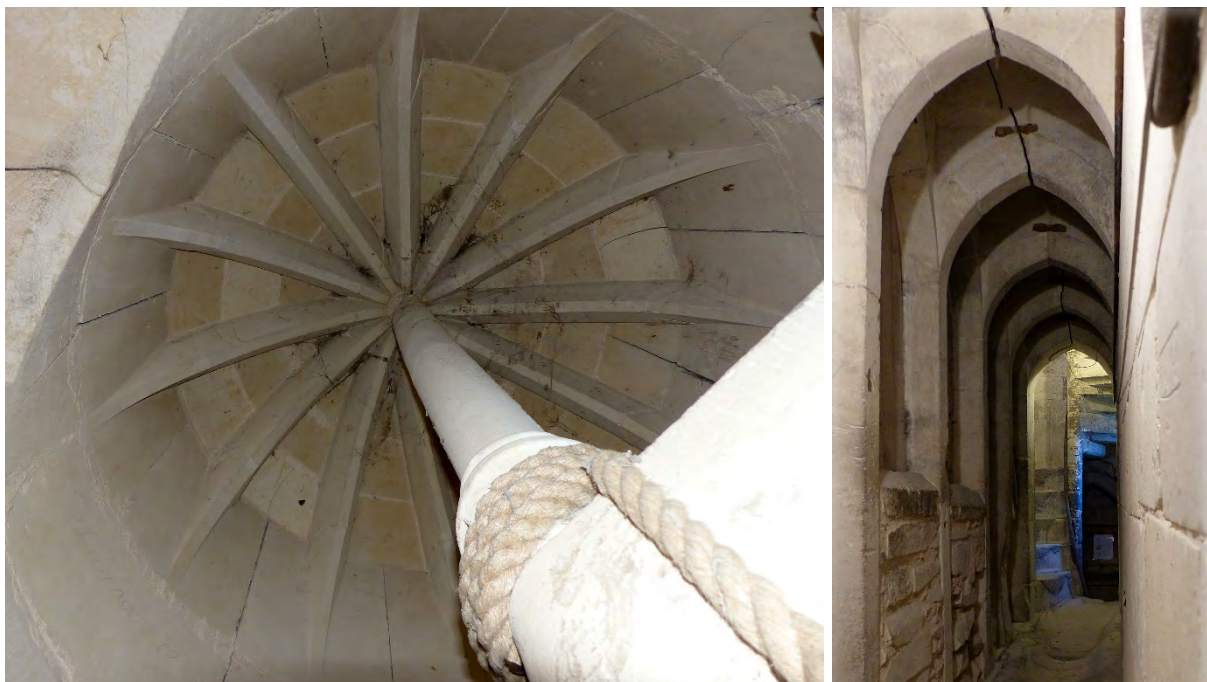
Fig. 9 (left). The vault at the top of the south-west stair.

Fig. 10 (right). The gallery viewed from the west.

south tower wall.) The stair is of stone newel form, rising clockwise on plan, and lit at intervals by small lancets with trefoil-cusped heads. The masonry lining the stair is in particularly fine large blocks of clunch. The stone winders have chamfered lower edges. Three narrow lancets light the stair at intervals, and to the right of the highest of these there is a well-executed scribed daisy-wheel design. The stair rises to just above the level of the former vault, where it is crowned by a remarkable vault (Fig. 9) consisting of twelve chamfered ribs supported at their intersection by a column rising from a moulded base set on top of the newel. At this level the stair opens on to an intramural gallery (Fig. 10) running the length of the south wall of the tower, lit by borrowed light from a five-light arcade opening into the tower. The openings are chamfered with broach stops; some have been partially infilled with stone, while the remainder have been closed off with timber boards. Where they face into the tower they are linked by a continuous chamfered sill. Arches spanning the gallery spring from the mullions and jambs framing the openings of the arcade, and between each pair of these (five in all) there is a small triangular vault bearing the weight of the wall core above. Traffic through the gallery has worn a deep trench in the soft clunch of the floor.

The reason why the stair rises initially in the south-west angle is so as not to impair the strength and integrity of the masonry forming the responds to the tall arch linking tower and nave. A stair in this position, however, cannot provide access for maintenance purposes to the nave roof. Once the height of the arch is cleared, therefore, the gallery serves to transfer movement to the south-east angle, where another stair ascends to the top of the tower. This stair also descends by a few steps to an external doorway, chamfered externally, which provides access to the south parapet gutter of the nave.

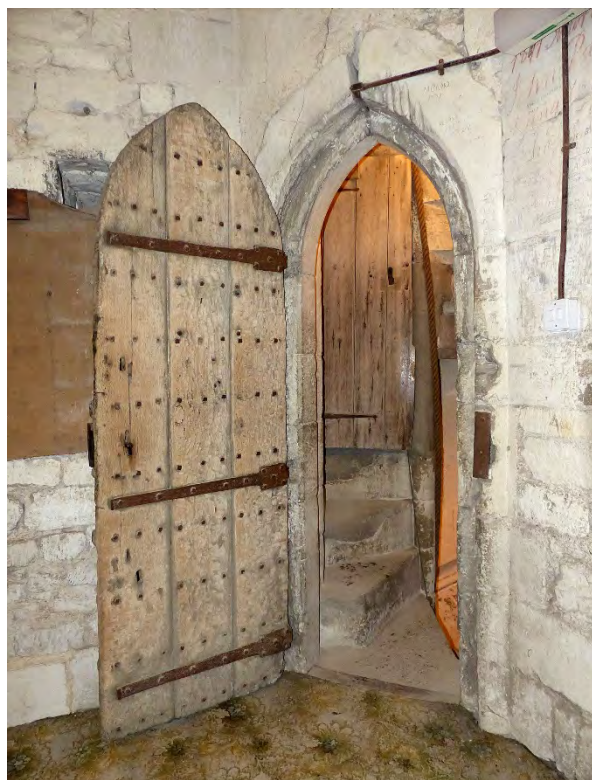
Fig. 11 (left). The doorway from the south-east stair to the ringing chamber, showing the 14<sup>th</sup>-century door.

The first level to be accessible from the south-east stair is the ringing chamber, which roughly corresponds to the external second stage of the tower. The floor structure, visible from ground level, consists of two east-west beams and heavy joists laid flat in the medieval manner. The beams and many of the joists have been renewed, but some of the joists appear to be original. A large trimmed hatch in the centre is for raising or lowering bells and other bulky items. That this floor level is original, in spite of much alteration, is indicated by the presence of a chamfered two-centred arched doorway opening off the stair at this height, and by the relative height of the windows lighting the second stage of the tower. The doorway retains what appears to be an original 14<sup>th</sup>-century door consisting of three planks and ten nailed ledges. Two of the boards have a tapered edge which is let into a groove in the adjacent board to prevent gaps opening up between them, and the wrought-iron, pintle-hung hinge straps are neatly let into the boards.

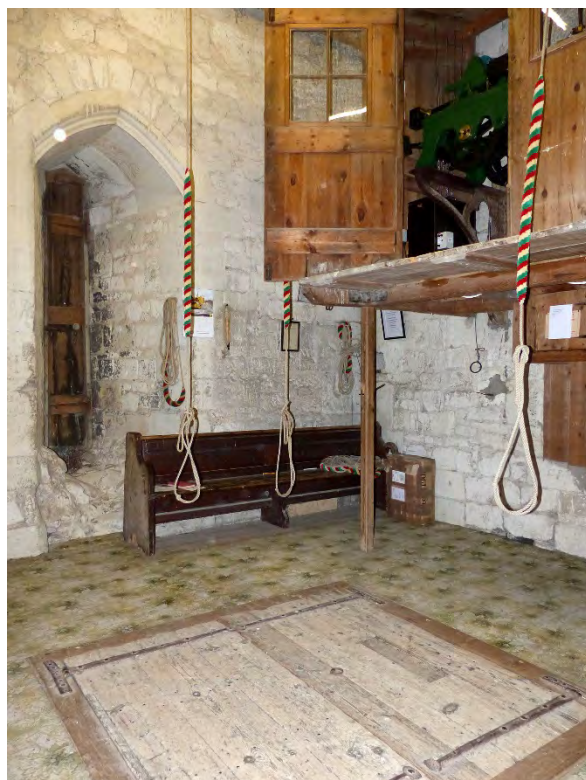
Fig. 12 (right). The ringing chamber interior, showing the south-facing lancet window, floor trap, clock cupboard top right, and re-set bench seat from the nave.

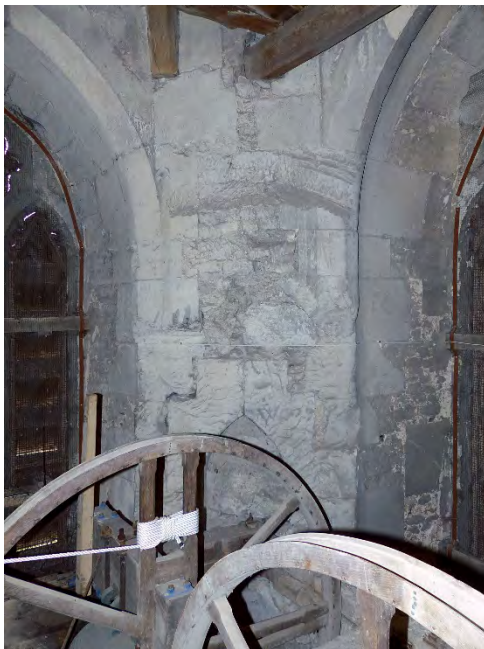
Fig. 13 (left). Interior of belfry, showing blocked doorway in south-east corner, indicated by pointed two-centred arch low down, its crown just above the further wheel.

The stair continues past the ringing chamber doorway and is lit by another lancet before reaching a doorway, now blocked, with a chamfered four-centred arched head. Arches of this form are rare before the late 14<sup>th</sup> century, but this one must correspond to the pointed two-centred rear arch visible inside the belfry (Fig. 13), and it appears to be an original feature, one moreover which conflicts with the present structure of the bell-frame, part of which is lodged in the blocking. Climbing the stair beyond the blocked belfry doorway there is one further lancet before the top of the tower is reached. The stair column is bridged by a depressed two-centred stone arch. A hatch gives access to the flat tower roof.

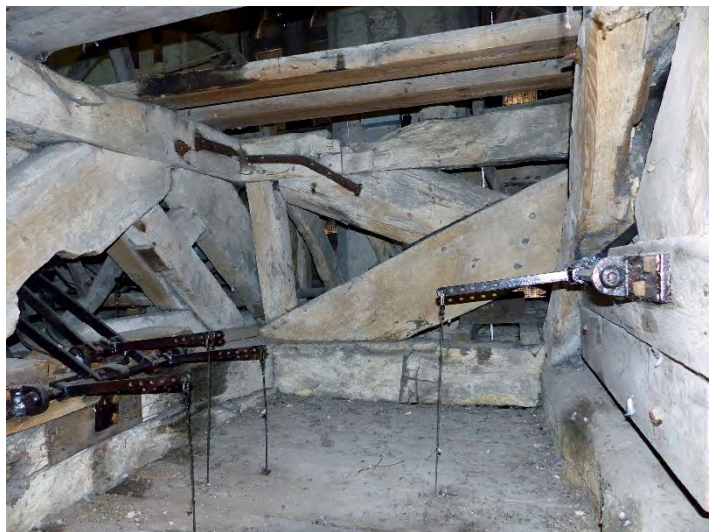
Fig. 14 (above). Detail of bell-frame.

A full analysis of the bell-frame (Fig. 14) is beyond the scope of this report. The bell-frame is of medieval appearance but, as noted, it conflicts with the blocked original entrance to the belfry, and must therefore be a secondary feature. The frame appears to be of a 'long-headed' type, an indication of a late-medieval (or later) date; the fact that it incorporates duplicate and scissor braces rules out a post-medieval date, and it is therefore likely that the frame dates from a 15<sup>th</sup>-century re-ordering of the bells.<sup>48</sup> The present arrangement forms six bell-pits, but this is clearly not the original arrangement. A previous report concluded that the frame originally housed four bells around a tenor pit, and that it was rearranged for six bells in 1694 (the date of the earliest surviving bell). The bell founders and dates are recorded as follows (clockwise from the north-east bell-pit):<sup>49</sup>

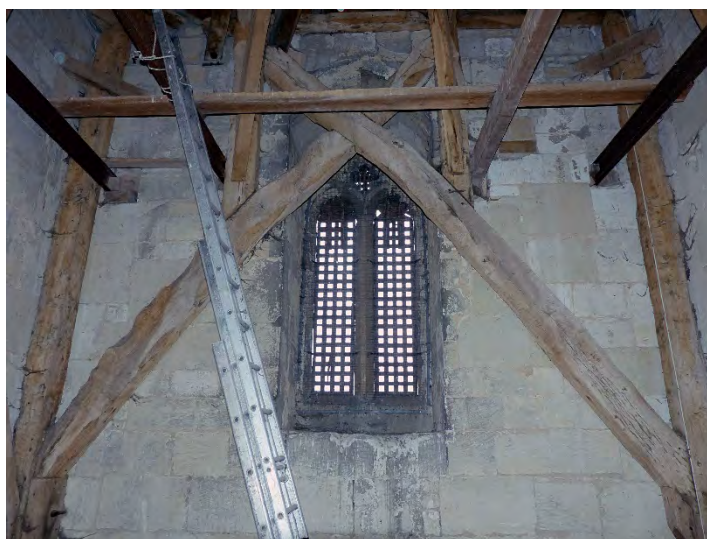
Fig. 15. Wall-posts and scissor-braces with struts rising from the latter just below the halving joint.

Above the belfry, the fourth stage of the tower is accessible only by ladder from the belfry. The floor is modern. The interior is lit by a two-light window in each wall. The principal feature of this stage is the timber frame designed to help support the spike. Large renewed stone corbels in the north-west, north-west and south-west corners, and one on each side of the canted wall in the south-east corner, support flying sill-plates, from which posts rise the full height of the stage to a wall-plate. From low down the posts, long, heavy scissor braces rise, crossing at a halving joint in front of the upper part of the windows, and from the backs of

these braces subsidiary posts rise, into the sides of which the upper ends of the scissor-braces are tenoned (Fig. 15). Long braces spring from these subsidiary posts (which act in the manner of wall-posts in an arch-braced roof, and have jowled heads to create a stronger joint with the beams resting on them) at an angle so as to intersect with the star-shaped arrangement of beams at the base of the spike, providing some mid-span support for the very heavy load imposed on the beams (Fig. 16). This timber-framed structure, with its square-cut sections, use of scissor-braces and, in the corners of the structure, unjowled posts, would seem not inconsistent with a later 14<sup>th</sup>-century date.

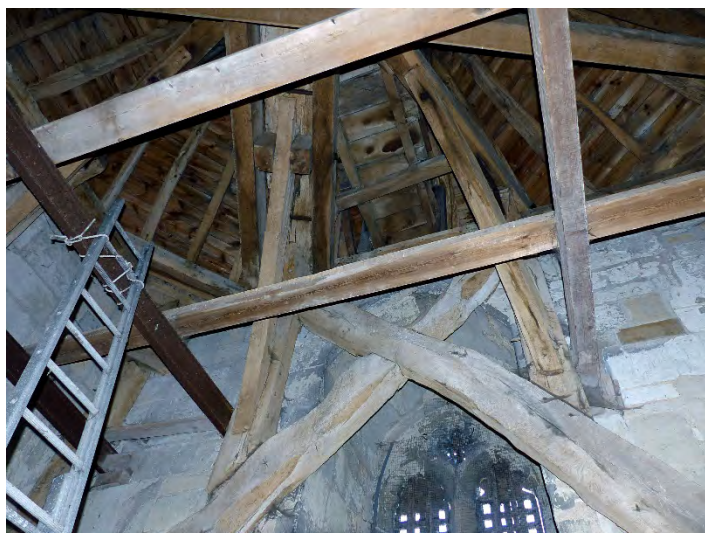
Fig. 16 (above). Braces rising from struts on the backs of the scissor-braces are angled in to meet the undersides of the beams forming the base of the spike.

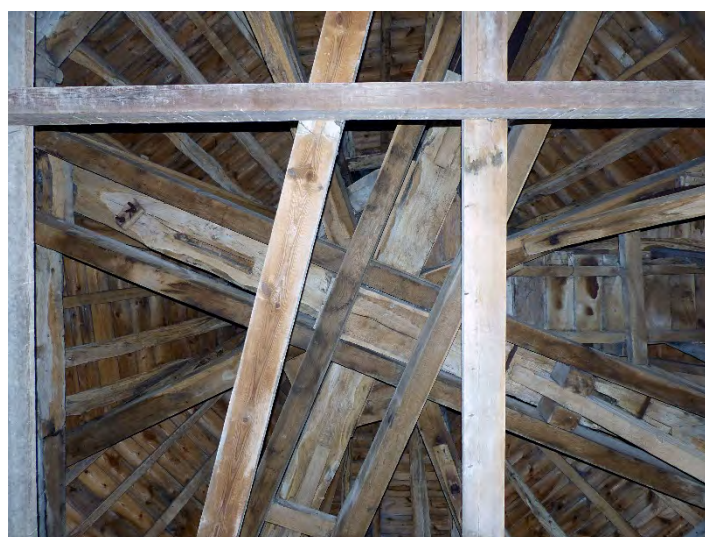
Fig. 17 (right). The base of the spike, seen from the fourth stage below. The principal beams form a cross, and lesser beams bisect the angles between them. Braces originally rose from the frame below to all eight beams.

The base of the spike, thus supported, consists of one heavy, square-section beam spanning roughly north-west to south-east, and another at right angles to it, their rotation in relation to the walls of the tower doubtless reflecting a desire not to impose the loads at the beam-ends directly over the windows in the fourth stage (Fig. 17). Four slighter half-beams converge on the junction of the two heavier ones, bisecting the angles between them to give a figure resembling an eight-pointed star on plan. A central post rises from the centre, and lesser posts rising from each beam define the inclination of the spire. The lowest portion of the spike has vertical sides, however, and these are formed by a further set of posts rising from nearer the perimeter of the tower. Long shores rise from the ends of the beams, past the outer and inner (inclined) posts to meet the central post, and higher up there are braces rising from the inclined posts to the central post.

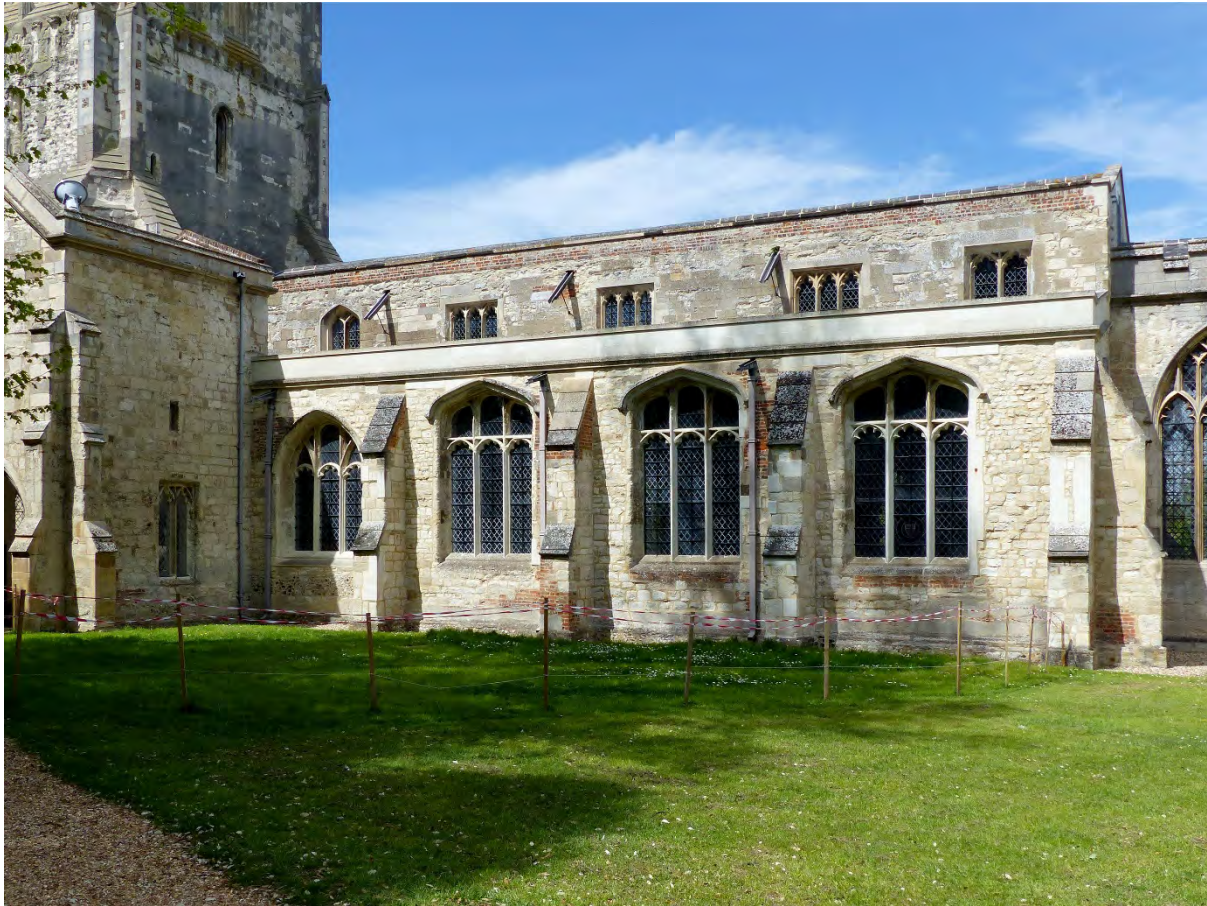
Fig. 18. Bays 3 to 6 of the south aisle and 2 to 6 of the clerestorey

below). Bay 3 retains an original later 14<sup>th</sup>-century three-light window with a two-centred arched head. The lights are cinquefoil-cusped at the springing level of the main arch, the outer ones beneath pointed two-centred arched heads and the central one beneath a four-centred head in the tympanum. Another original window occupies the east return, where it lights the Lady Chapel. This has more steeply pointed heads to the cinquefoil-cusped lights, and an array of super-mullions above. The renewed hood-mould has badly weathered head-stops. The corresponding window in the north aisle has a flamboyant tracery design with an ogee-headed central light. All the other windows lighting the north aisle are 15<sup>th</sup>-century replacements. The west return is blind.

The clerestorey has what appear to be the original windows in Bays 1 and 2 of the south elevation and Bays 3 and 4 of the north, but the two pairs are of different form. Those to the north are the earlier in style, consisting of two steeply pointed cinquefoil-cusped lights beneath a cavetto-moulded two-centred head overall. Those to the south have a four-centred arch containing two lights also with four-centred, cinquefoil-cusped heads. They appear to be unmoulded, but the extent of subsequent repair makes their original treatment uncertain.

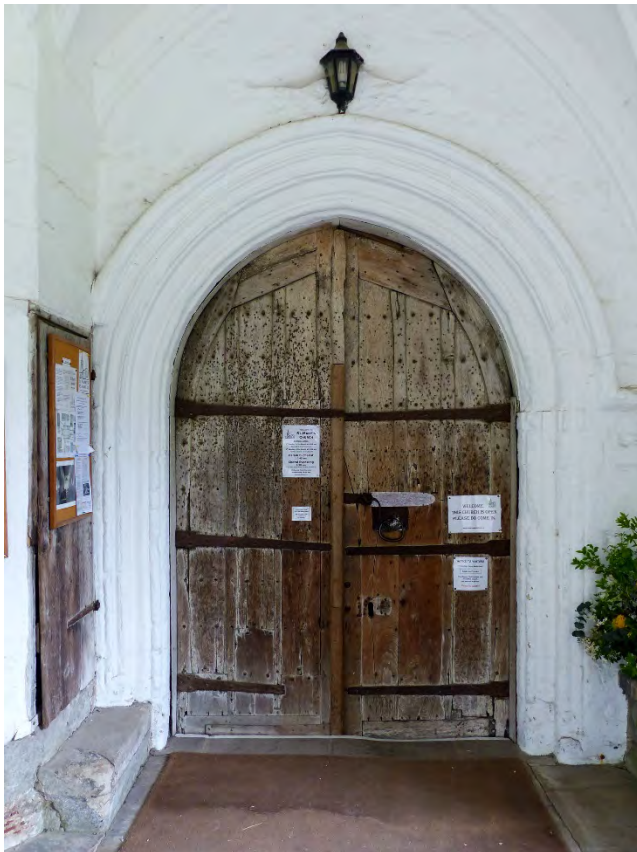
Fig. 19 (left). The south entrance, with its 14<sup>th</sup>-century double doors.

Entrances to the nave were provided for the laity in the conventional position one bay in from the west end. The principal entrance was from the south and is now enclosed by the later porch (Fig. 19). It has a two-centred arch, a broad moulded surround and a hood mould with one returned end (the stair turret rules out a return on the other side). The rear arch is ovolo-

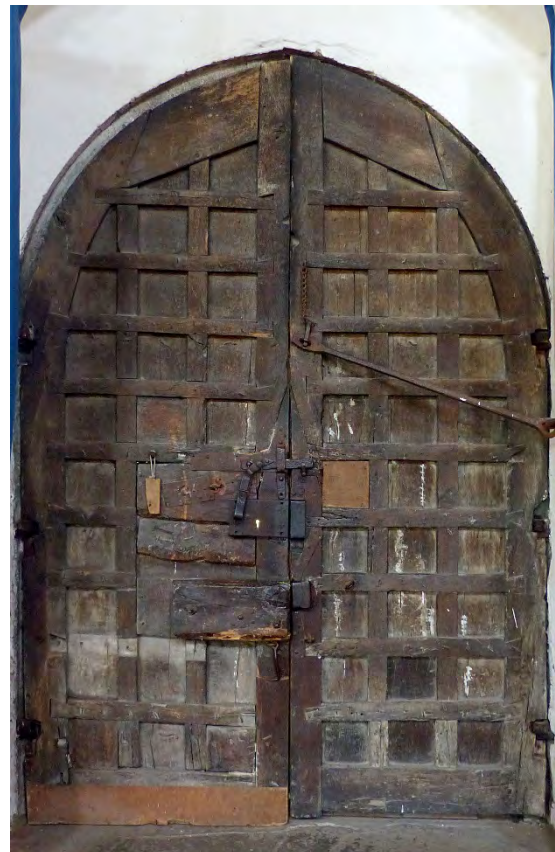
Fig. 20 (right). The doors from inside the south aisle.

moulded and depressed two-centred. The double-leaf doors are probably the originals. They consist of a morticed and tenoned frame (bottom rail, hanging and closing stiles and arched top), within which vertical planks are secured to a square lattice frame assembled with bare-faced dovetail joints (Fig. 20). The boards are held between the thicker vertical stiles of the frame, plank-and-muntin fashion, and the stiles are therefore visible on both faces, while the thinner horizontal rails pass over the backs of the boards and are halved over the stiles. The boards have a slightly cambered profile to the exterior, and the stiles are chamfered where they are joined. Nails secure the boards and stiles to the horizontal timbers. The long, plain, wrought-iron, pintel-hung hinge straps (three per leaf; one truncated) appear to be the originals and resemble those on the ringing chamber door. The early timber-cased rim lock and wrought iron door furniture are also of interest.

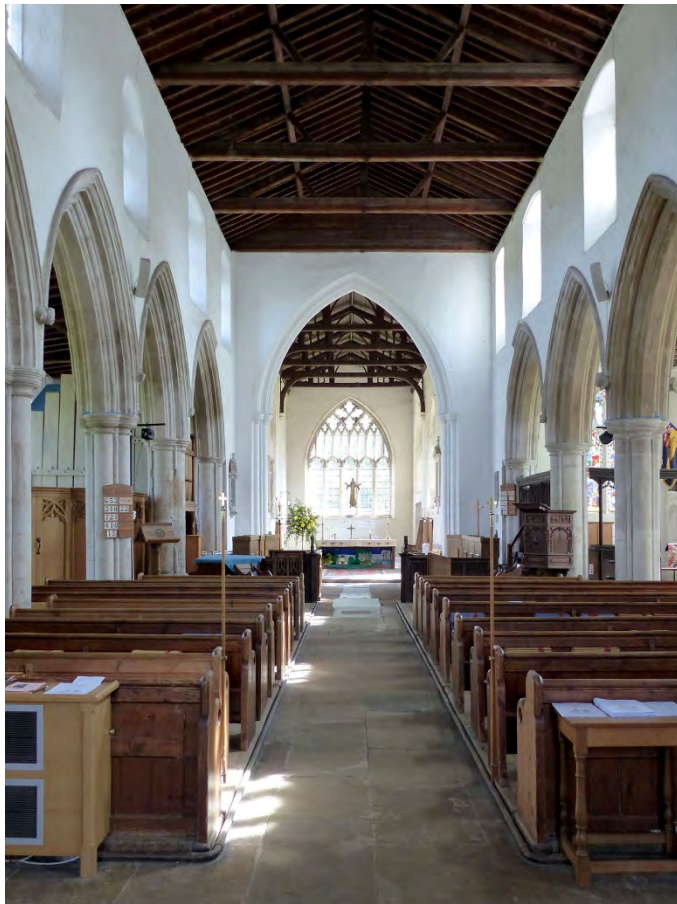
Fig. 21 (left). The nave looking east towards the chancel.

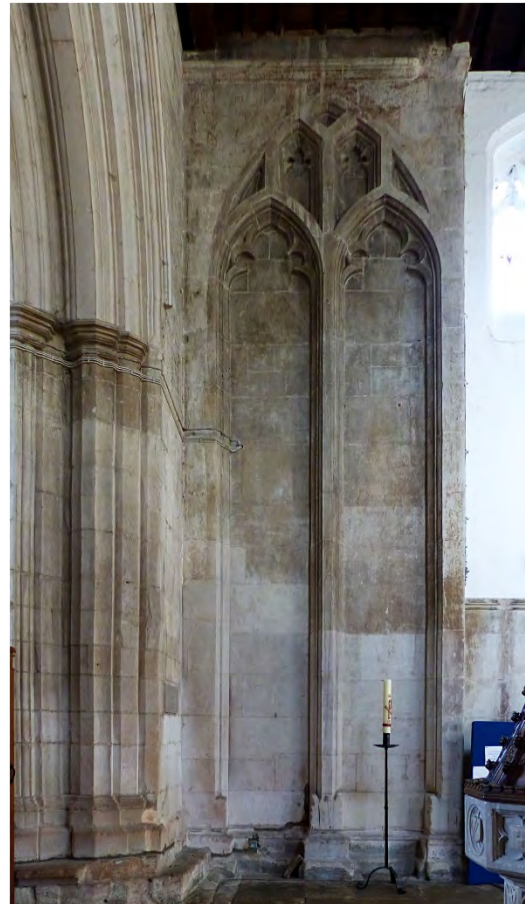
Fig. 22 (right). Bay 1 (west end of the nave), north side: the blind window disguising the tower buttress.

the tower) to *circa* 1380.<sup>50</sup> The arches of the arcade have hood-moulds with carved stops. At the west end Bay 1, the form of which is determined by the need to buttress the tall west tower, is treated as a blind pointed two-centred arched window, incorporating two cinquefoil-cusped lights with small trefoil—cusped lights between the super-mullions (Fig. 22).

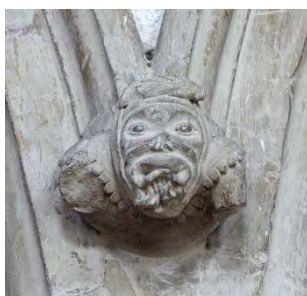
Fig. 23. Nave arcade label stops. Left pair from north side of nave; right pair from south side. From left to right: grotesque male face with scalloped cape; female head with star on forehead; monkey; lion.

The nave arcades have hood-moulds decorated with label stops in the form of human and animal heads (Fig. 23). Some have been defaced but the majority are either little-damaged or at least identifiable. The chancel arch at the east end follows the clustered semi-circular pier/respond type and the associated arch moulding. It is off-set north of the nave's central axis, no doubt reflecting the alignment of the previous chancel, as noted by Millard.<sup>51</sup> A hood-mould has been dressed back on the nave side (perhaps when the Royal Arms were painted

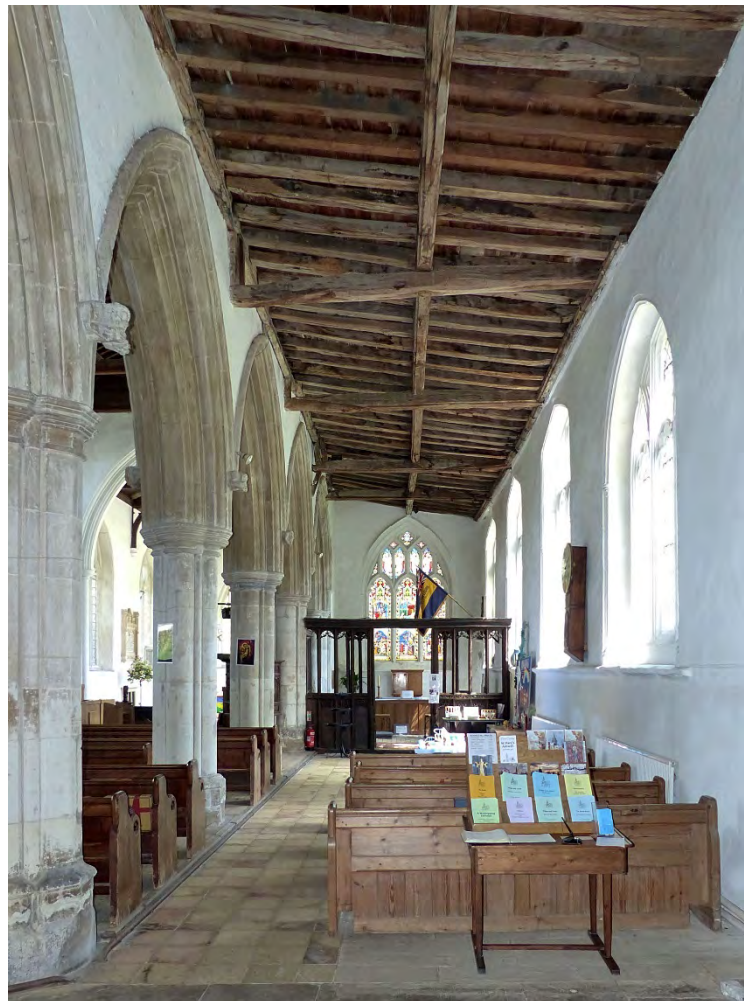
Fig. 24 Interior of south aisle, looking east towards the Lady Chapel (with later parclose screen).

The aisle has a seven-bay shallow mono-pitch roof (Fig. 24) which appears to be medieval in origin, though partially reconstructed in the 18<sup>th</sup> century. The half-trusses consist of a tie-beam off which, at the nave end, rises a short wall-post supporting a ridge-purlin (absent in Bay 6), while a side purlin rests directly on the tie-beam. Along the south wall lengths of cornice beam occupy the spaces between the trusses, except in Bays 1 to 3, where they are missing. The tie-beams and purlins are cavetto-moulded, probably indicating a medieval date. The common rafters are of flat to square-ish section and pegged directly over the ridge-purlin.

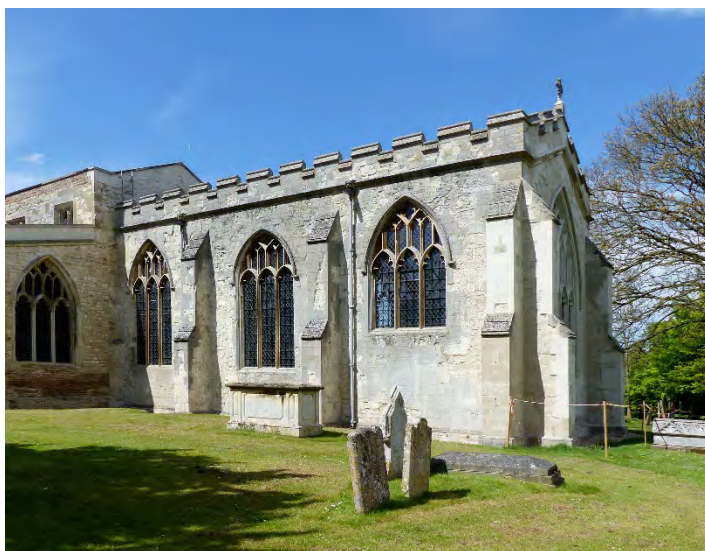
Fig. 25 (above). The chancel from the south-east, with the Lady Chapel window extreme left.

The chancel consists of three roughly equal bays and follows the conventional pattern in being lower and narrower than the nave (Fig. 25). The buttresses between the bays, and the angle buttresses at the east end, have shouldered set-backs which are modern in their present form but appear, unlike those on the tower, to reflect the pattern existing at least by the time of Charlotte Morice's sketches. The chancel was provided with an external doorway on the north side of the central bay. The windows and their hood-moulds have been substantially renewed. They are of three cinquefoil-cusped lights, the mullions continuing with super-mullions to form an upper tier of cinquefoil-cusped lights with quatrefoils in the spandrels. The south window in the east bay has a substantially higher sill than the other two south-facing windows in order to accommodate the sedilia inside. James Harraden's 1826 view (Fig. 2), and John Buckler's from a similar viewpoint, show the other two south windows blind up to the level of a transom at the same height as the sill of the easternmost.<sup>52</sup> On the north side the easternmost window position is blind because of the structure originally attached to this bay. On the same side, the central window incorporates a stepped sill respecting the position of an original external entrance or priest's doorway (Fig. 30). The large east window, recently restored, is of five lights, with super-mullions giving an upper tier of four pairs of lights, all cinquefoil-cusped, and quatrefoils or mouchettes occupying the spandrels.

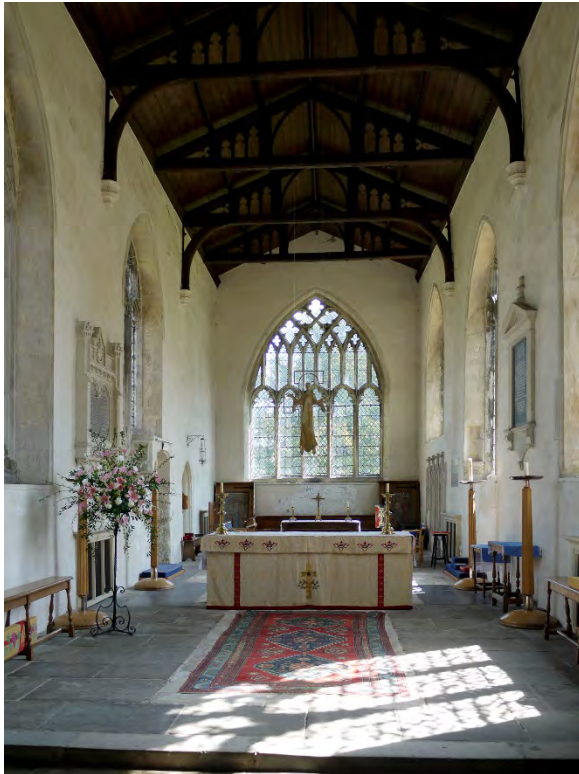
Fig. 27 (above). The chancel from the west.  
 Fig. 28 (top right). The sedilia and piscina.  
 Fig. 29 (bottom right). Twin doorways in the north wall of the chancel. On the left, the internal face of the priest's doorway. On the right, the doorway into the former vestry on the north side of the east chancel bay.

The chancel was re-roofed in six bays probably in 1873 as part of a wider restoration.<sup>72</sup> The builder was George M. Bates. The trusses (Fig. 27), which are elaborately stop-chamfered, incorporate a tie-beam, queen- and princess-struts, a central two-centred arch motif in slender timbers, and panels of trefoil-headed 'lights' and daggers in the outer positions. Alternate trusses also incorporate wall-posts resting on moulded stone corbels, with arch-braces up to the tie-beam. The queen-struts and the arch-braces are bolted to the tie-beams. At the wall-

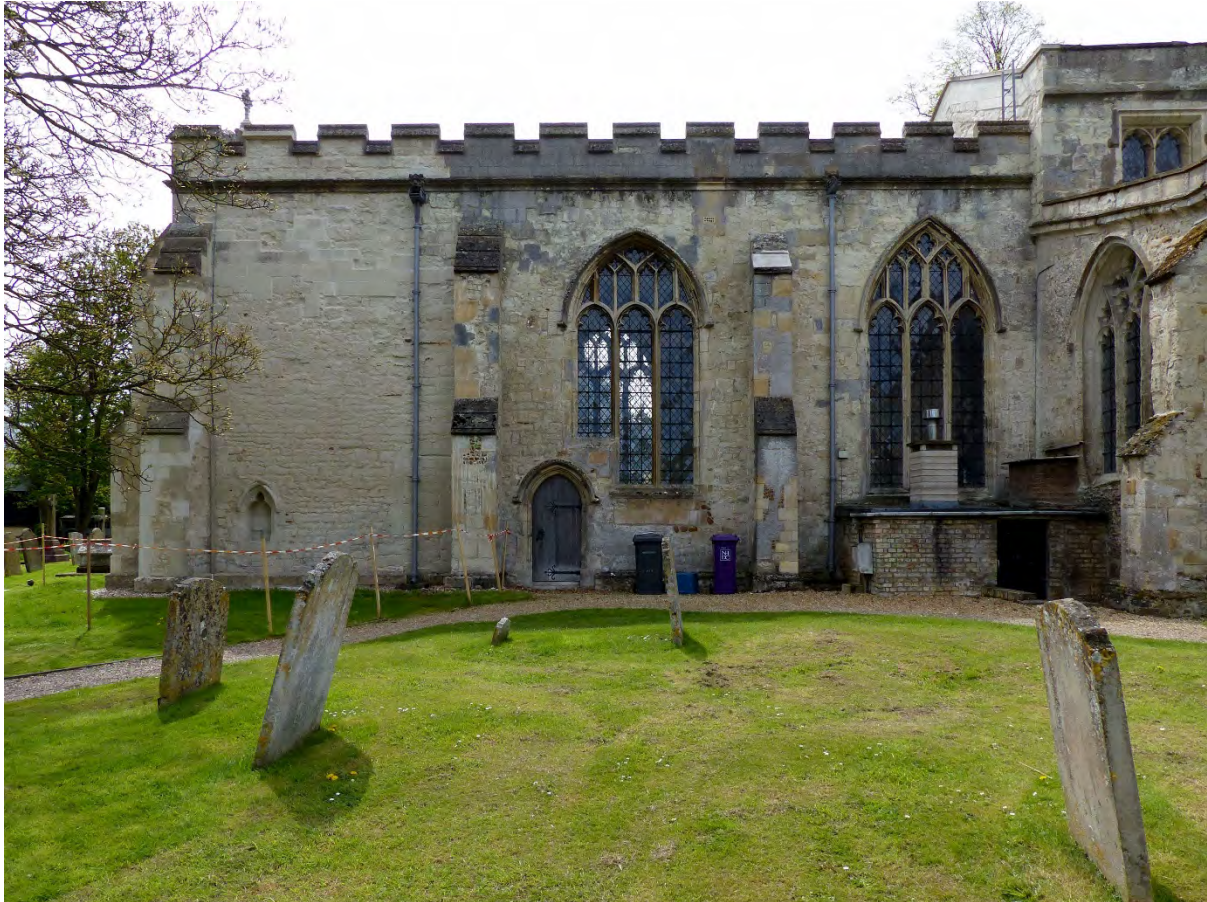
Fig. 30. The north elevation of the chancel, showing the blind eastern bay incorporating a blocked doorway to the demolished vestry, and a niche for a holy water stoup. The priest's doorway occupies the central bay.

There is clear evidence that when the chancel was built the east bay was adjoined to the north by what was probably a single-bay structure terminating roughly in line with the chancel's east end. There are three principal pieces of evidence for this: 1) the absence of a north chancel window in this bay; 2) noticeably inferior wall masonry in this bay, consisting of roughly coursed rubble (in contrast to the ashlar used elsewhere on the chancel), with some re-used stone, rising to about the second shouldering of the buttresses; 3) the presence of a piscina or stoup in what is now the external wall of the chancel; and 4) the presence of a doorway leading from the chancel into the lost structure. This doorway is identical in essentials to the priest's doorway entering the chancel from outside, and the two are placed side by side, with just a buttress intervening on the exterior. Each doorway has a pointed two-centred arch and

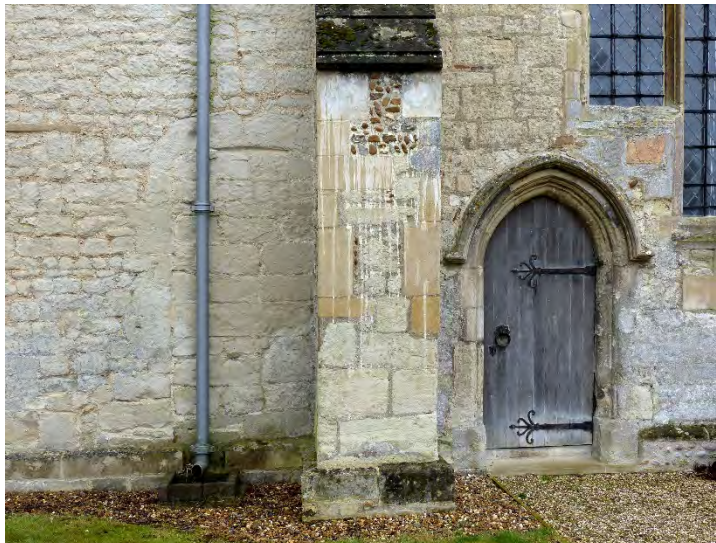
Fig. 32 (right). The priest's doorway (right) and the blocked doorway into the demolished sacristy (left).

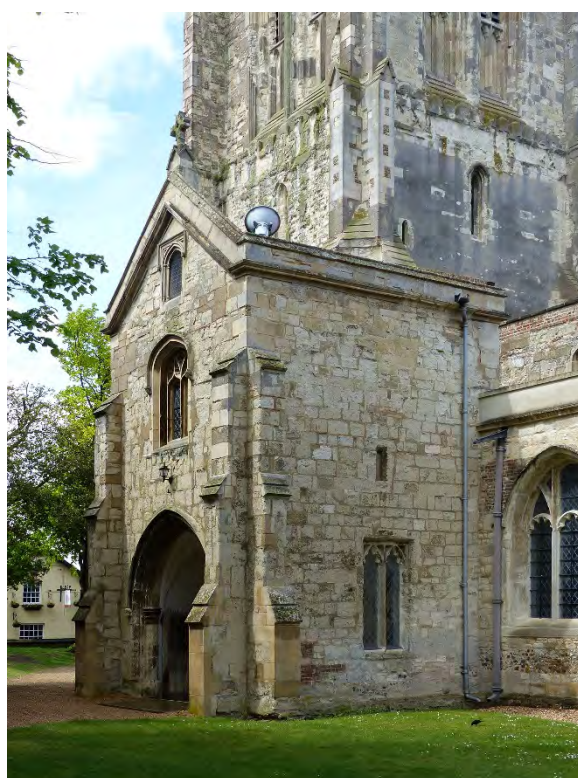
Fig. 34 (right). The south porch from the south-east, showing the reinstated Gothic south windows.

The gabled south elevation incorporates a moulded two-centred arched doorway with hood-mould and weathered head stops. The openings above are restored and evidence for the previous form of this area can be derived only from views by James Harraden, Charlotte Morice and John Buckler. They demonstrate that the chamber window had already been replaced once, and that no obvious details of the original opening remained. The niche in the gable, however, appears in the most detailed and reliable-looking of the views (those by Charlotte Morice) in much the same form as today. The odd feature of a south gable rising well clear of a much shallower-pitched roof is also clearly represented, notably on the Harraden view. The east and west return walls each incorporate a two-light ground-floor window. These have cinquefoil-cusped two-centred arched lights beneath an overall square head. External hood-moulds have been weathered or dressed back. Above, on both walls, there is a small, blocked, chamfered loop-light. The purpose of these is unclear, since they are set too high to light the ground floor and too low to light the chamber.

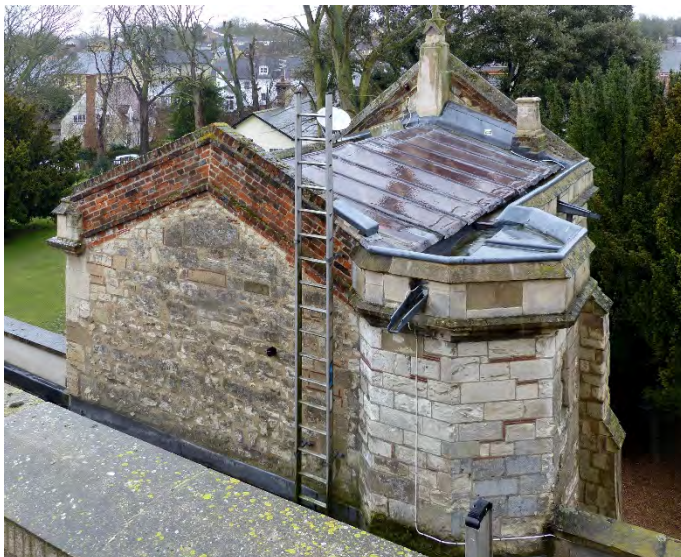
Fig. 35 (above). The south porch roof from the north-west, showing the stair turret. The brickwork and chimney probably date from the 1858 restoration.

the north-west corner where it meets the aisle wall, and angle buttresses to the south-west and south-east corners. The stair turret clips very closely the westernmost window of the south aisle, where the porch abuts at a straight joint. A cornice and parapet have been very largely renewed, but a small portion of original masonry survives on the east elevation. In the period since the south aisle was built its south wall appears to have moved out of vertical, and this probably accounts for a feature resembling a straight joint on the inside of the aisle, where new walling for the porch was raised plumb.

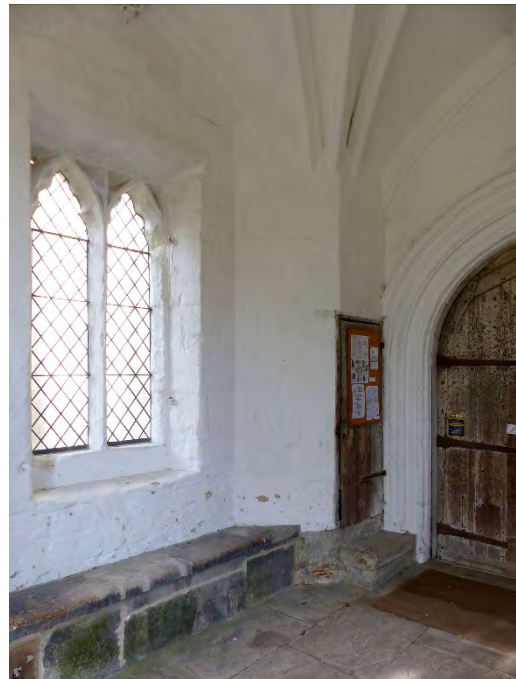
Fig. 36 (right). South porch interior, showing stair turret.

The interior of the ground floor, which incorporates stone benches along the east and west walls and has a stone-flagged floor, is well-lit from three sides. The windows have moulded square heads internally. The original access to the upper level was via a doorway, now blocked, in the south wall of the aisle. This has a two-centred arched head and a four-centred rear arch, and opened on to a newel stair rising clockwise to the first floor, lit at intervals by two plain loop-lights. A square-headed doorway, canted across the north-west corner of the plan, gives on to the first-floor room but has no clearly datable characteristics.<sup>61</sup>

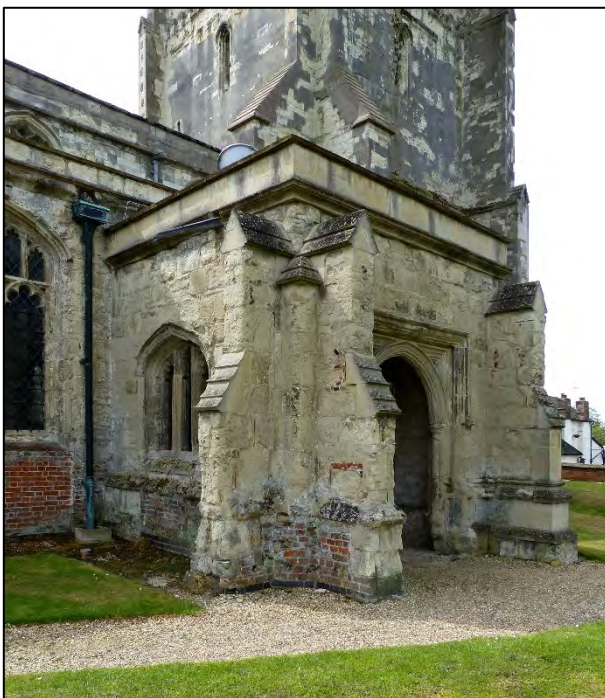
Fig. 37 (left). The north porch from the north-east.

The north porch is built in clunch ashlar, on a plinth of the same material (though largely rebuilt in red and blue brick) incorporating a lower chamfered course, an intermediate frieze course and a moulded top course incorporating reverse ogee mouldings. The clunch ashlar contrasts sharply with the clunch rubble and flint wall of the north aisle at the point where it abuts at straight joints. There are angle buttresses to the north-west and north-east corners, and a rebuilt cornice and parapet concealing the shallow-pitched roof. The north entrance has a richly moulded pointed two-centred arch springing from colonettes with moulded capitals, and set within a square-headed frame, also richly moulded, with pierced spandrels. The composition is completed by a hood-mould with small head stops, one defaced, one restored in cement.<sup>62</sup> The hood-mould is repeated internally, where the stops are better preserved. The jambs do not make an allowance for a door, but subsequently iron pintles were inserted in both jambs.

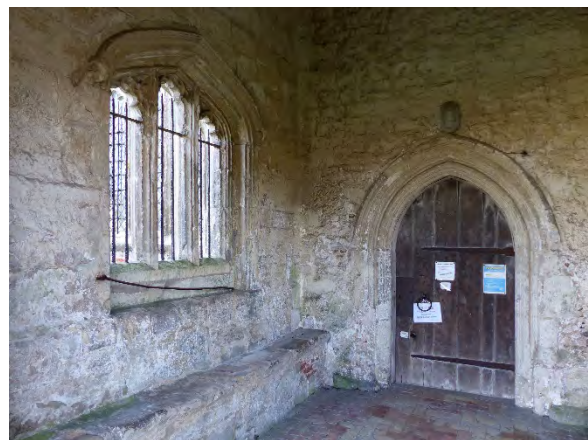
Fig. 38 (above). Interior view of the 15th-century north porch, showing the 14th-century north entrance to the church, the east porch window, and the stone bench, one of two lining the east and west walls.

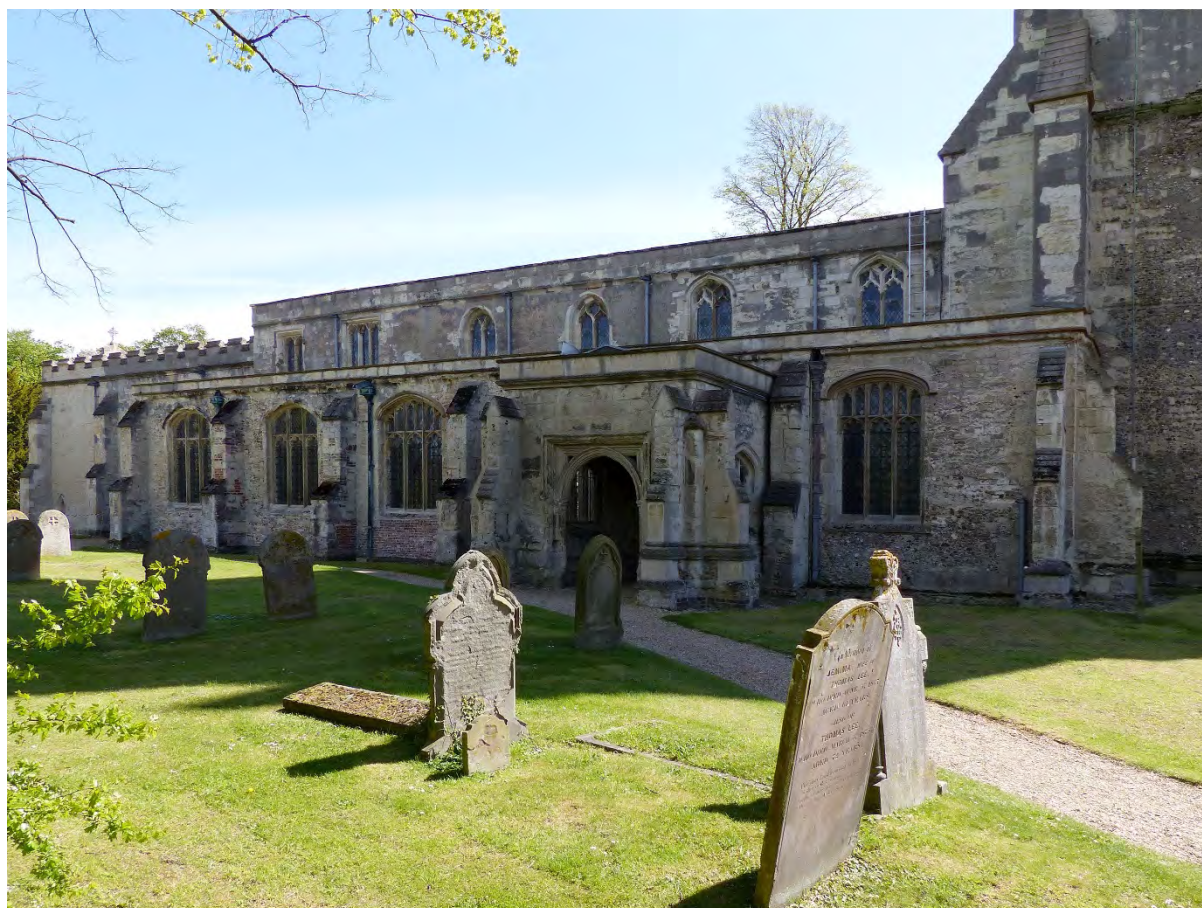
Fig. 39. The nave and north aisle from the north-west

During the 15<sup>th</sup> century most of the windows of the aisles and the nave clerestorey were renewed in the Perpendicular style. On the aisles all the windows except that in Bay 3 of the south aisle were replaced with four-centred arched openings consisting of three cinquefoil-cusped lights, and six trefoil-cusped, pointed-arched transom lights. The transom lights were created by alternating three super-mullions with the two rising through the transom. The original arrangement can be seen in Bays 1, 3 and 4 of the north aisle; elsewhere the super-mullions have been removed and the damage to the remaining elements of the window made good, albeit at the cost of creating some rather mis-shapen transom lights. Three windows were left unaltered: Bay 3 of the south aisle, and the east windows of both aisles. This may have been because of stained glass schemes which were judged particularly important (or which were defended by particular donor families).

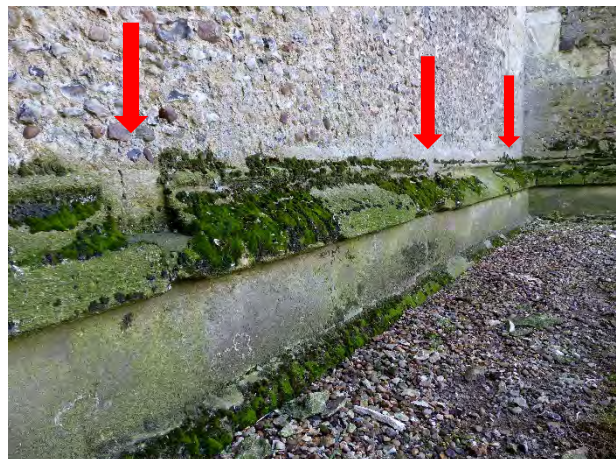
Fig. 41 (below). Section of the plinth at the base of the tower, showing three of the cut-outs for timber posts.

On the north side of the tower there is evidence for a former attached structure which, from its position, is likely to have had a pent roof. There are several types of evidence for this structure. The first consists of a row of four unevenly spaced notches in the moulded upper course of the tower plinth. These appear to be the seatings for upright timbers which either rested in them entirely or were perhaps notched into them but descended all the way to ground level. The timbers do not survive, and there is no clear evidence for fixings higher up the tower wall, or on the return of the north aisle or the corresponding buttress to the east, on each of which a roof scar might be anticipated. As with the structure on the north side of the chancel, it may be that subsequent weathering and stone replacement have removed evidence that may once have been visible. A clearly defined mortar-filled crease extending from buttress to buttress on the north wall of the tower, at a height just above the roof of the north aisle, seems to mark the top of the roof of the addition. Corresponding evidence for the fall of the roof, which should leave traces on the buttresses, is more elusive, though on the west buttress a diamond-shaped render patch just below the first set-back has the appearance of marking a purlin position. The final piece of evidence is a roughly arched doorway inserted in the return wall of the north aisle. The crudeness of its external face suggests that it provided access from the aisle into
