# Church of St Mary the Virgin, Ashwell

## Statement of Significance

Adam Menuge

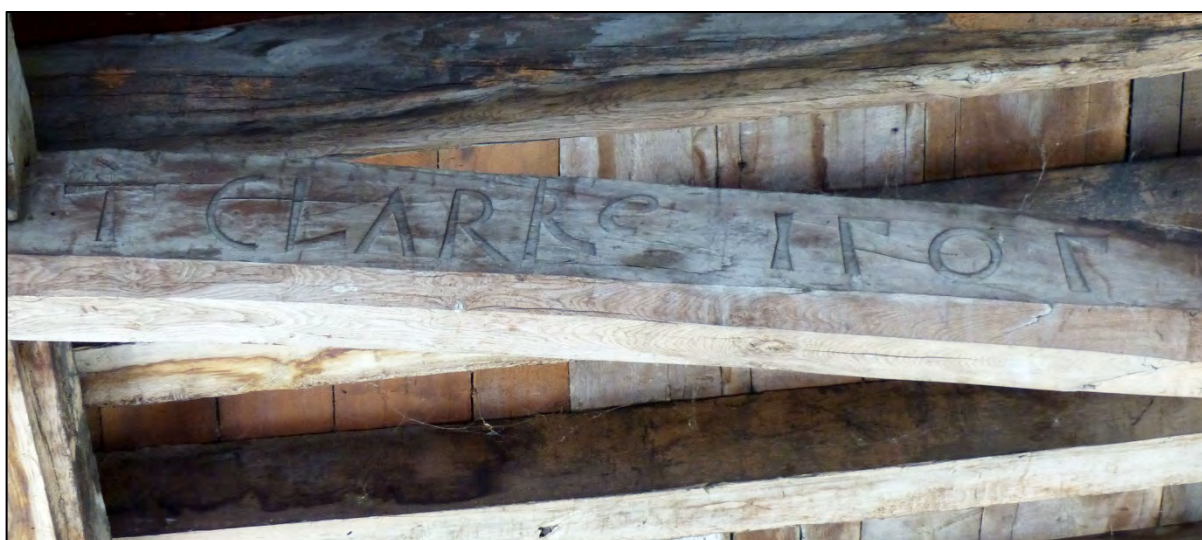
Fig. 42 (above). Tie-beam inscribed by T. Clarke, 1707. Fig. 43 (below). Tie-beam inscribed with 1764 date.

The south aisle roof was altered, probably in 1707, the date recorded (with the 7s reversed) next to a large inscription with the name 'T CLARKE' [sic] on the first tie-beam from the west.<sup>64</sup> A payment to Clarke is recorded in the Churchwardens' Accounts for that year, but it is unspecific, mentioning only 'Tho: Clarke his Bill', for which he was paid £2 8s 11d.<sup>65</sup> Roof repairs were evidently a recurrent need. On the soffit of the second tie-beam from the west appear the initials 'H + S + JS', very carefully cut with serifs, and darkened to contrast with the timber. On the west face of the same beam is the full-length inscription (mixing upper and lower-case letters):<sup>66</sup>

JULY · 27 · 1764 · T · SQUIER [Squier] · LAID · ME · HEAR · TO · LY · 100 · YEARS  
Other, undated repairs are apparent, for example, the fourth tie-beam from the west has a scarfed-in length at the north end, secured with large nails or spikes.

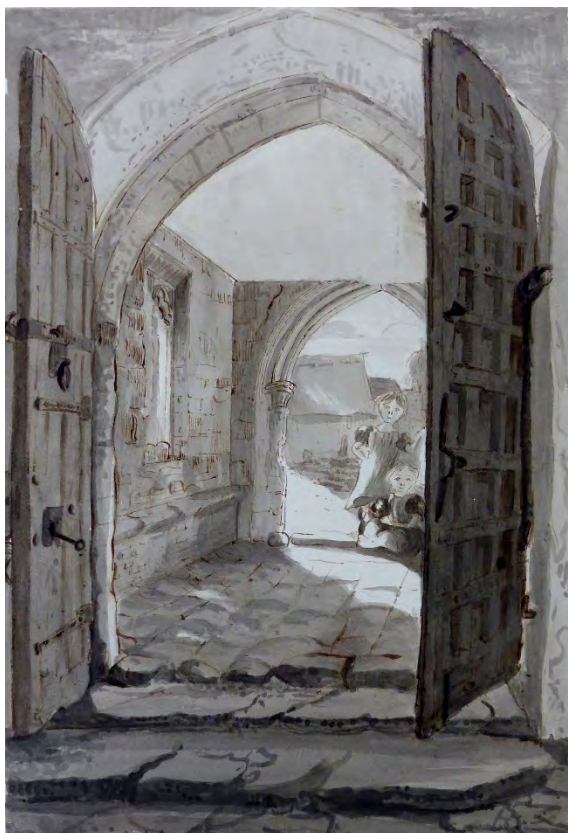
Fig. 44 (left). Charlotte Morice watercolour of south porch, looking south, showing a flat plaster ceiling (HALS).

Two views by Charlotte Morice depict the south porch before a major restoration later in the 19<sup>th</sup> century. They demonstrate that, probably in the 18<sup>th</sup> century, the upper floor was refenestrated with an upper and a lower pair of what may have been sash windows, and were at any rate wide, domestic-looking multi-pane windows. This would have made the chamber very well lit, and probably relates to the use of this room as a school. Another view by John Buckler, dated 1837, appears to equivocate over the form of the windows, showing them as simple two-light mullioned openings. Buckler may be 'correcting' his subject in the interests of a more harmonious (or historically reconstructed) image. Morice's watercolour looking southwards through the south porch shows a flat plaster ceiling just clipping the crown of the entrance arch. This is low enough to fit two low storeys of chambers over the entry, and thus to account for the windows on two levels above. It also accounts for the need to alter the access from the stair in the north-west corner, and to adjust the size of the door in the process (see below).

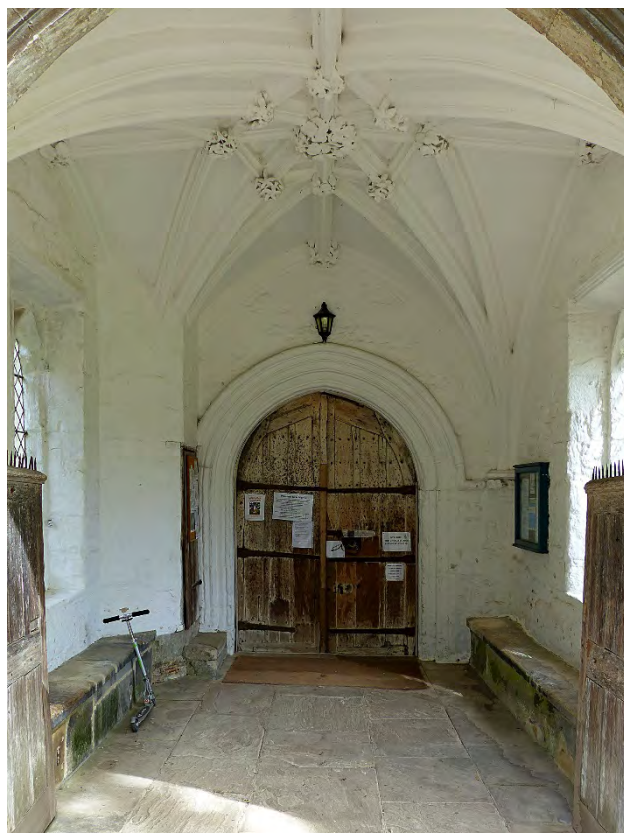
Fig. 45 (right). The interior of the south porch, from the south, showing the sexpartite vault inserted in 1858.

The south porch was extensively restored slightly later during Hodgson's incumbency. One source dates the work to 1858.<sup>68</sup> An account of recent work at the church published ten years later in 1868 noted that the cost (£120) was met by the vicar's father Mr C. Hodgson, 'hoping that this might lead to some more extensive improvements', and that 'about the same time' the nave floor was re-laid with York stone.<sup>69</sup> The work to the porch, for which no architect has yet been identified, involved removing the plaster ceiling over the entry (Fig. 45) and inserting the present vault (Fig. 48). The quadripartite rib-vault incorporates tiercerons, and short liernes define a central octagon. All the intersections, and the ends of the transverse and longitudinal ribs, are marked by carved foliate bosses. The central boss – the largest of the set – has a vine leaf and grapes design. The diagonal ribs and tiercerons spring from foliate capitals except in the north-west corner, where the stair turret intrudes.

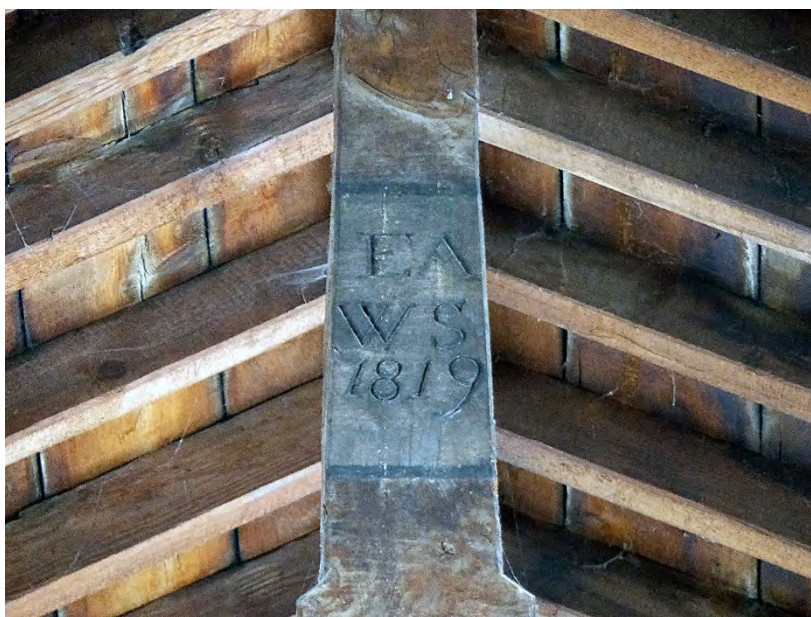
Fig. 46. 1819 inscription, with painted border, on oak king-post in nave roof.

The nave roof dates from 1819, judging by an inscription on a painted ground on the west face of the 5th king-post from the east. The inscription (Fig. 46) reads 'EA | WS | 1819', and the initials are probably those of the churchwardens in that year. The ten trusses include one against the east gable and another against the tower; these end trusses are concealed by boarding, but the king-post bolt is visible in each case. The king-post trusses are constructed principally in softwood but the king-posts, which taper towards the top, have expanded heads and

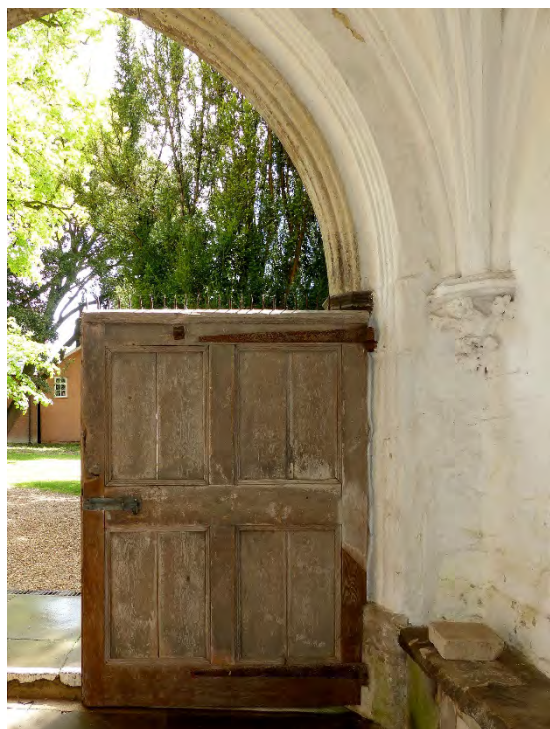
Fig. 47 (left). The panelled inner face of one of the gates to the south porch.

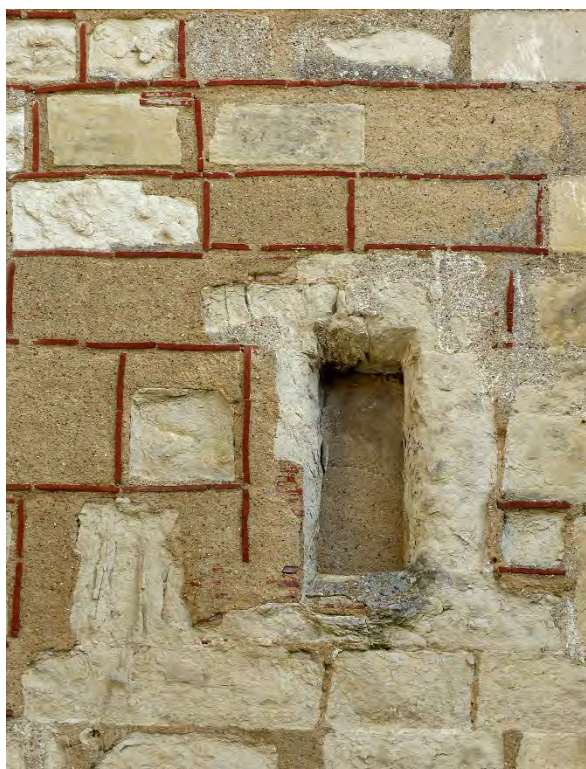
Fig. 49 (left). Tile and render repairs on the west wall of the south porch, an example of Weir's work.

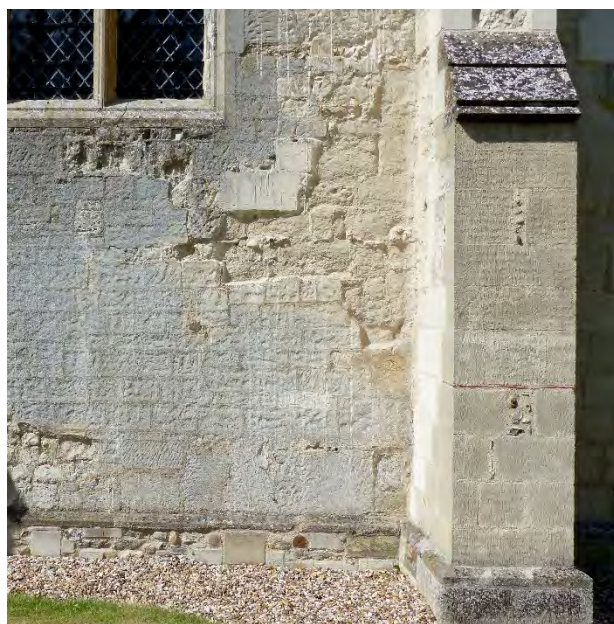
Fig. 50 (above). A mixture of piecemeal and systematic stone replacement, and render repairs with simulated tooling and mortar joints.

He commenced a scheme of replacing defective stonework with new stone in 1939. Contrasts between the approach adopted on behalf of the Commissioners and that demonstrated by Weir over more than a decade led to angry exchanges. On 16 September 1939, shortly after the outbreak of war, Miss B. Howes of the SPAB, temporarily working from Richmond (to evade the threat of air-raids?), forwarded to Weir a letter from Mrs Mary S. Raikes of Ducklake Farm, Ashwell, objecting to the 'ignorant "restoration"' of the chancel by the Commissioners. Mrs Raikes praised Weir's ongoing work on the south aisle, 'most carefully and successfully carried out with a minimum of damage to the character and beauty of the fabric'. She contrasted this with the work for the Ecclesiastical Commissioners, who 'have already patched one window in a manner which can only ruin the Chancel if it is carried out all over. They are making no attempt to match the colour of the local chalk-stone, or to soften the severity of their hard outlines'. One wonders whether Weir had some influence over the complainant. Passmore was clearly constrained by his budget. Under pressure, he was persuaded to abandon stone replacement in favour of plastic repairs by the Bidder Engineering Co. This then appears to be the origin of the rendered repairs, simulating stone, which are found on the chancel masonry (see Fig. 50).

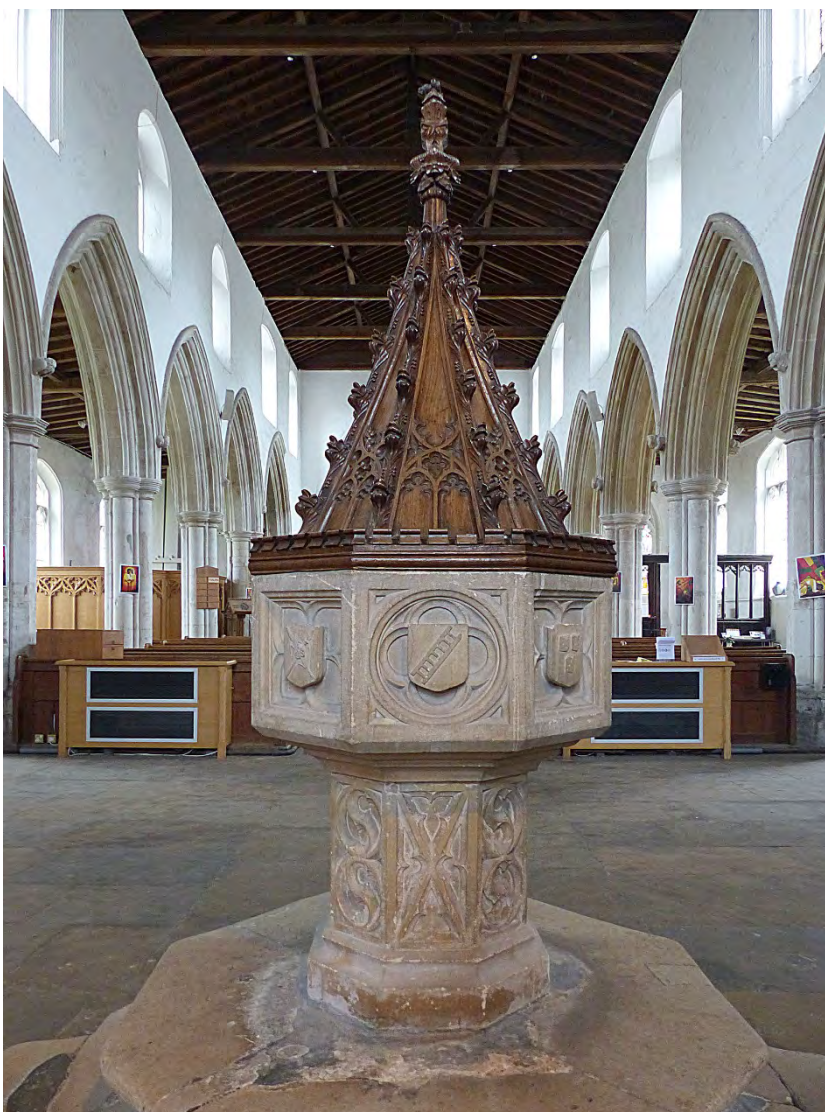
Fig. 51. The Victorian font and font cover, on a medieval octagonal stepped base. The shaft supporting the font is similar to the medieval shaft depicted by Buckler in the 1830s.

The font (Fig. 51) is placed in Bay 1 on the central axis of the tower and chancel arches. A drawing by John Buckler shows it from the east as it was in 1831. Of this, only the stepped plinth survives; the shaft, shaft base and bowl were replaced later in the 19<sup>th</sup> century. The plinth is octagonal, in the form of two steps, and there are projections to the lower step on the north, west and south sides, and a single projection from the west side of the upper step, perhaps to facilitate the priest's role in officiating at baptisms. The present shaft is also octagonal, with alternating saltires and pairs of roundels each containing enfolded mouchettes. Superficially it resembles that depicted by Buckler, but while the saltires are similar, Buckler shows quatrefoils in the roundels visible, and on one face he shows an arched and traceried panel, which the present shaft does not have. The present moulded base does not match the simpler base shown by Buckler, which instead reproduces stops of the form found at the base of blind-panelled bay (Bay 1) of the nave. He also shows a very simple octagonal bowl, whereas the present one has a moulded base and sunk square panels in each face, carved with the symbols of the Passion. An elaborate Gothic Revival timber font cover is doubtless contemporary with the present bowl.

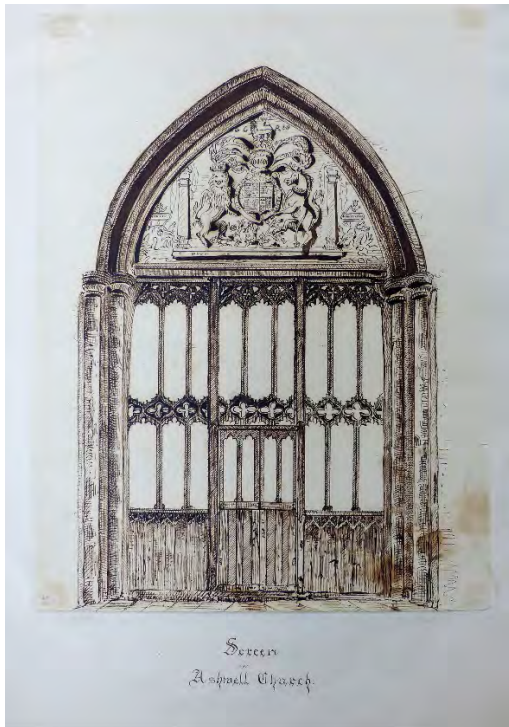
Fig. 52 (left). Charlotte Morice drawing of the rood screen and Royal Arms before their removal. (Hertfordshire Archives & Local Studies)

An 1839 directory refers to 'some fine carvings in oak, particularly a beautiful screen that separates the nave from the chancel'.<sup>87</sup> This is depicted in detail in one of Charlotte Morice's views (Fig. 52). The screen had a blind-arcaded plank base, on which were reared two tiers of cinquefoil-cusped open-work, with the cusping repeated at the base of the upper lights as well as at the head of both tiers, and creating a band of quatrefoils where the two tiers met. A central doorway opened on to the chancel and was topped by an arcade of small trefoil-cusped lights. Another view by Buckler (probably John Buckler), dated 1840, corroborates these details, albeit from a restricted viewpoint. The screen is likely to have supported the rood or cross conventionally placed here on the rood-beam, a practice which was outlawed after the Reformation. The screen survived, only for most of it to disappear at some time after 1840, perhaps in the poorly documented works of the early 1850s.

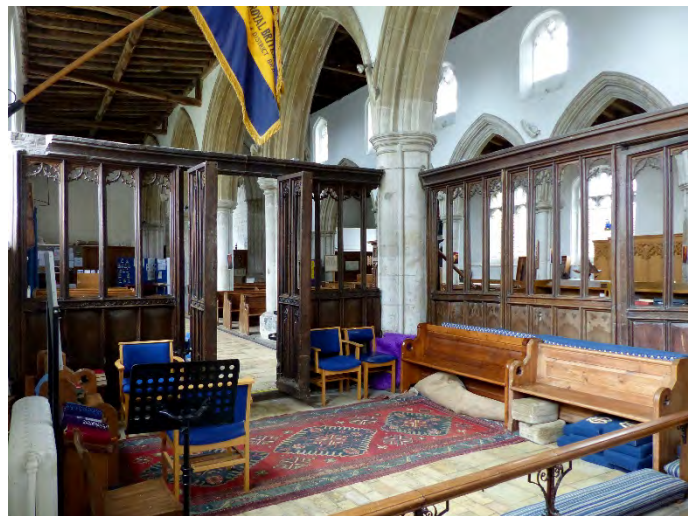
Fig. 53 (above). The parclose screen enclosing the Lady Chapel in the east end of the south aisle.

A parclose screen encloses Bay 6 of the south aisle, forming the north and west sides of the Lady Chapel, with a doorway in the middle of the west side (Fig. 53). It appears to be 15<sup>th</sup>-century work, but there is considerable evidence that it has been dismantled and re-erected in a different configuration.<sup>88</sup> The RCHME account of the building noted screens at the western end of both aisles, from which they appear to have been re-set at some time since 1910.<sup>89</sup> Charlotte Morice's interior view shows the screen somewhat indistinctly in what appears to be its present position *circa* 1840, and this is confirmed by Buckler's clearer depiction of parts of it, including the door. This demonstrates another of the changes to have occurred since 1840: Buckler shows a door which is three panels wide, and appears to be at the north end of the west side, whereas there are presently double-leaf doors, each two panels wide, positioned in the middle of the west side.

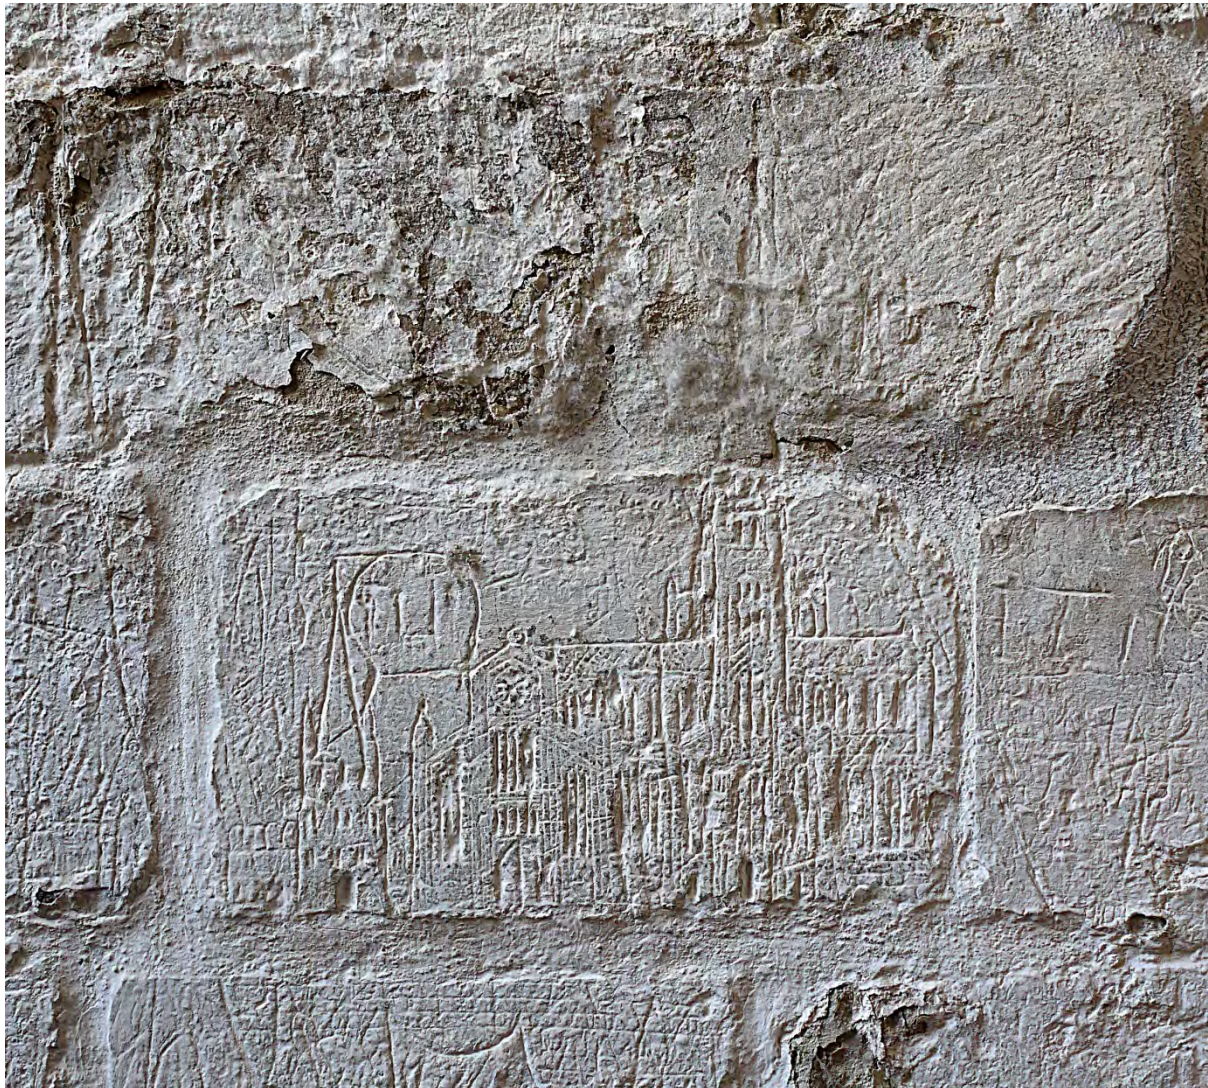
Fig. 55. The drawing on the north wall of the tower interpreted as representing Old St Paul's Cathedral, which was badly damaged in the Great Fire of London, 1666, and was subsequently demolished. The spire is visibly indistinct as a result of damp penetrating the stone.

During the tower repairs Weir attempted to safeguard the incised drawing of Old St Paul's (see Fig. 55, below). In a letter dated 22 October 1945, Weir related that in 1929 he 'had the stone taken out of the wall, put into a lead case and refixed in its position in the wall. The damp has dried out and the surface of the clunch has shown no deterioration, or sealing, during the interval'.<sup>81</sup>

The other particularly celebrated graffito (Fig. 55) is interpreted as depicting Old St Paul's Cathedral, which was severely damaged by fire in the Great Fire of London in 1666, and was subsequently demolished and rebuilt. Sherlock compares it with van den Wyngaerde's mid-16<sup>th</sup>-century view of London, and with a 1616 view by John Gipkyn, with both of which it has considerable similarity. He interprets it as viewed from the north, showing the east end of the

choir rotated through 90 degrees to express its form more clearly,<sup>101</sup> and faintly indicating the north transept in elevation against that of the tower. If Sherlock is correct, it shows the cathedral prior to the loss of the spire by lightning in 1561.<sup>102</sup> He notes that 'This is by far the most important of the drawings in Ashwell Church, not only because its subject is one of great importance but also because medieval drawings of buildings in such detail are rare even in manuscripts'.<sup>103</sup>

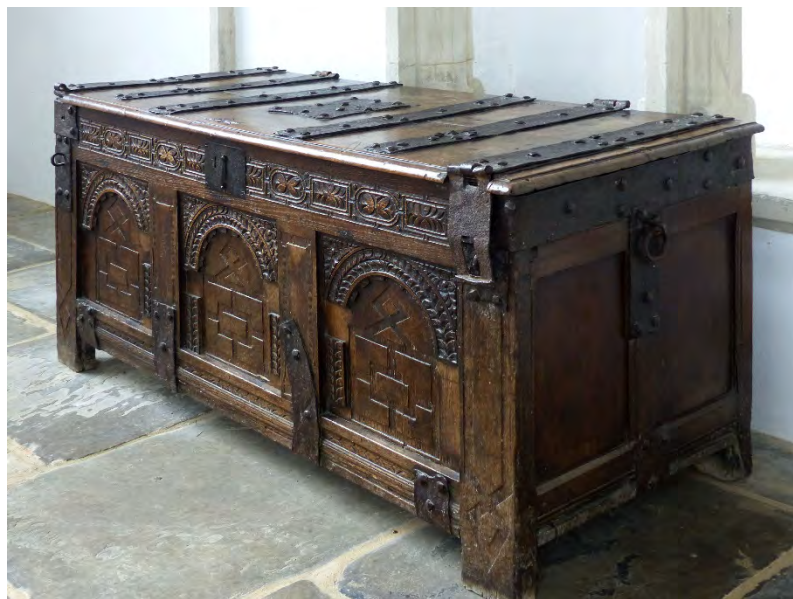
Fig. 56. The church chest in the chancel.

Placed on the floor of the chancel, against the south wall, is a fine early 17<sup>th</sup>-century oak chest, raised on short legs, and bound with wrought-iron straps secured with large nails (Fig. 56). The lid is attached by means of hasps at each end of the front, and there is a lock (with later lock-plate and escutcheon) to the centre. The front face of the chest is divided into three bays of blind arcading in the Jacobean manner. The pilasters, arches and spandrels are embellished with foliate carving, and there is a shallow-relief pattern reminiscent of rustication within each arcade bay. The stiles have shallow-relief channels terminating, on the longer corner stiles or legs, in an arrowhead motif at the base. The bottom rail is moulded with more foliate carving, while the deeper top rail has a jewelled frieze with further enrichment to the jewels. Chests were used to store vestments, documents and other valuables, 'the parish chest' eventually becoming a byword for the records of parish communities.<sup>104</sup>

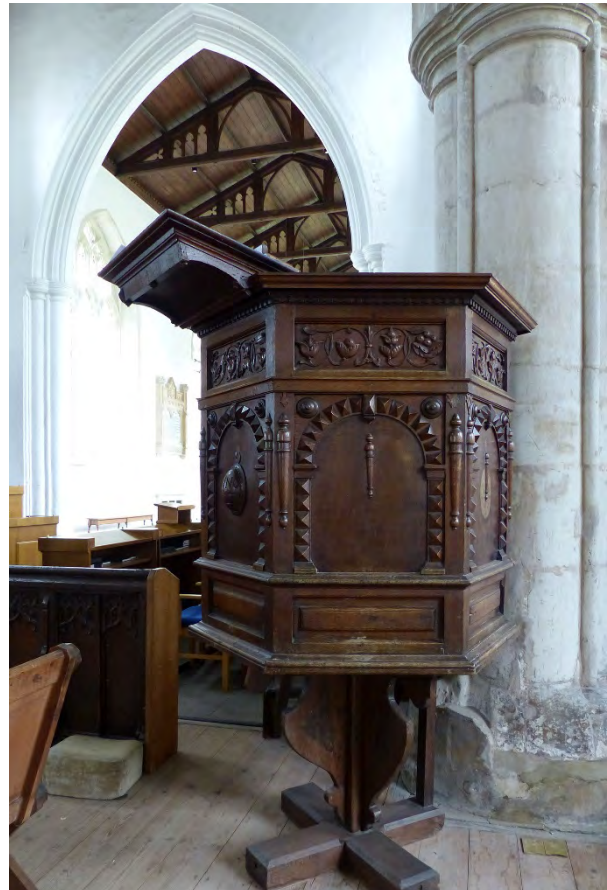
Fig. 57. The pulpit, dated 1627.

The hexagonal pulpit (Fig. 57) rests on a cruciform stand on the south side of the nave, next to the column dividing Bays 5 and 6, facing west. A ladder stair, of which the handrail and probably the carriages have been renewed, rises to the open east side of the pulpit. In the early 19<sup>th</sup> century it stood on the opposite side of the nave in Bay 6, and retained a sounding board. It is constructed principally of oak and bears the date 'ANNO | 1627'.<sup>105</sup> The decorative emphasis is provided by an arched panel on each face. Each has diamond-pointed rustication to the jambs and arch, and a patera in each spandrel; on the stiles framing each panel there are carved drops in the form of half-balusters with finials. A similar motif is applied to the centre of each arch. Beneath the arch there is a raised panel in each face. Above the arches there is a frieze treated with a scrolling pattern of flowers, fruit and foliage, topped by a cornice. On the same face in which the date appears, the lectern projects above the frieze.

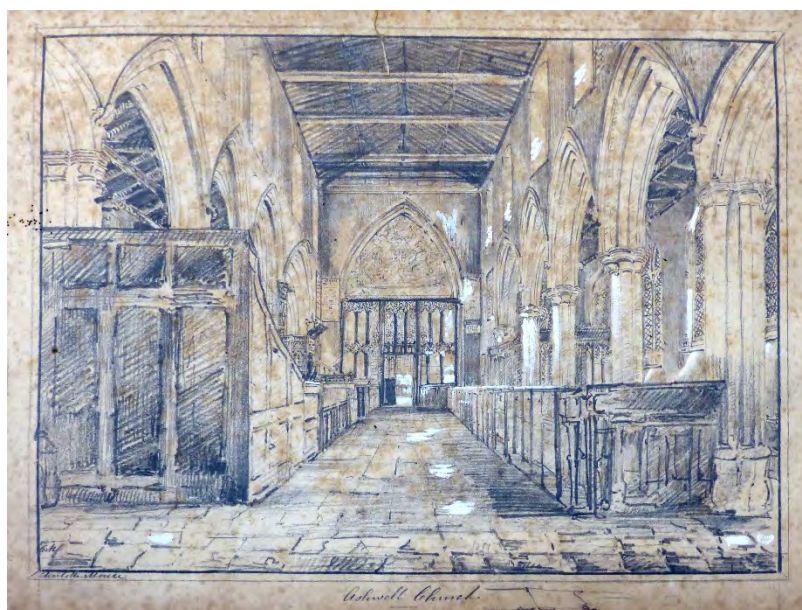
Fig. 59. Charlotte Morice's sketch showing the former boxpews in the nave, with the medieval rood screen and post-Reformation Royal Arms in the chancel arch. (Hertfordshire Archives and Local Studies)

Charlotte Morice (Fig. 59) and John Buckler show what appear to be late 17th-century box pews, with what appear in Buckler's drawing to be raised (bolection?) mouldings and some 'Gothic Survival' features, surviving as late as 1840. They were replaced in 1868 by freestanding softwood bench pews. Since the present pews do not relate to the mortices in the sills set in the nave floor, it is likely that these are relics of the former box pews.

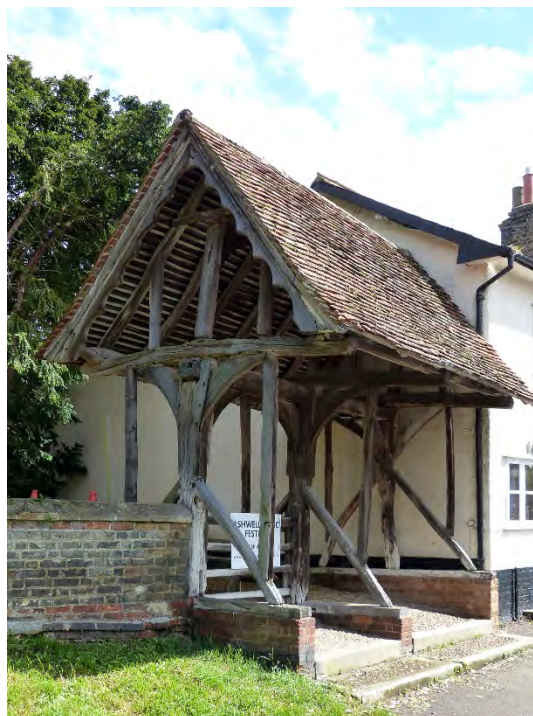
Fig. 61. Lychgate from the north-west.

The timber-framed lychgate, constructed of oak timbers, forms the entrance to the churchyard from the southern end of Mill St, and opens on to a path leading to the south porch (Fig. 61). Its form, including a simple crown-post roof, suggest a 15<sup>th</sup>-century date. The term was popularised in the 19<sup>th</sup> century and means 'corpse gate', since funeral processions would pause at the entrance to the churchyard to be met by the priest. A covered gate enabled the coffin or shrouded corpse to be laid down under cover. Aymer Vallance set out a simple typology of lychgate forms in 1920, pointing out that the great majority were either of the 'porch' type, with gables in line with the direction of passage, or the 'shed' type, in which the gables were at right angles to the approach. Ashwell's is of the 'shed' type.<sup>116</sup>

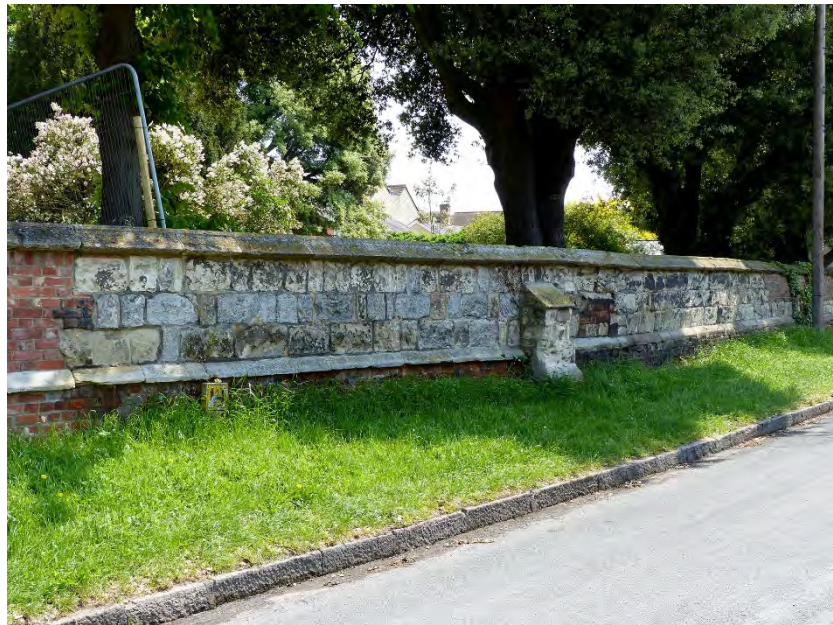
Fig. 65. The earliest surviving section of churchyard wall, of late-medieval date on a rebuilt plinth.

The wall has been considerably rebuilt, including two long stretches in the recent past, but it retains some medieval, 18<sup>th</sup>- and 19<sup>th</sup>-century fabric. There is a chamfered clunch top course to the plinth and a moulded limestone coping throughout. The plinth is otherwise wholly in brick. Above the plinth the earliest fabric is clearly the squared and coursed clunch of the middle section, just south of the tower, which incorporates a single short, shouldered buttress on the outer face (Fig. 65). This buttress appears in a number of drawings of the 1830s and 1840s. To the north and south of this stretch there is a more limited survival of clunch, forming between one and three irregular course immediately overlying the plinth. At the extreme south end of the wall, and for a long stretch at the north end, where the wall has a curved corner

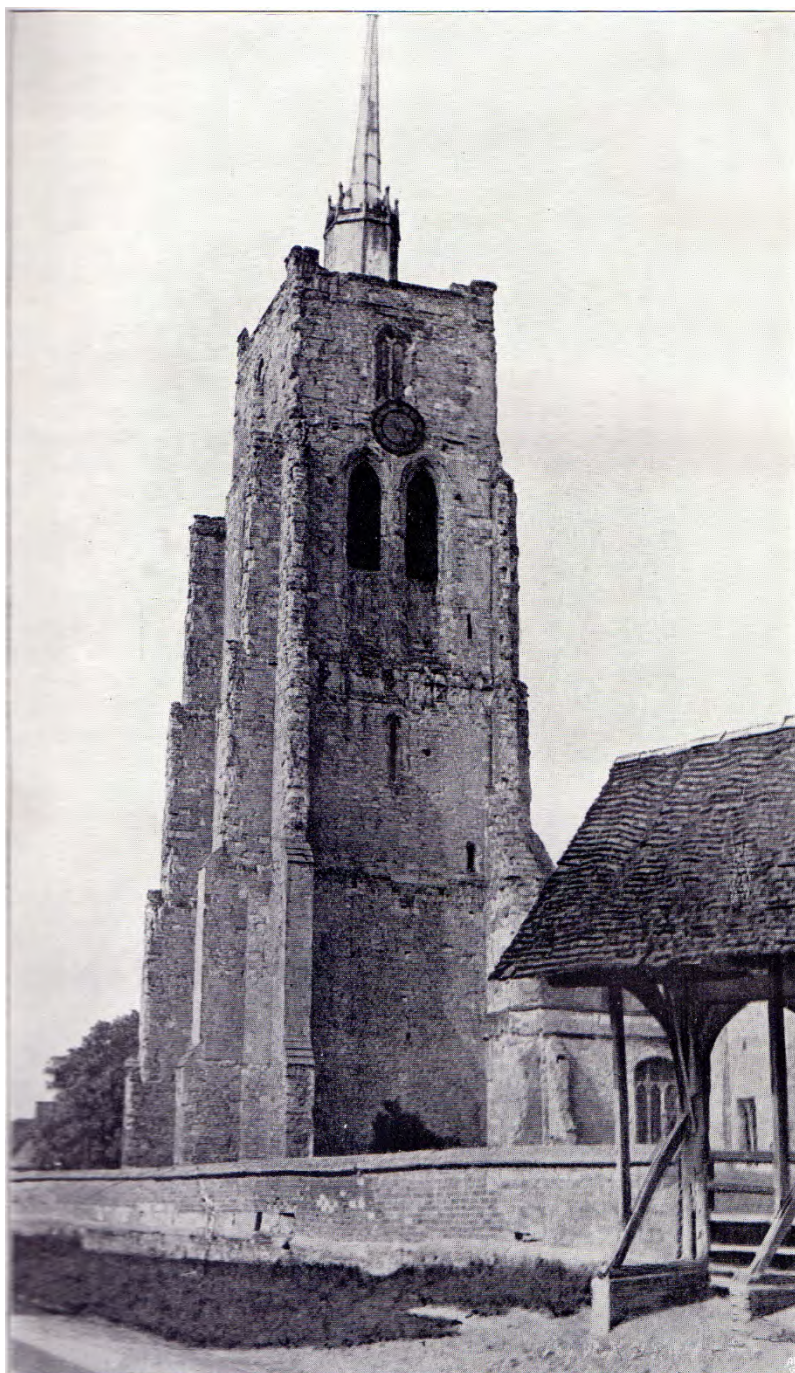
Fig. 73. Photograph published in RCHME (1911).

(2). **Parish Church of St. Mary**, stands under the hill at the edge of the great plain stretching N. and E. to Cambridge and the Fens, and is of flint rubble and clunch. The first four bays of the *Nave*, with clerestorey, and the chancel arch were constructed c. 1340–50; the *Chancel*, *West Tower* and *Aisles* were built, the last bay of the nave was inserted to connect it with the tower, and the clerestorey was completed c. 1360–80. A *North Vestry*, since destroyed, was also built in the 14th century. The *South Porch*, with parvise, was added c. 1420; and in the same century a *North Porch* was built, and some of the windows of the aisle were heightened. During the 19th century the chancel was repaired, and the roofs of the chancel and nave renewed. The lofty W. tower of four stages, the untouched though rather dilapidated condition of the whole fabric, the Latin verses commemorating the Black Death, and the drawing of what is supposed to be old St. Paul's, scratched on the wall of the tower, are features of peculiar interest.
