**Milksey Lane, Graveley - Phase 2**  
Flood Risk Assessment  
December 2024

Report Ref: 29161-FLD-0101

CLIENT: Gade Homes Ltd

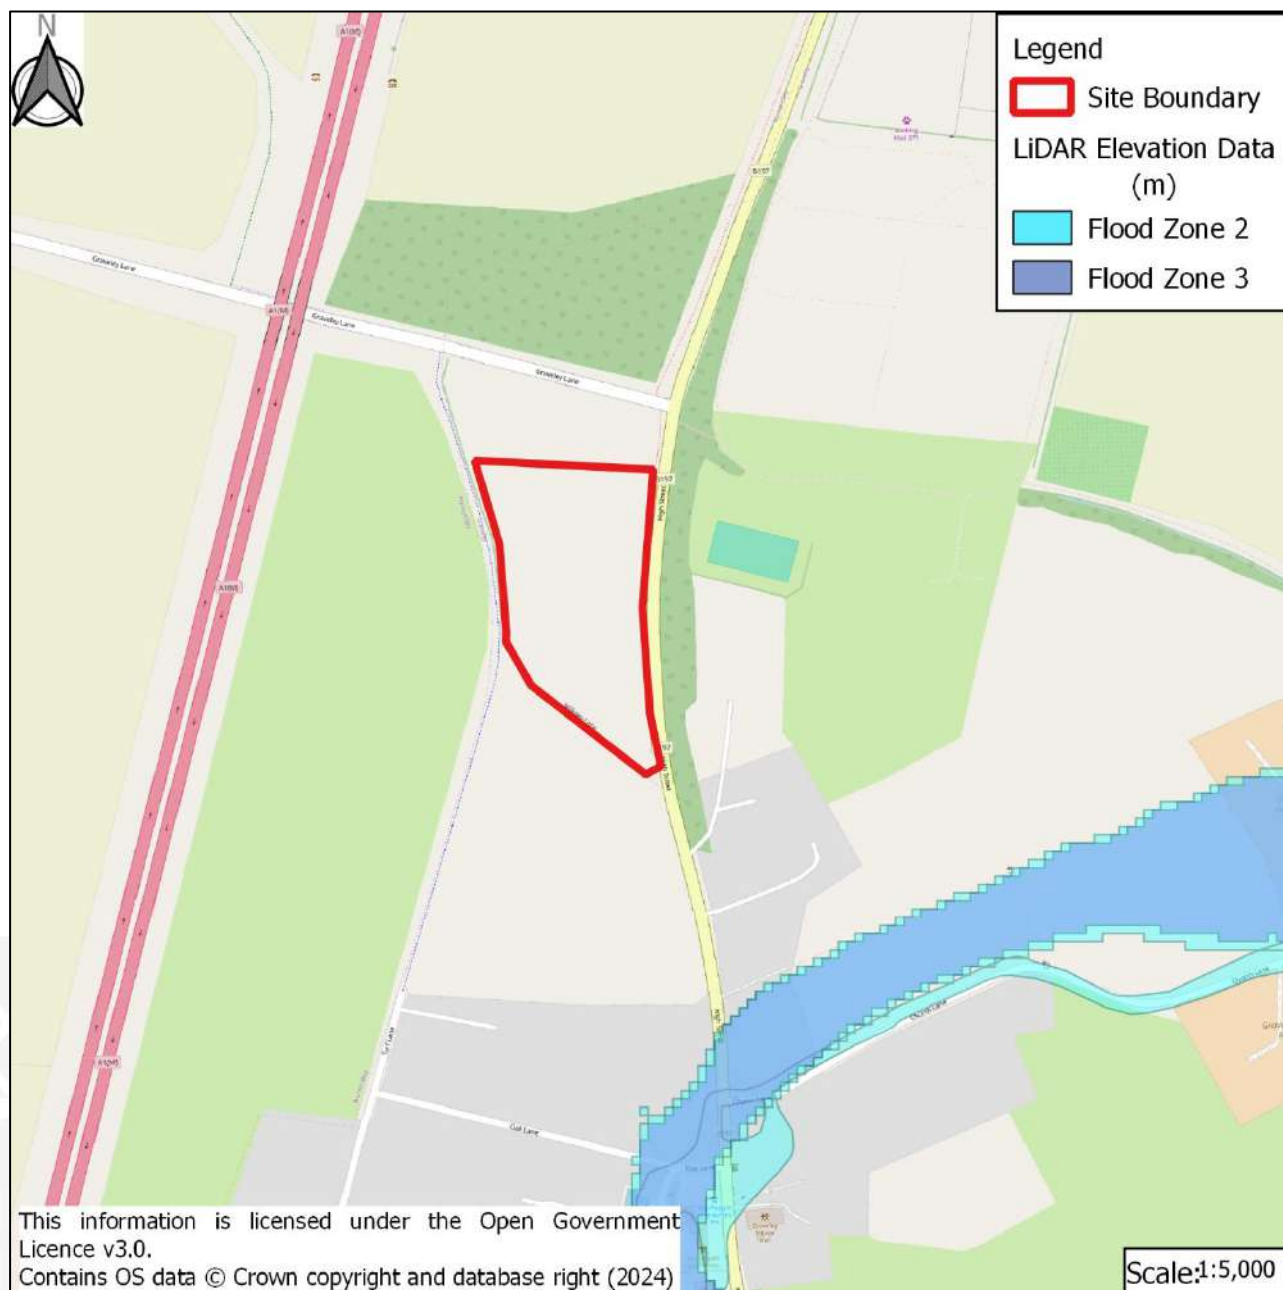
**Figure 4.1: Environment Agency's Flood Map for Planning (Rivers and Seas)**

- 4.1 The Flood Map for Planning is shown in Figure 4.1. The map shows the site lies within Flood Zone 1. Flood Zone 1 (FZ1) is defined as land assessed as having an annual probability of river flooding less than 0.1%.

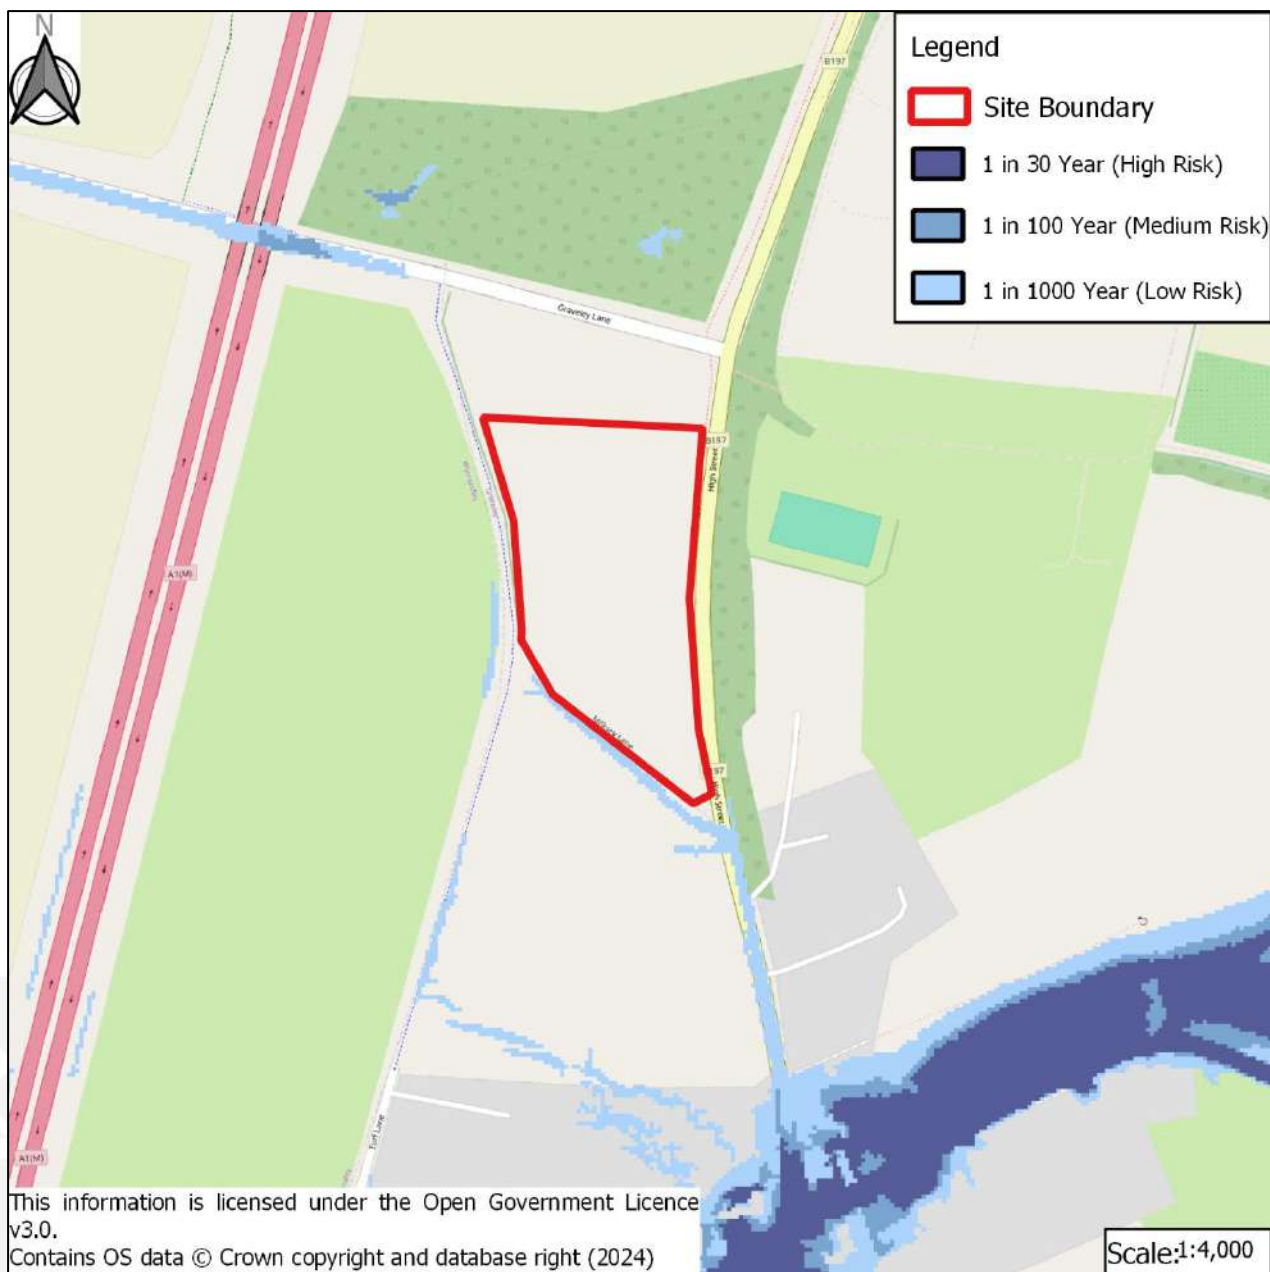
**Figure 4.2: Environment Agency's Flood Risk from Surface Water Map**

- 4.2 The Environment Agency Flood Risk from Surface Water Map (Figure 4.2) indicates that the site is at low risk of surface water flooding. A small flow route along the site's southern boundary, along Milksey Lane, flows south during the 1 in 1000-year storm event (low risk).

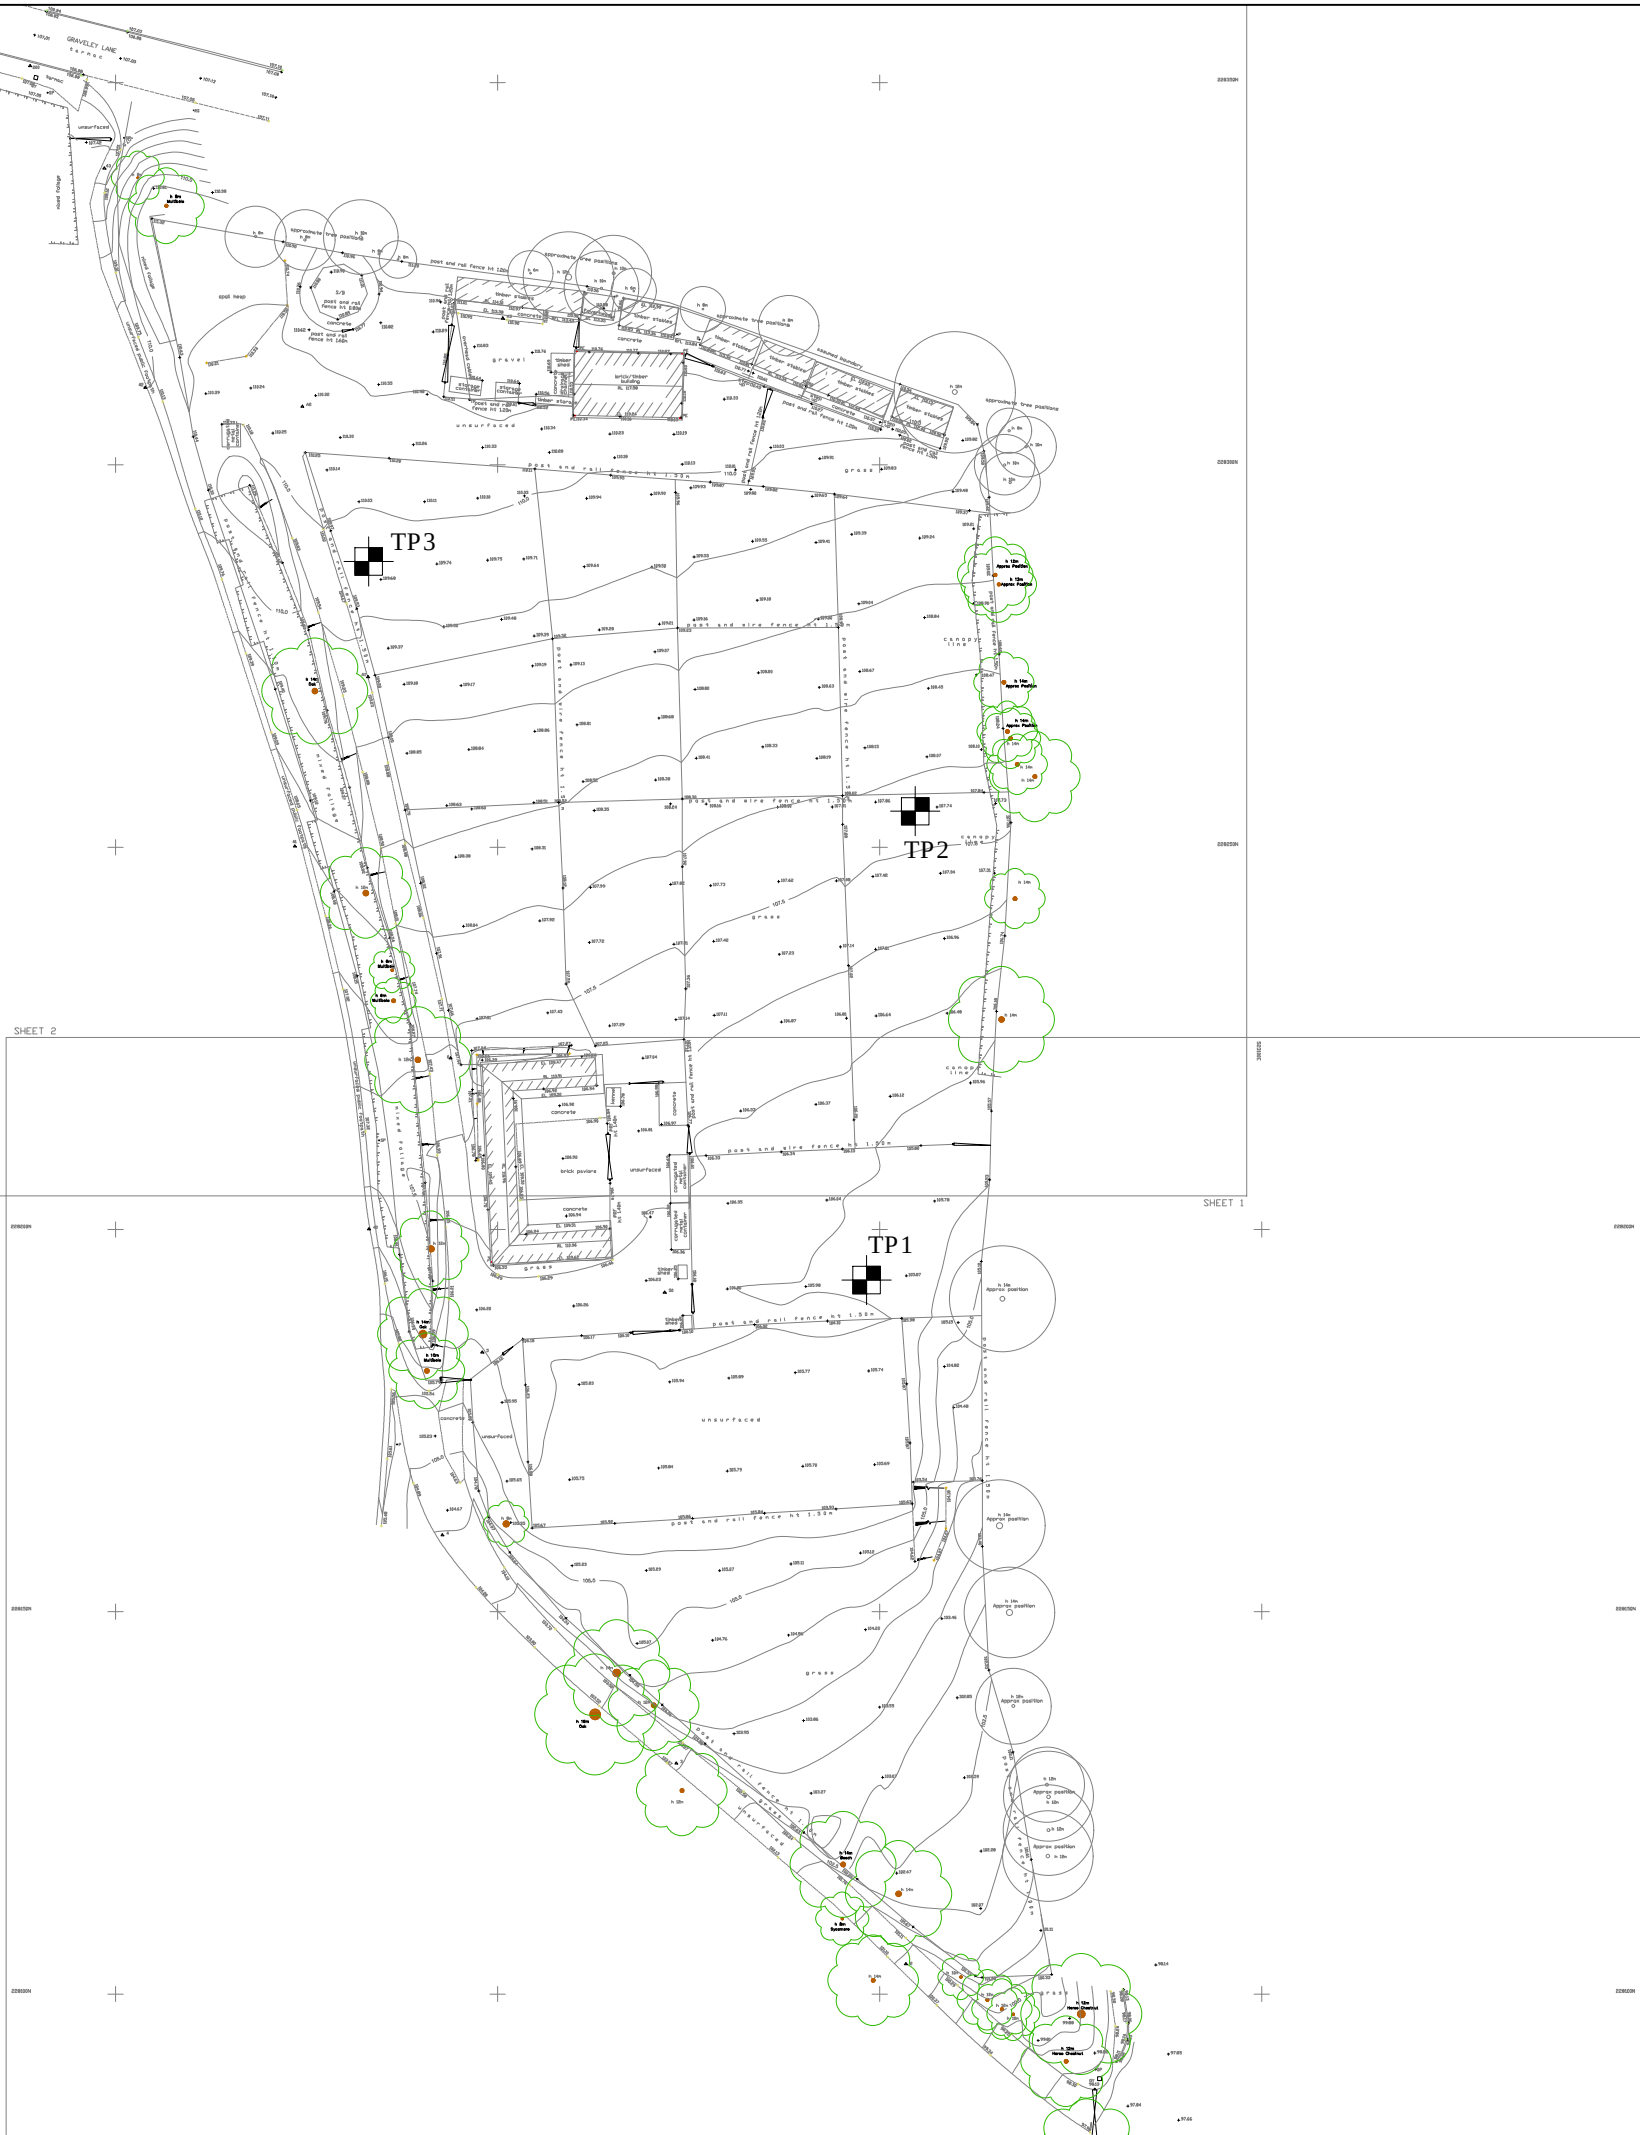
KEY:

■: SOAKAGE TEST LOCATIONS  
(TP1, TP2 & TP3)

Infiltration testing was undertaken in each of the 3no. trial pits (TP1 – TP3) in accordance with current guidance as detailed in BRE Digest 365, 'Soakaway Design' (2016).

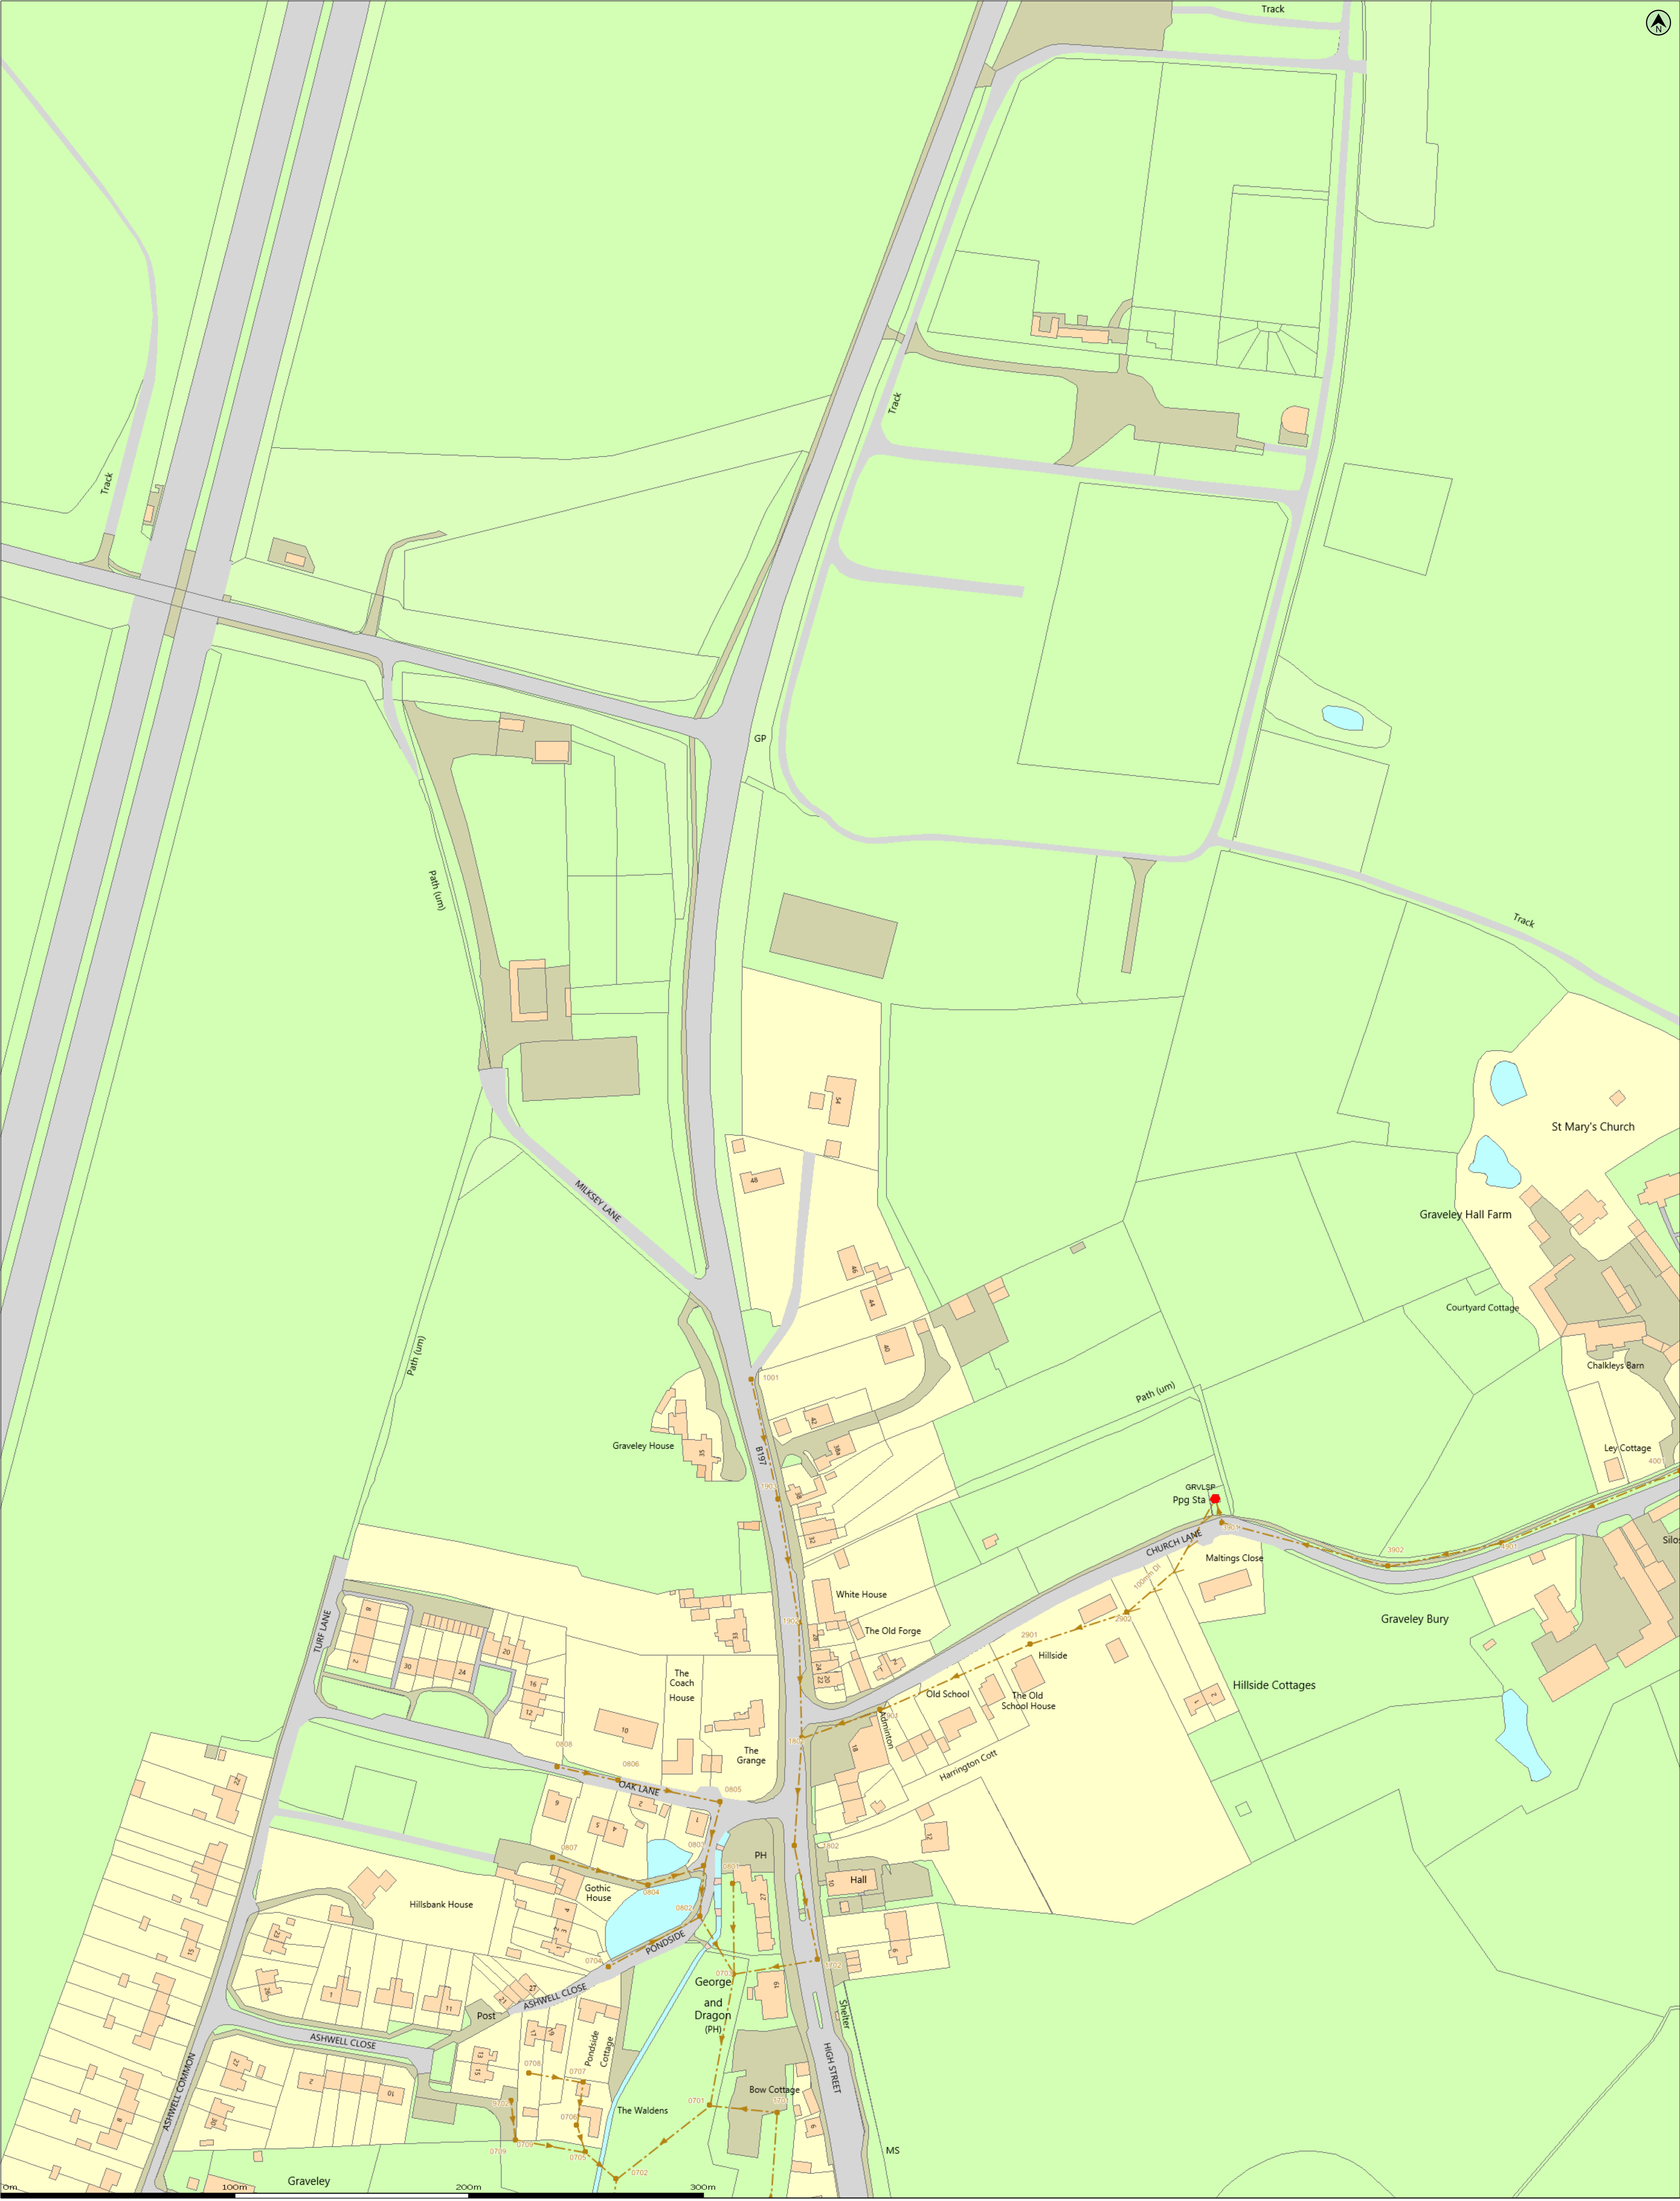
© Crown copyright and database rights 2018 Ordnance Survey 100019209  
Data updated: 04/03/18  
Scale: 1:1250  
Map Centre: 523140.228162  
Date: 27/02/18  
Our Ref: 254887 - 1  
Wastewater Plan A1  
Powered by digimap

- 3.11 Sewer records have been obtained from Anglian Water, see **Appendix E**. The records show there are no surface water sewers within the vicinity of the site. There is a foul water sewer within Milksey Lane, which flows south towards the George and Dragon public house.
- 3.12 The topographical survey shows there are two gullies on Milksey Lane, close to its junction with High Street. These gullies are assumed to outfall to the existing surface water sewers in High Street. The development is assumed to outfall into these gullies when rainfall conditions result in overland flows down Milksey Lane.

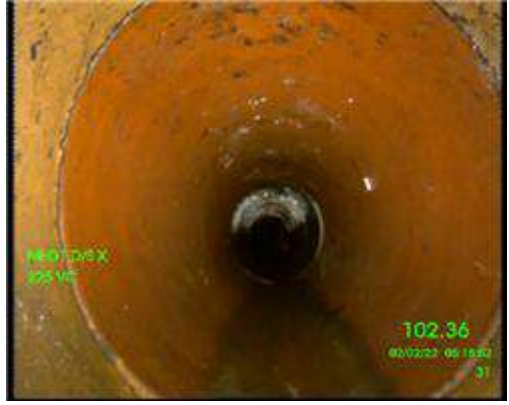
| Pos | Video Ref | Code | Cont. | Description | Image |
|---|---|---|---|---|---|
| 00.0m | 0:00:00 | WL | | Water level: 0%<br>Height/Diameter | Image Provided - Ref: 0_1<br> |

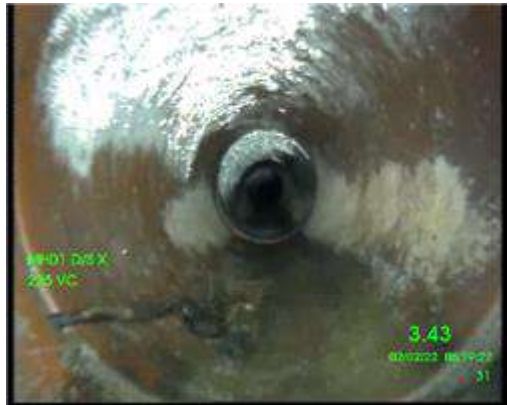
| Pos | Video Ref | Code | Cont. | Description | Image |
|---|---|---|---|---|---|
| 03.4m | 0:00:30 | RT | | Roots tap at joint - Severity 3 | Image Provided - Ref: 0_2<br> |

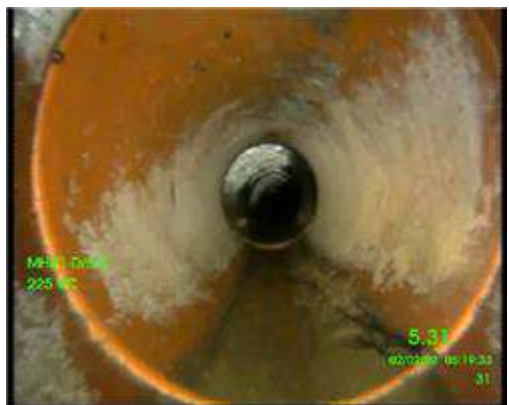
| Pos | Video Ref | Code | Cont. | Description | Image |
|---|---|---|---|---|---|
| 05.3m | 0:00:41 | RF | | Roots fine at joint - Severity 1 | Image Provided - Ref: 0_3<br> |

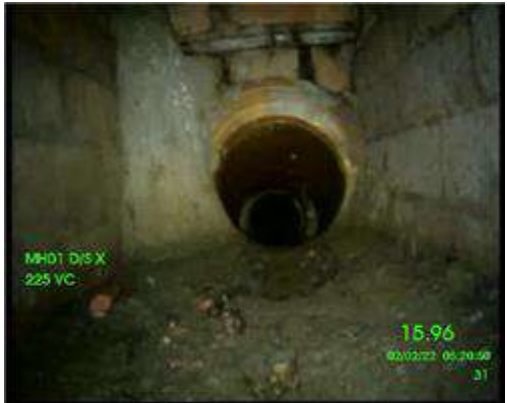
| Pos | Video Ref | Code | Cont. | Description | Image |
|---|---|---|---|---|---|
| 15.9m | 0:01:57 | WL | | Water level: 0%<br>Height/Diameter | <p>Image Provided - Ref: 0_10</p> |

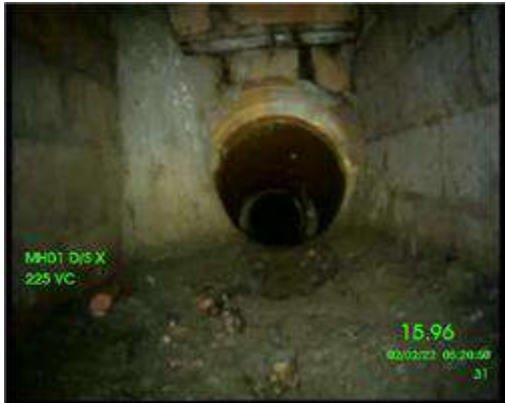
| Pos | Video Ref | Code | Cont. | Description | Image |
|---|---|---|---|---|---|
| 15.9m | | MHF | | Finish node type, manhole,<br>reference MH02<br>MH02 | <p>Image Provided - Ref: 0_9999</p> |

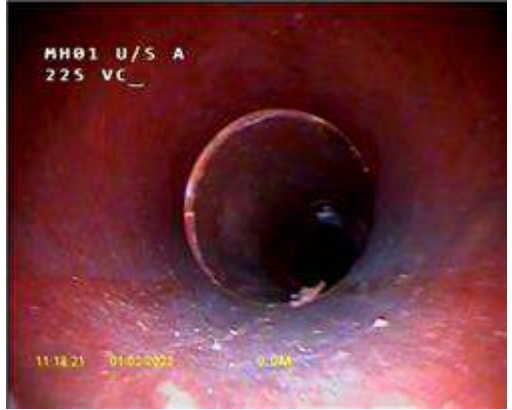
| Pos | Video Ref | Code | Cont. | Description | Image |
|---|---|---|---|---|---|
| 00.0m | 0:00:00 | WL | | Water level: 0% Height/Diameter | Image Provided - Ref: 2_1<br> |

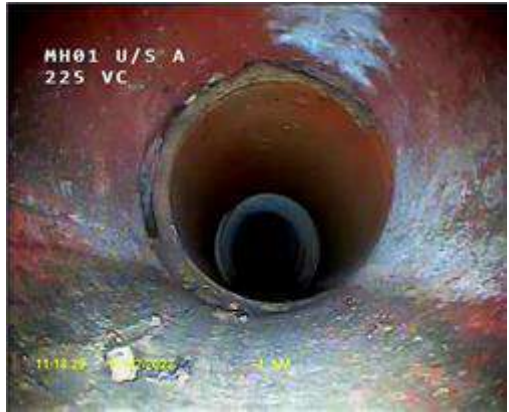
| Pos | Video Ref | Code | Cont. | Description | Image |
|---|---|---|---|---|---|
| 01.5m | 0:00:07 | JDM | | Joint displaced medium - Severity 2 | <p>Image Provided - Ref: 2_4</p> |

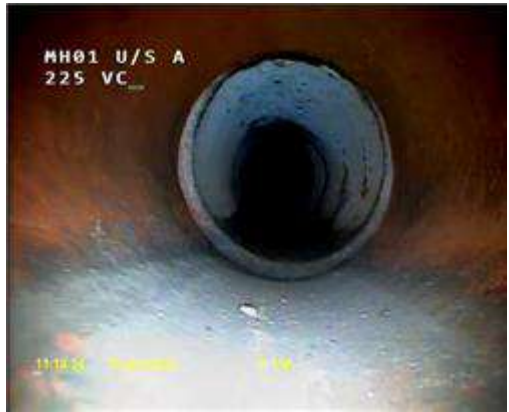
| Pos | Video Ref | Code | Cont. | Description | Image |
|---|---|---|---|---|---|
| 02.1m | 0:00:11 | JDM | | Joint displaced medium - Severity 2 | <p>Image Provided - Ref: 2_5</p> |

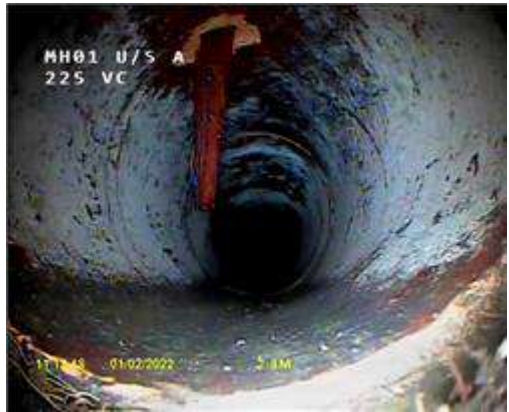
| Pos | Video Ref | Code | Cont. | Description | Image |
|---|---|---|---|---|---|
| 02.8m | 0:00:26 | OBI | | Other obstacle, protruding through wall from 11 o'clock to 12 o'clock: 60% cross-sectional area loss - Severity 4 | <p>Image Provided - Ref: 2_6</p> |

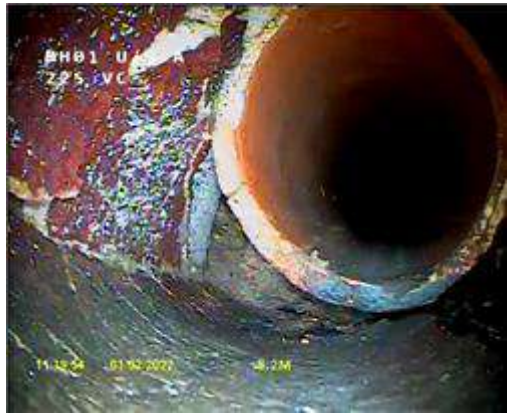
| Pos | Video Ref | Code | Cont. | Description | Image |
|---|---|---|---|---|---|
| 09.2m | 0:01:32 | SC | | Shape and/or size drain/sewer changes: Shape Changes To: 150mm Diameter | <p>Image Provided - Ref: 2_11</p> |

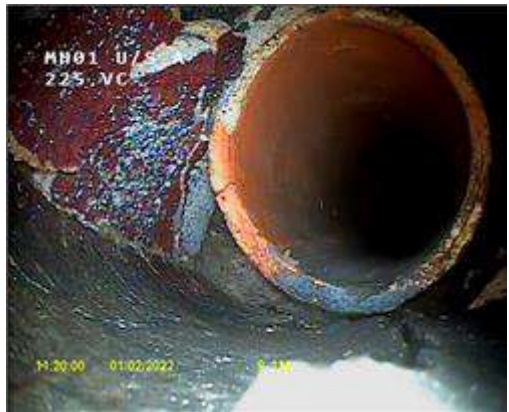
| Pos | Video Ref | Code | Cont. | Description | Image |
|---|---|---|---|---|---|
| 09.2m | | SA | | Survey abandoned<br>EOT | <p>Image Provided - Ref: 2_9999</p> |

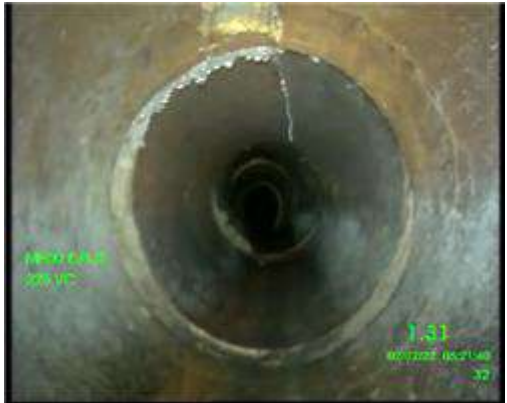
| Pos | Video Ref | Code | Cont. | Description | Image |
|---|---|---|---|---|---|
| 01.3m | 0:00:24 | CC | | Crack, circumferential from 10 o'clock to 01 o'clock - Severity 2 | Image Provided - Ref: 1_4<br> |

| Position | Code | Description | CD | Pic | Video Ref | |
|---|---|---|---|---|---|--|
| 01.3 | CC | Crack, circumferential 10-01 | | 1_4 | 0:00:24 | |

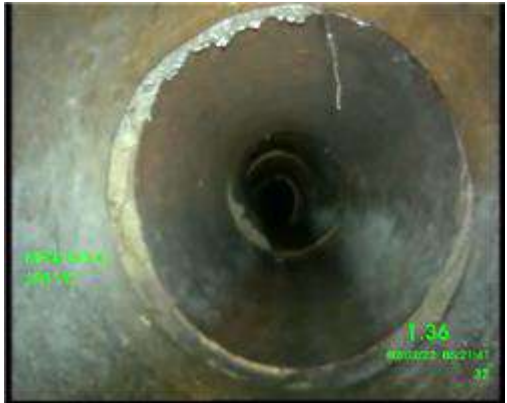
| Pos | Video Ref | Code | Cont. | Description | Image |
|---|---|---|---|---|---|
| 01.3m | 0:00:24 | OJM | | Open joint medium - Severity 2 | Image Provided - Ref: 1_5<br> |

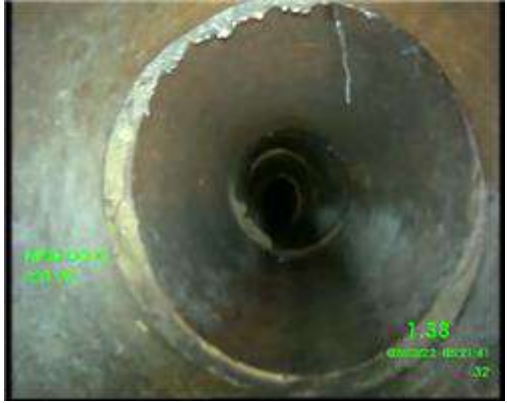
| Pos | Video Ref | Code | Cont. | Description | Image |
|---|---|---|---|---|---|
| 01.3m | 0:00:26 | DEE | | Attached deposits, encrustation from 10 o'clock to 01 o'clock: 5% cross-sectional area loss at joint - Severity 3 | Image Provided - Ref: 1_6<br> |

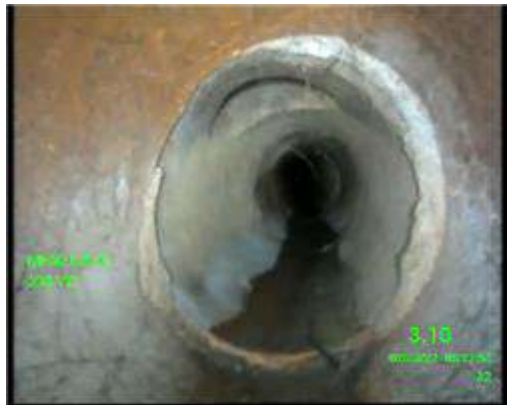
| Pos | Video Ref | Code | Cont. | Description | Image |
|---|---|---|---|---|---|
| 03.1m | 0:00:41 | JN | | Junction at 11 o'clock: 150mm Diameter | Image Provided - Ref: 1_10<br> |

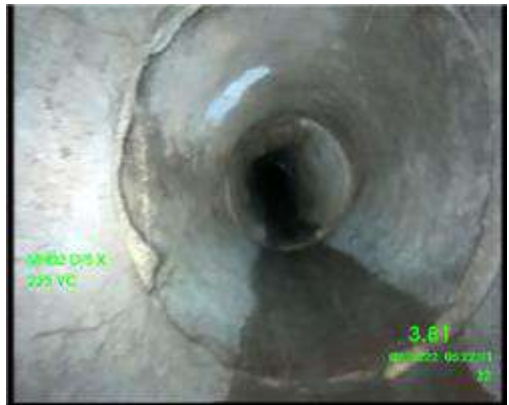
| Pos | Video Ref | Code | Cont. | Description | Image |
|---|---|---|---|---|---|
| 03.8m | 0:00:46 | DEE | | Attached deposits, encrustation from 07 o'clock to 10 o'clock: 5% cross-sectional area loss at joint - Severity 3 | Image Provided - Ref: 1_11<br> |

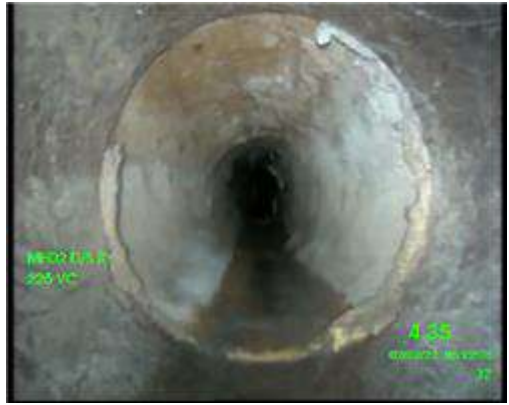
| Pos | Video Ref | Code | Cont. | Description | Image |
|---|---|---|---|---|---|
| 04.3m | 0:00:51 | DEE | | Attached deposits, encrustation from 01 o'clock to 09 o'clock: 5% cross-sectional area loss at joint - Severity 3 | Image Provided - Ref: 1_12<br> |

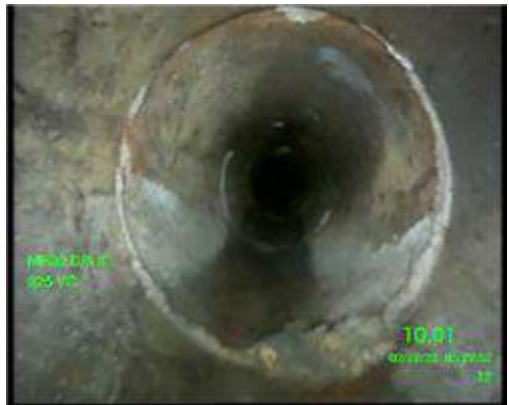
| Pos | Video Ref | Code | Cont. | Description | Image |
|---|---|---|---|---|---|
| 10.0m | 0:01:37 | DES | | Settled deposits fine: 5% cross-sectional area loss - Severity 2 | <p>Image Provided - Ref: 1_25</p> |

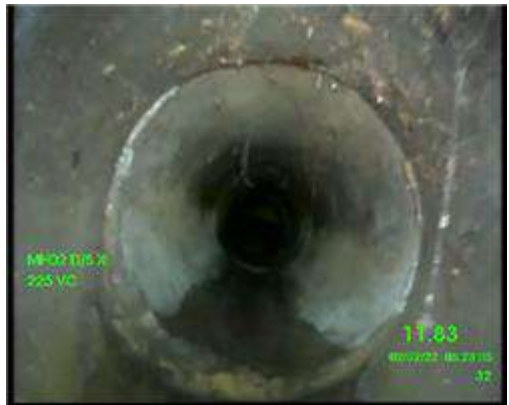
| Pos | Video Ref | Code | Cont. | Description | Image |
|---|---|---|---|---|---|
| 11.8m | 0:01:50 | DEE | | Attached deposits, encrustation from 06 o'clock to 09 o'clock: 10% cross-sectional area loss - Severity 3 | <p>Image Provided - Ref: 1_26</p> |

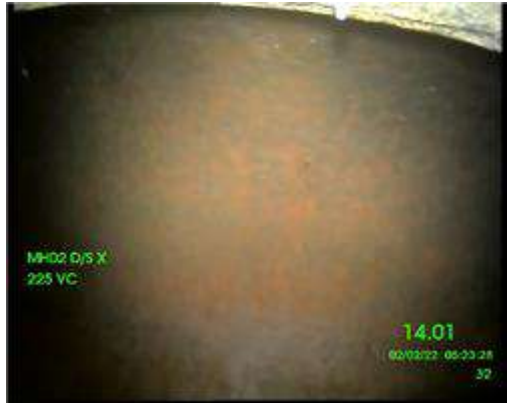
| Pos | Video Ref | Code | Cont. | Description | Image |
|---|---|---|---|---|---|
| 14.0m | 0:02:13 | WL | | Water level: 0% Height/Diameter | <p>Image Provided - Ref: 1_27</p> |

| Position | Code | Description | CD | Pic | Video Ref |
|---|---|---|---|---|---|
| 14.0 | WL | Water level 0% | | 1_2 | 0:02:13 |

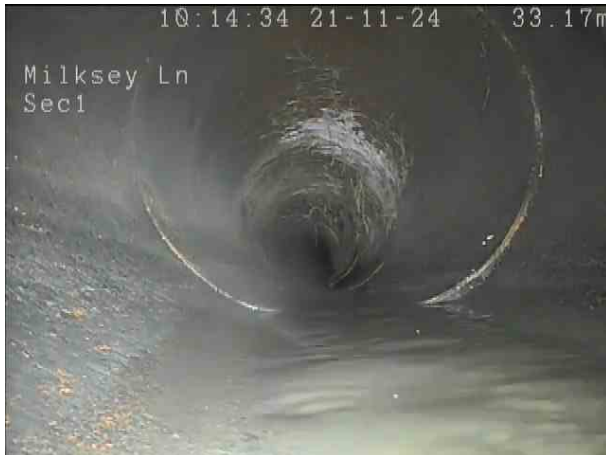
93e7a674-413d-43cd-a0ed-10f057f7ce26.png, 00:02:48,  
 33.50 m  
 Roots, fine at joint, finish

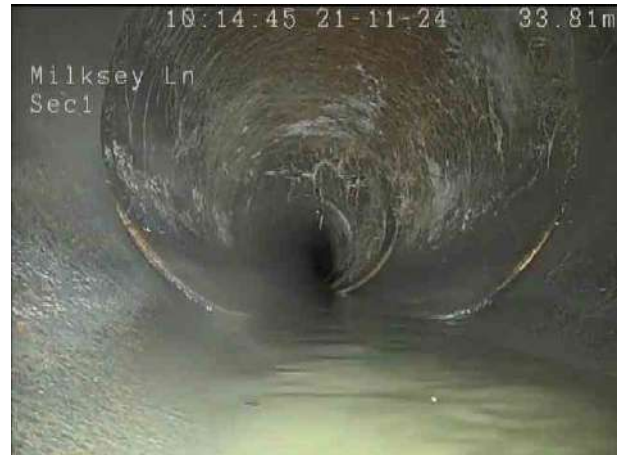
d3dc2325-8fee-4084-b3ff-8aad911865d1.png, 00:03:00, 34.00  
 m  
 Roots, fine at joint, start

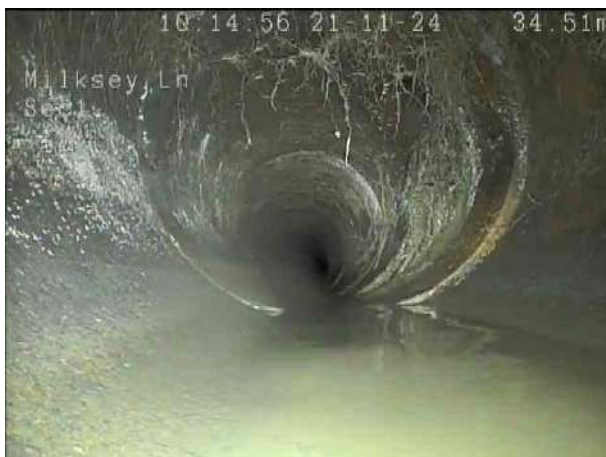
f539d5c1-cff1-4d3c-b9ef-aa45644b736d.png, 00:03:10, 35.00  
 m  
 Junction at 2 o'clock, 250mm dia

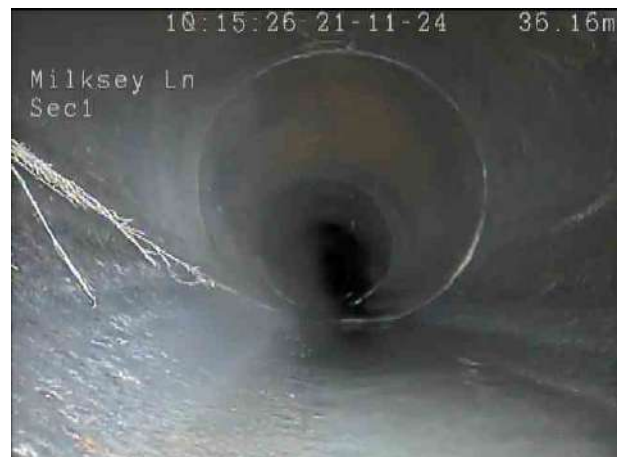
eb8eaf-11ce-49ac-99d1-1b747c865bb6.png, 00:03:41,  
 36.60 m  
 Roots, fine at joint, finish

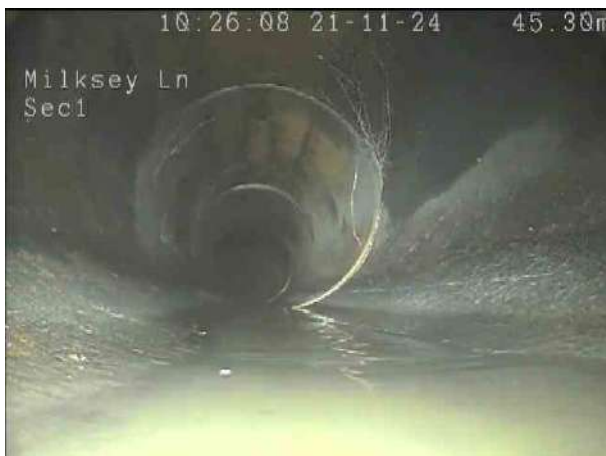
c820a393-d13f-4672-aaae-d84b78635713.png, 00:05:22,  
 45.30 m  
 Finish node, other special chamber, reference: SW1, Unable

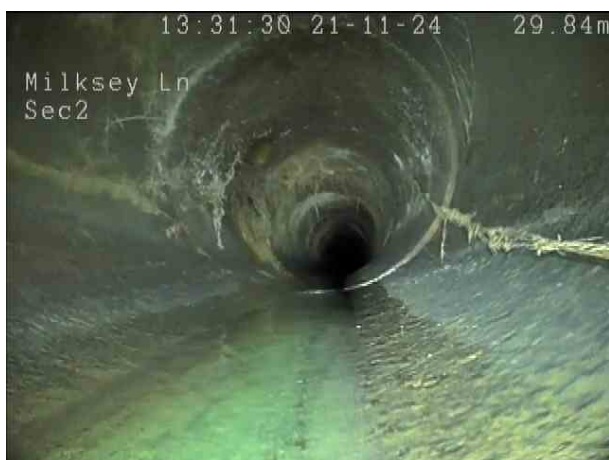
22677a1c-9702-415a-b762-6022f4cc53ea.png, 00:02:26,  
30.30 m  
Roots, fine at joint

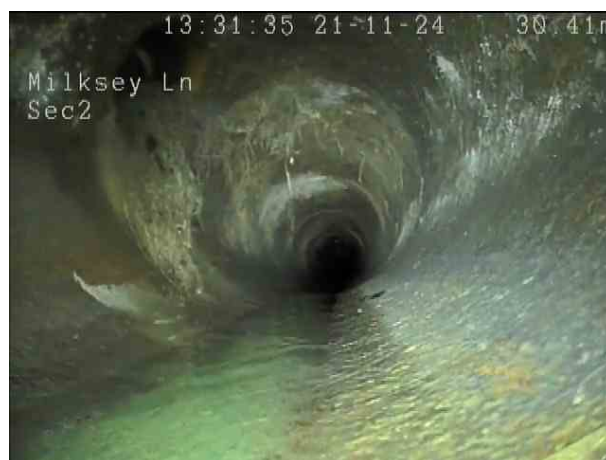
a02fb6f8-db22-495e-b60a-9fe1844e9d07.png, 00:02:32, 31.00  
m  
Junction at 10 o'clock, 150mm dia

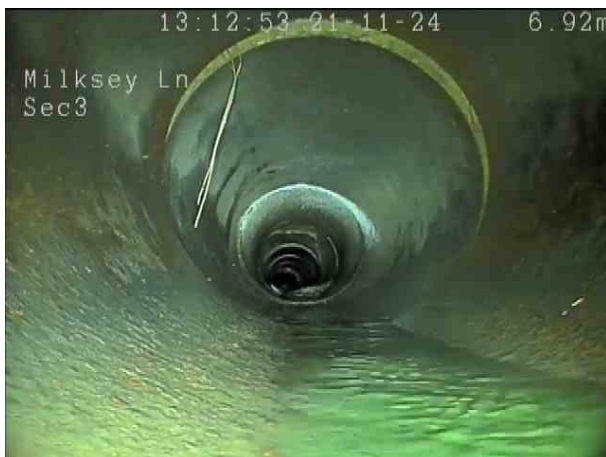
185b37ec-0349-4d34-8897-50f622d61a30.png, 00:00:53, 7.40  
m

Roots, fine at joint

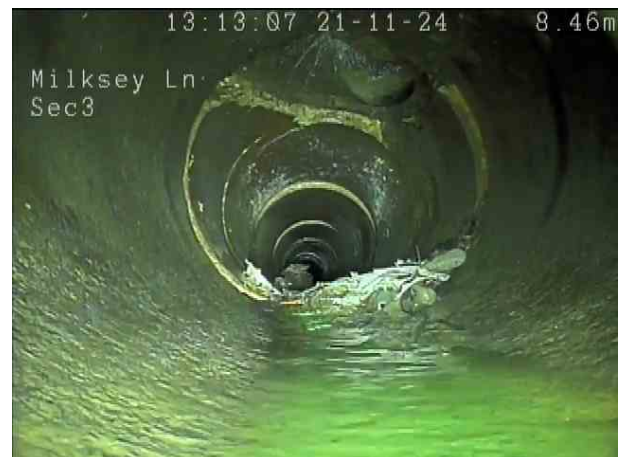
b65f7ef7-e37d-4f68-8e9d-51e517b19886.png, 00:01:07, 8.90  
m

Connection defective, connecting pipe is damaged at 1 o'clock,

| No. | m+ | Code | Observation |
|---|---|---|---|
| 5 | 8.90 | CXD | Connection defective, connecting pipe is damaged at 1 o'clock, 150mm dia |

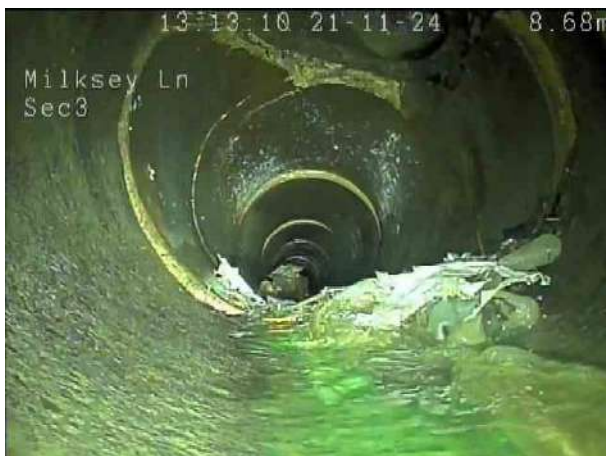
a74bc132-76af-4b72-b59a-9b0d10c1e1bd.png, 00:01:10, 8.90  
m

Roots, mass at joint, 10% cross-sectional area loss

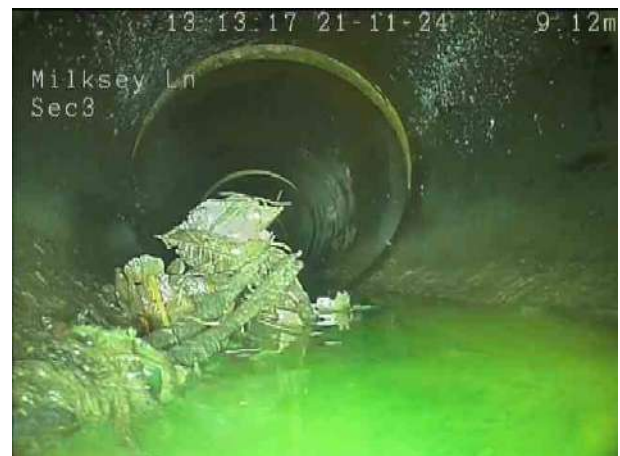
035ad4f6-410a-4705-9adf-9434a6787c09.png, 00:01:16, 9.20  
m

Settled deposits, other, 10% cross-sectional area loss, Leaves

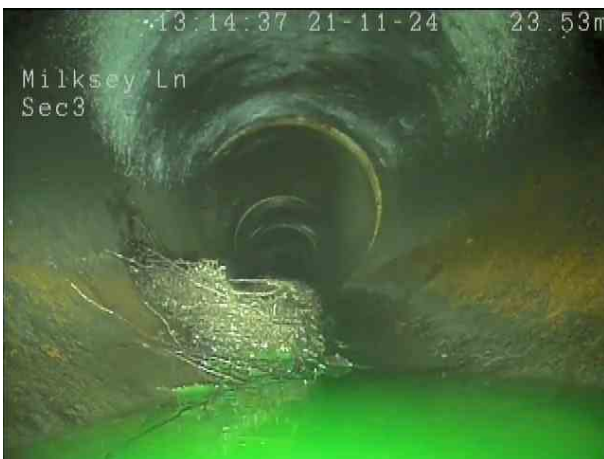
f4683594-3657-44ac-96e9-ee69abbc467a.png, 00:02:37, 23.80 m  
Roots, mass, 10% cross-sectional area loss, start

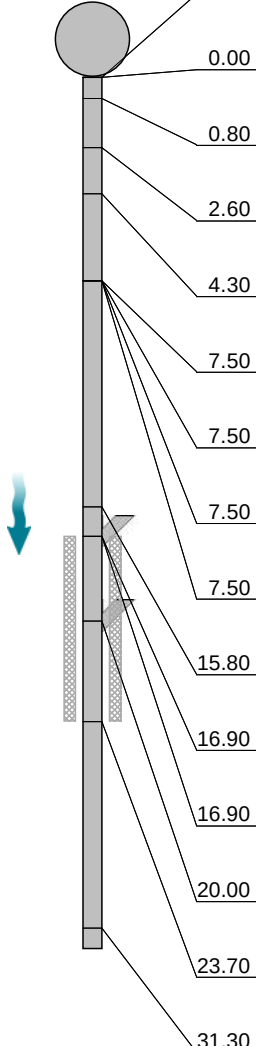
| Scale: 1:278 | Position [m] | Code | Observation | MPEG | Photo | Grade |
|---|---|---|---|---|---|---|
| Depth: 1790.00 m | | | | | | |
| | 0.00 | IC | Start node, inspection chamber, reference: SW4 | 00:00:01 | | |
| | 0.00 | WL | Water level, 5% of the vertical dimension: Running live | 00:00:01 | | |
| | 0.80 | RFJ | Roots, fine at joint | 00:00:19 | | 2 |

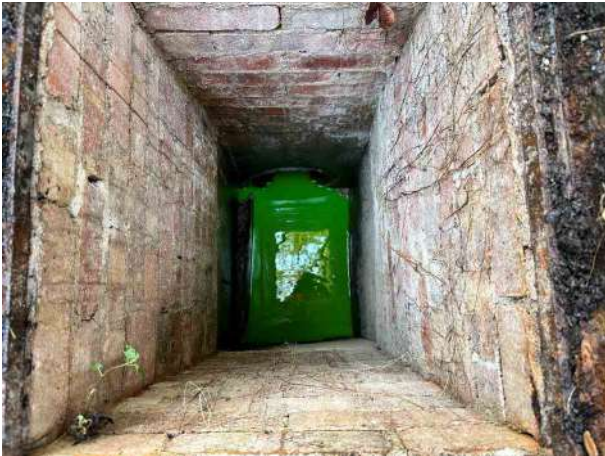
SW4.JPG, 00:00:01, 0.00 m  
Start node, inspection chamber, reference: SW4

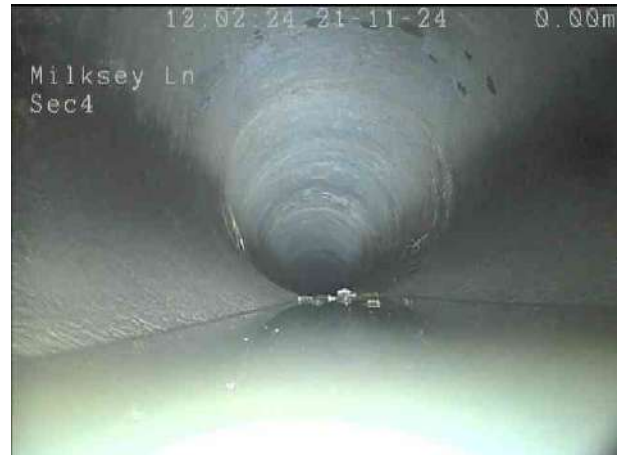
b08ece61-0da9-461a-8232-b92f97f60bf7.png, 00:00:01, 0.00 m

Water level, 5% of the vertical dimension, Running live

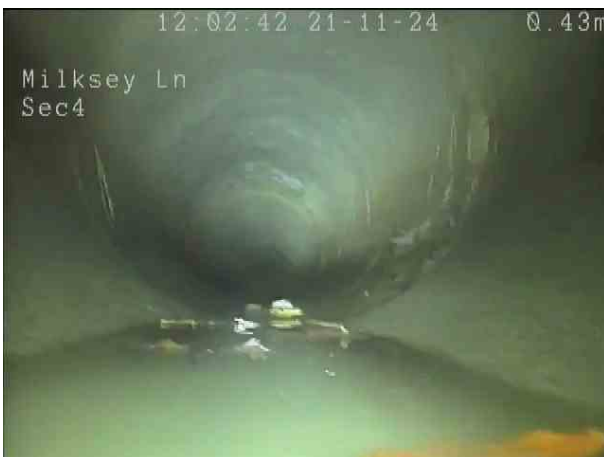
56f930ac-49f6-4b96-ada8-41c19fa769e6.png, 00:00:19, 0.80 m

Roots, fine at joint

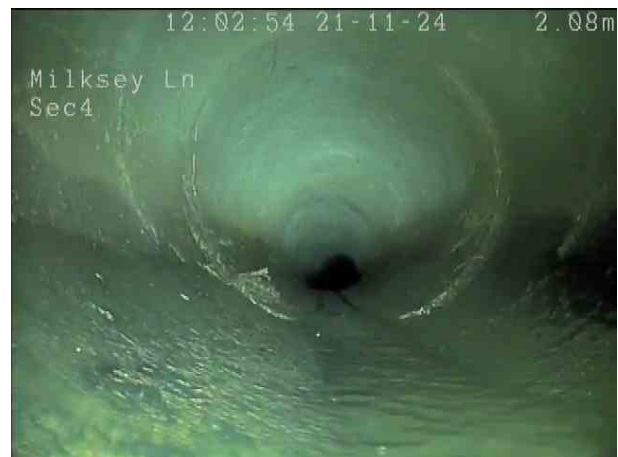
072a555f-51a2-4a4f-8c8c-0cdd0f3fb631.png, 00:00:31, 2.60 m

Roots, fine at joint

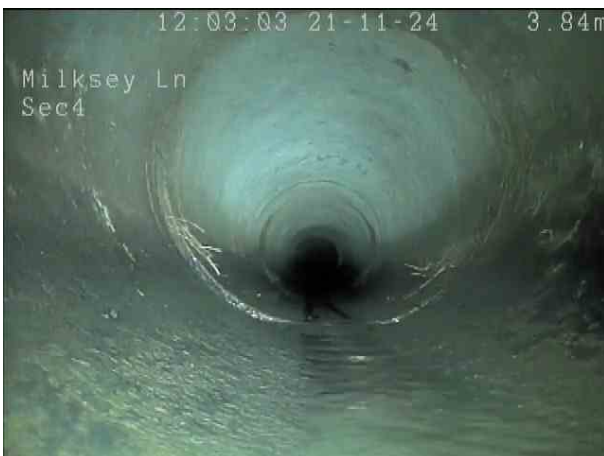
16363fe1-2ee0-4494-bdf9-0540b0de48e2.png, 00:00:40, 4.30 m

Roots, fine at joint

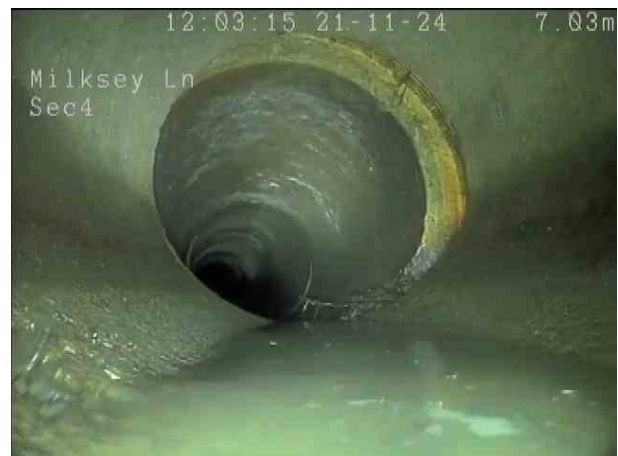
901fc6c2-b364-4fae-8fd9-338f3b128fc0.png, 00:00:52, 7.50 m

Line deviates left

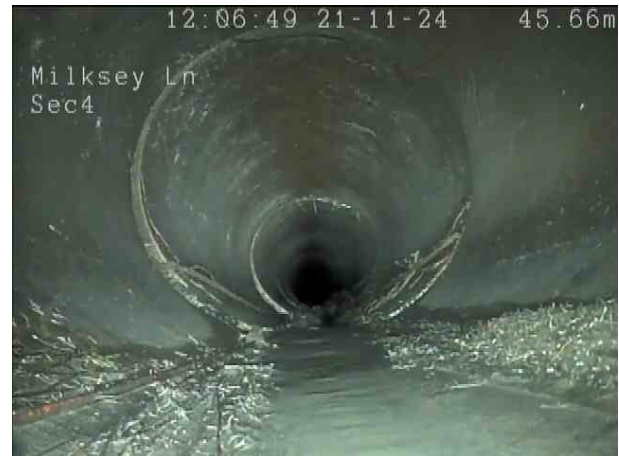
79ca1f7a-4d21-486e-864e-0eff7670a4b5.png, 00:04:17, 45.70 m  
Roots, mass at joint, 5% cross-sectional area loss, change

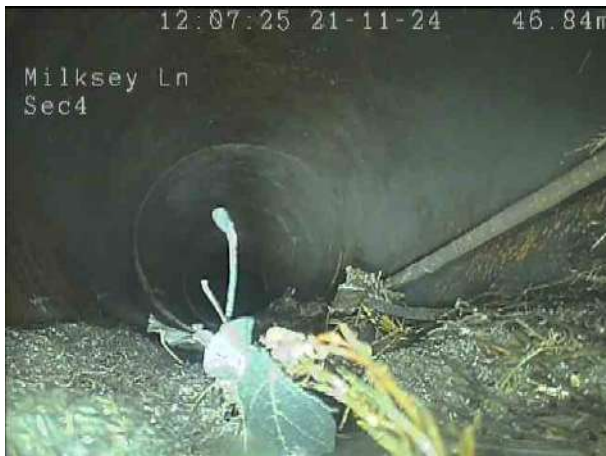
5aaf0228-9991-490b-b1c3-98dcc6b319a3.png, 00:04:52, 46.90 m  
Roots, mass at joint, 20% cross-sectional area loss, change
