**Milksey Lane, Graveley - Phase 2**  
Flood Risk Assessment  
December 2024

Report Ref: 29161-FLD-0101

CLIENT: Gade Homes Ltd

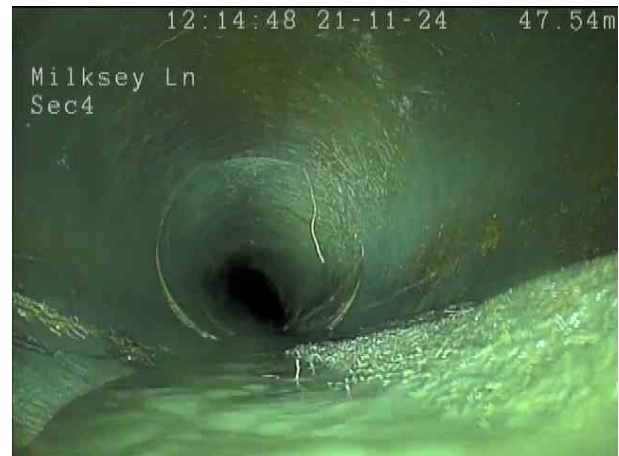
6d0965e6-bcb2-4139-864b-f7b8d1967d73.png, 00:05:12, 47.50 m  
Roots, mass at joint, 10% cross-sectional area loss, change

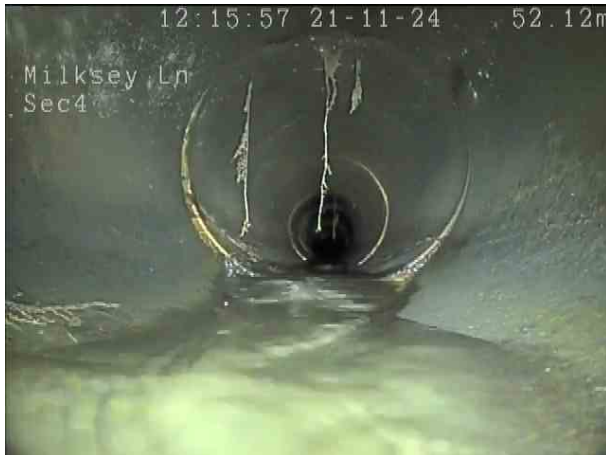
e827a749-dd39-424b-93f7-14ef3a2b5b4b.png, 00:06:21,

52.60 m

Roots, fine at joint

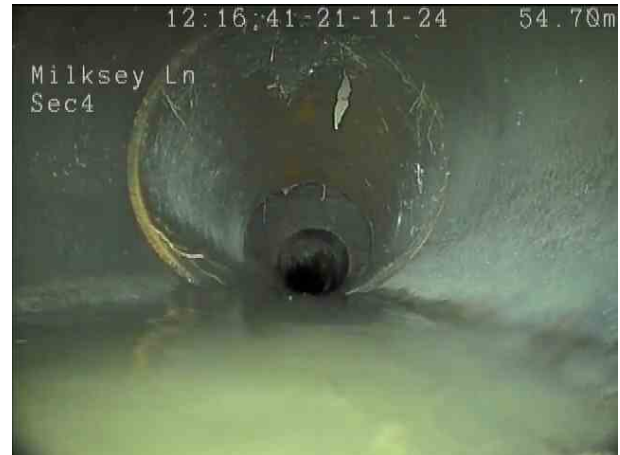
b464b4d0-19c6-4f8d-9bc6-851798832103.png, 00:07:05,

55.20 m

Roots, fine at joint

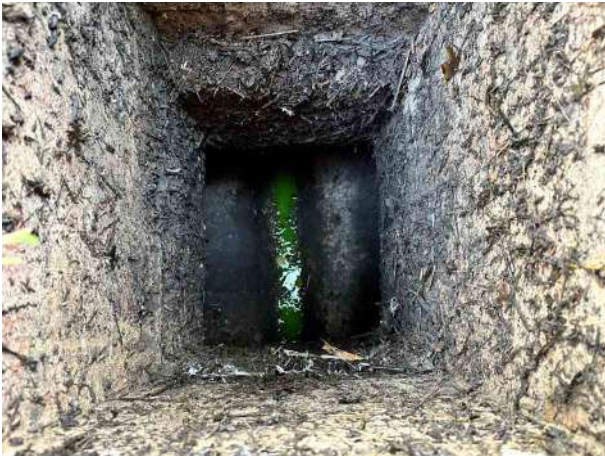
SW3.JPG, 00:00:01, 0.00 m  
Start node, inspection chamber, reference: SW3

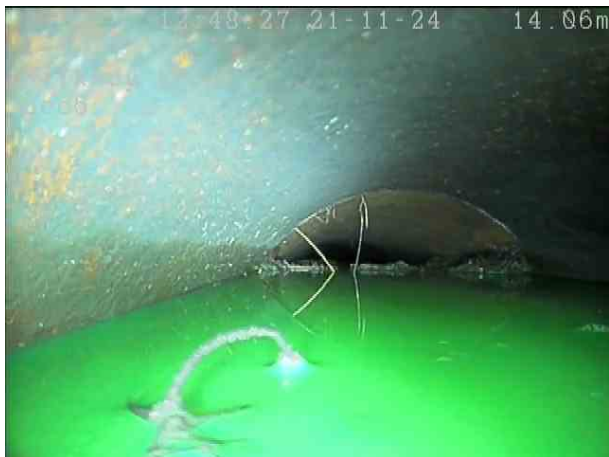
27453663-1dad-437a-b28e-5b72162ce29a.png, 00:02:25,  
14.10 m

Survey abandoned, Unable to proceed.
