## HERITAGE STATEMENT

**FOR REMOVAL OF EML/CEMENT RENDER AND REMOVAL OF HISTORIC WALL FINISHES FOR  
STRUCTURAL REPAIRS AT**

**MANOR FARM, GRAVELEY**

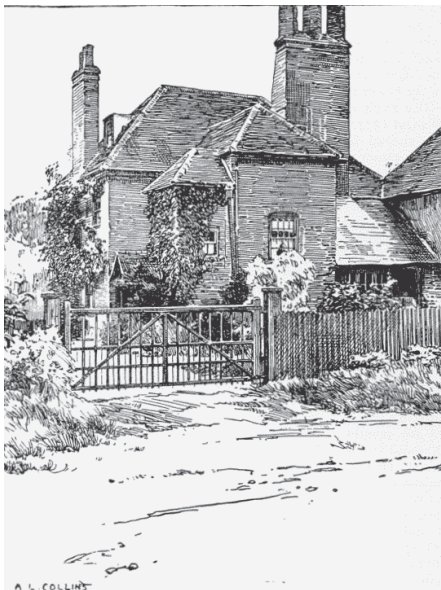
Taken from 'A History of the County of Herford: Volume 3', published in 1912, we find a second historic illustration which shows the later east facing dormer, the extension to the stair tower and the east porch. It does not show the west chimney yet in existence. It is not dated but is very much late-Victorian in style.

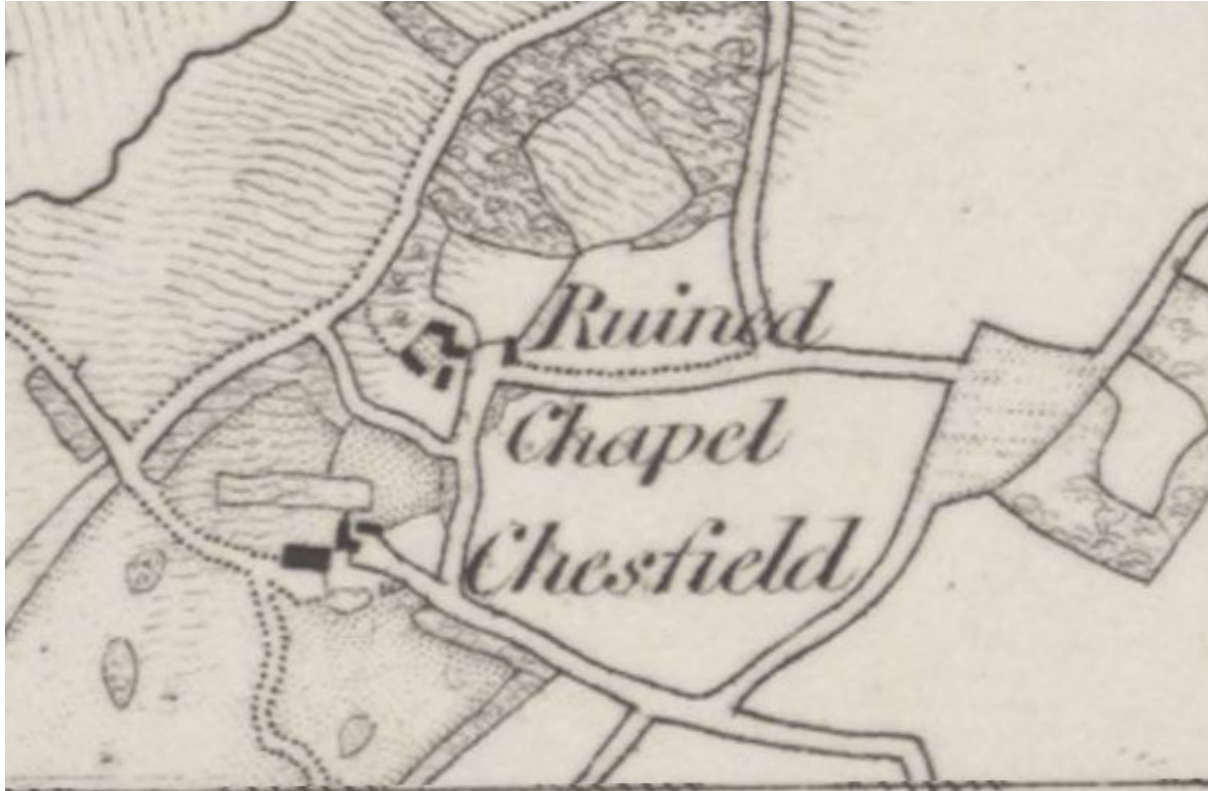
OS Old Series 1798-1898 - seems to show the main farmhouse as more extensive than it is today with a rear cross-wing projecting to the west.

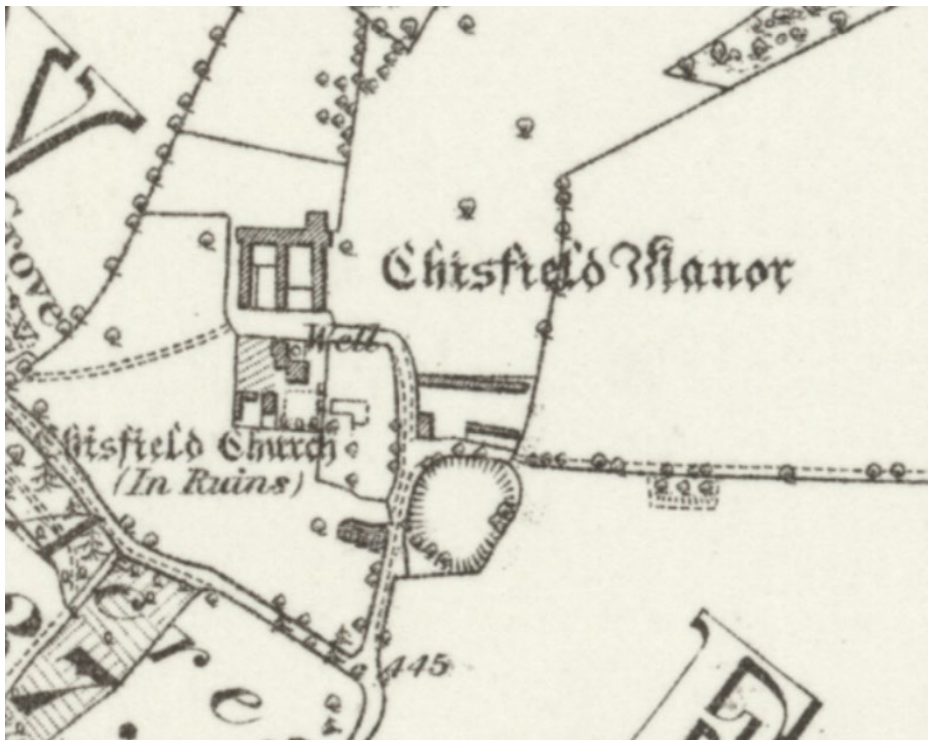
OS County maps 1830-80s –a vestigial west projection to the rear wing can still be seen on this map. Noted that the walled garden shows more buildings than existing today.

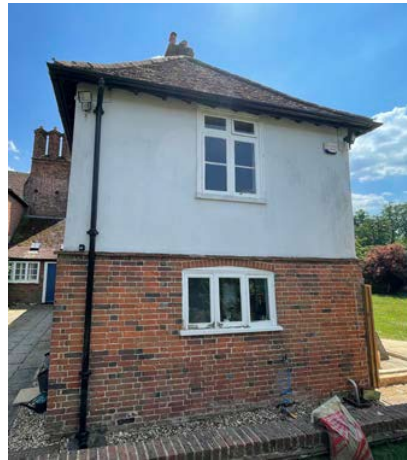
East façade of the north range

| | Proposal | Significance of affected fabric | Impact | Reasoning / mitigation /recording |
|---|---|---|---|---|
| 1. | Remove EML and cement render to north range and installation of vapour open materials | Low | Positive | The cementitious material is causing moisture build up in the historic frame. Its removal and the following reinstatement of vapour open materials is necessary to protect the building. |

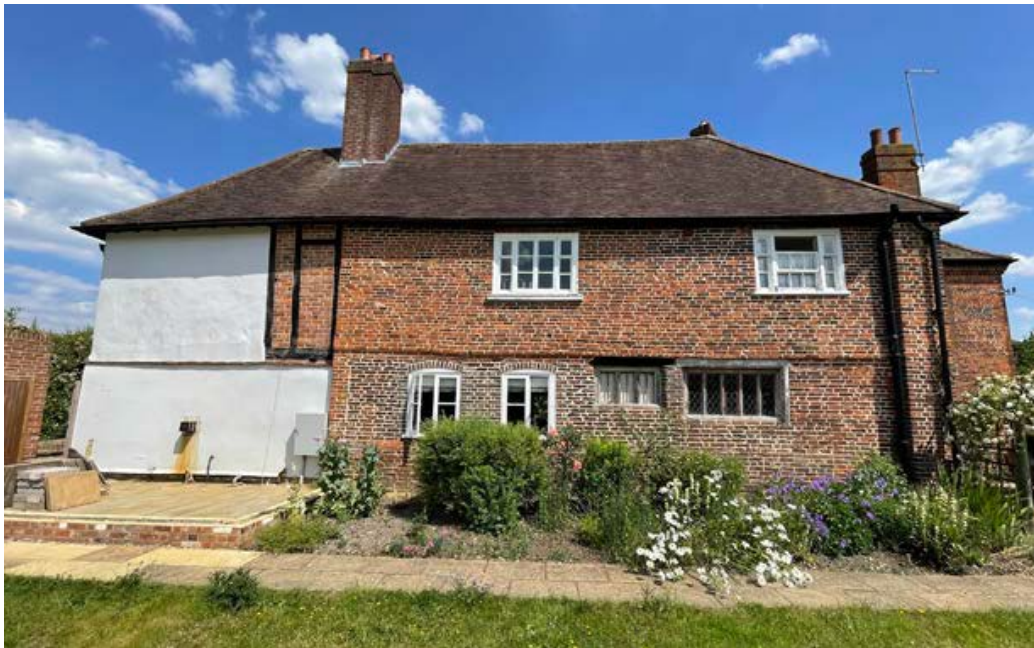
North façade of the north range

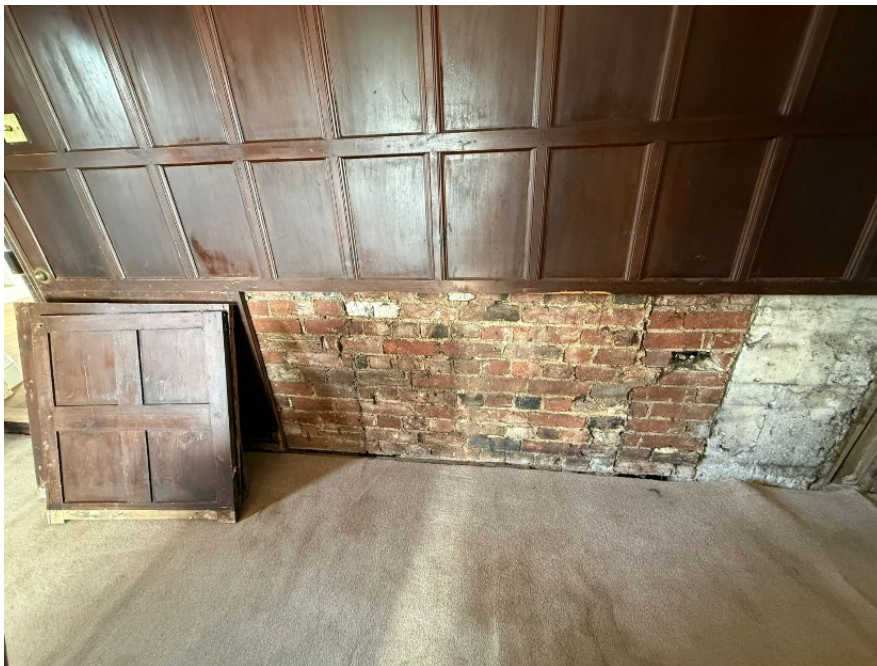
North wall of Living Room with modern panelling carefully removed. Evidence of historic hearth with brick infill. NB infill appears to be 'floating' with no clear structure below.

| | Proposal | Significance of affected fabric | Impact | Reasoning / mitigation /recording |
|---|---|---|---|---|
| 2. | Removal of modern and historic internal timber panelling to facilitate structural assessment to historic brickwork and any suitable repairs using stainless steel helifix bars and lime mortar | Low | Neutral | The panelling of this room is believed to be a C20th intervention, although in some areas the fabric is older than this. There is no evidence that any of the historic panelling was relocated from elsewhere within the building and may have been acquired to decorate the room to the taste of a previous owner. The removal of the panels has been proven to be possible without causing damage to the panels. Their removal will allow a full structural assessment of the fabric which is necessary given the finding elsewhere within the building |
