# Design & Access and Heritage Statements

For replacement glazing and a new  
rooflight for the utility/boot room wing

**Gannock Farmhouse, Sandon**

**Ref: DAHS/2420(1)**

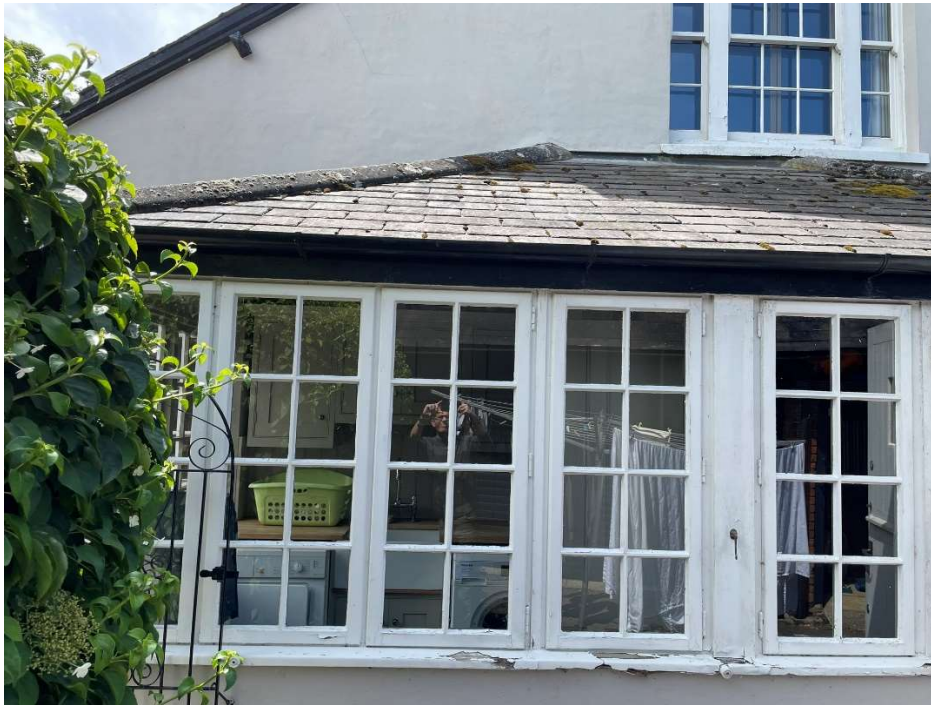
*Existing casements sitting proud of the surrounding frames*

The first part of the proposal is to replace all of the glazing and joinery which surrounds the utility/boot room wing. As identified above, this is a 20<sup>th</sup> Century addition, and the current windows and joinery appear to date from the 1980s. The casements have a stormproof style detail with the casements projecting beyond the frames. The windows are all single glazed but are beginning to fail in places due to rot having set in.

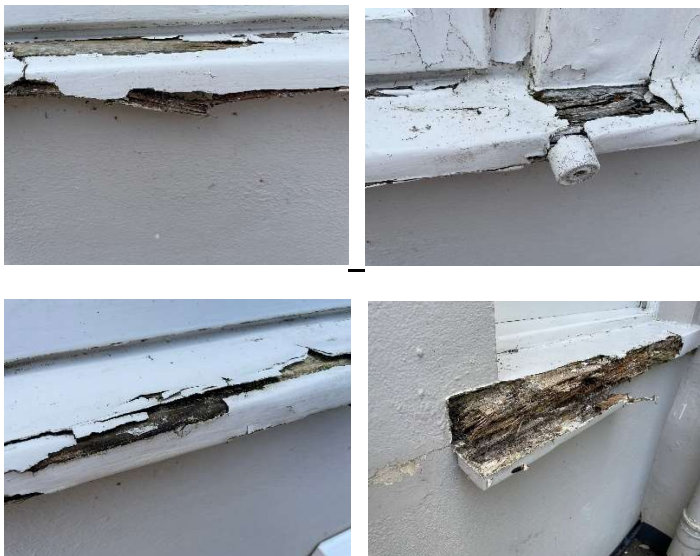
*Existing windows with rot setting in*

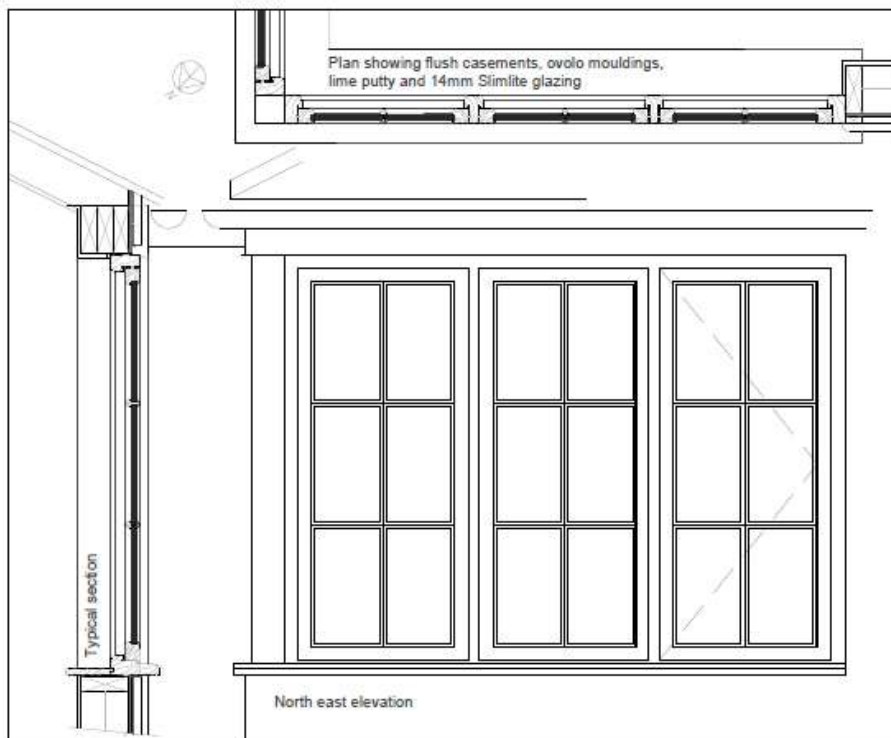
Extract from drawing 2420.07 showing flush casements, slim double glazing and less glazing bars

The existing windows are not historic and are replacements within a 20<sup>th</sup> century addition. Their replacement will not affect the significance of the listed building. As such, it is proposed to use slim double glazing in the replacement windows with flush casements and reduced glazing bar numbers to provide better proportions.

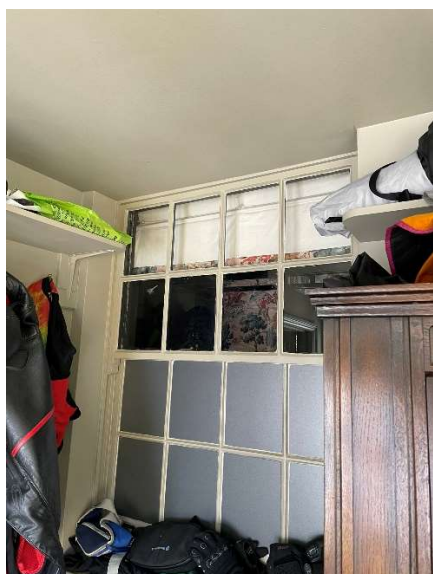
*Internal window with adjoining plasterboard ceiling which is to be removed to create a tapered shallow shaft for the new rooflight*

The rooflight will require a small amount of ceiling and rafters to be removed but the ceiling is plasterboard and the rafters date from the 20<sup>th</sup> Century. There is nothing special or significant about the fabric that is proposed to be removed.

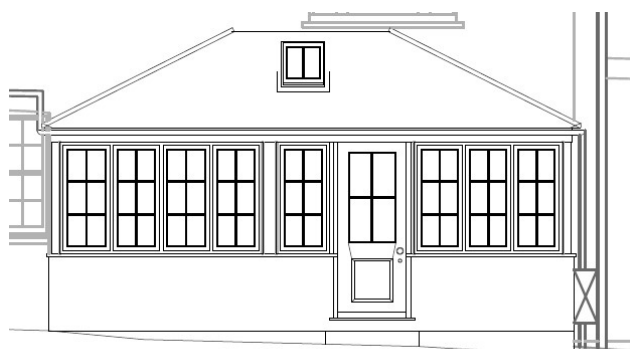
*Proposed conservation rooflight*

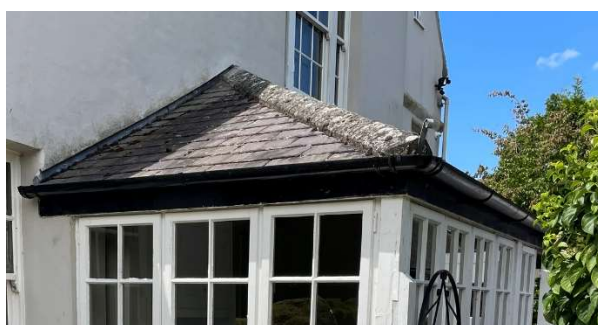
*Concrete hip tiles to be removed*

The existing roof hips have clunky concrete hip tiles which are too big for the size of the roof. It is proposed to remove these and add back traditional lead rolls to match those used on the 2013 single storey rear extension. The slates will remain as existing.

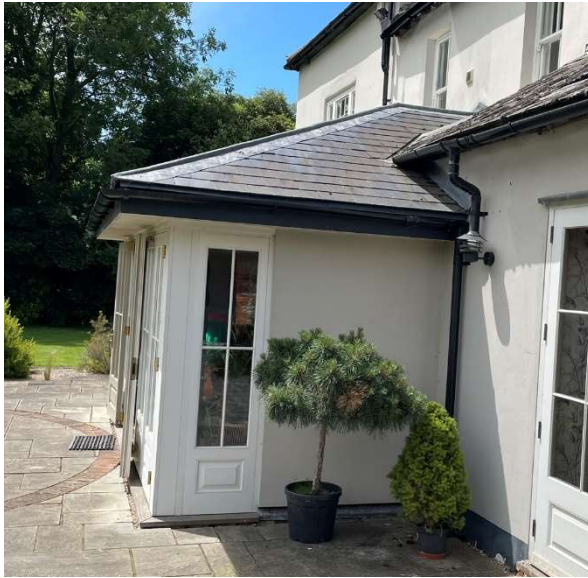
*Lead roll hips on the 2013 rear extension*

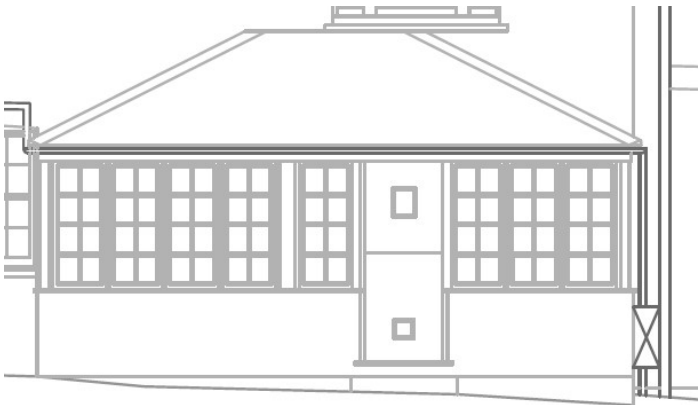
*Existing stable door*

The existing stable door is not particularly practical, is draughty and is not in keeping with the nearby external doors at the rear. It is proposed to replace the stable door with a glazed door with a timber bottom panel which will be similar in style to the other external doors.

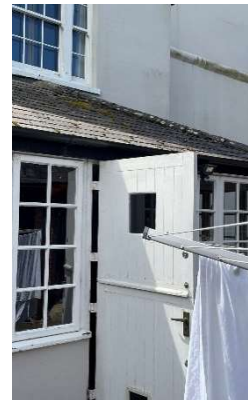
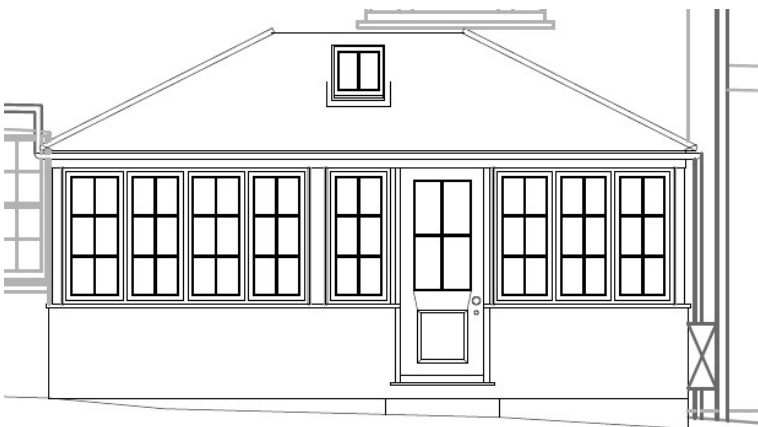
*Proposed half glazed door*
