**Temple Dinsley - 641-KS-06-MB-SH-A-90300 – P02**  
**Level 0, GA – Apartment 30 - Servants Hall**

**Apartment 30 – Plans of Significance – 641-KS-30-MB-DR-A-02040.**

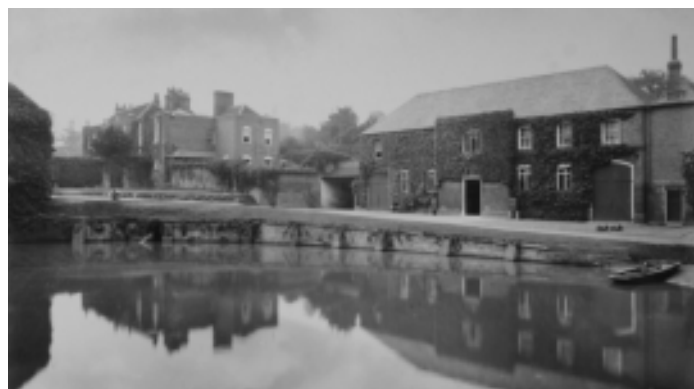
Pre- 1909 photo showing the East End of the building prior to the Lutyens' East Wing.

The photo taken pre-1909 shows the relationship between the main house and stable block prior to Lutyens East Wing. The room that forms Apartment 30 was part of the Lutyens' linking extension between the East Annexe and the Stable Block and has windows on the South and East external walls. It is proposed that this room remains largely unchanged and forms a one-bedroom Apartment. Due to the significance of this phase of Lutyens' proposals it is considered a sympathetic way of using this room and section of the building.

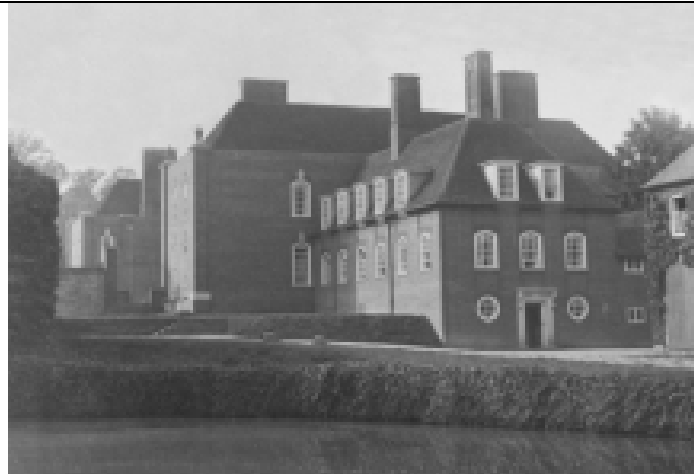
Post 1912 photo showing Lutyens' East Wing and Annexe completed prior to the 1913-14 linking section also carried out by Lutyens'.

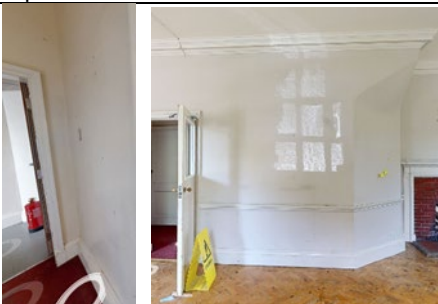
| Reference | Proposal | Significance of affected fabric | Impact | Reasoning and mitigation |
|---|---|---|---|---|
| A-Walls<br>30A.D2 | Section of EC20 wall demolished. | High<br>Early C20<br>1913-14 Lutyens | Low<br>Impact | <p>Opening within internal corridor wall positioned away from corner ceiling detail to minimise impact on features. Opening narrow and does not alter overall arrangement of room. The height of the opening would be similar to the existing door height adjacent. The opening within the wall will not be visible from the main corner room of Apartment 30 due to the new internal partition. Some loss of historic fabric. The alteration should be considered low impact.</p> |

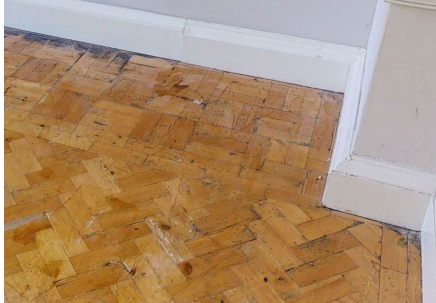
| Reference | Proposal | Significance of affected fabric | Impact | Reasoning and mitigation |
|---|---|---|---|---|
| B-Floors 30B.R2 | Change in floor finish due to C20 alteration at Level-1. | Moderate<br>Early C20<br>1913-14 Lutyens with evidence of late C20 | Low<br>Impact<br>Benefit | <p>Pattern within the 1911 parquet flooring shows margin border to room and change from herringbone to basketweave. Shows alteration of the room. To avoid lifting parquet flooring it is proposed that this floor be insulated from the underside (this floor forms the ceiling to the external undercroft).</p> |

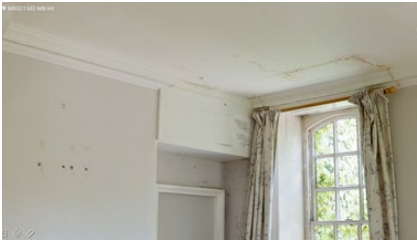
| Reference | Proposal | Significance of affected fabric | Impact | Reasoning and mitigation |
|---|---|---|---|---|
| C-Ceilings<br>30C.R1 | Ceiling - Lath and lime plaster to be repaired generally.<br>Ceiling - movement in corner of room and localised cracking to ceiling and cornice. To be prepared using stainless steel discs to secure lath locally. | High<br>Early C20<br>1913-14 Lutyens with evidence of late C20 alterations | Low<br>Impact<br>Benefit | <p>Lath and plaster ceiling to be repaired and any compartmentation to the apartment above or any required services (to be run within the ceiling void) are to be installed from above which minimises the impact of the proposal alterations on the historic fabric.</p> <p>Movement to be investigated. May be due to climbers on external wall or leaking guttering and pipework. Repairs using SS disks and skimming with new lime plaster is a sensitive way of repairing cracks and movement in lath once the cause has been rectified and the benefit of the repair preventing further dilapidation.</p> |

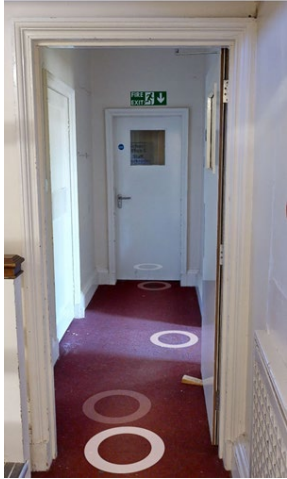
| Reference | Proposal | Significance of affected fabric | Impact | Reasoning and mitigation |
|---|---|---|---|---|
| D-Doors<br>30D-DG01<br>30D-DG01<br>30D.P1 | Remove modern C20 fire door. This door will become the main entrance door to Apartment 30 and shall be replaced with a contemporary fire and security door. | Low<br>Late C20<br>School alterations | Low<br>Impact | <p>Door position unaltered with door architrave and skirting retained. The door has been replaced historically for a late C20 fire door. As this doorway shall form the entrance to apartment 30 (from a shared circulation space) a panelled timber 'front' door with compartmentation and security specification will be required</p> |

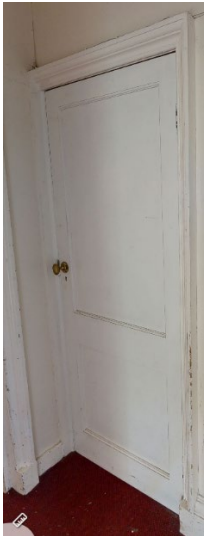
| Reference | Proposal | Significance of affected fabric | Impact | Reasoning and mitigation |
|---|---|---|---|---|
| D-Doors<br>30D-DG02<br>30D-DG02<br>30D.P2 | Early C20 two panel door to understairs cupboard and architrave, skirting to be slightly adjusted and retained.<br>Slight removal of wall to accommodate fire compartmentation lining. | Moderate<br>Early C20<br>1913-14 Lutyens | Low<br>Impact | <p>Door position unaltered with door architrave, doorcase, skirtings retained. These service doors have various panel heights that do not match. Some may have been moved here from a different part of the building.</p> |

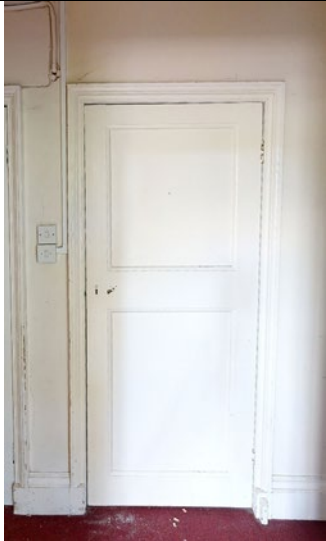
| Reference | Proposal | Significance of affected fabric | Impact | Reasoning and mitigation |
|---|---|---|---|---|
| D-Doors<br>30D-DG03<br>30D.P3 | Early C20 two panel door. Doorway to be closed off. Doorway retained and lined on opposite side. | Moderate<br>Early C20<br>1913-14 Lutyens | Low<br>Impact | <p>Timber door to be kept shut permanently, door opening to be infilled behind to become part of the party/fire compartment wall. Reduces impact of closing off doorway. These service doors have various panel heights that do not match.</p> |

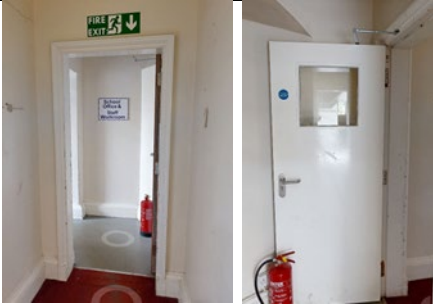
| Reference | Proposal | Significance of affected fabric | Impact | Reasoning and mitigation |
|---|---|---|---|---|
| D-Doors<br>30-DG04<br>30-DG04<br>30D.P4 | New timber panelled doorway to ensuite. Door repositioned within corridor to form ensuite. Reusing doorcase and architrave, alter skirting. Modern C20 fire door removed. Architrave and joinery reused in new position (30-DG04). | Moderate<br>Early C20<br>1913-14 Lutyens<br>architrave.<br>Low<br>Late C20<br>School alterations | Low<br>Impact | <p>The fire door to the corridor is a C20th school alteration so the replacement of this door has no impact on historic fabric. The doorway position looks to have been introduced after 1911, and this wall position would have framed the fireplace within the Service Hall. Access from the corridor would have been through the service door 30-DG03.</p> |

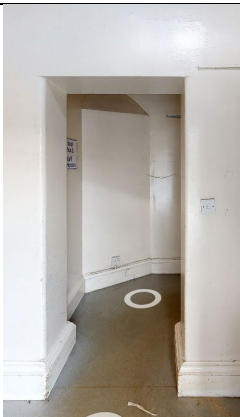
| Reference | Proposal | Significance of affected fabric | Impact | Reasoning and mitigation |
|---|---|---|---|---|
| D-Doors<br>30-DG05<br>30D.P5 | Infill EC20 door opening as part of 30D.P3 compartment wall. This section of wall formed the corner of part of the original stable block, with the opening perhaps formed towards the middle of the C20. | Moderate<br>Early C20<br>1913-14 Lutyens | Low<br>Impact | <p>The opening in this wall appears to have been formed during the latter part of the C20 when there was a requirement to alter the layout of accommodation for the</p> |

| Reference | Proposal | Significance of affected fabric | Impact | Reasoning and mitigation |
|---|---|---|---|---|
| | | | | <p>school. This wall formed part of the original corner of the stable block which we know from historical photographs had one single window opening at this floor level. Reinstating the wall is considered of low impact to the historic fabric. The overall proposals of removing the access between the East wing and the annexe should also be considered however the benefit of altering the building into separate apartments, and the positive benefits this should bring to the building fabric, should outweigh any detrimental impact, on the way the building would have historically been experienced.</p> |

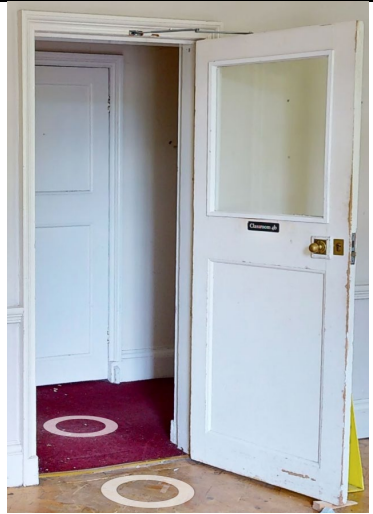
| Reference | Proposal | Significance of affected fabric | Impact | Reasoning and mitigation |
|---|---|---|---|---|
| D-Doors<br>30-DG06<br>30D.R1 | Early C20 door to be repaired with upper glazing light replaced. | Moderate<br>Early C20<br>1913-14 Lutyens | Low<br>Impact<br>Benefit | <p>Door has been adapted during the late C20 with upper panel replaced with a glazing light. Alteration likely carried out by the school. A door closer has also been fitted to the door and historic frame that shall be removed. Architrave, doorcase, skirtings retained and repaired for decoration. Glazing light shall be replaced with a more sympathetic mould detail.</p> |

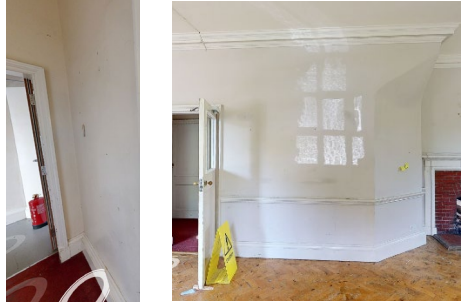
| Reference | Proposal | Significance of affected fabric | Impact | Reasoning and mitigation |
|---|---|---|---|---|
| F-New Openings<br>30F.P1 | Form new opening in section of EC20 wall. | High<br>Early C20<br>1913-14 Lutyens | Low<br>Impact | <p>Opening within internal corridor wall positioned away from corner ceiling detail to minimise impact on existing historic fabric and features. Opening narrow and does not alter overall arrangement of rooms so the alteration should be considered low impact. The height of the opening would be similar to the existing door height adjacent. The opening within the wall will not be visible from the main corner room of Apartment 30 due to the new internal partition. Some loss of historic fabric.</p> |

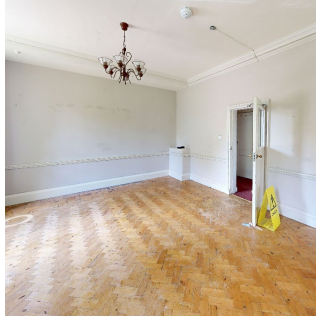
| Reference | Proposal | Significance of affected fabric | Impact | Reasoning and mitigation |
|---|---|---|---|---|
| J-Internal Fixtures and Fittings 30J.P1 | Kitchen units. | High<br>Early C20<br>1913-14 Lutyens | Low<br>Impact | <p>Installation of kitchen joinery within the main corner room of Apartment 30 will be restricted to the internal west corner of the main room. Inbuilt joinery in this location, minimises the Projection into room minimal and maintains the visual arrangement and sequence of the windows. Low impact to the historic fabric and proportions of the room. Maintains corner view provided by windows on the South and East Elevations.</p> |

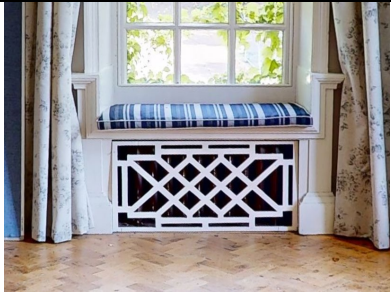
| Reference | Proposal | Significance of affected fabric | Impact | Reasoning and mitigation |
|---|---|---|---|---|
| 30K.R1 | 5nr. EC20 Radiator covers below each window seat retained. | High<br>Early C20<br>1913-14 Lutyens | Low<br>Impact<br>Benefit | <p>These form part of a Lutyens interior joinery design with radiator covers, window seat and dado rail that are of high significance. These will be retained and</p> |

| Reference | Proposal | Significance of affected fabric | Impact | Reasoning and mitigation |
|---|---|---|---|---|
| | | | | repaired where required. The cover in the north east corner will need repaired as it has suffered from water damage. |

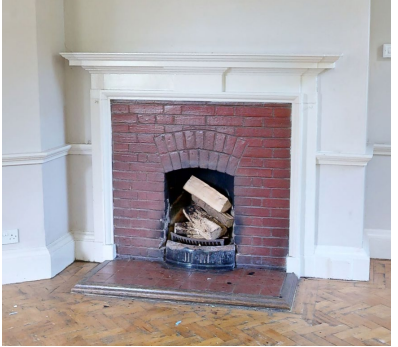
| Reference | Proposal | Significance of affected fabric | Impact | Reasoning and mitigation |
|---|---|---|---|---|
| N-Fireplaces<br>30N.R1 | Early C20 painted timber surround retained and redecorated. | High<br>Early C20<br>1913-14 Lutyens | Low<br>Impact<br>Benefit | <p>Brick cleaned. Clay hearth tiles retained. Grate ironwork repaired and painted. Flue re-lined - for installation of small stove.</p> |
