**The White Horse, Kimpton  
Architectural Heritage Impact Assessment**

December 2024

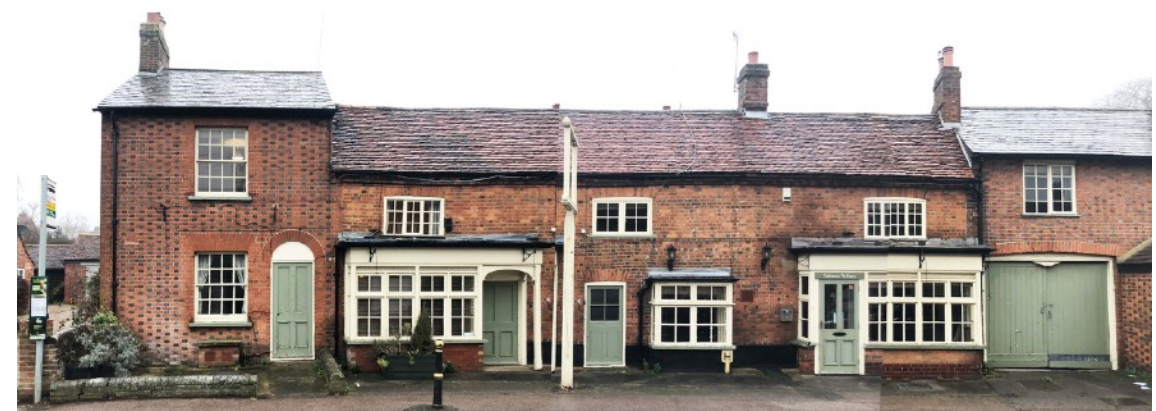
Fig 1. Existing Front Elevation
