# HEXTON MANOR

**Scope of Works to  
accompany an Application  
for Listed Building Consent  
for the proposed internal  
alterations to Hexton  
Manor**

SEPTEMBER 2024

*Architech Limited*

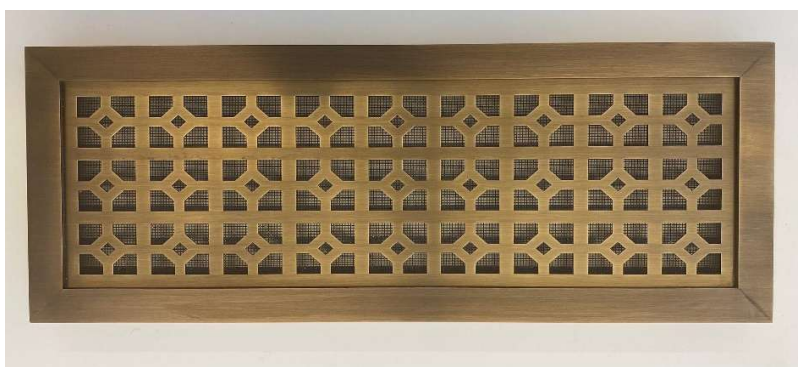
Berkley Floor Grill to trench heating

We will choose an antique brass floor grill similar to that shown below which will match the colour and finish of the furniture on the box sash windows.

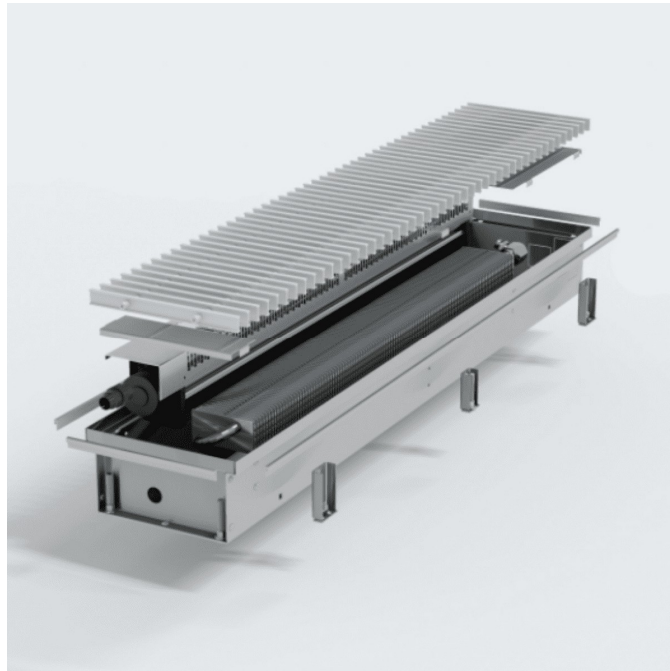
Trench heating image

Therefore, we proposed to install trench heating to these areas as shown on the accompanying ground floor plan. These trench heaters will provide a large amount of heat in these critical areas and will be less visually intrusive than a column radiator, the top of which would sit above the line of the adjacent windowboard.

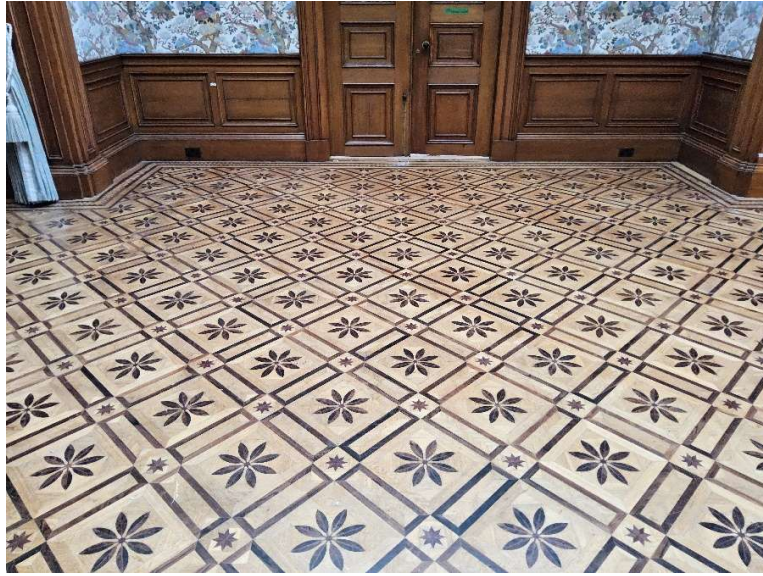
Existing Hall Floor

We believe that this current parquet floor covering in the hall (pictured below) was imported from Belgium in the early 20<sup>th</sup> century and an image dated 1905 is referenced in the Heritage Statement accompanying our previous application for Listed Building Consent.

We therefore know that this floor covering is not an original feature of the dwelling which is further evidenced by the floorboards below not being consistent with the original pitch pine floorboards located in the northern part of the first and second floors. The existing floor covering is a thin veneer and has been poorly maintained for several decades. Refurbishment of this floor would be difficult as all of the darker petals to the pattern are Rosewood which is no longer permitted to be used in the uk.

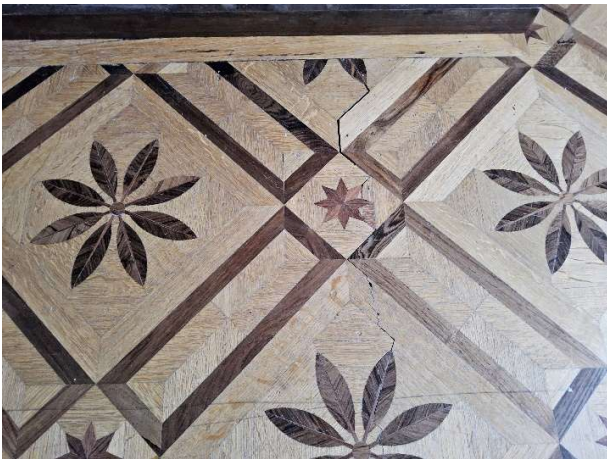
Separation of Joints and Cracking

The floor covering is showing significant signs of wear, age and deteriorating in places as shown in the photographs below. We feel that, with the major renovation of Hexton Manor being undertaken, we need to address the issue of the deteriorating and worn hall floor and replace it with a new traditional floor that will be in-keeping with the stature of this historic manor house.

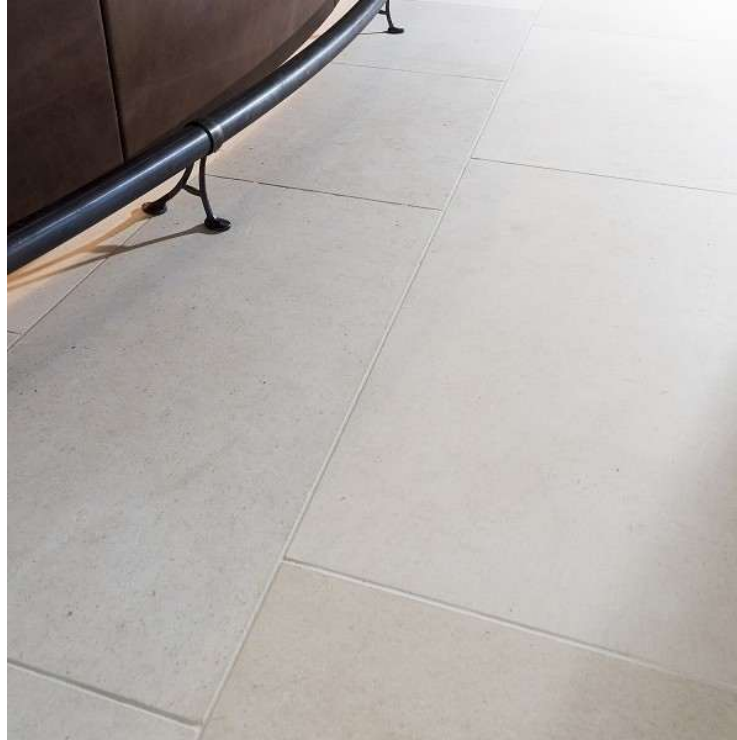
Therefore, this application proposes to remove this existing floor covering in the hall and replace it with Jordans Basebed Portland stone tiles (see illustrative image below).

This traditional material will add to the splendor of this reception area and will lighten the otherwise very dark hall. It will provide a welcome contrast to the renovated
