# Growing Baldock

Appendix 12.5 Ground Investigation Interpretive Report BA10 Area

Ground Investigation Interpretive Report –  
Area BA10

Project Reference: 2899

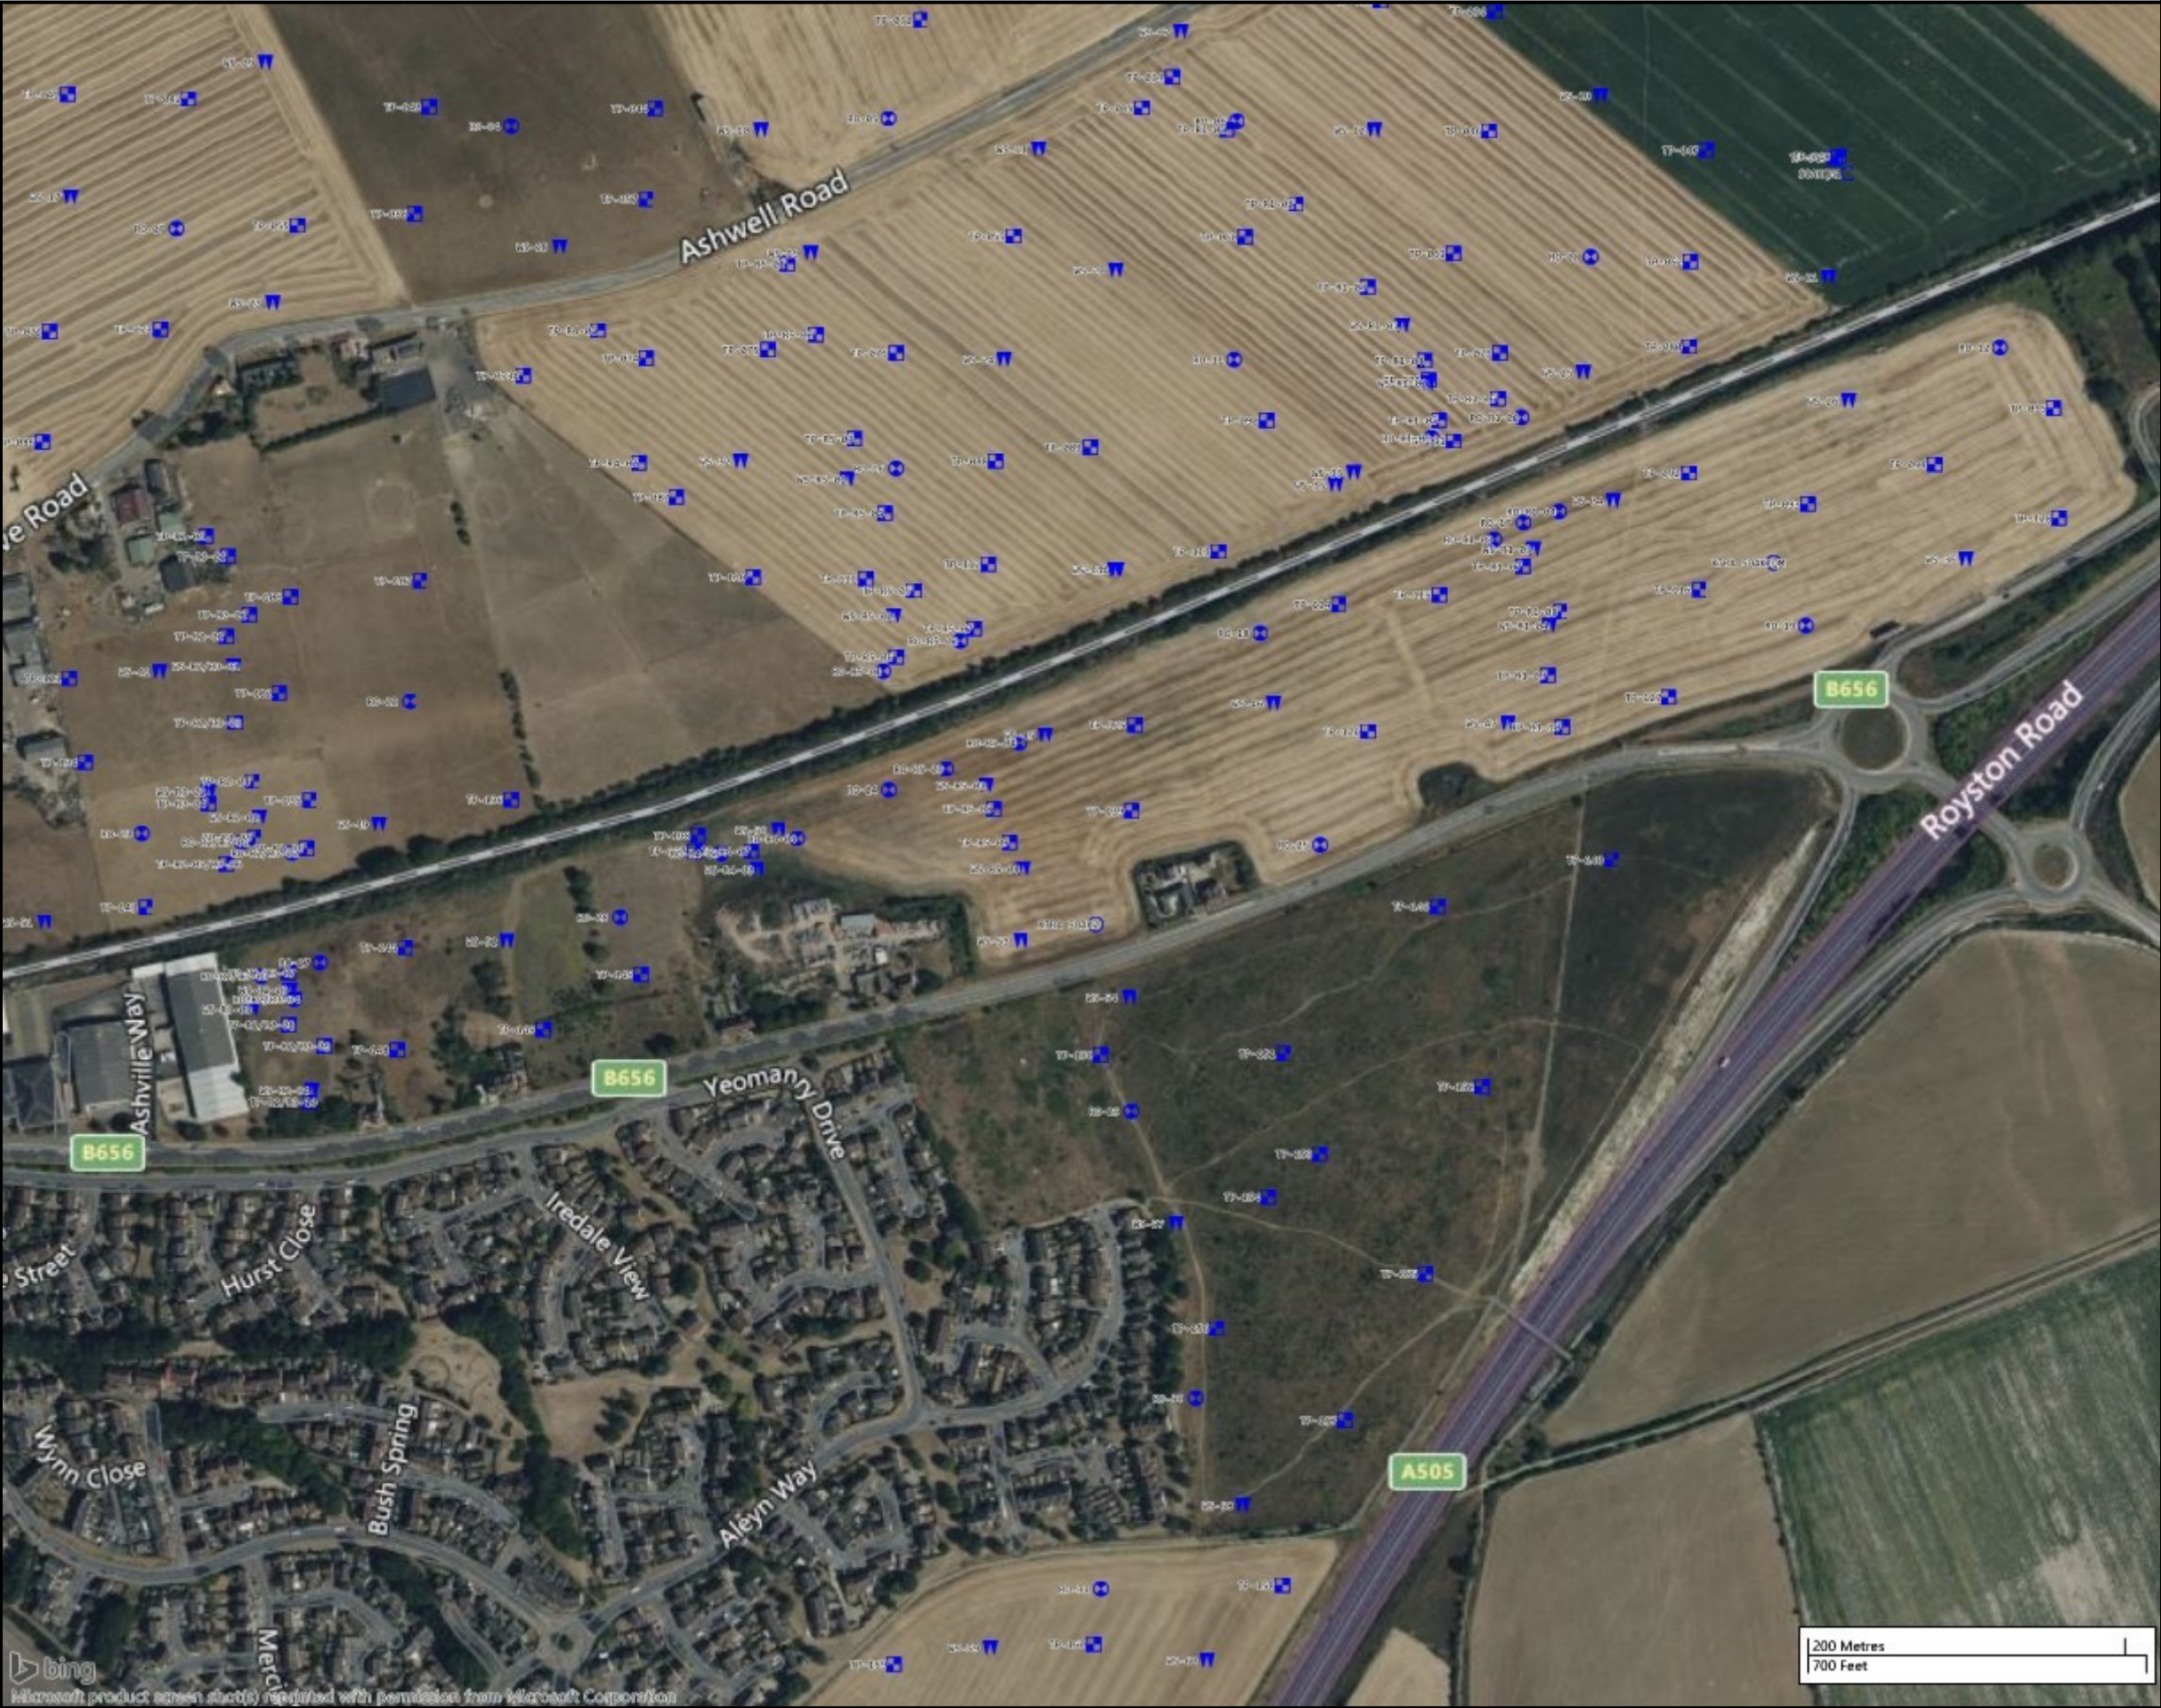
Title: Site Plan  
Scale: 1:4250  
Engineer: Stephen J Fisk  
Contractor:

- Legend Key
- Locations By Type - Empty
  - Locations By Type - RC
  - Locations By Type - TP
  - Locations By Type - WLS

| <b>Appendix B</b> | Drawing No. 2899-003 – Exploratory Hole Location Plan<br>Exploratory Hole Logs (Trial Pits Logs)<br>Exploratory Hole Logs (Window Sample Borehole Logs)<br>Exploratory Hole Logs (Rotary Borehole Logs)<br>Infiltration Testing Results |
