# Growing Baldock

Appendix 12.2 Ground Investigation Interpretive Report BA1 Area

Ground Investigation Interpretive Report –  
BA1 Area

Project Reference: 2899

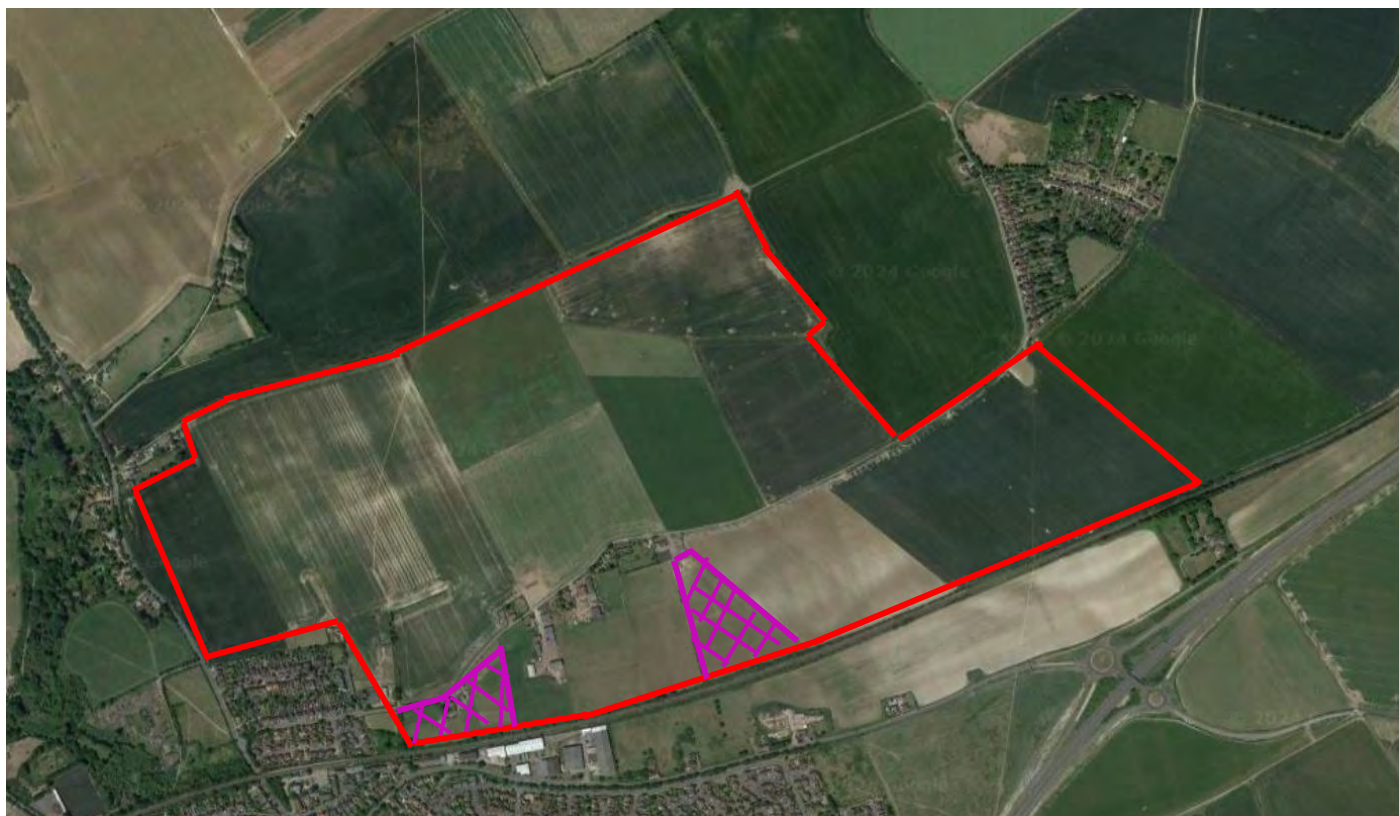
Fig.2 – Aerial Photograph Showing the Development Area in red (approximate). The areas show with purple hatching were inaccessibility due to tenancy restriction.

For the purposes of this ground investigation report “The Site” refers to area that can be seen outlined in red in Figure 2 below.

The exploratory hole locations were carried out on a grid of spacing between 50m (proposed residential areas) to 75m (soft landscaping areas) across the site. Two areas are currently utilised as horse paddocks (indicated on Fig 2 below) and no access was available into these areas during the investigations.

The approximate National Grid References (NGR) for the centre of the site is **TL 25303 34864**. A general site location plan of the site is shown in Figure 1 and an aerial photograph in Figure 2.

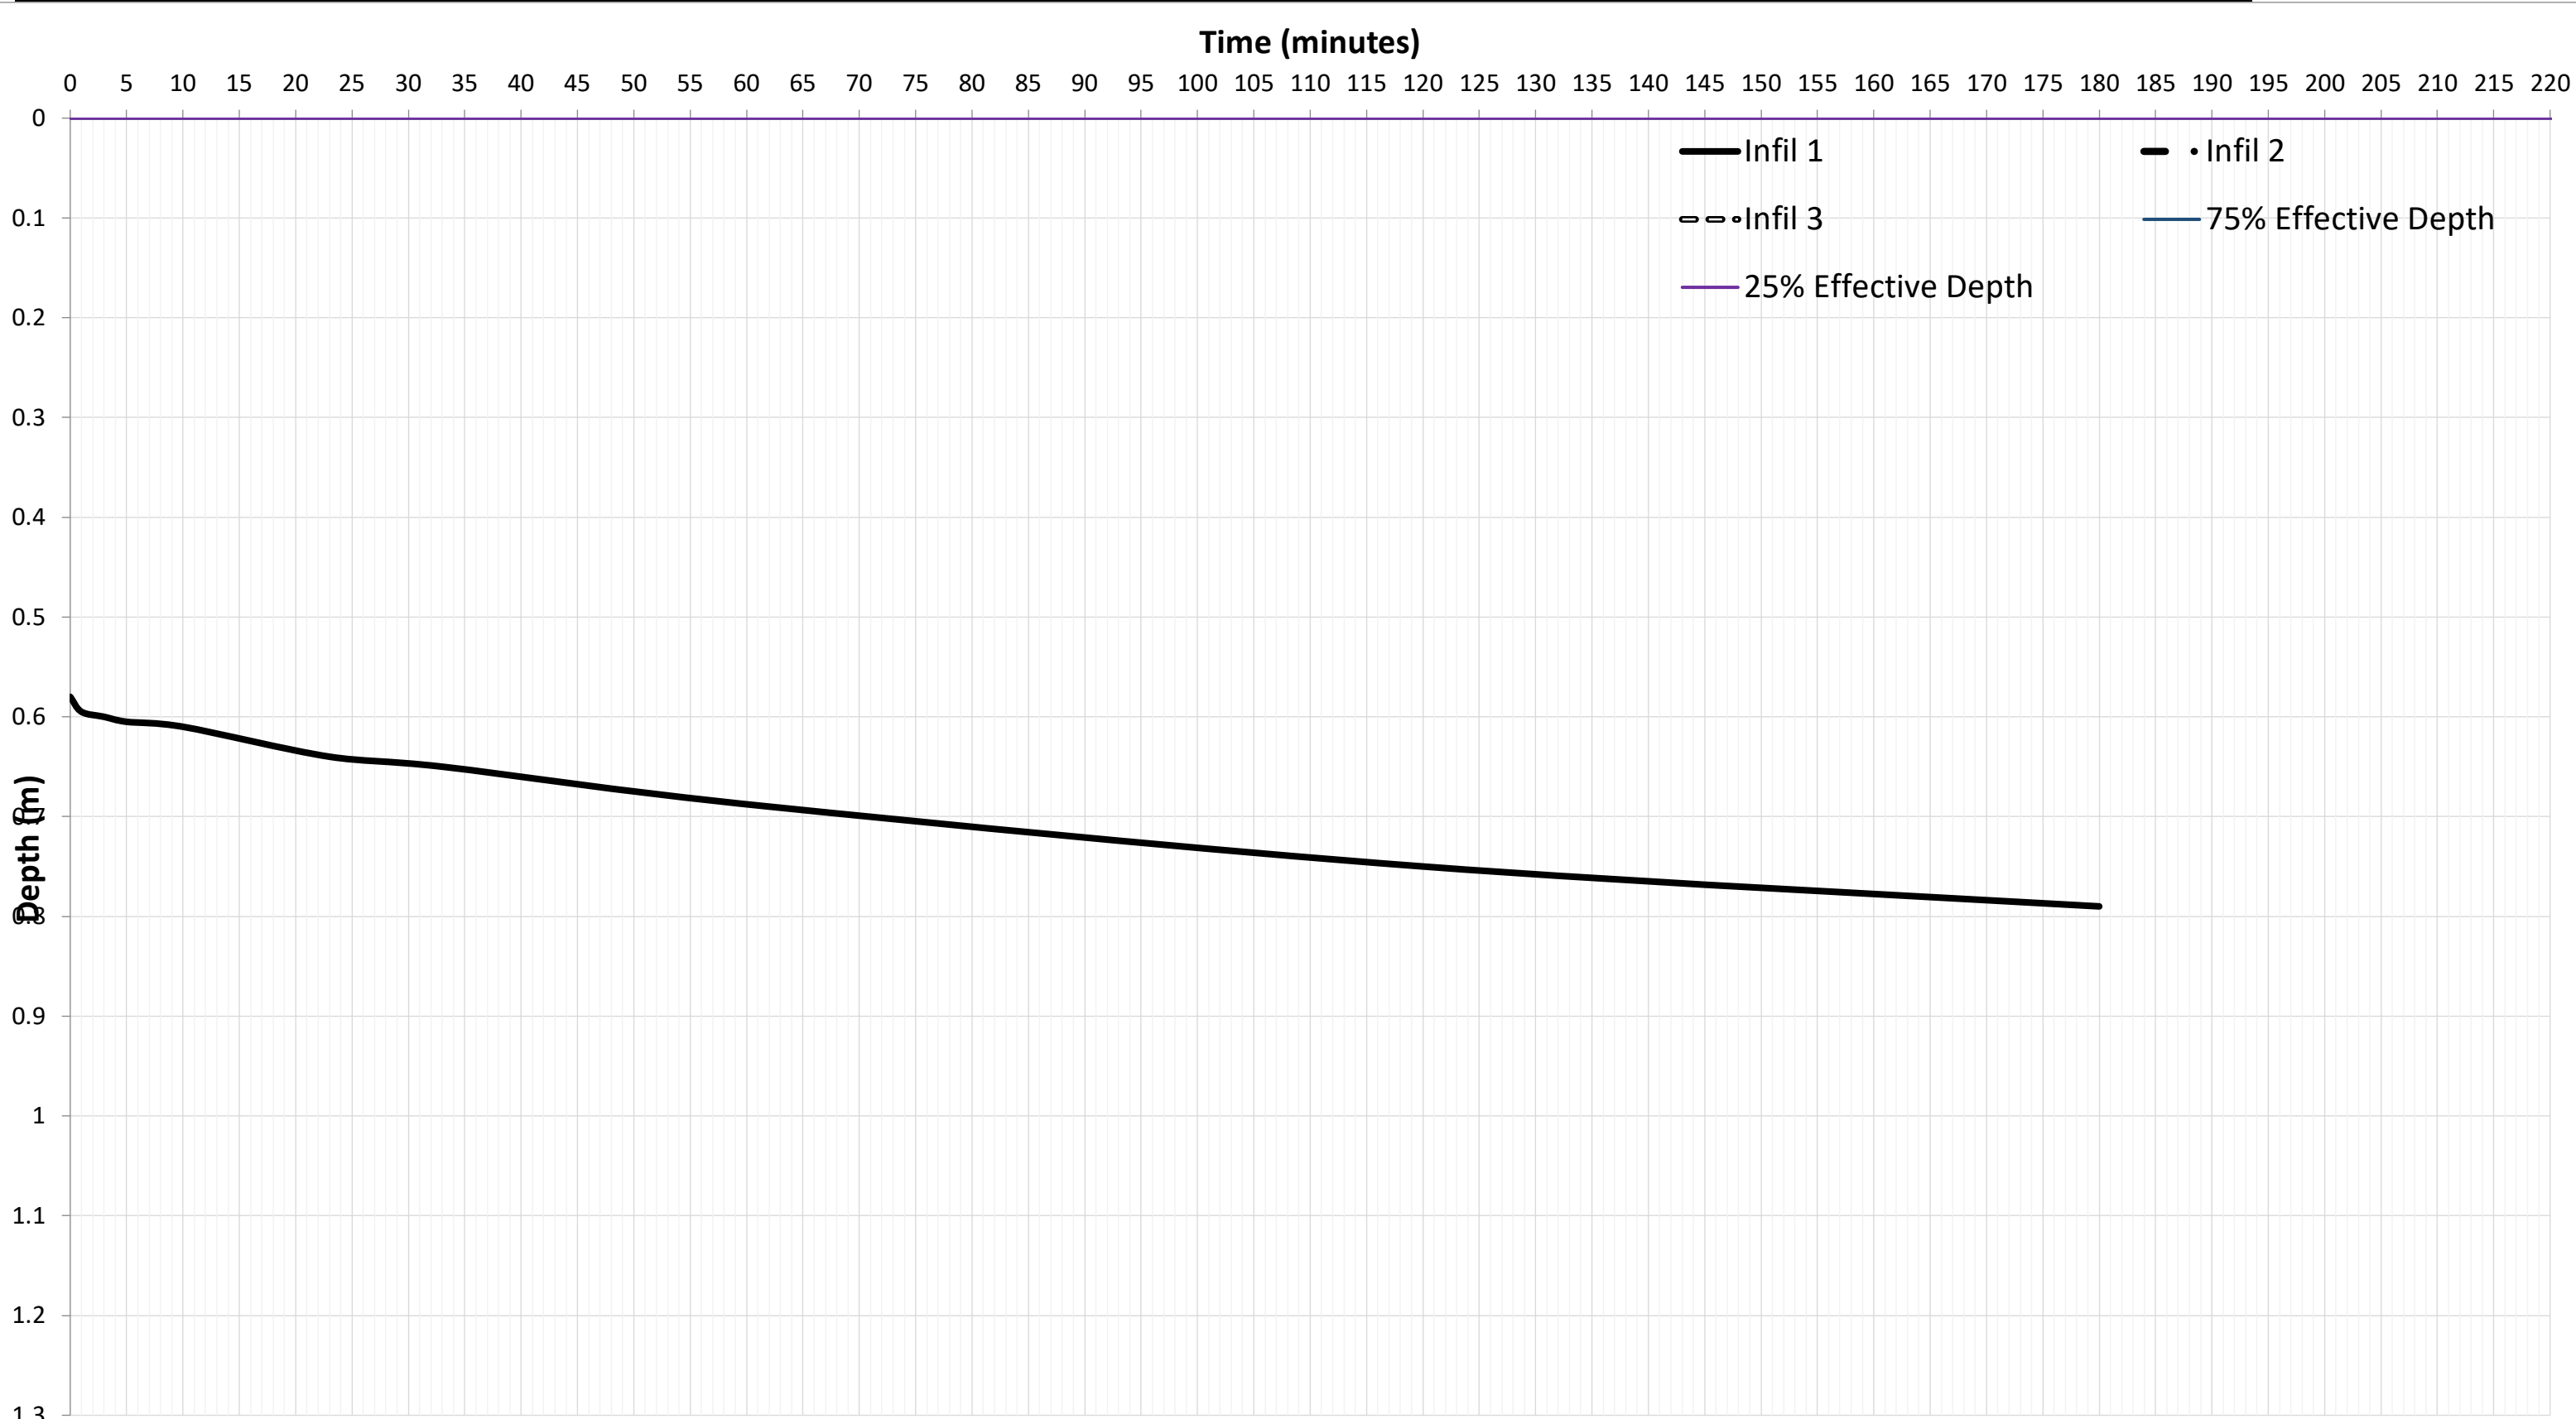
NOTE:

Water level did not fall to below the 25% full level within 24 hrs for fill 1 - Soil infiltration rate based on effective drainage only
