# FLOOD RISK & DRAINAGE

**Milksey Lane, Graveley - Phase 2**  
Flood Risk Assessment  
September 2025

Report Ref: 29161-FLD-0101 Rev A

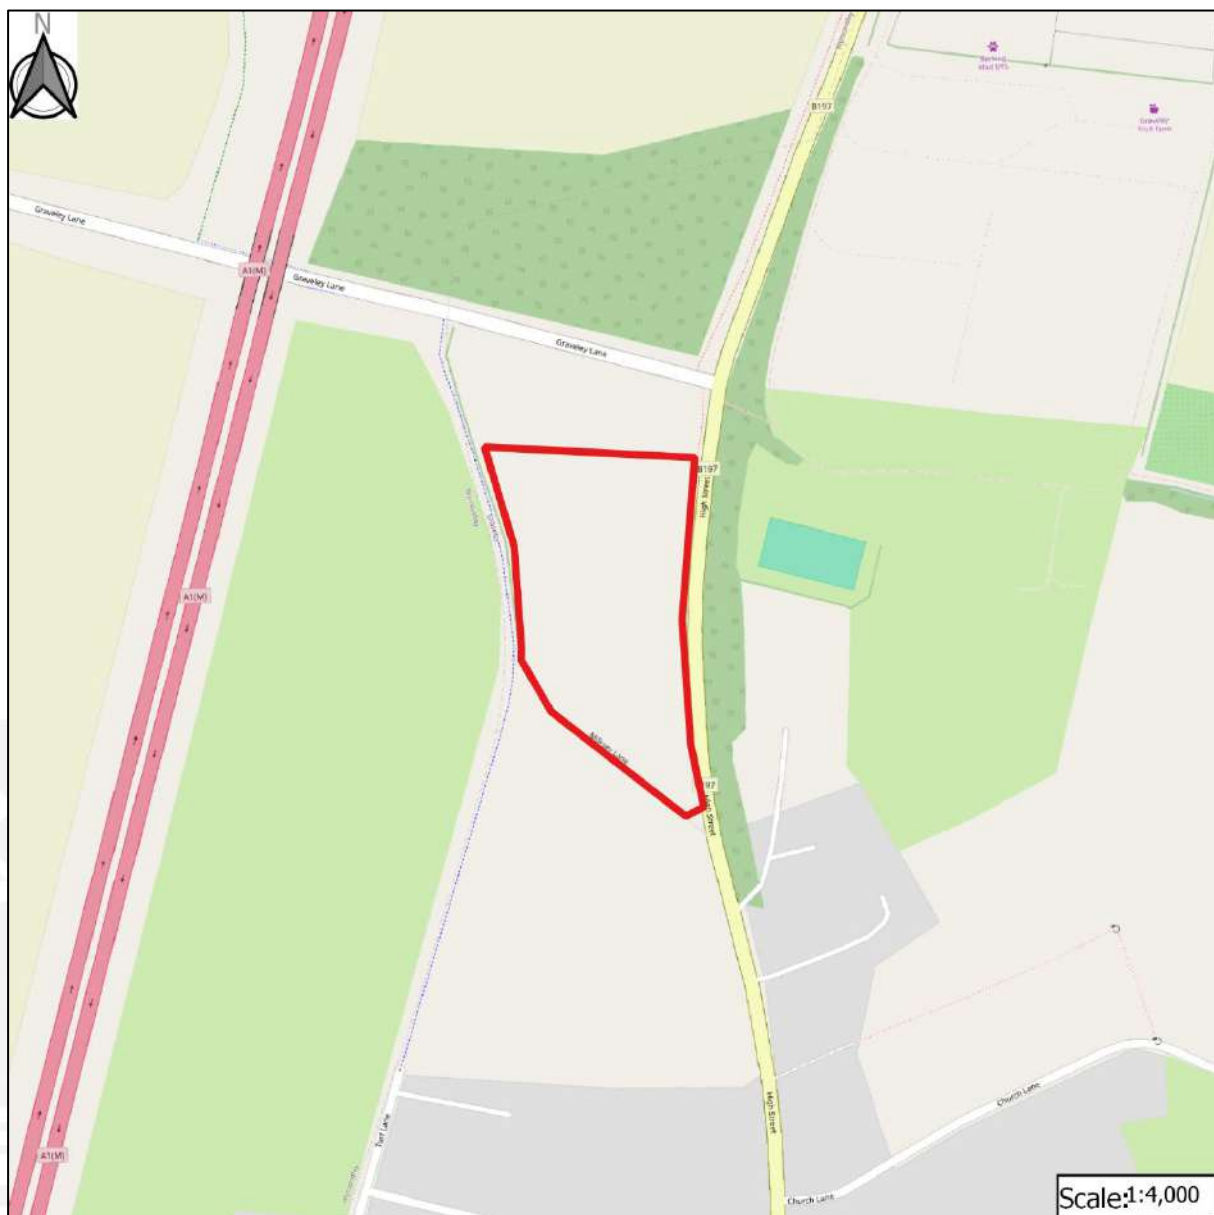
**Figure 3.1: Site Location Plan**

- 3.1 The Ordnance Survey National Grid Reference (NGR) for the centre of the site, E:523023, N:228248. The development site is to the north of Graveley with the current site use assumed to be existing greenfield land. Therefore, it is assumed to be subject to a natural regime of runoff and/or infiltration where ground conditions permit.
- 3.2 The site is bounded to the north by Graveley Lane and to the east is High Street. To the south and west of the site is Milksey Lane and the A1m is further west. The site location is shown in Figure 3.1.

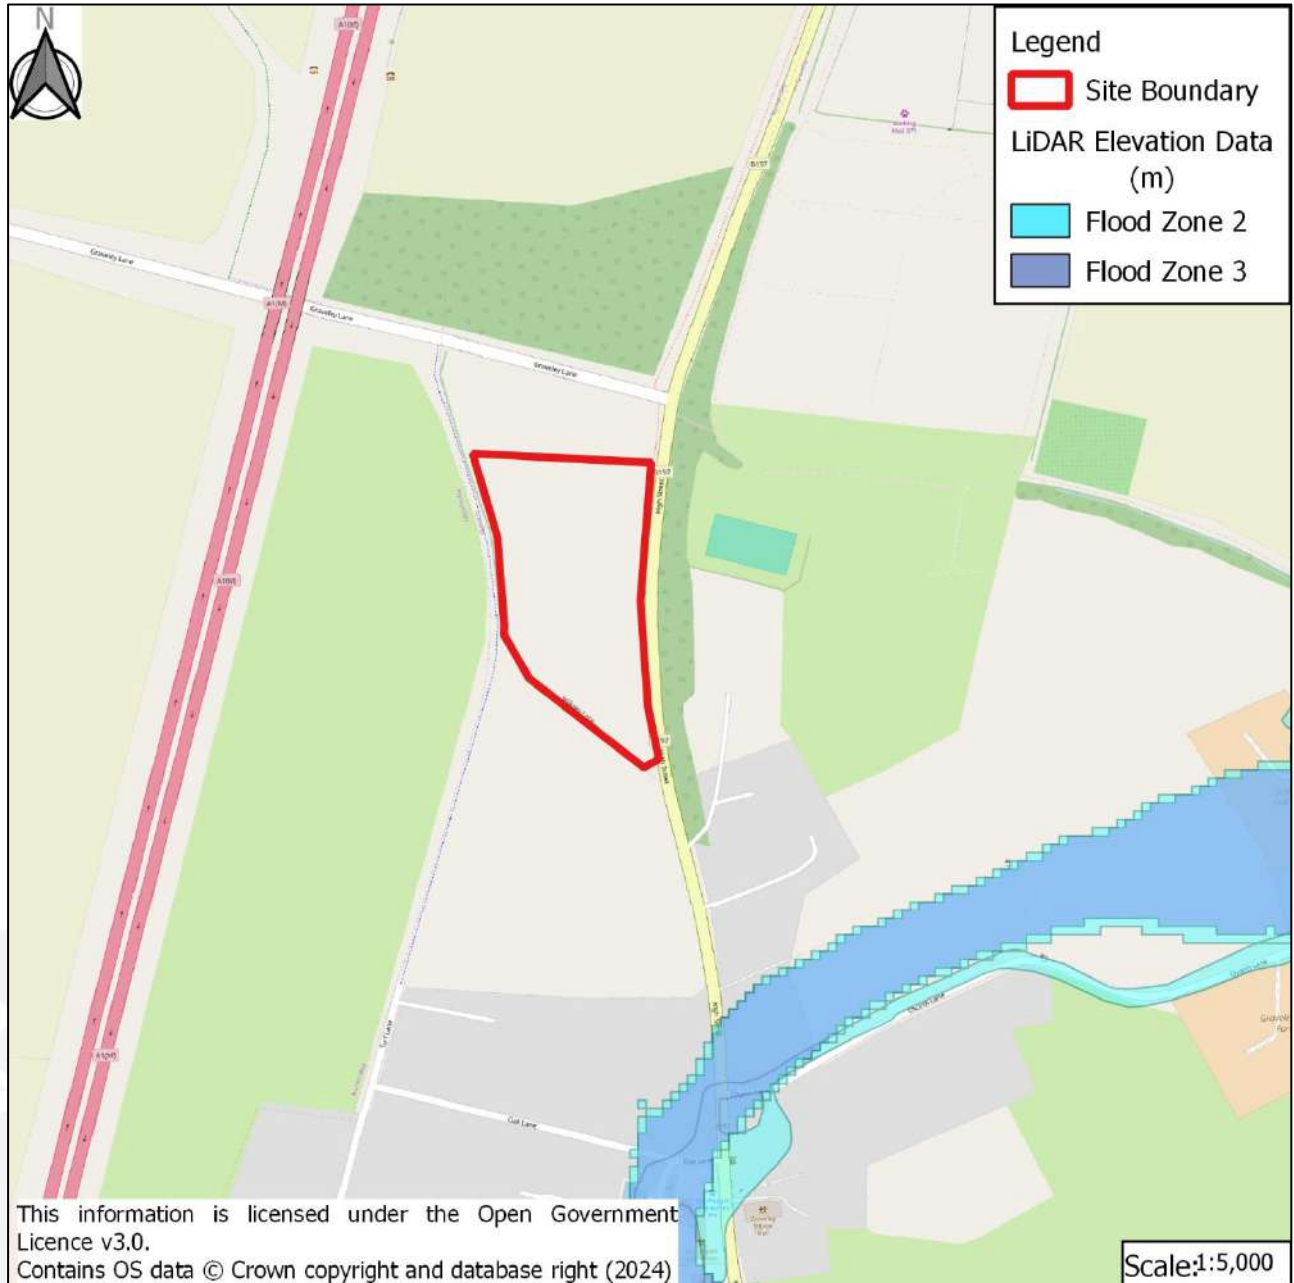
**Figure 4.1: Environment Agency's Flood Map for Planning (Rivers and Seas)**

- 4.1 The Flood Map for Planning is shown in Figure 4.1. The map shows the site lies within Flood Zone 1. Flood Zone 1 (FZ1) is defined as land assessed as having an annual probability of river flooding less than 0.1%.

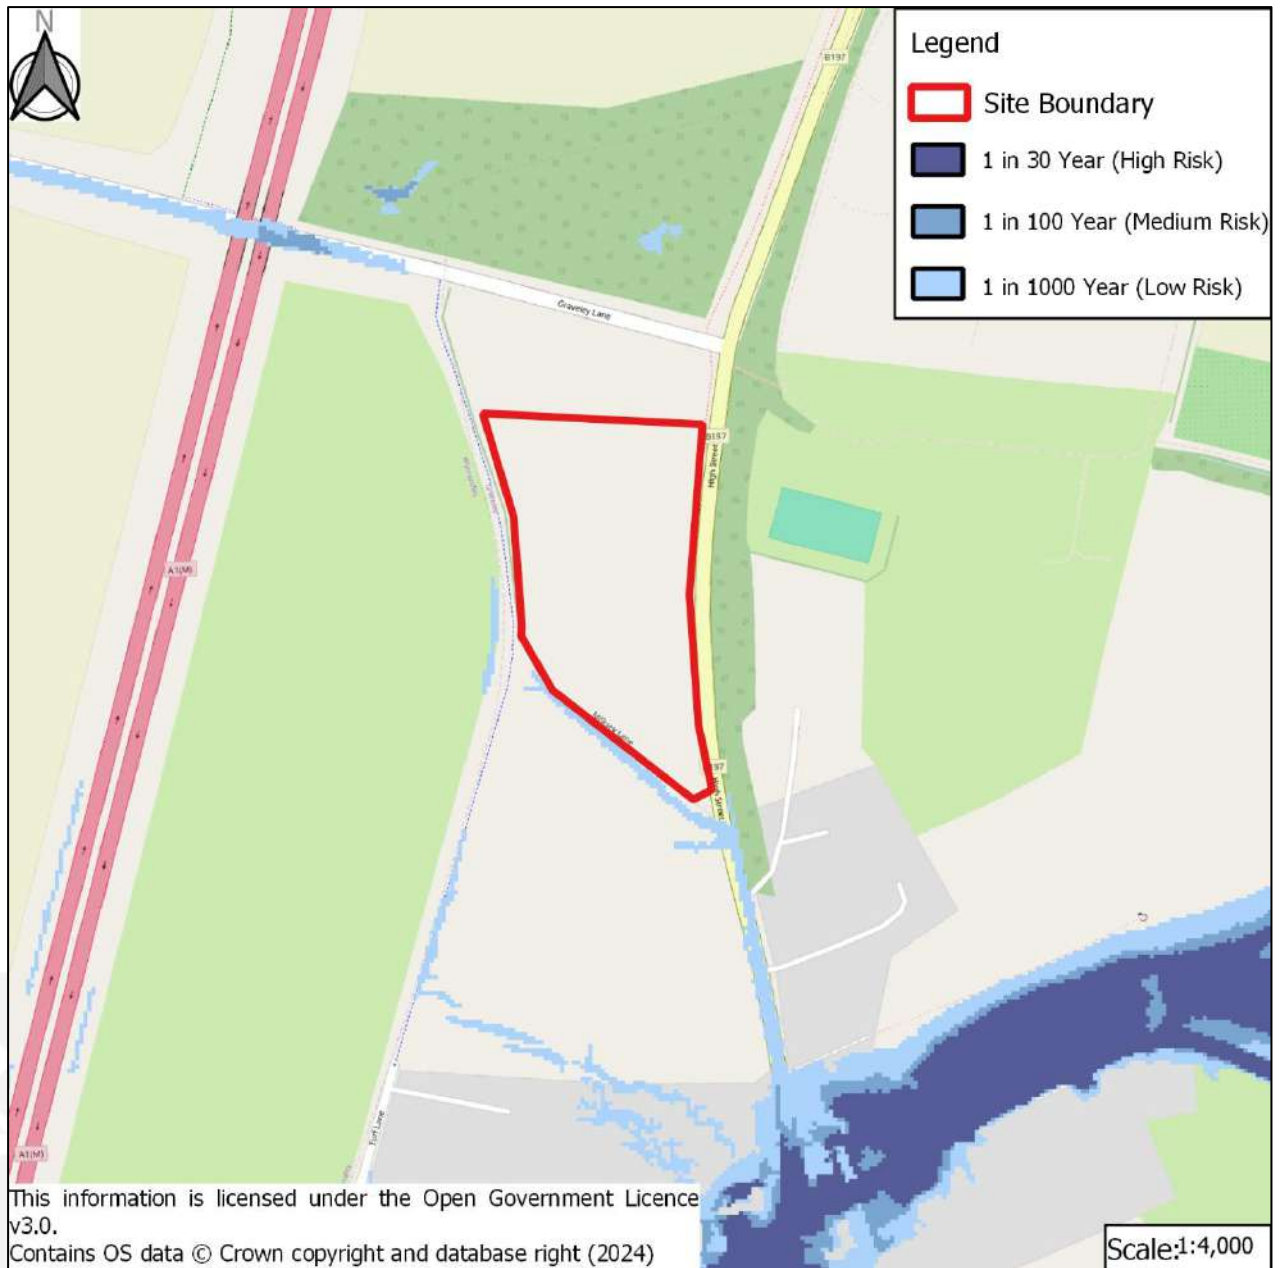
**Figure 4.2: Environment Agency's Flood Risk from Surface Water Map**

- 4.2 The Environment Agency Flood Risk from Surface Water Map (Figure 4.2) indicates that the site is at low risk of surface water flooding. A small flow route along the site's southern boundary, along Milksey Lane, flows south during the 1 in 1000-year storm event (low risk).

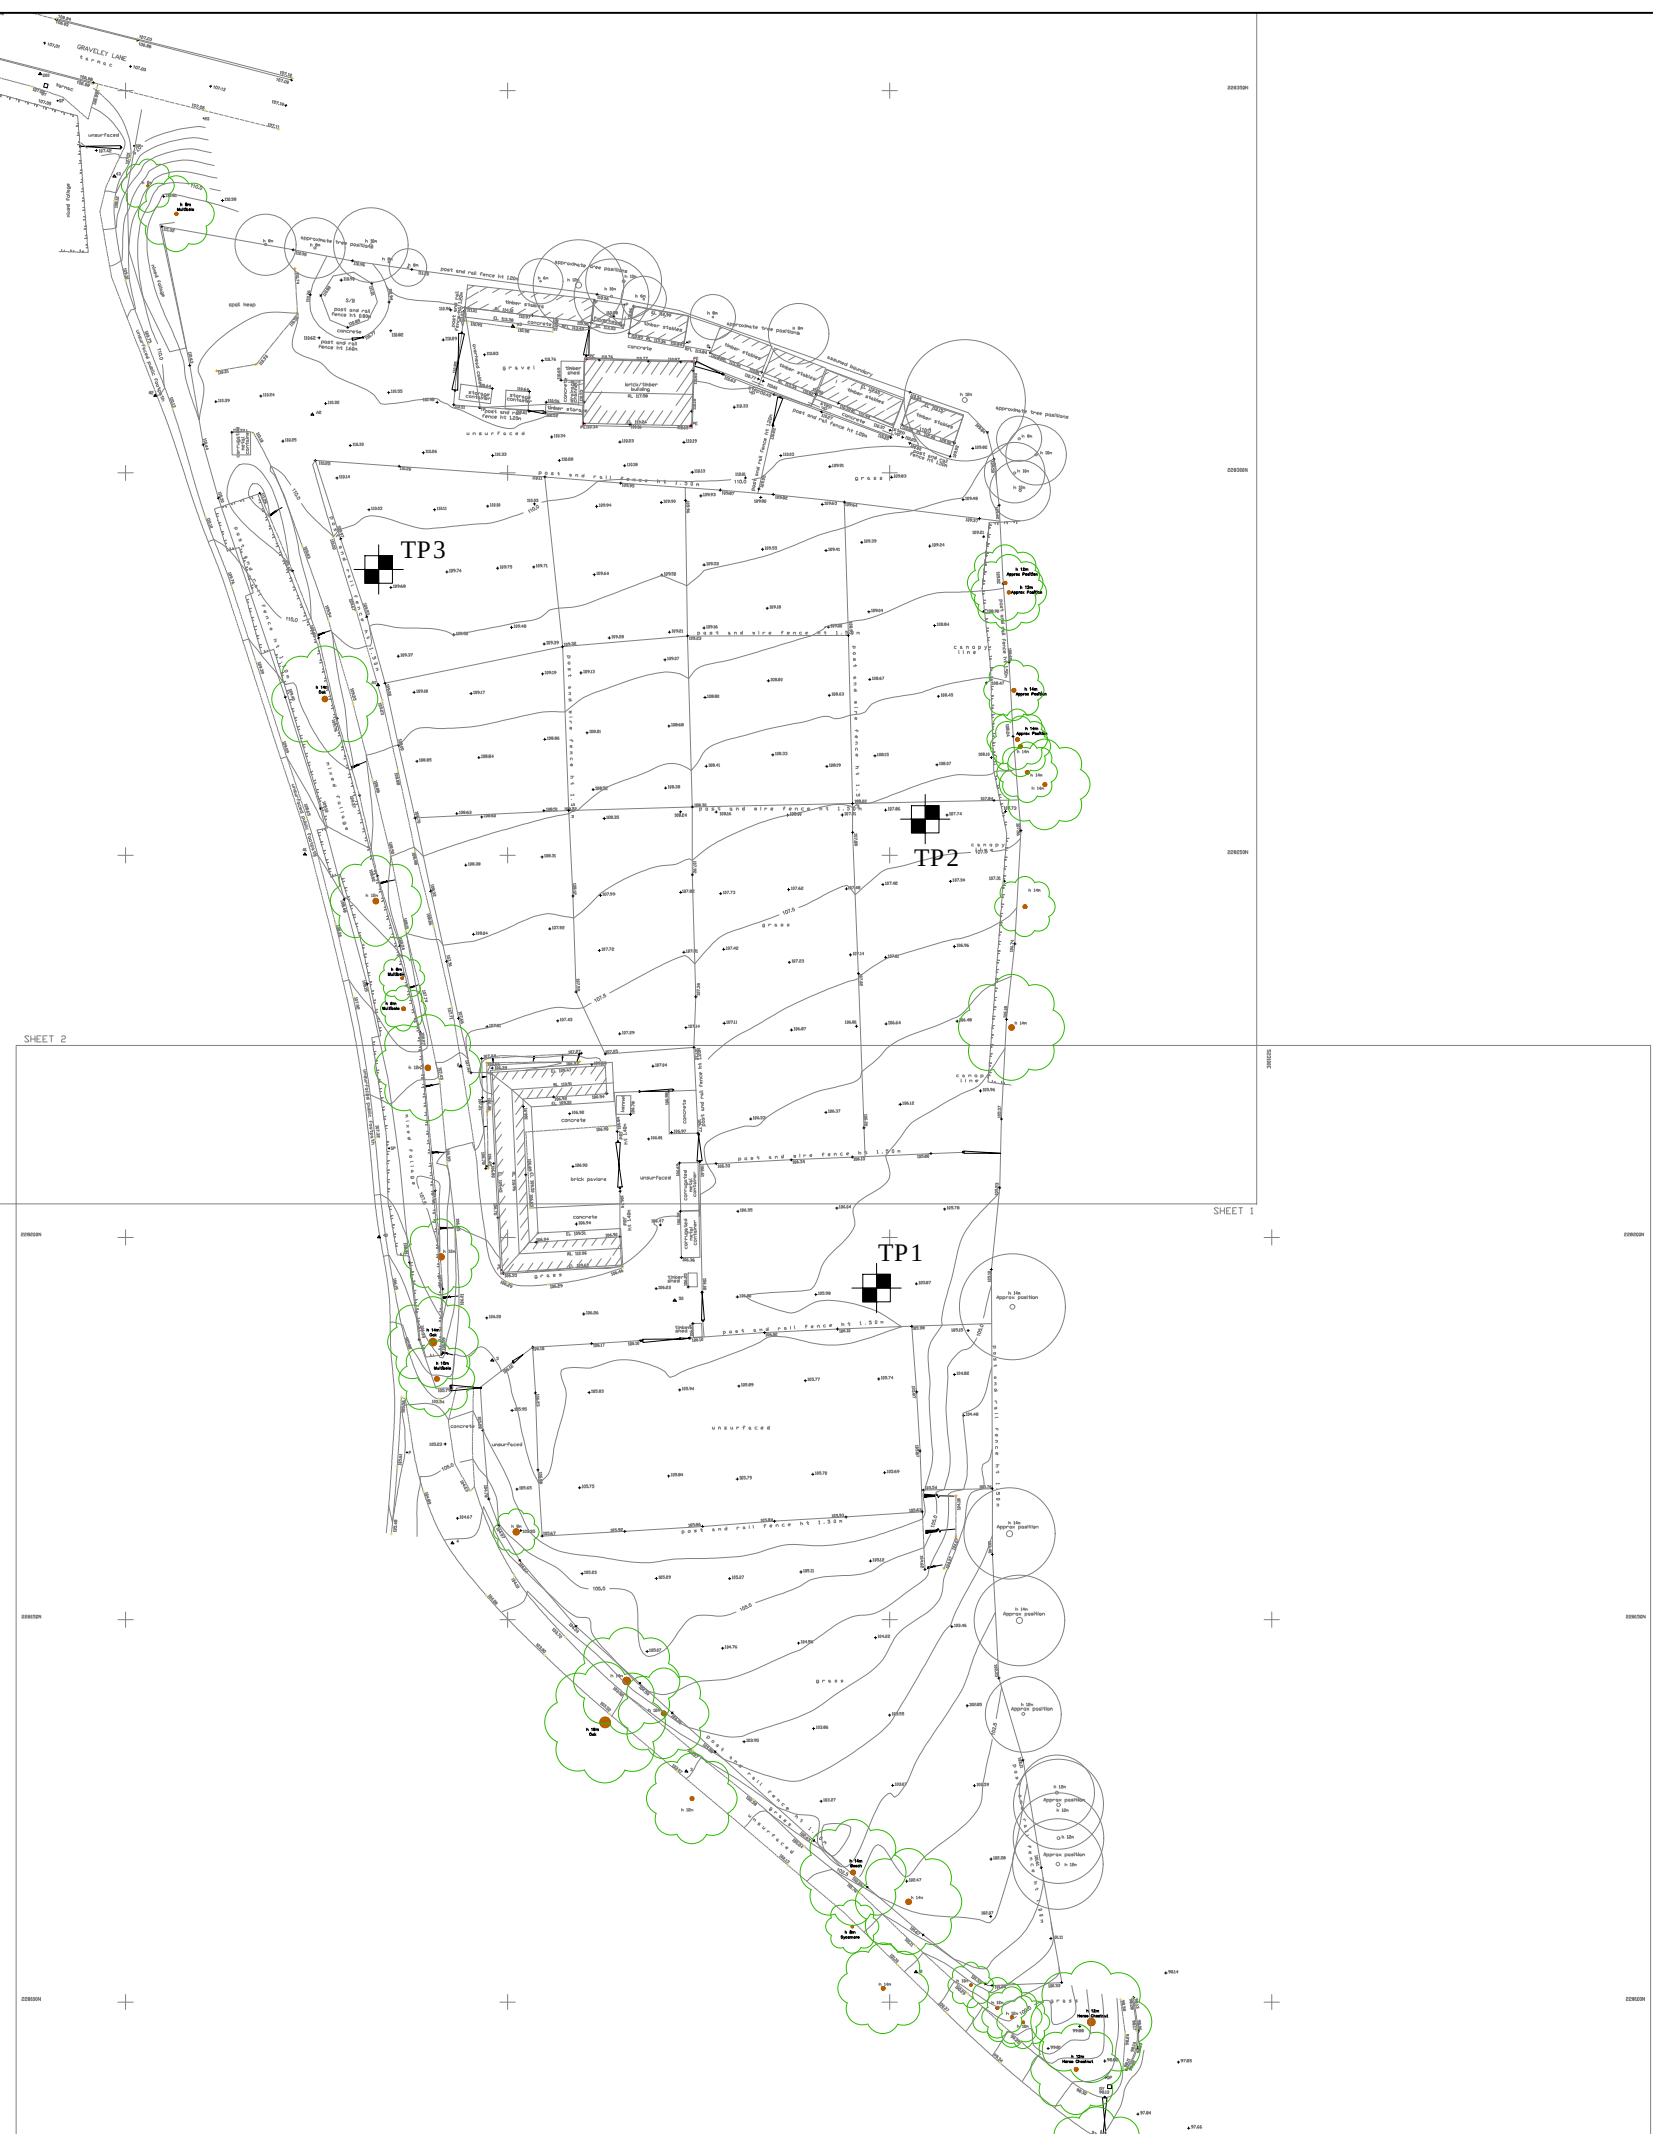
KEY:

■: SOAKAGE TEST LOCATIONS  
(TP1, TP2 & TP3)

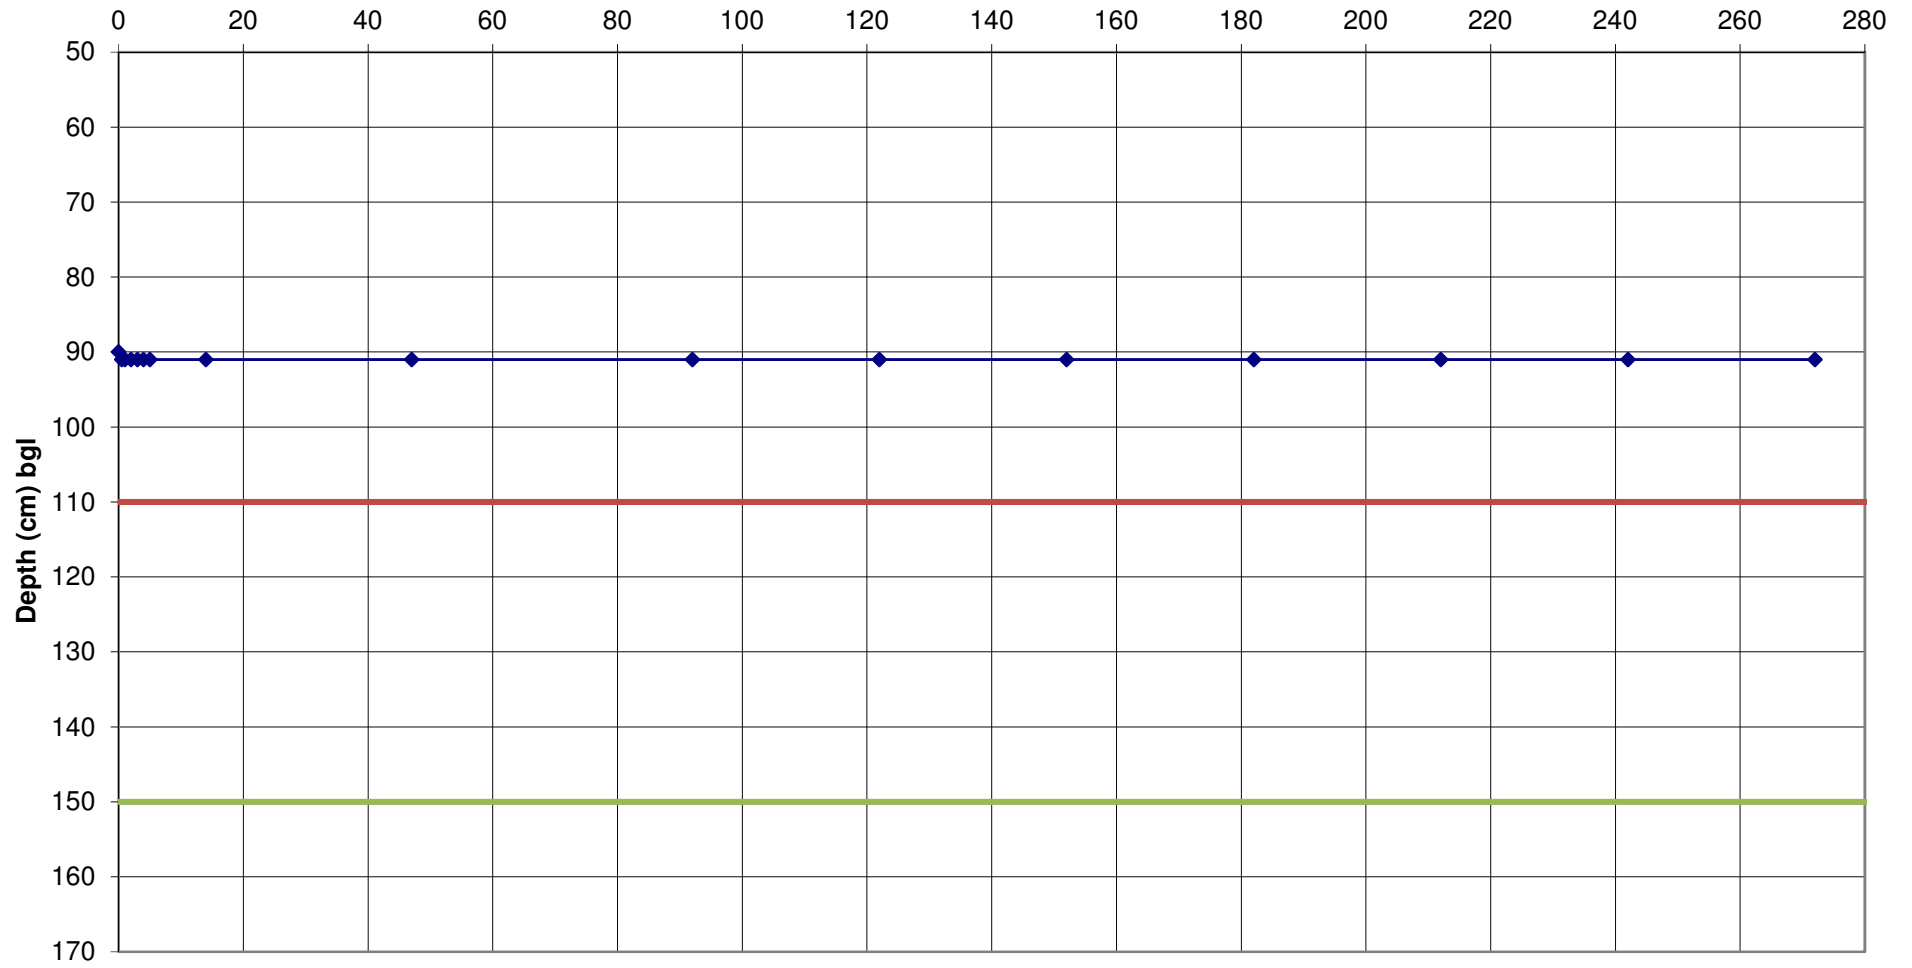
# Milksey Lane, Graveley, Hitchin - TP2 - Test 1

—◆— Measured data      —■— 25% Empty      —▲— 75% Empty

Time (min)

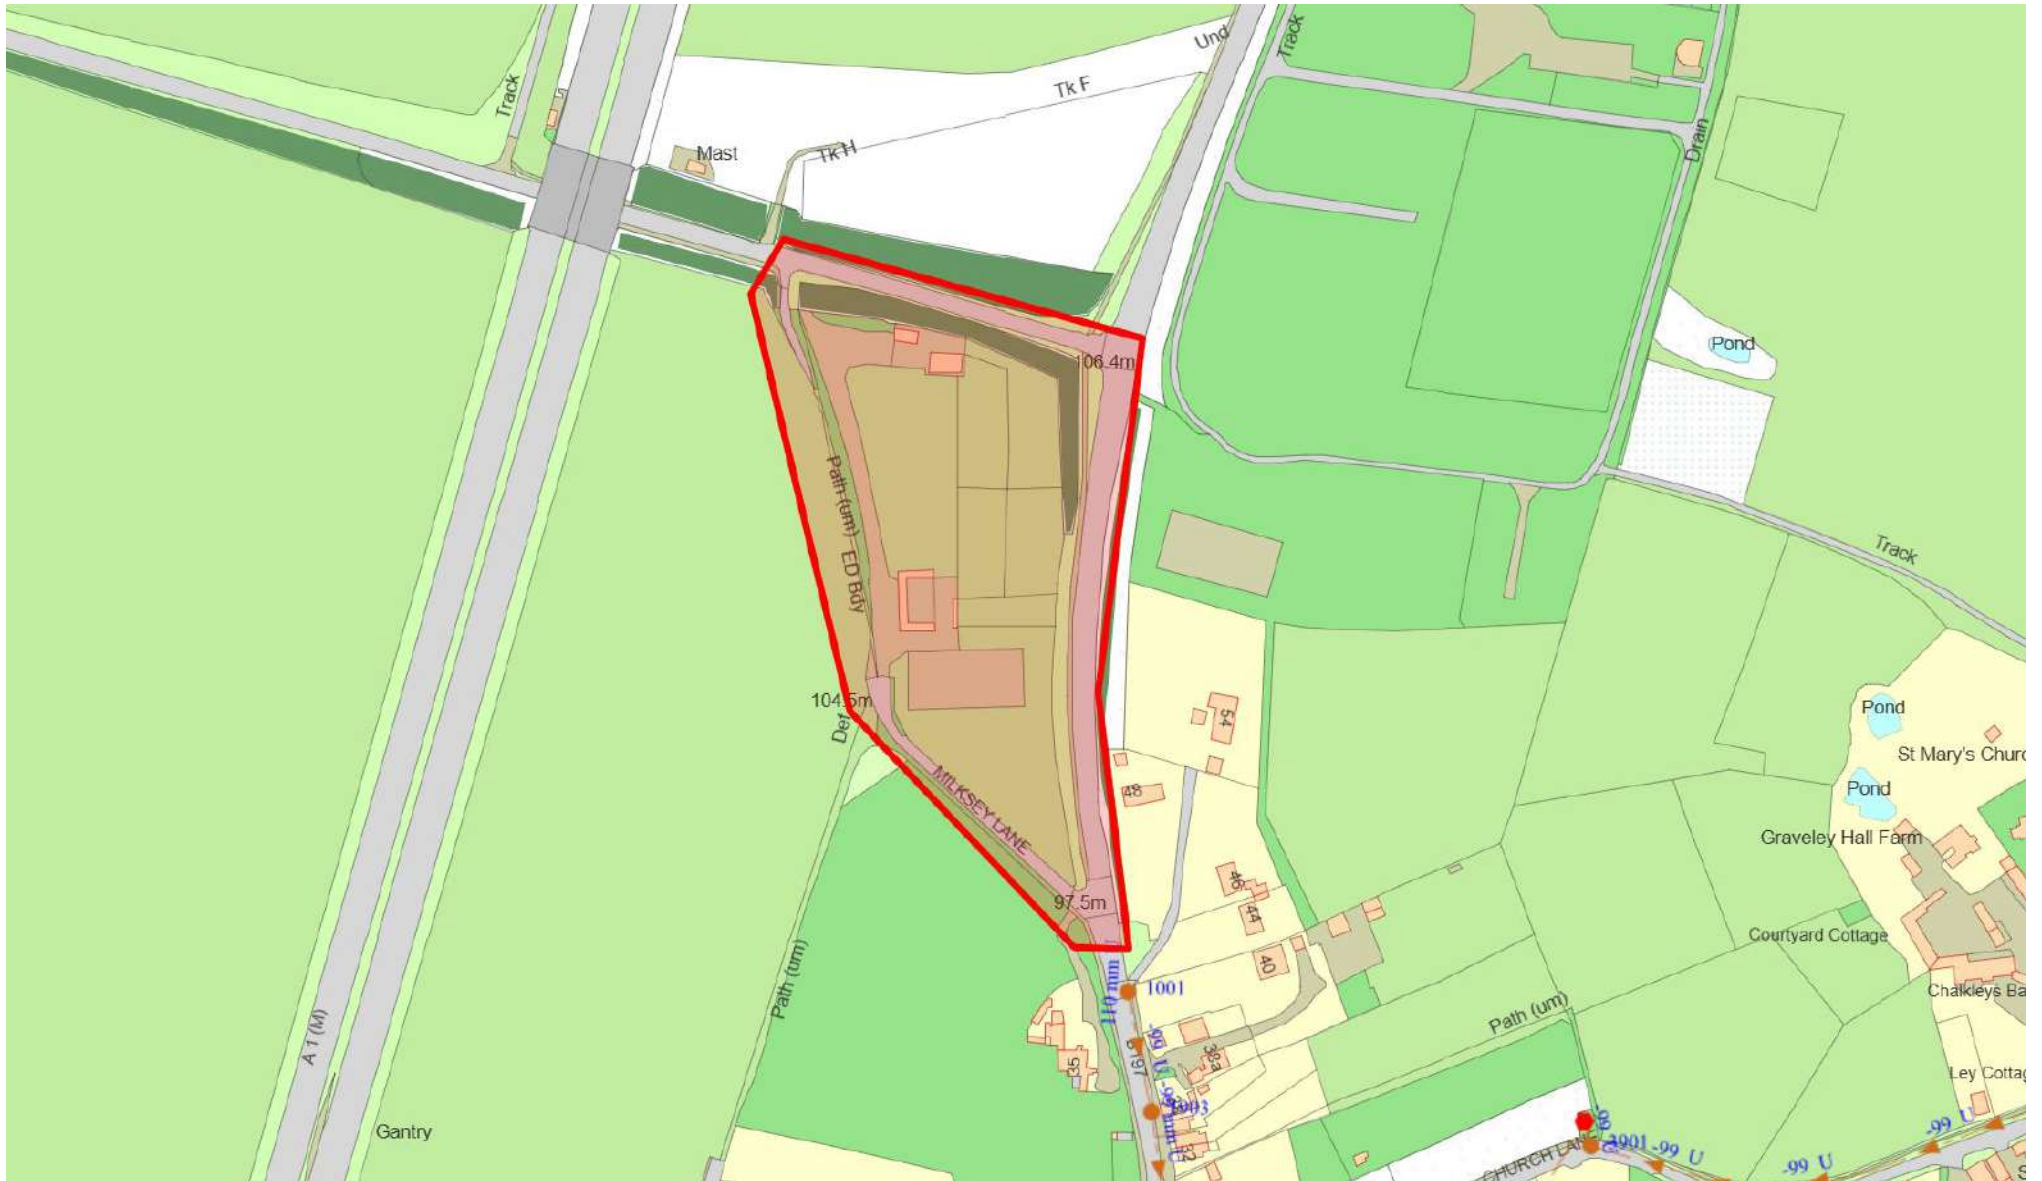
**Figure 1: The site boundary for the proposed development as shown on Anglian Water asset records.**

The proposed development site boundary is highlighted on Anglian Water's asset record in figure 1. Additionally, it is highly recommended that you carry out a thorough investigation of your proposed working area to establish whether any unmapped public or private sewers and lateral drains are in existence.

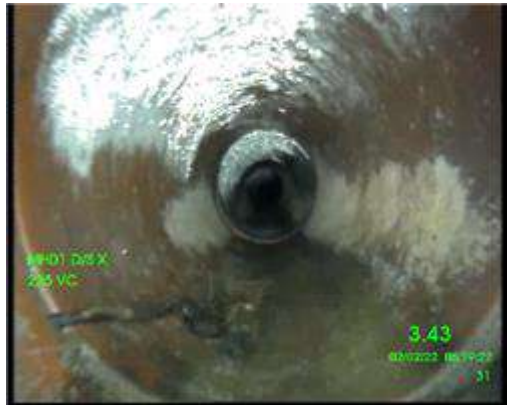
| Pos | Video Ref | Code | Cont. | Description | Image |
|---|---|---|---|---|---|
| 03.4m | 0:00:30 | RT | | Roots tap at joint - Severity 3 | Image Provided - Ref: 0_2<br> |

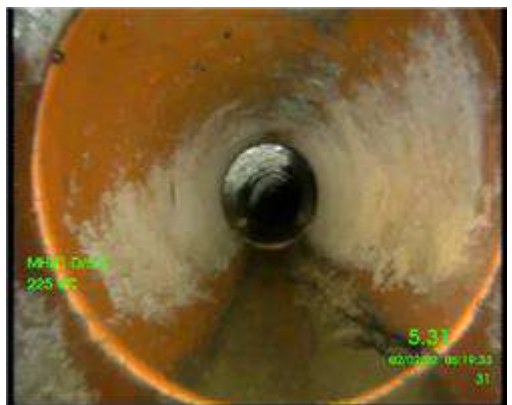
| Pos | Video Ref | Code | Cont. | Description | Image |
|---|---|---|---|---|---|
| 05.3m | 0:00:41 | RF | | Roots fine at joint - Severity 1 | Image Provided - Ref: 0_3<br> |

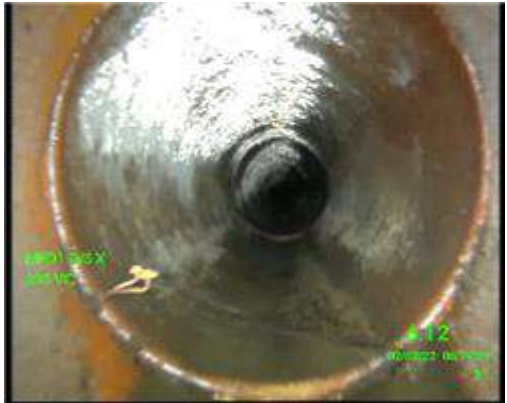
| Pos | Video Ref | Code | Cont. | Description | Image |
|---|---|---|---|---|---|
| 06.1m | 0:00:47 | RF | | Roots fine at joint - Severity 1 | Image Provided - Ref: 0_4<br> |

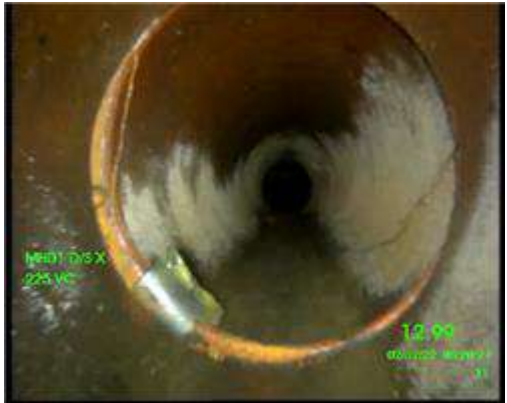
| Pos | Video Ref | Code | Cont. | Description | Image |
|---|---|---|---|---|---|
| 12.9m | 0:01:34 | OBX | | Other obstacles, other object in invert from 07 o'clock to 08 o'clock: 10% cross-sectional area loss - Severity 3<br>POSSIBLE PIECE OF GLASS | Image Provided - Ref: 0_5<br> |

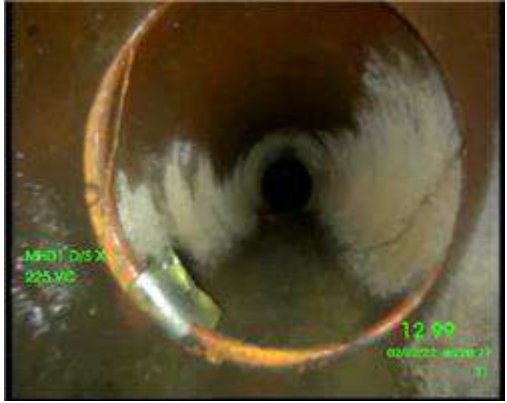
| Pos | Video Ref | Code | Cont. | Description | Image |
|---|---|---|---|---|---|
| 12.9m | 0:01:35 | CC | | Crack, circumferential from 08 o'clock to 10 o'clock - Severity 2 | Image Provided - Ref: 0_6<br> |

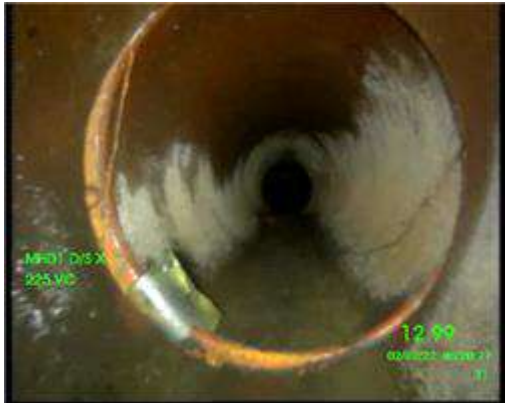
| Pos | Video Ref | Code | Cont. | Description | Image |
|---|---|---|---|---|---|
| 12.9m | 0:01:35 | CS | | Cracks spiral from 03 o'clock to 05 o'clock - Severity 3 | Image Provided - Ref: 0_7<br> |

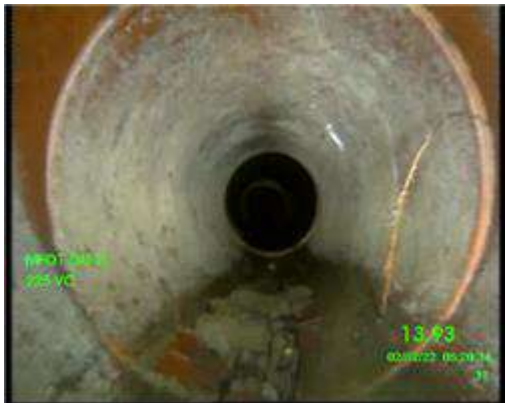
| Pos | Video Ref | Code | Cont. | Description | Image |
|---|---|---|---|---|---|
| 13.9m | 0:01:42 | RF | | Roots fine at joint - Severity 1 | Image Provided - Ref: 0_8<br> |

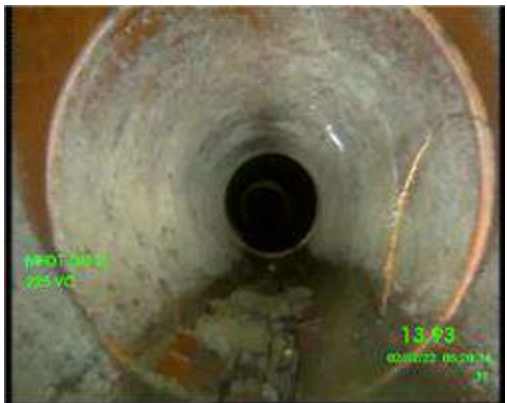
| Pos | Video Ref | Code | Cont. | Description | Image |
|---|---|---|---|---|---|
| 13.9m | 0:01:42 | DES | | Settled deposits fine: 10% cross-sectional area loss - Severity 2 | Image Provided - Ref: 0_9<br> |

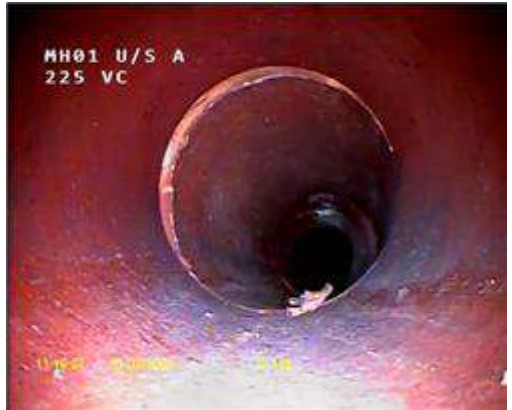
| Pos | Video Ref | Code | Cont. | Description | Image |
|---|---|---|---|---|---|
| 00.1m | 0:00:00 | JDM | | Joint displaced medium - Severity 2 | Image Provided - Ref: 2_2<br> |

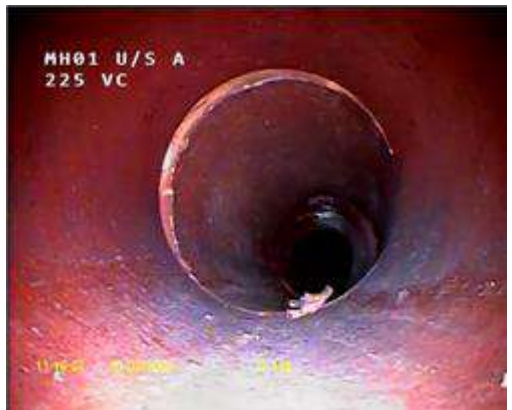
| Pos | Video Ref | Code | Cont. | Description | Image |
|---|---|---|---|---|---|
| 00.1m | 0:00:00 | LR | | Line of drain/sewer deviates right | Image Provided - Ref: 2_3<br> |

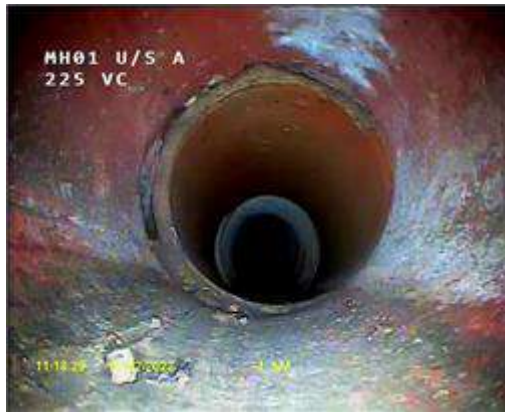
| Pos | Video Ref | Code | Cont. | Description | Image |
|---|---|---|---|---|---|
| 01.5m | 0:00:07 | JDM | | Joint displaced medium - Severity 2 | Image Provided - Ref: 2_4<br> |

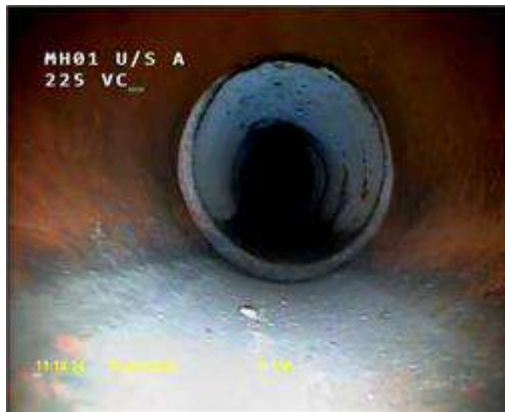
| Pos | Video Ref | Code | Cont. | Description | Image |
|---|---|---|---|---|---|
| 02.1m | 0:00:11 | JDM | | Joint displaced medium - Severity 2 | Image Provided - Ref: 2_5<br> |

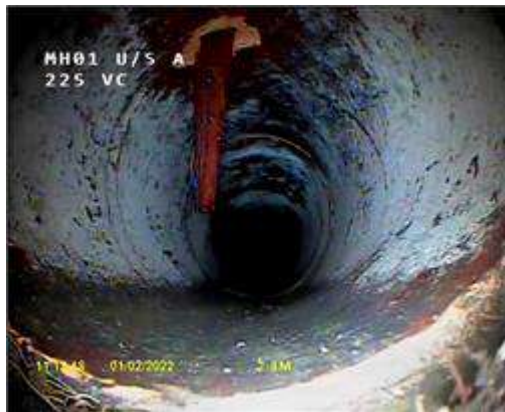
| Pos | Video Ref | Code | Cont. | Description | Image |
|---|---|---|---|---|---|
| 02.8m | 0:00:26 | OBI | | Other obstacle, protruding through wall from 11 o'clock to 12 o'clock: 60% cross-sectional area loss - Severity 4 | Image Provided - Ref: 2_6<br> |

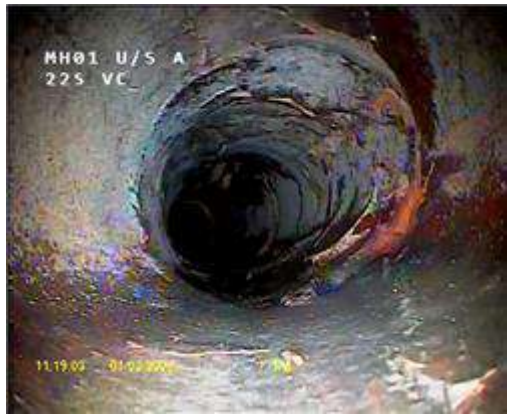
| Pos | Video Ref | Code | Cont. | Description | Image |
|---|---|---|---|---|---|
| 07.3m | 0:00:42 | FM | S1 | Fracture multiple 7.3m - 9.2m from 12 o'clock to 12 o'clock - Severity 4 | Image Provided - Ref: 2_7<br> |

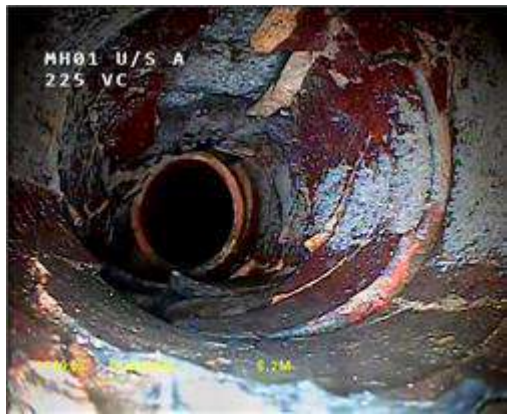
| Pos | Video Ref | Code | Cont. | Description | Image |
|---|---|---|---|---|---|
| 08.2m | 0:00:46 | B | | Broken pipe from 11 o'clock to 01 o'clock - Severity 4 | Image Provided - Ref: 2_8<br> |

| Position | Code | Description | CD | Pic | Video Ref | |
|---|---|---|---|---|---|--|
| 08.2 | B | Broken pipe 11-01 | | 2_8 | 0:00:46 | |

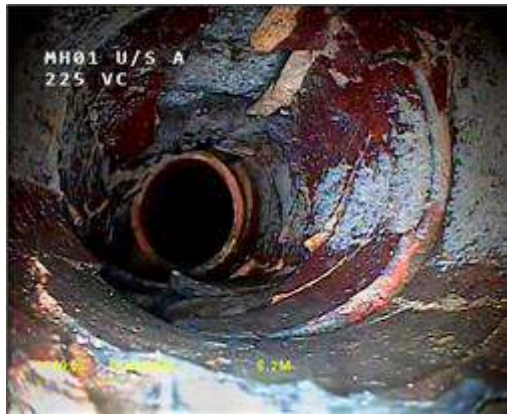
| Pos | Video Ref | Code | Cont. | Description | Image |
|---|---|---|---|---|---|
| 08.2m | 0:00:46 | FM | | Fracture multiple from 05 o'clock to 07 o'clock - Severity 4 | Image Provided - Ref: 2_10<br> |

| Position | Code | Description | CD | Pic | Video Ref | |
|---|---|---|---|---|---|--|
| 08.2 | FM | Fracture multiple 05-07 | | 2_1 | 0:00:46 | |

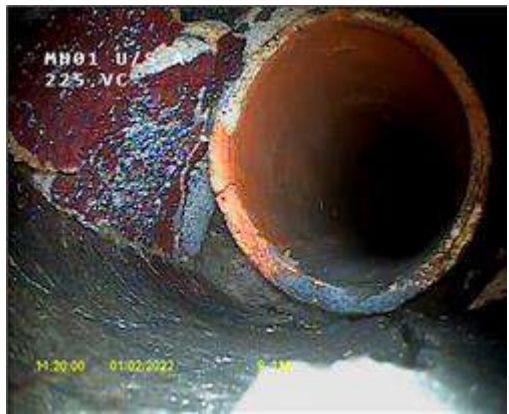
| Pos | Video Ref | Code | Cont. | Description | Image |
|---|---|---|---|---|---|
| 09.1m | 0:01:39 | WL | | Water level: 0% Height/Diameter | Image Provided - Ref: 2_12<br> |

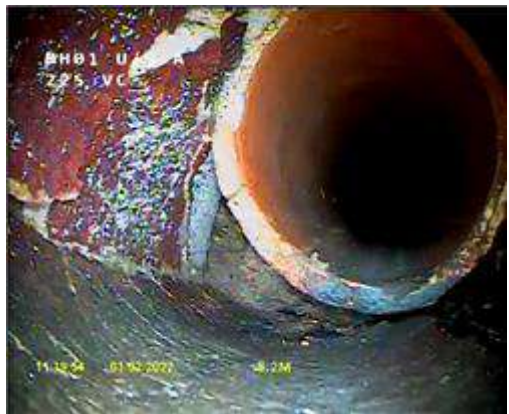
| Pos | Video Ref | Code | Cont. | Description | Image |
|---|---|---|---|---|---|
| 09.2m | 0:01:32 | SC | | Shape and/or size drain/sewer changes: Shape Changes To: 150mm Diameter | Image Provided - Ref: 2_11<br> |

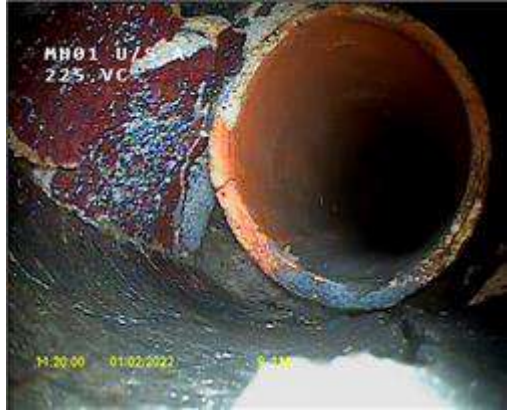
| Pos | Video Ref | Code | Cont. | Description | Image |
|---|---|---|---|---|---|
| 09.2m | | SA | | Survey abandoned<br>EOT | <p>Image Provided - Ref: 2_9999</p> |

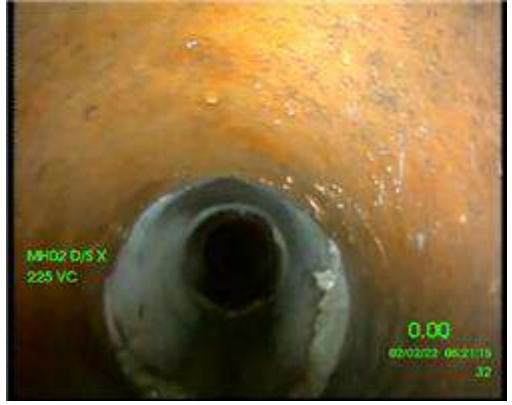
| Pos | Video Ref | Code | Cont. | Description | Image |
|---|---|---|---|---|---|
| 00.0m | 0:00:00 | WL | | Water level: 0%<br>Height/Diameter | Image Provided - Ref: 1_1<br> |

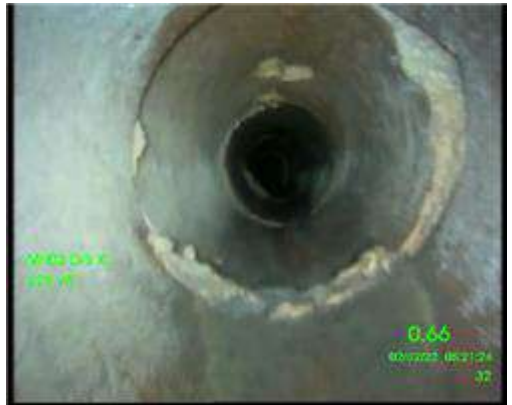
| Pos | Video Ref | Code | Cont. | Description | Image |
|---|---|---|---|---|---|
| 00.6m | 0:00:09 | DEE | | Attached deposits, encrustation from 02 o'clock to 08 o'clock:<br>10% cross-sectional area loss at joint - Severity 3 | Image Provided - Ref: 1_2<br> |

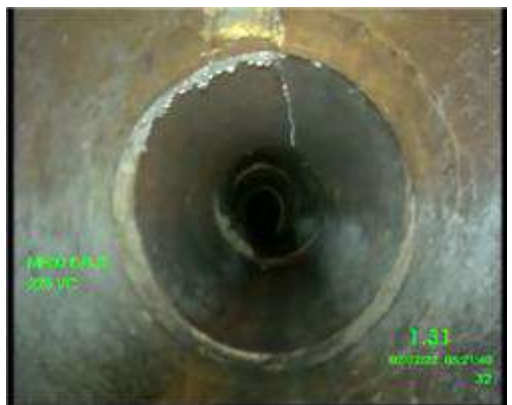
| Pos | Video Ref | Code | Cont. | Description | Image |
|---|---|---|---|---|---|
| 01.3m | 0:00:24 | CC | | Crack, circumferential from 12 o'clock to 03 o'clock - Severity 2 | Image Provided - Ref: 1_3<br> |

| Position | Code | Description | CD | Pic | Video Ref | |
|---|---|---|---|---|---|--|
| 01.3 | CC | Crack, circumferential 12-03 | | 1_3 | 0:00:24 | |

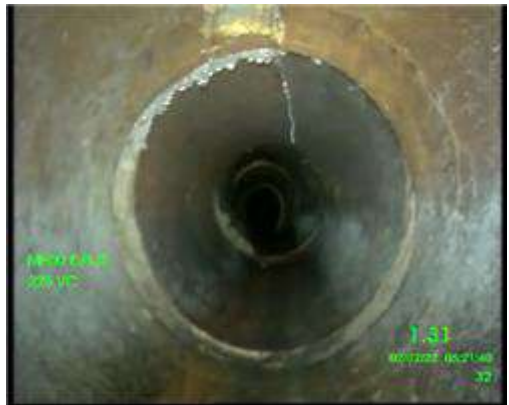
| Pos | Video Ref | Code | Cont. | Description | Image |
|---|---|---|---|---|---|
| 01.3m | 0:00:24 | CC | | Crack, circumferential from 10 o'clock to 01 o'clock - Severity 2 | Image Provided - Ref: 1_4<br> |

| Position | Code | Description | CD | Pic | Video Ref | |
|---|---|---|---|---|---|--|
| 01.3 | CC | Crack, circumferential 10-01 | | 1_4 | 0:00:24 | |

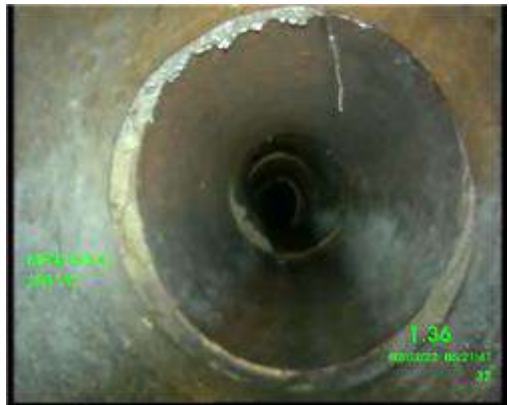
| Pos | Video Ref | Code | Cont. | Description | Image |
|---|---|---|---|---|---|
| 01.3m | 0:00:24 | OJM | | Open joint medium - Severity 2 | Image Provided - Ref: 1_5<br> |

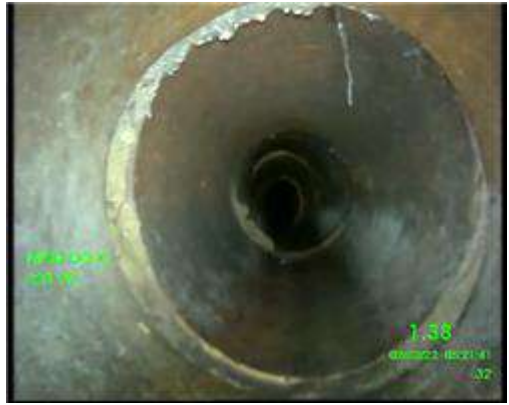
| Pos | Video Ref | Code | Cont. | Description | Image |
|---|---|---|---|---|---|
| 01.3m | 0:00:26 | DEE | | Attached deposits, encrustation from 10 o'clock to 01 o'clock: 5% cross-sectional area loss at joint - Severity 3 | Image Provided - Ref: 1_6<br> |

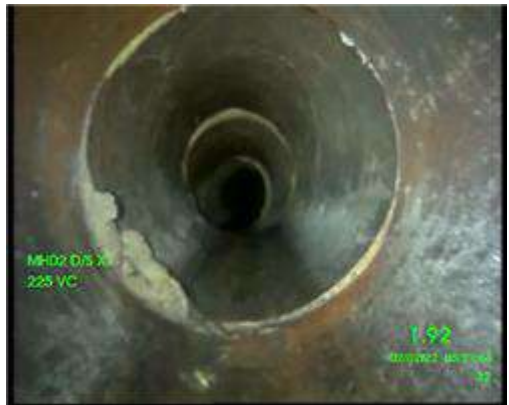
| Pos | Video Ref | Code | Cont. | Description | Image |
|---|---|---|---|---|---|
| 01.3m | 0:00:31 | DEE | | Attached deposits, encrustation from 07 o'clock to 09 o'clock: 10% cross-sectional area loss at joint - Severity 3 | Image Provided - Ref: 1_7<br> |

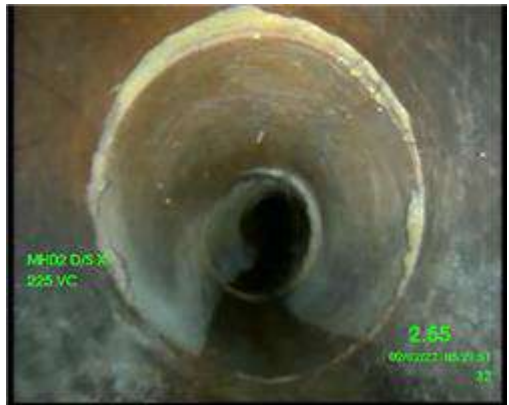
| Pos | Video Ref | Code | Cont. | Description | Image |
|---|---|---|---|---|---|
| 02.5m | 0:00:36 | DEE | | Attached deposits, encrustation from 10 o'clock to 02 o'clock: 5% cross-sectional area loss at joint - Severity 3 | Image Provided - Ref: 1_8<br> |

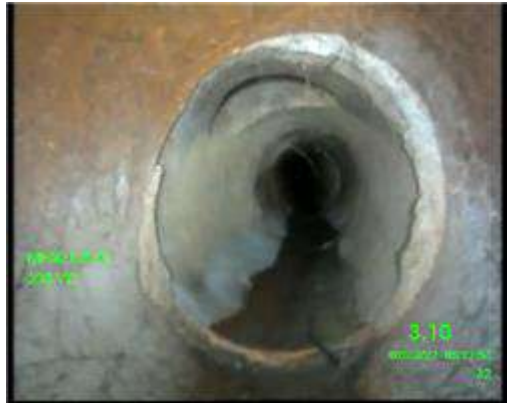
| Pos | Video Ref | Code | Cont. | Description | Image |
|---|---|---|---|---|---|
| 03.1m | 0:00:41 | DEE | | Attached deposits, encrustation from 11 o'clock to 09 o'clock: 10% cross-sectional area loss at joint - Severity 3 | Image Provided - Ref: 1_9<br> |

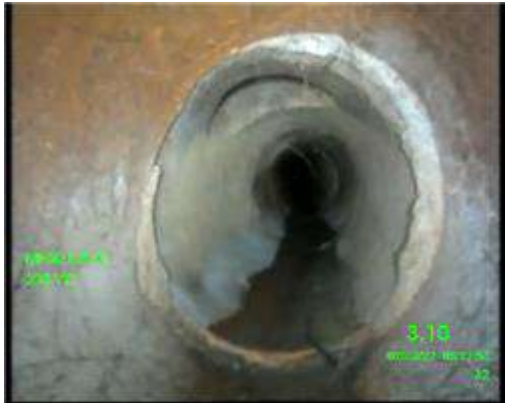
| Pos | Video Ref | Code | Cont. | Description | Image |
|---|---|---|---|---|---|
| 03.1m | 0:00:41 | JN | | Junction at 11 o'clock: 150mm Diameter | Image Provided - Ref: 1_10<br> |

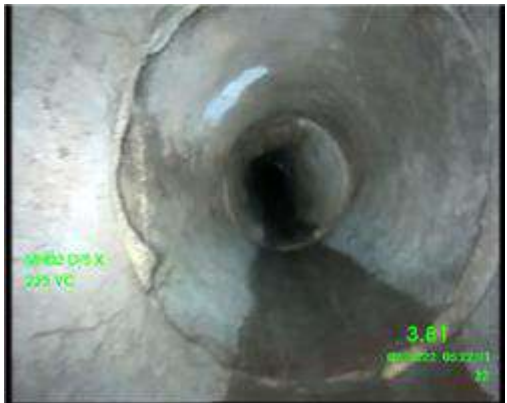
| Pos | Video Ref | Code | Cont. | Description | Image |
|---|---|---|---|---|---|
| 03.8m | 0:00:46 | DEE | | Attached deposits, encrustation from 07 o'clock to 10 o'clock: 5% cross-sectional area loss at joint - Severity 3 | Image Provided - Ref: 1_11<br> |

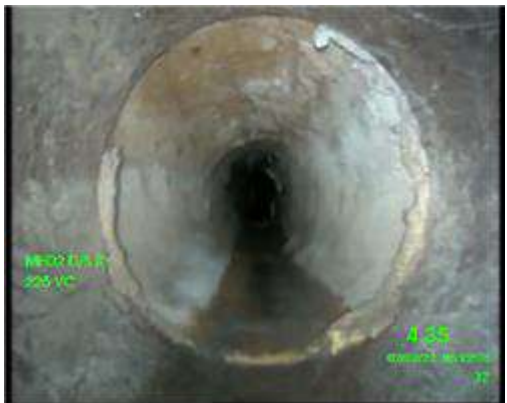
| Pos | Video Ref | Code | Cont. | Description | Image |
|---|---|---|---|---|---|
| 04.3m | 0:00:51 | DEE | | Attached deposits, encrustation from 01 o'clock to 09 o'clock: 5% cross-sectional area loss at joint - Severity 3 | Image Provided - Ref: 1_12<br> |

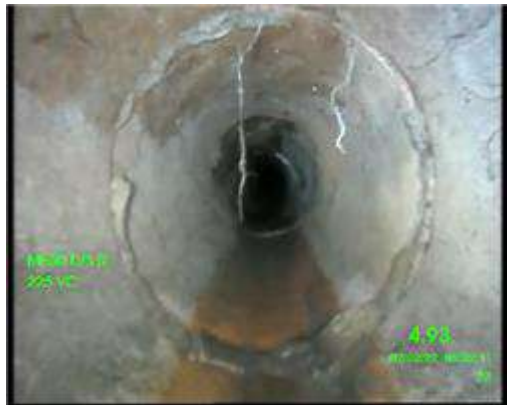
| Pos | Video Ref | Code | Cont. | Description | Image |
|---|---|---|---|---|---|
| 04.9m | 0:00:55 | DEE | | Attached deposits, encrustation from 10 o'clock to 12 o'clock: 5% cross-sectional area loss at joint - Severity 3 | Image Provided - Ref: 1_13<br> |

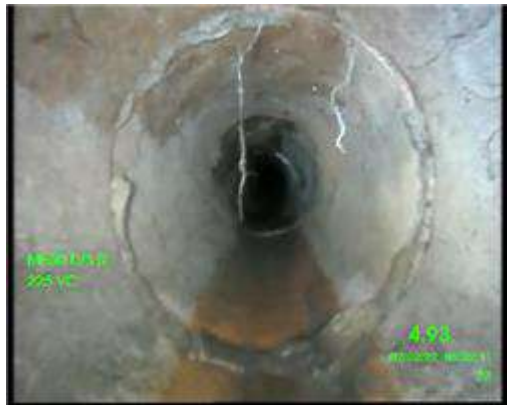
| Pos | Video Ref | Code | Cont. | Description | Image |
|---|---|---|---|---|---|
| 04.9m | 0:00:55 | DEE | | Attached deposits, encrustation from 03 o'clock to 09 o'clock: 5% cross-sectional area loss at joint - Severity 3 | Image Provided - Ref: 1_14<br> |

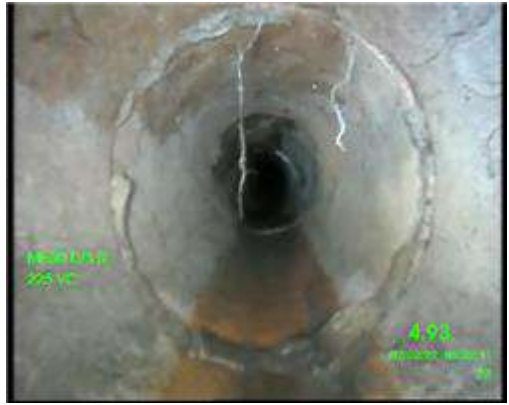
| Pos | Video Ref | Code | Cont. | Description | Image |
|---|---|---|---|---|---|
| 04.9m | 0:00:55 | RF | | Roots fine - Severity 1 | Image Provided - Ref: 1_15<br> |

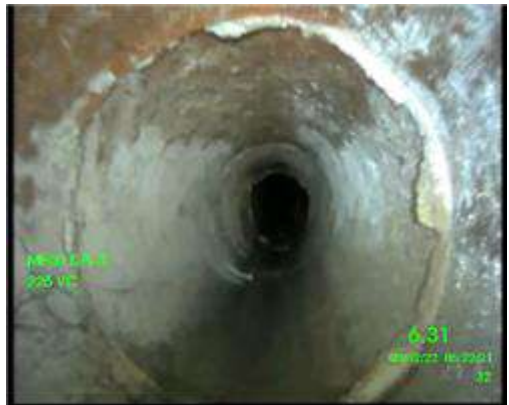
| Pos | Video Ref | Code | Cont. | Description | Image |
|---|---|---|---|---|---|
| 06.3m | 0:01:06 | DEE | | Attached deposits, encrustation from 12 o'clock to 05 o'clock: 5% cross-sectional area loss at joint - Severity 3 | Image Provided - Ref: 1_16<br> |

| Position | Code | Description | CD | Pic | Video Ref | |
|---|---|---|---|---|---|--|
| 06.3 | DEE | Attached deposits, encrustation 12-05 5% at joint | | 1_1 | 0:01:06 | |

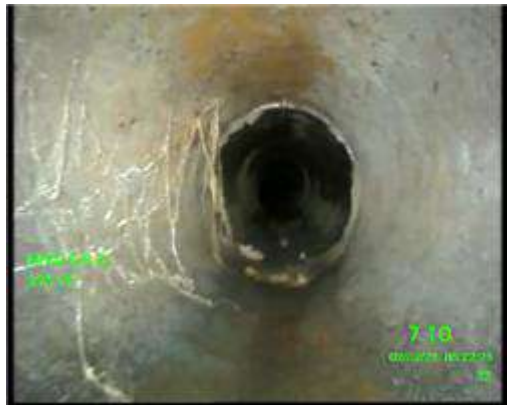
| Pos | Video Ref | Code | Cont. | Description | Image |
|---|---|---|---|---|---|
| 07.1m | 0:01:13 | RM | | Roots mass: 20% cross-sectional area loss - Severity 4 | Image Provided - Ref: 1_17<br> |

| Position | Code | Description | CD | Pic | Video Ref | |
|---|---|---|---|---|---|--|
| 07.1 | RM | Roots mass 20% | | 1_1 | 0:01:13 | |
