# FLOOD RISK & DRAINAGE

**Milksey Lane, Graveley - Phase 2**  
Flood Risk Assessment  
September 2025

Report Ref: 29161-FLD-0101 Rev A

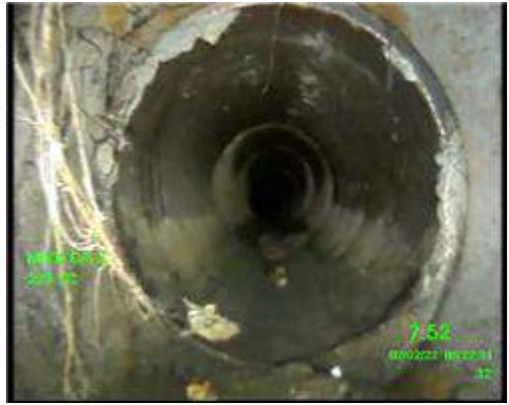
| Pos | Video Ref | Code | Cont. | Description | Image |
|---|---|---|---|---|---|
| 07.5m | 0:01:16 | JDM | | Joint displaced medium - Severity 2 | Image Provided - Ref: 1_18<br> |

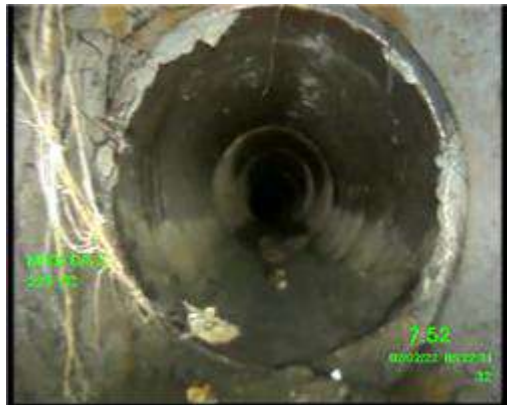
| Pos | Video Ref | Code | Cont. | Description | Image |
|---|---|---|---|---|---|
| 07.5m | 0:01:16 | DEE | | Attached deposits, encrustation from 03 o'clock to 05 o'clock: 5% cross-sectional area loss at joint - Severity 3 | Image Provided - Ref: 1_19<br> |

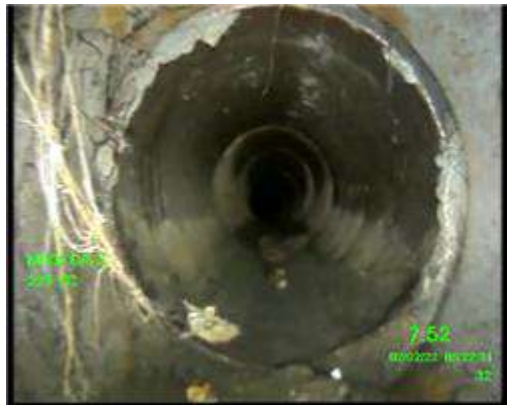
| Pos | Video Ref | Code | Cont. | Description | Image |
|---|---|---|---|---|---|
| 07.5m | 0:01:16 | DEE | | Attached deposits, encrustation from 06 o'clock to 11 o'clock: 5% cross-sectional area loss at joint - Severity 3 | Image Provided - Ref: 1_20<br> |

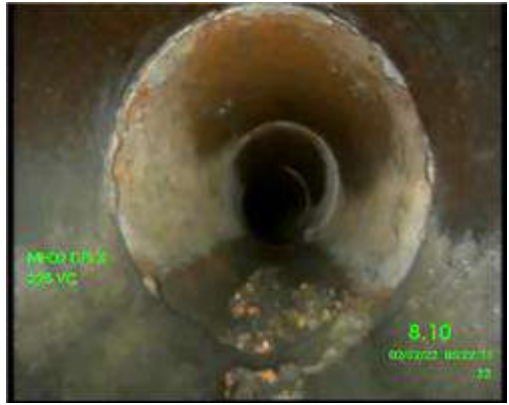
| Pos | Video Ref | Code | Cont. | Description | Image |
|---|---|---|---|---|---|
| 08.1m | 0:01:21 | DER | | Settled deposits coarse: 5% cross-sectional area loss - Severity 3 | Image Provided - Ref: 1_21<br> |

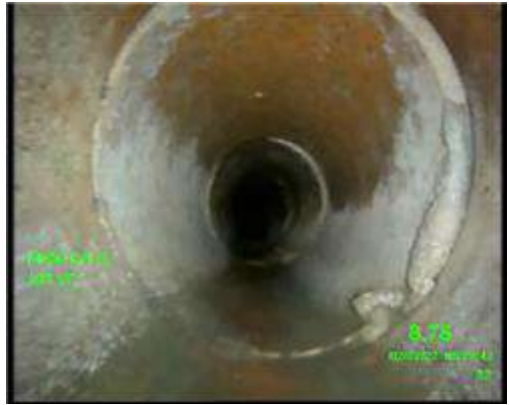
| Pos | Video Ref | Code | Cont. | Description | Image |
|---|---|---|---|---|---|
| 08.7m | 0:01:26 | DEE | | Attached deposits, encrustation from 03 o'clock to 05 o'clock: 10% cross-sectional area loss at joint - Severity 3 | Image Provided - Ref: 1_22<br> |

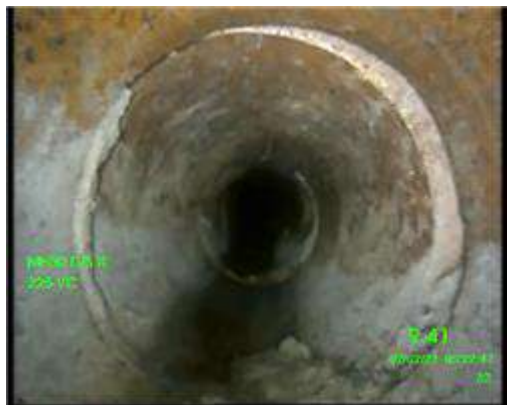
| Pos | Video Ref | Code | Cont. | Description | Image |
|---|---|---|---|---|---|
| 09.4m | 0:01:32 | JDM | | Joint displaced medium - Severity 2 | Image Provided - Ref: 1_23<br> |

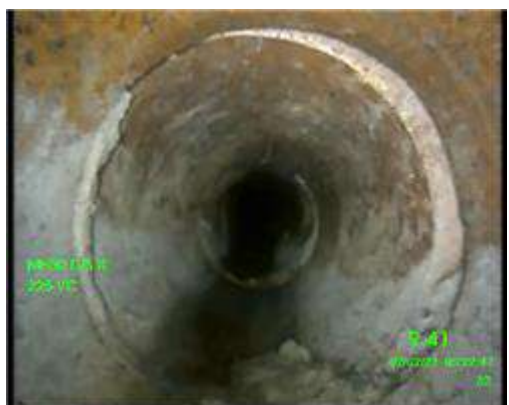
| Pos | Video Ref | Code | Cont. | Description | Image |
|---|---|---|---|---|---|
| 09.4m | 0:01:32 | DEE | | Attached deposits, encrustation from 07 o'clock to 10 o'clock: 5% cross-sectional area loss at joint - Severity 3 | Image Provided - Ref: 1_24<br> |

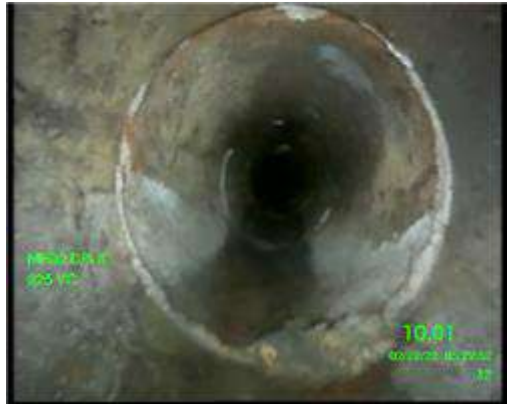
| Pos | Video Ref | Code | Cont. | Description | Image |
|---|---|---|---|---|---|
| 10.0m | 0:01:37 | DES | | Settled deposits fine: 5% cross-sectional area loss - Severity 2 | Image Provided - Ref: 1_25<br> |

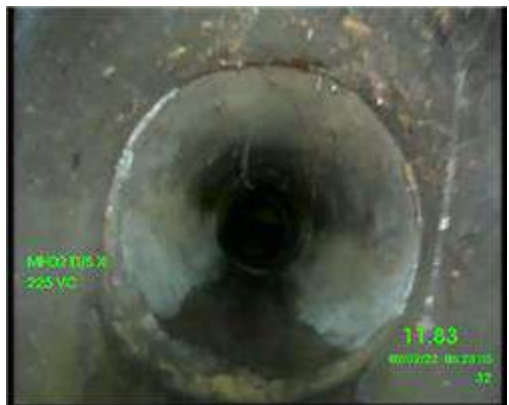
| Pos | Video Ref | Code | Cont. | Description | Image |
|---|---|---|---|---|---|
| 11.8m | 0:01:50 | DEE | | Attached deposits, encrustation from 06 o'clock to 09 o'clock: 10% cross-sectional area loss - Severity 3 | Image Provided - Ref: 1_26<br> |

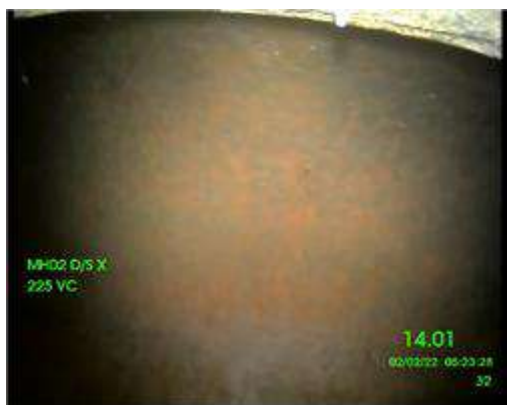
| Pos | Video Ref | Code | Cont. | Description | Image |
|---|---|---|---|---|---|
| 14.0m | 0:02:13 | WL | | Water level: 0% Height/Diameter | Image Provided - Ref: 1_27<br> |

| Position | Code | Description | CD | Pic | Video Ref |
|---|---|---|---|---|---|
| 14.0 | WL | Water level 0% | | 1_2 | 0:02:13 |

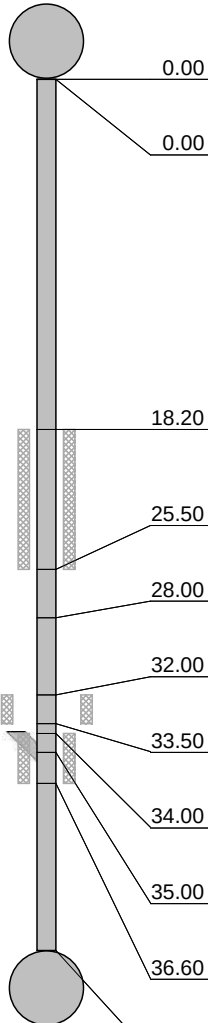
<div>0.00</div><div>0.00</div><div>18.20</div><div>25.50</div><div>28.00</div><div>32.00</div><div>33.50</div><div>34.00</div><div>35.00</div><div>36.60</div><div>45.30</div><div>SW1</div><div>Depth: 1240.00 m</div></div>

<table><tr><td>IC</td><td>Start node, inspection chamber, reference: SW2</td><td>00:00:00</td><td></td></tr></table>

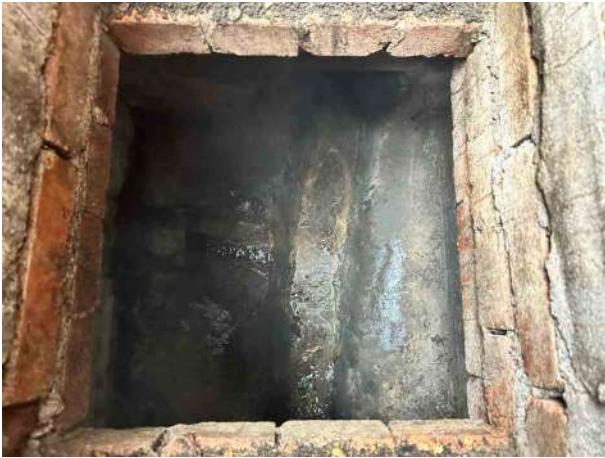
SW2.JPG, 00:00:00, 0.00 m  
Start node, inspection chamber, reference: SW2

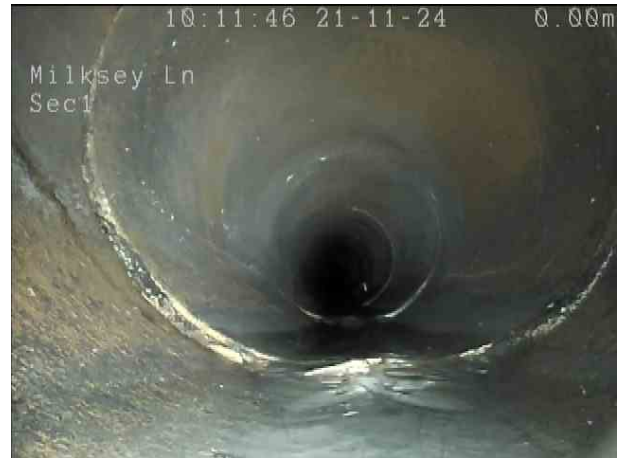
71a36dd9-3d53-40b7-b06d-b984787a84b6.png, 00:00:01, 0.00 m  
Water level, 5% of the vertical dimension, Running live

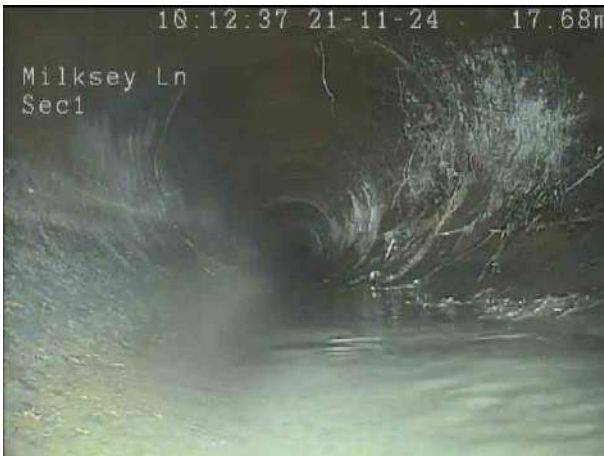
b2a526c9-151c-40f6-809e-3401277c87f8.png, 00:00:51, 18.20 m  
Roots, fine at joint, start

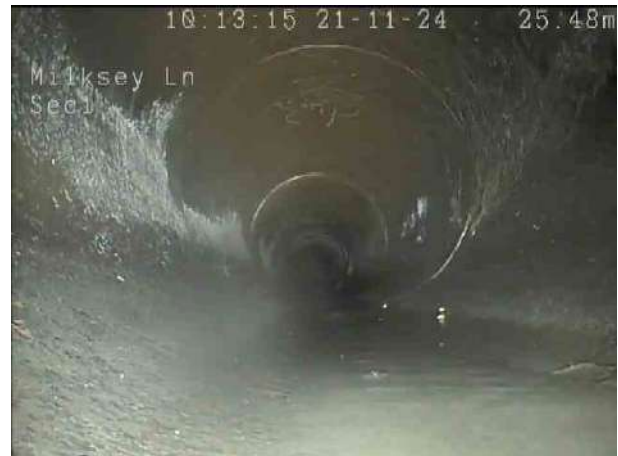
7b70e5a9-b297-4289-a504-2282be5e6a94.png, 00:01:30, 25.50 m  
Roots, fine at joint, finish

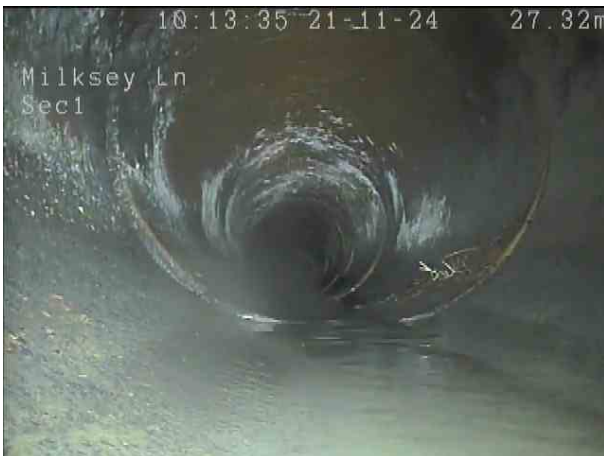
29270812-47d4-47e3-94d8-0189b74d66e6.png, 00:01:50, 28.00 m  
Roots, fine at joint

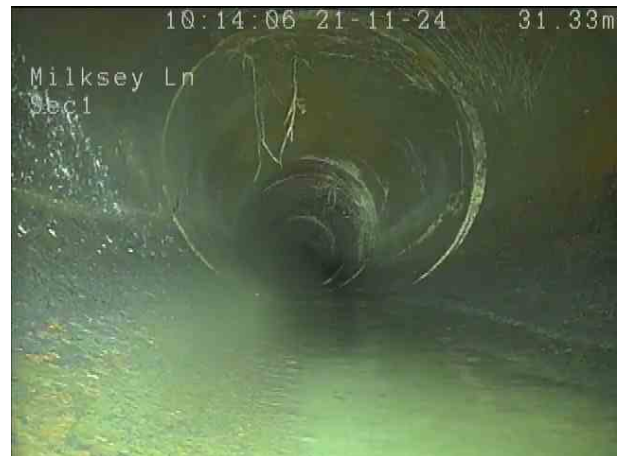
f2520338-991b-4d49-a4b7-b083027ddd3.png, 00:02:21, 32.00 m  
Roots, fine at joint, start

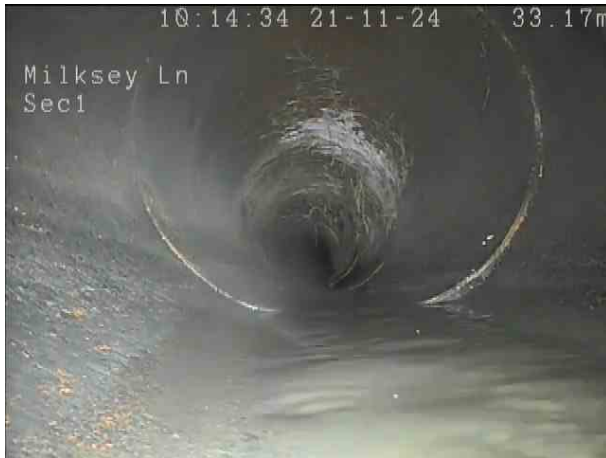
93e7a674-413d-43cd-a0ed-10f057f7ce26.png, 00:02:48,  
33.50 m  
Roots, fine at joint, finish

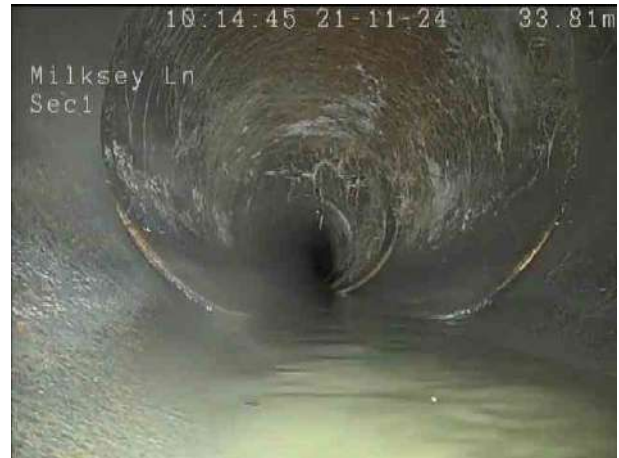
d3dc2325-8fee-4084-b3ff-8aad911865d1.png, 00:03:00, 34.00  
m  
Roots, fine at joint, start

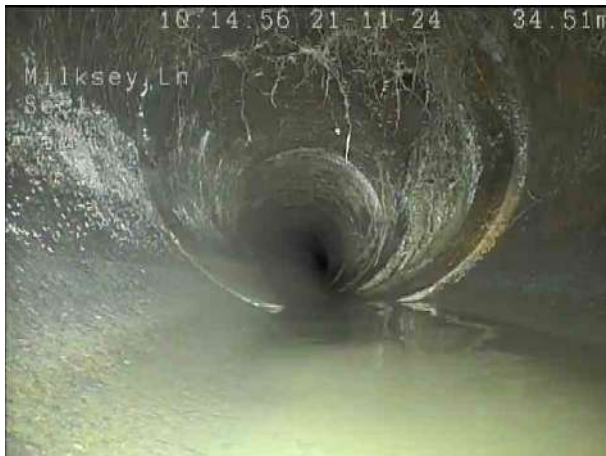
f539d5c1-cff1-4d3c-b9ef-aa45644b736d.png, 00:03:10, 35.00  
m  
Junction at 2 o'clock, 250mm dia

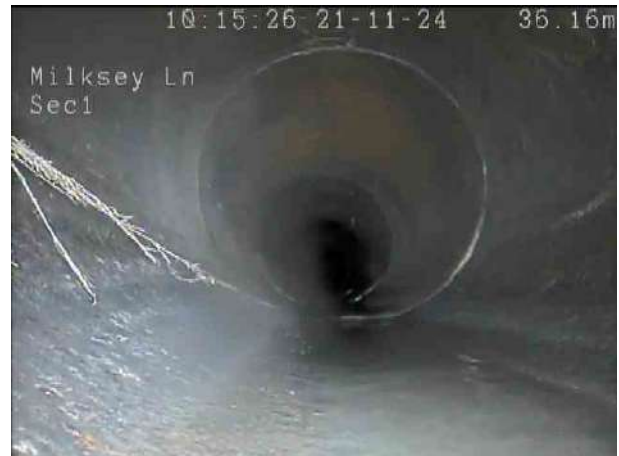
eb8eaf-11ce-49ac-99d1-1b747c865bb6.png, 00:03:41,  
36.60 m  
Roots, fine at joint, finish

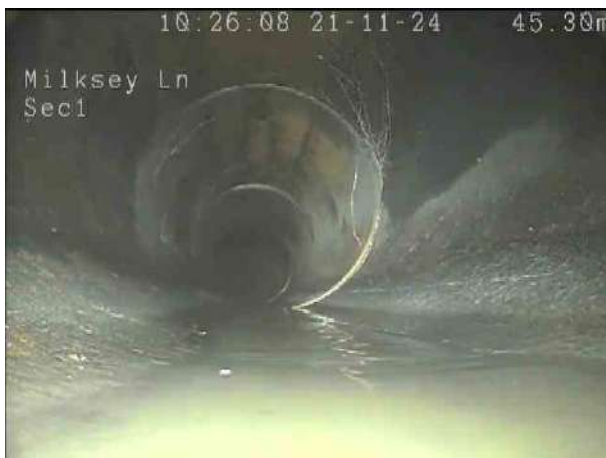
c820a393-d13f-4672-aaae-d84b78635713.png, 00:05:22,  
45.30 m  
Finish node, other special chamber, reference: SW1, Unable

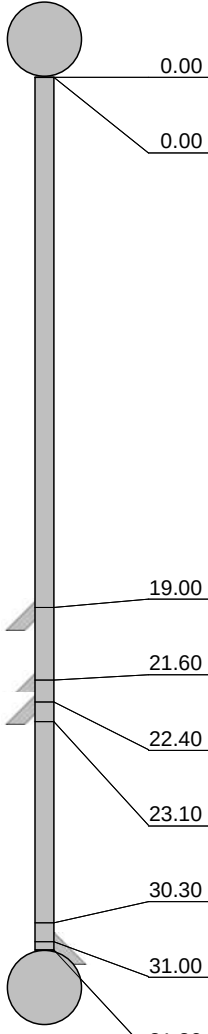
| Scale: 1:271 | Position [m] | Code | Observation | MPEG | Photo | Grade |
|---|---|---|---|---|---|---|
| | 0.00 | IC | Start node, inspection chamber, reference: SW1 | 00:00:01 | | |
| | 0.00 | WL | Water level, 5% of the vertical dimension: Running live | 00:00:01 | | |

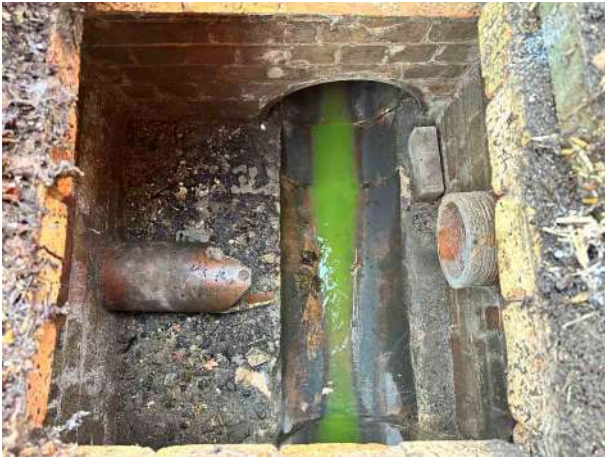
SW1.JPG, 00:00:01, 0.00 m  
Start node, inspection chamber, reference: SW1

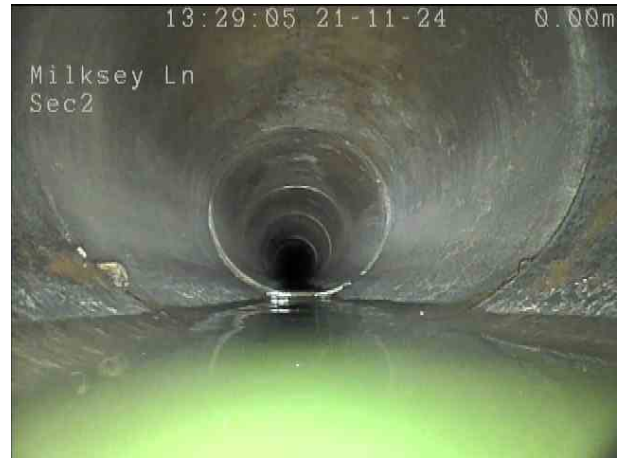
bbc34e50-7b20-4962-8c3e-7d5df5e63530.png, 00:00:01, 0.00 m

Water level, 5% of the vertical dimension, Running live

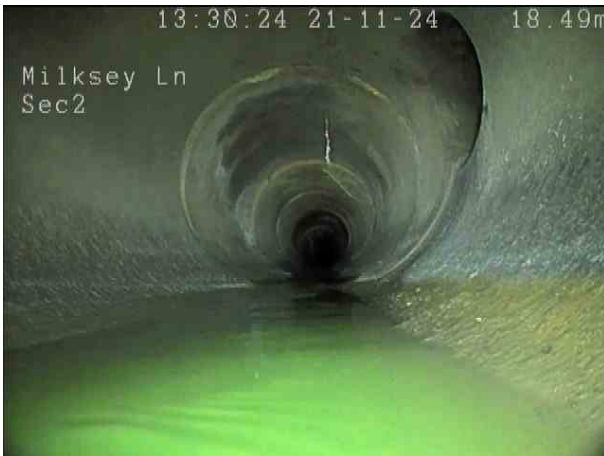
cc336df9-275d-4a12-b918-de934bef365d.png, 00:01:20, 19.00 m

Junction at 2 o'clock, 150mm dia

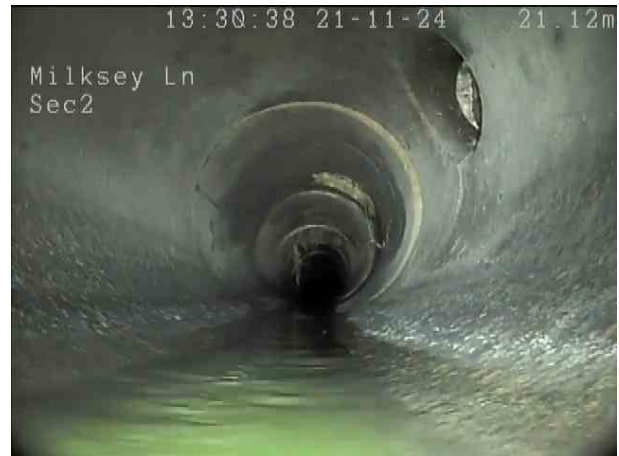
078ccda-603a-4452-89f4-d46438b8e00f.png, 00:01:34, 21.60 m

Junction at 2 o'clock, 150mm dia

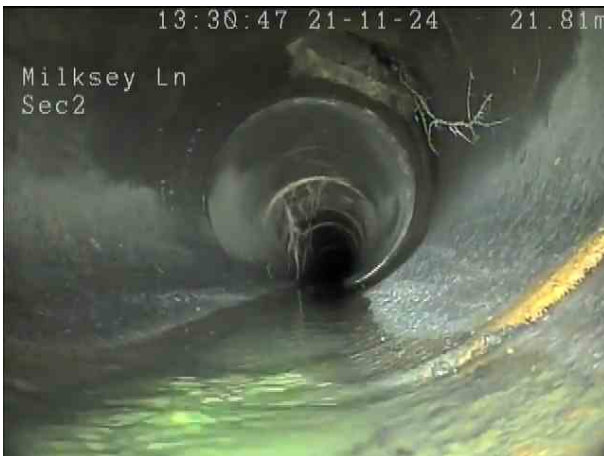
1a8d78c2-db60-4994-8570-c8d9b8ef25bd.png, 00:01:43, 22.40 m

Connection other than junction at 1 o'clock, 150mm dia

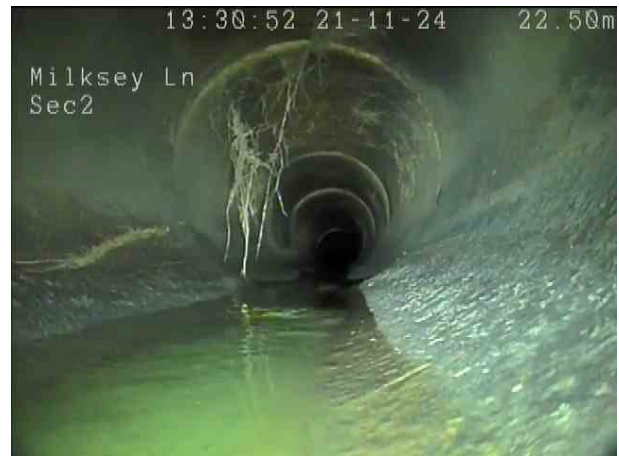
6d8b6261-9768-4338-a8de-f9a113c922da.png, 00:01:48, 23.10 m

Roots, fine at joint

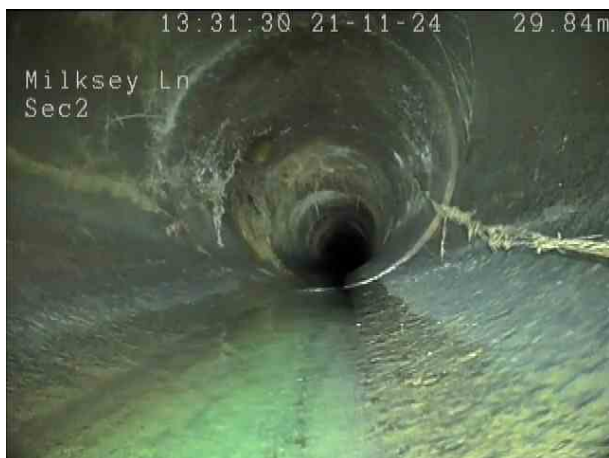
22677a1c-9702-415a-b762-6022f4cc53ea.png, 00:02:26,  
30.30 m  
Roots, fine at joint

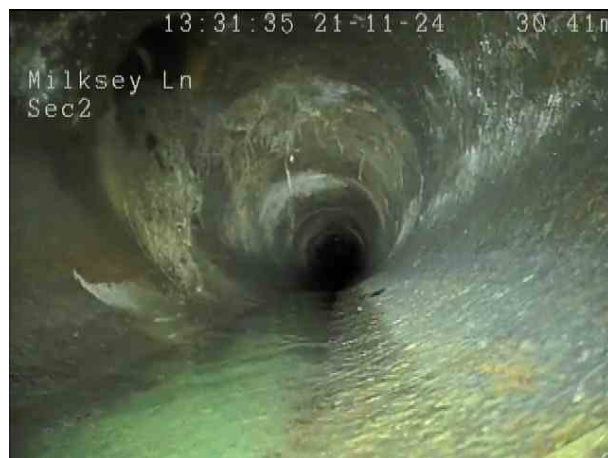
a02fb6f8-db22-495e-b60a-9fe1844e9d07.png, 00:02:32, 31.00  
m  
Junction at 10 o'clock, 150mm dia

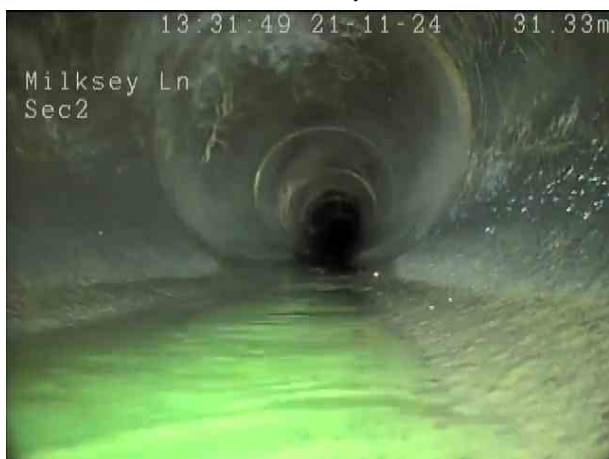
6587682b-d075-46d0-bbc0-423006ded360.jpg, 00:02:45,  
31.30 m  
Finish node, other special chamber, reference: SW2, Cross

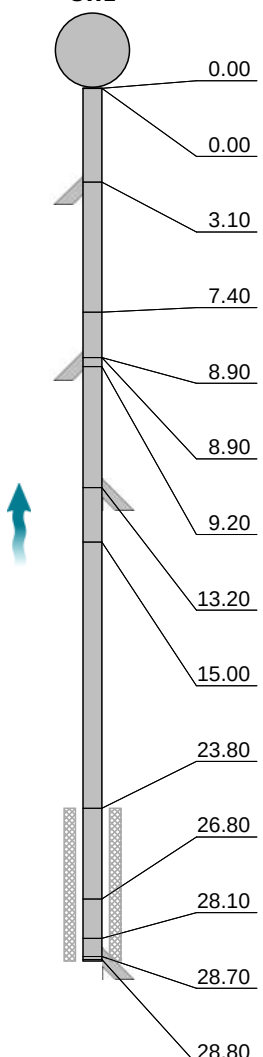
| Scale: 1:250 | Position [m] | Code | Observation | MPEG | Photo | Grade |
|---|---|---|---|---|---|---|
| | 0.00 | IC | Start node, inspection chamber, reference: SW2 | 00:00:00 | | |
| | 0.00 | WL | Water level, 5% of the vertical dimension: Running live | 00:00:00 | | |
| | 8.90 | CXD | Connection defective, connecting pipe is damaged at 1 o'clock, 150mm dia | 00:01:07 | | |
| | 28.70 | CXI | Connection defective, connecting pipe is intruding at 9 o'clock, 150mm dia, intrusion: 5% | 00:03:34 | | 3 |

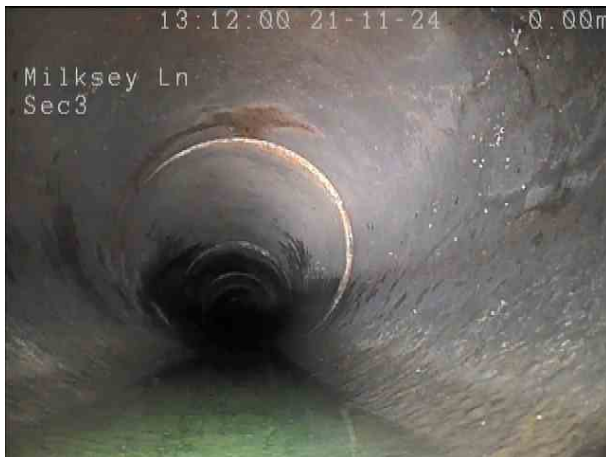
99624c56-6d41-4af9-ad73-06a8ec7e4514.png, 00:00:00, 0.00  
m  
Water level, 5% of the vertical dimension, Running live

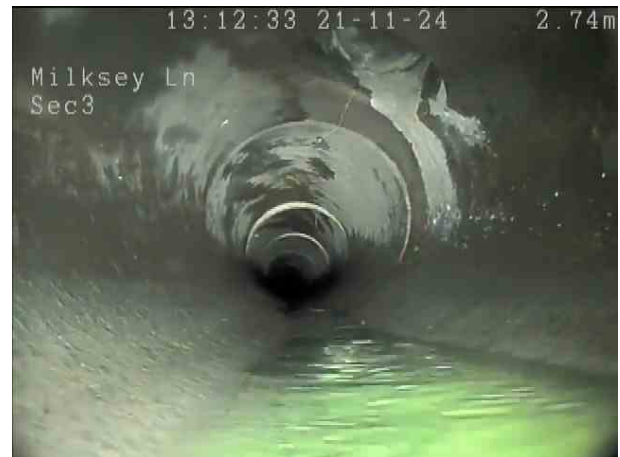
401ab29a-4c70-4d57-8003-c0800992f88c.png, 00:00:33, 3.10  
m  
Junction at 1 o'clock, 150mm dia

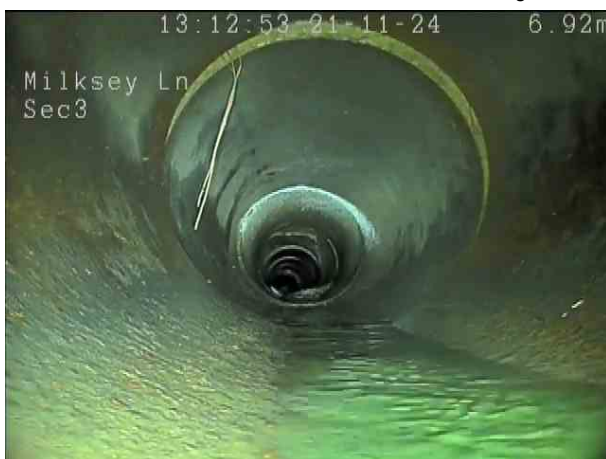
185b37ec-0349-4d34-8897-50f622d61a30.png, 00:00:53, 7.40  
m  
Roots, fine at joint

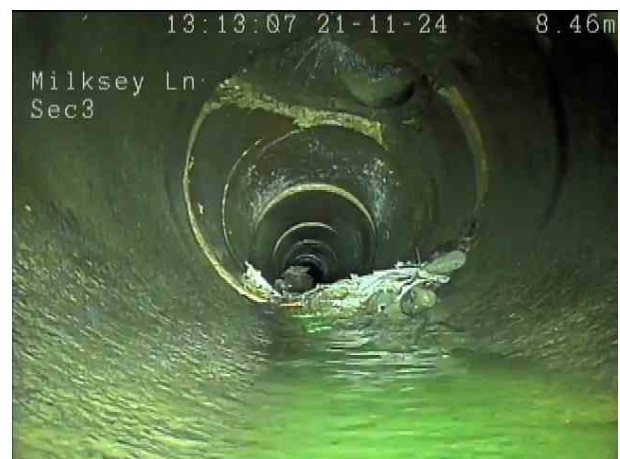
b65f7ef7-e37d-4f68-8e9d-51e517b19886.png, 00:01:07, 8.90  
m  
Connection defective, connecting pipe is damaged at 1 o'clock,

| No. | m+ | Code | Observation |
|---|---|---|---|
| 5 | 8.90 | CXD | Connection defective, connecting pipe is damaged at 1 o'clock, 150mm dia |

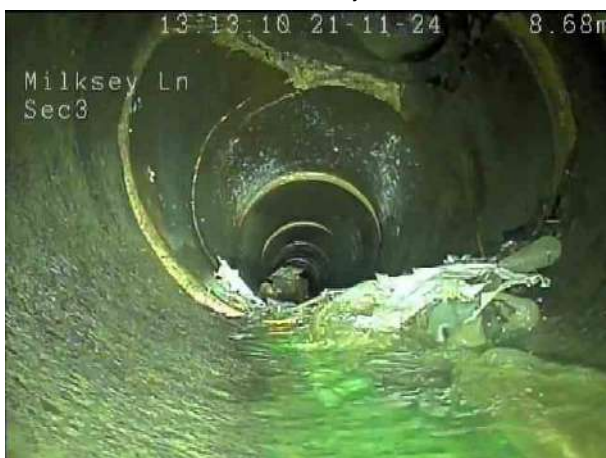
a74bc132-76af-4b72-b59a-9b0d10c1e1bd.png, 00:01:10, 8.90  
m  
Roots, mass at joint, 10% cross-sectional area loss

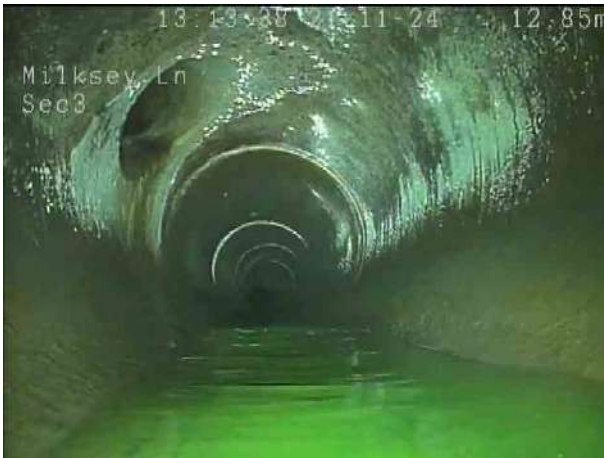
ced530b9-5c45-4fb0-bd8a-c44cf9934782.png, 00:01:38, 13.20 m  
Junction at 10 o'clock, 150mm dia

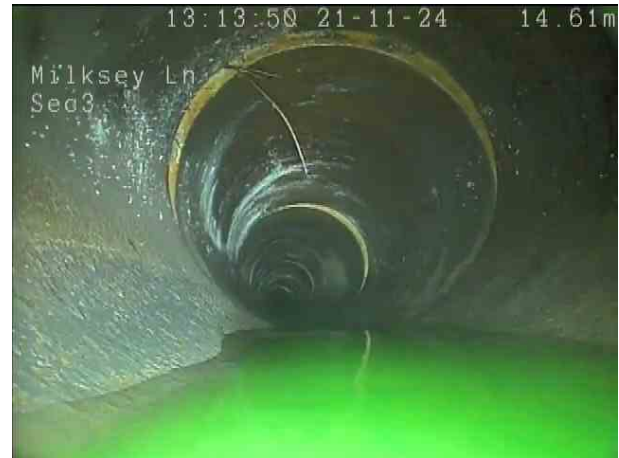
76ad6ec8-b119-4354-9085-b3d31c6acbea.png, 00:01:50, 15.00 m  
Roots, fine at joint

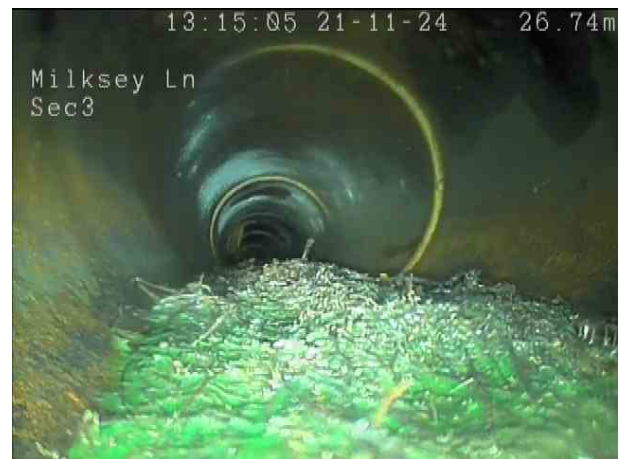
834ecfe2-25ef-439e-99da-13f364f33e35.png, 00:03:05, 26.80 m  
Roots, mass, 20% cross-sectional area loss, change

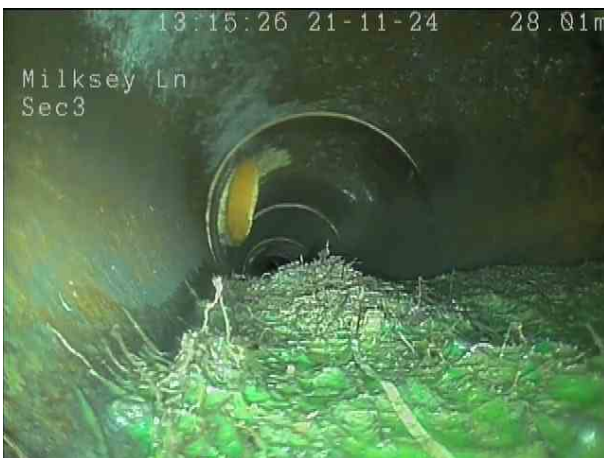
17d09909-7178-4815-81a0-ae1a1d9967ac.png, 00:03:26, 28.10 m  
Roots, mass, 40% cross-sectional area loss, change

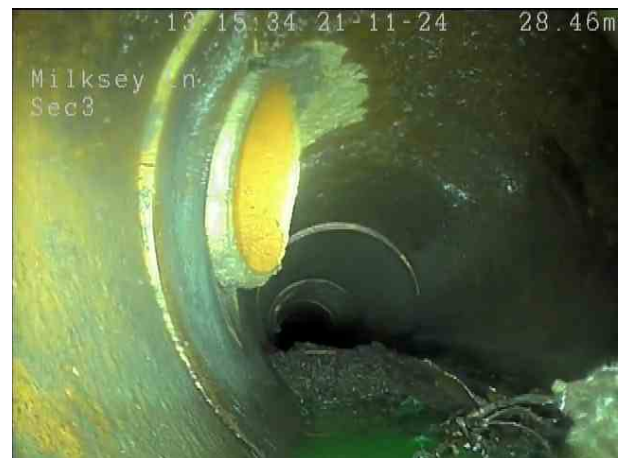
c149e879-bbbf-4cb7-8b94-35e5cef6f891.png, 00:03:34, 28.70 m  
Connection defective, connecting pipe is intruding at 9 o'clock,

| No. | m+ | Code | Observation |
|---|---|---|---|
| 13 | 28.70 | CXI | Connection defective, connecting pipe is intruding at 9 o'clock, 150mm dia, intrusion: 5% |

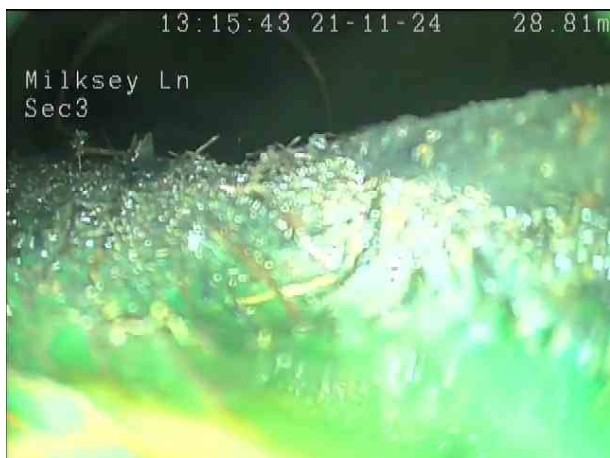
60fcfc24-6691-4d58-9d84-d8bf17bcf9fa.png, 00:03:43, 28.90  
m

Roots, mass, 50% cross-sectional area loss, finish

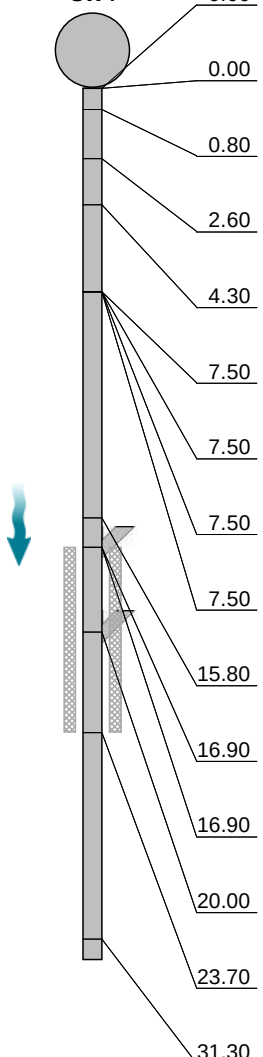
| Scale: 1:278 | Position [m] | Code | Observation | MPEG | Photo | Grade |
|---|---|---|---|---|---|---|
| | 0.00 | IC | Start node, inspection chamber, reference: SW4 | 00:00:01 | | |
| | 0.00 | WL | Water level, 5% of the vertical dimension: Running live | 00:00:01 | | |

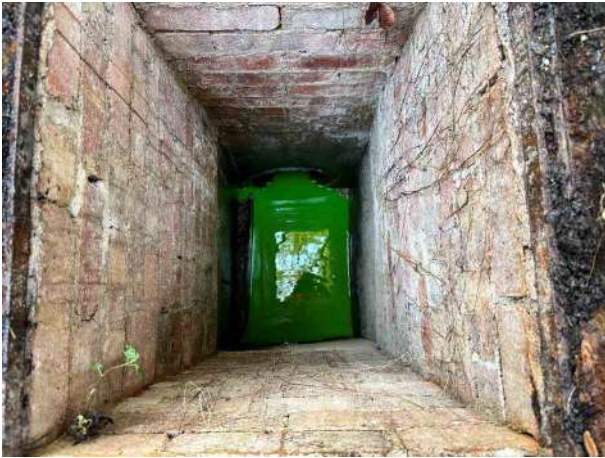
SW4.JPG, 00:00:01, 0.00 m  
Start node, inspection chamber, reference: SW4

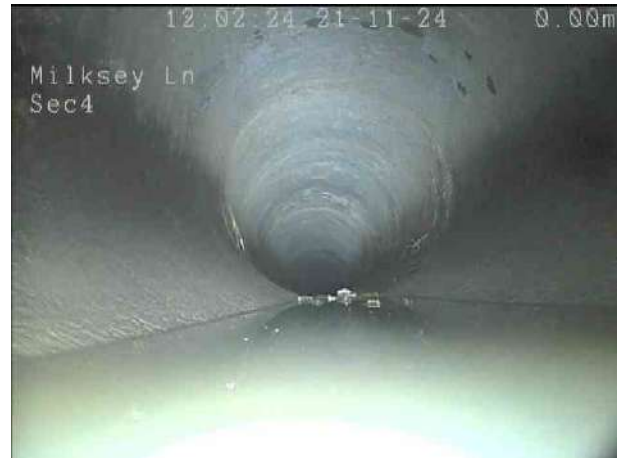
b08ece61-0da9-461a-8232-b92f97f60bf7.png, 00:00:01, 0.00 m  
Water level, 5% of the vertical dimension, Running live

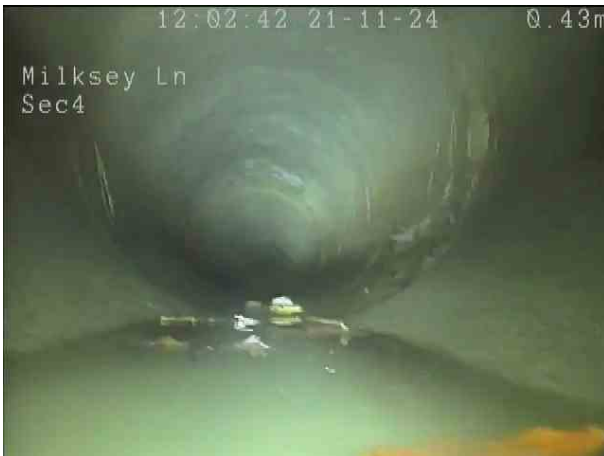
56f930ac-49f6-4b96-ada8-41c19fa769e6.png, 00:00:19, 0.80 m  
Roots, fine at joint

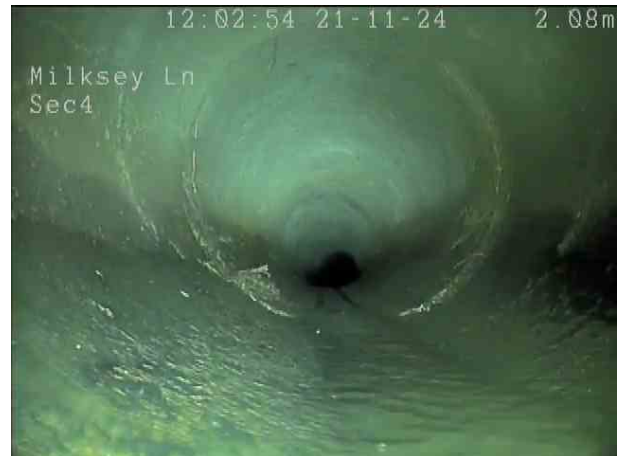
072a555f-51a2-4a4f-8c8c-0cdd0f3fb631.png, 00:00:31, 2.60 m  
Roots, fine at joint

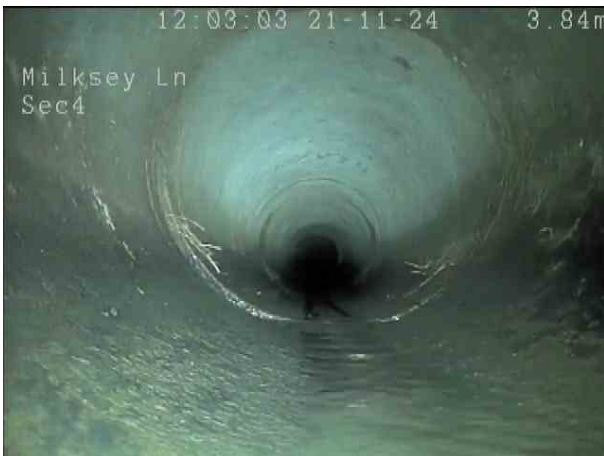
16363fe1-2ee0-4494-bdf9-0540b0de48e2.png, 00:00:40, 4.30 m  
Roots, fine at joint

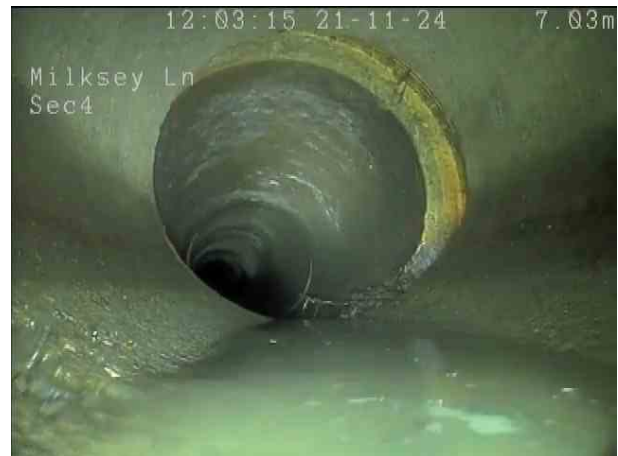
901fc6c2-b364-4fae-8fd9-338f3b128fc0.png, 00:00:52, 7.50 m  
Line deviates left

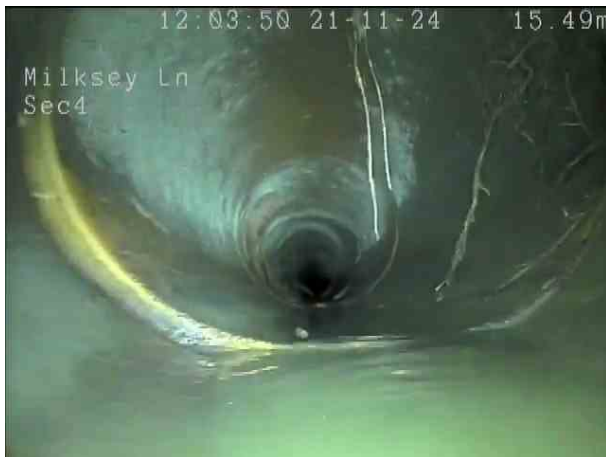
a0bce399-a450-4d3d-a9e2-3ac84516f48a.png, 00:01:27,  
15.80 m  
Roots, fine at joint

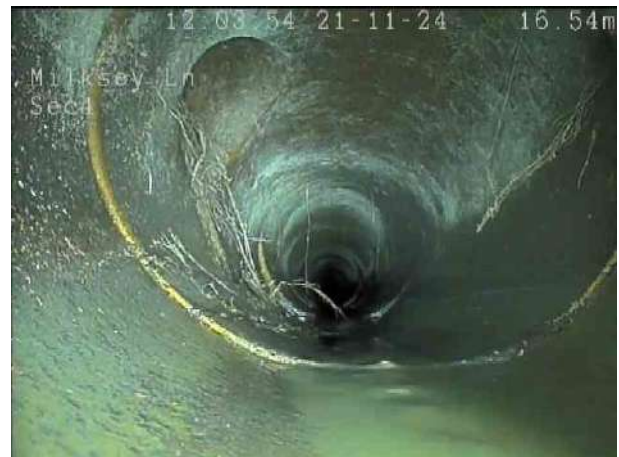
777f24de-9b4a-467c-a4c1-97b24560e6a4.png, 00:01:31,  
16.90 m  
Junction at 10 o'clock, 150mm dia

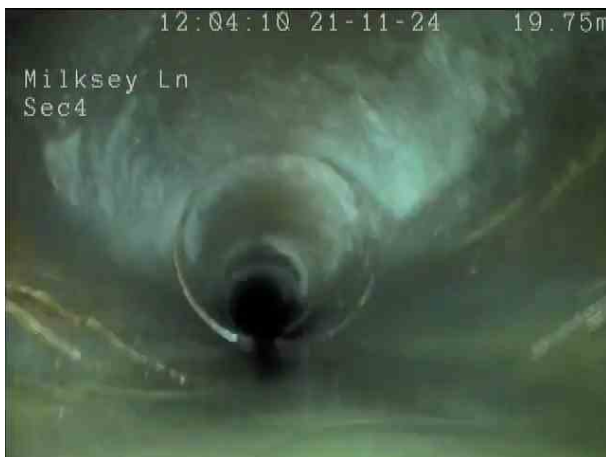
2f2d61b5-d4e9-458a-92f8-9caf123dfb0f.png, 00:01:47, 20.00  
m  
Junction at 10 o'clock, 150mm dia

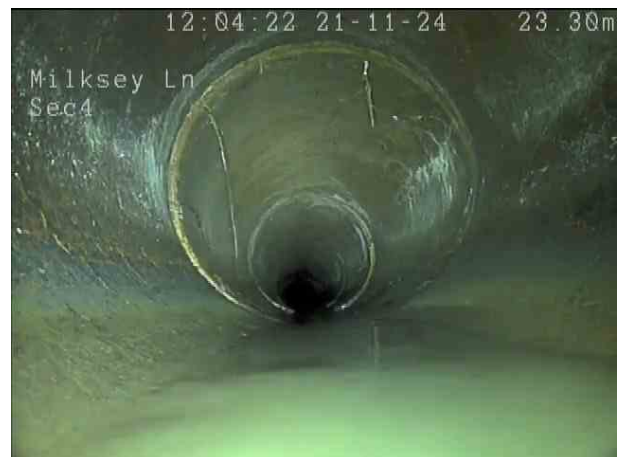
1961e4e5-49af-4402-9bc2-7fe234b19399.png, 00:01:59,  
23.70 m  
Roots, fine, finish

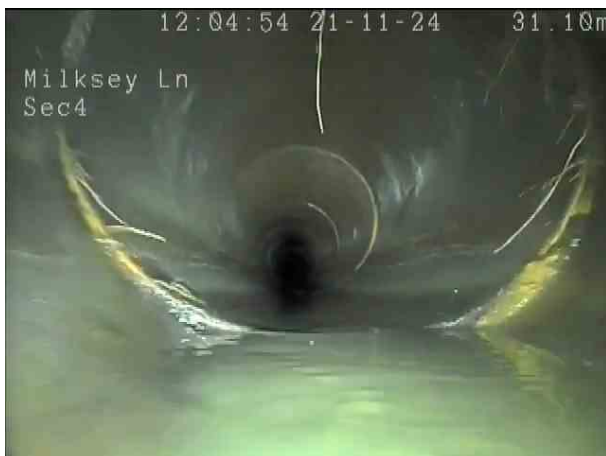
630009ea-0182-45c2-8f0f-673835fbabb3.png, 00:02:30, 31.30  
m  
Roots, fine at joint

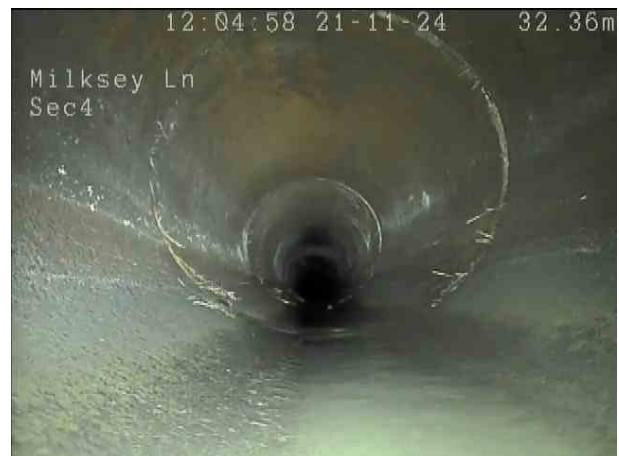
ced64048-de0d-4066-a821-b95732ef483e.png, 00:02:35,  
32.80 m  
Roots, fine at joint

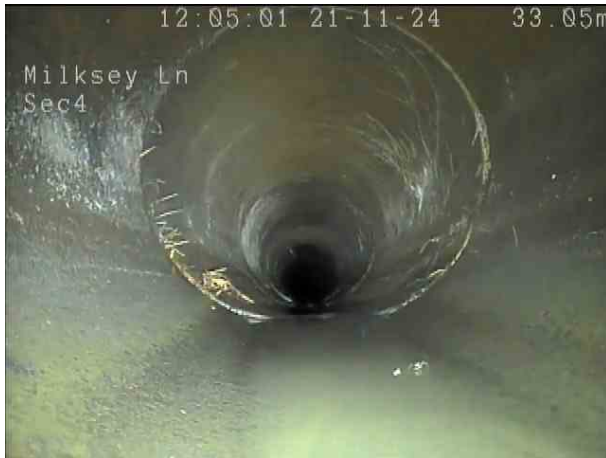
bafb911b-6cbc-4a8f-9351-8adddeb6f59d.png, 00:02:38, 33.50 m  
Roots, fine at joint

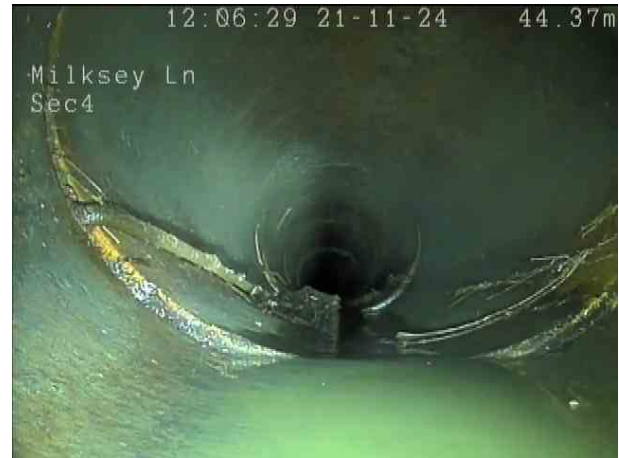
e6347e56-5449-4c1b-87a2-0c68d97f732a.png, 00:03:57, 44.50 m  
Roots, tap at joint, start

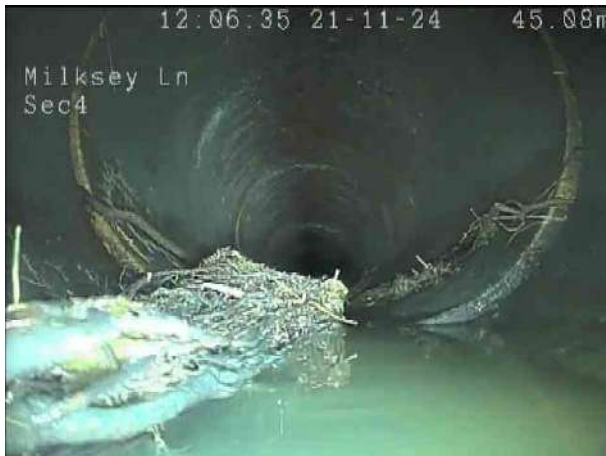
2ac8cc72-35a9-48b6-8983-1817bcbaa44d.png, 00:04:03, 45.30 m  
Roots, mass at joint, 15% cross-sectional area loss, start

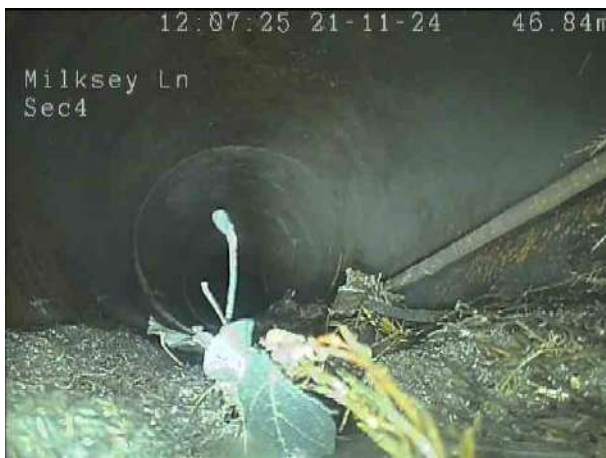
5aaf0228-9991-490b-b1c3-98dcc6b319a3.png, 00:04:52, 46.90 m  
Roots, mass at joint, 20% cross-sectional area loss, change

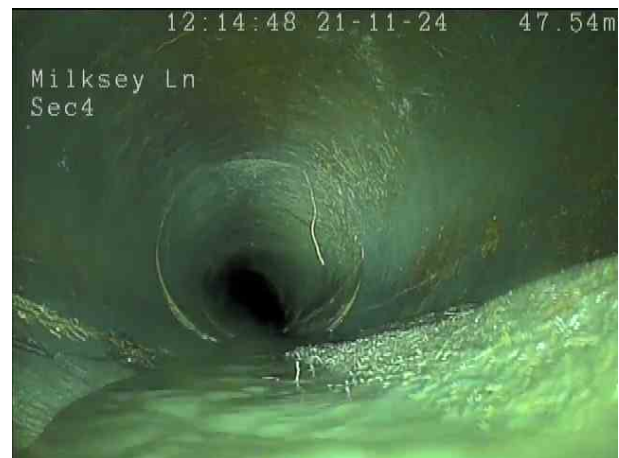
6d0965e6-bcb2-4139-864b-f7b8d1967d73.png, 00:05:12, 47.50 m  
Roots, mass at joint, 10% cross-sectional area loss, change

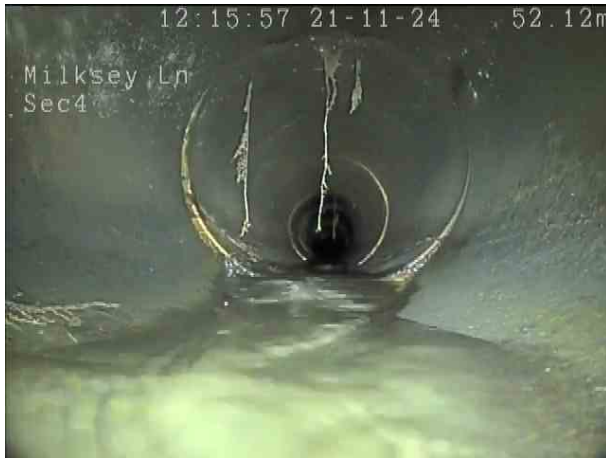
e827a749-dd39-424b-93f7-14ef3a2b5b4b.png, 00:06:21,

52.60 m

Roots, fine at joint

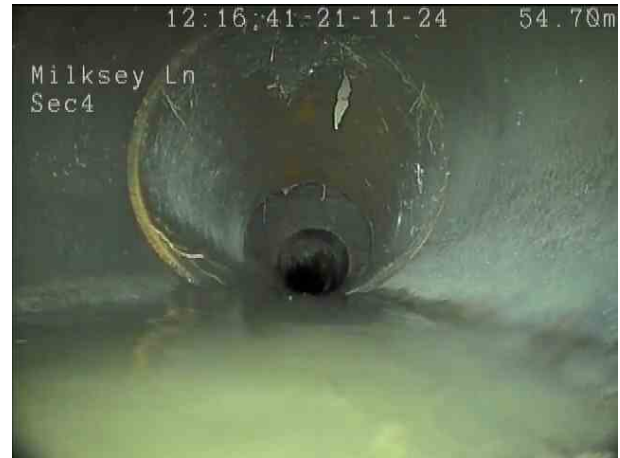
b464b4d0-19c6-4f8d-9bc6-851798832103.png, 00:07:05,

55.20 m

Roots, fine at joint

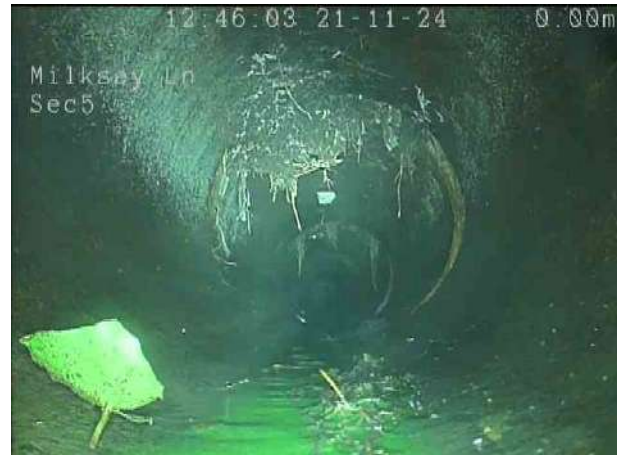
9de1fb91-efca-4e0c-b9ff-25405ad3fe57.png, 00:00:01, 0.00 m  
Water level, 0% of the vertical dimension

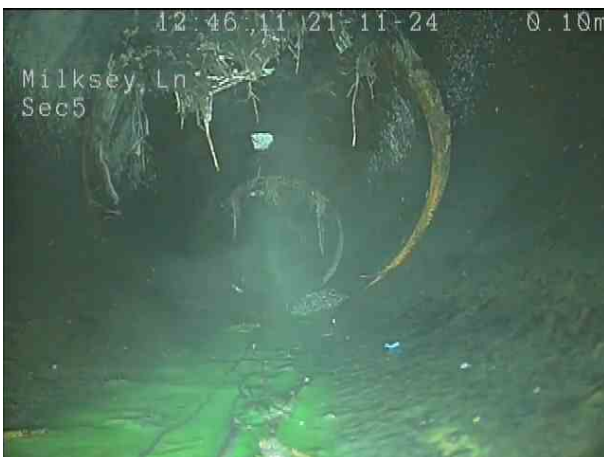
d75d1e6c-e1ee-4a24-8fba-f6bf955d0141.png, 00:00:08, 0.50 m  
Roots, mass at joint, 10% cross-sectional area loss, start

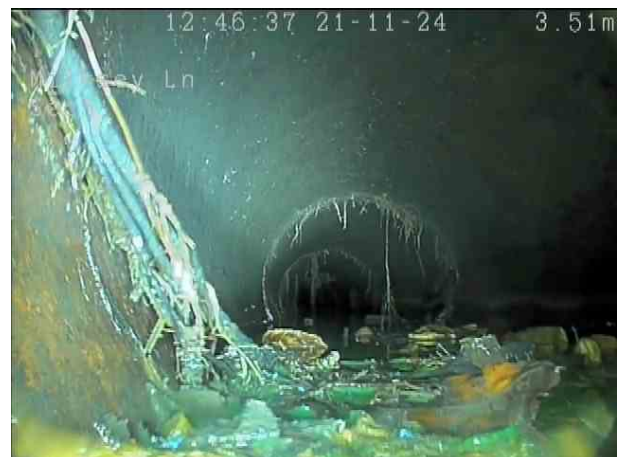
03c760a4-c011-424d-a0e7-884292924b45.png, 00:00:35, 3.50 m  
Roots, mass at joint, 30% cross-sectional area loss, change

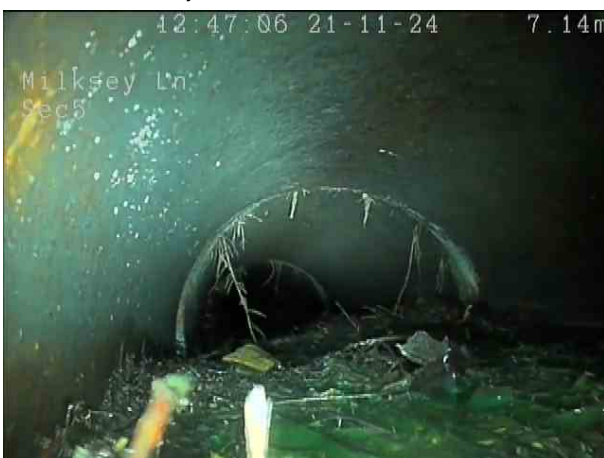
eb2e7dfa-f1ef-47fd-8f0b-1463f61647f4.png, 00:01:04, 7.10 m  
Roots, mass at joint, 60% cross-sectional area loss, change

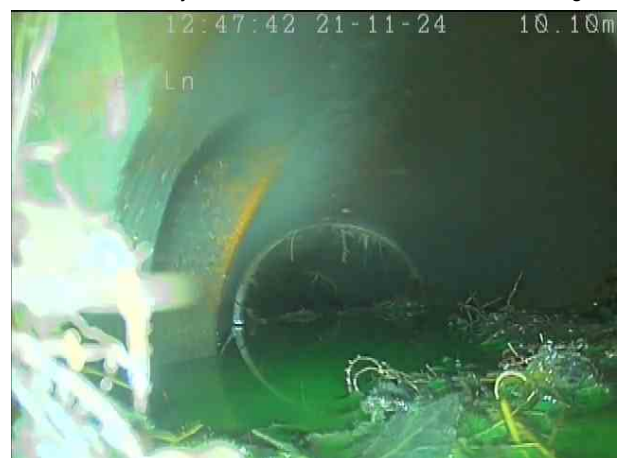
4eba2138-032a-41ca-878b-b013038afdcd.png, 00:01:40, 10.30 m  
Junction at 9 o'clock, 225mm dia

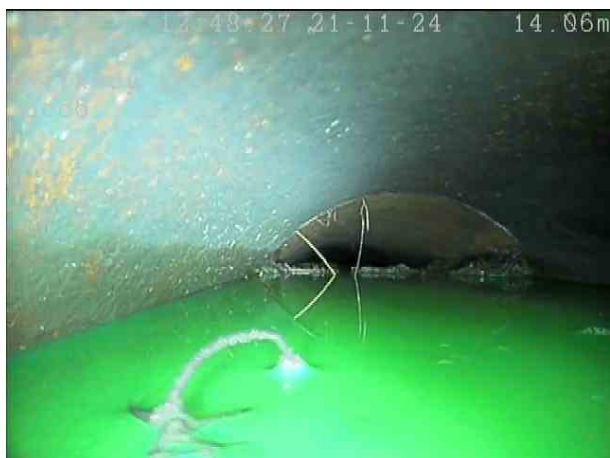
27453663-1dad-437a-b28e-5b72162ce29a.png, 00:02:25,  
14.10 m

Survey abandoned, Unable to proceed.
