Subject: Solar and battery farm, Land west of Ashwell Rd - NHDC ref 22/00741/FP

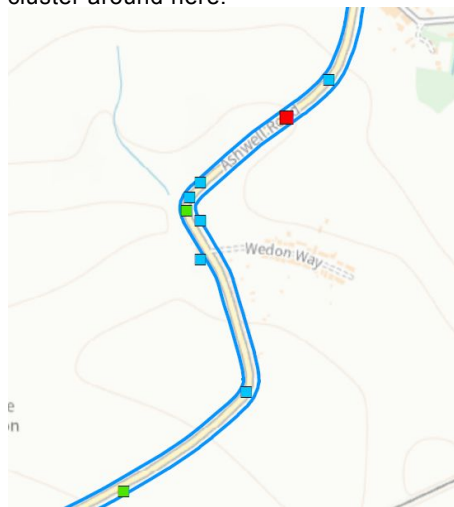
- We have thoroughly investigated accident history along the full stretch of Bygrave Road, going back to when our records started. There have been numerous accidents along the route over the years, however it's clear that most of these are driver error, involve alcohol/drugs, or in the case of pedestrians and cyclists, these have been very infrequent with no obvious pattern. What does stand out however are accidents at or on approach to bends where speed may have been issues, and there's a clear cluster around here:

Whilst accidents arising from speeding is still essentially driver error, the historic accident data implies that there is something more of a pattern and trend here, and it would seem reasonable to expect you to look into this specific section of the route in more detail, and propose measures. There are already some permanent warning signs around here, such as these:
