## Central Block – Proposed Apartment 11 – Plan of Significance

Extract from Level 1 GA, Plan as Existing. Plan of significance shows the evolution of the central block.

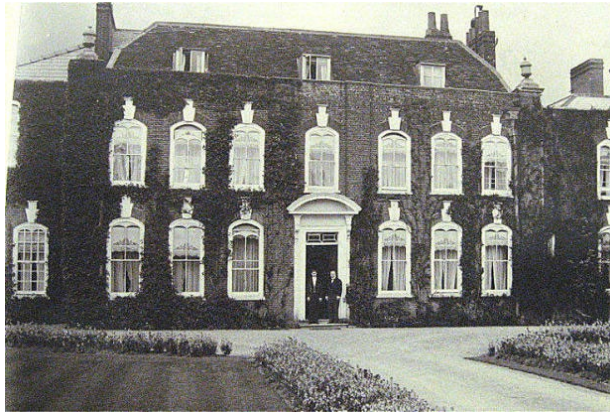
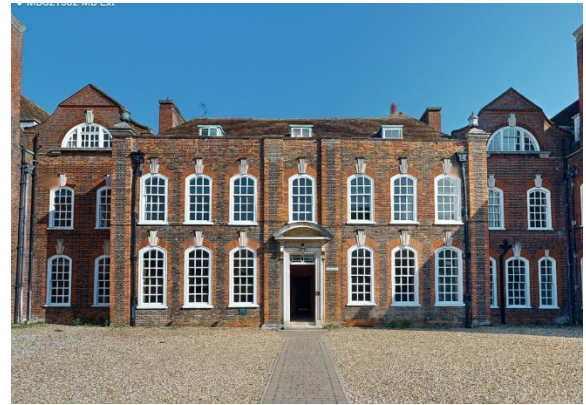
South Elevation (Front). Mid C19 shows the Georgian front of Temple Dinsley, central block. C21 photo showing central block with Lutyens side wings extensions.

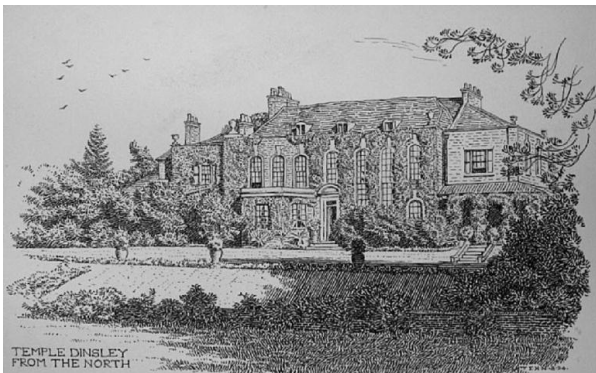
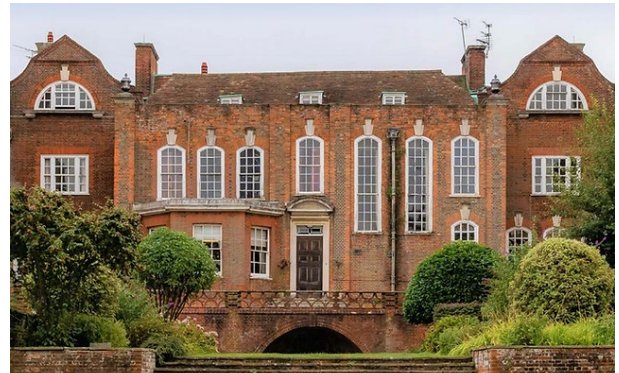
| Reference | Proposal | Significance of affected fabric | Impact | Reasoning and mitigation |
|---|---|---|---|---|
| North Elevation (Rear). Pre-Lutyens sketched picture showing rear bay window. C21 photo showing rear terrace and side wings. | | | | |

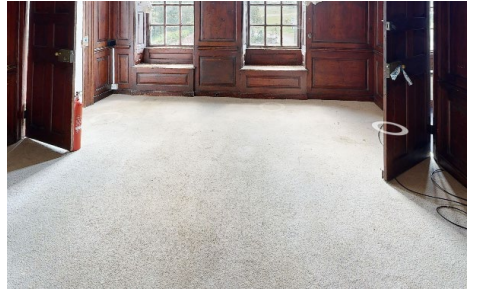
| Reference | Proposal | Significance of affected fabric | Impact | Reasoning and mitigation |
|---|---|---|---|---|
| B-Floors<br>Generally<br>11B.D1 | Remove C20 soft flooring (carpet and vinyl) throughout. Retain existing timber flooring beneath. | Low.<br>Late C20 finishes added by the School. | Benefit | <p>The soft flooring is in poor condition, and it is required to be lifted to reveal the historic timber floor, which will enable like-for-like repairs to be carried out, as well as the thermal, acoustic and fire upgrade.</p> |

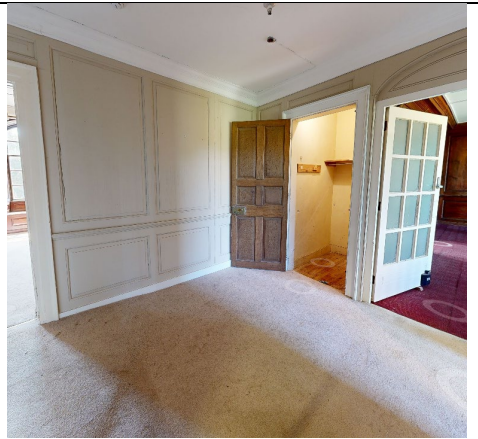
| Reference | Proposal | Significance of affected fabric | Impact | Reasoning and mitigation |
|---|---|---|---|---|
| B-Floors<br>11B.P1 | Existing wooden flooring to be retained and repaired when required. It is proposed to carefully lift the existing boards to allow for inspection and repair of timber floor joists, and insertion of new breathable insulation between the joists, Fire and Sound proofing treatment. Existing boards to then be re-laid and left as finish flooring. New tiled flooring laid including decoupling membrane on bathroom, en-suite and kitchen. | High.<br>C18 | Neutral Impact.<br>Repairs of Benefit. | <p>Revealing the historic timber flooring enables like-for-like repairs to be carried out.<br/>The proposed membrane laid in bathrooms, kitchen and ensuites ensures that any overlaid floor finish will not adhere and damage the historic fabric.</p> |

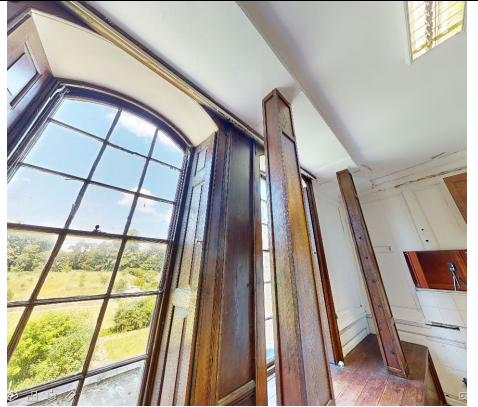
| Reference | Proposal | Significance of affected fabric | Impact | Reasoning and mitigation |
|---|---|---|---|---|
| C-Ceiling<br>11C.D1 | Remove section of modern dropped ceiling that conceals the bearer. | Low.<br>C20 alteration. | Positive impact. | |

| Reference | Proposal | Significance of affected fabric | Impact | Reasoning and mitigation |
|---|---|---|---|---|
| | | | | <p>Benefit: to reinstate the former ceiling height, to remove unsympathetic alteration -yet necessary at the time.</p> |

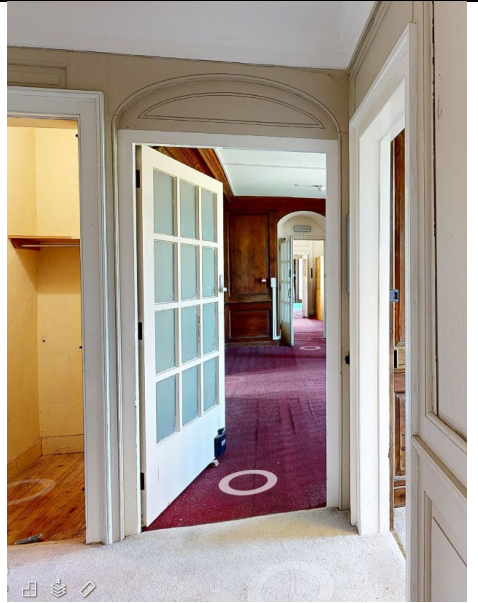
| Reference | Proposal | Significance of affected fabric | Impact | Reasoning and mitigation |
|---|---|---|---|---|
| D-Doors<br>11D.P1 | 11-DF02. C20 glazed timber door to be removed. New door fitted, to be main entrance security door grade, and fire rated. To match lobby/landing original timber panelling. | Moderate. Circa 1980s door of no significance within Lutyens panelled surround. | Benefit. | <p>The door is a later addition, it does not match with the original timber panelling around it. A replacement door to match the adjacent historic door into the room will improve the architectural design, appearance and understanding of the space.</p> |

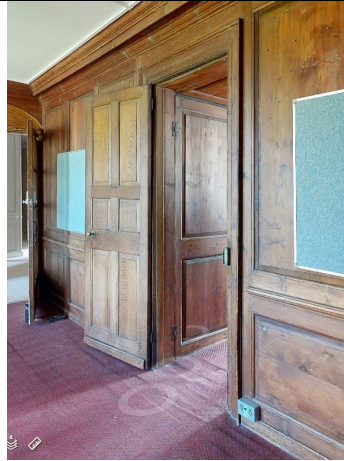
| Reference | Proposal | Significance of affected fabric | Impact | Reasoning and mitigation |
|---|---|---|---|---|
| D-Doors<br>11D.P2 | 11-DF01. EC20 timber doors to be kept permanently, door | High. C18 | Neutral Impact | |

| Reference | Proposal | Significance of affected fabric | Impact | Reasoning and mitigation |
|---|---|---|---|---|
| | openings to be infill behind. Original ironmongery to be retained. | | | <p>The door set will remain, in fixed-shut position, therefore there will be no visual impact to the staircase lobby. Door will be lined on the internal side to form a compartment wall for fire and acoustic separation.</p> |

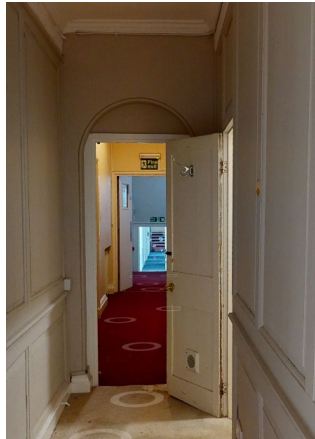
| Reference | Proposal | Significance of affected fabric | Impact | Reasoning and mitigation |
|---|---|---|---|---|
| D-Doors 11D.P3 | 11-DF06. Modern door and doorcase to be removed. Door opening to be infilled. Outer archway to be retained. | Negative. C20 addition. | Low impact | <p>The existing door and infill is unsympathetic and detracts from the appearance of the historic outer arch. The proposal to infill in timber stud reveals the simplicity of the C18 arch. The proposal is reversible, built in lightweight non-load bearing timber stud partition, as part of compartment wall for fire and acoustic separation.</p> |

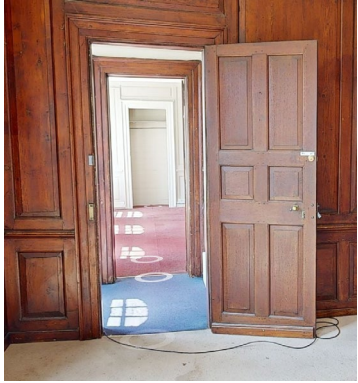
| Reference | Proposal | Significance of affected fabric | Impact | Reasoning and mitigation |
|---|---|---|---|---|
| D-Doors 11D.P5 | 11-DF10. To fit a new oak timber door in existing door opening. Design and joinery to match existing, to be LHS hung. Ironmongery to suit style. | High. C18 and EC20 Lutyens | Low impact. Benefit. | <p>Existing door has original ironmongery that doesn't allow changing the door swing or hanging without compromising ironmongery or doorcase lining. Hence the door is proposed to be fitted in the cub'd in the sitting room. New like-for-like design timber door is proposed.</p> |

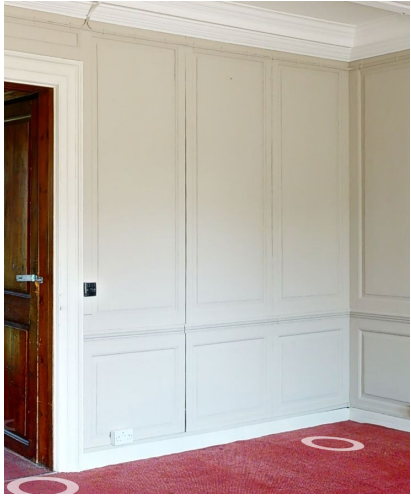
| Reference | Proposal | Significance of affected fabric | Impact | Reasoning and mitigation |
|---|---|---|---|---|
| D-Doors 11D.P6 | 11-DF16. To reinstate jib/secret door. | High. C18 and EC20 Lutyens | Low impact. Benefit. | |

| Reference | Proposal | Significance of affected fabric | Impact | Reasoning and mitigation |
|---|---|---|---|---|
| | | | | This is to provide access to the inner room, that is the sitting room, from the lobby via the corridor. |

| Reference | Proposal | Significance of affected fabric | Impact | Reasoning and mitigation |
|---|---|---|---|---|
| | | | | <p>to-back cupboards formed. It is unclear the relation of the narrow space with the jib door.</p> <p>It is proposed to reinstate the jib door to provide a direct passage from the lobby entrance to the sitting room, as to comply with Fire Strategy.</p> |

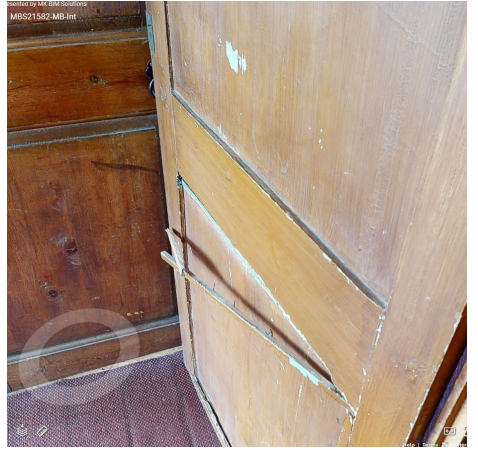
| Reference | Proposal | Significance of affected fabric | Impact | Reasoning and mitigation |
|---|---|---|---|---|
| D-Doors<br>11D.R1 | 11-DF14 To repair inner face of panels. To fit new ironmongery to sympathetically reflect the style of the door. | High.<br>C18 and EC20<br>Lutyens. | Low<br>impact.<br>Benefit. | <p>The like-for-like repairs are beneficial to the longevity of the historic joinery.</p> |

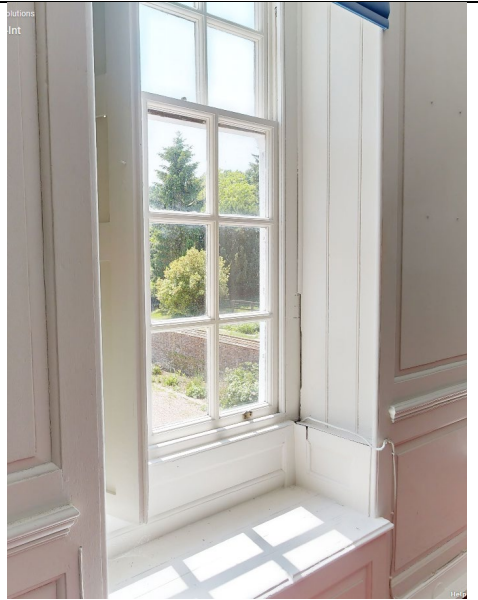
| Reference | Proposal | Significance of affected fabric | Impact | Reasoning and mitigation |
|---|---|---|---|---|
| E-Window 11E.R2 | Reinstate missing shutter. | High. C18 and EC20 Lutyens. | Positive impact. | <p>Benefit, to reinstate the original feature and improve use.</p> |

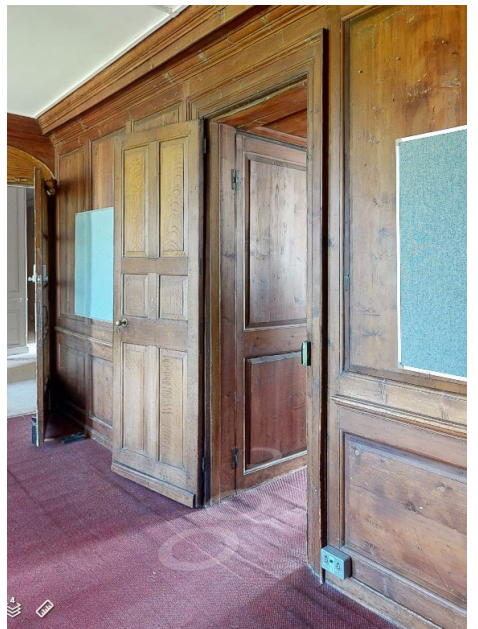
| Reference | Proposal | Significance of affected fabric | Impact | Reasoning and mitigation |
|---|---|---|---|---|
| G-New internal partitions 11G.P1 | Infill door opening behind a EC20 door (to be kept permanently shut) with lightweight non-load bearing timber stud partition, as part of compartment wall. | High. C18 and EC20 Lutyens. | Low impact | <p>The infill is inserted within the existing opening, so there is no loss of historic fabric. This is reversible.<br/>The door set will remain, in fixed-shut position, therefore there will be no visual impact to the staircase lobby.</p> |

| Reference | Proposal | Significance of affected fabric | Impact | Reasoning and mitigation |
|---|---|---|---|---|
| | | | | Door will be lined on the internal side to form a compartment wall for fire and acoustic separation. |

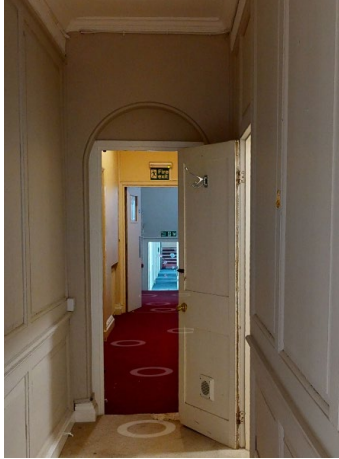
| Reference | Proposal | Significance of affected fabric | Impact | Reasoning and mitigation |
|---|---|---|---|---|
| G-New internal partitions 11G.P2 | Remove modern door and doorcase, infill door opening with lightweight non-load bearing timber stud partition, as part of compartment wall. Over archway to be retained. | High.<br>C18 and EC20 Lutyens adjacent.<br><br>Negative.<br>Late C20 infill and door. | Low impact | <p>The infill is inserted within the existing opening, so there is no loss of historic fabric. The proposal is reversible. The original archway detail is retained and clearer to see. The proposal is to built in lightweight non-load bearing timber stud partition, as part of compartment wall for fire and acoustic separation.</p> |

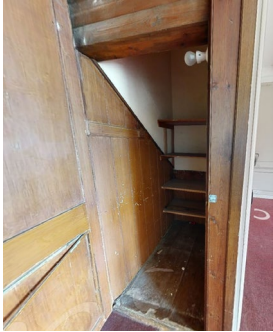
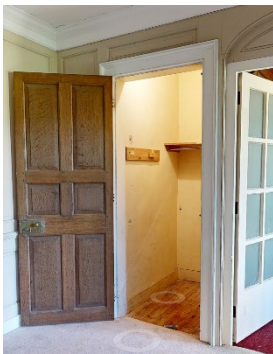
| Reference | Proposal | Significance of affected fabric | Impact | Reasoning and mitigation |
|---|---|---|---|---|
| G-New internal partitions 11G.P3 (11G.D1) | To remove existing partition between cupboards, and to re-erect it further along. | High.<br>C18 and EC20 Lutyens adjacent. | Low impact. | <p>There is evidence that the narrow space housed a staircase to the attic, which later was removed, and the back-</p> |

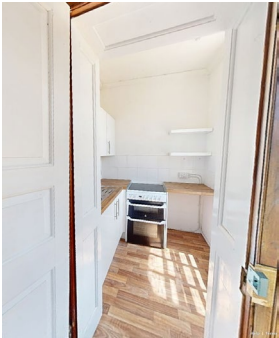
| Reference | Proposal | Significance of affected fabric | Impact | Reasoning and mitigation |
|---|---|---|---|---|
| J-Internal fixtures and fittings 11J.D1 | To strip modern kitchen units, tiling and associated plumbing, drainage, electrics, etc. | Neutral/negative. C20 additions. | Neutral impact overall. | <p>Modern fittings, added by the school. The replacement will have a neutral impact.</p> |

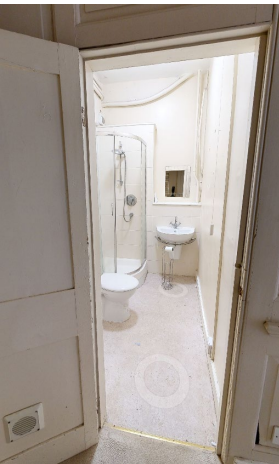
| Reference | Proposal | Significance of affected fabric | Impact | Reasoning and mitigation |
|---|---|---|---|---|
| J-Internal fixtures and fittings 11J.D2 | Remove modern sanitary ware units and associated plumbing. | Neutral/negative. C20 additions. | Neutral impact overall. | <p>Modern fittings, added by the school. The replacement will have a neutral impact.</p> |

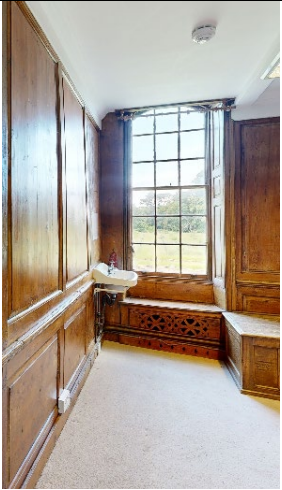
| Reference | Proposal | Significance of affected fabric | Impact | Reasoning and mitigation |
|---|---|---|---|---|
| J-Internal fixtures and fittings 11J.D3 | Remove modern basin and associated plumbing. | Neutral/negative. C20 additions. | Low impact. Benefit. | |

| Reference | Proposal | Significance of affected fabric | Impact | Reasoning and mitigation |
|---|---|---|---|---|
| | | | | <p>The removal of the modern fitting will be an enhancement to allow the panel to be better seen, without obstruction.</p> |

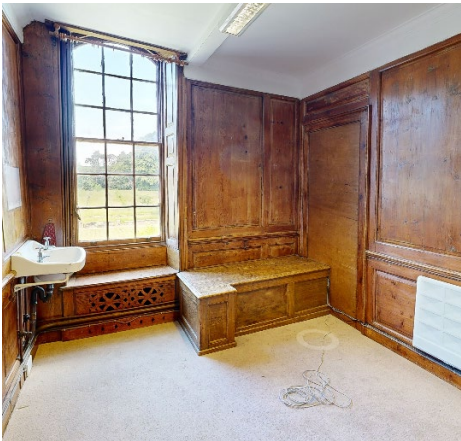
| Reference | Proposal | Significance of affected fabric | Impact | Reasoning and mitigation |
|---|---|---|---|---|
| L- Panelling 11L.D1 | To remove low level timber boxing and steelwork concealed in it, in both rooms. And to remove the metal posts cladded with timber panelling. The steelwork was retrofitted to rectify a failing timber joisted floor above. | Low. C20 alteration. | Low impact. Benefit. | |

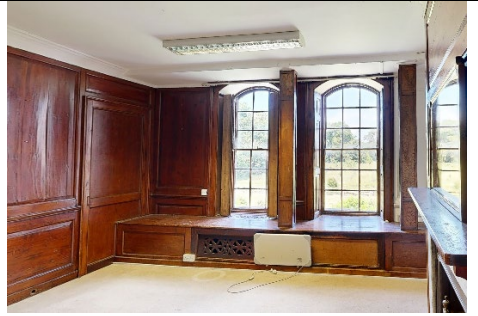
| Reference | Proposal | Significance of affected fabric | Impact | Reasoning and mitigation |
|---|---|---|---|---|
| | | | | <p>To reinstate the former floor space of both rooms.<br/>Additional steelwork will be inserted at ceiling level, replacing the existing bearer.</p> |

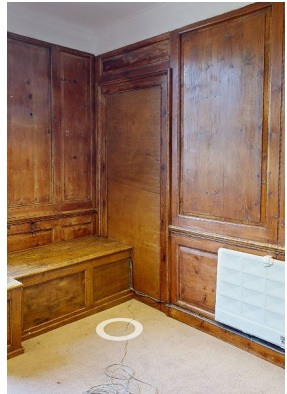
| Reference | Proposal | Significance of affected fabric | Impact | Reasoning and mitigation |
|---|---|---|---|---|
| L-<br>Panelling<br>11L.D2 | To remove modern timber panelling infill of the original doorway.<br>Replacement with a timber panelling that reflects the style of wall panelling. | High.<br>C18 and EC20 Lutyens. | Low impact.<br>Benefit | <p>The proposal is to reinstate a moulded panel within the former doorway. This will enhance the architectural design and language of the room.</p> |

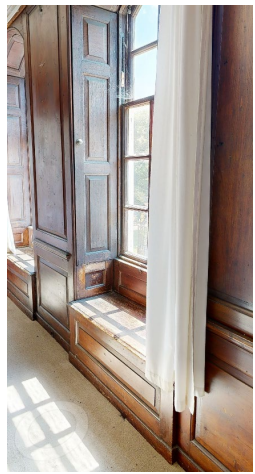
| Reference | Proposal | Significance of affected fabric | Impact | Reasoning and mitigation |
|---|---|---|---|---|
| L-<br>Panelling<br>11L.R1 | EC20 timber wall panelling to have no alterations. All existing panelling to be retained. Careful sanding and staining when required. Where existing C21 modern fixtures/fittings removed, panelling to be splice repaired using like-for-like material and finishes. | High.<br>C18 and EC20 Lutyens. | No impact.<br>Repairs of benefit. | <p>No alterations are proposed to the wall panelling.</p> |

| Reference | Proposal | Significance of affected fabric | Impact | Reasoning and mitigation |
|---|---|---|---|---|
| | | | | Any required repairs are beneficial for the appearance and longevity of the timber panelling. |

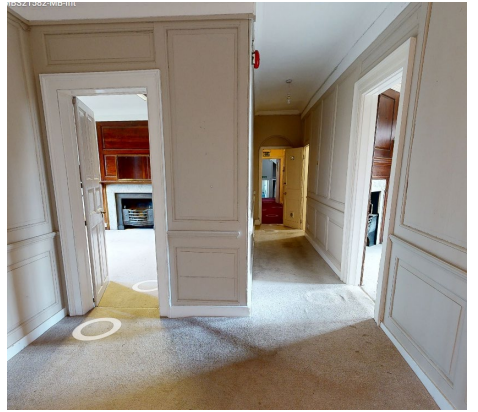
| Reference | Proposal | Significance of affected fabric | Impact | Reasoning and mitigation |
|---|---|---|---|---|
| L-<br>Panelling<br>11L.R2 | EC20 timber wall panelling to have no alterations. All existing panelling to be retained,. Where existing C21 modern fixtures/fittings removed, panelling to be splice repaired using like-for-like material and finishes. Redecorate throughout. | High.<br>C18 and EC20 Lutyens. | No impact.<br>Repairs of benefit. | <p>No alterations are proposed to the wall panelling.<br/>Any required repairs are beneficial for the appearance and longevity of the timber panelling.</p> |

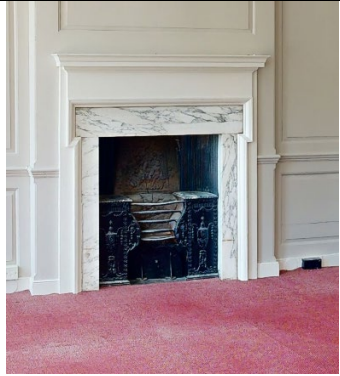
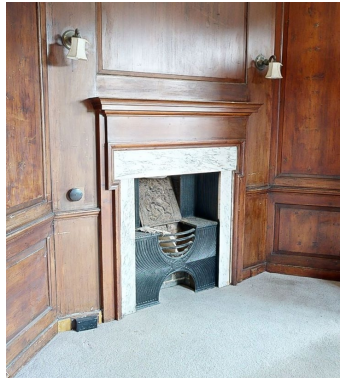
| Reference | Proposal | Significance of affected fabric | Impact | Reasoning and mitigation |
|---|---|---|---|---|
| N-<br>Fireplace<br>11N.R1 | EC20 fireplace stone surround and crate to be retained. Hearth to be retained or reinstated if found missing. Flue re-lined to allow use of the fireplace. | High.<br>C18 and EC20 Lutyens. | Neutral. | |

| Reference | Proposal | Significance of affected fabric | Impact | Reasoning and mitigation |
|---|---|---|---|---|
| | | | | <p>No proposed works or alterations to the fireplaces. If hearths are not found these will be reinstated with stone hearth in keeping with the style and age of the fireplace features.</p> |

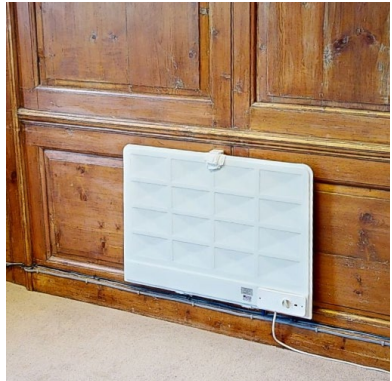
| Reference | Proposal | Significance of affected fabric | Impact | Reasoning and mitigation |
|---|---|---|---|---|
| P-Services 11P.D1 | Remove modern panel radiator.<br>Replacement radiator. | Neutral.<br>C20 addition. | Neutral.<br>Benefit. | <p>Modern fittings, added by the school. The replacement will have a neutral impact and reflects the style of the existing cast iron rads.</p> |

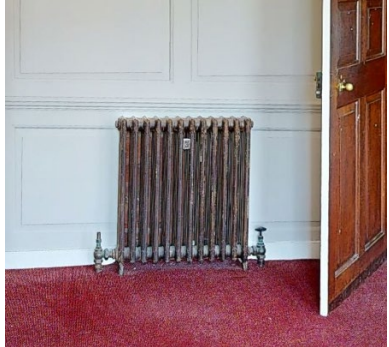
| Reference | Proposal | Significance of affected fabric | Impact | Reasoning and mitigation |
|---|---|---|---|---|
| P-<br>Services<br>11P.R1 | Cast iron radiators refurbished to work with new heating system. | High.<br>EC20 Lutyens | Benefit | <p>These are to be retained and refurbished. This will preserve the historic fixtures and enhance the use of the building.</p> |
