C18 Central Block and Lutyens East Wing – Proposed Apartment 10 Dining Room – Plan of Significance

**641-KS-06-MB-SH-A-90100-P02****Temple Dinsley Level 0, GA – Apartment 10 – Dining Room**

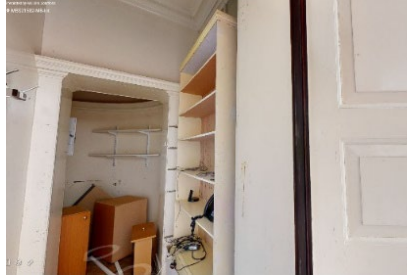
| Reference | Proposal | Significance of affected fabric | Impact | Reasoning and mitigation |
|---|---|---|---|---|
| A-Walls 10A. D1 | C20th partition to be demolished to form a sizable utility room. | Low. Partition is post Lutyens. | Benefit. No harm. | <p>Benefit: to reinstate Lutyens plan and improve use. The proposal involves reinstating the narrow space beside the front room, to form an utility room of the original proportions. Access from the apartment corridor is via a new opening in the post Lutyens curved wall.</p> |

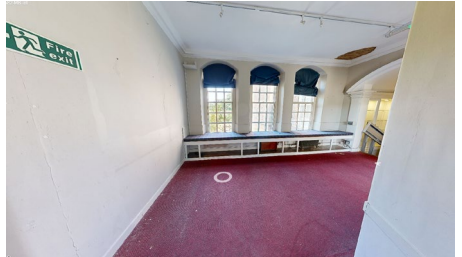
| Reference | Proposal | Significance of affected fabric | Impact | Reasoning and mitigation |
|---|---|---|---|---|
| A-Walls 10A.R2 | North rooms inner face walls repairs to lime plaster carried out as required. Breathable paint. | High. Early C20 Lutyens | No Impact. Repairs of Benefit. | <p>The like-for-like repairs are beneficial for the viability of the building. The decorations are consistent with the character of the spaces.</p> |

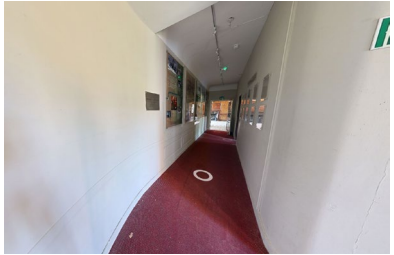
| Reference | Proposal | Significance of affected fabric | Impact | Reasoning and mitigation |
|---|---|---|---|---|
| A-Walls<br>10A.R3 | South wall entrance/corridor timber panelling to remain. Redecorate. | High.<br>Early C20 Lutyens | No Impact.<br>Repairs / re-decorations are of benefit. | <p>The south wall of the corridor once formed part of the back room, prior to the insertion of the corridor, therefore the panelling is original. The retention of the later corridor wall makes the use flexible.</p> |

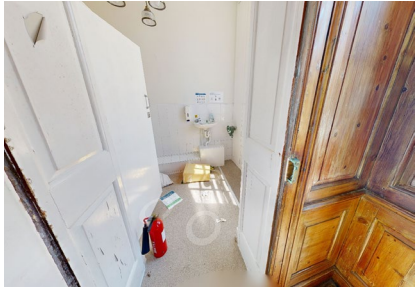
| Reference | Proposal | Significance of affected fabric | Impact | Reasoning and mitigation |
|---|---|---|---|---|
| B-Floors<br>10B.P1 | Following C20 modern carpet finish removal, new tiled flooring laid including decoupling membrane to bathroom, shower room, WC and Utility room. | Low.<br>Late C20 finishes added by School. | Benefit | <p>Benefit: Revealing the historic timber floor enables like-for-like repairs to be carried out and the proposed membrane ensures that any future finish will not adhere to the historic fabric.</p> |

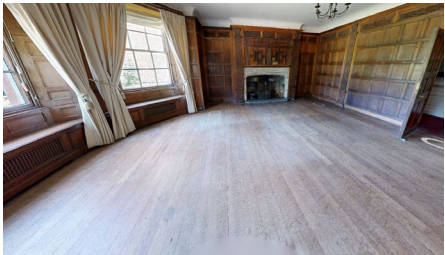
| Reference | Proposal | Significance of affected fabric | Impact | Reasoning and mitigation |
|---|---|---|---|---|
| B-Floors<br>10B.R2 | Existing wooden flooring to be retained and repaired when required. It is proposed to carefully lift the existing boards to allow for inspection and repair of existing suspended timber floor joists, and insertion of new breathable insulation between the joists. Existing boards to be re-laid once floor repairs complete. | High.<br>Early C20 Lutyens. | Benefit. | <p>The historic floor finish remains visible. Benefit: Breathable insulation will benefit the use and improve the thermal performance of the building. The careful like-for-like repairs are of benefit for the longevity of the building.</p> |

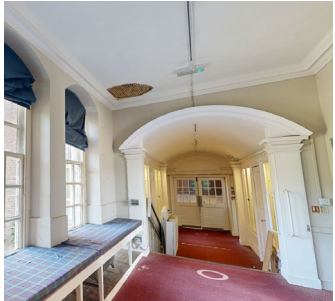
| Reference | Proposal | Significance of affected fabric | Impact | Reasoning and mitigation |
|---|---|---|---|---|
| C-Ceilings<br>10C.R1 | Ceiling - Lath and lime plaster to be repaired generally. And to be redecorated. | High.<br>Early C20 Lutyens | Low Impact<br>Benefit | <p>The like-for-like repairs are beneficial for the viability of the building. Lath and plaster ceiling to be repaired when required. Any compartmentation to the apartment above or any required services (to be run within the ceiling void) are to be installed from above, to minimise the impact of the proposal alteration on the historic fabric.</p> |

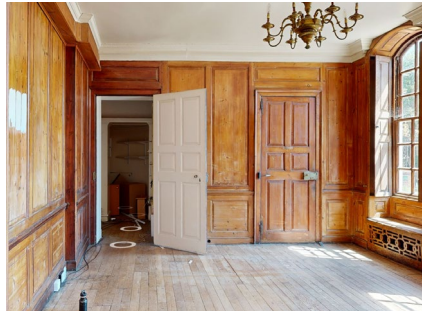
| Reference | Proposal | Significance of affected fabric | Impact | Reasoning and mitigation |
|---|---|---|---|---|
| D-Doors<br>10D.P2 | C18 timber doors to be kept shut permanently, door openings to be infilled behind. | High.<br>C18 | Neutral impact. | <p>Both doors and the proportions of the entrance hall will remain unaltered and the proposal is reversible.</p> <p>The door sets will remain, in fixed-shut position, therefore there will be no visual impact to the entrance lobby. Doors will be lined on the internal side to form a compartment wall for fire and acoustic separation.</p> |

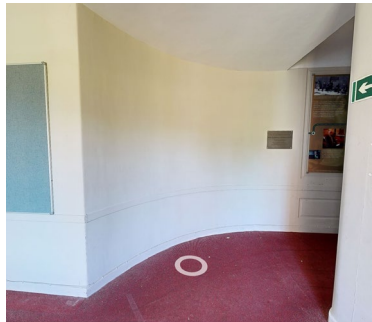
| Reference | Proposal | Significance of affected fabric | Impact | Reasoning and mitigation |
|---|---|---|---|---|
| D-Doors<br>10-DG02 &<br>10-DG03<br>10D.P3 | New timber door, frame, and architraves to match. | Moderate.<br>C20 alteration. | Neutral impact. | <p>Reason: This partition is a C20 later addition formed when the corridor was inserted. There is no loss of historic fabric</p> |

| Reference | Proposal | Significance of affected fabric | Impact | Reasoning and mitigation |
|---|---|---|---|---|
| F-New openings 10F.P1 | To form two new door openings in the curved C20 wall. | Low. C20 alteration. | Neutral impact. | As per note D-Doors 10-DG02 & 10-DG03. 10D.P3 |

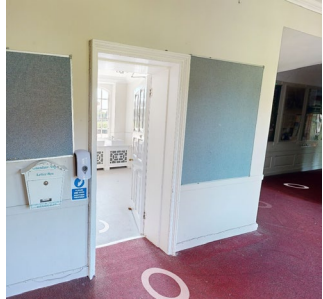
| Reference | Proposal | Significance of affected fabric | Impact | Reasoning and mitigation |
|---|---|---|---|---|
| D-Doors<br>10-DG05<br>10D.P4 | C20 timber door to be kept shut permanently, door opening to be infill behind. | Moderate.<br>C20 alteration. | Low level benefit. | <p>Benefit: the door is an insertion into Lutyens' wall so its closure would reinstate the designed layout.</p> |

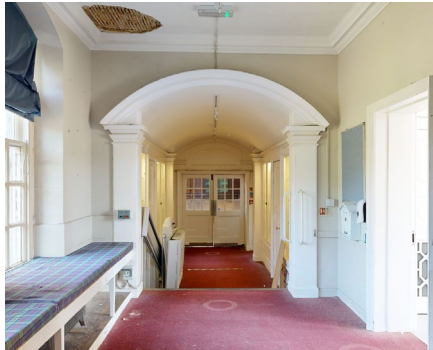
| Reference | Proposal | Significance of affected fabric | Impact | Reasoning and mitigation |
|---|---|---|---|---|
| D-Doors<br>10-DG07<br>10D.P6 | New timber double door and doorcase, under the moulded-decorated archway. Door joinery to match. | High.<br>Early C20 Lutyens | Low impact. | <p>The new door sits within the Lutyens moulded-decorated archway. Reversible.</p> |

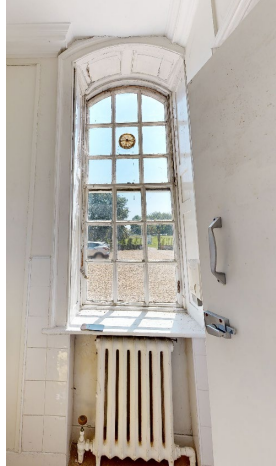
| Reference | Proposal | Significance of affected fabric | Impact | Reasoning and mitigation |
|---|---|---|---|---|
| E-Windows<br>10E.R1 | C18 and 1911 'Lutyens' timber sash windows repairs. Splice repairs when required. Resin repairs for localized repairs. Replacement of broken glass panes. Perished putty replacement. Easing of window sashes and adjusting of window weights. Original ironmongery to be retained. Ease and adjust as required. New ironmongery to comply with Building Regulations. To redecorate internally and externally. | High.<br>C18 and EC20 Lutyens | Repairs Benefit | |

| Reference | Proposal | Significance of affected fabric | Impact | Reasoning and mitigation |
|---|---|---|---|---|
| | | | | <p>Original sash windows are to be retained and repaired carefully. Ironmongery retained and repaired. The like-for-like repairs are beneficial for the viability and appearance of the building. Replacement of non-original ironmongery to sympathetically reflect the style of the window will improve their appearance.</p> |

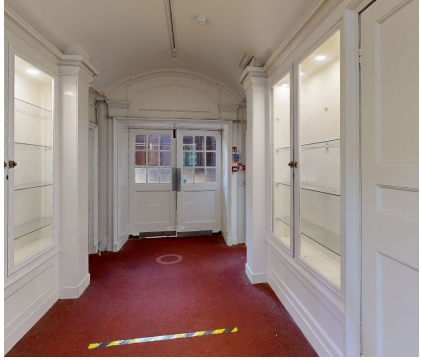
| Reference | Proposal | Significance of affected fabric | Impact | Reasoning and mitigation |
|---|---|---|---|---|
| G-New internal partitions. 10G.P2 | Infill EC20 walkthrough with lightweight non-load bearing timber stud partition, as part of compartment wall. | High. EC20 Lutyens | Low impact. | <p>The partition is inserted within the existing columned projections. This is a reversible alteration with no loss of historic fabric.</p> |

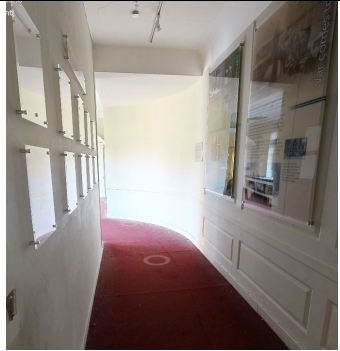
| Reference | Proposal | Significance of affected fabric | Impact | Reasoning and mitigation |
|---|---|---|---|---|
| G-New internal partitions. 10G.P3 | To form a pair of timber panelled reveals, architrave, and flat head. Moulding to match historic details in the dressing room. | High. EC20 Lutyens | Neutral impact. Benefit. | |

| Reference | Proposal | Significance of affected fabric | Impact | Reasoning and mitigation |
|---|---|---|---|---|
| | | | | <p>The proposal will discease the dropped ceiling behind and add an elegant feature to the corridor/entrance.</p> |

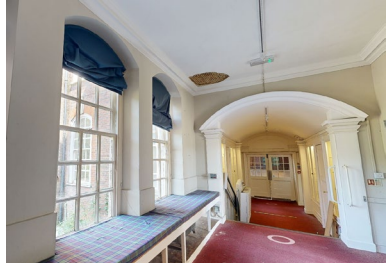
| Reference | Proposal | Significance of affected fabric | Impact | Reasoning and mitigation |
|---|---|---|---|---|
| J-Internal fixtures and fittings 10J.D1 | To strip C21 bench and stair lift. | Neutral/negative C20 additions. | Benefit. | <p>The removal of late C20 stairlift and bench will be an enhancement to allow the Lutyens mouldings and details to be better seen.</p> |

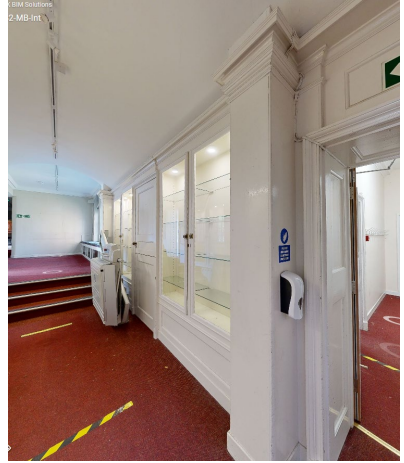
| Reference | Proposal | Significance of affected fabric | Impact | Reasoning and mitigation |
|---|---|---|---|---|
| K-Joinery<br>10K.D1 | To strip modern glazed cabinets and solid door cupboards. | Low.<br>Late C20 alteration by the School. | Positive impact. | <p>The cabinets are a later addition. The top cornice is original, and this is retained.</p> |

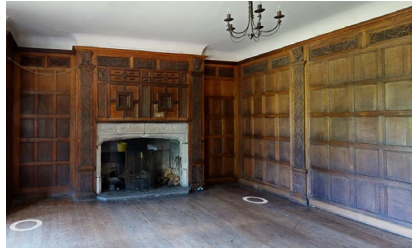
| Reference | Proposal | Significance of affected fabric | Impact | Reasoning and mitigation |
|---|---|---|---|---|
| L-Panelling<br>10K.P1 | EC20 timber wall panelling in the kitchen / diner / living room to have no alterations proposed. | High.<br>C18 and EC20 Lutyens. | None | |

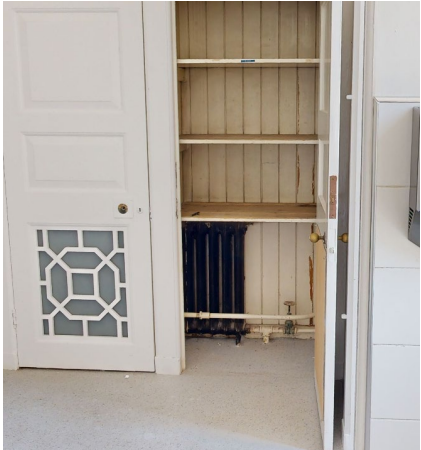
| Reference | Proposal | Significance of affected fabric | Impact | Reasoning and mitigation |
|---|---|---|---|---|
| P-Services<br>10P.R1 | Cast iron radiators refurbished to work with new heating system. | High.<br>EC20 Lutyens | Benefit. | <p>These are to be retained and refurbished. This will preserve the historic fixtures and enhance the use of the building.</p> |
