## Second Floor – Proposed Landing – Plan of Significance

**641-KS-06-MB-SH-A-90960 – P01**  
**Temple Dinsley Level 2, GA – Common Areas – 2nd Floor 01**

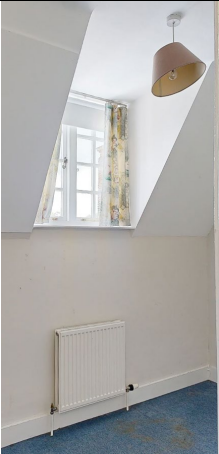
| Reference | Proposal | Significance of affected fabric | Impact | Reasoning and mitigation |
|---|---|---|---|---|
| A-Walls<br>ME-A.D2 | Remove section of external wall including dormer window | Neutral<br>C20 alterations<br><br>Neutral<br>MC20 window | Low – Neutral Impact | <p>Location in east external wall for new opening to proposed link to lift</p> <p>Lift access is necessary to provide resident/visitor accessibility to upper floor apartments.</p> <p>The location of the alterations are unobtrusive within the hidden roof above the Hall and the fabric was changed when the roof was raised.</p> <p>Refer to F-New openings CAF.D2</p> |

| Reference | Proposal | Significance of affected fabric | Impact | Reasoning and mitigation |
|---|---|---|---|---|
| F-New openings ME-F.D2 | Form opening in external wall to provide access to new external passenger lift | Moderate - low C20 additions to building affected at 2 <sup>nd</sup> floor. Proposed structure will sit away from existing masonry wall. | Low Impact | <p>Location for new passenger lift</p> <p>Proposed lift shaft will be visually obscured by surrounding walls and roofs. Access at 2<sup>nd</sup> floor via new opening formed at approximate location of existing dormer window. The proposed lift shaft will be located away from the original Lutyens external brickwork at 1<sup>st</sup> floor.</p> <p>Refer to A-Walls CAA. D2</p> |

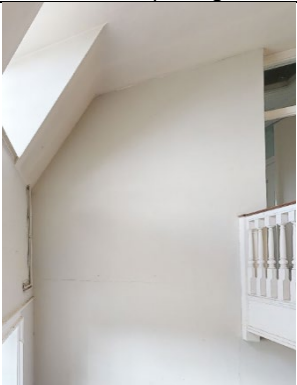
| Reference | Proposal | Significance of affected fabric | Impact | Reasoning and mitigation |
|---|---|---|---|---|
| B-Floors<br>ME-A.P2 | Form extension to landing over stairwell to provide access to Apartment 19 Helena. | Neutral<br>C20 alterations | Neutral | <p>Location of proposed extension to landing in front of existing wall</p> <p>The stair at this level is C20 and the landing detail and balusters would match the existing. It provides access to Apartment 19.</p> <p>The location is unobtrusive and the fabric was changed when the roof was raised.</p> <p>Refer to Helena Impact Table F-New openings 19F. D1</p> |

| Reference | Proposal | Significance of affected fabric | Impact | Reasoning and mitigation |
|---|---|---|---|---|
| H-Stairs<br>ME-H.D1 | Remove section of C20 existing painted timber balustrade at 2 <sup>nd</sup> floor level to allow installation of new section of landing. | Low<br>C20 alterations | Low Impact | <p>Existing C20 balustrade to be removed to allow landing to be extended over stair.</p> |

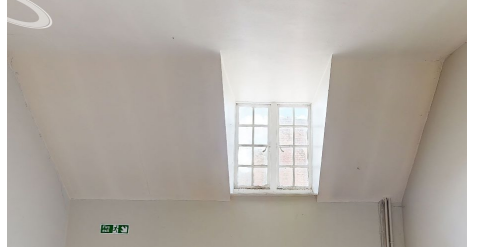
| Reference | Proposal | Significance of affected fabric | Impact | Reasoning and mitigation |
|---|---|---|---|---|
| C-Ceilings ME-C. D1 | Removal of MC20 plasterboard linings to sloping section of ceiling adjacent to dormer window. | Moderate<br>Lutyens 1909 roof raised c1935<br><br>Neutral C20<br>Plasterboard linings C20 alterations | Low Impact<br><br>Benefit | <p>Dormer window over stairwell EW W02</p> <p>Plasterboard linings to sloping sections of ceiling are to be removed to allow the roof structure to be assessed/recorded/condition investigated, the roof void insulated. This is considered to be a positive impact which will benefit the building fabric, the internal environment and the viability of the building for future use.</p> <p>The coved/rolled plaster junction between the flat and sloping ceiling will be reinstated.<br/>No historic fabric is affected.</p> |

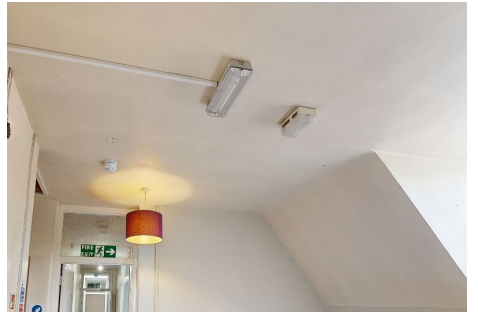
| Reference | Proposal | Significance of affected fabric | Impact | Reasoning and mitigation |
|---|---|---|---|---|
| C-Ceilings ME-C. D2 | Removal of existing plasterboard ceilings above stair and throughout 2 <sup>nd</sup> floor circulation area. | Moderate<br>Lutyens 1909 roof raised c1935<br><br>Neutral C20 alterations<br>Plasterboard linings | Low-Moderate Impact | <p>Flat ceiling in corridor and over stairwell</p> <p>Remove existing services access hatch to roof void in ceiling at head of stairs</p> |

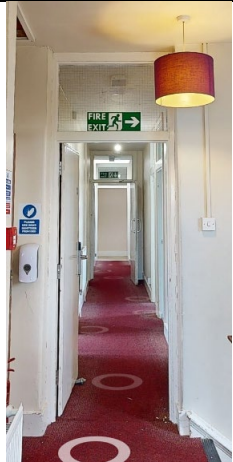
| Reference | Proposal | Significance of affected fabric | Impact | Reasoning and mitigation |
|---|---|---|---|---|
| D-Doors<br>ME-D.D1 | Removal of existing painted flush panel C20 fire door/frame/glazed panel over. | Neutral/Negative<br>Late C20 alterations | Low Impact | <p>Existing C20 door to be removed</p> |

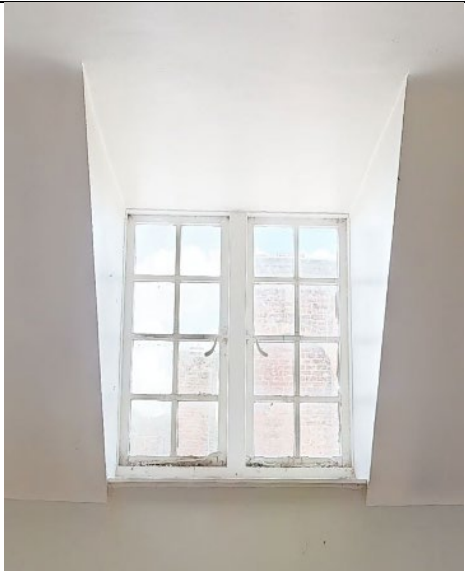
| Reference | Proposal | Significance of affected fabric | Impact | Reasoning and mitigation |
|---|---|---|---|---|
| E-Windows<br>ME-E.R1 | Renovation of C20 timber casement dormer window | Neutral<br>C20 (1935) alterations | Low Impact<br><br>Benefit & Enhance | <p>MC20 dormer window above stairwell EW W02</p> <p>The existing timber multi-pane window will be repaired/renovated/redecorated and upgraded with slim-line double glazing which will improve the comfort of the</p> |

| Reference | Proposal | Significance of affected fabric | Impact | Reasoning and mitigation |
|---|---|---|---|---|
| | | | | internal environment and the viability of the historic building for future use.<br>Splice repairs to be carried out where required. Resin for more localised repair. Perished putty replacement. Easing of window as required. Original 'monkey tail' casement latches to be retained for reuse. New ironmongery/locking is to comply with building regulations where required. The repairs will improve the appearance and longevity of the window. |

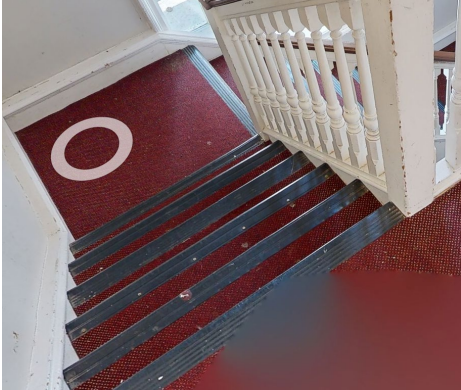
| Reference | Proposal | Significance of affected fabric | Impact | Reasoning and mitigation |
|---|---|---|---|---|
| H-Stairs<br>ME-H.P1 | Upgrading of MC20 stair and balustrade between 1 <sup>st</sup> and 2 <sup>nd</sup> floor levels. | Low<br>MC20 (1935) stair flights to access the units in the roof | Low Impact | <p>Common stair to 2<sup>nd</sup> floor</p> <p>Existing carpet covering and nosings to be removed to allow investigation of construction. Upgrading works will be carried out to the stair to comply with Building Regulations fire protection and impact sound requirements.</p> |

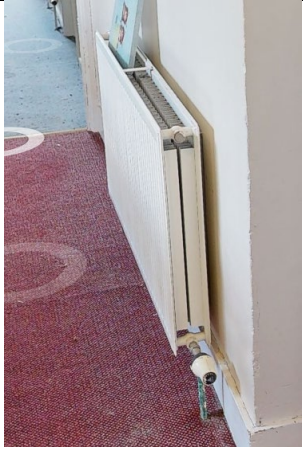
| Reference | Proposal | Significance of affected fabric | Impact | Reasoning and mitigation |
|---|---|---|---|---|
| J-Internal fixtures and fittings<br>ME-J.D1 | Removal of C20 pressed steel wall mounted radiator | Neutral | Neutral Impact | <p>C20 radiator to be removed</p> <p>Radiator and associated pipework to be removed.</p> |
