# 9-10 High Street, Hitchin North Hertfordshire

## Sustainable Drainage Systems (SuDS) Strategy Assessment and Report

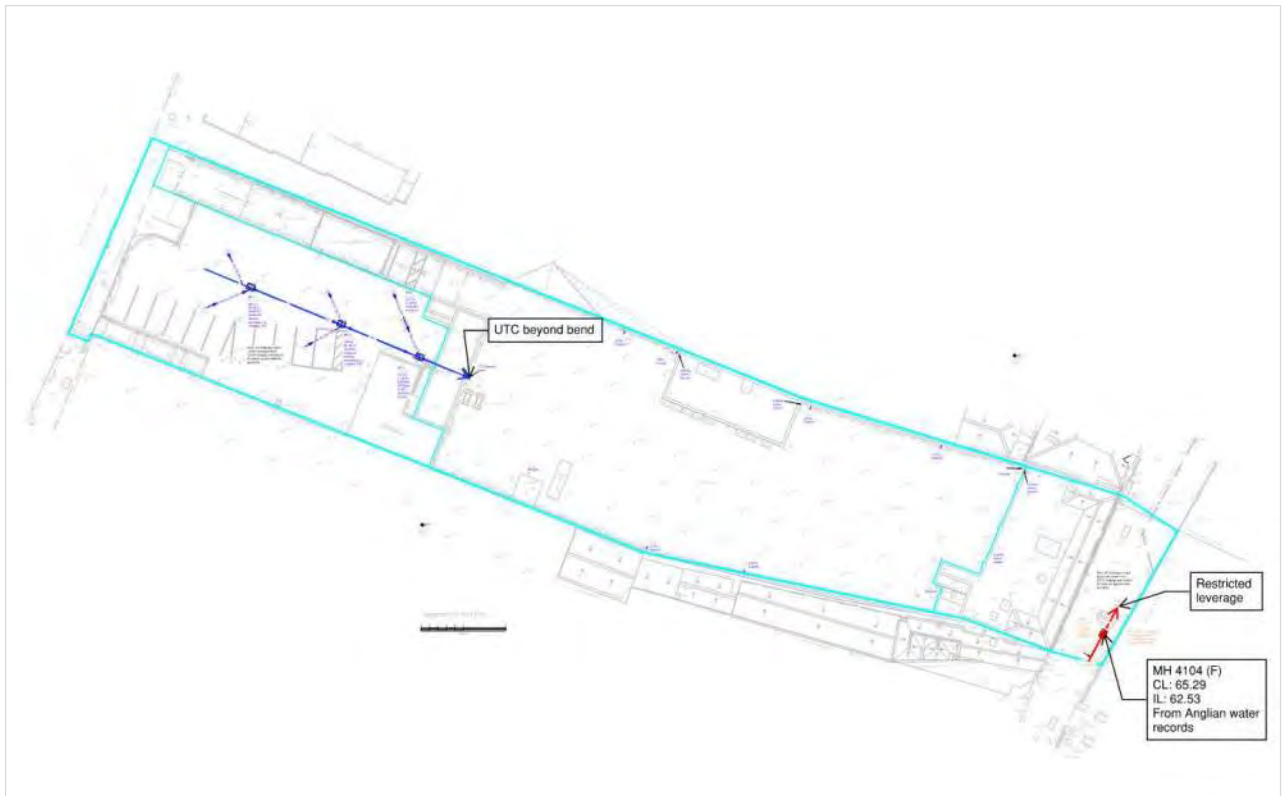
Figure 2.4: Drainage CCTV Survey Layout. (Source: Survey Solutions).

A CCTV drainage survey was undertaken to investigate the drainage connections from within the site and how these connect into the public sewer. Most manholes were inaccessible and hence their outfalls could not be determined. The CCTV drainage survey shows that a 100mm diameter surface water drainage pipe runs from the carpark then into the building where the CCTV information becomes unavailable from that point due to camera bend limitations. Survey information on the foul water run at the front, along High Street, is also limited due to restricted leverage. The drainage survey layout and full report is found in Appendix C.

Based on the sewer records and drainage CCTV survey, the site is presumed to be draining combined surface and foul into the 300-mm foul sewer running along High Street.

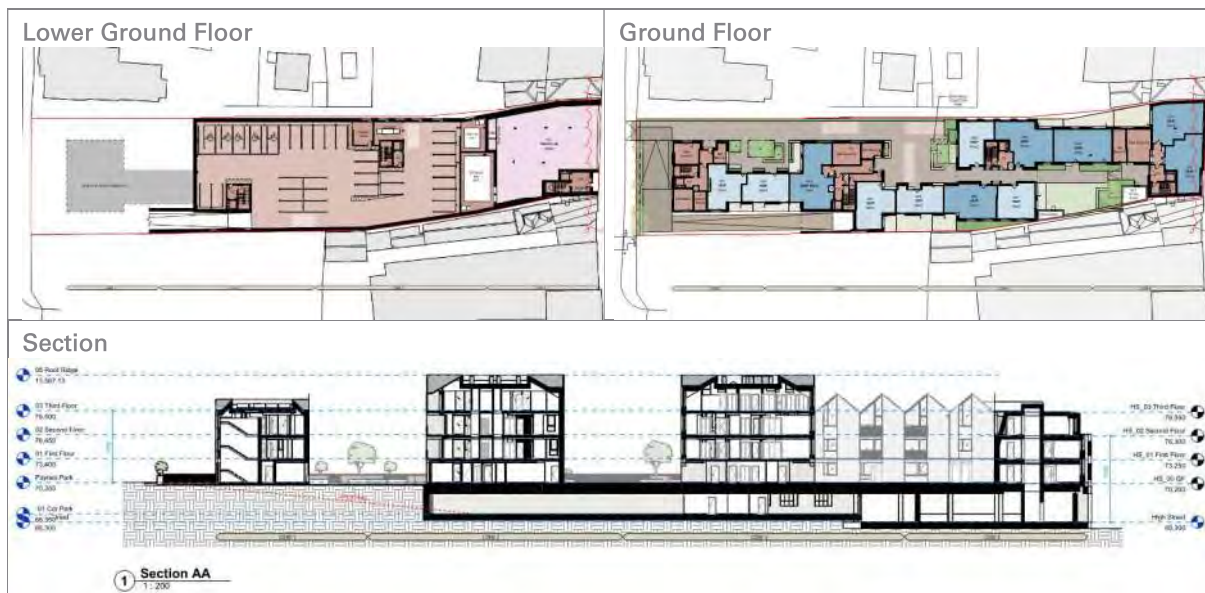
The development proposal is for the demolition of the existing building to provide one retail unit and car parking on the lower ground floor, along with a residential scheme of 44 units from ground floor to the third floor. The proposed lower ground and third floor layout is shown in Figure 3.1.

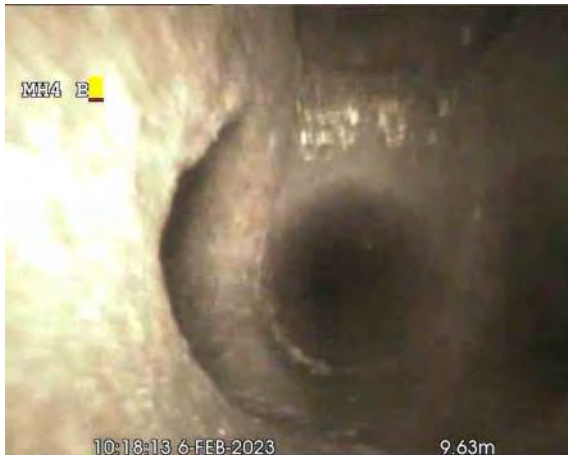
1aa8beed-8b10-4fb9-bd2a-54018b71e46a.jpg, 00:00:38, 9.83 m  
Junction at 3 o'clock, 100mm dia

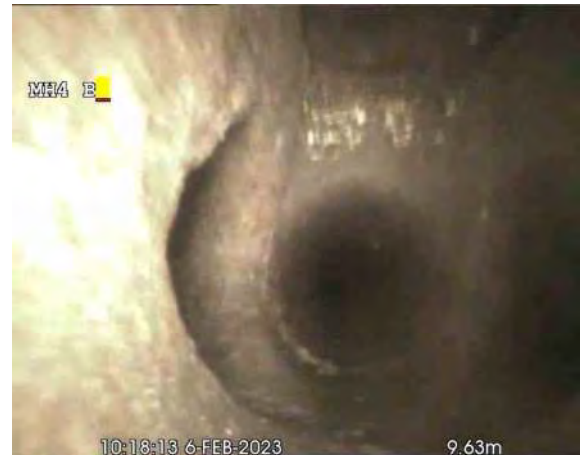
ee64899a-ccf0-4f8f-aebf-3013d63588b8.jpg, 00:00:38, 9.83 m  
Junction at 9 o'clock, 100mm dia

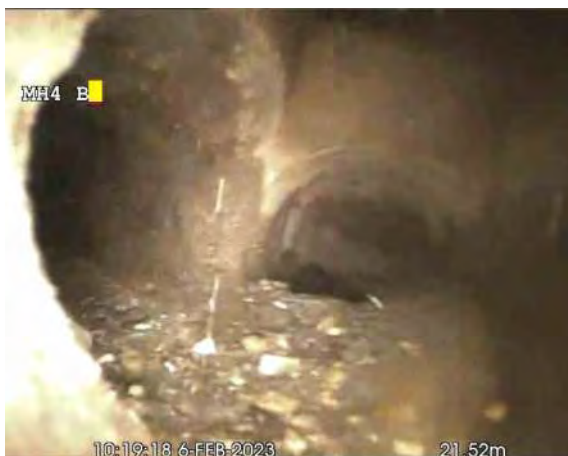
51395fd3-0329-4168-beb3-8c67e194c290.jpg, 00:01:44, 21.62 m  
Junction at 9 o'clock, 100mm dia
