## Tudor House, Preston (257)

Listed Building Consent **Part 2/2**

Minor Works  
June 2025

**Michael Collins Architect LLP**

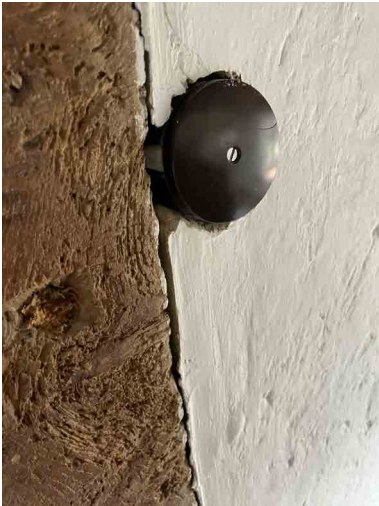
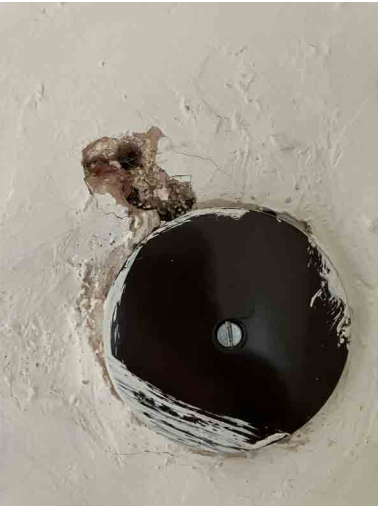
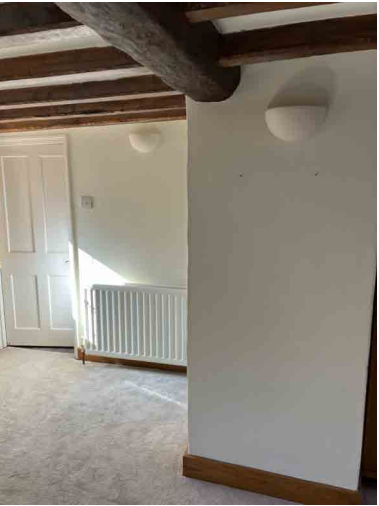
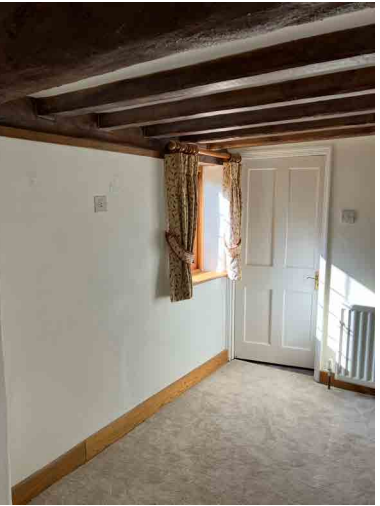
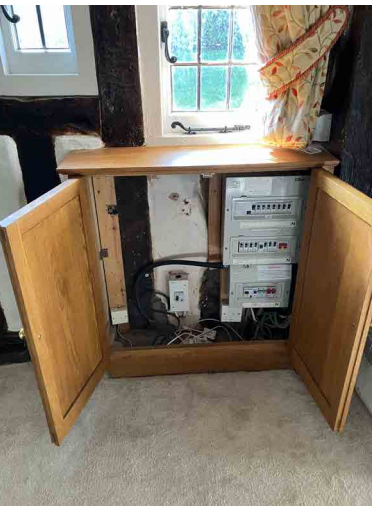
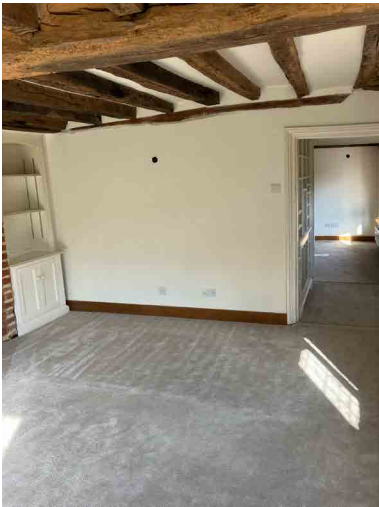
The enhancement of electrical outlets will provide the optimal occasion for the upgrade of services and improvement of lighting in both storeys of the building. The current state of the house has resulted in wall lights becoming visible, as illustrated in the accompanying images. In certain locations, the lighting has been found to be outdated. The project involves the replacement of the existing lighting with LED strips along the beams, with the aim of enhancing their aesthetic appeal.

The electrical works are to be carried out in the majority of the house, with the exception of the kitchen and the two bedrooms that are not the primary bedroom.

The plans on the following page illustrate the new electrical layout. In addition, any electrical enhancement undertaken for the purpose of addressing a safety concern will be executed on a like-for-like basis.

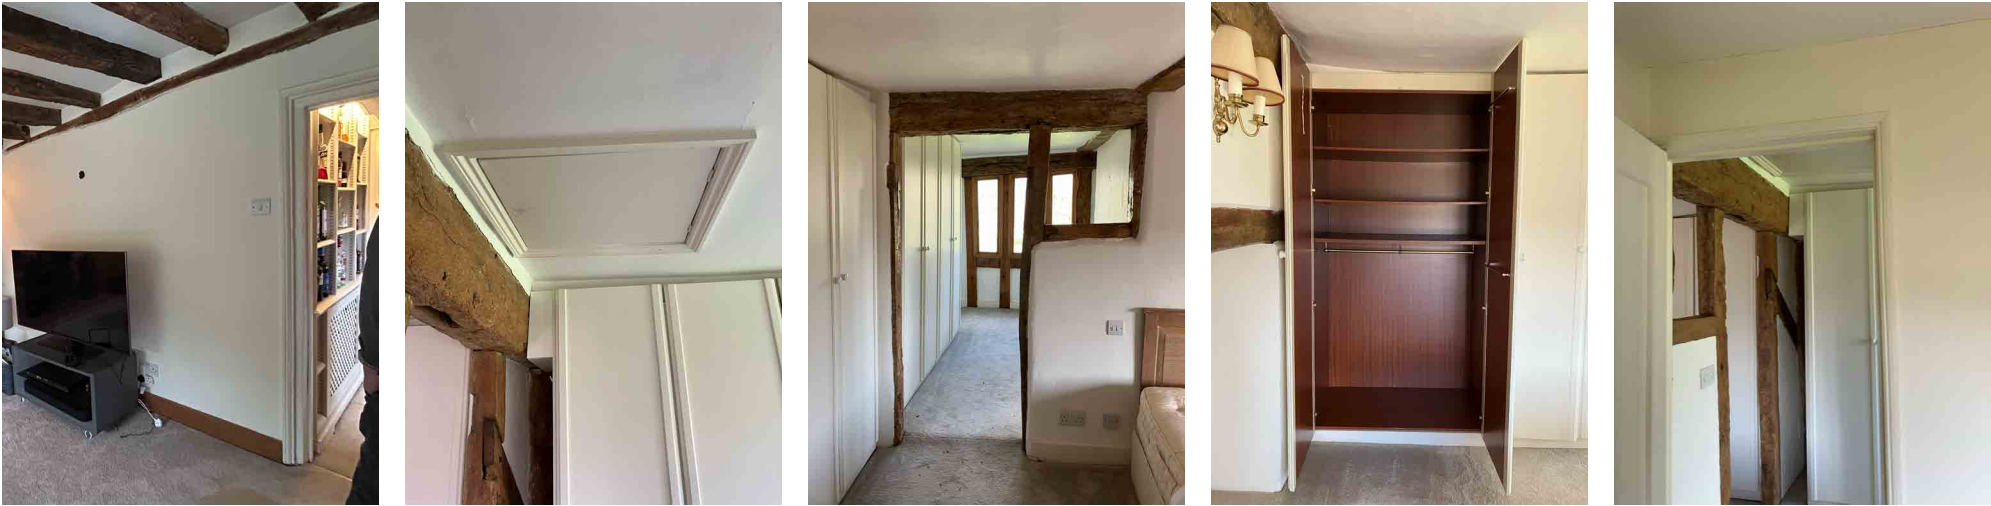
The existing built-in furniture, particularly in the primary bedroom, is outdated and not original feature. This LBC application is intended to renovate the furniture. On the ground floor, the existing shelving facing the French doors leading to the garden will be replaced to modernise the interior; the new shelving will have the same holding system as the previous shelving. A functional wall unit has been meticulously designed for the sitting room. The cabinet will be self-supporting and will not cause any damage to the wall structure.

On the first floor, the existing dressing area will be replaced for the aforementioned reasons. This will result in a more user-friendly set of cupboards. As shown in the schematic plan, incorporating supplementary joinery along the designated wall sections is a viable option for enhancing storage capacity in the primary bedroom. This joinery will be standalone and will be carefully detailed to not compromise the historic fabric of the building.

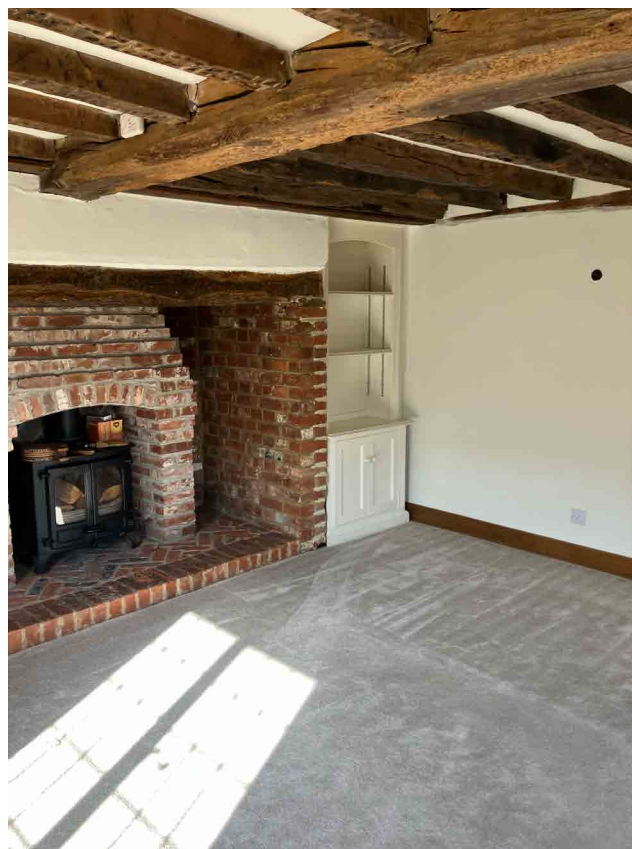
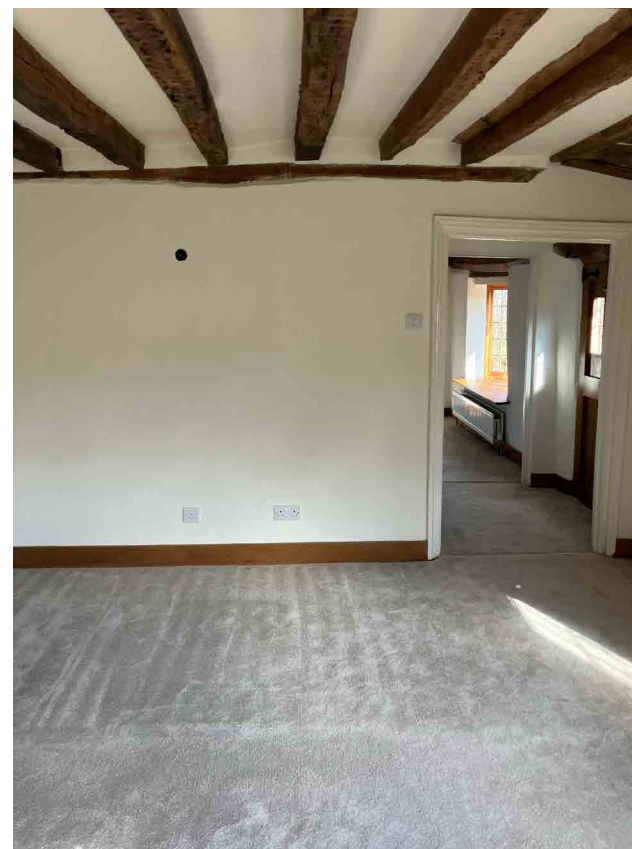
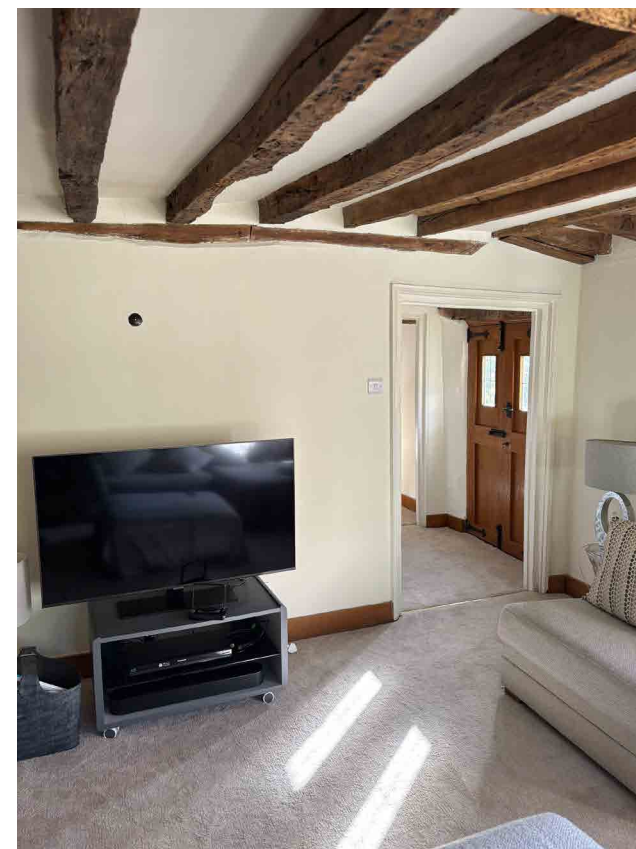
The works subject to this planning application are intended to fill in one of the two doors that currently facilitate access to the sitting room on the ground floor. The objective of this intervention is to optimise the room's layout, which already boasts an acceptable proportion, by eliminating the redundant door.

As this work is a light infill intervention, it is considered to be a minor intervention on the fabric of the building formed with timber framework and clad joinery. This would not have any impact on the historical fabric and would therefore be easily reversible, should be required in the future.
