# FLOOD RISK & DRAINAGE

**Milksey Lane, Graveley - Phase 2**  
Flood Risk Assessment  
September 2025

Report Ref: 29161-FLD-0101 Rev A

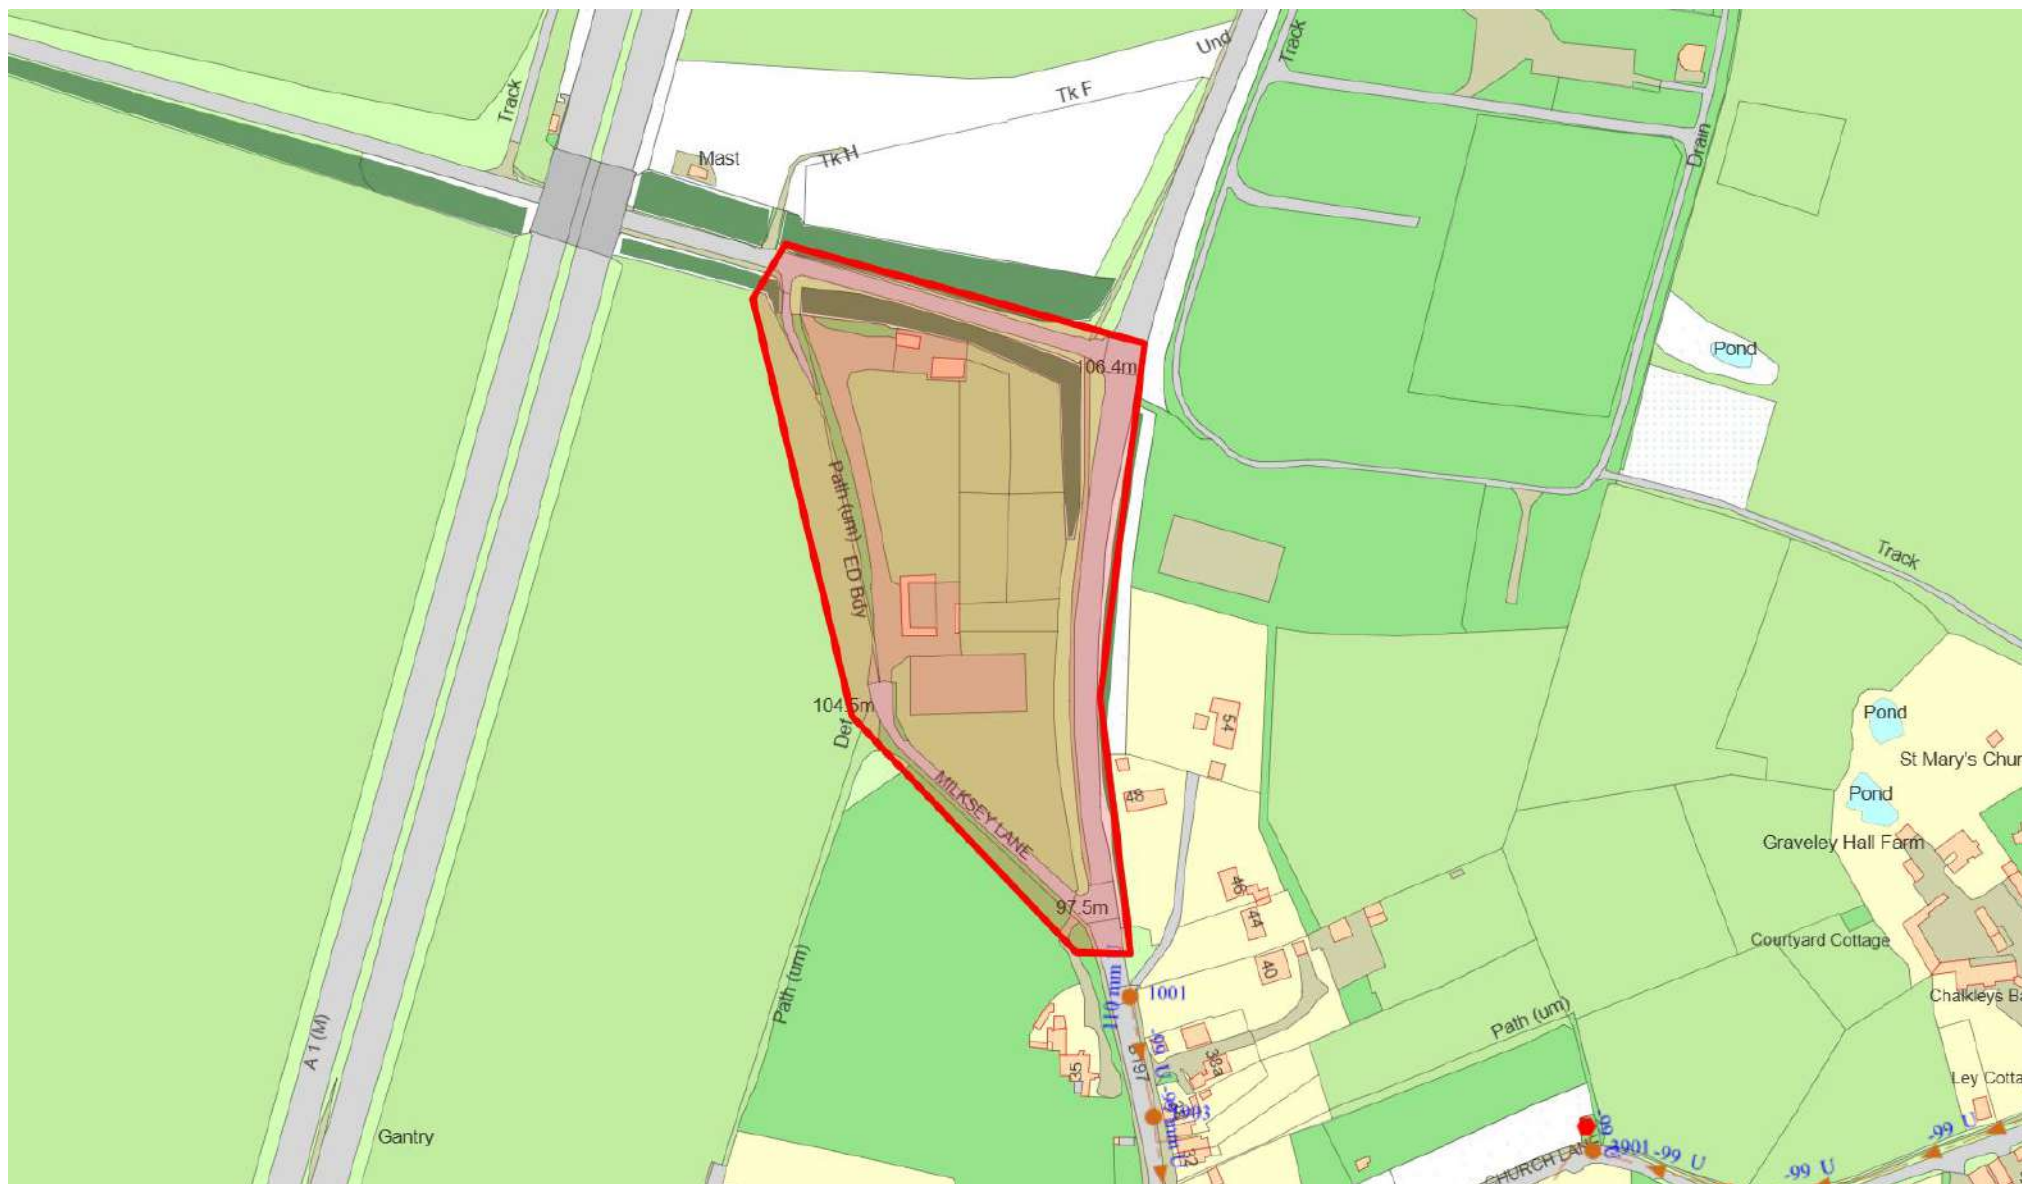
Figure 1: The site boundary for the proposed development as shown on Anglian Water asset records.

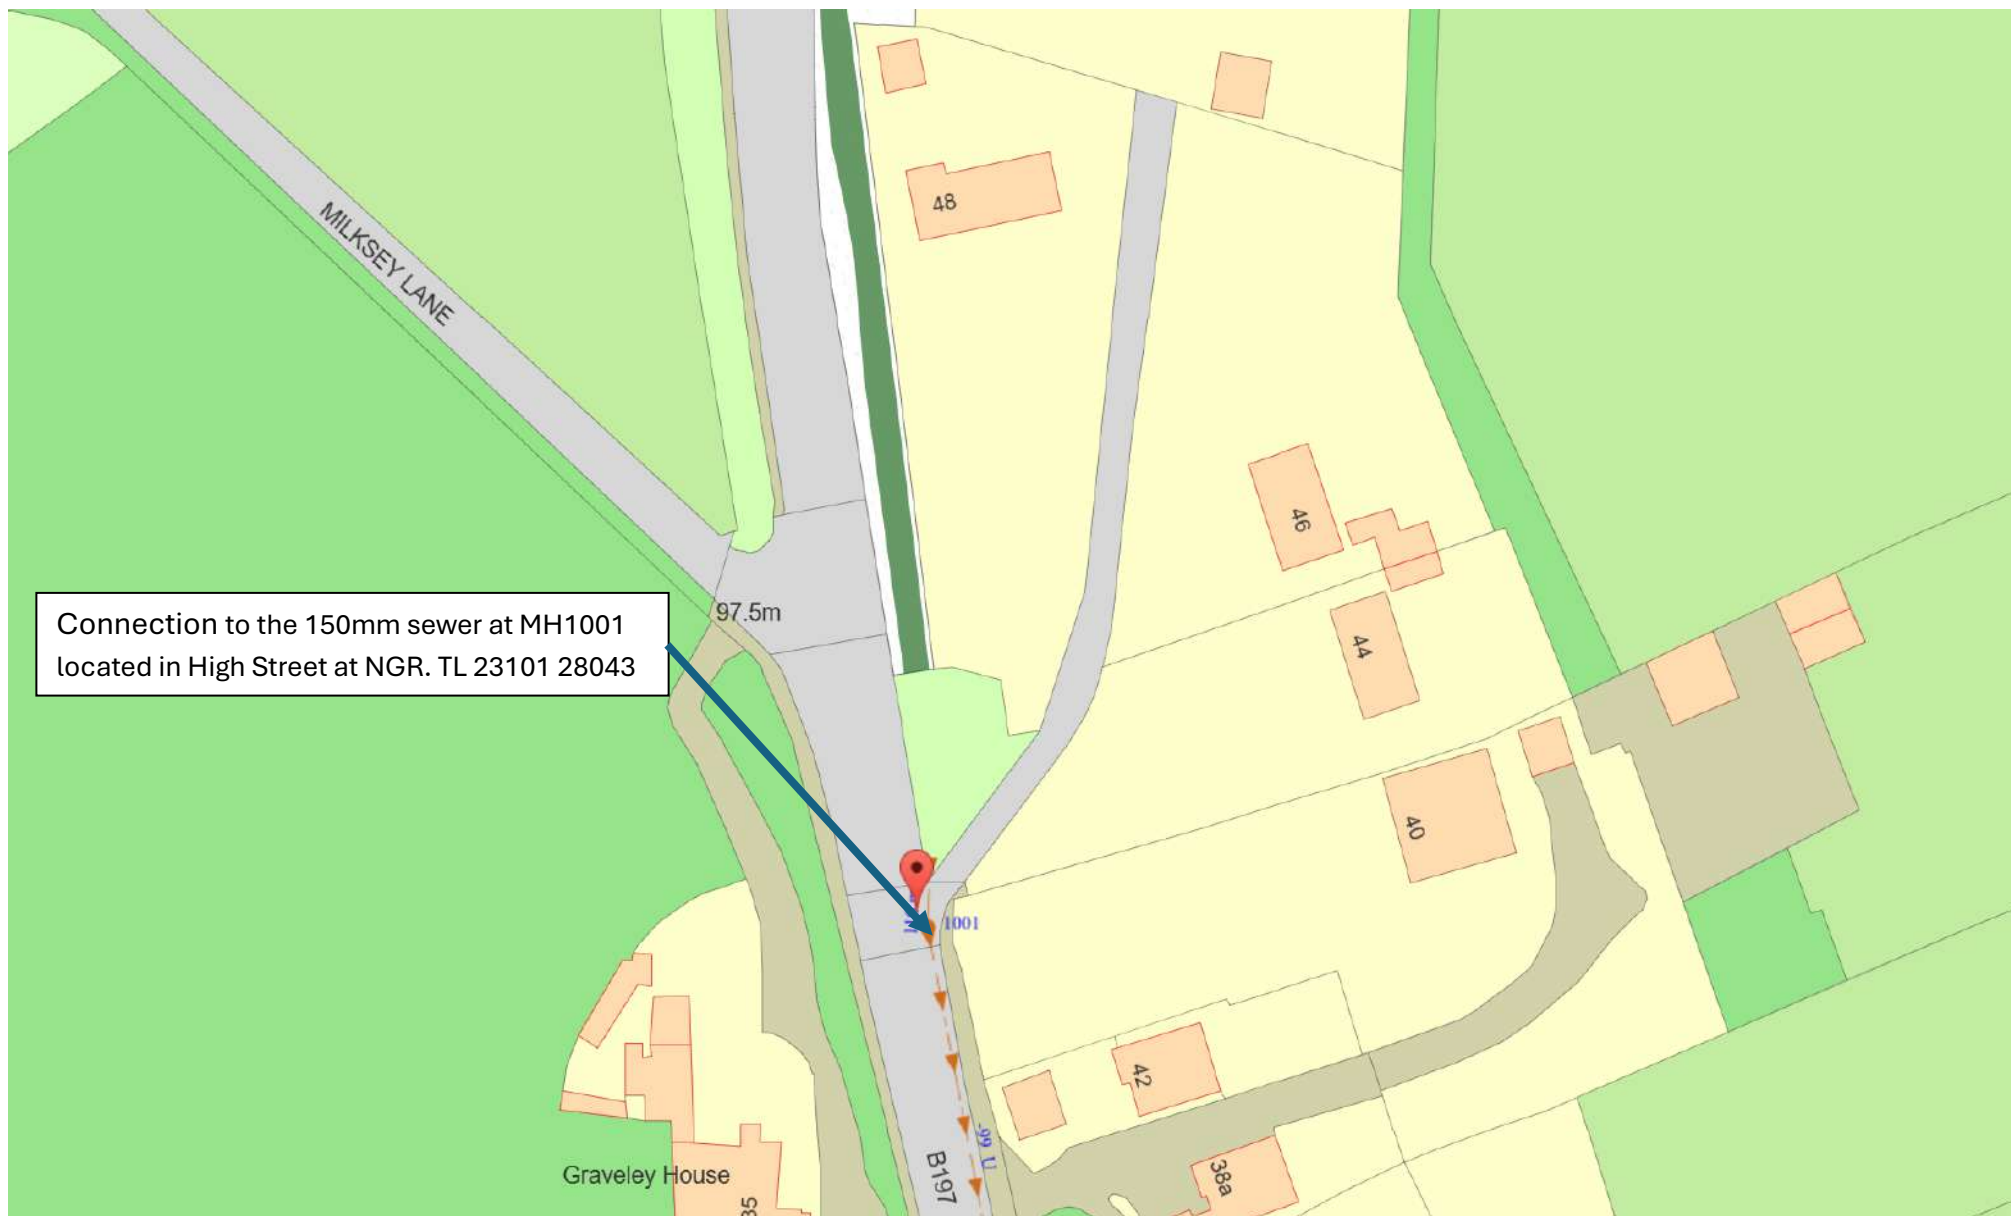
**Figure 2: Showing your water recycling foul point of connection**

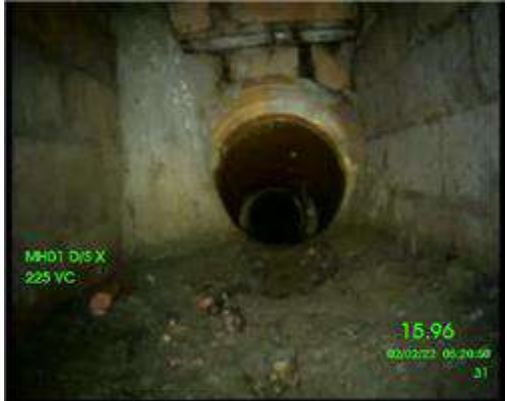
| Pos | Video Ref | Code | Cont. | Description | Image |
|---|---|---|---|---|---|
| 15.9m | 0:01:57 | WL | | Water level: 0%<br>Height/Diameter | <p>Image Provided - Ref: 0_10</p> |

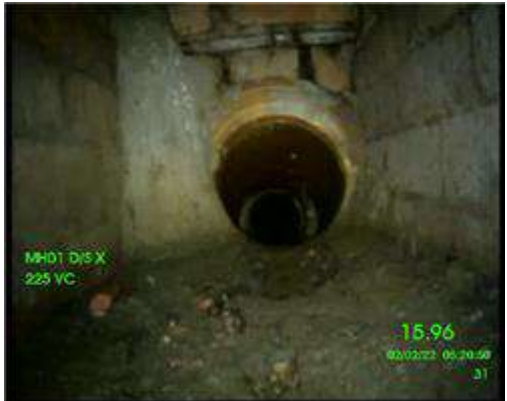
| Pos | Video Ref | Code | Cont. | Description | Image |
|---|---|---|---|---|---|
| 15.9m | | MHF | | Finish node type, manhole,<br>reference MH02<br>MH02 | <p>Image Provided - Ref: 0_9999</p> |

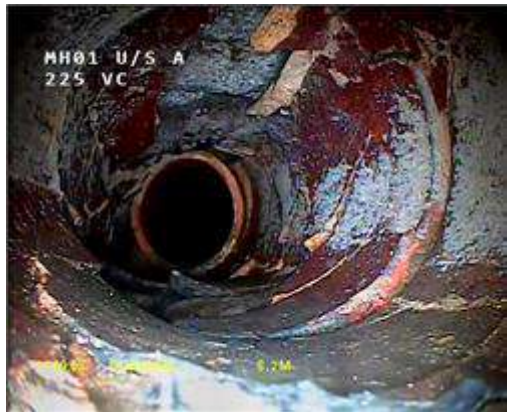
| Pos | Video Ref | Code | Cont. | Description | Image |
|---|---|---|---|---|---|
| 08.2m | 0:00:46 | FM | | Fracture multiple from 05 o'clock to 07 o'clock - Severity 4 | <p>Image Provided - Ref: 2_10</p> |

| Position | Code | Description | CD | Pic | Video Ref | |
|---|---|---|---|---|---|--|
| 08.2 | FM | Fracture multiple 05-07 | | 2_1 | 0:00:46 | |

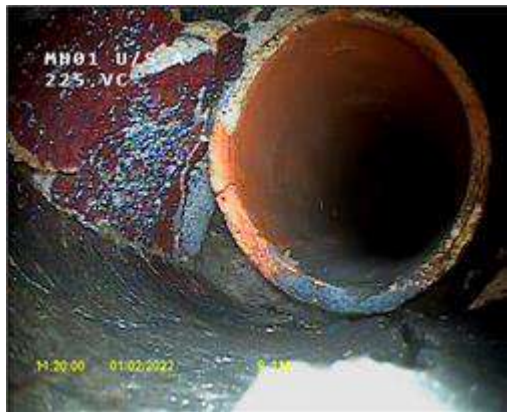
| Pos | Video Ref | Code | Cont. | Description | Image |
|---|---|---|---|---|---|
| 09.1m | 0:01:39 | WL | | Water level: 0% Height/Diameter | <p>Image Provided - Ref: 2_12</p> |

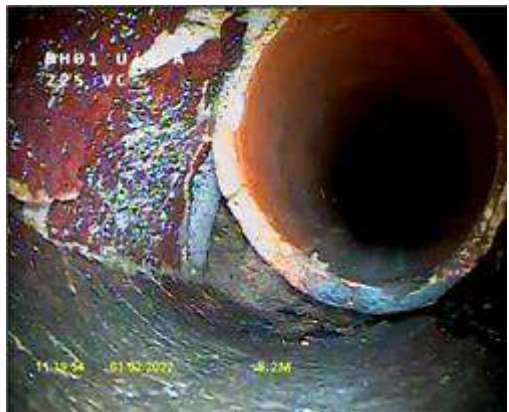
| Pos | Video Ref | Code | Cont. | Description | Image |
|---|---|---|---|---|---|
| 09.2m | 0:01:32 | SC | | Shape and/or size drain/sewer changes: Shape Changes To: 150mm Diameter | <p>Image Provided - Ref: 2_11</p> |

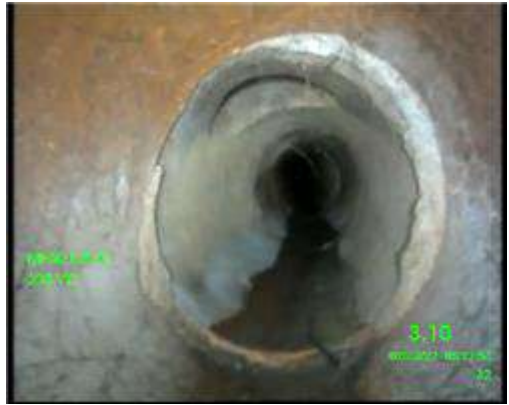
| Pos | Video Ref | Code | Cont. | Description | Image |
|---|---|---|---|---|---|
| 03.1m | 0:00:41 | JN | | Junction at 11 o'clock: 150mm Diameter | Image Provided - Ref: 1_10<br> |

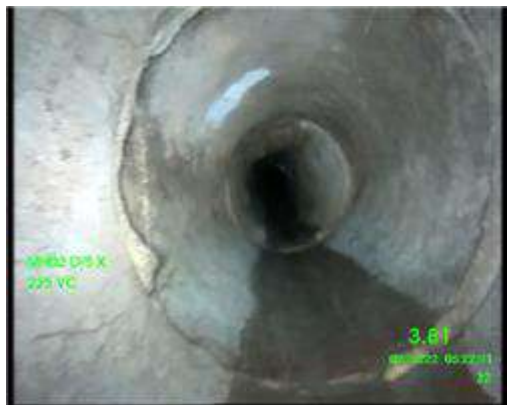
| Pos | Video Ref | Code | Cont. | Description | Image |
|---|---|---|---|---|---|
| 03.8m | 0:00:46 | DEE | | Attached deposits, encrustation from 07 o'clock to 10 o'clock: 5% cross-sectional area loss at joint - Severity 3 | Image Provided - Ref: 1_11<br> |

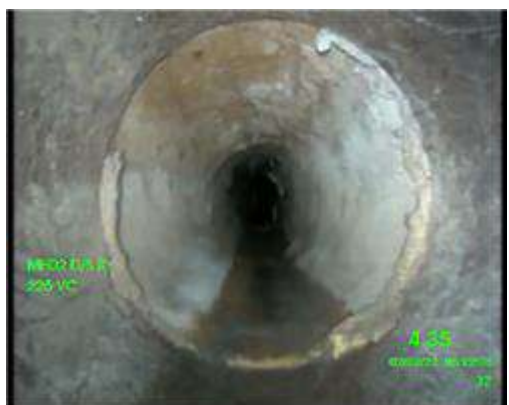
| Pos | Video Ref | Code | Cont. | Description | Image |
|---|---|---|---|---|---|
| 04.3m | 0:00:51 | DEE | | Attached deposits, encrustation from 01 o'clock to 09 o'clock: 5% cross-sectional area loss at joint - Severity 3 | Image Provided - Ref: 1_12<br> |

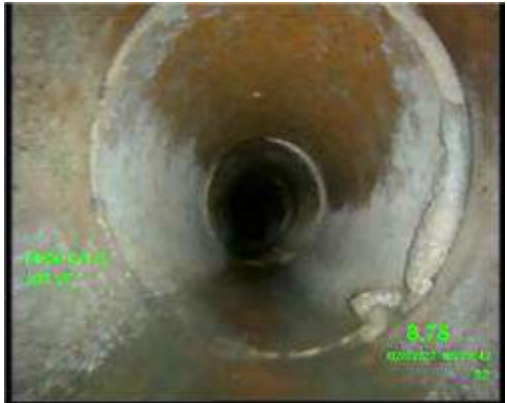
| Pos | Video Ref | Code | Cont. | Description | Image |
|---|---|---|---|---|---|
| 08.7m | 0:01:26 | DEE | | Attached deposits, encrustation from 03 o'clock to 05 o'clock: 10% cross-sectional area loss at joint - Severity 3 | Image Provided - Ref: 1_22<br> |

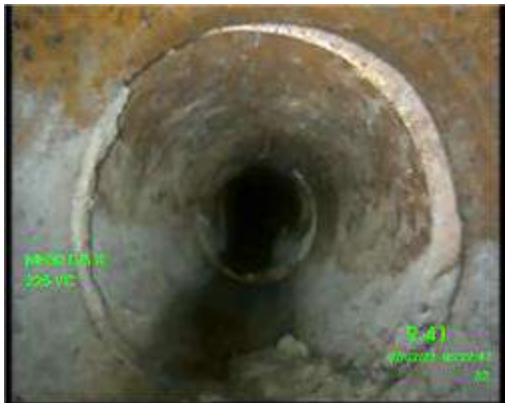
| Pos | Video Ref | Code | Cont. | Description | Image |
|---|---|---|---|---|---|
| 09.4m | 0:01:32 | JDM | | Joint displaced medium - Severity 2 | Image Provided - Ref: 1_23<br> |

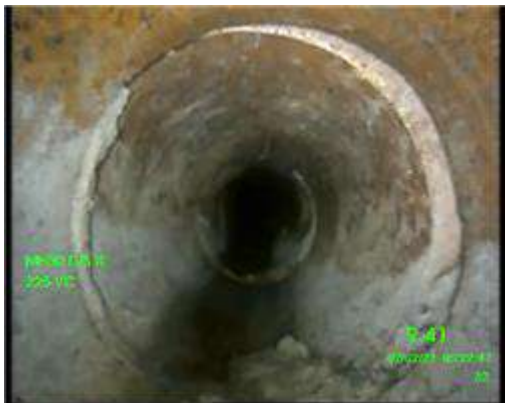
| Pos | Video Ref | Code | Cont. | Description | Image |
|---|---|---|---|---|---|
| 09.4m | 0:01:32 | DEE | | Attached deposits, encrustation from 07 o'clock to 10 o'clock: 5% cross-sectional area loss at joint - Severity 3 | Image Provided - Ref: 1_24<br> |

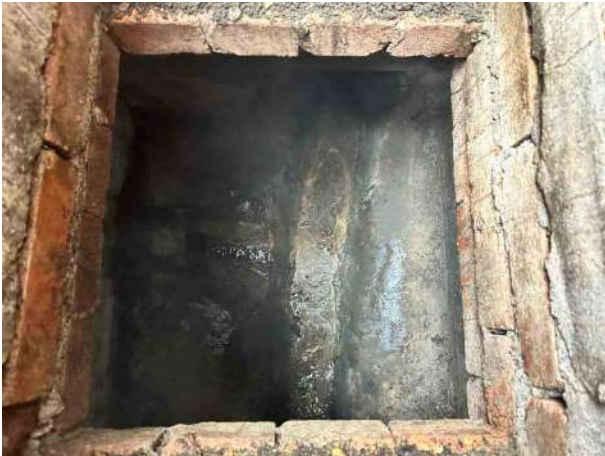
SW2.JPG, 00:00:00, 0.00 m  
 Start node, inspection chamber, reference: SW2

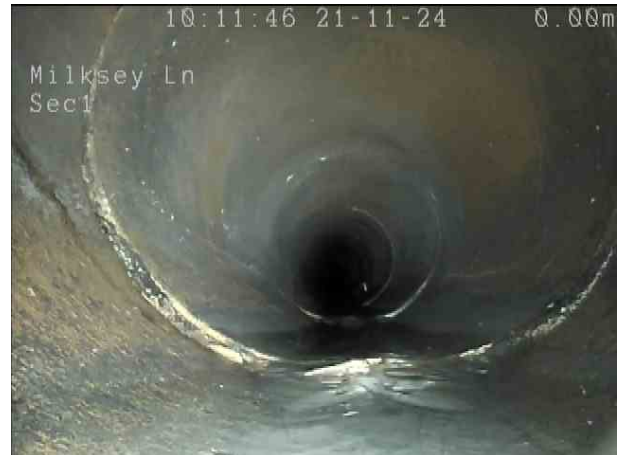
71a36dd9-3d53-40b7-b06d-b984787a84b6.png, 00:00:01, 0.00 m  
 Water level, 5% of the vertical dimension, Running live

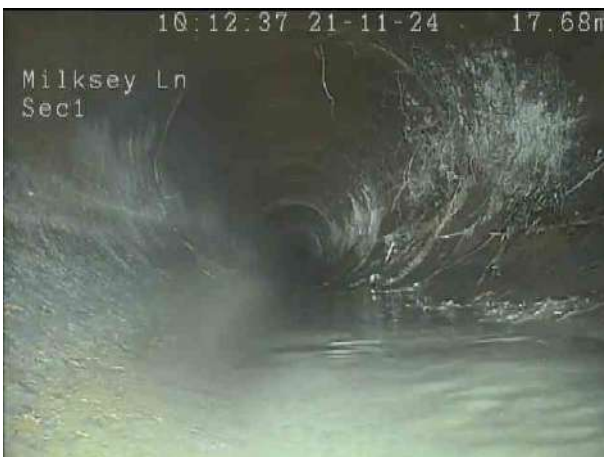
b2a526c9-151c-40f6-809e-3401277c87f8.png, 00:00:51, 18.20 m  
 Roots, fine at joint, start

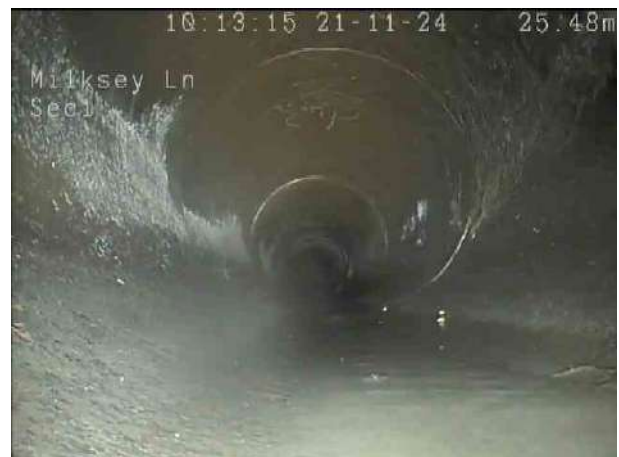
7b70e5a9-b297-4289-a504-2282be5e6a94.png, 00:01:30, 25.50 m  
 Roots, fine at joint, finish

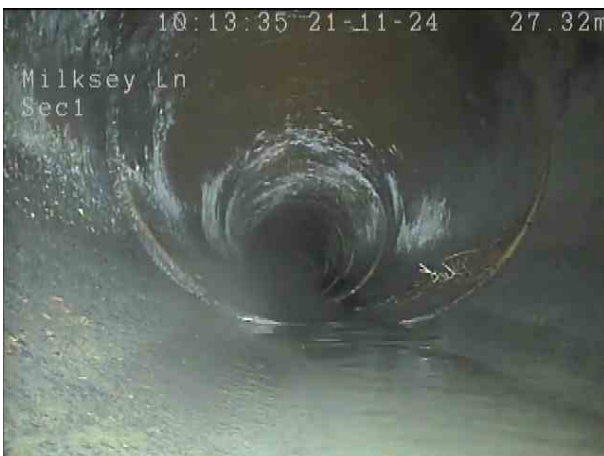
29270812-47d4-47e3-94d8-0189b74d66e6.png, 00:01:50, 28.00 m  
 Roots, fine at joint

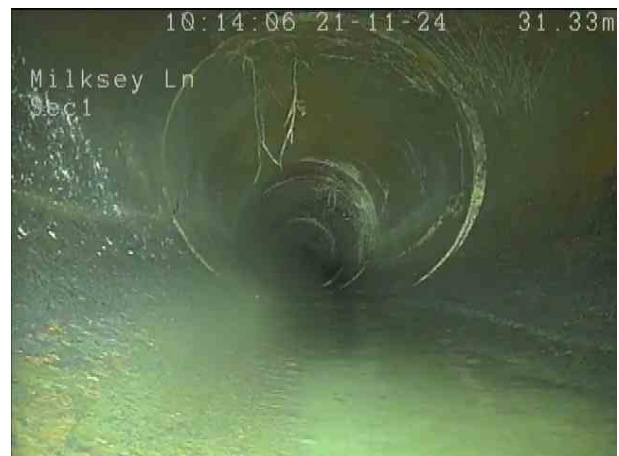
f2520338-991b-4d49-a4b7-b083027ddd3.png, 00:02:21, 32.00 m  
 Roots, fine at joint, start

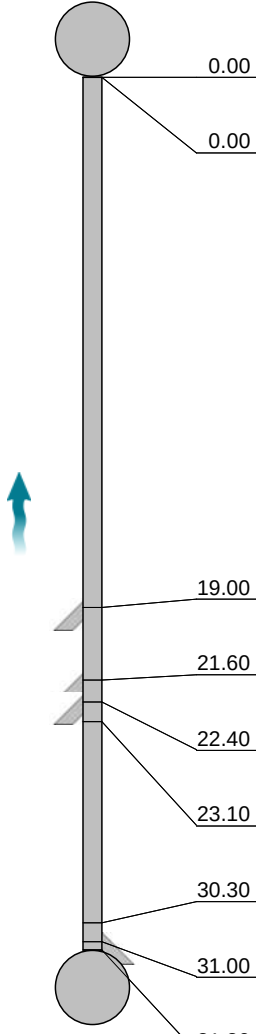
| Scale: 1:271 | Position [m] | Code | Observation | MPEG | Photo | Grade |
|---|---|---|---|---|---|---|
| | 0.00 | IC | Start node, inspection chamber, reference: SW1 | 00:00:01 | | |
| | 0.00 | WL | Water level, 5% of the vertical dimension: Running live | 00:00:01 | | |

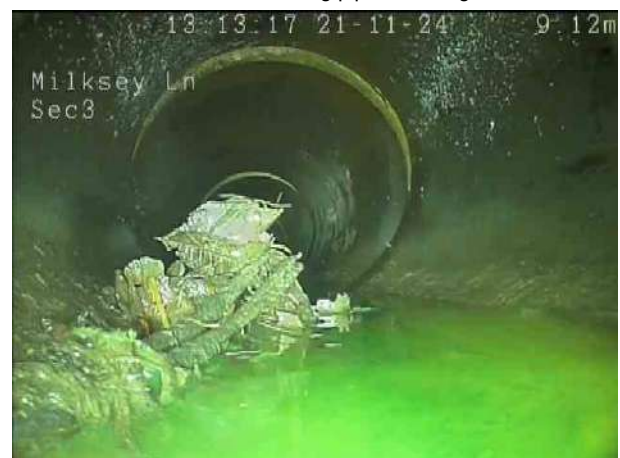
035ad4f6-410a-4705-9adf-9434a6787c09.png, 00:01:16, 9.20  
m  
Settled deposits, other, 10% cross-sectional area loss, Leaves

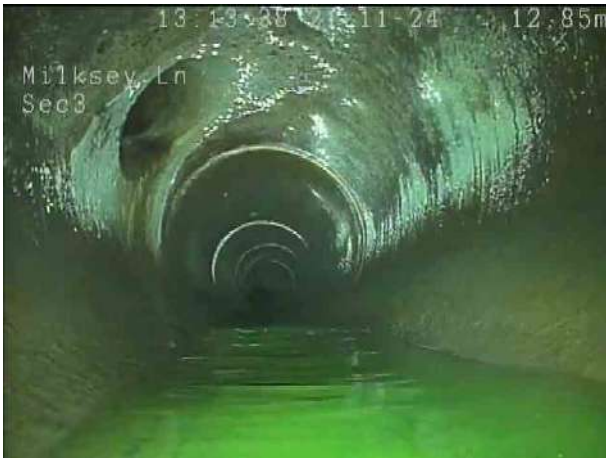
ced530b9-5c45-4fb0-bd8a-c44cf9934782.png, 00:01:38, 13.20 m  
Junction at 10 o'clock, 150mm dia

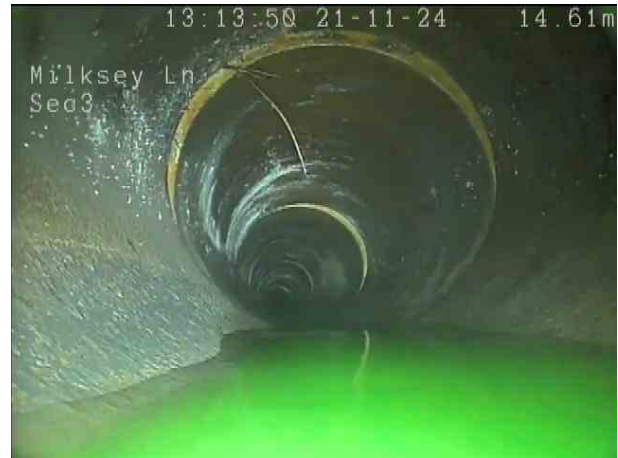
76ad6ec8-b119-4354-9085-b3d31c6acbea.png, 00:01:50, 15.00 m  
Roots, fine at joint

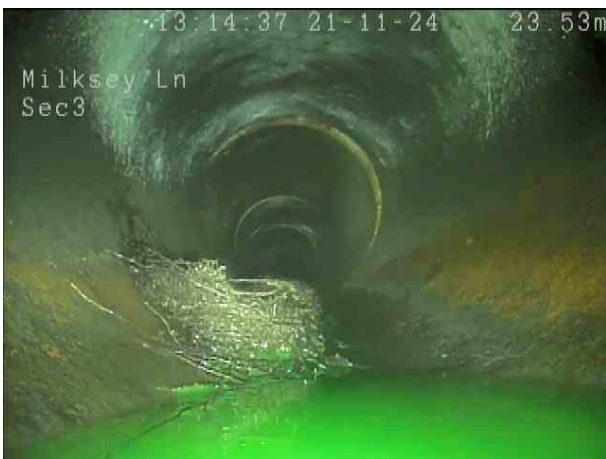
f4683594-3657-44ac-96e9-ee69abbc467a.png, 00:02:37, 23.80 m  
Roots, mass, 10% cross-sectional area loss, start

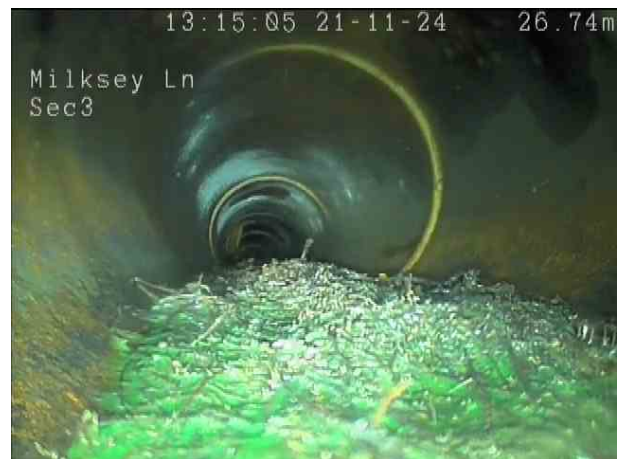
834ecfe2-25ef-439e-99da-13f364f33e35.png, 00:03:05, 26.80 m  
Roots, mass, 20% cross-sectional area loss, change

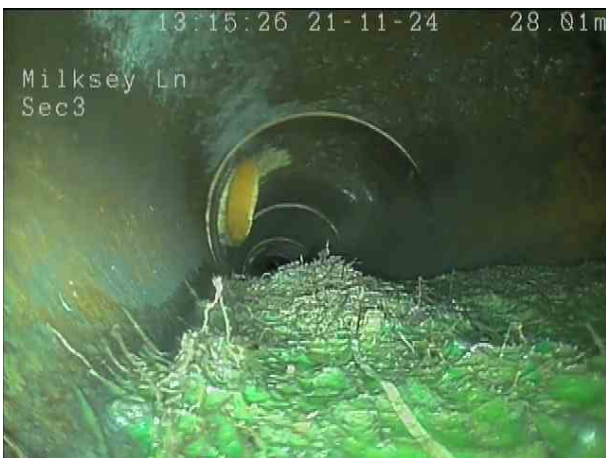
17d09909-7178-4815-81a0-ae1a1d9967ac.png, 00:03:26, 28.10 m  
Roots, mass, 40% cross-sectional area loss, change

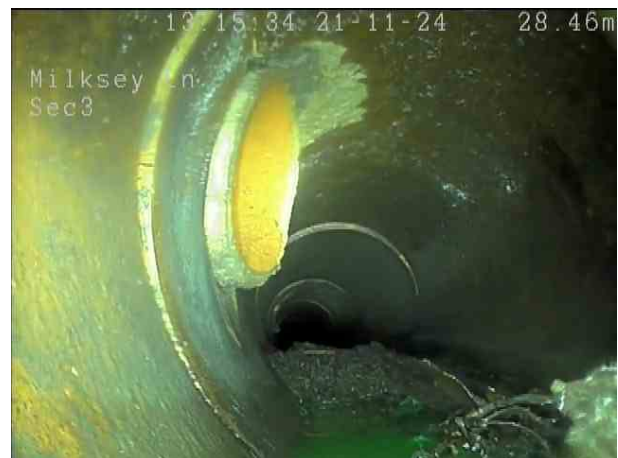
c149e879-bbbf-4cb7-8b94-35e5cef6f891.png, 00:03:34, 28.70 m  
Connection defective, connecting pipe is intruding at 9 o'clock,

| No. | m+ | Code | Observation |
|---|---|---|---|
| 13 | 28.70 | CXI | Connection defective, connecting pipe is intruding at 9 o'clock, 150mm dia, intrusion: 5% |

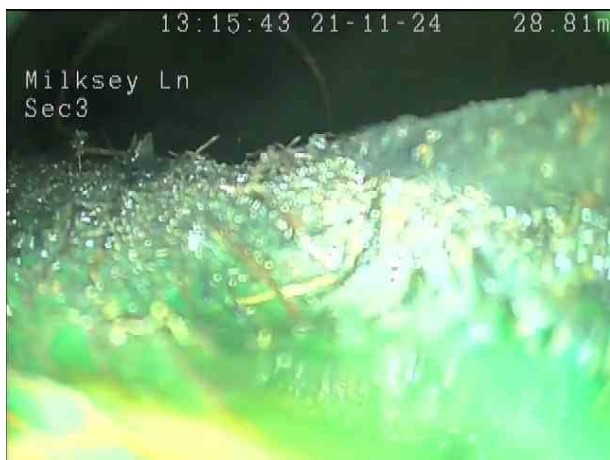
60fcfc24-6691-4d58-9d84-d8bf17bcf9fa.png, 00:03:43, 28.90  
m

Roots, mass, 50% cross-sectional area loss, finish

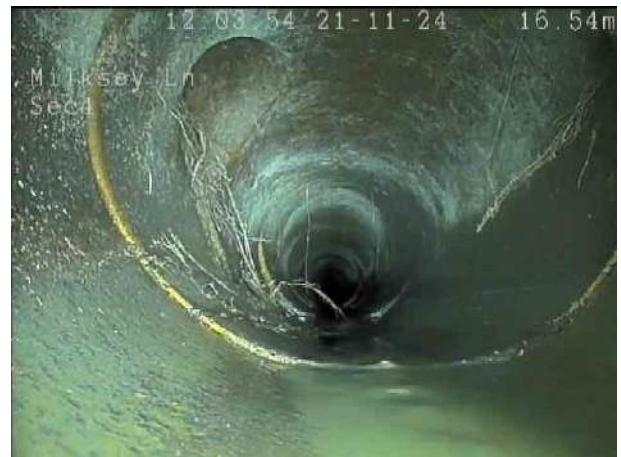
777f24de-9b4a-467c-a4c1-97b24560e6a4.png, 00:01:31,  
16.90 m  
Junction at 10 o'clock, 150mm dia

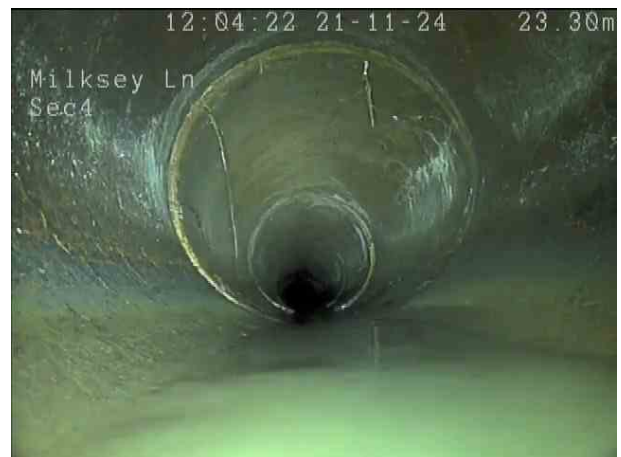
1961e4e5-49af-4402-9bc2-7fe234b19399.png, 00:01:59,  
23.70 m  
Roots, fine, finish

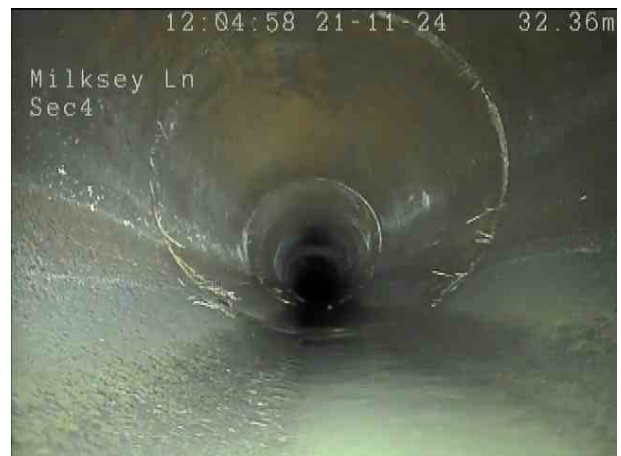
ced64048-de0d-4066-a821-b95732ef483e.png, 00:02:35,  
32.80 m  
Roots, fine at joint

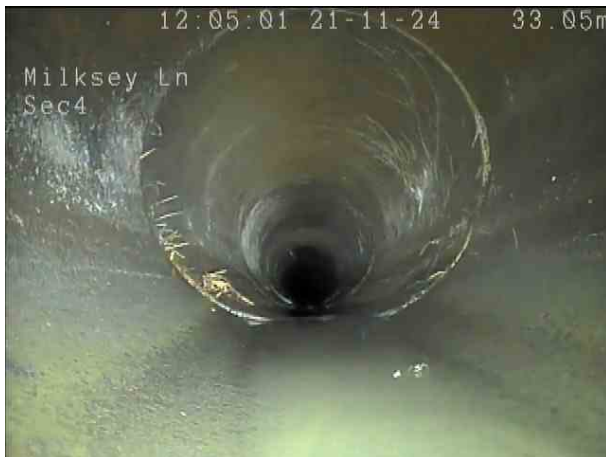
bafb911b-6cbc-4a8f-9351-8adddeb6f59d.png, 00:02:38, 33.50 m  
Roots, fine at joint

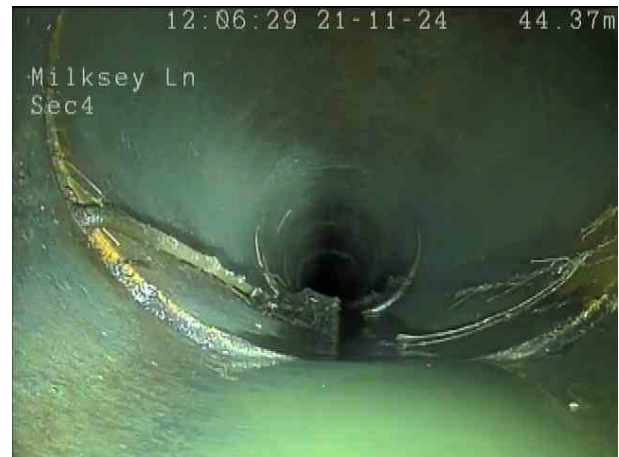
e6347e56-5449-4c1b-87a2-0c68d97f732a.png, 00:03:57, 44.50 m  
Roots, tap at joint, start

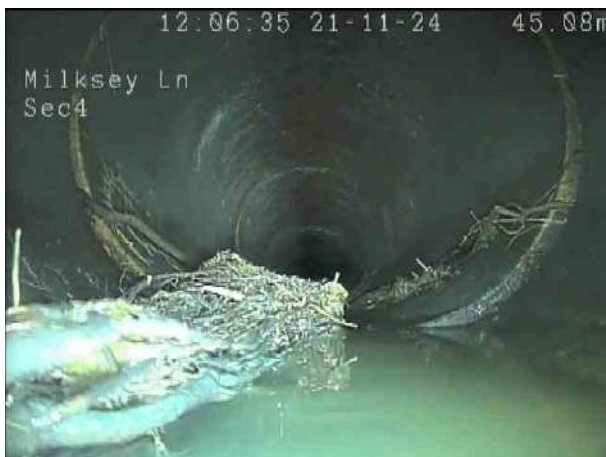
2ac8cc72-35a9-48b6-8983-1817bcbaa44d.png, 00:04:03, 45.30 m  
Roots, mass at joint, 15% cross-sectional area loss, start

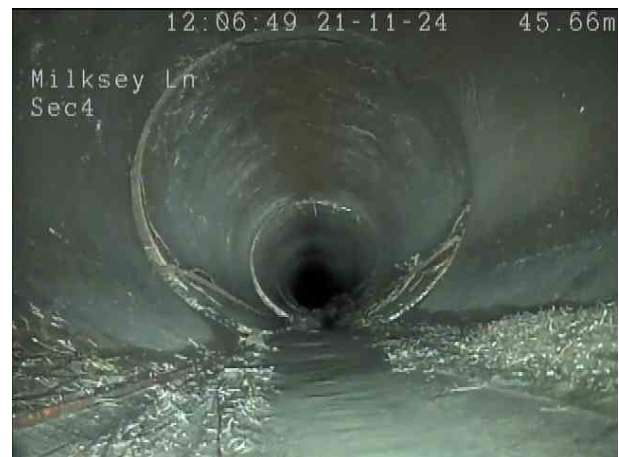
79ca1f7a-4d21-486e-864e-0eff7670a4b5.png, 00:04:17, 45.70 m  
Roots, mass at joint, 5% cross-sectional area loss, change

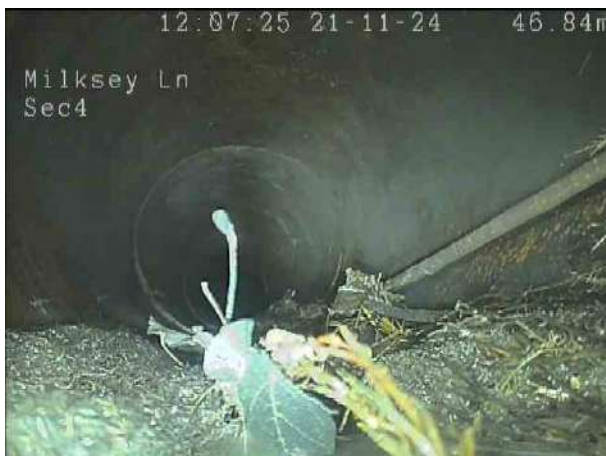
5aaf0228-9991-490b-b1c3-98dcc6b319a3.png, 00:04:52, 46.90 m  
Roots, mass at joint, 20% cross-sectional area loss, change

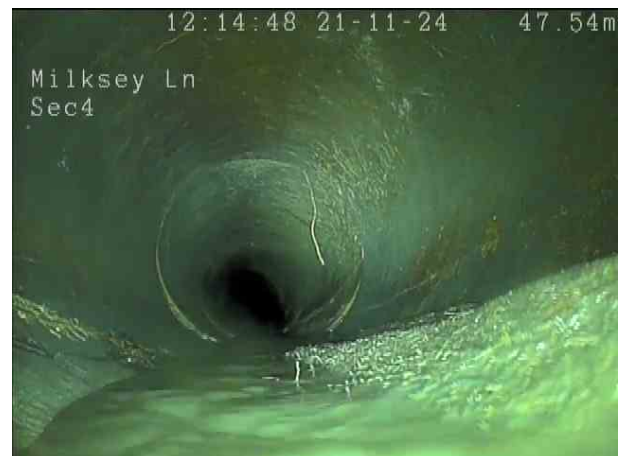
6d0965e6-bcb2-4139-864b-f7b8d1967d73.png, 00:05:12, 47.50 m  
Roots, mass at joint, 10% cross-sectional area loss, change
