## **Proposal to replace eight windows at 49 Silver Street, Ashwell, SG7 5QL**

### **Summary**

Conservation officer approval is sought to replace 8 single-glazed windows (6 double casement, 2 single casement) with timber subframes and metal casements (12 panes per casement), with hardwood timber framed windows (6 panes per casement), using LandVac vacuum glass. The existing windows are rotten, rusted and cracked, currently allowing water ingress through the panes and through the wooden frames, and damaging the walls and render of the property. The proposed replacements have been designed to maximise retention of heritage features of the existing windows, while improving the durability and energy efficiency of the building.

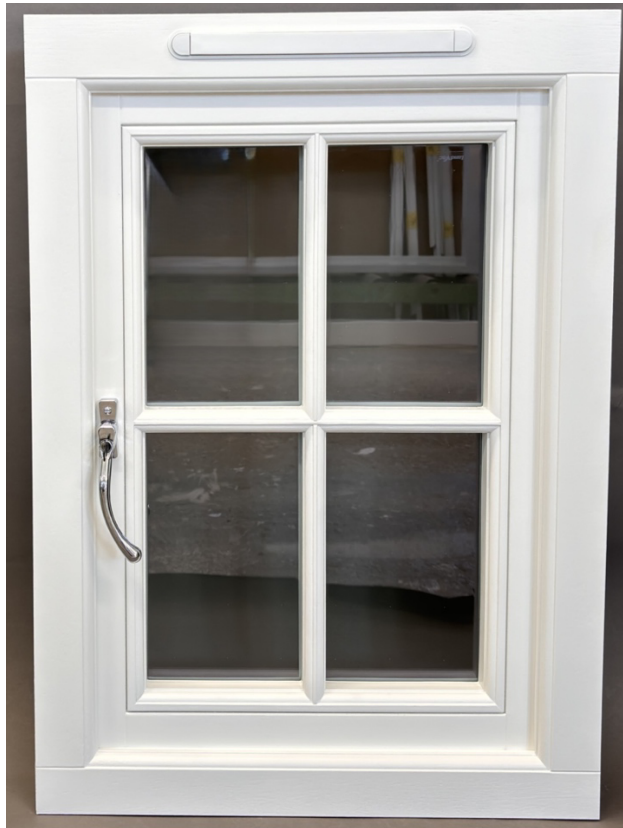
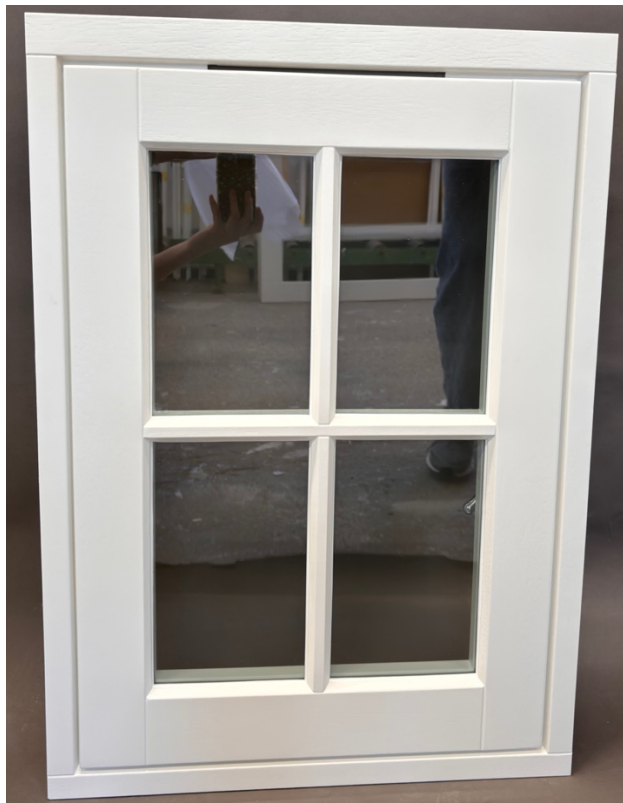
We do not currently have a photograph of the 6-pane windows that we will install but an impression of how the Ovolo bars will look can be conveyed from the following photographs of a four-pane version in the same materials.

Image 3: Four-pane version (front and rear) to demonstrate the overall aesthetic of the Maruti timber and vacuum glazing with Ovolo stick on bars, note that our planned windows will be six-pane not four.
