**Temple Dinsley**  
**Level 1, GA – Apartment 03 – Vivian Pain**  
**1909 Lutyens, West Wing**

**641-KS-06-MB-SH-A-90030 P01**  
**Temple Dinsley Level 1, GA – Apartment 03 – Vyvyen Prain**

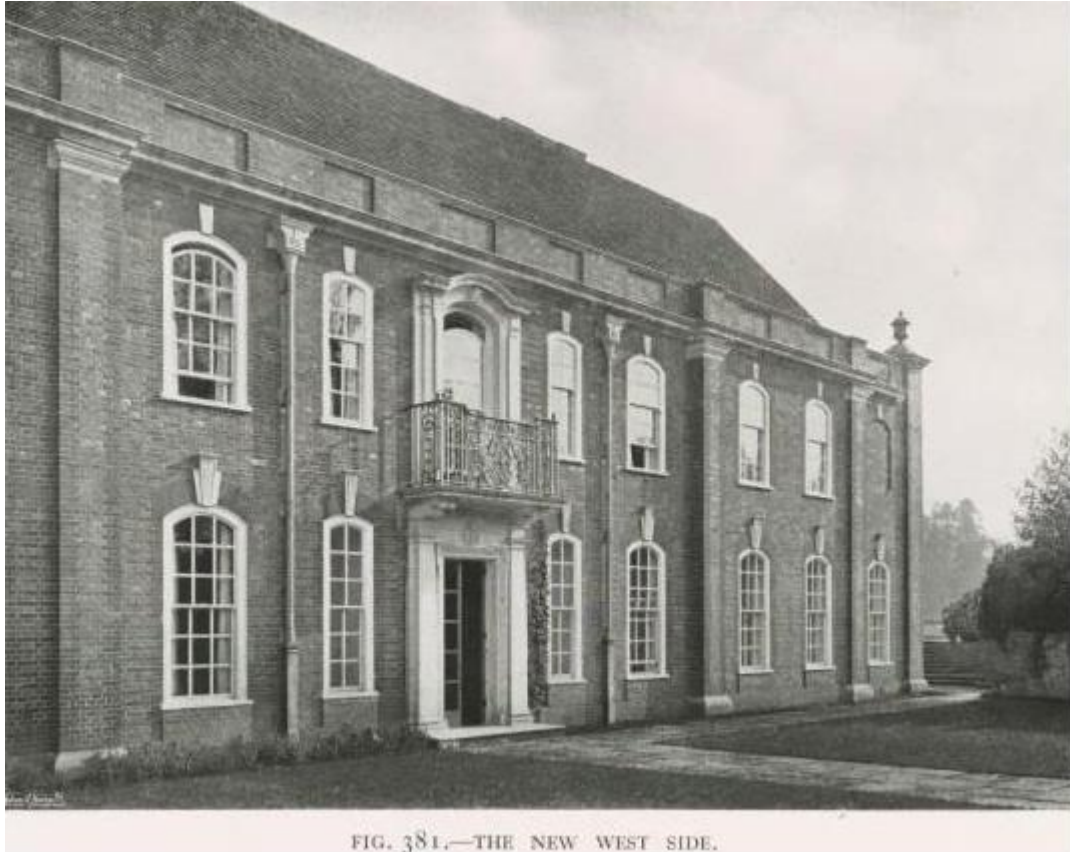
West Elevation of Lutyens' West Wing prior to the roof being raised.

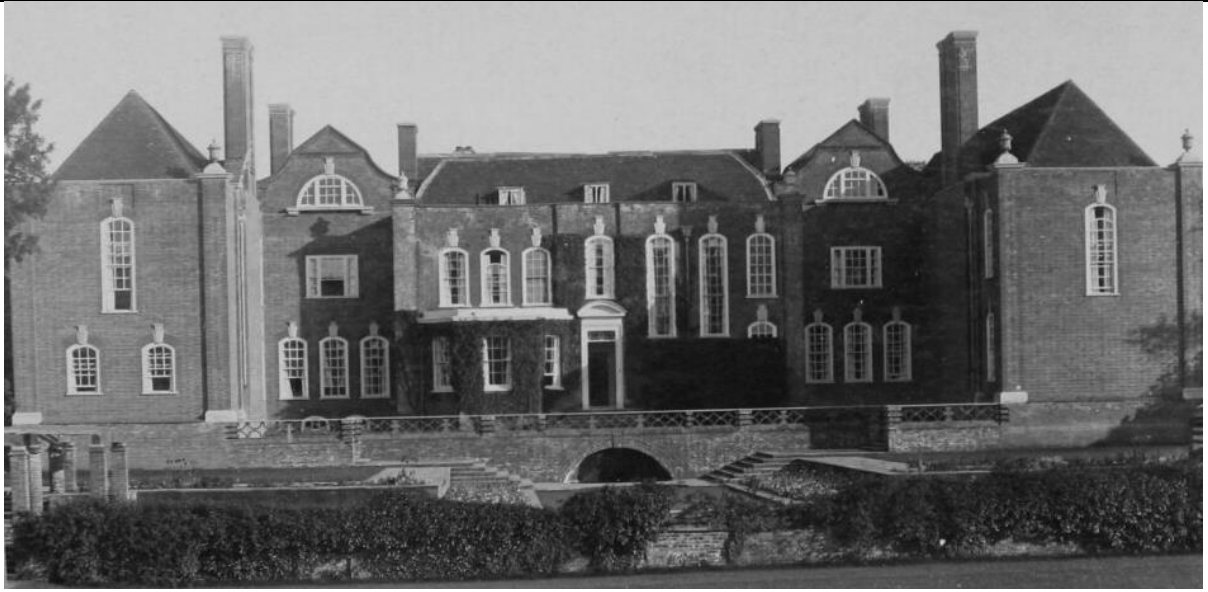
North Elevation of Lutyens' West Wing which shows us there was a single window on the north Elevation of the West wing.

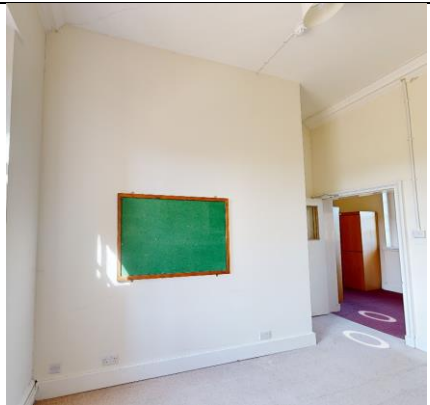
| Reference | Proposal | Significance of affected fabric | Impact | Reasoning and mitigation |
|---|---|---|---|---|
| A-Walls<br>03A.D1 | Remove LC20 timber stud partition. | Low<br>LC20<br><br>High<br>1909 Lutyens' West Wing. | Positive impact.<br>Benefit. | <p>Benefit: The removal of the LC20th partitions will open-up the 1909 Lutyens spaces to their original proportions as well as removing awkward junctions and detailing created by these divisions. Removal of these later partitions will also reveal the wall panelling, fireplace and window arrangement as it was originally intended to be viewed. This involves no loss of historic fabric and is of architectural and visual benefit.</p> |

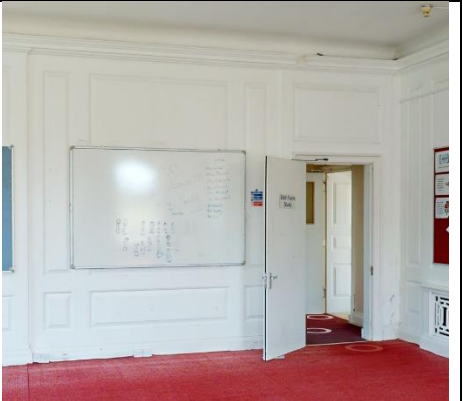
| Reference | Proposal | Significance of affected fabric | Impact | Reasoning and mitigation |
|---|---|---|---|---|
| C-Ceilings<br>03C.R1 | Ceiling - Lath and lime plaster to be repaired generally. | High<br>1909 Lutyens lathe and plaster.<br><br>Low<br>Altered MidC20 | Positive impact.<br>Benefit. | |

| Reference | Proposal | Significance of affected fabric | Impact | Reasoning and mitigation |
|---|---|---|---|---|
| | | | | Benefit: Where damaged, original /altered Lutyens lath and plaster ceilings are to be repaired like-for-like and any compartmentation to the apartment above or any required services (to be run within the ceiling void) are to be installed from above to minimise the impact of the proposed alterations on the historic fabric. The floor above is not historic following the school alteration in the MC20. |

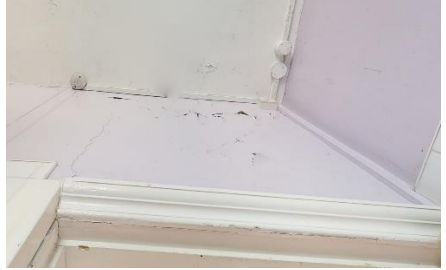
| Reference | Proposal | Significance of affected fabric | Impact | Reasoning and mitigation |
|---|---|---|---|---|
| C-Ceilings 03C.P1 | Existing plaster board and gypsum plaster finish to be repaired like for like. | Neutral<br>Late C20 plasterboard finish layer. | Neutral impact. | <p>Ceilings of LC20th plasterboard to be repaired like for like. Plasterboard removed and replaced where access is required for installation of services.</p> |

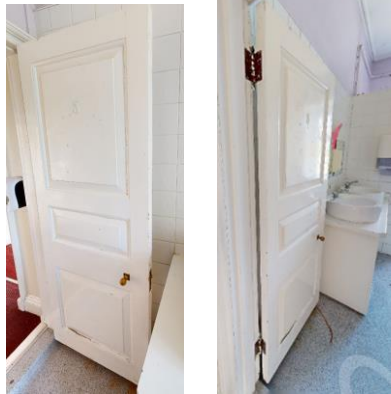
| D-Doors 03-DF02 3D.R1 | Lutyens 1909 3 panelled door. | High<br>Lutyens 1909 | Positive<br>Impact.<br>Benefit. | <p>Benefit: The door will be a painted solid timber raised and fielded panelled door, with detailing to match the existing Lutyens door within the first floor of the west wing – as shown in the image above.</p> |

| 03-DF03 - 03-DF06 | New internal panelled doors to match existing Lutyens' 3 panelled doors. | High<br>1909 Lutyens' | Positive<br>Impact<br>Benefit. | Reinstating panelled doors (to match 03-DF02) in existing openings where the original architraves, doorcases and skirtings have been retained. Positive Impact. Benefit. |

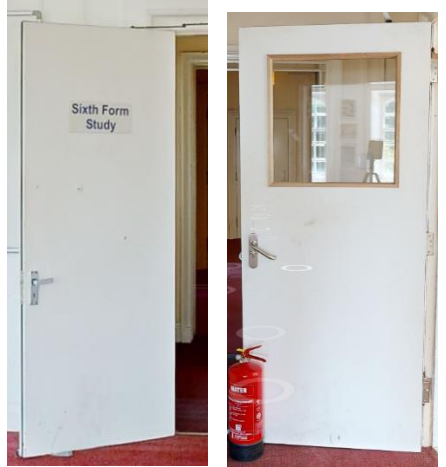
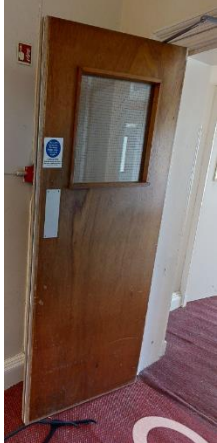
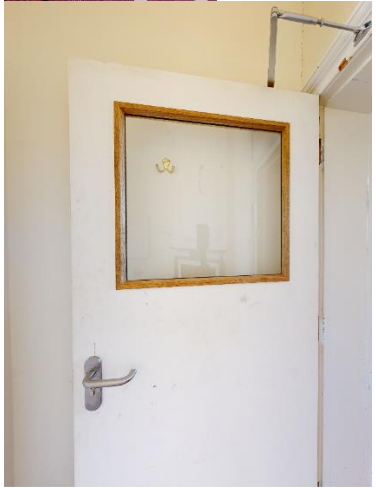
| Reference | Proposal | Significance of affected fabric | Impact | Reasoning and mitigation |
|---|---|---|---|---|
| 03-DF07-DF10 | Existing LC20 flush fire rated doors to be removed. | Low<br>LC20 interventions.<br><br>High<br>Setting of West Wing | Positive Impact.<br>Benefit | <p>All doors bring no benefit to the historic setting or fabric. Positive Impact.</p> |

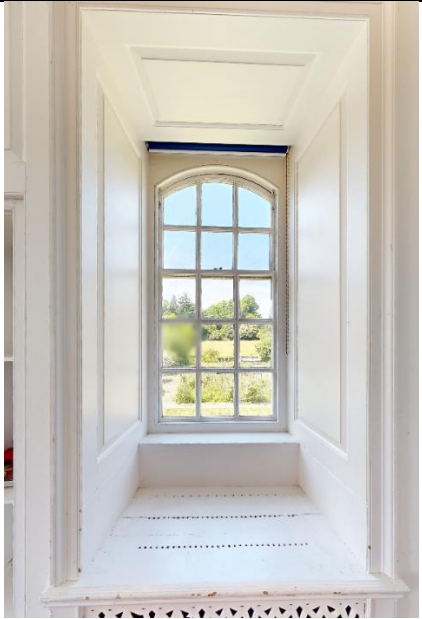
| Reference | Proposal | Significance of affected fabric | Impact | Reasoning and mitigation |
|---|---|---|---|---|
| E-Windows<br>03-WF01 –<br>03-WF08 | All 1909 'Lutyens' sashes to be retained and repaired. | High<br>1909 Lutyens | Positive Impact.<br>Benefit. | |

| Reference | Proposal | Significance of affected fabric | Impact | Reasoning and mitigation |
|---|---|---|---|---|
| | | | | <p>Splice repairs carried out where required. Resin repairs for more localised repair. Replacement lights for any broken panes and subsequent to removal of extract fans. Perished putty replacement. Easing of windows and weights adjusted as required. Original ironmongery retained. New ironmongery shall be required to comply with building regulations. Renewal of finishes. These repairs will aid the longevity of these significant windows.</p> |

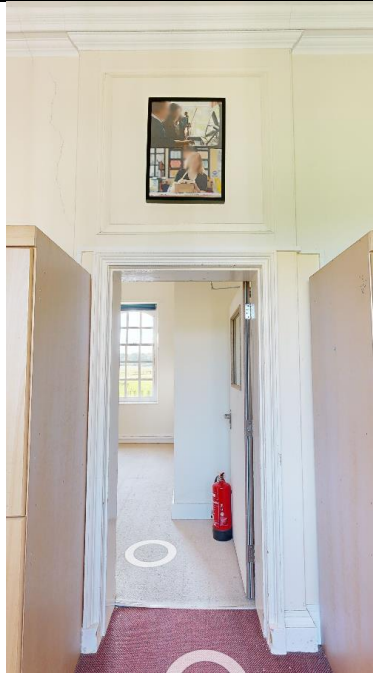
| Reference | Proposal | Significance of affected fabric | Impact | Reasoning and mitigation |
|---|---|---|---|---|
| G – New Internal Partition<br>03G.P1 | Infill feature doorway. | High<br>1909 Lutyens' West Wing. | Moderate Impact | Original door position. Panelled door has been removed by school and replaced with a fire door. It is proposed that a replacement false panelled door be inserted on the north side of the infill partition. The south side of the opening will be lined completely however the architrave will remain. Considered moderate impact as this room has already been divided, is a secondary room and the visual features that indicate a doorway will remain. To form part of compartment wall, between bedroom and communal hallway. |

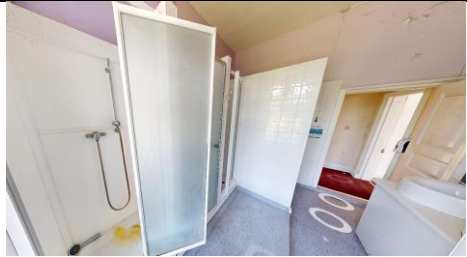
| Reference | Proposal | Significance of affected fabric | Impact | Reasoning and mitigation |
|---|---|---|---|---|
| J-Internal Fixtures and Fittings 03J.D1 | Remove C21 sanitaryware and partitioning. | Low LC21 interventions. | Positive Impact Benefit | <p>Modern communal shower room and toilets, unsympathetic to the setting and lack of ventilation along with non-breathable paints show damp issues. Positive Impact of removal.</p> |

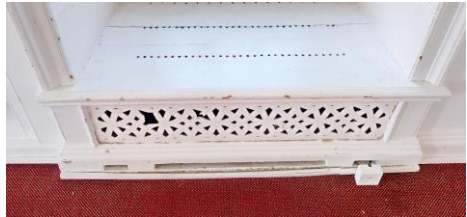
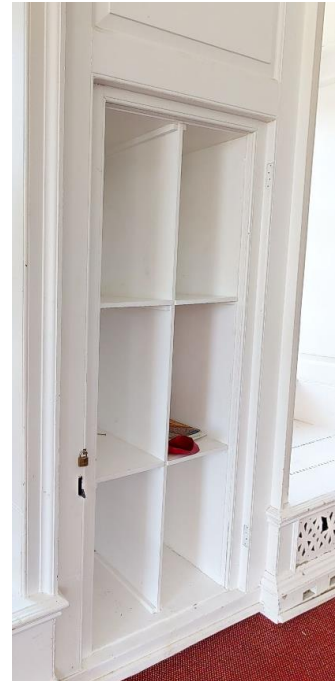
| Reference | Proposal | Significance of affected fabric | Impact | Reasoning and mitigation |
|---|---|---|---|---|
| K-Joinery 03K.R1 | Existing Lutyens' 1909 joinery to be retained. | High 1909 Lutyens | Neutral impact. | <p>All existing Lutyens' 1909 joinery to be repaired where necessary, re-finished and retained in-situ. Unfortunately, the cupboard doors within this panelled room have been removed. It is proposed that these would not be replaced and shall remain as alcoves.</p> |

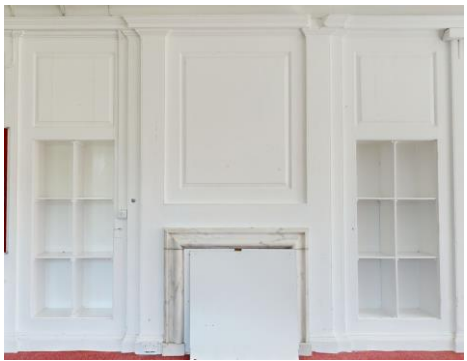
| Reference | Proposal | Significance of affected fabric | Impact | Reasoning and mitigation |
|---|---|---|---|---|
| N-Fireplaces<br>03N.R1 | Repair former fireplace. | High<br>1909 Lutyens | Positive impact. Benefit. | <p>Benefit: The repair of the existing fireplace will restore the original 1909 Lutyens design features. Ventilation to be provided.</p> |

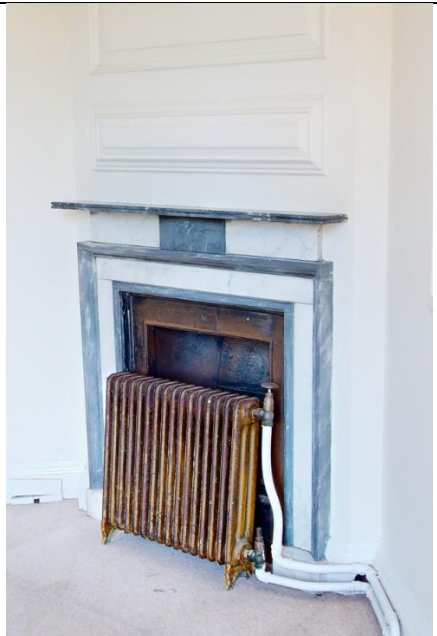
| Reference | Proposal | Significance of affected fabric | Impact | Reasoning and mitigation |
|---|---|---|---|---|
| N-Fireplaces<br>03N.R2 | Repair former fireplace. | High<br>1909 Lutyens | Positive impact.<br>Benefit. | <p>Benefit: The repair of the existing fireplace will restore the original 1909 Lutyens design features. Ventilation to be provided.</p> |

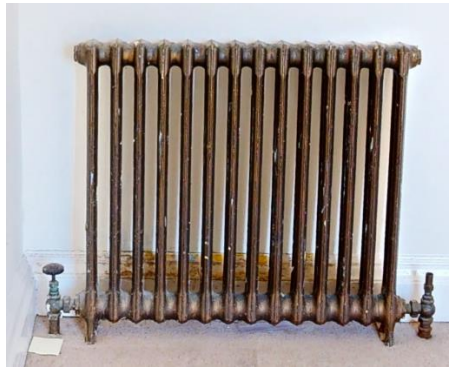
| Reference | Proposal | Significance of affected fabric | Impact | Reasoning and mitigation |
|---|---|---|---|---|
| P-Services<br>03P.R1 | Cast Iron radiators to be refurbished/restored to work with new heating system. | High<br>Early C20<br>1909 Lutyens | Neutral impact<br>Benefit | <p>Benefit: These are to be refurbished and retained.</p> |

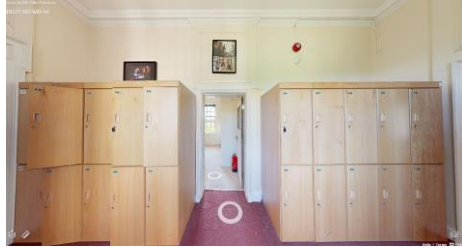
| Reference | Proposal | Significance of affected fabric | Impact | Reasoning and mitigation |
|---|---|---|---|---|
| R-Fire and Soundproofing 03R.P2 | Compartmentation between communal hall and Apartment 3. | High 1909 Lutyens | Low Impact | Existing wall construction to be investigated to determine whether additional linings or treatments need to be applied. It is proposed that any linings would be applied to South side of the wall to preserve the panelling on the North side within the communal hallway.<br> |
