# 9-10 High Street, Hitchin North Hertfordshire

## Sustainable Drainage Systems (SuDS) Strategy Assessment and Report

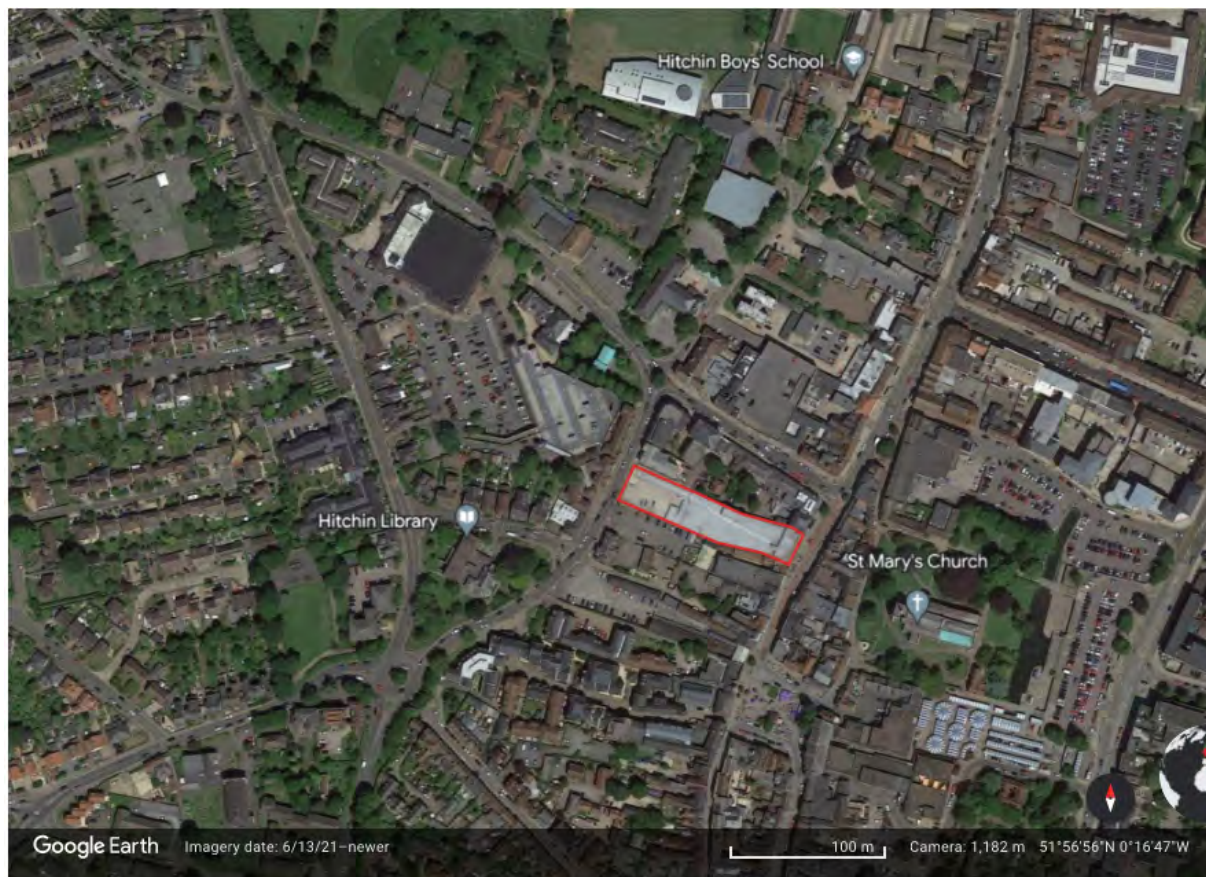
Figure 2.1: Existing site, showing site boundary.

The site is occupied by an existing building with two (2) retail units and a rooftop car park and another paved car park at the rear ground level. The site fronts to the High Street, a pedestrianised street lined with main retails within the town and is mainly accessible through the Paynes Park road from behind. The site postcode is SG5 1BH and the OS coordinates are 518398 (E) and 229148 (N). A site location plan is provided below in Figure 2.1, with the indicative site boundary.

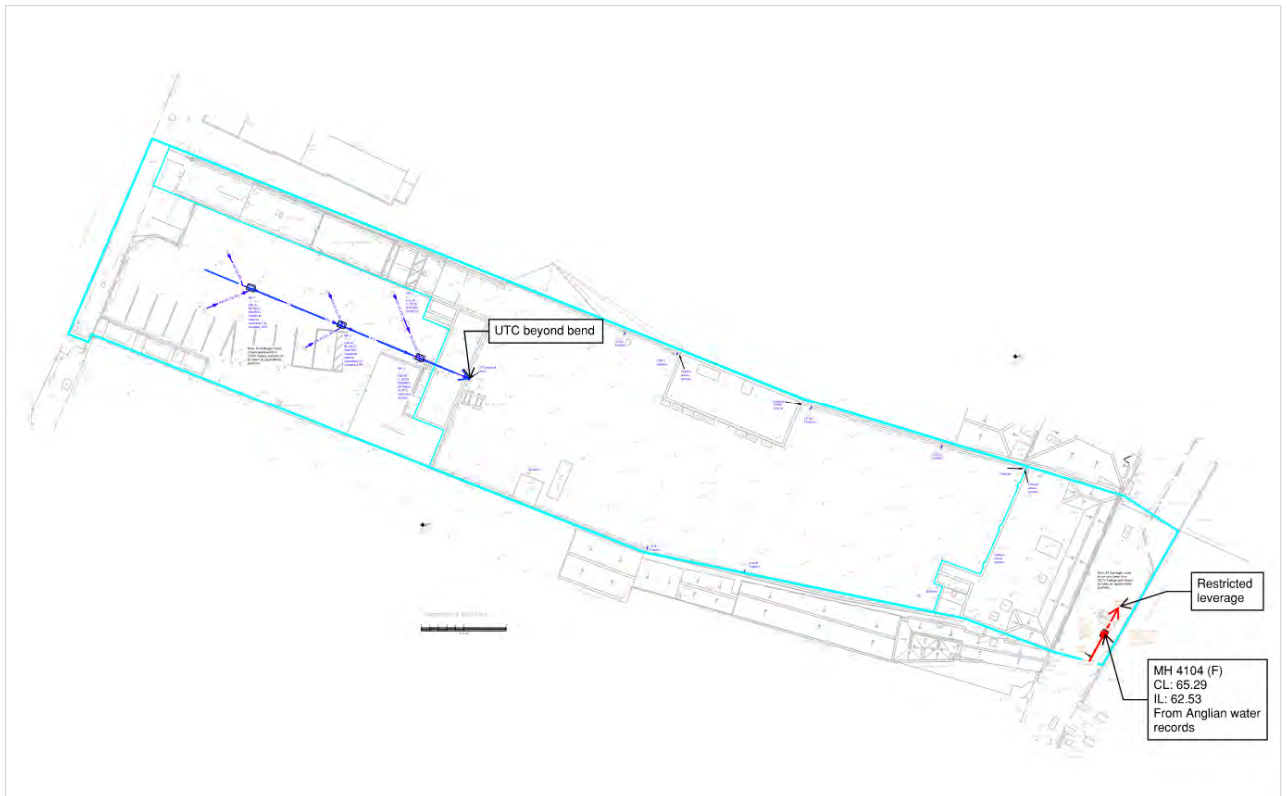
Figure 2.4: Drainage CCTV Survey Layout. (Source: Survey Solutions).

A CCTV drainage survey was undertaken to investigate the drainage connections from within the site and how these connect into the public sewer. Most manholes were inaccessible and hence their outfalls could not be determined. The CCTV drainage survey shows that a 100mm diameter surface water drainage pipe runs from the carpark then into the building where the CCTV information becomes unavailable from that point due to camera bend limitations. Survey information on the foul water run at the front, along High Street, is also limited due to restricted leverage. The drainage survey layout and full report is found in Appendix C.

Based on the sewer records and drainage CCTV survey, the site is presumed to be draining combined surface and foul into the 300-mm foul sewer running along High Street.

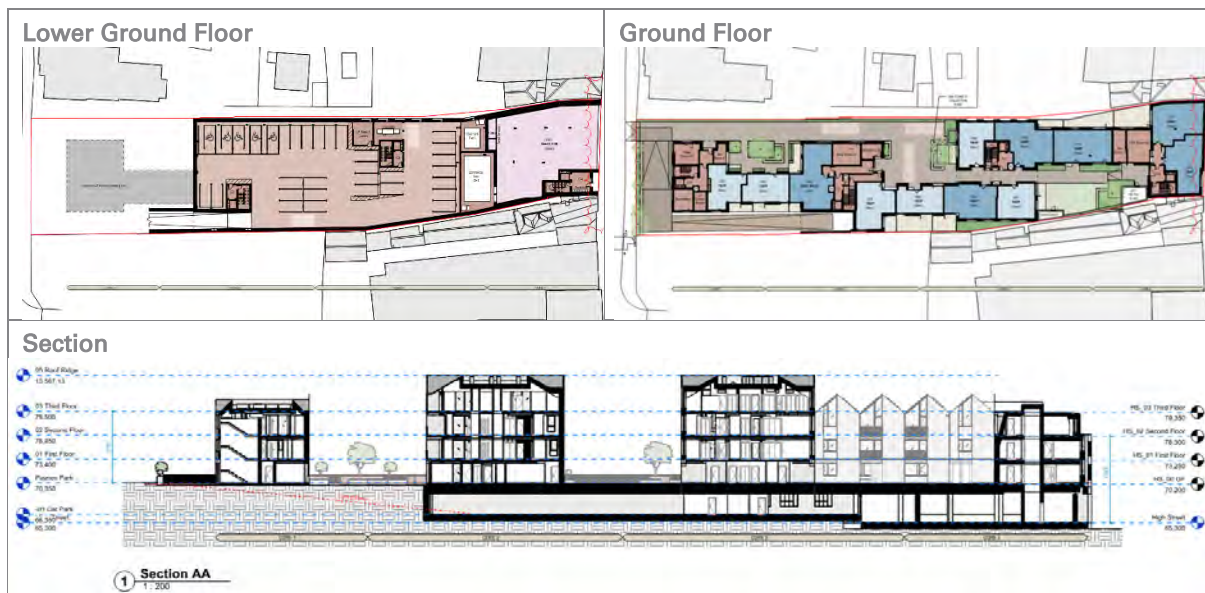
Figure 3.1: Proposed LGF and GF layouts and section.

The development proposal is for the demolition of the existing building to provide one retail unit and car parking on the lower ground floor, along with a residential scheme of 44 units from ground floor to the third floor. The proposed lower ground and third floor layout is shown in Figure 3.1.

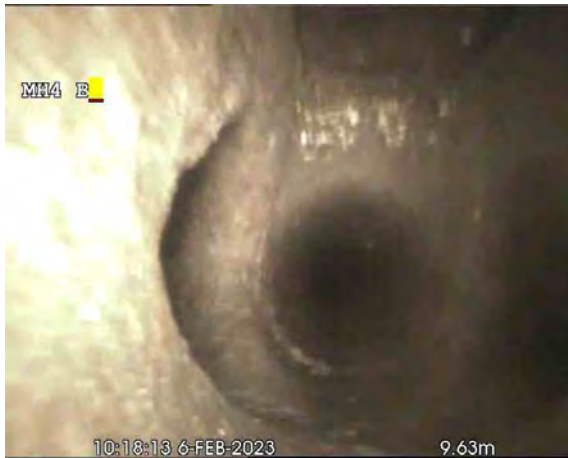
1aa8beed-8b10-4fb9-bd2a-54018b71e46a.jpg, 00:00:38, 9.83 m  
Junction at 3 o'clock, 100mm dia

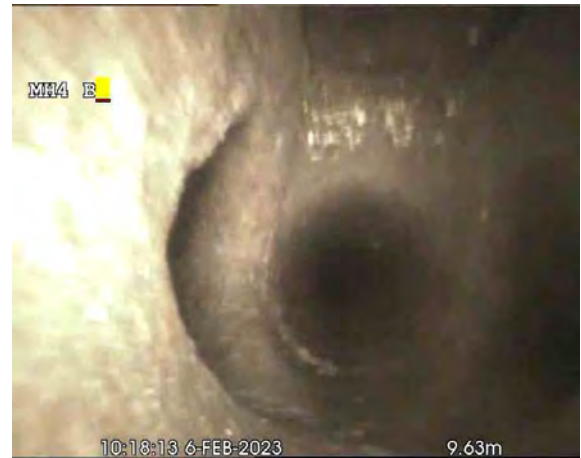
ee64899a-ccf0-4f8f-aebf-3013d63588b8.jpg, 00:00:38, 9.83 m  
Junction at 9 o'clock, 100mm dia

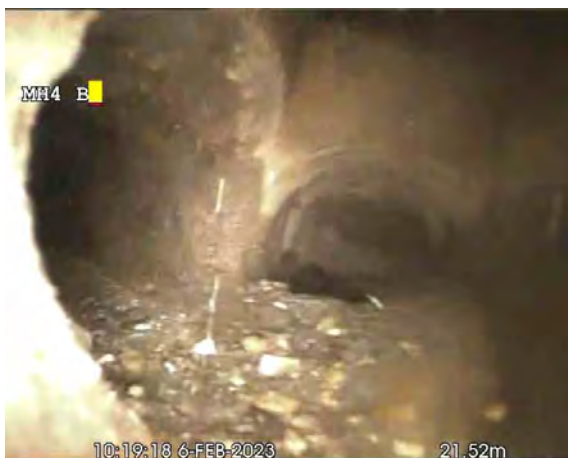
51395fd3-0329-4168-beb3-8c67e194c290.jpg, 00:01:44, 21.62 m  
Junction at 9 o'clock, 100mm dia
