# 203 Heritage Impact Assessment

Kitchen Extraction System

32 Sun Street, Hitchin

**Michael Collins Architects Ltd**

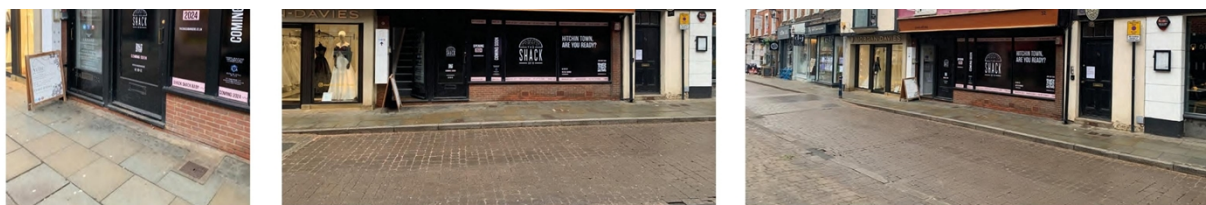
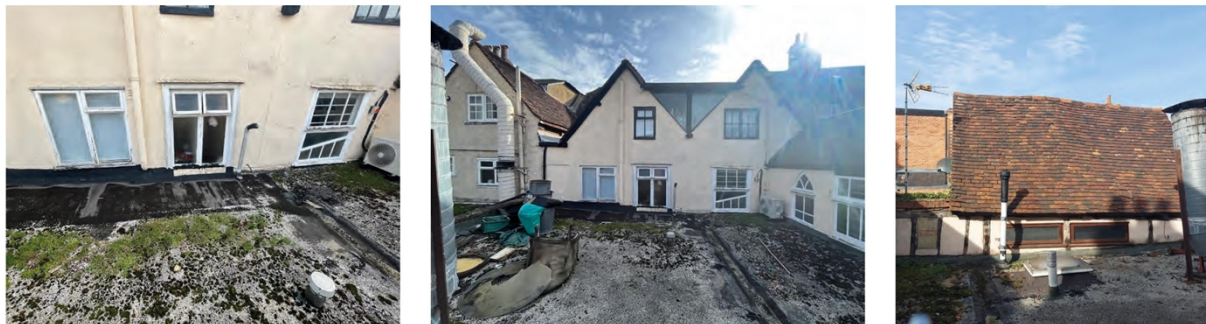
Existing Rear Facade and Roof

Fig. 2 — Pre-refurbishment condition of the rear facade and flat roof, showing the existing aged extraction ductwork, plant equipment and felt roof surface. Source: Michael Collins Architects Ltd, Design and Access Statement, July 2024.

Key features of the existing fabric include: the 18th-century stucco front elevation; the rear elevation with stucco finish and 1980s timber-framed windows; the pitched clay-tiled roof at the front; and the felt flat roof at the rear covering the 1960s single-storey rear extension. The photographs below illustrate the pre-refurbishment condition of the rear facade and flat roof, showing the existing aged extraction ductwork and the established pattern of plant and services in this backland location.

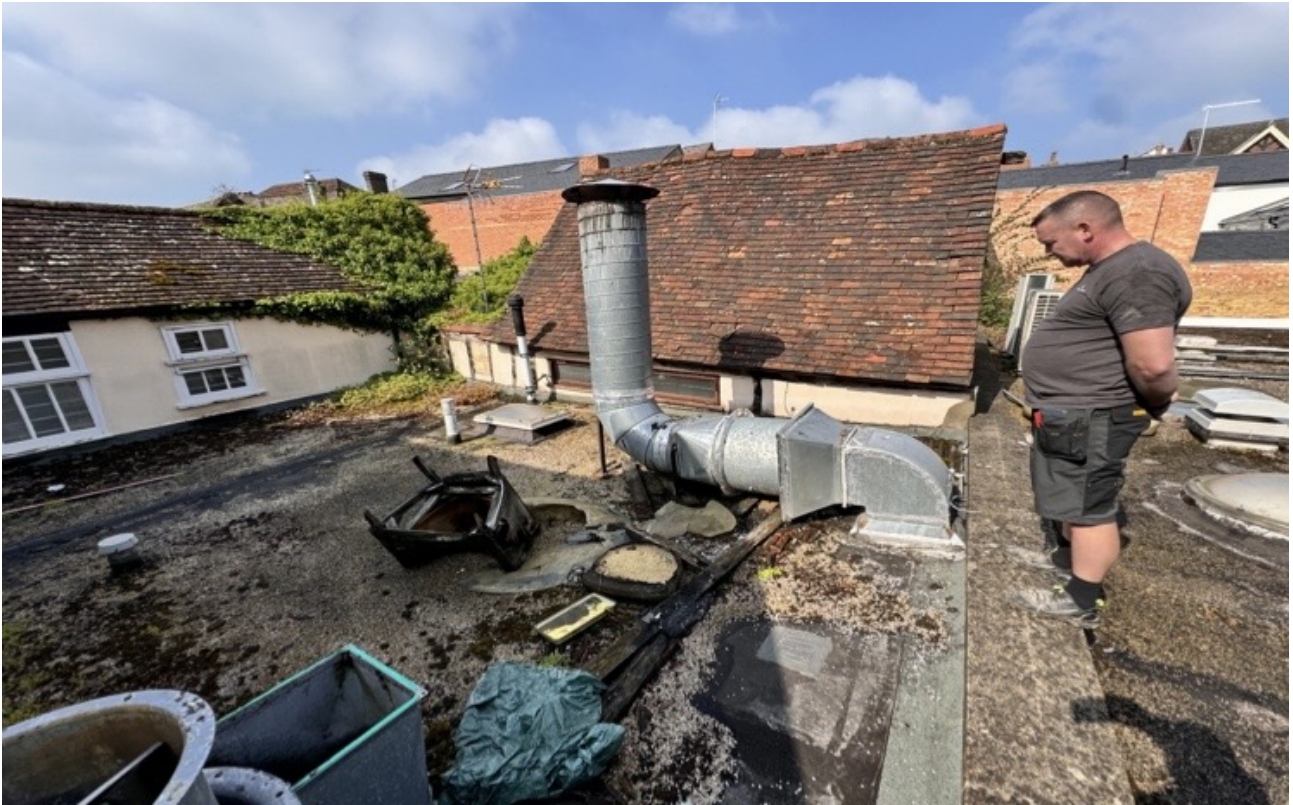
*Fig. 3 — Pre-installation condition of the flat roof showing the old, non-compliant extraction system mid-removal. The dilapidated ductwork, corroded components, and general state of disrepair are evident. The new system connects to the same pre-existing roof openings. Source: Fusion Hot Ltd, October 2025.*

Prior to the refurbishment, the premises operated with an existing extraction system serving the previous restaurant use. This consisted of aged galvanised ducting and a roof-mounted fan in poor condition, with no grease filtration or noise control measures. Internal ducting was corroded, showing grease and condensate leakage, with inadequate fan performance. The arrangement did not comply with DW/172 kitchen ventilation standards.

Critically, the new extraction system occupies openings previously used by the old ductwork. The installation does not introduce new penetrations in a previously unaffected location; rather it replaces an existing arrangement in the same general position with a modern, compliant, and better-performing system. The old system was removed in full prior to installation of the new equipment.

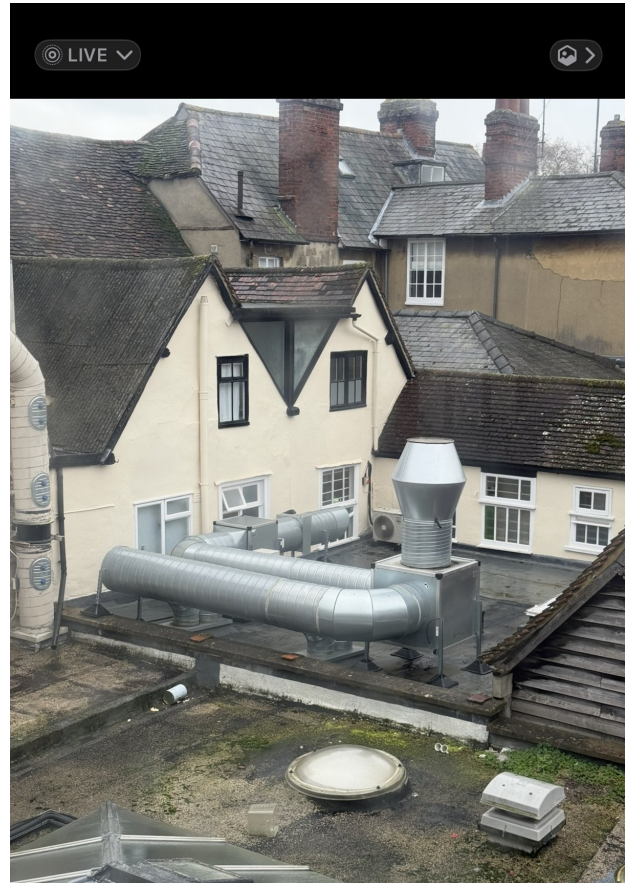
*Fig. 6 — Context view of the installed system showing the wider backland area. Multiple existing roof-mounted plant items and AC units are visible on neighbouring properties, demonstrating the established servicing character of this area.*

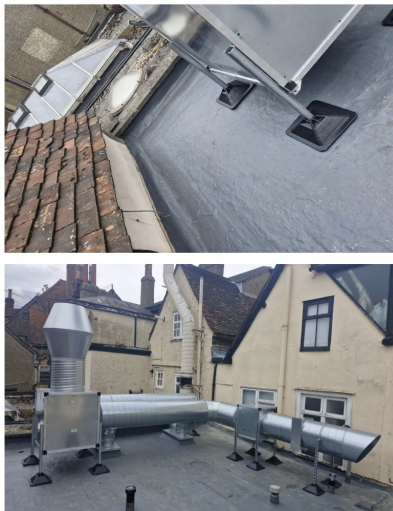
*Fig. 7 — The installed extraction system viewed from the upper storey of 23 Market Place, December 2025. The galvanised ductwork and 560 mm discharge cowl are visible on the 1960s flat roof extension, away from the historic rear elevation.*

The system serves a 4,450 mm x 1,200 mm x 500/500 mm stainless-steel kitchen canopy fitted with removable baffle filters and LED lighting. The 560 mm duct diameter and matching CVAT 560 fan provide the correct airflow for the kitchen's extract demand, with face velocity and airflow rates typical of similar commercial kitchens.

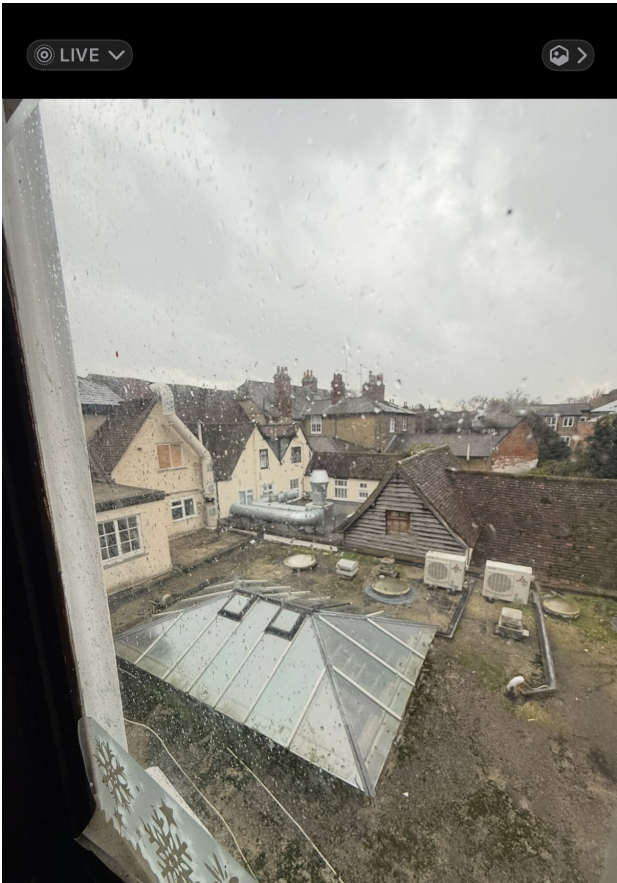
*Fig. 8 — Wider context view of the backland area from 23 Market Place showing the concentration of roof-mounted plant, AC units and services across neighbouring commercial properties.*
