| | <div>STRUCTURAL INSPECTION RECORD</div> <div>DERELICT BUILDING at BIRDS HILL, LETCHWORTH GARDEN CITY</div> | | | | | | REFERENCE: |
| | | | | | | | 7040 – IR-02 |
| PROJECT | BIRDS HILL, LETCHWORTH GARDEN CITY, SG6 1JE | | | | | | |
| BRIEF | KSA carried out a non-intrusive structural inspection on 13 <sup>th</sup> May 2026 on behalf of Greenchurch Developments Limited. | | | | | | |

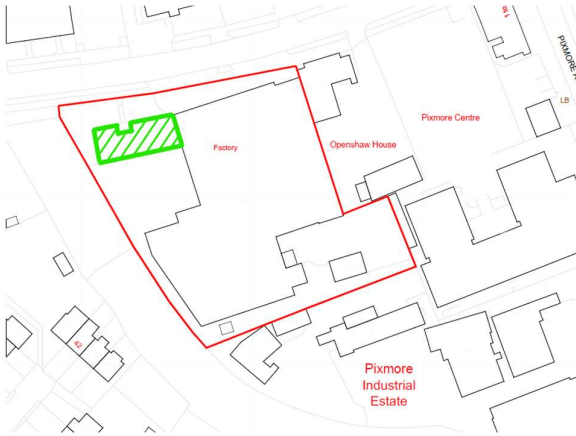
| | The inspection was requested to assess the structural condition of the derelict building highlighted in green below and to report on the findings and recommendations for the building. | | | | | | |
