**641-KS-06-MB-SH-A-90060-P02**  
**Temple Dinsley Level 0, GA – Apartment 06 – Bakersfield**

**641-KS-06-MB-SH-A-90070 – P03**  
**Temple Dinsley Level 0, GA – Apartment 7&8 – Art Block**

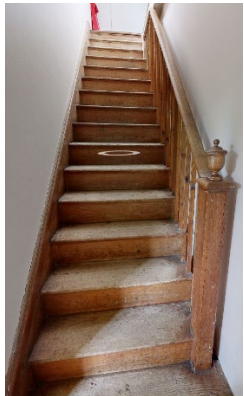
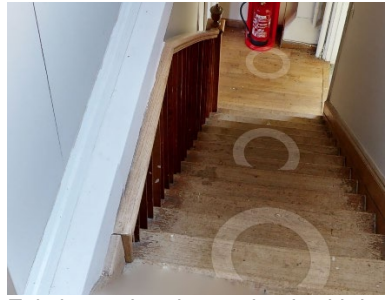
| Reference | Proposal | Significance of affected fabric | Impact | Reasoning and mitigation |
|---|---|---|---|---|
| | | | | <p>Existing stair to be retained, with handrail and balustrade adapted at first floor level to create galleried landing. Lower partition altered to provide compartmentation.</p> |

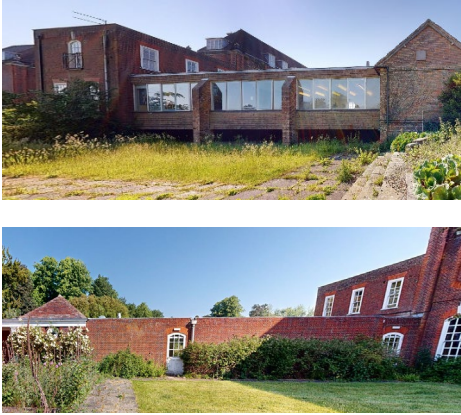
| Reference | Proposal | Significance of affected fabric | Impact | Reasoning and mitigation |
|---|---|---|---|---|
| A-Walls<br>7A.P1 | Conversion of 1970's Art Block and extension of ancillary basement to form bedroom accommodation. | <p>High</p> <p>Adjacent Buildings include 1909 Lutyens' Pavilion and corner of Lutyens' West Wing</p> <p>Low</p> <p>1970's Art Block<br/>Additional Mid C20 West Wing two storey Extension to the North.</p> | Moderate | <p>The Art Block is a 1988 school addition with clean contemporary lines, large format glazing and vertical clay wall tiles. The North Elevation is modern with the design more sympathetic and subservient to the historic setting to the South (the Rose Garden, Pavilion and West Wing). Planning drawings from 1988 show that there was an intention to form a basement set of classrooms however this work was not completed and the basement forms a small storage area below the suspended floor. The formation of habital basement shall impact the neighbouring historic buildings as a series of underpinning and retaining structures will be required. All ground works shall protect the existing structures. The South Elevation shall be repaired and retained sympathetically whilst works to the North Elevation will keep the lightweight appearance through use of a modern glazing system, and minimal visual change to the setting.</p> |

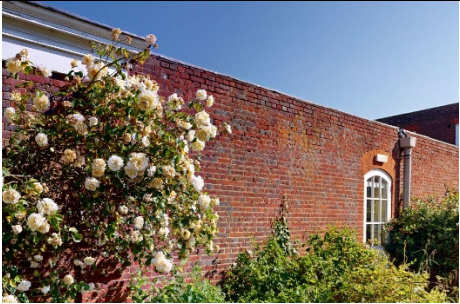
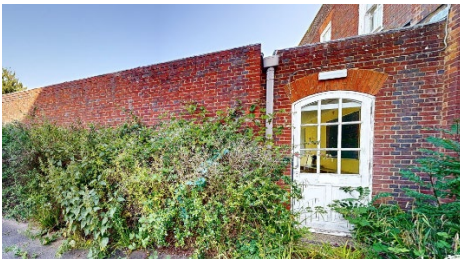
| Reference | Proposal | Significance of affected fabric | Impact | Reasoning and mitigation |
|---|---|---|---|---|
| A-Walls<br>7A.D1<br>and 7A.P2<br>8A.D1<br>and 8A.P2 | Demolition and rebuilding of South wall of Art Block to form parapet with coping stone. | Low - Moderate significance – wall is rebuilt along the historic line of most of the Kitchen Garden wall, rebuilt later with new doorways in 1988. The bricks, joints and coping differ and are later than the c1908-9 Pavilion.<br><br>Rose Garden – High Significance | Moderate Benefit | <p>The South wall of the Art block has been rebuilt as part of the works to form the building in the 1970's. The wall follows the line of the original garden wall (illustrated in the image above of the 1909 West Wing) which is shown to have a coping stone. The wall has been rebuilt in 1970's sympathetically by matching the brick to Lutyens' Pavilion and the West Wing – likely reusing some bricks. However, the weather detail to the top of the wall, where the roof felt laps without any upstand, flashing or coping, is poor and has visibly failed. To rebuild and introduce a coping will be a improvement and longterm benefit. The arches are modern Bulmer brick arches which are sympathetic to Lutyens' design and shall be reused. The stone coping will be kept lower in height to the moulded cornice of the Pavilion maintaining the expected hierarchy. The overall height of the wall will be unchanged. Unsympathetic rainwater hoppers and downpipes shall be replaced.</p> |

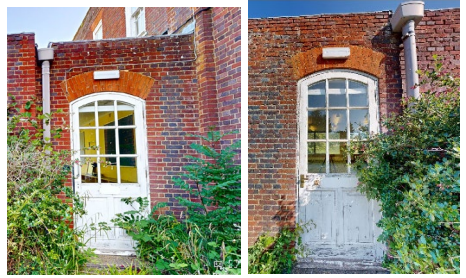
| Reference | Proposal | Significance of affected fabric | Impact | Reasoning and mitigation |
|---|---|---|---|---|
| D-Doors<br>7D-DG01<br>8D-DG01<br>7D-DG01<br>8D-DG01 | Removal late C20 doors and replacement of external doors to match existing in appearance but upgrade to specification of weatherproofing and ironmongery shall be required. | High Setting of South Elevation and Rose Garden<br><br>Neutral/Negative Late C20 Doors | Low Impact | <p>Doors are late C20 with rudimentary repairs but have been designed to copy the curved heads of the West Wing windows and Lutyens' external doors to the pavilion. The brick arches are Bulmer bricks. The intention would be to retain the brick gauged arches but replace the doors with similar appearance. Doors to have solid bottom panels with midrail and glazed upper lights 3x3. Glazing shall be narrow double glazing with integral glazing bars and ironmongery to comply with building regulations. The external bulkhead lights shall be removed and replaced with sympathetic wall lights placed to the side of doors. The replacement external doors are considered as a benefit with low impact on historic fabric and setting.</p> |

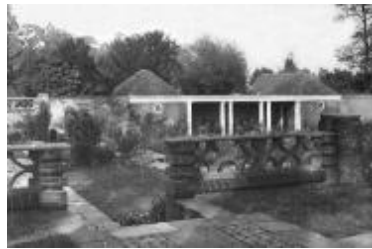
Lutyens' Pavilion looking from the Rose Garden. Circular window is open with a pivot hinge. Photos early C20.

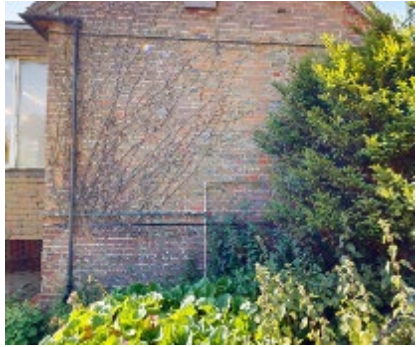
| Reference | Proposal | Significance of affected fabric | Impact | Reasoning and mitigation |
|---|---|---|---|---|
| A-Walls<br>9A.P2 | Removal of redundant services to North Elevation of East Pavilion Building. Reinstall door opening as a window (refer to 9E-WG05). | High<br>Early C20<br>1909 Lutyens<br>Remnants of Pre 1884 Outbuilding<br><br>Negative<br>Window infill | Tidying services<br>Low<br>Impact<br>Benefit<br><br><br>Window<br>High<br>impact<br>Benefit | <p>Three panels of brickwork visible on this elevation show the evolution of the outbuilding. The lower section of the wall is part of the C19 brick outbuildings that were ancillary to Temple Dinsley. At the wall plate height of the gable we can see the additional section, which is part of the 1909 Lutyens' phase. The roof plan shows to achieve the visual symmetry of the pavilion buildings on the South Elevation, the garden wall height to the South conceals the lower eaves on the East Pavilion. The East Pavilion building is wider than the West Pavilion building. This is visible on the North Elevation but not the South.</p> <p>Three panels of brickwork visible. There is a blocked up doorway positioned centrally on the gable. The varied brickwork and perp joint arrangement confirm this. The doorway is likely to have been blocked up as part of the 1909 Lutyens' design..</p> |

| Reference | Proposal | Significance of affected fabric | Impact | Reasoning and mitigation |
|---|---|---|---|---|
| 9E-WG05<br>Refer to detailed notes within 9A.P2 | New Window within reinstated opening to match 9E-WG04. | High<br>Early C20<br>1909 Lutyens<br>Remnants of Pre 1884 Outbuilding | Low<br>Impact<br>Benefit | <p>As discussed previously the window is to be reinstated. The brick height of WG04 matches that of the visible panel so the design of the new window shall be a casement to match WG04 with narrow double glazing and integral glazing bars.</p> <p>WG05 window position with queen closers retained and the size and proportions of proposed window are designed to suit the evidence and better reveal the historic design of this building.</p> |

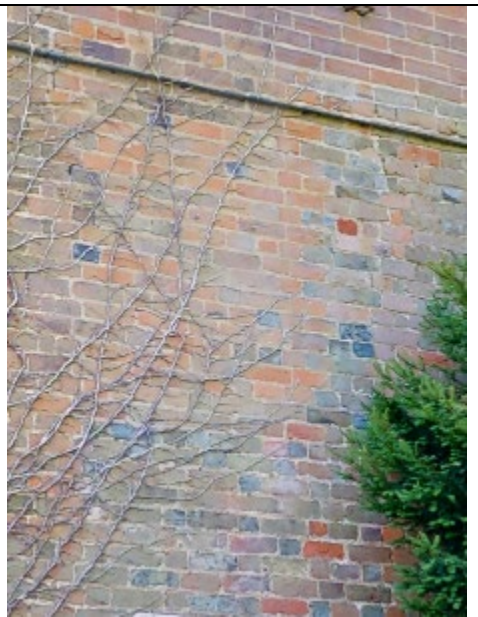
| Reference | Proposal | Significance of affected fabric | Impact | Reasoning and mitigation |
|---|---|---|---|---|
| | | | | <p>Three types of brickwork form the north gable of the East Pavilion. The Queen Closers that would have framed the door opening are clearly visible in the above image and will guide the width of the opening to be reinstated. Reinstating the door opening will have a positive impact on the appearance of the Pavilion to the North and will allow views and connection, from the Pavilion to the North, that were originally intended.</p> |

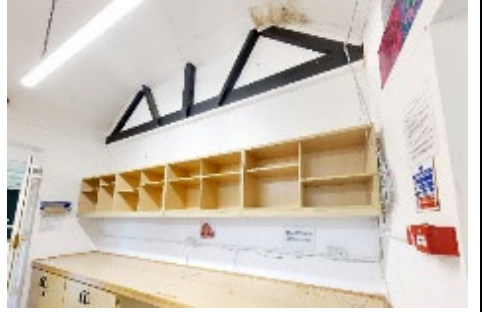
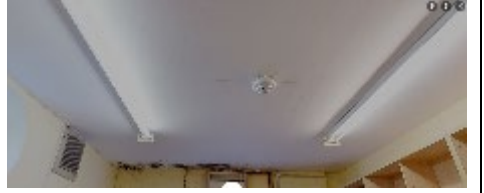
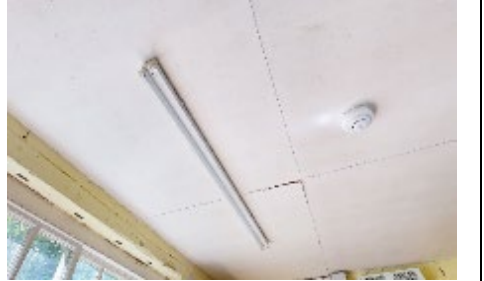
| Reference | Proposal | Significance of affected fabric | Impact | Reasoning and mitigation |
|---|---|---|---|---|
| C-Ceilings<br>9C.D1 | Ceiling – Remove all modern linings that have been applied to underdraw the existing rafters in both pavilion buildings. | Truss / Structure<br>High<br>Early C20<br>1911 Lutyens with<br><br>Linings<br>Neutral/Negative<br>Late C20/C21<br>alterations | Low<br>Impact<br>Benefit | <p>Both pavilions have been lined with modern boards. These shall be removed which is considered a positive impact and will allow the condition of the roof structure to be assessed and recorded.</p> |

| Reference | Proposal | Significance of affected fabric | Impact | Reasoning and mitigation |
|---|---|---|---|---|
| C-Ceilings /Roof<br>9C.R1 | Repair any damaged structural timbers. | Structure<br>High<br>Early C20<br>1911 Lutyens<br><br>Neutral/Negative<br>Late C20/C21<br>alterations | Low<br>Impact<br>Benefit | Both pavilions have been lined with modern boards. These shall be removed which is considered a positive impact and will allow the condition of the roof structure to be assessed and recorded. |

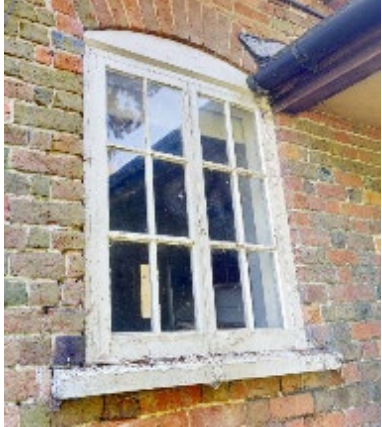
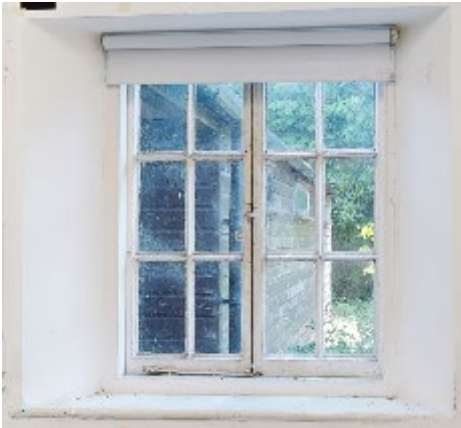
| Reference | Proposal | Significance of affected fabric | Impact | Reasoning and mitigation |
|---|---|---|---|---|
| E-Windows<br>9E-WG04 | 1909 Lutyens' casement to be retained and repaired. | High Early C20 1909 Lutyens | Low Impact Benefit | <p>Splice repairs carried put where required. Resin repairs for more localised repair. Replacement lights for any broken panes. Perished putty replacement. Easing of window as required. Original ironmongery retained. New ironmongery shall be required to comply with building regulations. Window locks. The repairs will improve the appearance and longevity of the window.</p> |

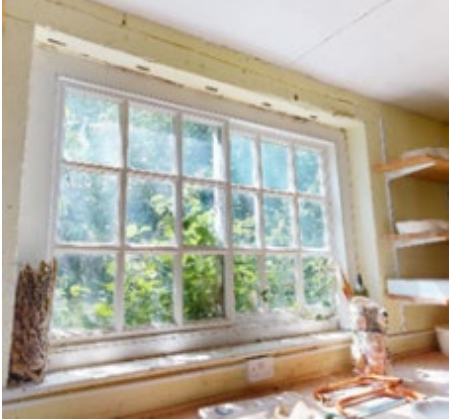
| Reference | Proposal | Significance of affected fabric | Impact | Reasoning and mitigation |
|---|---|---|---|---|
| E-Windows<br>9E-WG08 | 1909 Lutyens' sliding casement to be retained and repaired. | High<br>Early C20<br>1909 Lutyens | Low<br>Impact<br>Benefit | <p>Original sliding casement which looks to be in a good condition. Splice repairs carried put where required. Resin repairs for more localised repair. Replacement lights for any broken panes. Perished putty replacement. Easing of window as required. Original ironmongery retained. New ironmongery shall be required to comply with building regulations. The repairs will improve the appearance and longevity of the window.</p> |

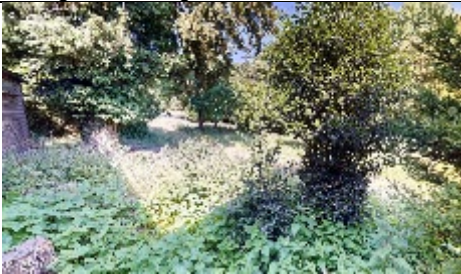
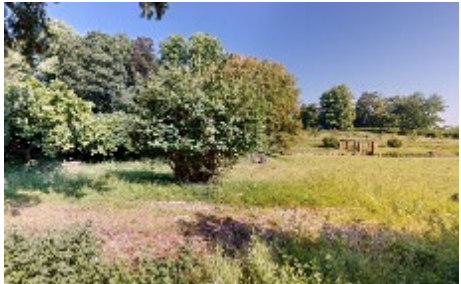
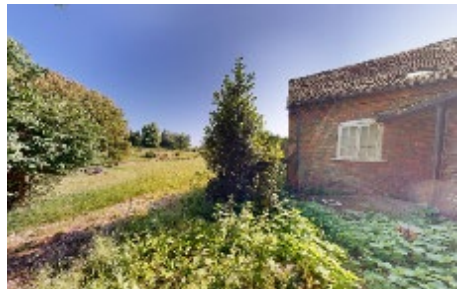
| Reference | Proposal | Significance of affected fabric | Impact | Reasoning and mitigation |
|---|---|---|---|---|
| V-Views<br>9V | Views from Apartment 9 will not address the south and shall be directed towards the North, West and East. View of the Pavilion from the South will be unchanged. | High<br>Early C20<br>1909 Lutyens | Low<br>Impact | <p>Views shall be directed towards the Second Rose Garden, the North and Pergola Garden to the East. The intention is for these gardens to be restored and maintained. View of the pavilion, from the Gardens to the North, will have minimal change. Removal of the sheds and insertion of a building designed sympathetically and constructed with materials of high quality will have a positive impact on the setting. The link extension will be arranged between the brick pavilions so the historic form of the pavilion can still be read. Self-seeded Holly Tree (T611) of low grade (refer to Arboriculturists report and proposals) shall be removed. The footprint of the link extension has been carefully considered with consultation with a SE (Report) and Arboriculturalist to ensure the footing design addresses the issues of building within the RPZ (Root Protection Zone) of the Yew Tree (T612).</p> |

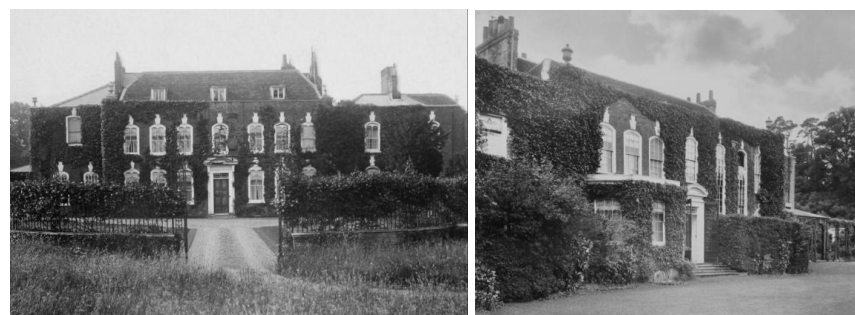
Photos of front and rear elevations of central block pre EC20 Lutyens works.

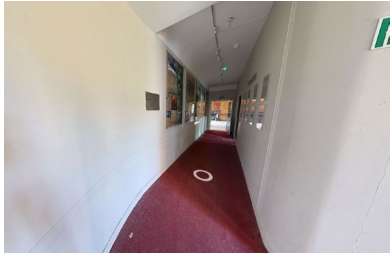
| Reference | Proposal | Significance of affected fabric | Impact | Reasoning and mitigation |
|---|---|---|---|---|
| A-Walls<br>10A.R3 | South wall entrance/corridor timber panelling to remain. Redecorate. | High.<br>Early C20 Lutyens | No Impact.<br>Repairs / re-decorations are of benefit. | <p>The south wall of the corridor once formed part of the back room, prior to the insertion of the corridor, therefore the panelling is original. The retention of the later corridor wall makes the use flexible.</p> |

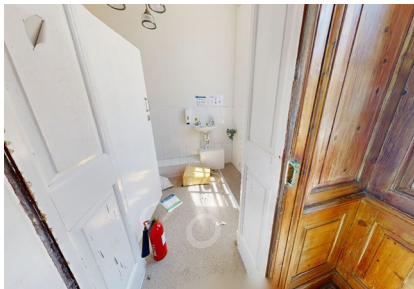
| Reference | Proposal | Significance of affected fabric | Impact | Reasoning and mitigation |
|---|---|---|---|---|
| B-Floors<br>10B.P1 | Following C20 modern carpet finish removal, new tiled flooring laid including decoupling membrane to bathroom, shower room, WC and Utility room. | Low.<br>Late C20 finishes added by School. | Benefit | <p>Benefit: Revealing the historic timber floor enables like-for-like repairs to be carried out and the proposed membrane ensures that any future finish will not adhere to the historic fabric.</p> |

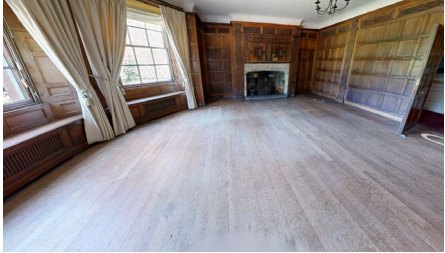
| Reference | Proposal | Significance of affected fabric | Impact | Reasoning and mitigation |
|---|---|---|---|---|
| B-Floors<br>10B.R2 | Existing wooden flooring to be retained and repaired when required. It is proposed to carefully lift the existing boards to allow for inspection and repair of existing suspended timber floor joists, and insertion of new breathable insulation between the joists. Existing boards to be re-laid once floor repairs complete. | High.<br>Early C20 Lutyens. | Benefit. | <p>The historic floor finish remains visible. Benefit: Breathable insulation will benefit the use and improve the thermal performance of the building. The careful like-for-like repairs are of benefit for the longevity of the building.</p> |

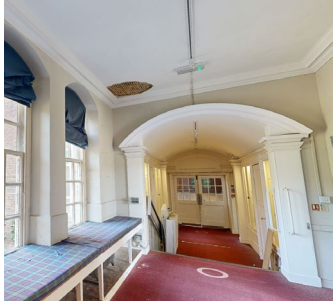
| Reference | Proposal | Significance of affected fabric | Impact | Reasoning and mitigation |
|---|---|---|---|---|
| C-Ceilings<br>10C.R1 | Ceiling - Lath and lime plaster to be repaired generally. And to be redecorated. | High.<br>Early C20 Lutyens | Low<br>Impact<br>Benefit | <p>The like-for-like repairs are beneficial for the viability of the building. Lath and plaster ceiling to be repaired when required. Any compartmentation to the apartment above or any required services (to be run within the ceiling void) are to be installed from above, to minimise the impact of the proposal alteration on the historic fabric.</p> |

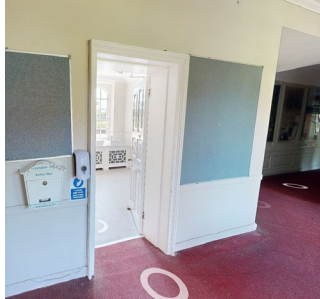
| Reference | Proposal | Significance of affected fabric | Impact | Reasoning and mitigation |
|---|---|---|---|---|
| D-Doors<br>10-DG05<br>10D.P4 | C20 timber door to be kept shut permanently, door opening to be infill behind. | Moderate.<br>C20 alteration. | Low level benefit. | <p>Benefit: the door is an insertion into Lutyens' wall so its closure would reinstate the designed layout.</p> |

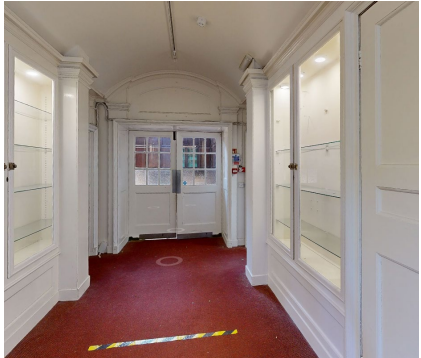
| Reference | Proposal | Significance of affected fabric | Impact | Reasoning and mitigation |
|---|---|---|---|---|
| G-New internal partitions. 10G.P2 | Infill EC20 walkthrough with lightweight non-load bearing timber stud partition, as part of compartment wall. | High. EC20 Lutyens | Low impact. | <p>The partition is inserted within the existing columned projections. This is a reversible alteration with no loss of historic fabric.</p> |

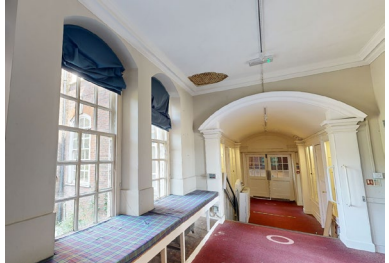
| Reference | Proposal | Significance of affected fabric | Impact | Reasoning and mitigation |
|---|---|---|---|---|
| J-Internal fixtures and fittings 10J.D1 | To strip C21 bench and stair lift. | Neutral/negative C20 additions. | Benefit. | <p>The removal of late C20 stairlift and bench will be an enhancement to allow the Lutyens mouldings and details to be better seen.</p> |

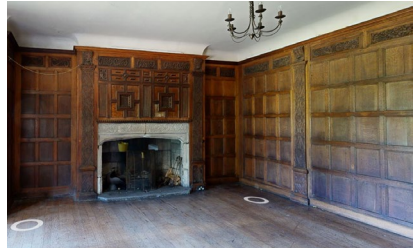
| Reference | Proposal | Significance of affected fabric | Impact | Reasoning and mitigation |
|---|---|---|---|---|
| L-Panelling<br>10K.P1 | EC20 timber wall panelling in the kitchen / diner / living room to have no alterations proposed. | High.<br>C18 and EC20 Lutyens. | None | |

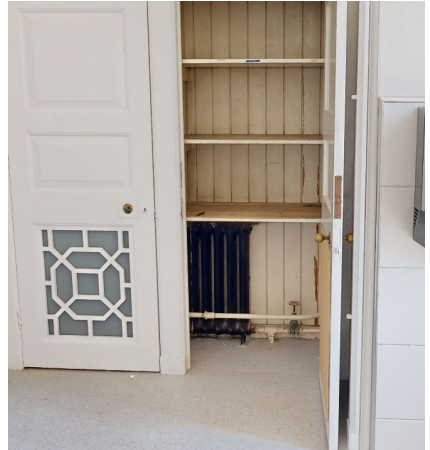
| Reference | Proposal | Significance of affected fabric | Impact | Reasoning and mitigation |
|---|---|---|---|---|
| P-Services<br>10P.R1 | Cast iron radiators refurbished to work with new heating system. | High.<br>EC20 Lutyens | Benefit. | <p>These are to be retained and refurbished. This will preserve the historic fixtures and enhance the use of the building.</p> |

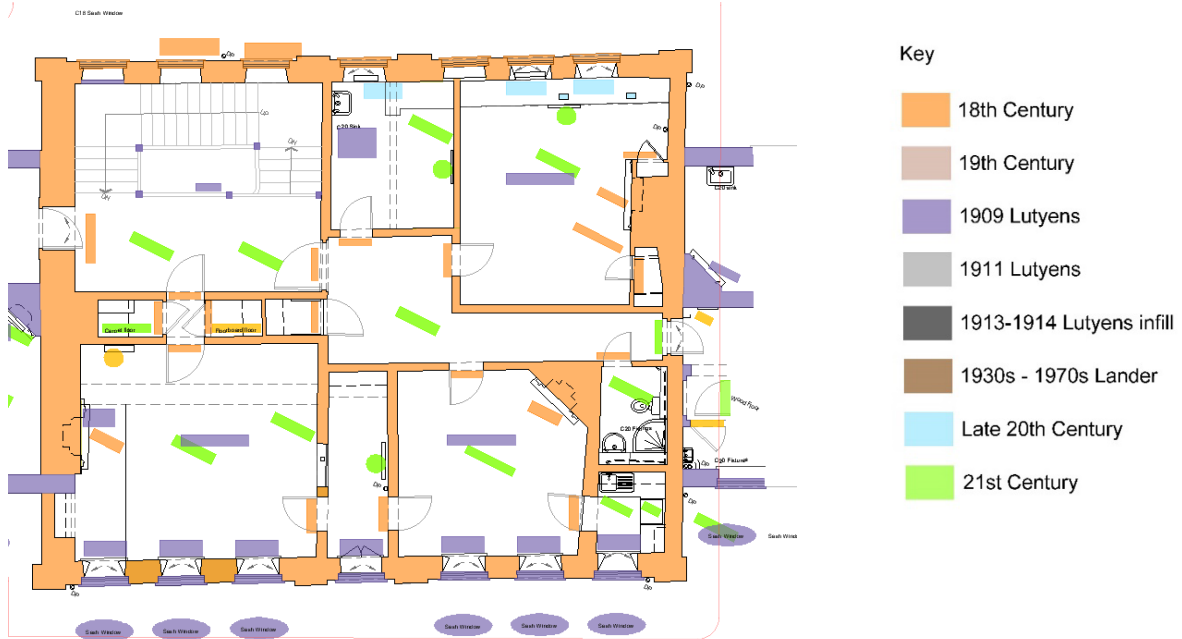
Extract from Level 1 GA, Plan as Existing. Plan of significance shows the evolution of the central block.

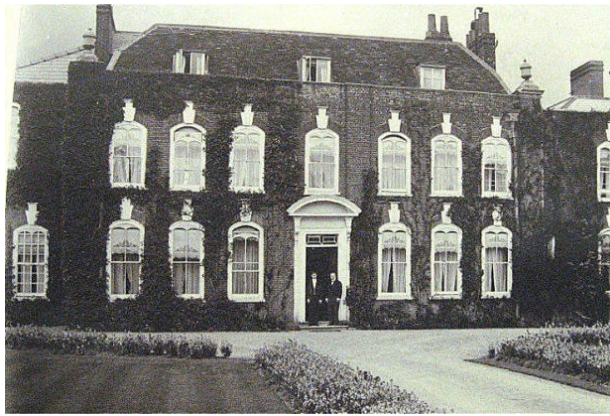
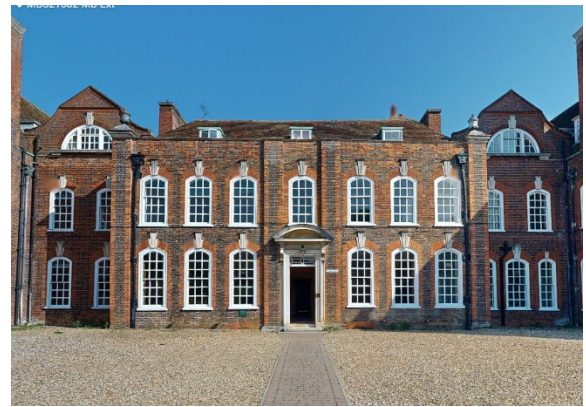
South Elevation (Front). Mid C19 shows the Georgian front of Temple Dinsley, central block. C21 photo showing central block with Lutyens side wings extensions.

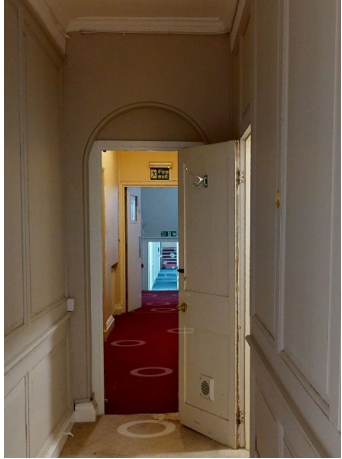
| Reference | Proposal | Significance of affected fabric | Impact | Reasoning and mitigation |
|---|---|---|---|---|
| G-New internal partitions 11G.P2 | Remove modern door and doorcase, infill door opening with lightweight non-load bearing timber stud partition, as part of compartment wall. Over archway to be retained. | High.<br>C18 and EC20 Lutyens adjacent.<br><br>Negative.<br>Late C20 infill and door. | Low impact | <p>The infill is inserted within the existing opening, so there is no loss of historic fabric. The proposal is reversible. The original archway detail is retained and clearer to see. The proposal is to built in lightweight non-load bearing timber stud partition, as part of compartment wall for fire and acoustic separation.</p> |

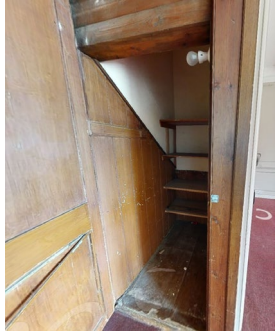
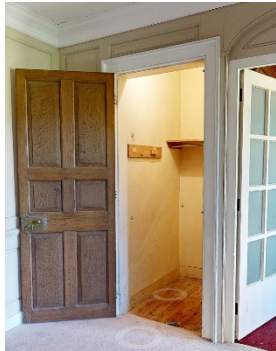
| Reference | Proposal | Significance of affected fabric | Impact | Reasoning and mitigation |
|---|---|---|---|---|
| G-New internal partitions 11G.P3 (11G.D1) | To remove existing partition between cupboards, and to re-erect it further along. | High.<br>C18 and EC20 Lutyens adjacent. | Low impact. | <p>There is evidence that the narrow space housed a staircase to the attic, which later was removed, and the back-</p> |

| Reference | Proposal | Significance of affected fabric | Impact | Reasoning and mitigation |
|---|---|---|---|---|
| | | | | <p>to-back cupboards formed. It is unclear the relation of the narrow space with the jib door.</p> <p>It is proposed to reinstate the jib door to provide a direct passage from the lobby entrance to the sitting room, as to comply with Fire Strategy.</p> |
