**641-KS-06-MB-SH-A-90017– P01**

**Temple Dinsley Level 1, GA – Apartment 17 - Almina**

## East Wing – Proposed Apartment 18 – Plan of Significance

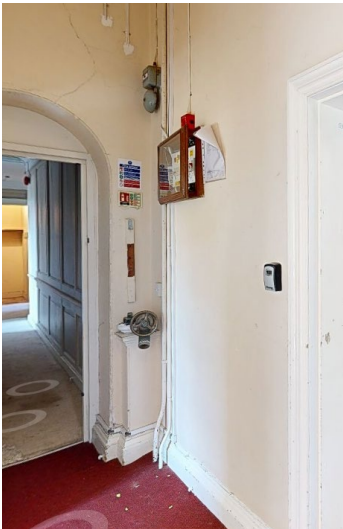
| Reference | Proposal | Significance of affected fabric | Impact | Reasoning and mitigation |
|---|---|---|---|---|
| <u>J-Internal fixtures and fittings</u><br>17J.R2 | Retain hydrant, glazed door timber cabinet and bell<br><br>Tidy services and remove redundant late C20 cabling and meter box. | High.<br>Early C20 Lutyens<br><br>Low<br>Mid-late C20 addition. | Benefit | <p>The early C20 fixtures show clear evidence of its past use as a school, which adds interest and character to the space. It is important they are retained as evidence of its past.</p> |

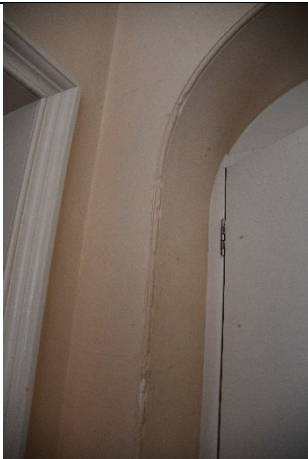
| Reference | Proposal | Significance of affected fabric | Impact | Reasoning and mitigation |
|---|---|---|---|---|
| <u>M-Finishes</u><br>17M.R1 | Repair plaster beaded edge in the archway. | High.<br>Early C20 Lutyens | Benefit | <p>Damaged due to its location, it is proposed to carry out repairs to reinstate the beading.</p> |

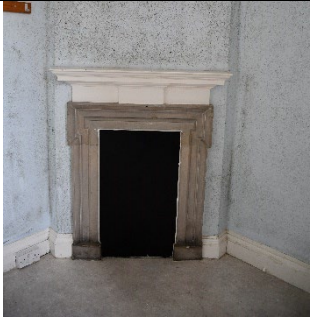
| Reference | Proposal | Significance of affected fabric | Impact | Reasoning and mitigation |
|---|---|---|---|---|
| <u>N-Fireplace</u> | Reinstate fireplace. To remove existing screen, | High.<br>Early C20 Lutyens | Benefit | |

| Reference | Proposal | Significance of affected fabric | Impact | Reasoning and mitigation |
|---|---|---|---|---|
| 17N.R1 | investigate and allow to install a fireplace grate that suits the period of the fireplace. | | | <p>Benefit. The proposal reinstates original features, adding interest to the rooms.</p> |

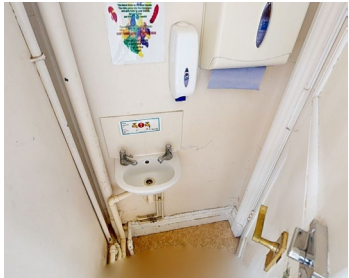
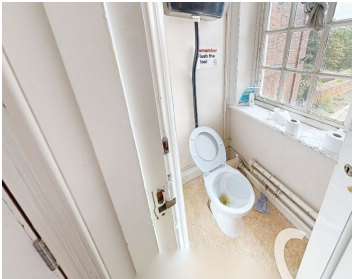
| Reference | Proposal | Significance of affected fabric | Impact | Reasoning and mitigation |
|---|---|---|---|---|
| <u>P-Services</u><br>17P.D2 | Remove modern sanitaryware and associated plumbing. | Neutral/negative. Late C20 alteration by the School. | Neutral. Benefit | <p>The present WC becomes a dressing alcove. The pieces are modern of no historic value.</p> |

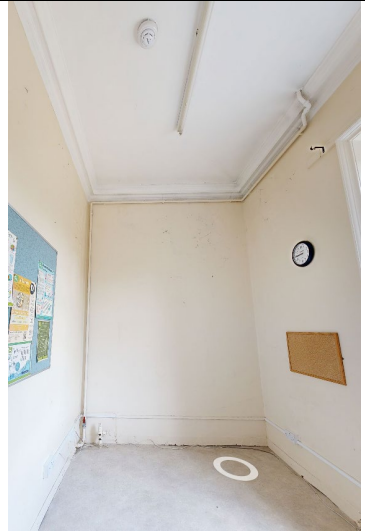
| Reference | Proposal | Significance of affected fabric | Impact | Reasoning and mitigation |
|---|---|---|---|---|
| <u>P-Services</u><br>17P.D3 | Remove modern plumbing, cabling, | Neutral/negative. | Benefit. No harm | |

| Reference | Proposal | Significance of affected fabric | Impact | Reasoning and mitigation |
|---|---|---|---|---|
| | plastic conduit, fire alarm fittings, etc. | Late C20 alteration by the School. | | <p>The existing modern electrics, lighting/emergency lighting, smoke alarms and associated trunking and conduits are related to use by the School. These are to be removed and replaced to an appropriate residential standard.</p> <p>The proposal is to be an enhancement to the new use of the building.</p> |

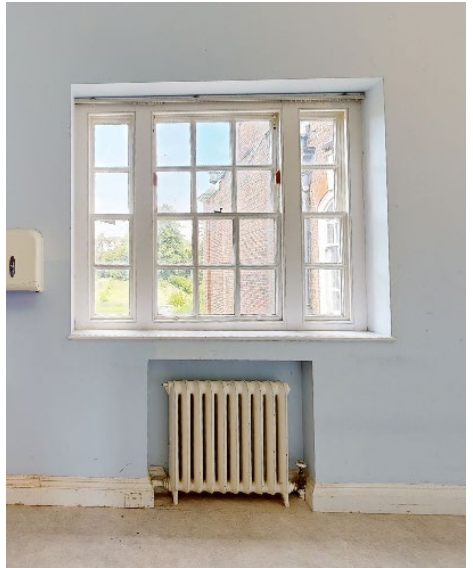
| Reference | Proposal | Significance of affected fabric | Impact | Reasoning and mitigation |
|---|---|---|---|---|
| <u>P-Services</u><br>17P.R1 | Cast iron radiators refurbished to work with new heating system. | High.<br>Potentially EC20<br>Lutyens | Neutral impact.<br>Benefit. | <p>These are to be retained and refurbished. This will preserve the historic fixtures and enhance the use of the building.</p> |

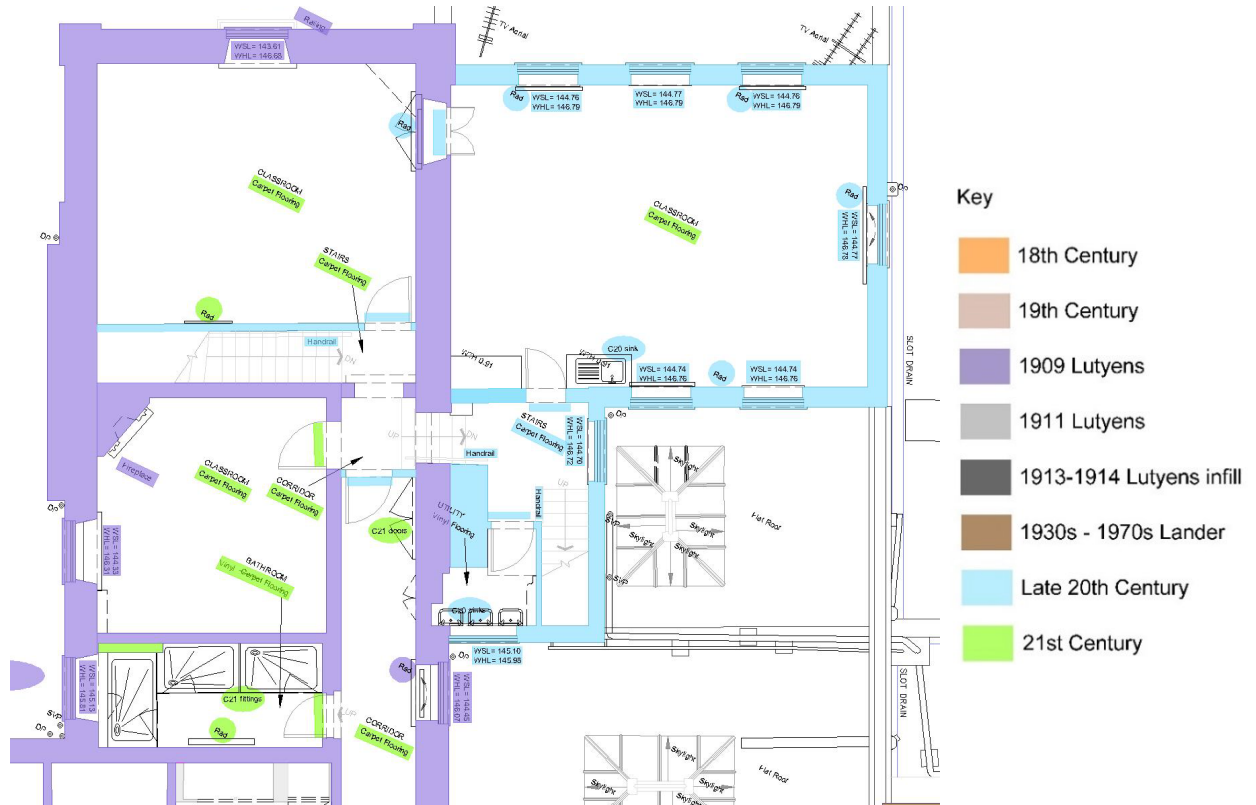
Extract from Level 1 GA, Plan as Existing. Plan of significance shows the evolution of the rear East Wing (North), and part of the east link to the former Georgian manor house (central block) and later C20 additions forming the East annex.

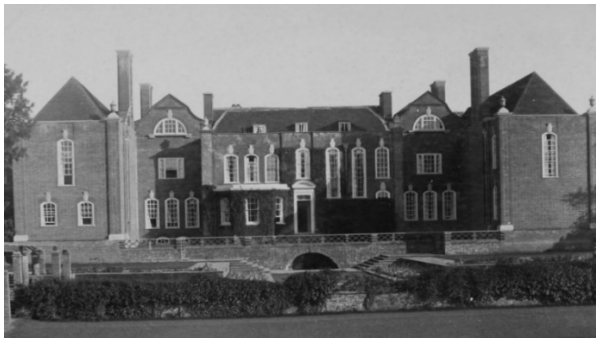
North rear elevation photo, post-Lutyens.

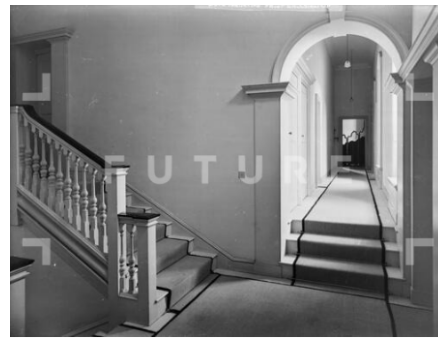
Country Life archive photo of the interior of the services staircase and corridor to the northern end of the East Wing.

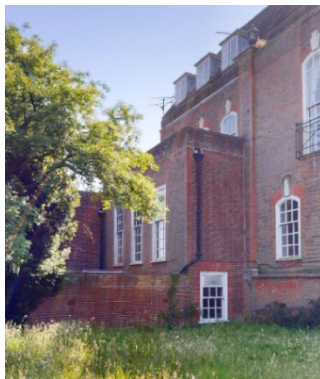
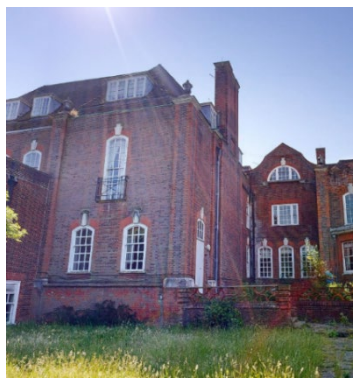
The present-day photos show the rear elevation of east annex with the post Lutyens' two storey extension, and Lutyens east wing.

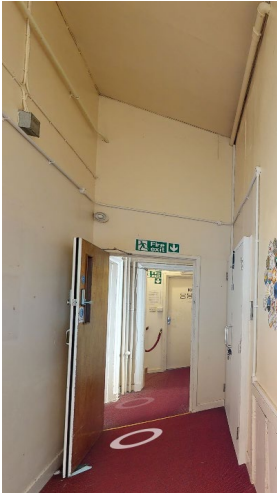
| Reference | Proposal | Significance of affected fabric | Impact | Reasoning and mitigation |
|---|---|---|---|---|
| <u>A-Walls</u><br>18A.D1 | Demolish modern corridor partition and doorway. | Neutral/negative<br>Late C20 alteration<br>by the School | Benefit | <p>The partition is a modern addition in the former corridor of the east wing. It has not significance or relevance as it doesn't form part of the former layout.</p> |

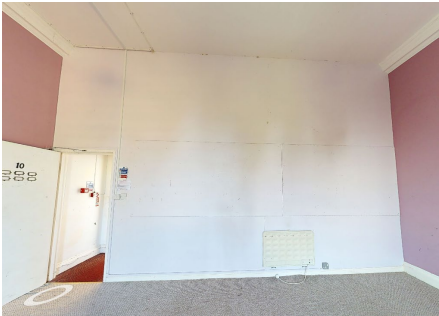
| Reference | Proposal | Significance of affected fabric | Impact | Reasoning and mitigation |
|---|---|---|---|---|
| <u>A-Walls</u><br>18A.D2 | Demolish modern partition and doorway that encloses the modern staircase that comes from the ground floor. | Neutral/negative<br>Late C20 alteration<br>by the School | Benefit | <p>The partition is a modern addition done by the School. It has not significance or relevance as it doesn't form part of the former layout.</p> <p>The proposal allows then the reinstatement of the original floor space.</p> |

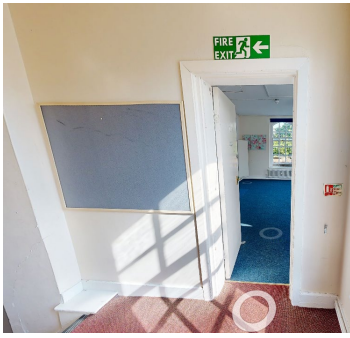
| Reference | Proposal | Significance of affected fabric | Impact | Reasoning and mitigation |
|---|---|---|---|---|
| <u>A-Walls</u><br>18A.D3 | Widen the doorway into the rear room of the east annex, from the stair-lift tower, with a view to insert a double door. | Low<br>Mid-late C20 | Low | <p>The current single door appears small in proportion to the size of the room that opens to. Given also the proposed use of this room, as an open plan living space, it seems proportionate to increase it and become a double door.</p> |

| Reference | Proposal | Significance of affected fabric | Impact | Reasoning and mitigation |
|---|---|---|---|---|
| <u>D-Doors</u><br>18D.P4<br>18-DF08 | Fit a new double door to the widened doorway. Door design in line with existing joinery. | Low<br>Mid-late C20 | Neutral | |

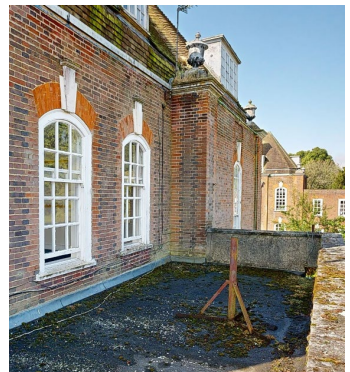
| Reference | Proposal | Significance of affected fabric | Impact | Reasoning and mitigation |
|---|---|---|---|---|
| <u>A-Walls</u><br>18A.D4 | Open up bottom of existing central window to form a doorway to the rear terrace. | Low<br>Mid-late C20 | Low | <p>The proposal allows to access and benefit from the rear north terrace what overlooks over the rear gardens. The existing opening and brickwork detailing will remain unchanged, only the brickwork bottom section will be demolished. Stone cill inserted and new door fitted in line with the architectural style of the windows.</p> |

| Reference | Proposal | Significance of affected fabric | Impact | Reasoning and mitigation |
|---|---|---|---|---|
| <u>D-Doors</u><br>18D.P5<br>18-DF03 | To form a new doorway in the existing window opening, to access the rear terrace. Design in the architectural style of the external joinery of this part of the building. | Low<br>Mid-late C20 | Low | |

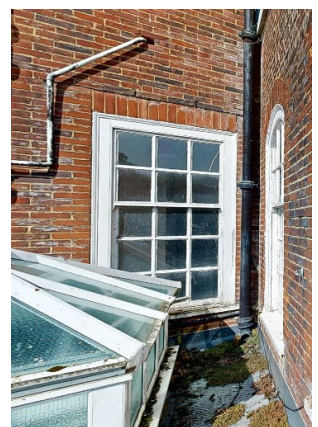
| Reference | Proposal | Significance of affected fabric | Impact | Reasoning and mitigation |
|---|---|---|---|---|
| <u>A-Walls</u><br>18A.D5 | Open up bottom of existing window to form a doorway to the middle terrace. | Low<br>Mid-late C20 | Low | |

| Reference | Proposal | Significance of affected fabric | Impact | Reasoning and mitigation |
|---|---|---|---|---|
| | | | | The proposal allows to access and benefit from the middle inner terrace. The existing opening and brickwork detailing will remain unchanged, only the brickwork bottom section will be demolished. Stone cill inserted and new door fitted in line with the architectural style of the windows. |

| Reference | Proposal | Significance of affected fabric | Impact | Reasoning and mitigation |
|---|---|---|---|---|
| <u>D-Doors</u><br>18D.P3<br><br>18-DF02 | Form a new doorway in the existing window opening, to access the middle inner terrace.<br><br>Design in the architectural style of the external joinery of this part of the building. | Low<br>Mid-late C20 | Low | |

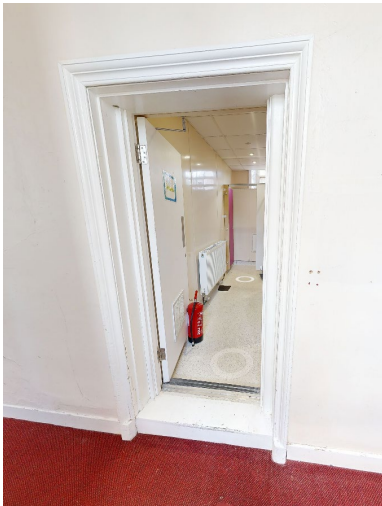
| Reference | Proposal | Significance of affected fabric | Impact | Reasoning and mitigation |
|---|---|---|---|---|
| <u>A-Walls</u><br>18A.P2 | Remove modern solid door. Infill doorway while retaining original architraves and door lining. | High.<br>Early C20 Lutyens | Low | <p>The infill is reversible and inserted within the original door lining, which will be retained.</p> |

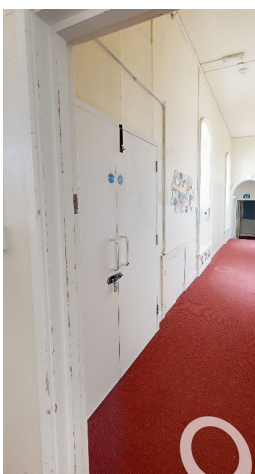
| Reference | Proposal | Significance of affected fabric | Impact | Reasoning and mitigation |
|---|---|---|---|---|
| <u>A-Walls</u><br>18A.P3 | Following the decommissioning of the lift and demolition of lift shaft, infill load bearing wall. | High.<br>Early C20 Lutyens | Low | <p>The infill does not affect any historic fabric.</p> |

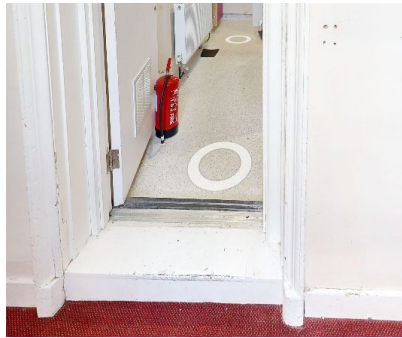
| Reference | Proposal | Significance of affected fabric | Impact | Reasoning and mitigation |
|---|---|---|---|---|
| <u>B-Floors</u><br><u>18B.D1</u> | Take up raised floor, added by the School to run the shower cubicles drainage and services. | Neutral/negative<br>Late C20 alteration<br>by the School | Benefit | <p>The removal is an improvement, as it reverts the original floor level.</p> |

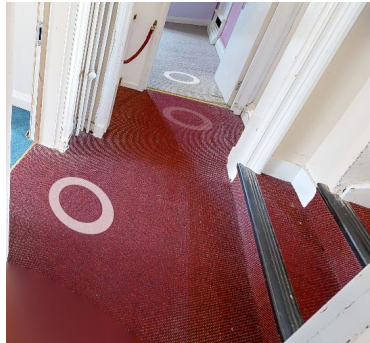
| Reference | Proposal | Significance of affected fabric | Impact | Reasoning and mitigation |
|---|---|---|---|---|
| <u>B-Floors</u><br><u>18B.P2</u> | <p>C20 modern soft flooring to be stripped and exposed existing wood flooring throughout.</p> <p>Wood flooring to be carefully lifted, to upgrade it thermally and fireproofing. To run services within it. Then to re-lay floorboards and carry out like-for-like repairs if required.</p> <p>To lay a decoupling layer when new flooring is to be laid.</p> | <p>Low.<br/>Soft flooring to be late C20 finishes by the School.</p> <p>High.<br/>Wood flooring to be early C20 Lutyens</p> | Benefit. | <p>Benefit: revealing the historic timber flooring enables like-for-like repairs to be carried out. This improves breathability and enables its appearance to be appreciated.</p> |

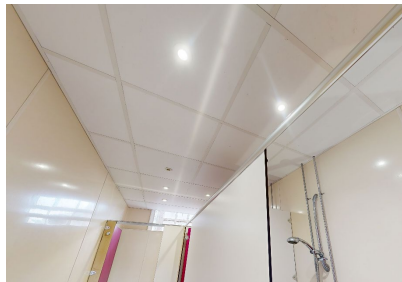
| Reference | Proposal | Significance of affected fabric | Impact | Reasoning and mitigation |
|---|---|---|---|---|
| <u>C-Ceilings</u><br><u>18C.D1</u> | Take down suspended tiled ceiling. | Neutral/negative<br>Late C20 alteration<br>by the School | Benefit | <p>The removal is an improvement, as it reverts the original room height.</p> |

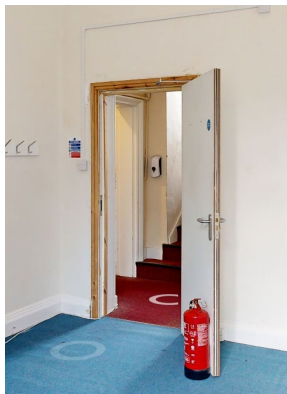
| Reference | Proposal | Significance of affected fabric | Impact | Reasoning and mitigation |
|---|---|---|---|---|
| <u>D-Doors</u><br>18D.P2<br><br>18-DF05 | Remove modern fire door and replace it with a panelled door that harmonises with the architectural style of this part of the building. | High.<br>Early C20 Lutyens | Positive | <p>The proposal aims to be an enhancement to the present joinery arrangement. No historic fabric is affected.</p> |

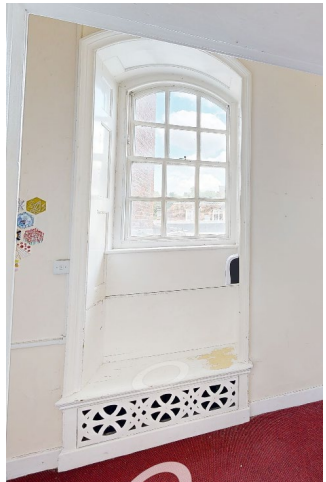
| Reference | Proposal | Significance of affected fabric | Impact | Reasoning and mitigation |
|---|---|---|---|---|
| <u>E-Windows</u><br>18E.R1 | EC20 'Lutyens' timber sash windows repairs and later windows to be splice repairs when required. Resin repairs for localized repairs. Replacement of broken glass panes. Perished putty replacement. Easing of window sashes and adjusting of window weights. Original ironmongery to be retained. Ease and adjust as required. New ironmongery to comply with Building Regulations. To redecorate internally and externally. | High.<br>Early C20 Lutyens | Benefit | <p>Original sash windows are to be retained and repaired carefully. Ironmongery retained and repaired. The like-for-like repairs are beneficial for the viability and appearance of the building. Replacement of non-original ironmongery to sympathetically reflect the style of the window will improve their appearance.</p> |

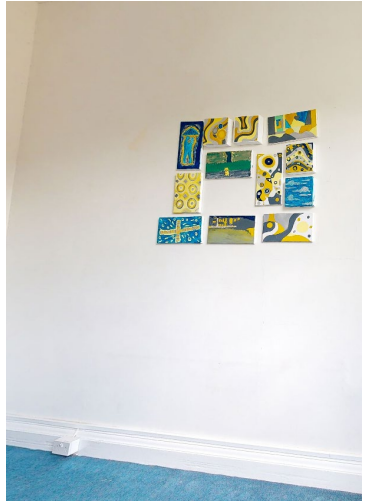
| Reference | Proposal | Significance of affected fabric | Impact | Reasoning and mitigation |
|---|---|---|---|---|
| <u>F-New openings</u><br>17F.P1 | Form a new doorway opening to access adjacent room that becomes en-suite to the bedroom. | High.<br>Early C20 Lutyens | Moderate | |

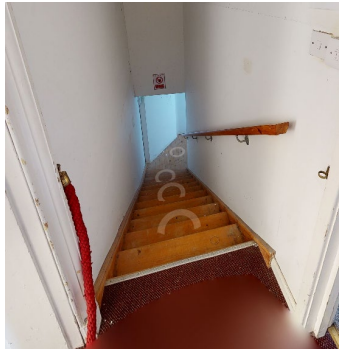
| Reference | Proposal | Significance of affected fabric | Impact | Reasoning and mitigation |
|---|---|---|---|---|
| <u>H-Stairs</u><br>18H.D2 | Demolish modern staircase that comes from floor below. | Neutral/negative<br>Late C20 alteration by the School | Benefit | <p>This is a modern alteration, so there is not harm to the historic fabric. Removing the staircase and enclosure reinstates the original floor space.</p> |

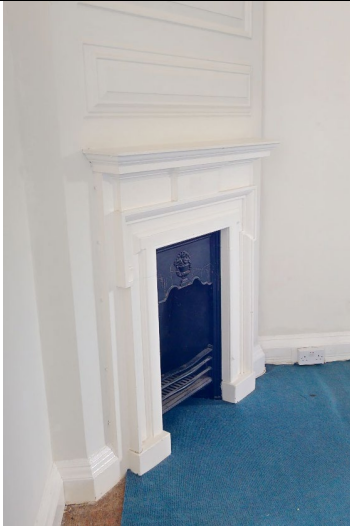
| Reference | Proposal | Significance of affected fabric | Impact | Reasoning and mitigation |
|---|---|---|---|---|
| | | | | <p>Retaining any original features is a benefit which also adds character to the room.</p> |

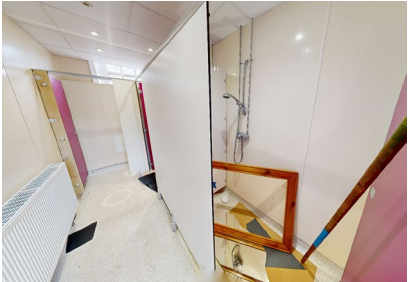
| Reference | Proposal | Significance of affected fabric | Impact | Reasoning and mitigation |
|---|---|---|---|---|
| <u>P-Services</u><br>18P.D1 | Remove and cart away showers, modern partitions and boxing with associated services, plumbing and drainage. | Neutral/negative<br>Late C20 alteration<br>by the School | | <p>The shower cubicles are of no use to the apartment. The proposal reinstate the room volume.</p> |

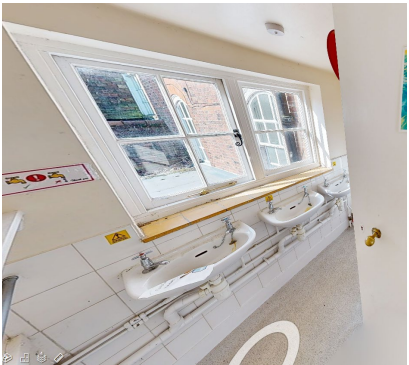
| Reference | Proposal | Significance of affected fabric | Impact | Reasoning and mitigation |
|---|---|---|---|---|
| <u>P-Services</u><br>18P.D2 | Remove and cart away wash hand basins with associated services, plumbing and drainage | Neutral/negative<br>Late C20 alteration<br>by the School | | <p>The sanitaryware is of no use to the apartment.</p> |

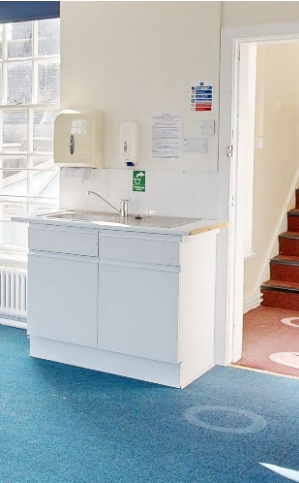
| Reference | Proposal | Significance of affected fabric | Impact | Reasoning and mitigation |
|---|---|---|---|---|
| <u>P-Services</u><br>18P.D4 | Remove sink and units, and any associated services, plumbing and waste. | Neutral/negative<br>Late C20 alteration<br>by the School | Neutral | <p>This is a modern fitting added by the school that is of no use to the apartment, and an obstruction to the proposed layout arrangement.</p> |

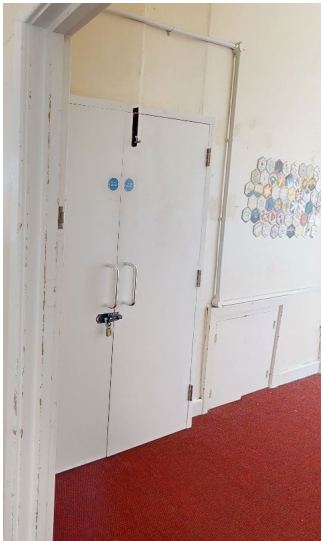
| Reference | Proposal | Significance of affected fabric | Impact | Reasoning and mitigation |
|---|---|---|---|---|
| <u>Q-Lift</u><br>18Q.D1 | To decommission modern lift. To demolish modern lift enclosure and strip modern solid timber doors, architraves and doorcase. | Low.<br>Late C20 alteration by the School. | Low impact. | <p>Main wall to be infilled.<br/>To lay a new flooring at floor and ceiling level inside the existing shaft. To comply with Fire, Sound and Thermal compartmentation requirements.<br/>The space behind becomes part of the utility room.</p> <p>No historic fabric or fittings are affected.</p> |

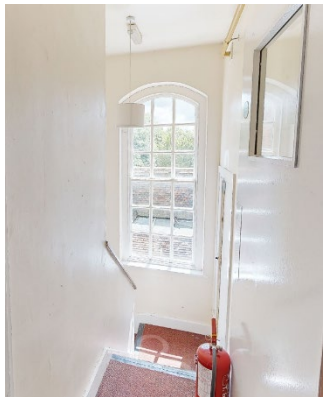
| Reference | Proposal | Significance of affected fabric | Impact | Reasoning and mitigation |
|---|---|---|---|---|
| | | | | <p>RHS north room (29b)<br/> The wall to the east side is an internal partition. Wall to the north is external.</p> <p>1no external wall below window in Room 30a</p> <p>3no external walls in Room 30b</p> <p>External walls to existing stairwell (south and east walls)</p> |

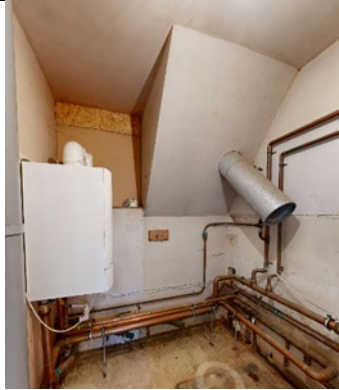
| Reference | Proposal | Significance of affected fabric | Impact | Reasoning and mitigation |
|---|---|---|---|---|
| | | | | <p>Boiler Room<br/>External wall to west.</p> |

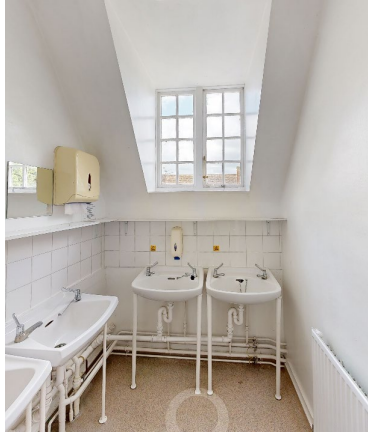
| Reference | Proposal | Significance of affected fabric | Impact | Reasoning and mitigation |
|---|---|---|---|---|
| | | | | <p>Partially tiled external wall to washroom<br/>(west side of east wing)</p> |

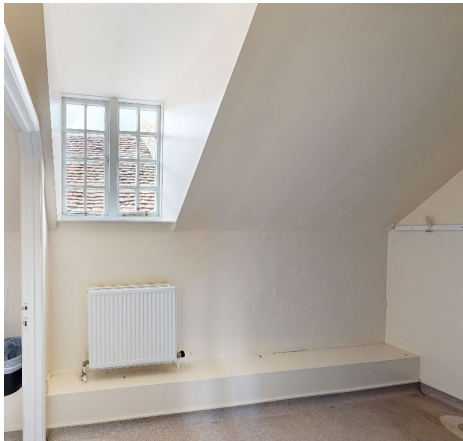
| Reference | Proposal | Significance of affected fabric | Impact | Reasoning and mitigation |
|---|---|---|---|---|
| | | | | <p>Damp to shower room wall<br/>(east side of east wing)</p> |

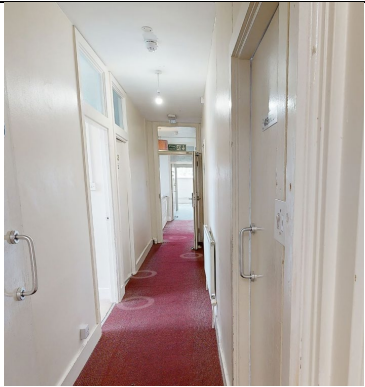
| Reference | Proposal | Significance of affected fabric | Impact | Reasoning and mitigation |
|---|---|---|---|---|
| | | | | <p>Existing corridor<br/>Remove plasterboard lined timber partitions forming central corridor.</p> |

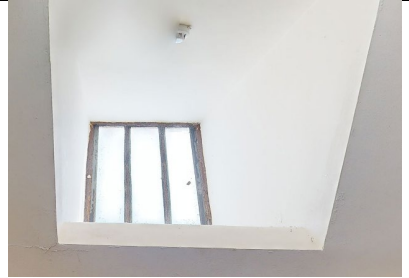
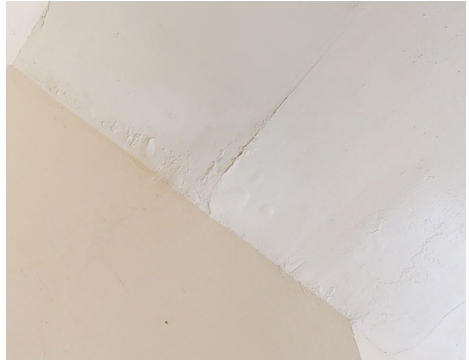
| Reference | Proposal | Significance of affected fabric | Impact | Reasoning and mitigation |
|---|---|---|---|---|
| | | | | <p>Lift lobby rooflight</p> <p>Plasterboard ceiling to lobby and linings to rooflight to be removed.</p> <p>Replacement/retention of existing rooflights to be confirmed.</p> <p>Roof void access hatch to be removed along with plasterboard ceiling linings.</p> <p>Ceiling to stairwell<br/>(above 2<sup>nd</sup> floor landing)</p> <p>Evidence of water ingress from flat roof above. Existing C20 roof coverings &amp; decking to be repaired/replaced. C20 plasterboard linings to be removed and any necessary repairs to timber joists carried out prior to installation of insulation and new linings.</p> |

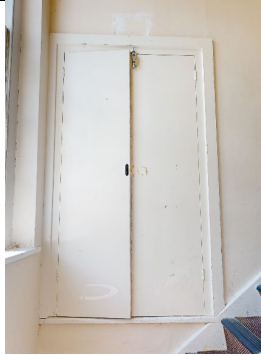
| Reference | Proposal | Significance of affected fabric | Impact | Reasoning and mitigation |
|---|---|---|---|---|
| D-Doors 20D.D4 | Painted flush panel C20 double doors and ironmongery to service cupboard on stair half-landing to be removed. | Neutral<br>C20 alterations | Low<br>Impact | <p>C20 cupboard on stairwell half-landing doors to be removed</p> |

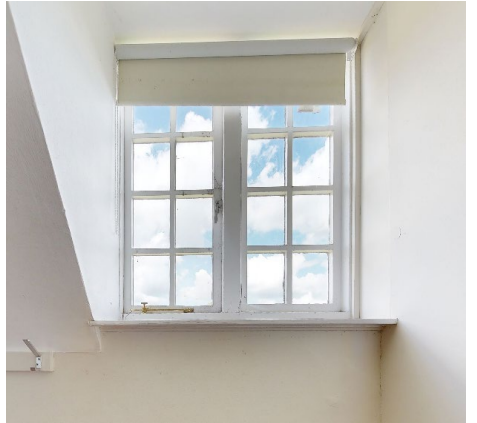
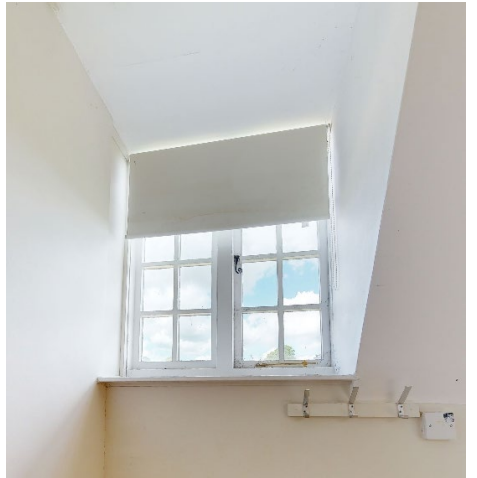
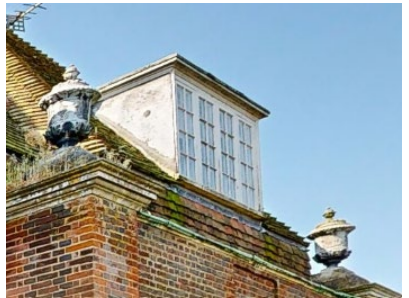
| Reference | Proposal | Significance of affected fabric | Impact | Reasoning and mitigation |
|---|---|---|---|---|
| E-Windows<br>20E.D1 | Removal of C20 timber dormer window | Low C20 alterations | Low Impact<br><br>Benefit & Enhance | <p>Right side of window Room 29a</p> <p>Left side of window Room 29b</p> <p>External view of window W09</p> |

| Reference | Proposal | Significance of affected fabric | Impact | Reasoning and mitigation |
|---|---|---|---|---|
| | | | | <p>Window is to be removed and replaced with a new window with a reduced sill height of the adjacent west side window. The reduced sill level will enhance aspect/views out of the room. Slim-line double glazing will improve the comfort of the internal environment and the viability of the historic building for future use.</p> <p>Refer to note A-Walls 20A.P3</p> |

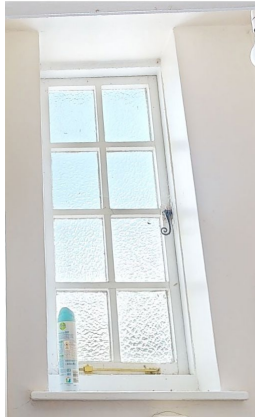
| Reference | Proposal | Significance of affected fabric | Impact | Reasoning and mitigation |
|---|---|---|---|---|
| E-Windows 20E.R1 | Renovation of C20 timber casement and dormer windows<br>W03<br>W01<br>W04 & W14 | Low<br>C20 alterations | Low<br>Impact<br><br>Benefit & Enhance | <p>Window to WC</p> <p>The existing timber multi-pane windows will be repaired/renovated/redecorated and upgraded with slim-line double glazing which improve the comfort of the internal environment and the viability of the historic building for future use. Splice repairs to be carried out where required. Resin for more localised repair. Perished putty replacement. Easing of window as required. Original 'monkey tail' casement latches to be retained for reuse. New ironmongery/locking is to comply with building regulations where required. The repairs will improve the appearance and longevity of the window.</p> |

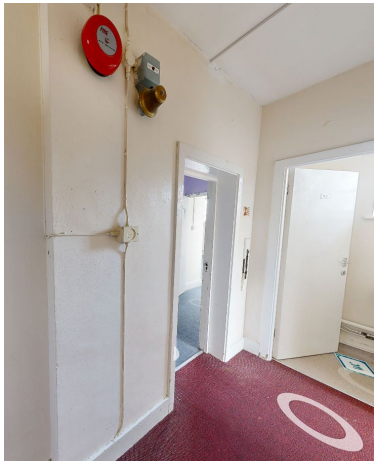
| Reference | Proposal | Significance of affected fabric | Impact | Reasoning and mitigation |
|---|---|---|---|---|
| F-New openings<br>20F. D1 | Form opening in masonry partitions between lift lobby and Room 29b and Room 30A | Low<br>C20 alterations | Low<br>Impact | <p>Remove section of wall to form 2no new door openings</p> <p>Remove masonry partition including north wall of wc</p> |

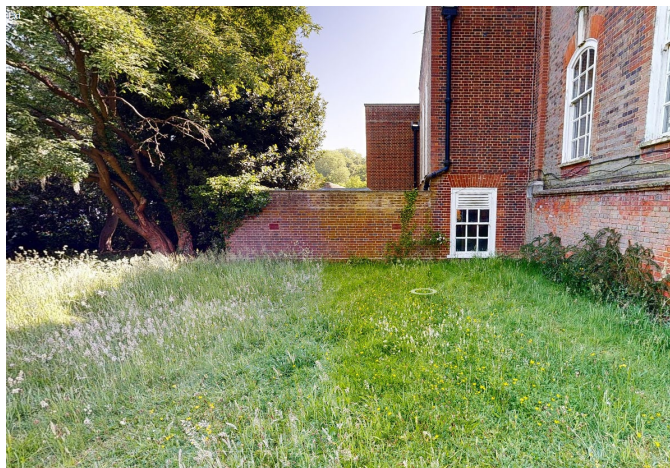
Recent photo of the rear elevation of east block (dated 2023). Recent photo of late C21 single storey toilet block and rear east block (dated 2023).

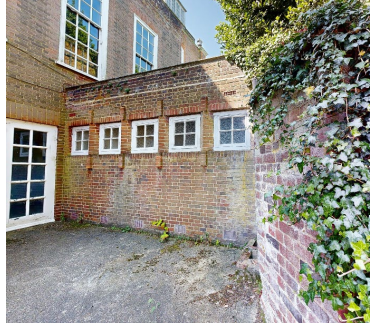
| Reference | Proposal | Significance of affected fabric | Impact | Reasoning and mitigation |
|---|---|---|---|---|
| <u>A-Walls</u><br>21A. D1 | To demolish late C20 toilets block. | Neutral/negative.<br>Late C20 addition by the School. | Positive impact. | <p>The block is an unsympathetic modern single storey flat roofed addition. Its demolition allows the use of the floor space for amenity to the apartment. And it will provide unobstructed views over the large rear garden, from inside the apartment and from the patio/garden. It will reinstate a gap between the rear wall of the house and the rear garden walls.</p> |

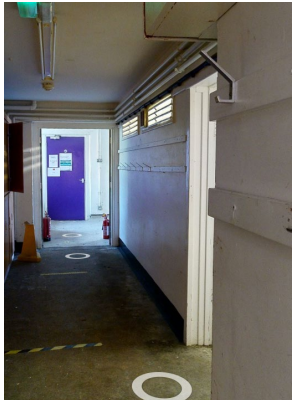
| Reference | Proposal | Significance of affected fabric | Impact | Reasoning and mitigation |
|---|---|---|---|---|
| <u>A-Walls</u><br>21A. D3 | To demolish C20 brickwork walls. | Neutral/negative.<br>Late C20 alteration.<br>This area was an infill of open space adjacent Lutyens' East Wing.<br><br>Low. There are incomplete rooms below the former stair and store of the 1908 plan. The brickwork is fragmentary and mainly at plinth level as these spaces | Neutral impact | |
