## **BS5837:2012 TREE SURVEY AND ARBORICULTURAL IMPACT ASSESSMENT: 1 The Drive, Blackmore End, AL4 8LE**

Our reference: GHA/DS/160282:25

# Arboricultural Impact Assessment

Location: 1 The Drive, Blackmore End, AL4 8LE  
Our reference: GHA/DS/162820:25  
Client: Mr and Mrs Beale  
Dated: 13<sup>th</sup> March 2025  
Prepared by: Glen Harding MICFor, MSc (Forestry), MArborA  
Date of Inspection: 11<sup>th</sup> January 2025

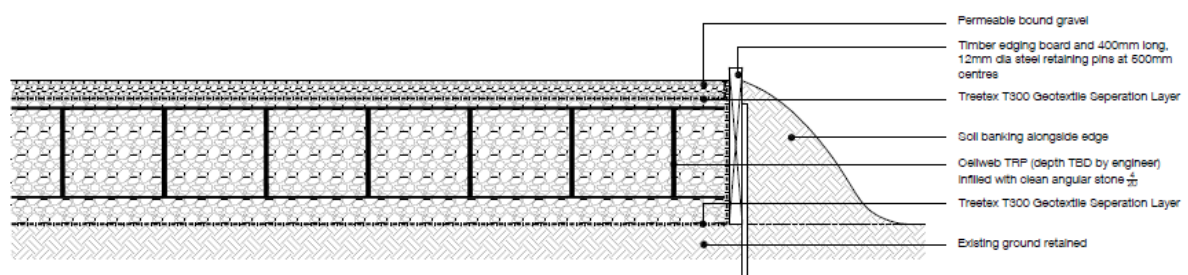
#### **No dig drive makeup**

Below is a diagram detailing the makeup of the new drive and also a typical cross the installation methodology is included below this diagram.

- 6.7 Where sections of the new parking is within the RPA of T7 and T8, a no-dig construction will be necessary, to ensure that all existing ground levels are retained in their current form, as well as ensuring that satisfactory moisture and oxygen can be obtained from the underlying soil by any tree roots in this area. A design for this proposed access route must be drawn up by a structural engineer, in close co-ordination with the retained arboriculturalist. A preliminary method statement has been included at section 8 of this document.

- 6.8 Where sections of the new path are within the RPA of T8, a no-dig construction will be necessary, to ensure that all existing ground levels are retained in their current form, as well as ensuring that satisfactory moisture and oxygen can be obtained from the underlying soil by any tree roots in this area. A design for this proposed access route must be drawn up by a structural engineer, in close co-ordination with the retained arboriculturalist. Porous materials must be used to ensure rainwater can penetrate the soil beneath the new patio.

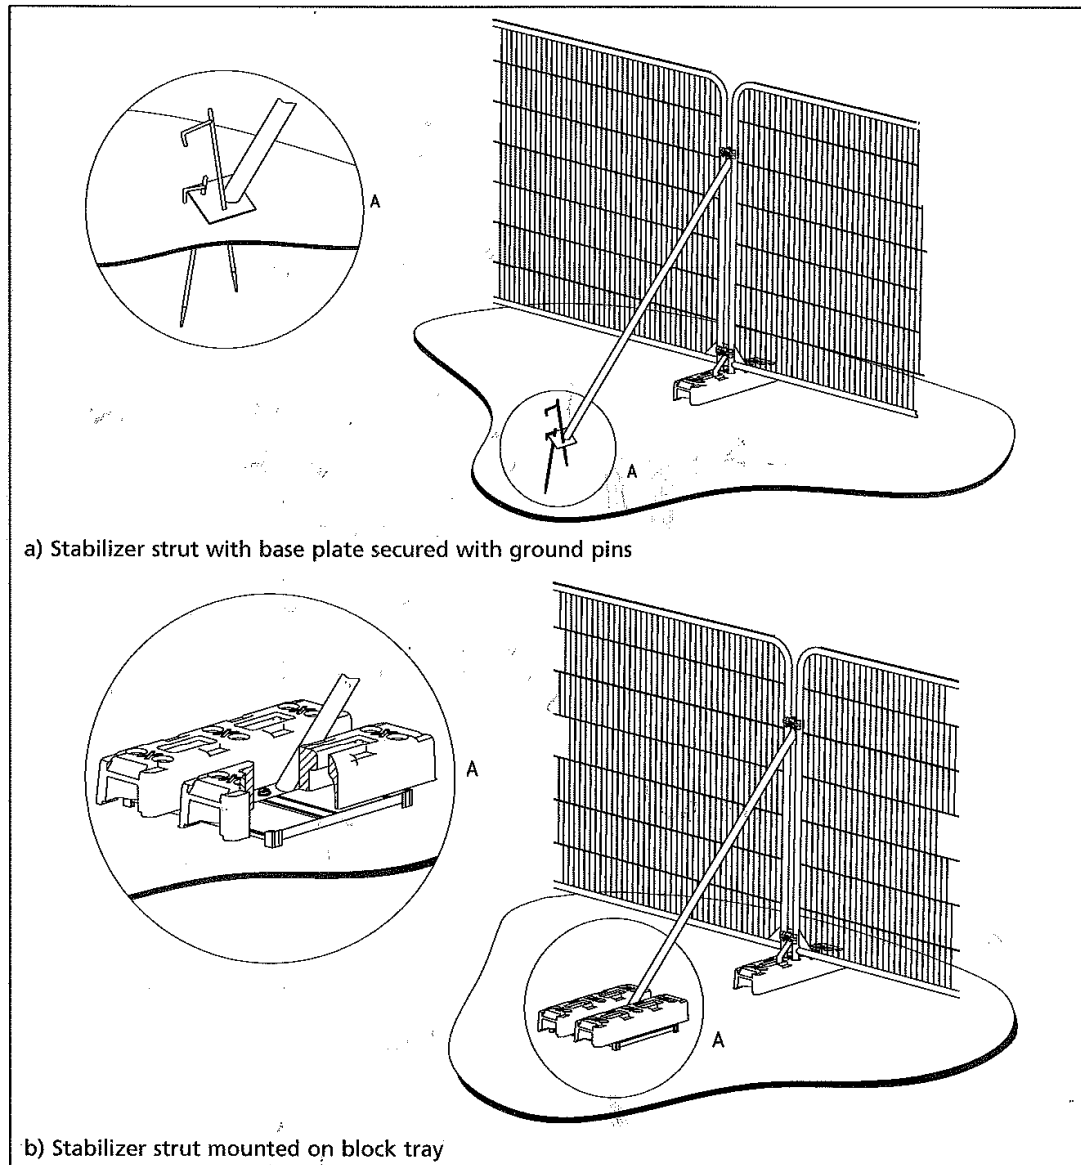
Figure 3 Examples of above-ground stabilizing systems

# **TREE FENCING DETAIL**
