## Ground Floor – Middle Entrance + Stair + Lift – Plan of Significance

**641-KS-06-MB-SH-A-90930 – P01****Temple Dinsley Levels 0 & 1, GA – Middle Entrance – Common Areas – Ground & First Floors**

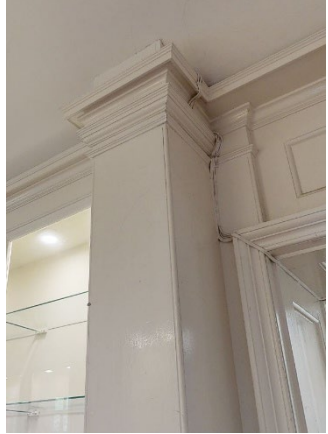
| Reference | Proposal | Significance of affected fabric | Impact | Reasoning and mitigation |
|---|---|---|---|---|
| A-Walls<br>ME-A.P1 | Investigate construction of EC20 timber lined pilasters forming compartment partition to Apartment 10. | High<br>Early EC20 (1909)<br>Lutyens | Low<br>Impact<br><br>Enhance | <p>LHS pilaster below curved ceiling</p> <p>Retain EC20 (1909) Lutyens mouldings at head and remove MC20 mouldings to both sides.<br/>Carefully remove pilaster panel to both sides to determine internal construction and appropriate method of compartmentation. Reinstate panels, sand back oil based paint finish and redecorate with flame retardant breathable paint.</p> <p>The pilasters will be retained in their original state with MC20 additions removed. The proposed infill partition is reversible.</p> |

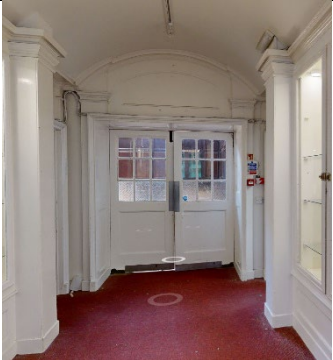
| Reference | Proposal | Significance of affected fabric | Impact | Reasoning and mitigation |
|---|---|---|---|---|
| A-Walls<br>ME-A.P2 | Alterations to previously adjusted door opening. | Moderate – Low<br>MC20 alterations to 1909 Lutyens | Low<br>Impact<br><br>Enhance | |

| Reference | Proposal | Significance of affected fabric | Impact | Reasoning and mitigation |
|---|---|---|---|---|
| | | | | <p>Adjusted doorcase</p> <p>MC20 doors and panelled lining and architrave to be removed. Pilasters to be reformed to the original Lutyens proportions.</p> |

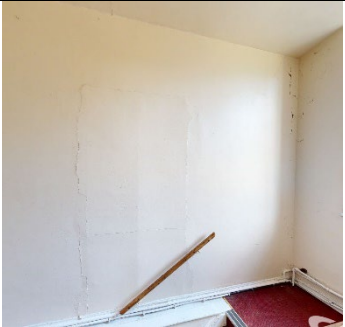
| Reference | Proposal | Significance of affected fabric | Impact | Reasoning and mitigation |
|---|---|---|---|---|
| A-Walls<br>ME-A.P3 | Investigate construction of wall and infilled opening and upgrade as necessary to form compartment wall to Apartment 10. | High-moderate<br>Early C20<br>1909 Lutyens<br><br>Low<br>C20 infill | Low<br>Impact<br><br>Enhance | <p>Wall adjacent to cellar stairs<br/>Wall to be upgraded to comply with building Regulations requirements for fire and sound insulation. The appearance of the wall will be improved.</p> |

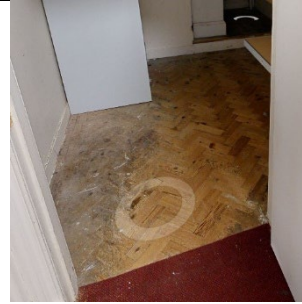
| Reference | Proposal | Significance of affected fabric | Impact | Reasoning and mitigation |
|---|---|---|---|---|
| B-Floors<br>ME-B.P1 | Investigate construction of floor within below stairs cupboard/store. | High-Moderate<br>Early C20<br>1909 Lutyens | Low<br>Impact | <p>Floor in below stairs cupboard</p> <p>Open up oak parquet floor and timber boards at higher level to rear to investigate construction. Carry out repairs as necessary. Insulation strategy to be confirmed. Oak parquet to be repaired and sanded back to a smooth clean surface and flame retardant breathable varnish applied.</p> |

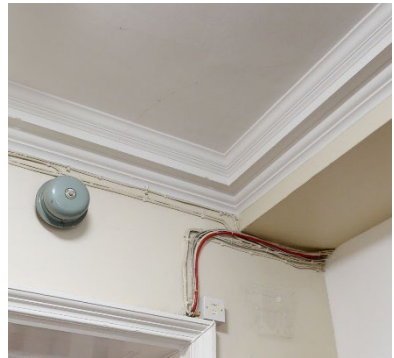
| Reference | Proposal | Significance of affected fabric | Impact | Reasoning and mitigation |
|---|---|---|---|---|
| C-Ceilings<br>ME-C. R1 | Investigate lath and plaster ceilings to all areas of entrance, corridor and below stairs cupboard. | High<br>Early C20<br>1909 Lutyens | Low<br>Impact | <p>Lath and plaster ceiling to be opened up to determine thickness of plaster. If underlining with plasterboard is necessary to achieve Building Regulations requirements for compartmentation, the existing ceiling will be retained. If underlining is not necessary carry out repairs to areas of cracking. Pin back laths and rake out cracks. Repair with lime plaster.</p> <p>Coving to be repaired as necessary and redecorated.</p> <p>Coving to corridor</p> |

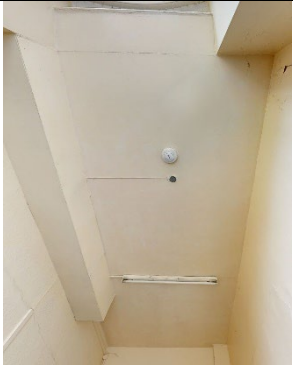
| Reference | Proposal | Significance of affected fabric | Impact | Reasoning and mitigation |
|---|---|---|---|---|
| C-Ceilings<br>ME-C. P1 | Investigate construction of ceiling over cellar stairs. | Neutral<br>Plasterboard ceiling. | Low<br>Impact | <p>Ceiling over cellar stairs</p> <p>Straight crack to ceiling behind window suggests ceiling is plasterboard. Investigate to determine requirement for underlining to comply with Building Regulations compartmentation to 1<sup>st</sup> floor.</p> |

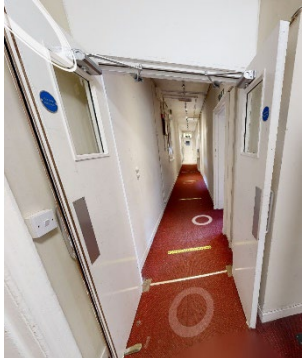
| Reference | Proposal | Significance of affected fabric | Impact | Reasoning and mitigation |
|---|---|---|---|---|
| D-Doors<br>ME-D.D1 | Removal of all C20 fire doors/frames/glazed screens located in entrance area and in corridor and to cellar stair lobby. | Neutral<br>Late C20 alterations | Low<br>Impact | <p>Glazed lobby doors to be removed. Cupboard door to be replaced.</p> <p>Lobby doors to be replaced</p> |

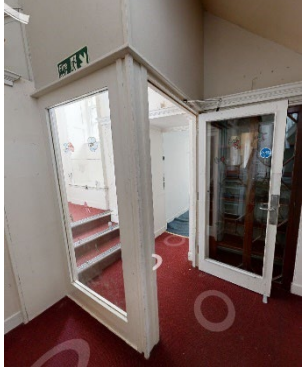
| Reference | Proposal | Significance of affected fabric | Impact | Reasoning and mitigation |
|---|---|---|---|---|
| D-Doors<br>ME-D.D2 | Removal of C20 fire doors/frames/glazed screens located off landings from 1 <sup>st</sup> to 2 <sup>nd</sup> floor. | Neutral<br>Late C20 alterations | Low<br>Impact | <p>1<sup>st</sup> floor landing lobby<br/>Remove doors and partitions above and make good to below stair linings.</p> |

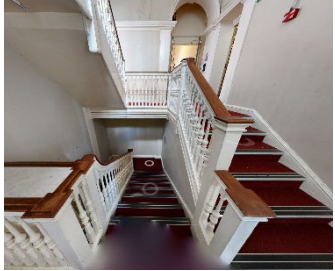
| Reference | Proposal | Significance of affected fabric | Impact | Reasoning and mitigation |
|---|---|---|---|---|
| H-Stairs<br>ME-H.P3 | Repairs and renovation to stair flights from 1 <sup>st</sup> to 2 <sup>nd</sup> floor including balustrade and handrails | High-Low<br>EC20 (1909)<br>Lutyens<br><br>Stair from 1 <sup>st</sup> floor landing to 2 <sup>nd</sup> floor is MC20 replica | Low Impact | <p>View of Middle Entrance stair from 1<sup>st</sup> floor landing</p> |
